## Calendar Year 2014 Report to the Rio Grande Compact Commission

U. S. Department of the Interior  
Bureau of Reclamation  
Albuquerque Area Office  
Albuquerque, New Mexico

March 2015

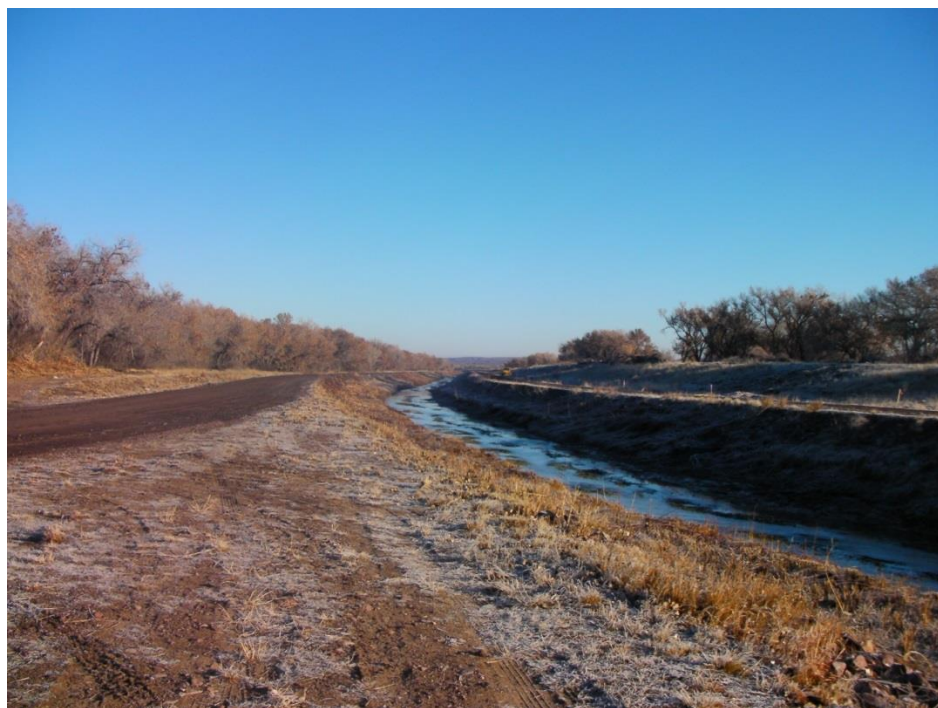
Figure 5: LFCC mowed areas at Otero Bridge (Jan 2015)

- **Low Flow Conveyance Channel (LFCC) Vegetation Removal:** The purpose of the work on the LFCC is to improve wasteway flow conveyance and water salvage capabilities, improve maintenance access, and reduce potential safety risks to the general public and maintenance crews. Maintenance consisted of removing large vegetation and normal mowing operations. Figure 5 depicts a typical section of LFCC moving and/or vegetation removal. The main section of focus was in between Escondida Park and Brown Arroyo. This work was done by the Socorro Field Division and was in preparation for the USACE levee project in that area.

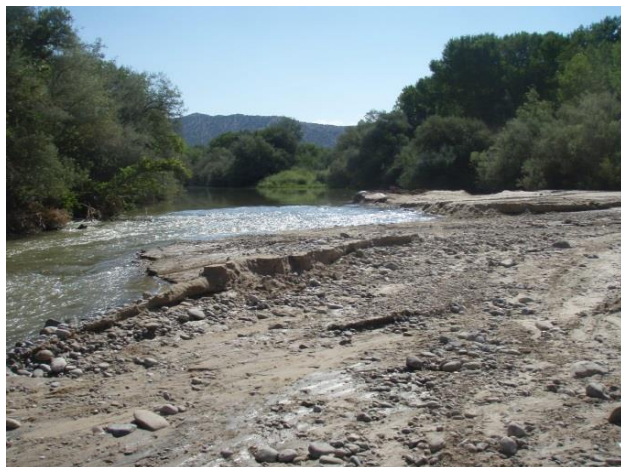
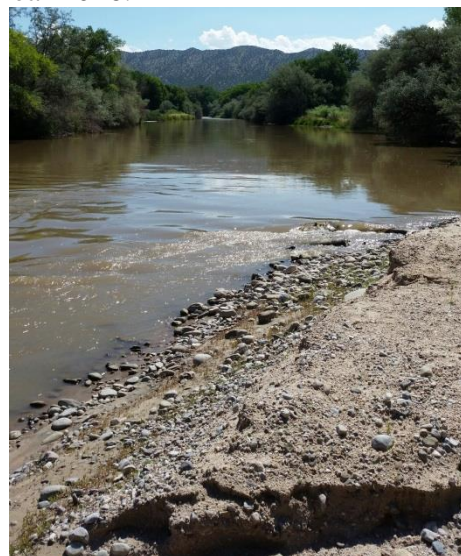
Figure 6: Looking upstream at the Rio Grande River and Truchas Arroyo Confluence (Sept 2013 & July 2014, respectively, Benoit)

The flood event also caused the breach of a non-Reclamation arroyo berm, and deposited a large amount of sediment in the adjacent agricultural orchard, south of the Truchas Arroyo. The flood flows traveled through the orchard and breached the southern La Rinconada Dike approximately 800 feet downstream. The dike did not fail on the river side, the portion meant to withstand high flows, but instead was breached by arroyo flows on the land side.

A Reclamation crew has monitored the site and collected elevation data in January and July, 2014. Surveys have shown the reduction of the sediment deposit. Figure 6 shows the difference in the original sediment deposit (left) and the remaining amount (right) after the river has mobilized the sediment for just under a year. The river has moved much of the small material leaving the larger material to armor the bed. Reclamation began removal of the sediment deposit in January 2015. The breach in the La Rinconada Dike will not be fixed during the time of the sediment deposit removal due to new trees being planted in the orchard. The new trees do not allow space for Reclamation construction equipment. Reclamation will pursue a small contract with a private contractor to repair the dike in Fiscal Year 2016.

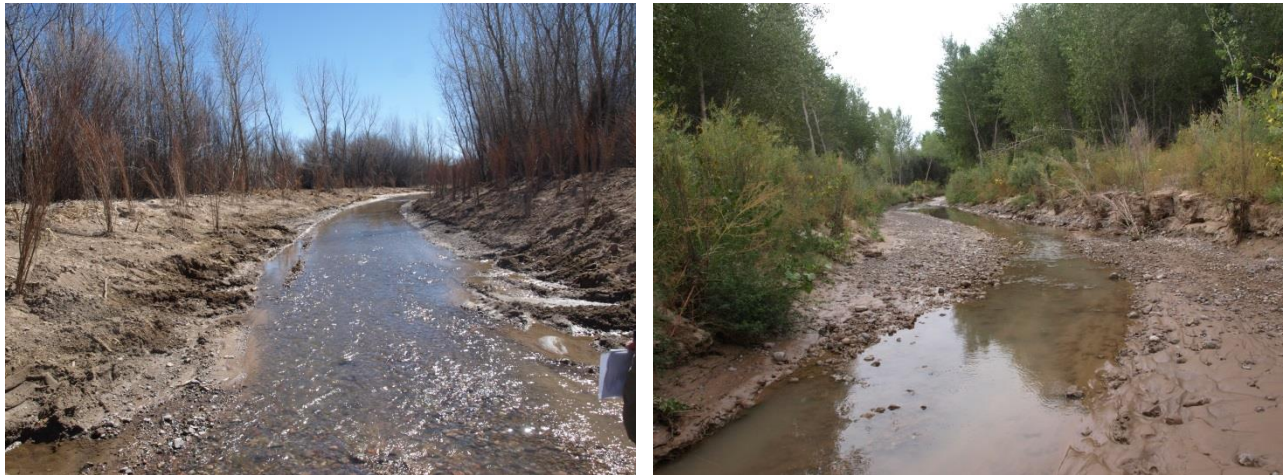
Figure 7: Floodplain side channel at San Ildefonso Priority Site, 0 and 6 months after construction (March 2014 and September 2014, respectively, AuBuchon)

This priority site is located at RM 259. In spring 2007, a river maintenance project was constructed by Reclamation's Socorro Field Division to provide protection for the San Ildefonso fishing pond. During the spring runoff of 2009, the channel eroded through a line of dense vegetation planted as part of the project. This erosion resulted in the loss of up to 75 feet of bankline upstream of the previous project area. This bank erosion exposed and threatened to flank three of the buried rock vanes. Reclamation worked with the Pueblo de San Ildefonso to construct a temporary solution prior to the 2010 spring runoff. The project consisted of a buried trench riprap revetment and a riprap windrow. This 2010 temporary protection work allowed for the development and permitting of a longer term solution. The longer term solution was divided into two phases. The first phase involved construction of seven bendway weirs; the second phase involves installing a floodplain side channel on the west side to complement bendway weir

work from the first phase. The first phase was completed in March 2013 with vegetation being planted on the created floodplain terrace in January 2014. The second phase was constructed from January 2014 to March 2014. This site has undergone natural adjustments (bed lowering and widening) since the project completion, as can be seen in the time sequence of pictures in figure 7.

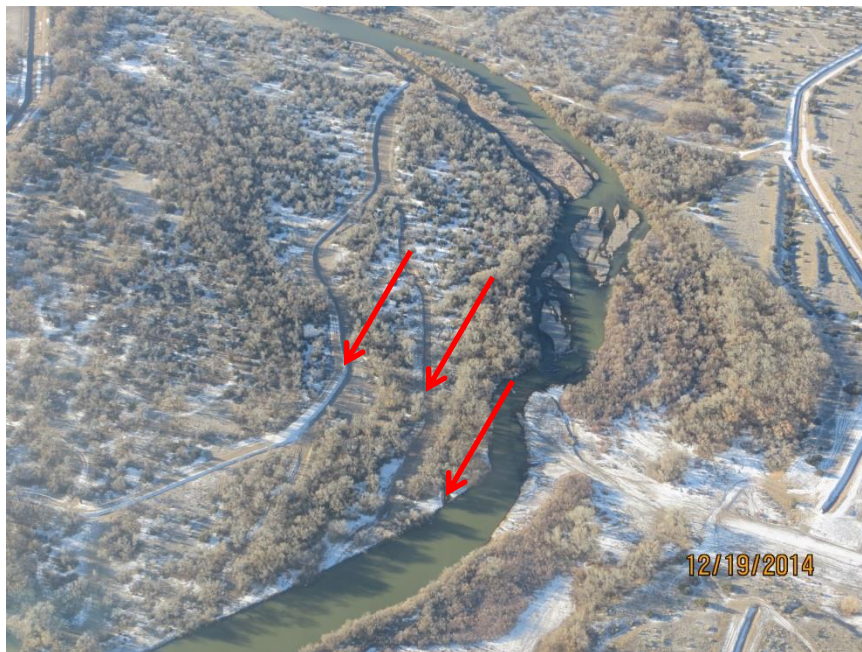
Figure 8: Three Side Channels (Dec 2014)

The second phase is augmentation of natural flow paths to take advantage of overbanking on the existing eastern terrace, in an effort to develop side channels through the terrace. Three side channels were excavated on the eastern floodplain. The construction of the first side channel closest to the main channel only required lowering of the inlet so that overflowing flows slightly below 3,000 cfs would follow an existing flow path on the eastern terrace. The second side channel has the inlet approximately 0.5 foot higher than that of the first side channel and was anticipated to flow at discharges slightly above 3,000 cfs. The third side channel is the most eastern side channel (figure 8). This side channel has a berm on the east side to provide short term floodplain capacity in advance of the anticipated geomorphic changes that will provide a long term floodplain capacity. The third side channel, with a bottom elevation 0.5 foot higher than the second channel, is anticipated to flow before significant overbanking flows for any of the side channels occur. Besides the three side channels, there is also a redirection berm and ditch. This feature is meant to strategically intercept and redirect overbanking flows from an upstream oxbow area so that it does not affect the unconsolidated spoil levee system. The construction of the flow augmentation work was completed in April 2014 and an as-built survey was performed in May 2014. The design at this project site had a dual purpose of providing adequate channel capacity and creating an opportunity to increase vegetation diversity. Reclamation has been working with the Pueblo de Cochiti on a P.L. 93-638 contract to facilitate planting, monitoring, and maintenance of vegetation on the eastern terrace for at least three years, as well as monitoring geomorphic changes and biological response of the project.

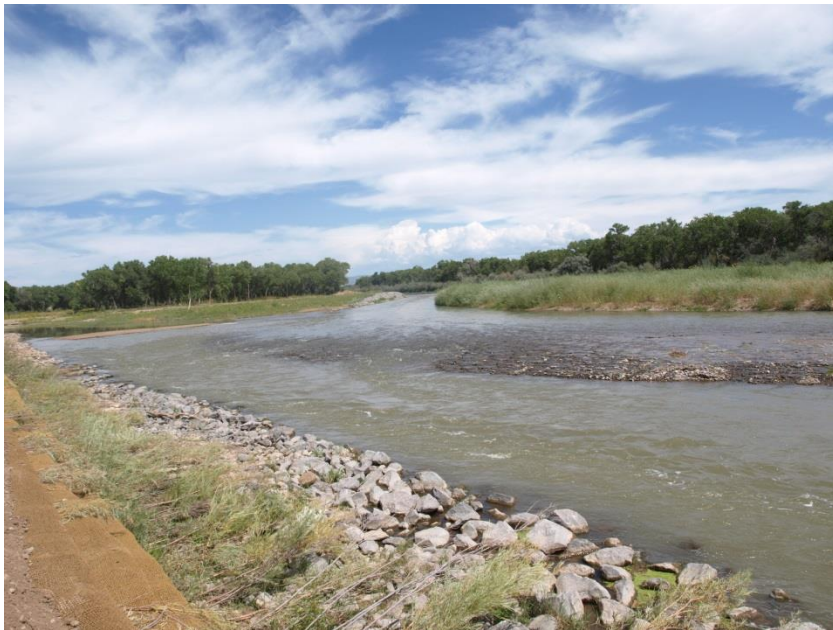
Figure 9: Looking upstream after completion of RM 223.9 Site

The three project sites were divided into two phases, RM 225.1 as Phase 1, and RM 224.6 and RM 223.9 as Phase 2. Detailed designs, construction drawings, a project description, and environmental compliance for RM 225.1 were completed in September 2012. Construction began for this site in October 2012 and was completed in January 2013. The project description for RM 224.6 and RM 223.9 was completed in the spring of 2012 and detailed designs, construction drawings, and environmental compliance were completed in 2013. Construction for RM 224.6 started in October 2013 and was complete in February 2014. Construction for RM 223.9 began in February 2014 and was completed September 2014. The construction work at RM 223.9 realigned the middle channel and altered the main flow path of the river. Figure 9 below shows the realignment of the center channel along with the installed longitudinal stone toe and bioengineered bank.

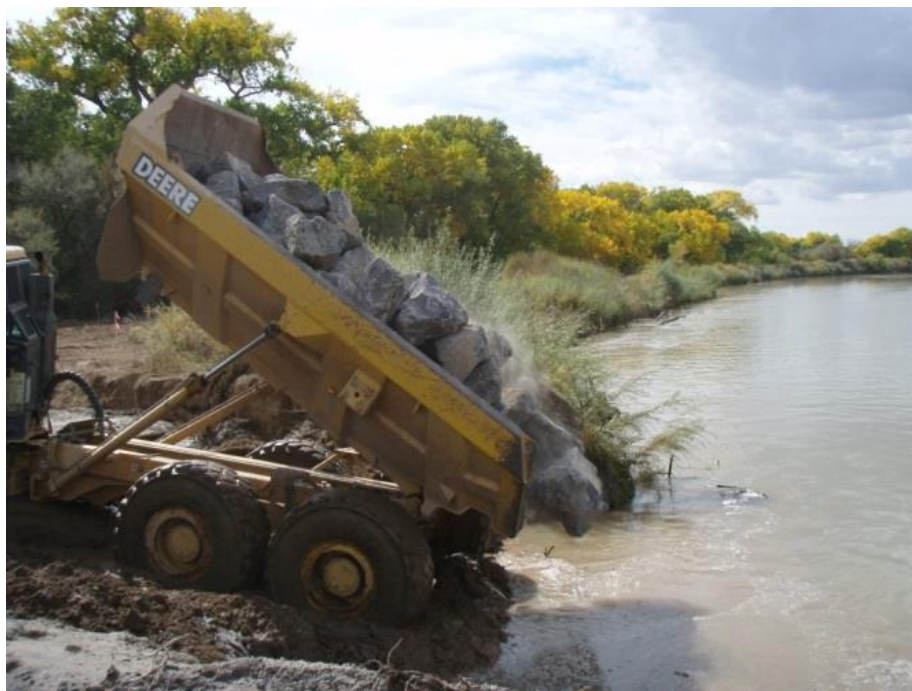
Figure 10: Placement of riprap for bendway weir (October 2014, Bui)

The three sites for the downstream project are on two consecutive meander bends on the Rio Grande between RM 210 and 210.3. In the design process, it was decided that combining the three sites into one comprehensive project would be helpful in evaluating impacts between sites. The selected preferred alternative was a combination of the longitudinal fill stone toe protection (LFSTP) and bendway weir alternatives coupled with the removal and/or destabilization of bars. The construction of the downstream sites started in September 2014. As of January 2015, 13 bendway weirs were constructed along the east bankline (figure 10) and construction of the LFSTP along the west bankline was initiated. Bar removal on the western floodplain is on-going (figure 11). It is expected that construction at this downstream group of sites will continue through most of this year. Coyote willow planting is also planned with certain design features. Planting is expected to occur in the dormant season following completion rock feature construction.

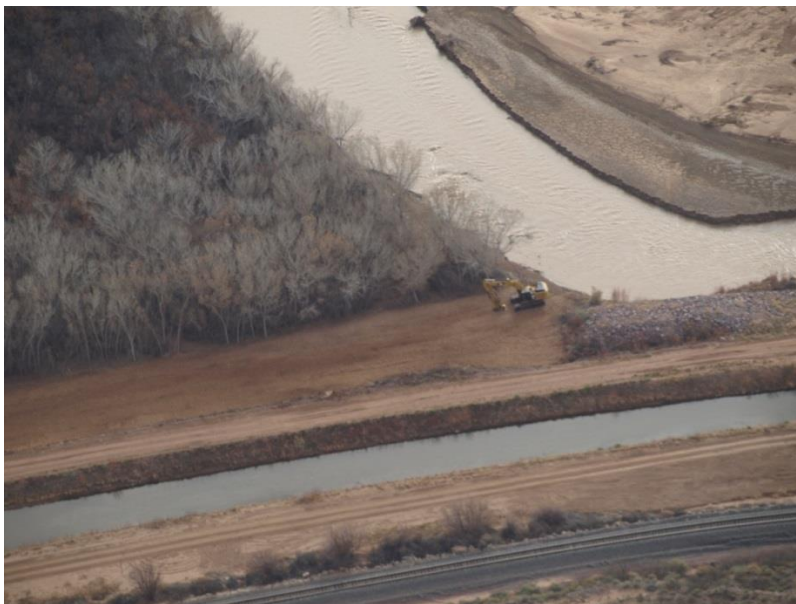
Figure 12: Construction on Phase 3 at the Drain Unit 7 Priority Site (December 2014, AuBuchon)

The Drain Unit 7 River Maintenance Priority Site is located 500 feet upstream of San Acacia Diversion Dam, on the right bankline of the Rio Grande at RM 116.3. The river was actively eroding a spoil levee embankment that protects the Drain Unit 7 Extension irrigation structure. The design at this site involved protection of the Drain Unit 7 Extension spoil levee with riprap along the river side of the eastern spoil levee for a length of approximately 1,030 feet. Construction of the first two phases of this work was completed in 2009 and provided protection for 650 feet of the spoil levee. The final phase 3 work to extend the riprap protection for the remaining 380 feet to achieve the full design length is being done currently and as originally designed is being placed on an as necessary basis (i.e. adaptive maintenance). A site visit in 2013, detected a meander bend that threatened to flank the riprap protection placed in the first two phases. Plans for implementing the third phase were then put into motion. Construction work for the third phase began in December 2014 (figure 12) and is expected to be completed in early 2015. The third phase of work will tie into an existing rock groin field, providing future flanking protection.

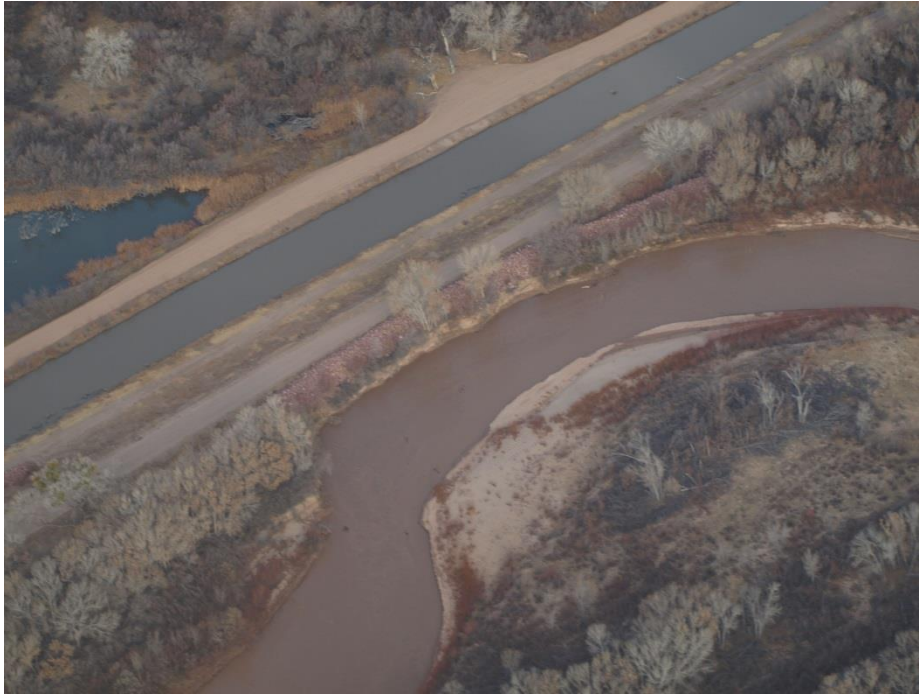
Figure 13: Fort Craig Bend, pump site, and LFCC (December 2014, Aubuchon)

Historically, the Rio Grande has been a wide, braided, and relatively straight river channel. During recent years, the degree of meandering has increased in several areas as a more sinuous planform has developed. This has caused the formation of multiple bends including Fort Craig Bend near RM 64 (figure 13) and the S-curve bend at RM 60. The outside of these bends are near the western edge of the confined floodplain and adjacent to the spoil levee and the LFCC. Continued bank erosion and lateral migration at these locations threatens to breach the spoil levee and cause damage to the LFCC, access road, and Fort Craig pump site. Downstream water delivery and habitat for endangered species are also likely to be negatively impacted by a breach. A multi-disciplinary project team is currently being established to develop and evaluate alternatives to reduce maintenance frequency, increase water salvage, and enhance wildlife habitat. The multi-disciplinary project team decided to combine Fort Craig Bend and RM 60 into one comprehensive project because the two sites are close to each other.

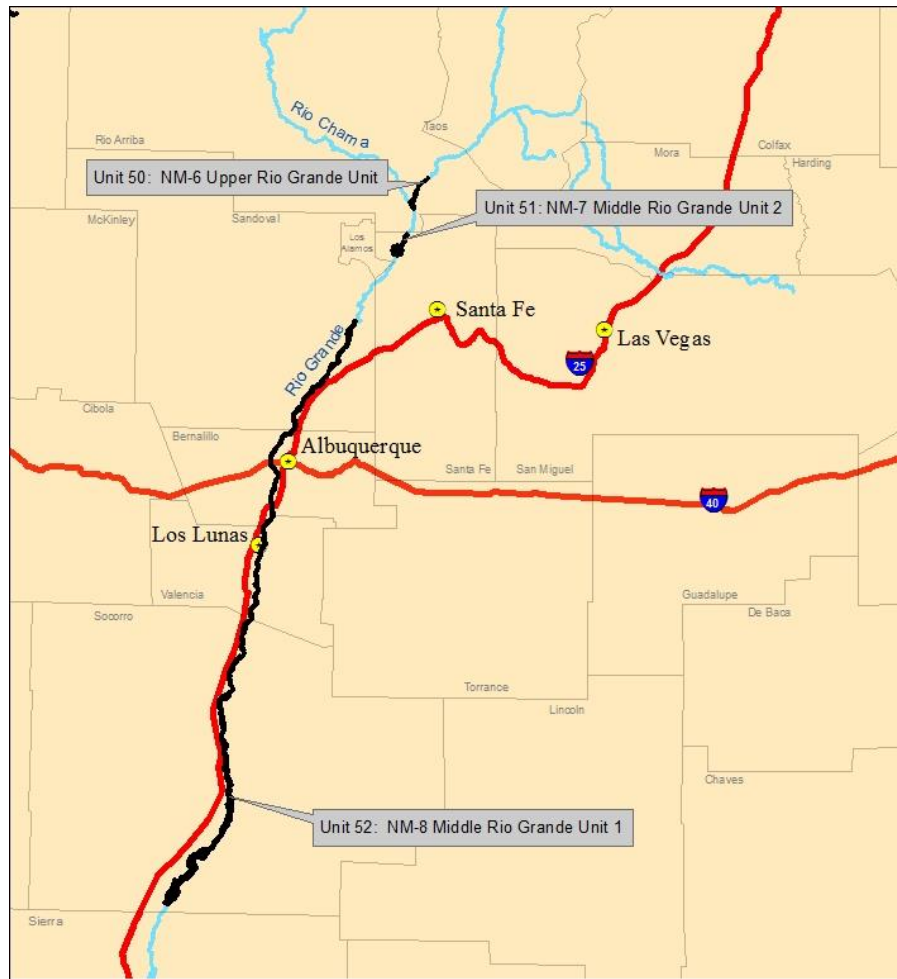
Unit 51: NM-7 Middle Rio Grande 2: This proposed critical habitat is 1,173 acres in extent and is a 6 mile long continuous segment of the Middle Rio Grande starting from the Highway 502 Bridge at the south end of the San Ildefonso Pueblo upstream to a point on the river in Rio Arriba County south of La Mesilla.

Unit 52: NM-8 Middle Rio Grande 1: This proposed critical habitat segment is 61,959 acres in extent and is a continuous 170 long from rivermile 54 at Elephant Butte Reservoir upstream to just below Cochiti Dam. Within this reach is the largest breeding population of western yellow-billed cuckoos north of Mexico.

Figure 15: Proposed critical habitat locations along the Rio Grande in New Mexico
