M/V ALEC OWEN MAITLAND
Coral Reef Restoration Monitoring Report
Monitoring Events 2004-2007
Florida Keys National Marine Sanctuary
Monroe County, Florida

January 2008

J. Harold Hudson
Joe Schittone
Jeff Anderson
Erik C. Franklin
Alice Stratton

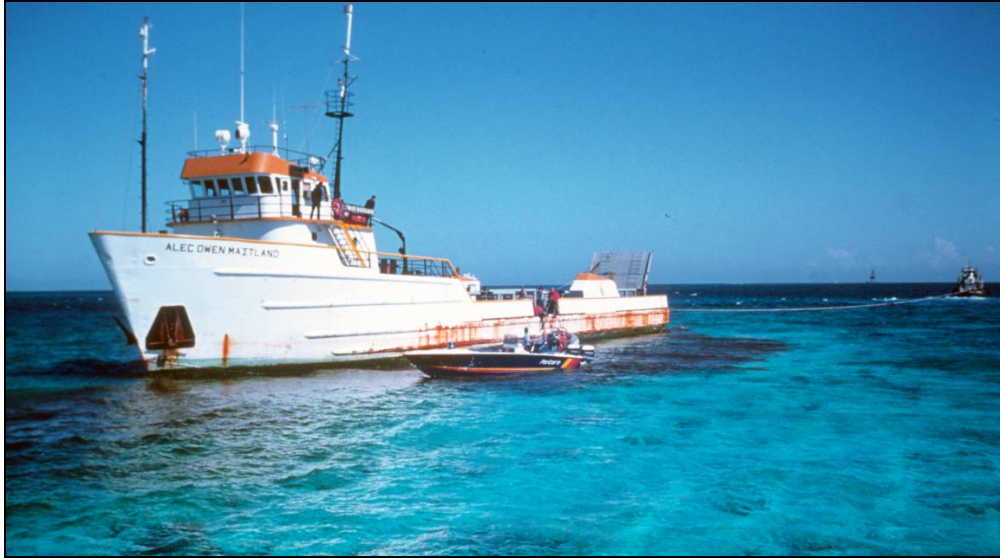
Figure 2. M/V *Alec Owen Maitland* aground south of South Carysfort Reef (photo credit: Paige Gill NMSP/NOAA).

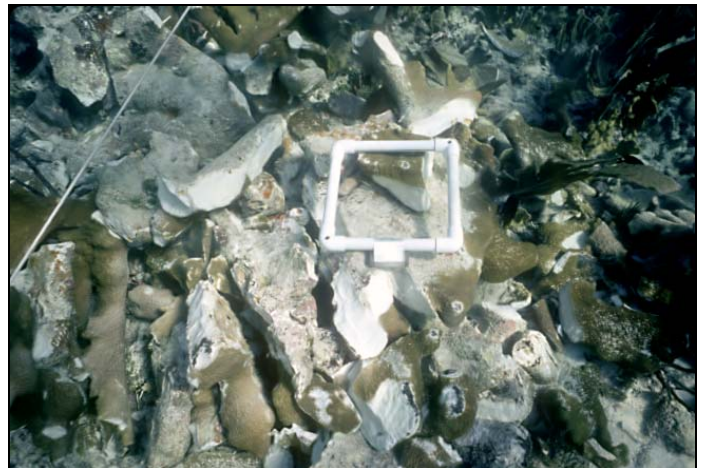
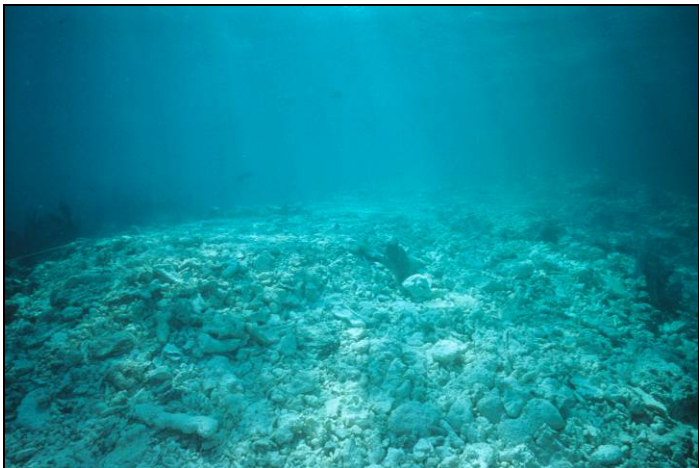
Figure 3. Top row: Fractured *Siderastrea siderea* and *Acropora palmata* colonies. Bottom row: Rubble area and wall of blowhole crater (quadrat is 25 cm × 25 cm) (photo credits: Harold Hudson NMSP/NOAA).

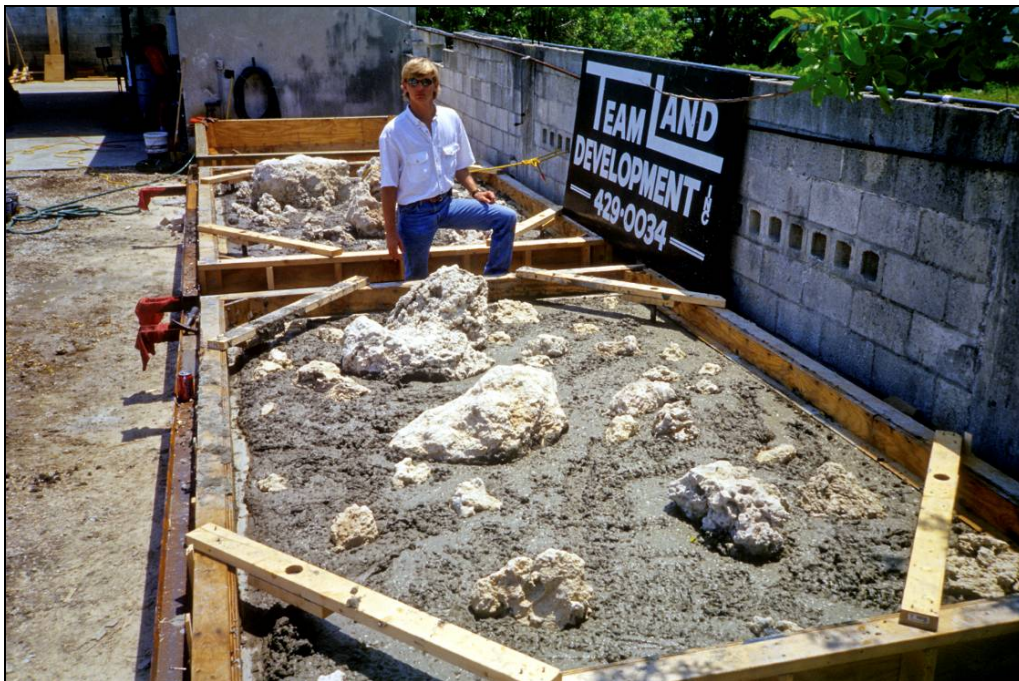
The armor units were designed in six sizes to accommodate the crater’s complex and varying geometry. Each unit weighed approximately 9.5-10 tons above water. The units were designed to withstand wave and current forces anticipated in a once-in-25-year-storm event. The structure has withstood the passage of several close hurricanes (Georges in 1998 and at least seven more recent storms, to be discussed below). Overall, the restoration was intended to “re-create a stable foundation which closely emulates the adjacent natural seabed and which would foster future recruitment of the local biota” (Bodge 1996).

Figure 5. Pre-cast concrete and limestone boulder armor unit used in the *Maitland* restoration (photo credit: Harold Hudson NMSP/NOAA).

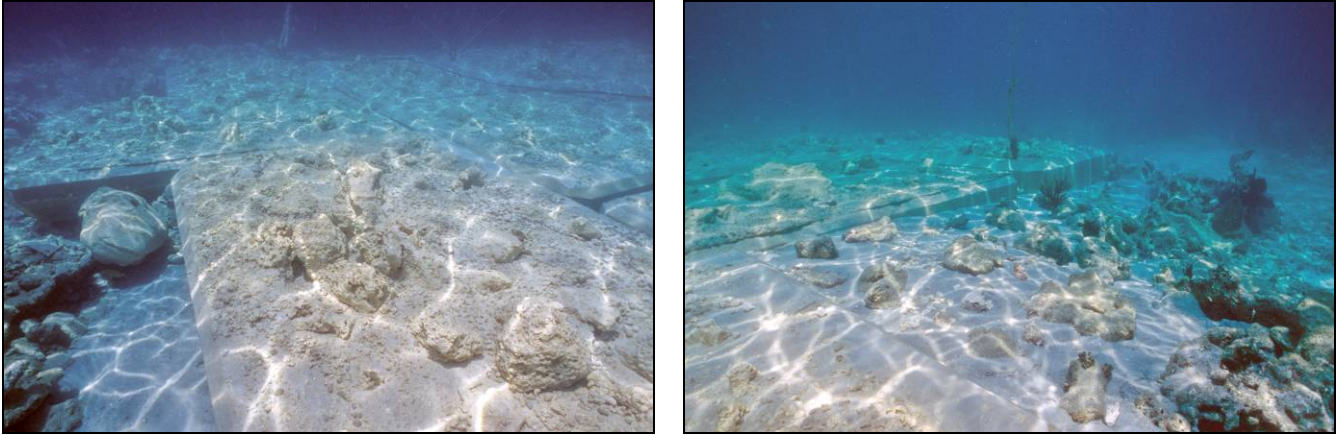
Figure 7. Completed restoration with armor units (left) and “puddle pour” with limestone “dressing” stones (right) (photo credits: Harold Hudson NMSP/NOAA).

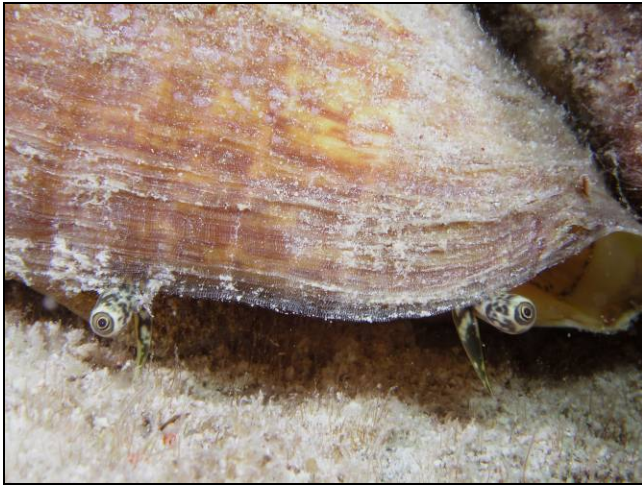
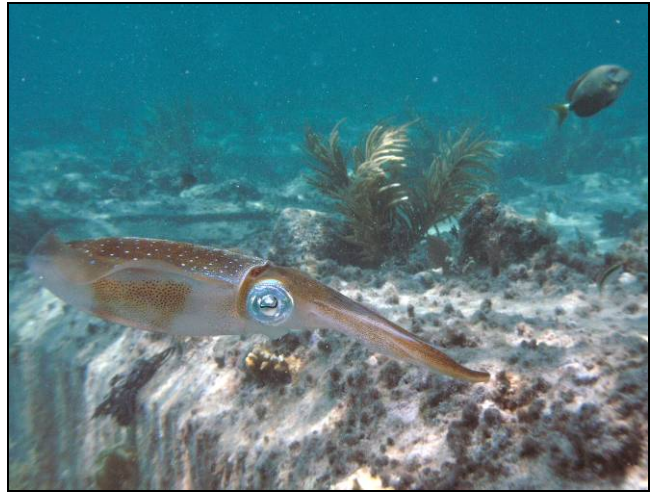
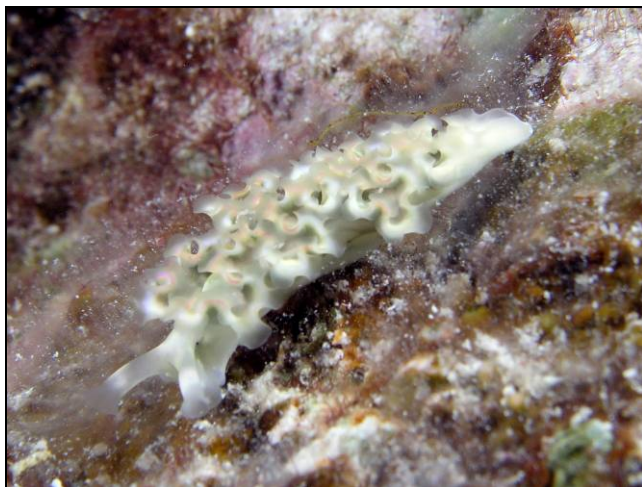
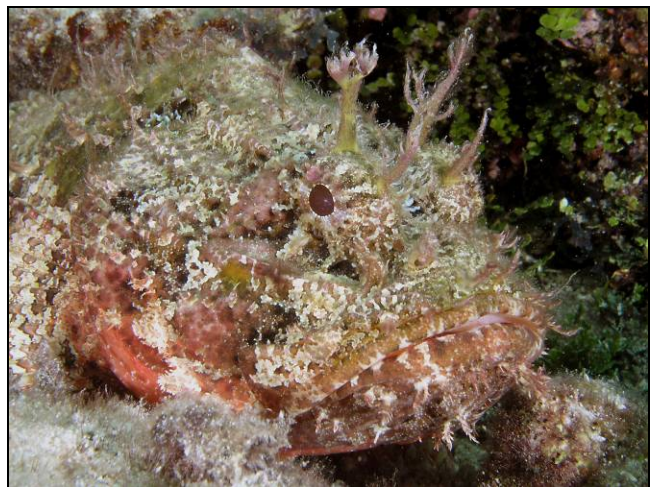
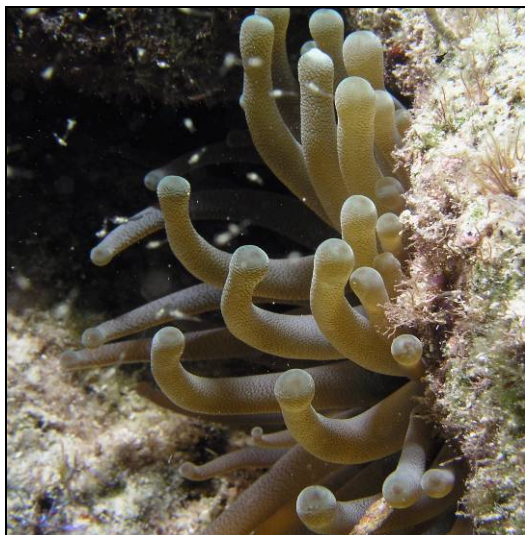
Although not included in this analysis, numerous vagile fauna were observed on the restoration site. The habitat value of the restoration modules was likely enhanced by the colonization of sessile fauna (Figure 9).

Figure 9. Fauna living in and around *Maitland* restoration armor units. Starting from upper left: young queen conch (*Strombus gigas*), Caribbean reef squid (*Sepioteuthis sepioidea*), lettuce sea slug (*Elysia crispata*), spotted scorpionfish (*Scorpaena plumieri*), and giant anemone (*Condylactis gigantea*) (photo credits: Jeff Anderson NMSP/NOAA).

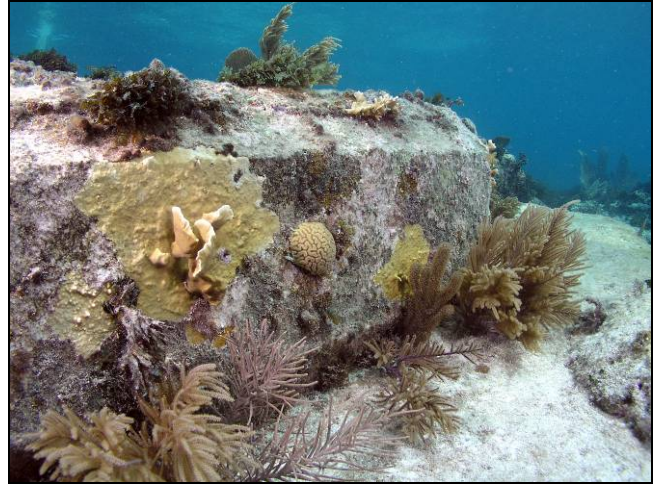
Despite the close passage of three hurricanes between the 2004 and 2005 monitoring events (see METHODOLOGY), the stability and surface of all 40 reef restoration armor units and puddle pour areas were again found to be visually and tactilely sound with no visible cracks in the concrete surface nor undermining of the armor units and surrounding puddle pour areas.

Figure 14. Restoration armor units showing biological condition 10 years after installation (photo credits: Jeff Anderson NMSP/NOAA).
