***M/V WELLWOOD***  
**Coral Reef Restoration Monitoring Report**  
**Monitoring Events 2004-2006**  
**Florida Keys National Marine Sanctuary**  
**Monroe County, Florida**

June 2007

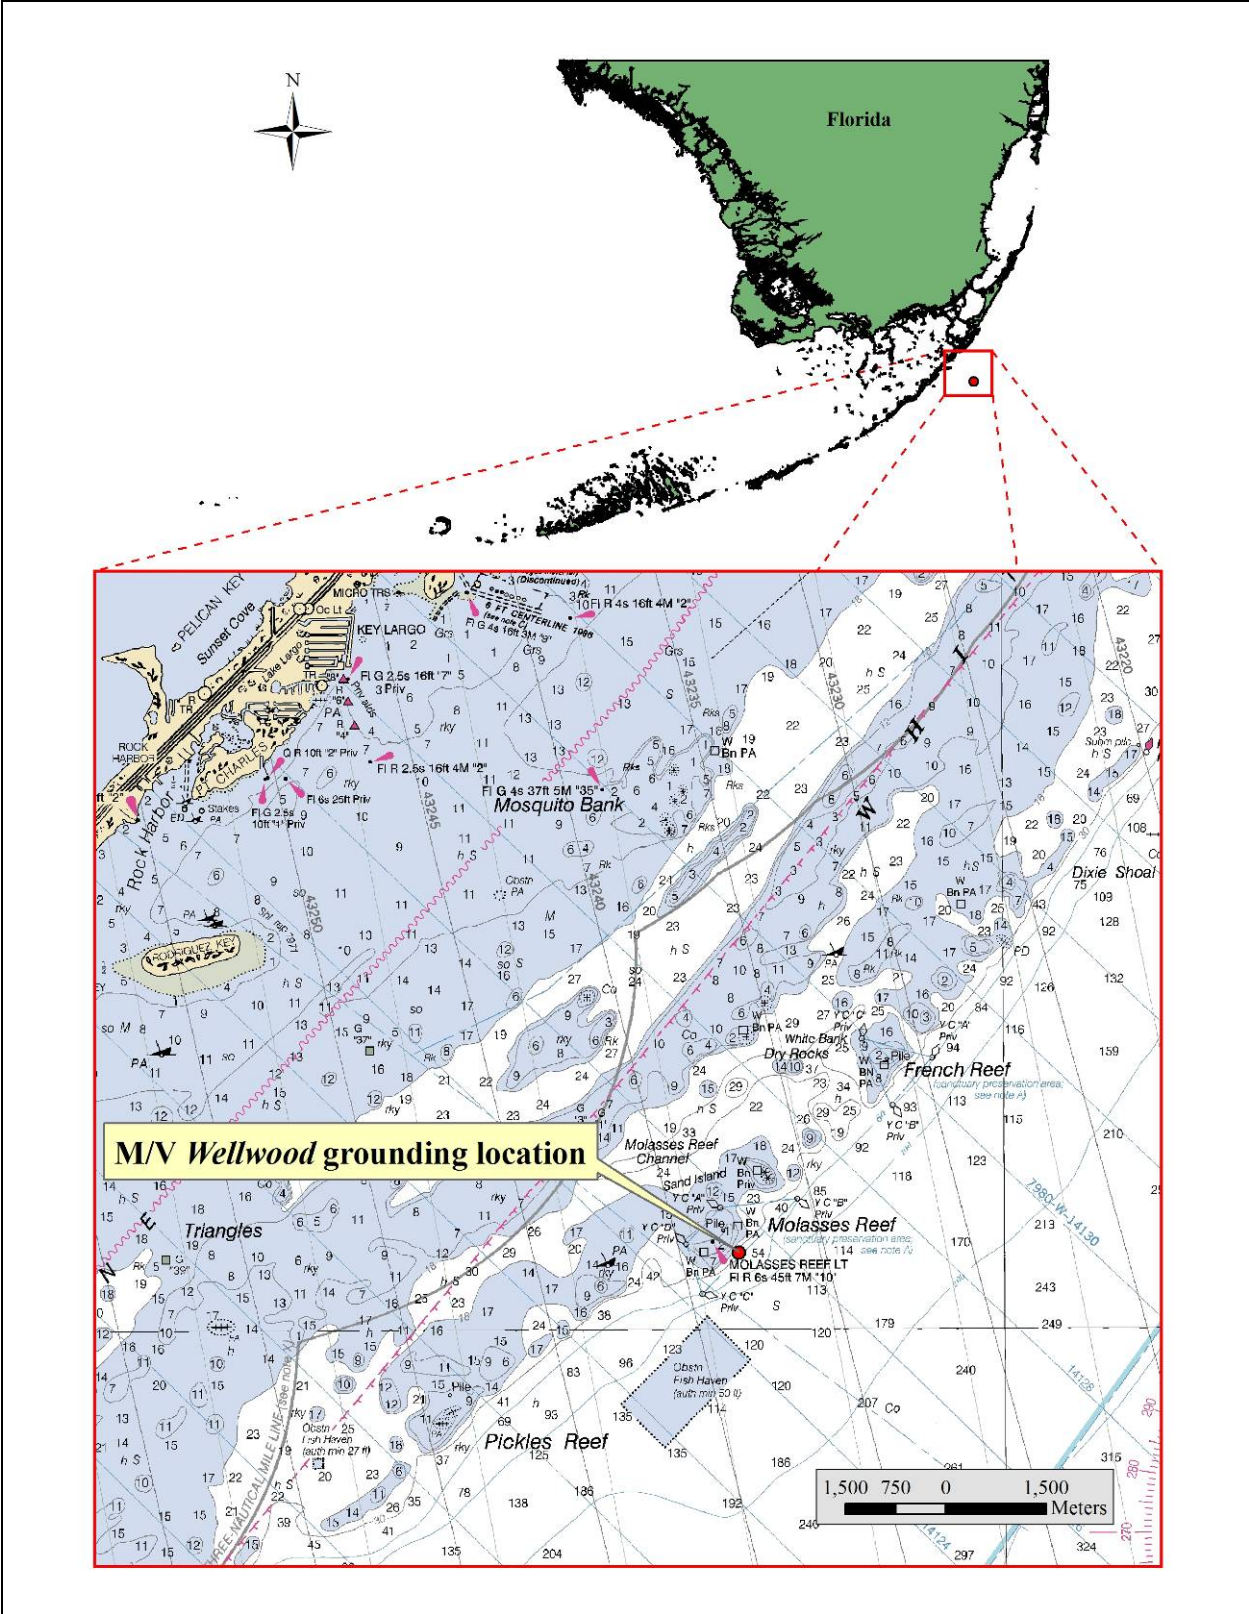
**Figure 1.** Location (shown on NOAA Chart 11462) that the M/V *Wellwood* ran aground at Molasses Reef on August 4, 1984.

On August 4, 1984, the M/V *Wellwood*, a 122-meter Cypriot-registered freighter, ran aground on the upper forereef of Molasses Reef, about 6 nautical miles southeast of Key Largo, in a minimum of 6 meters of water (Figure 1). The *Wellwood* remained aground for 12 days, causing more destruction as time went on. Additional injury occurred as result of initial attempts to power off the reef, from tugboat propeller wash abrasion, from extended periods of shading under the vessel, and from cable abrasion during several failed attempts to remove the vessel from the reef. The grounding destroyed 5,805 m<sup>2</sup> of living corals and injured over 75,000 m<sup>2</sup> of reef habitat, including fracturing of 644 m<sup>2</sup> of coral reef framework (Hudson and Diaz 1988).

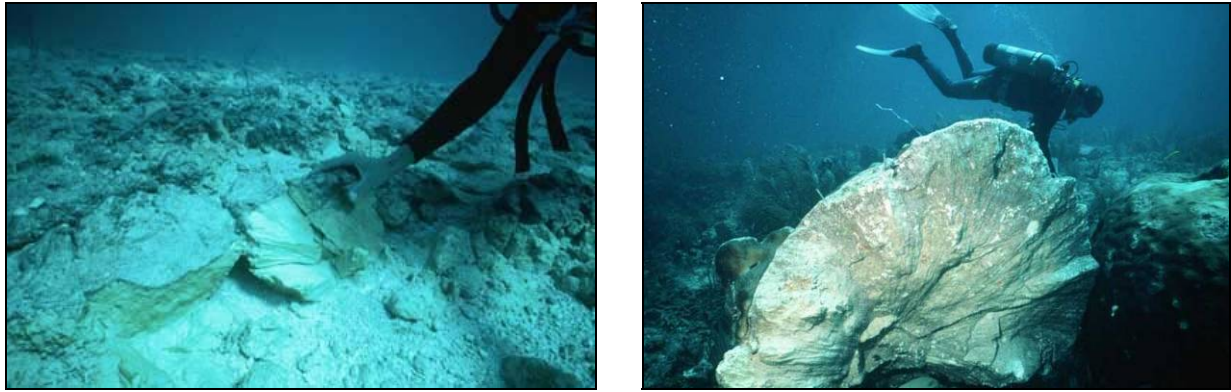
**Figure 2.** Fractured reef substrate exposed by hurricane Kate (Hudson and Diaz 1988) (photo credit: Harold Hudson, left) and split *Montastraea faveolata* colony (photo credit: FKNMS, right) resulting from the M/V *Wellwood* grounding

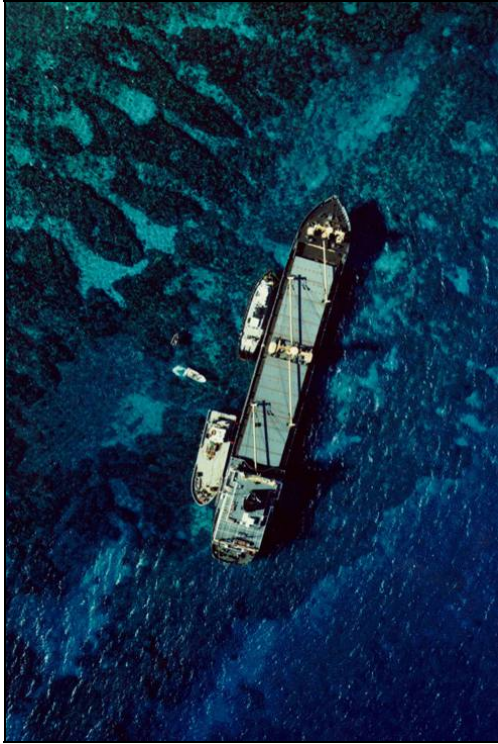
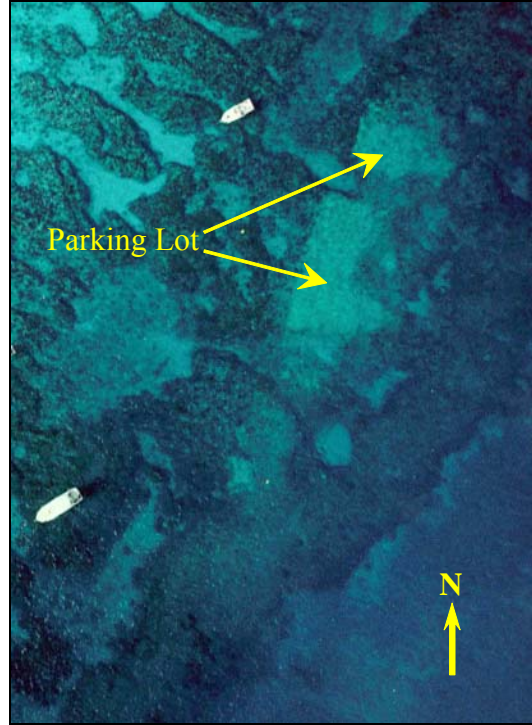
The most prominent feature of the injury site was an area known as the “parking lot” where the hull of the *Wellwood* finally came to rest. This entire area was crushed as a result of hull pounding and experienced severe shading for the 12 days the vessel was aground. The combined effects resulted in near total destruction of the coral cover (Figure 3 and Figure 4).

**Figure 3.** M/V *Wellwood* aground on Molasses Reef (left) and “parking lot” area after removal (right).

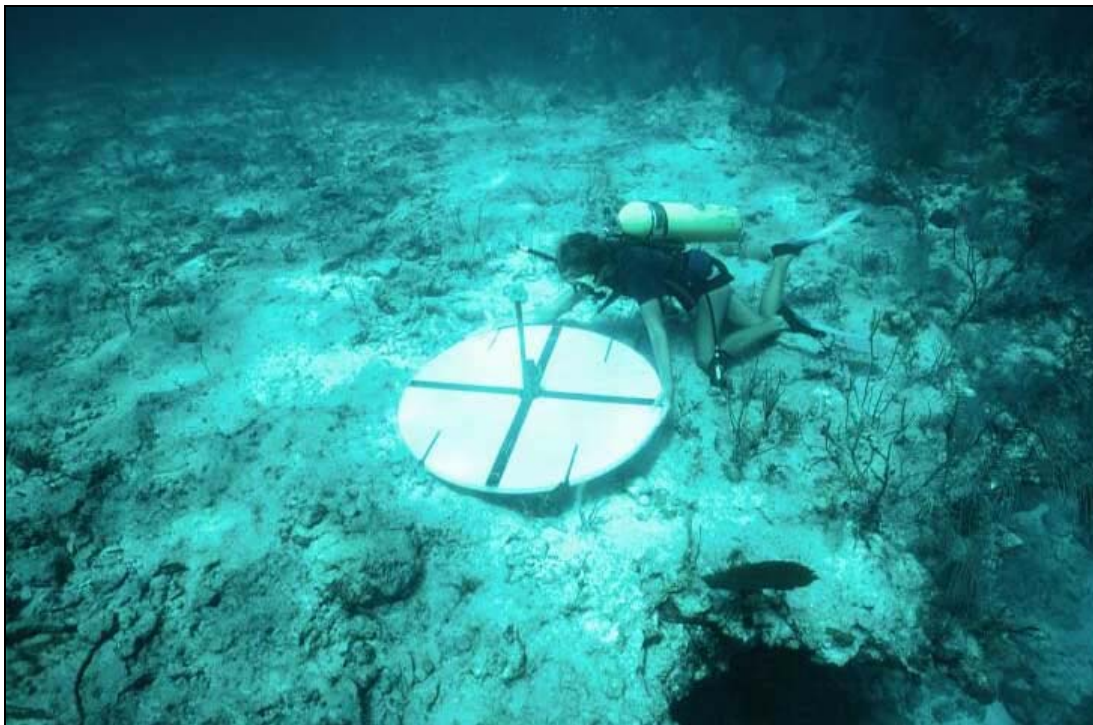
**Figure 4.** Diver installing 1 m diameter reference marker in the “parking lot” for geo-referencing aerial photography (photo credit: Harold Hudson).

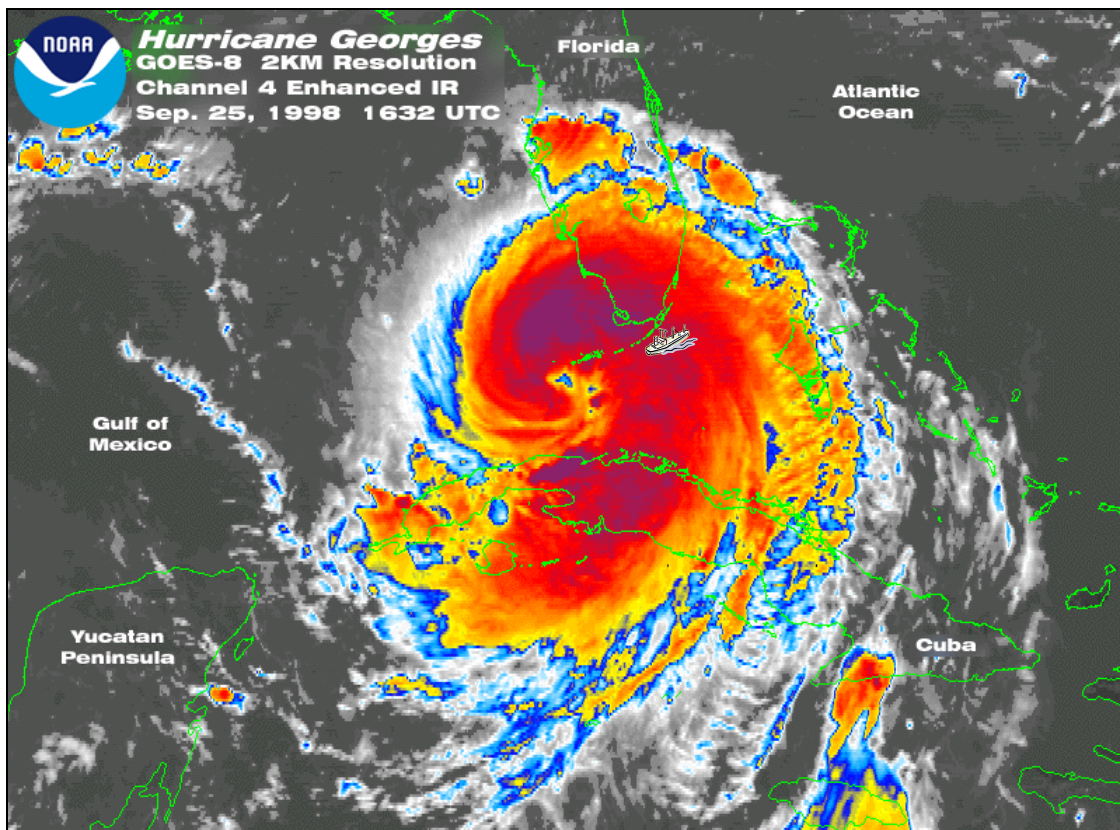
**Figure 5.** Hurricane Georges relative to the M/V *Wellwood* grounding site (ship graphic not to scale).

Meanwhile, in 1998 a significant storm, Hurricane Georges, had severely impacted the *Wellwood* site. The storm passed approximately 80 miles to the southwest of the site, with winds approaching 100 mph (Figure 5). At 1400 UTC (10 a.m. local time) on September 25, 1998, NOAA's National Data Buoy Center's Coastal-Marine Automated Network (C-MAN) recording station on the nearby Molasses Reef Lighthouse recorded sustained 46 kts (53 mph) winds, and a peak gust of 53 kts (61 mph). After the hurricane's passage, it was found that large areas of the site had been scoured out. Once exposed, the underlying unconsolidated rubble and sediment was mobilized during the storm, causing further scour and the formation of large craters at the site. While such scouring is typical of hurricane injury, NOAA believed the grounding injuries exacerbated the hurricane's effects, and that additional injuries would continue absent restoration. Restoration undertaken in 2002 was planned by National Marine Sanctuary Program (NMSP) headquarters and Florida Keys staff, in collaboration with marine engineers from the commercial firm of Coastal Planning and Engineering, Inc. (CP&E).

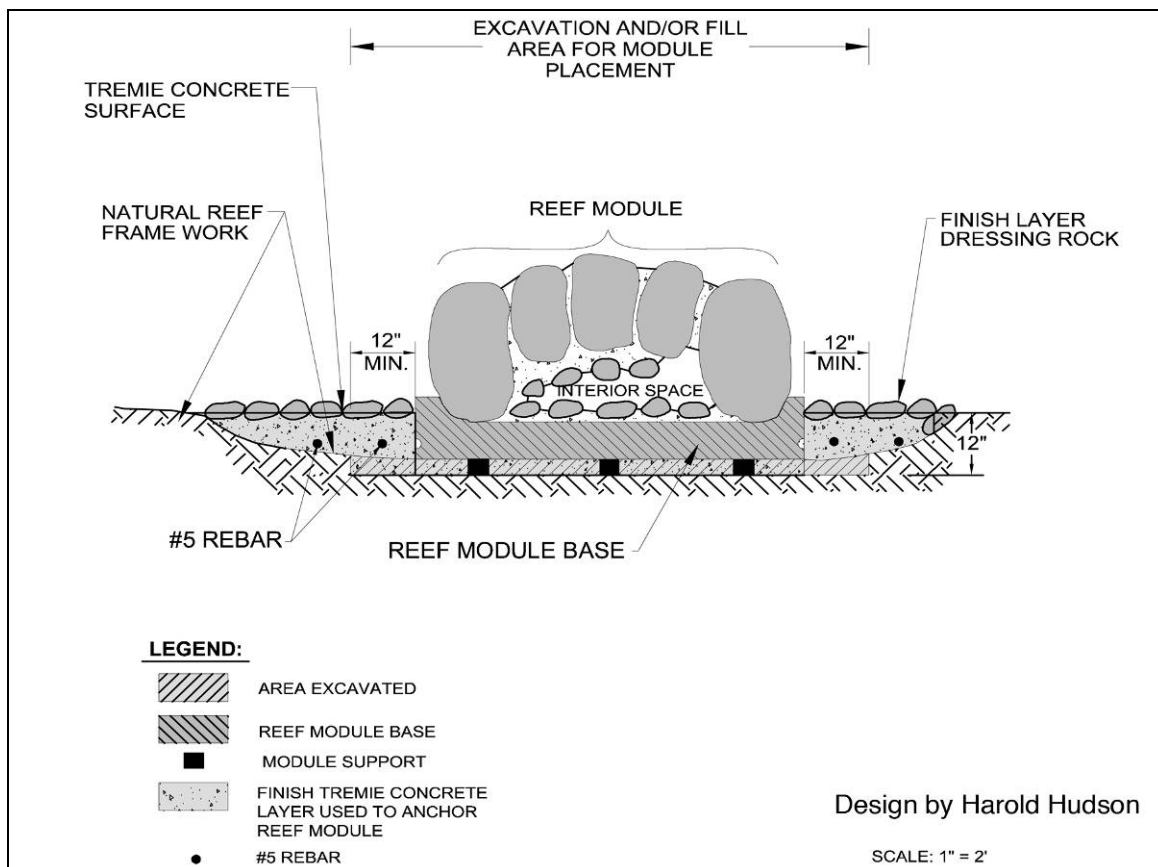
**Figure 6.** Cross section of installed reef restoration module.

The reef restoration design consisted of the placement of 22 reef modules and/or limestone boulders, stabilized with a tremie pour of concrete within the 14 repair sites depicted in Figure 7. An aluminum frame outline of the reef module, which was constructed by NOAA, was used to determine the exact location, orientation and accurate leveling of each reef module prior to placement at the repair site. Reef module placement was contingent upon placement of the modules in natural and/or excavated receiver sites, allowing tremie pour concrete to secure the module to the reef. Excavation of the existing rock substrate was often conducted to provide the appropriate receiver site for module placement. Each module was placed on 5-10 cm supports to allow concrete to flow under the module, in addition to providing a minimum 30 cm wide and deep apron entirely around each module (Figure 8). After the reef module was placed, concrete was tremie poured within the excavated depression, cementing the reef module into the existing reef substrate. A total of 9 repair sites received reef modules.

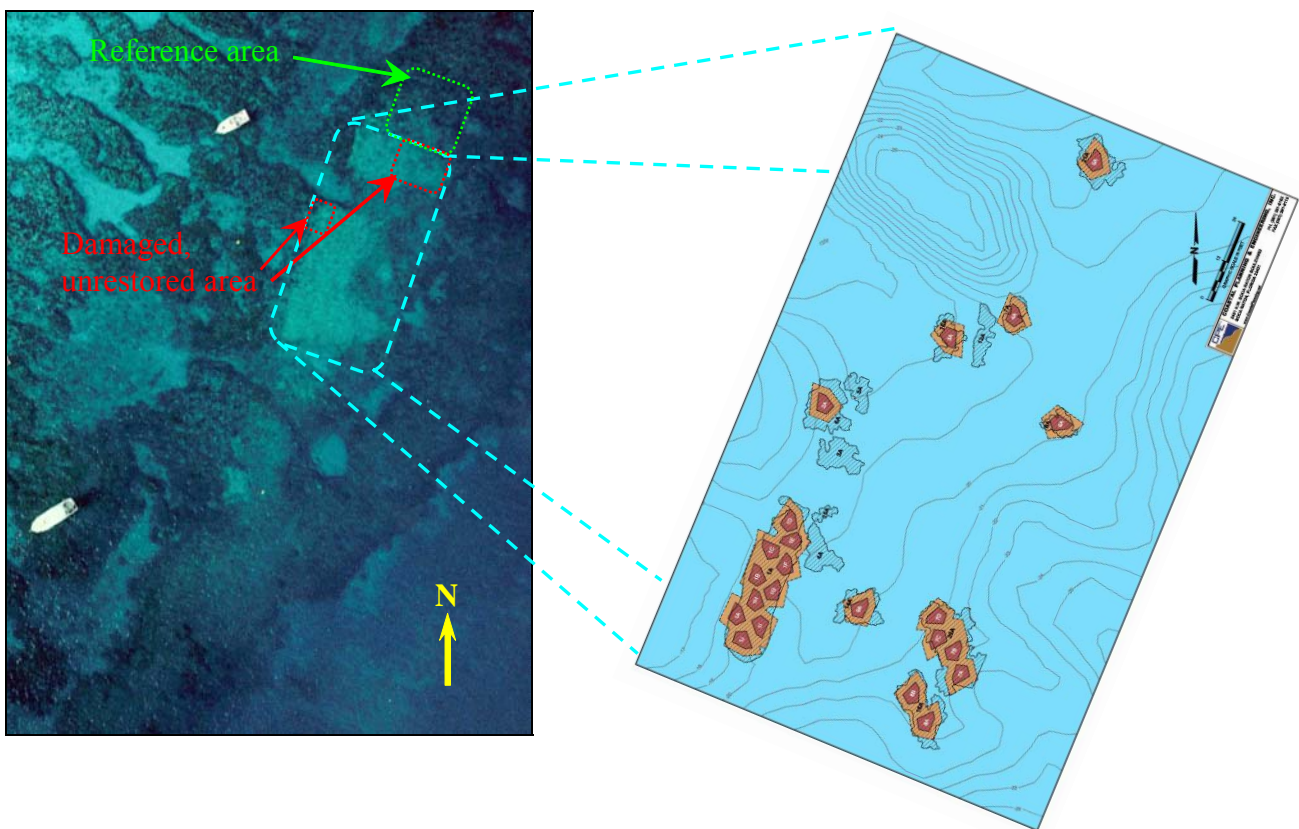
**Figure 7.** Aerial photograph of “parking lot” damage area with Reference and Damaged, unrestored sampling areas (left) and a bathymetric schematic diagram depicting locations of reef restoration modules (shaded in brown) and “puddle pour” restoration areas (striped areas) (right). Please note, area boundaries and reef restoration module locations are not geo-rectified in these images. Bathymetric reef restoration schematic diagram courtesy of Coastal Planning & Engineering, Inc.

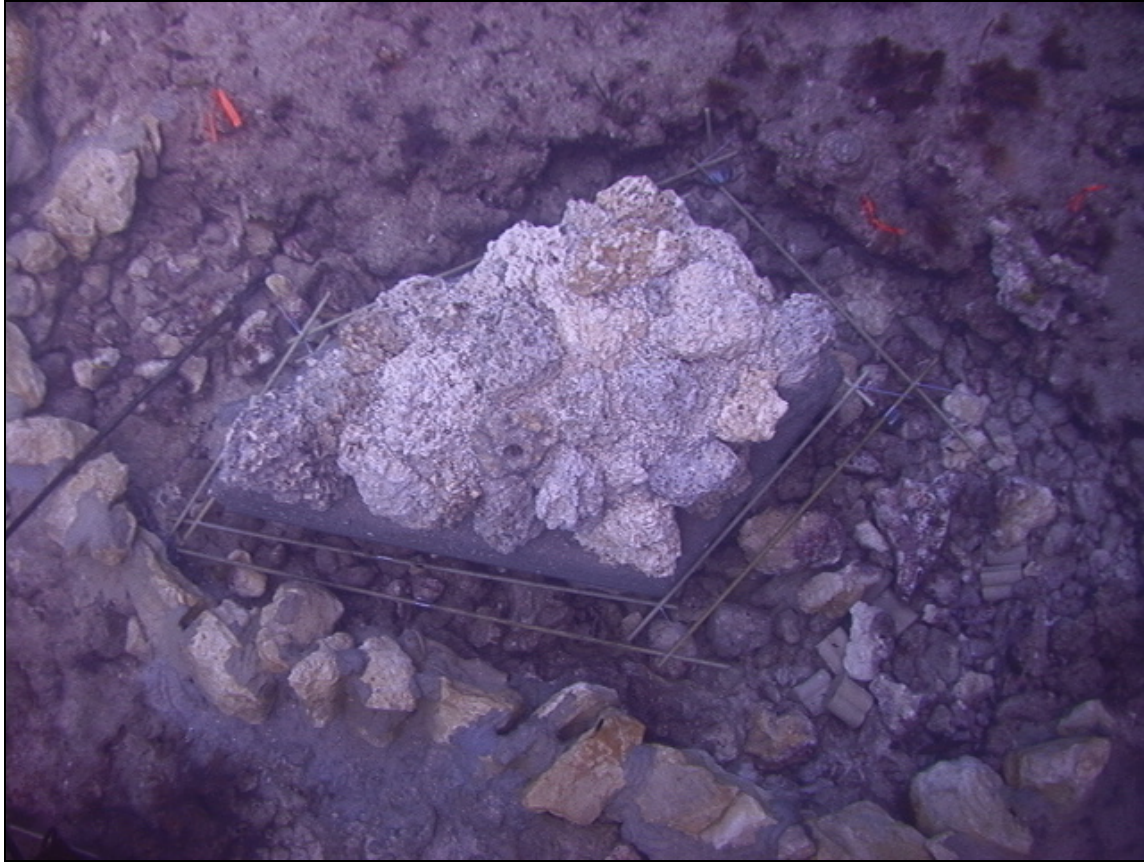
**Figure 8.** Reef restoration module and reinforcing rods in excavation crater ready to accept tremie pour concrete (photo credit: FKNMS).

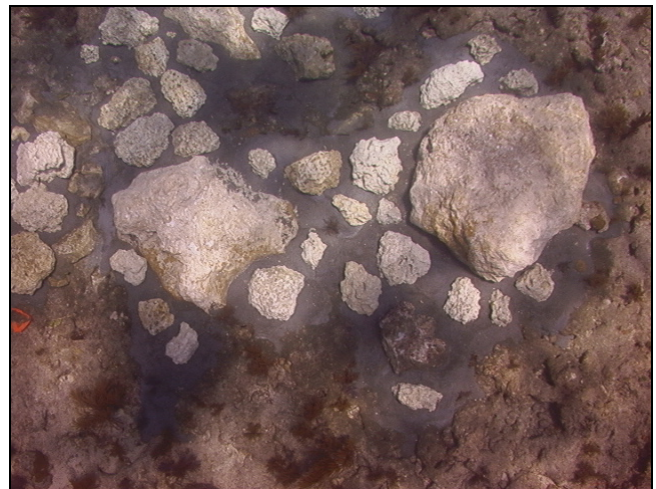
**Figure 9.** Completed restoration with reef restoration modules (left) and "puddle pour" with boulders (right) each surrounded by limestone "dressing" stones (photo credit: Coastal Planning and Engineering, Inc.).

The remaining 5 sites were determined to be too small and/or shallow to accommodate reef restoration modules. At these sites, a combination of 1-2 ton limestone boulders and tremie poured concrete, referred to as a “puddle pour,” were used to fill the excavation. Limestone rock dressing stones, 25-45 cm in diameter were pressed into the fresh concrete at close intervals to increase rugosity and provide a more natural substrate. The concrete embedded boulders projected 50-100 cm above the dressing stones in all “puddle pour” applications (Hudson and Franklin 2005). A total of 185 m<sup>2</sup> of damaged reef substrate was repaired using these two restoration techniques (Figure 9).

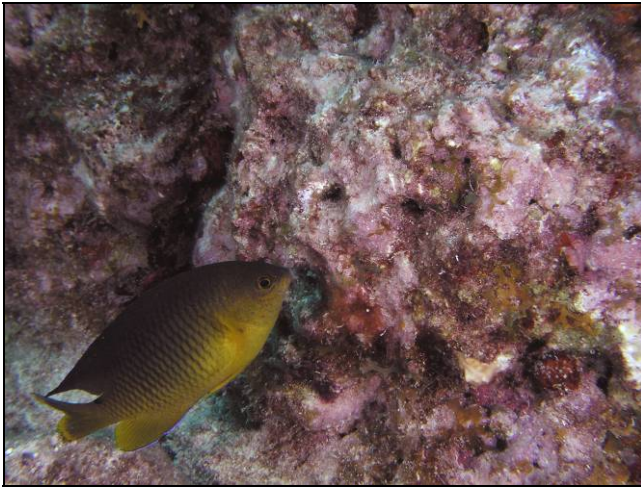
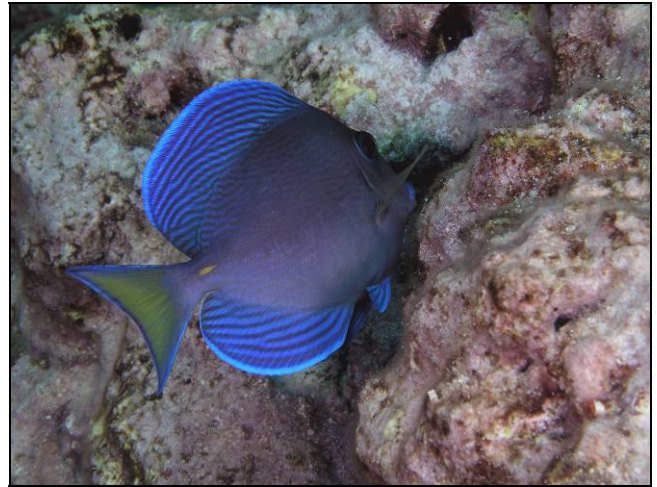
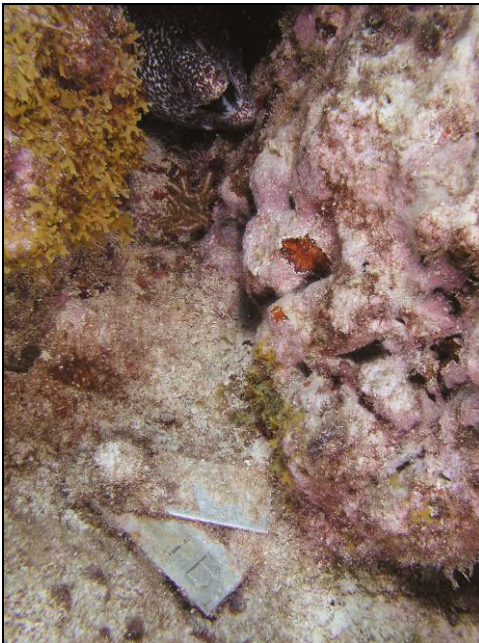
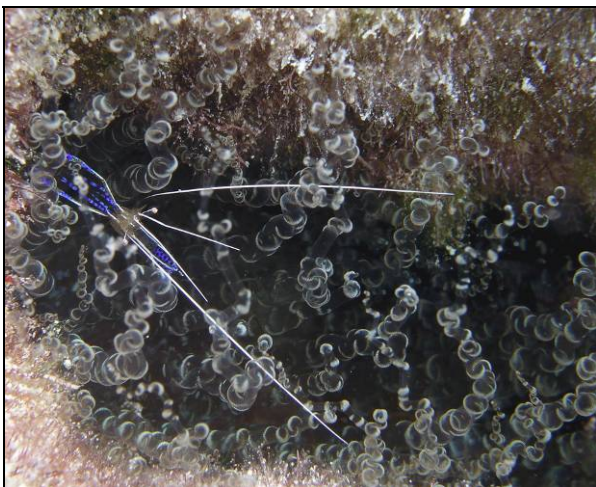
**Figure 11.** Fauna living in and around reef restoration modules. Starting from upper left: cocoa damselfish (*Stegastes variabilis*), blue tang (*Acanthurus coeruleus*), spotted moray eel (*Gymnothorax moringa*), long-spined urchin (*Diadema antillarum*), and Pederson cleaner shrimp (*Periclimenes pedersoni*) in corkscrew anemone (*Bartholomea annulata*) (photo credit: Jeff Anderson).

Although not included in this analysis, numerous vagile fauna were observed using the restoration modules (Figure 11). This was undoubtedly due to both the benthic organisms already colonizing the module structures, as well as the shelter afforded by the cave intentionally designed within the modules (Figure 6). A separate fish monitoring project is described in the DISCUSSION section of this report.

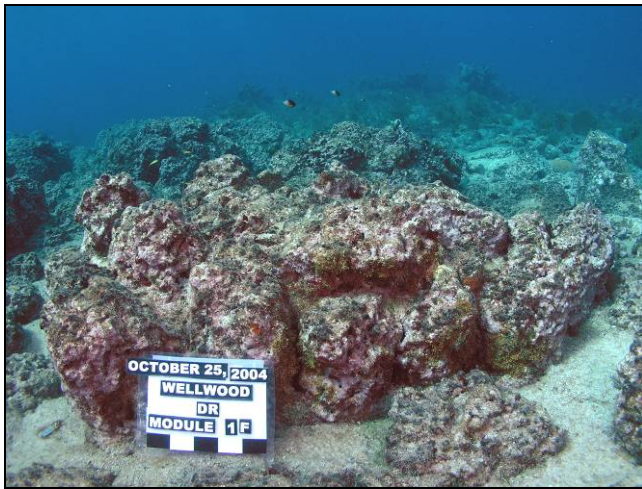
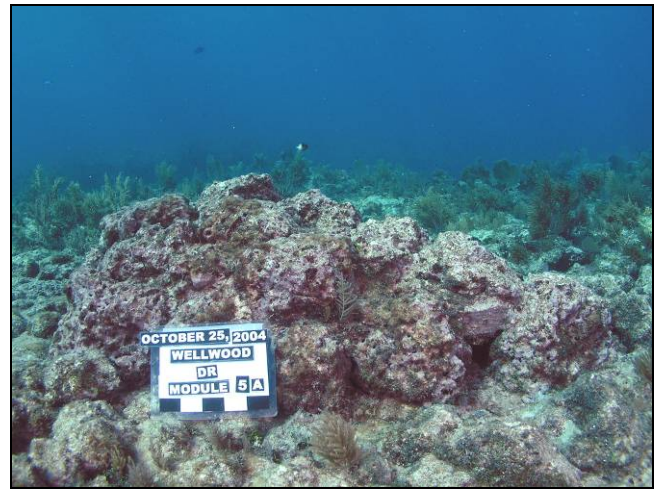
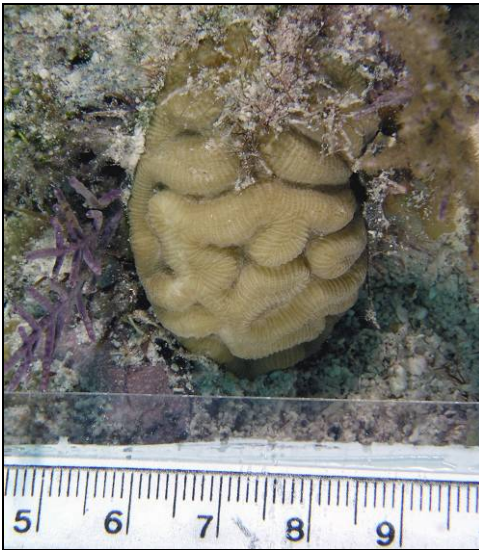
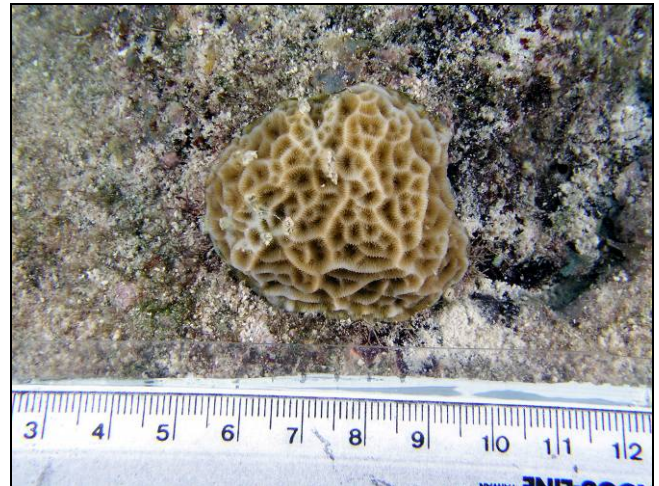
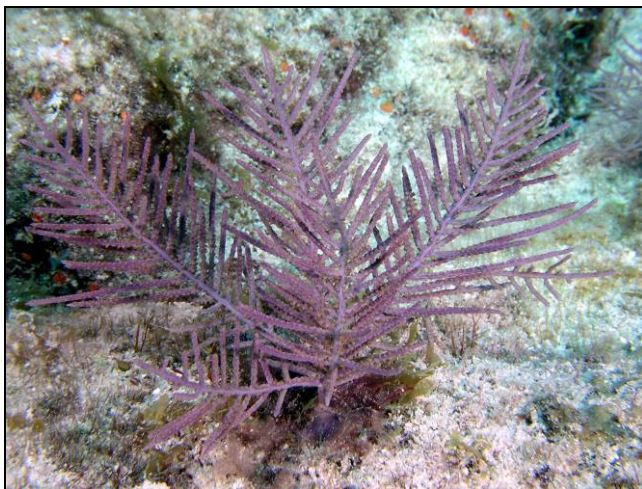
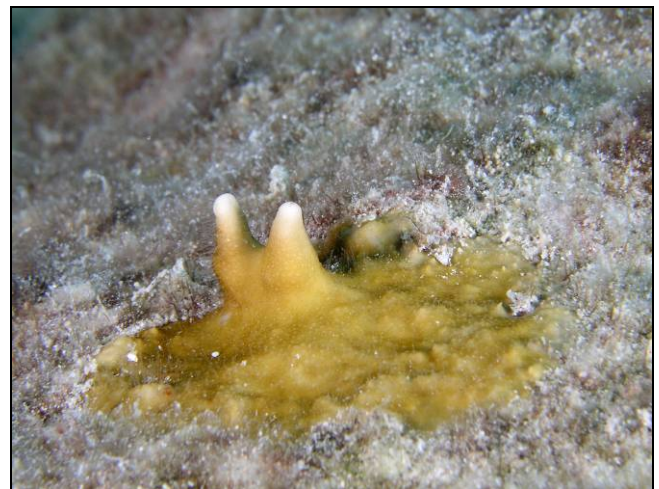
The 2004 monitoring occurred 2 years after the restoration, at which time the stability and surface of all 22 restoration modules and puddle pour areas were found to be visually and tactilely sound. The modules were found in place with a stable attachment to the substrate and no visible cracks in the concrete surface.

The biological condition of the restoration site was developing. Macroalgae, crustose coralline algae, soft, and hard corals were all recruiting to the restoration modules and surrounding concrete puddle pour areas (Figure 12). For photographs of all 22 restoration modules, see APPENDIX 2.

**Figure 12.** Restoration modules showing biological condition 2 years after installation along with close-up photos of representative benthic organisms surveyed. Starting from middle left: *Diploria labyrinthiformis*, *Agaricia* sp., *Pseudopterogorgia* sp., and *Millepora* sp. (photo credit: Jeff Anderson).

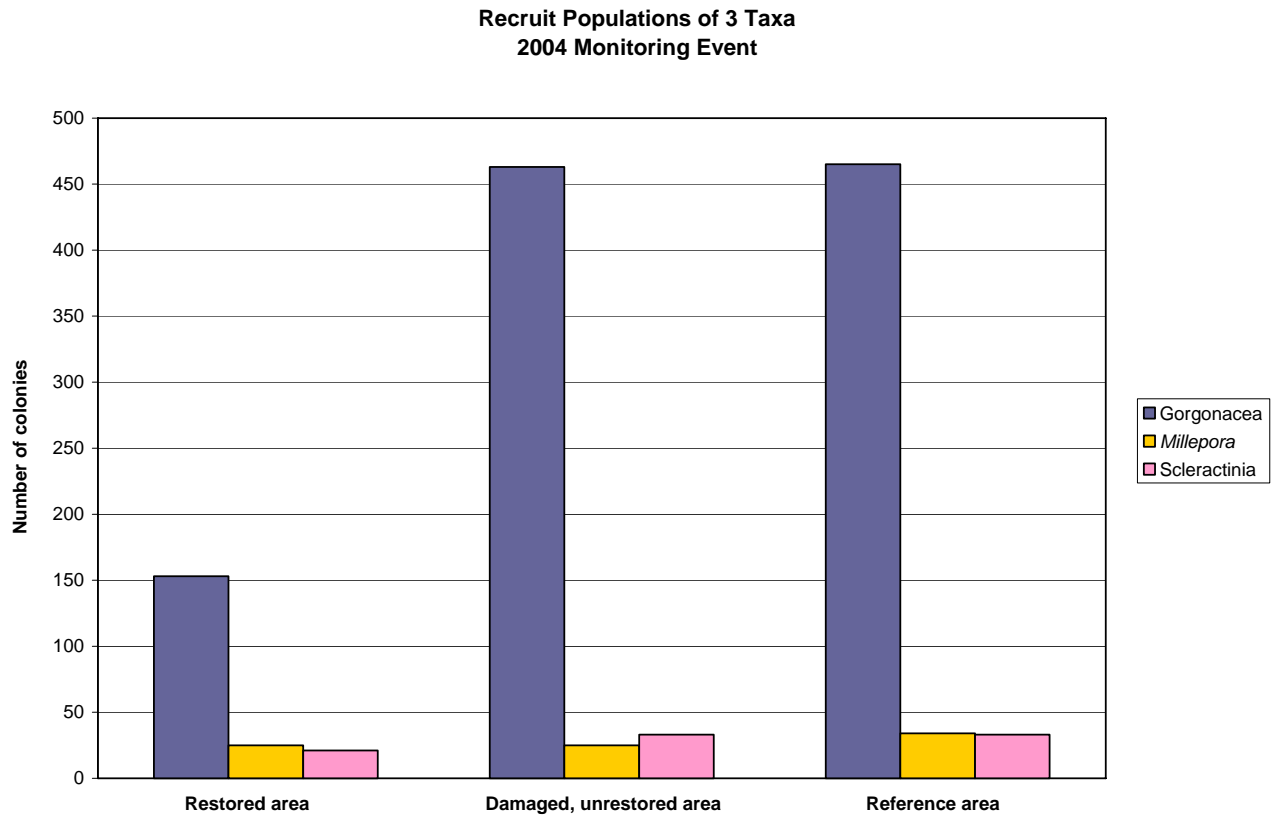
Figure 13 suggests that the three areas contained approximately the same number of organisms, with the exception of the obvious large difference in the populations of Gorgonians. Analysis revealed that sampling areas and colony numbers were highly significantly associated ( $P = 0.0005$ ).

**Figure 13.** 2004 recruit populations, at the Order level (Genus level for *Millepora*), in the Restored, Damaged, unrestored, and Reference sampling areas at the M/V *Wellwood* restoration site.

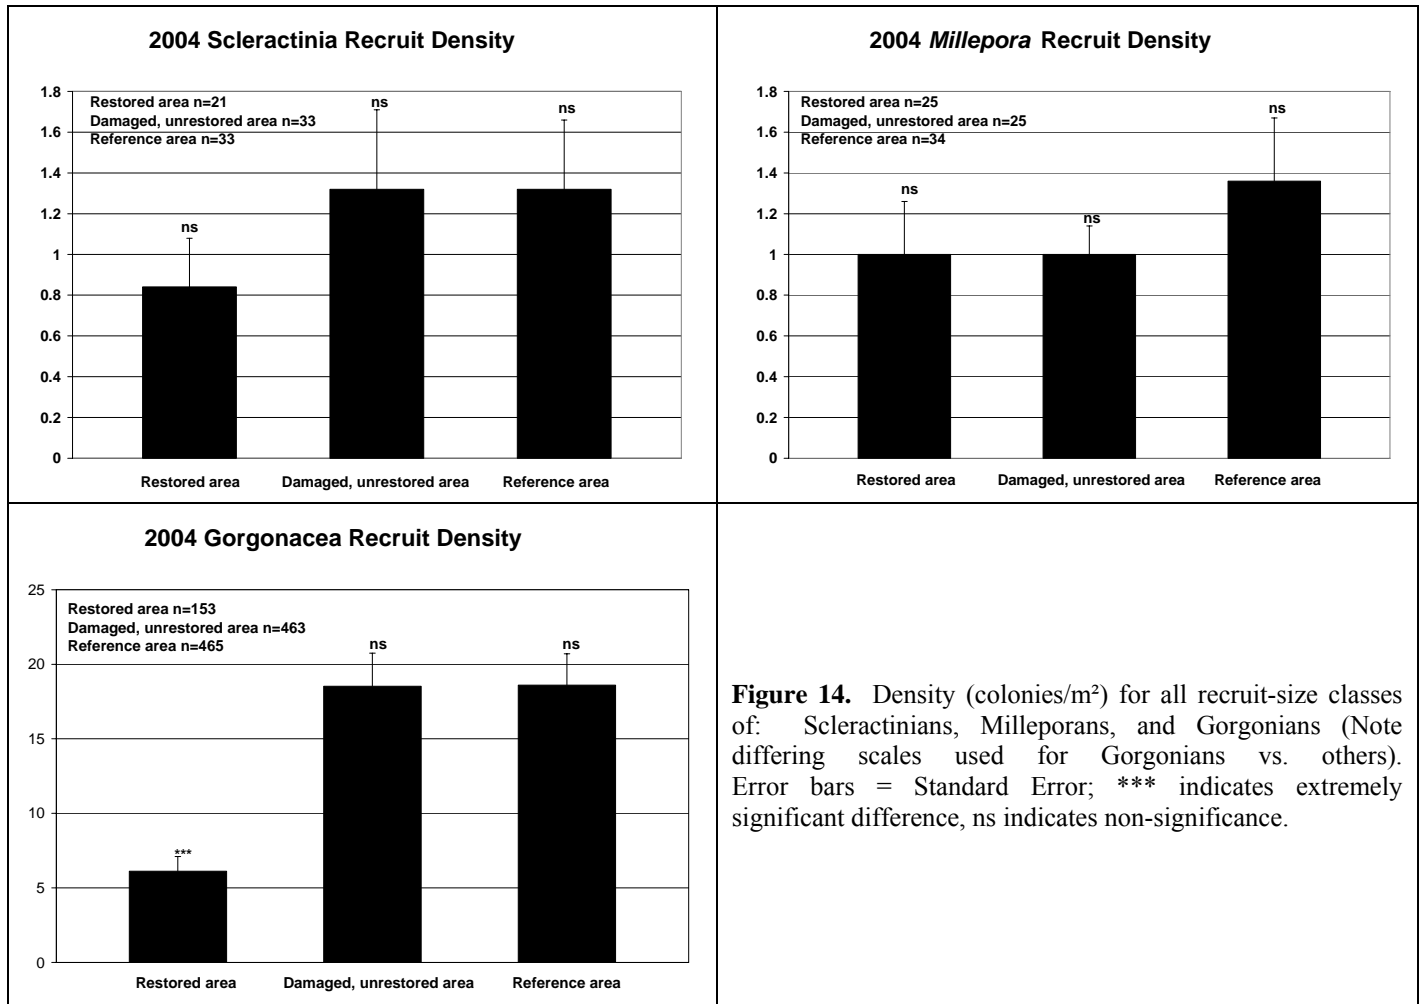
**Figure 14.** Density (colonies/m<sup>2</sup>) for all recruit-size classes of: Scleractinians, Milleporans, and Gorgonians (Note differing scales used for Gorgonians vs. others). Error bars = Standard Error; \*\*\* indicates extremely significant difference, ns indicates non-significance.

Statistical analysis of recruit densities (colonies/m<sup>2</sup>) demonstrated Scleractinian recruits had no significant difference between sampling areas ( $P = 0.5023$ ) (Figure 14). Similarly, analysis of *Millepora* recruits detected no significant difference between sampling areas ( $P = 0.5911$ ). Analysis of Gorgonian data revealed the densities were extremely significantly different between sampling areas ( $P < 0.0001$ ). The restored area evidenced difference; the other two areas were not shown to be significantly different.

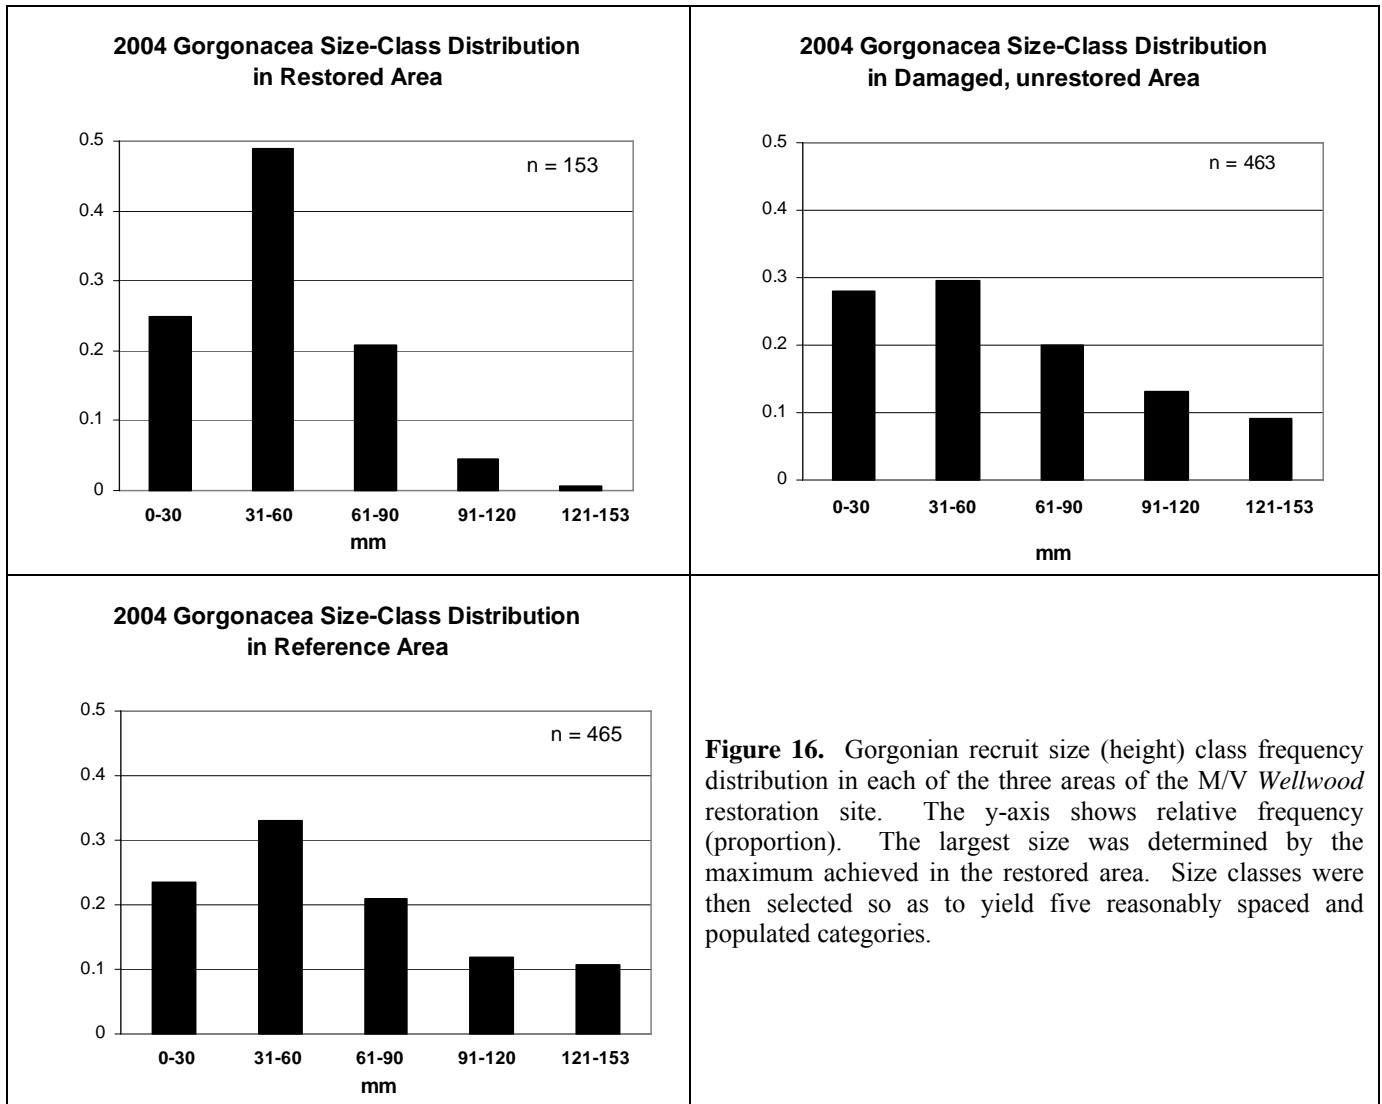
**Figure 16.** Gorgonian recruit size (height) class frequency distribution in each of the three areas of the M/V *Wellwood* restoration site. The y-axis shows relative frequency (proportion). The largest size was determined by the maximum achieved in the restored area. Size classes were then selected so as to yield five reasonably spaced and populated categories.

The size class frequency distributions of some of the taxa were next determined. Figure 16 shows the relative frequencies of the Gorgonians divided into size classes, the maxima of which was determined by the maximum size of the colonies in the restored area. Figure 17 shows the results of the same analysis for Milleporans.

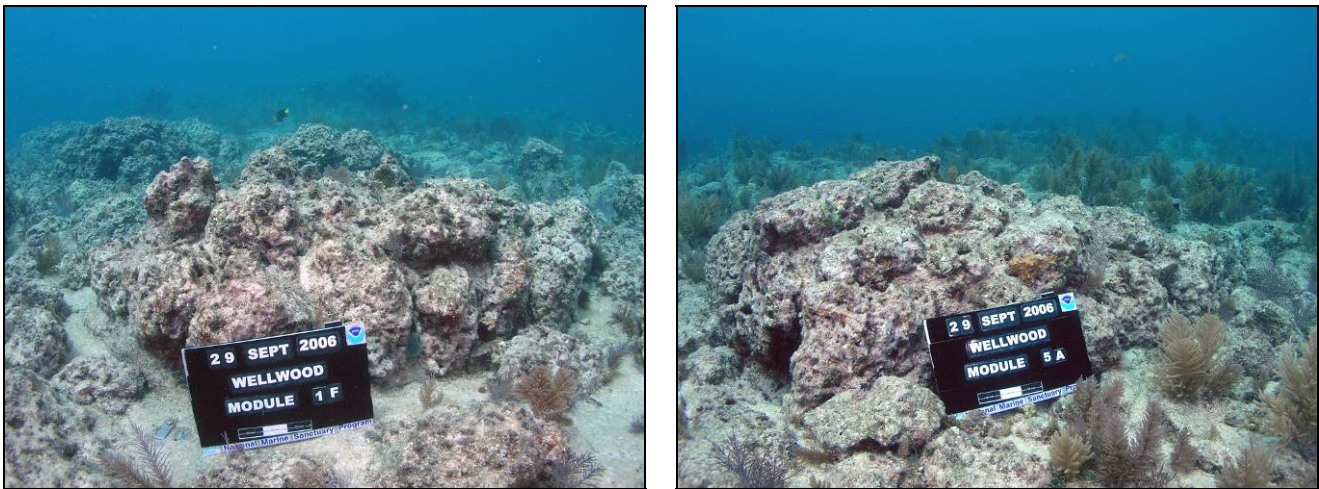
Despite the near passage of 4 hurricanes during the 2005 storm season, the stability and surface of all 22 reef restoration modules and puddle pour areas were again found to be visually and tactilely sound.

The biological condition of the restoration site continued to progress. Macroalgae, crustose coralline algae, soft, and hard corals were all still present on the restoration modules and surrounding concrete puddle pour areas (Figure 19). For photographs of all 22 restoration modules, see APPENDIX 2.

**Figure 19.** Restoration modules showing biological condition 4 years after installation (photo credit: Jeff Anderson). Compare to the same 2 modules shown in Figure 12.

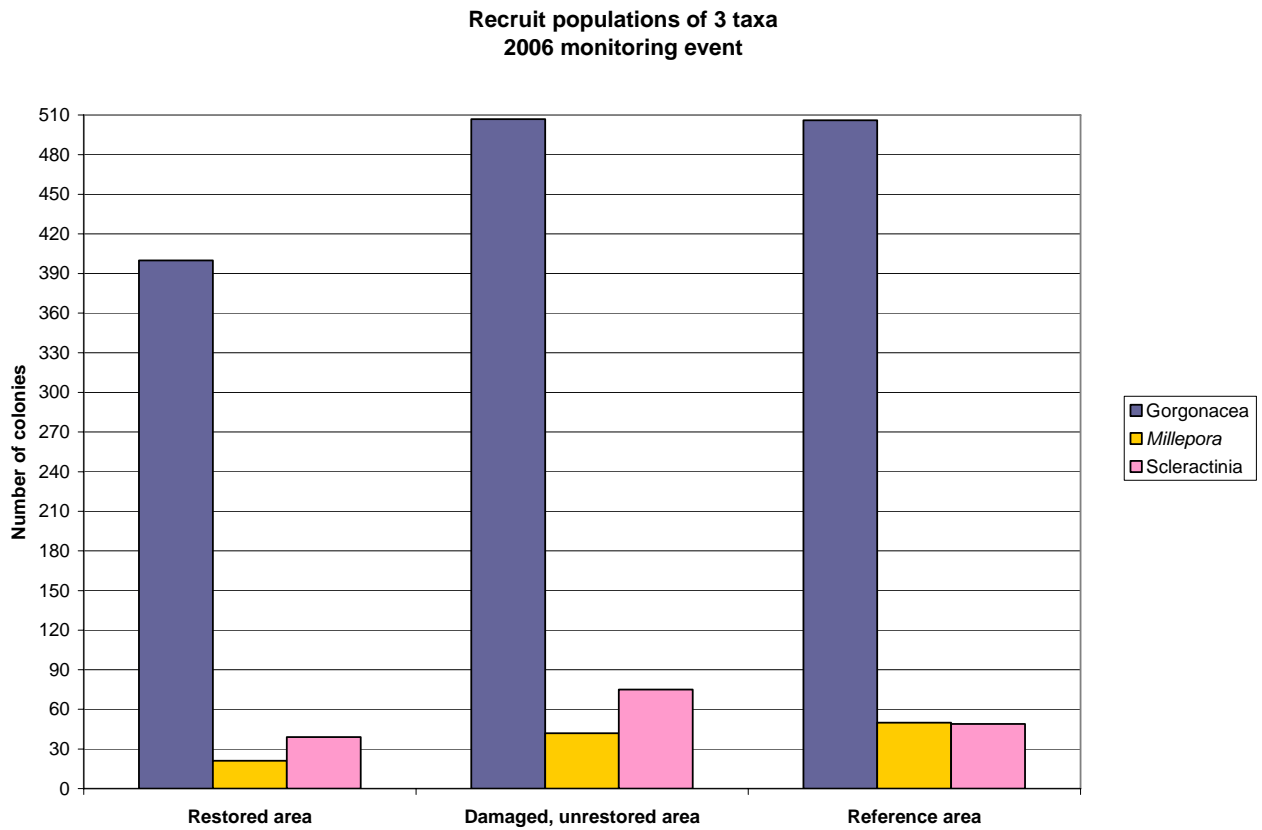
**Figure 20.** 2006 recruit populations, at the Order level (Genus level for *Millepora*), in the Restored, Damaged, unrestored, and Reference sampling areas at the M/V *Wellwood* restoration site.

Figure 20 suggests that the three sites contained reasonably similar recruit populations, although as in 2004, analysis revealed that areas and colony numbers were significantly associated ( $P = 0.0161$ ).

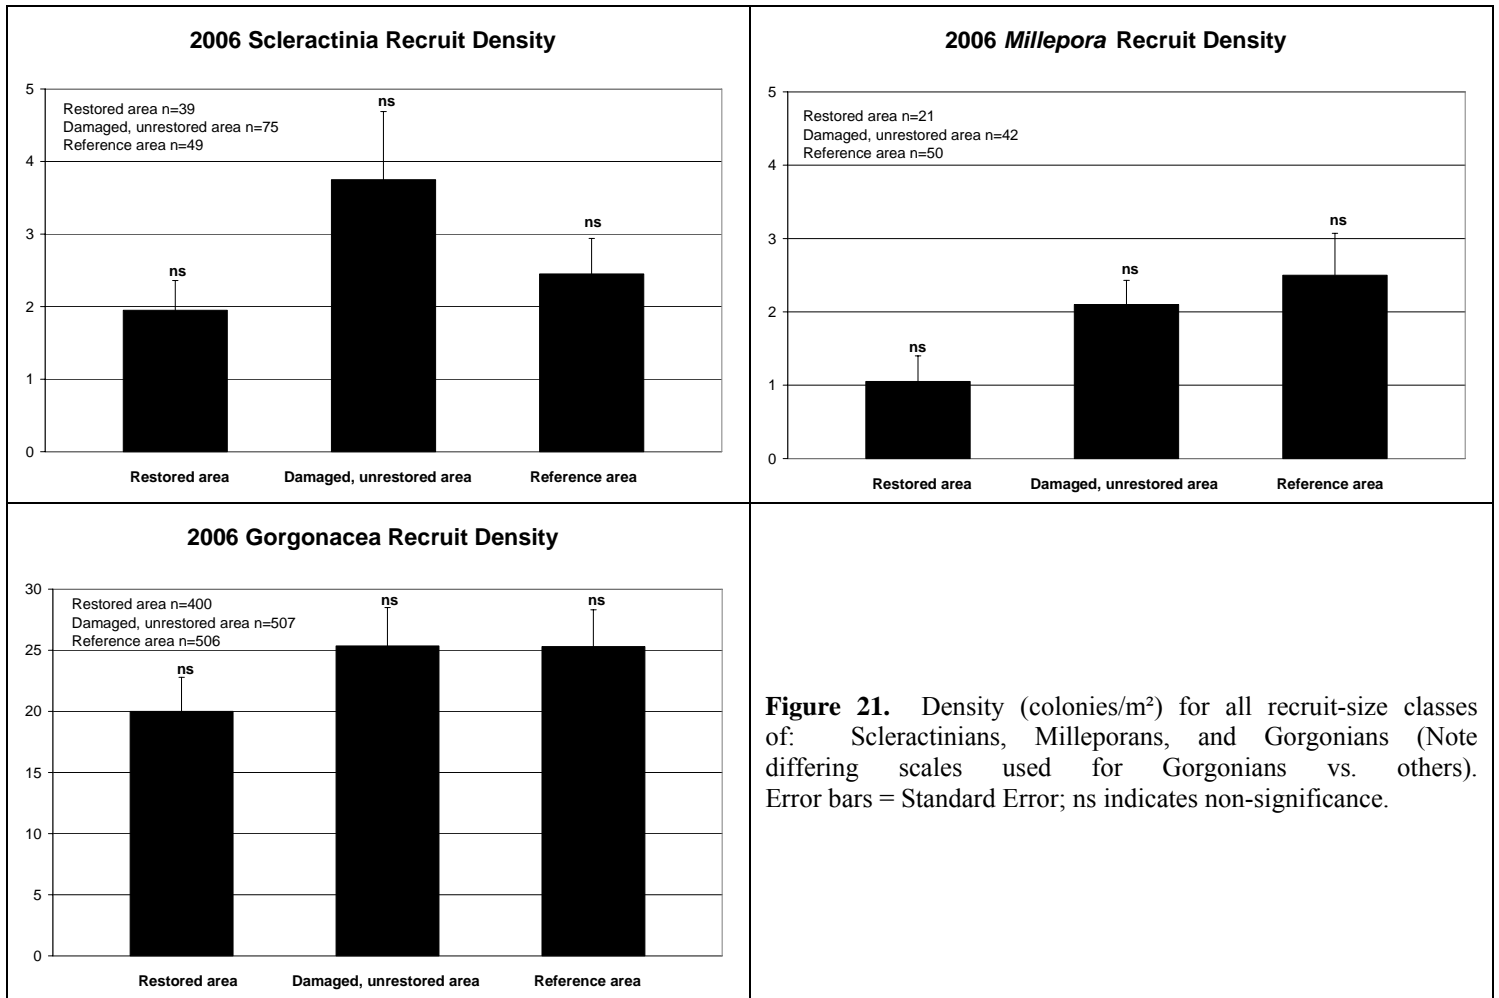
Again, overall recruit densities (colonies/m<sup>2</sup>) were examined (Figure 21). For Scleractinian recruits, no significant difference was detected between sampling areas ( $P = 0.3852$ ). Analysis of *Millepora* recruit density revealed overall significant variation ( $P = 0.0412$ ), though there were no significant differences between sampling areas found by the pairwise comparative tests. Analysis demonstrated that for Gorgonians, the densities were not significantly different between sampling areas ( $P = 0.3517$ ).

2004 ( $P < 0.0001$ ) (Figure 14), were by 2006 no longer statistically different between the sampling areas (Figure 21).
