***M/V WELLWOOD***  
**Coral Reef Restoration Monitoring Report**  
**Monitoring Events 2004-2006**  
**Florida Keys National Marine Sanctuary**  
**Monroe County, Florida**

June 2007

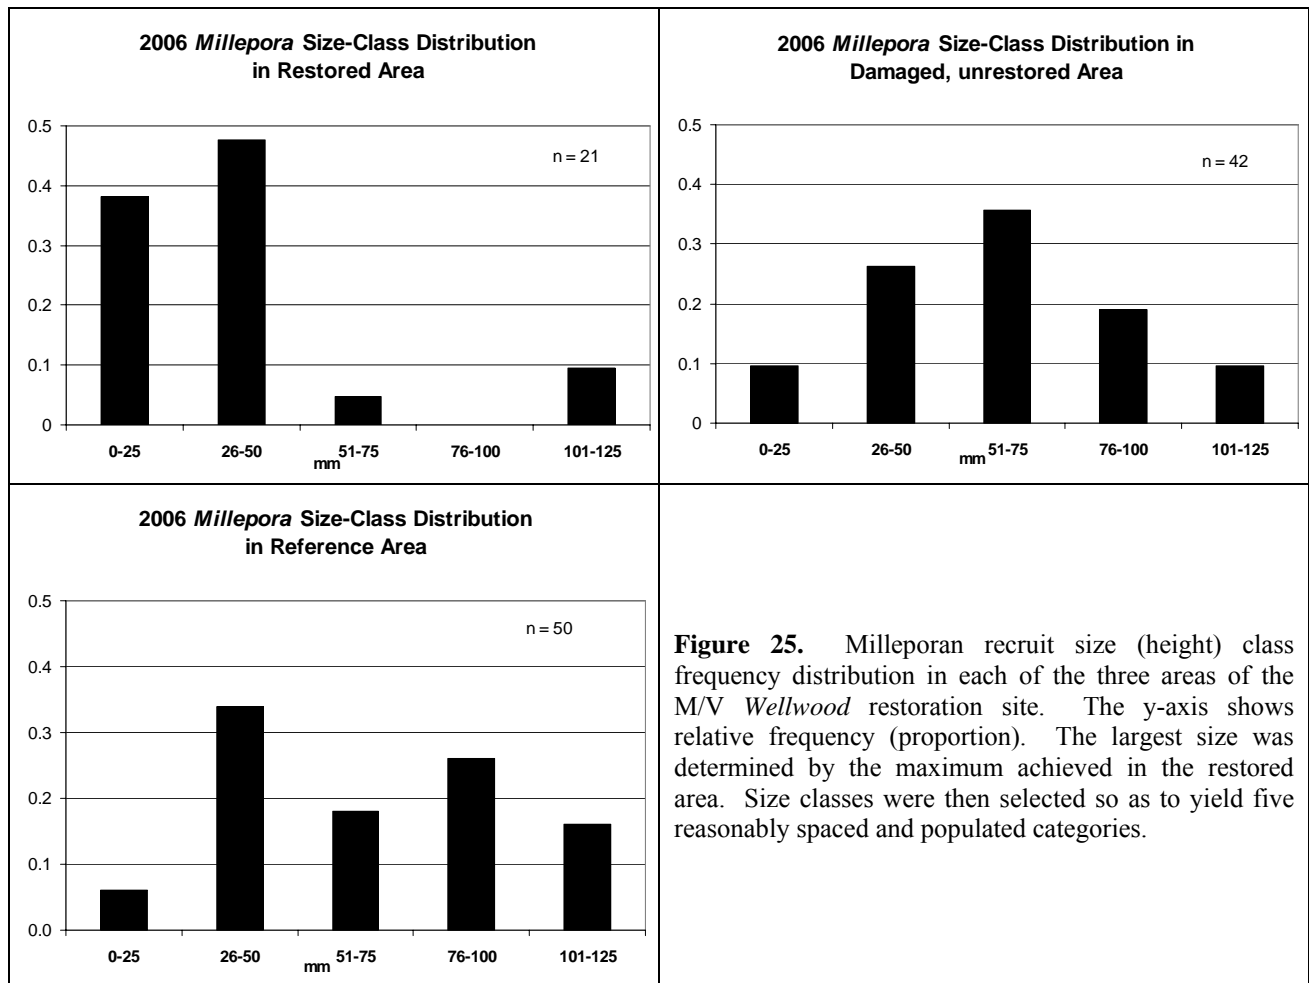
**Figure 25.** Milleporan recruit size (height) class frequency distribution in each of the three areas of the M/V *Wellwood* restoration site. The y-axis shows relative frequency (proportion). The largest size was determined by the maximum achieved in the restored area. Size classes were then selected so as to yield five reasonably spaced and populated categories.

The 2006 size class frequency distribution data of the Gorgonians is presented somewhat differently than it was for the 2004 results. The change was necessitated because of the increased presence of the common sea fan, *Gorgonia ventalina*; in 2004 it comprised only about 1% of the Gorgonian populations, in 2006 it made up as much as 12% (in the restored area) of the totals (Note: practically all others in the Order were comprised of the Genus *Pseudopterogorgia*—sea plumes.). Since growth rates between the Genera differ greatly, *G. ventalina* is depicted separately. Figure 23 shows the relative frequencies of the Gorgonians except *G. ventalina*, divided into size classes, the maxima of which being determined by the maximum size of the colonies in the restored area. Figure 24 shows the same analysis for *G. ventalina* whereas Figure 25 shows the same analysis for all species of Milleporans.

Given the data collected to date, one of the most interesting and potentially important results demonstrated was the fact that in 2006, the size-class frequency distributions revealed that the restored area always had a greater proportion of all taxa populations in the smallest size category (Figure 23, Figure 24, Figure 25, Figure 26, and Figure 27). Perhaps this is indicative of the fact that by this time, the modules had become preferential recruitment substrate. If so, in the coming years, as the absolute number of recruits to the areas continues to converge, and as the proportionately greater restored area small recruit cohort progresses through the size categories, overall populations in the restored area should overtake those at the other locations (assuming no differential mortality).

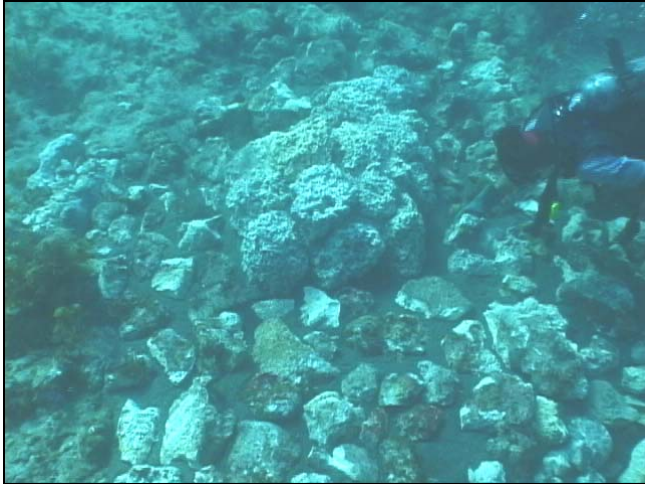
## APPENDIX 1

Photographs of completed reef restoration module and puddle pour installations from June-July 2002  
(photo credits: Florida Keys National Marine Sanctuary and Coastal Planning and Engineering, Inc.).

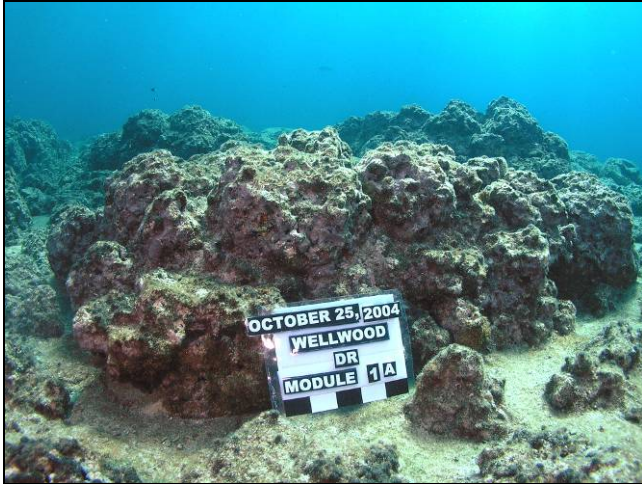
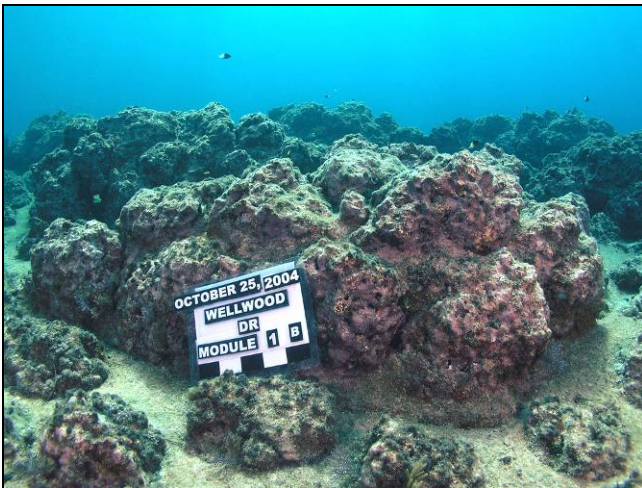
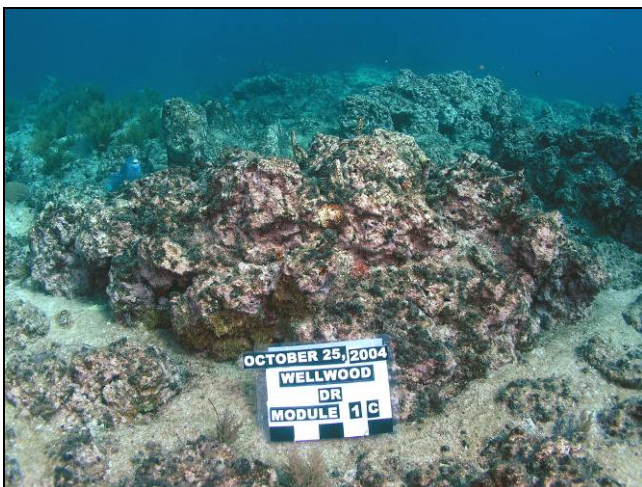
## APPENDIX 2

Comparative photographs of reef restoration modules from October 2004 (left) and September 2006 (right) (photo credits: Jeff Anderson).

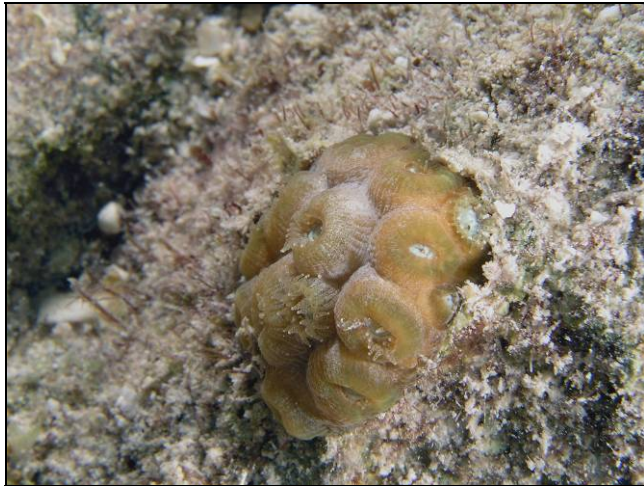
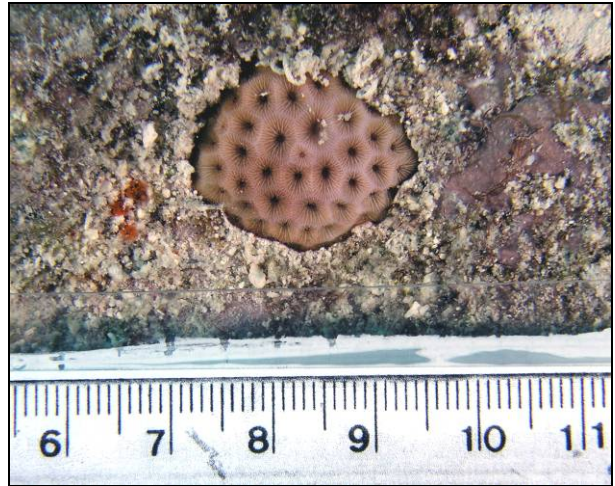
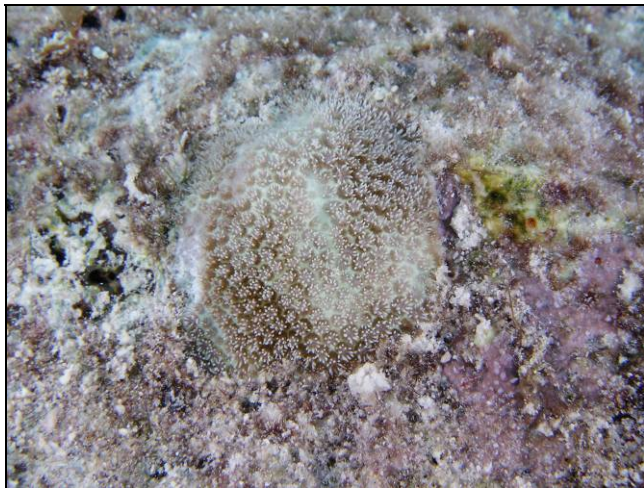
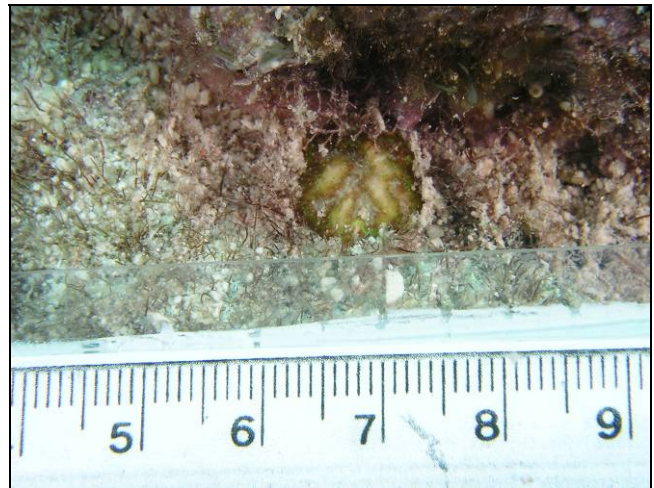
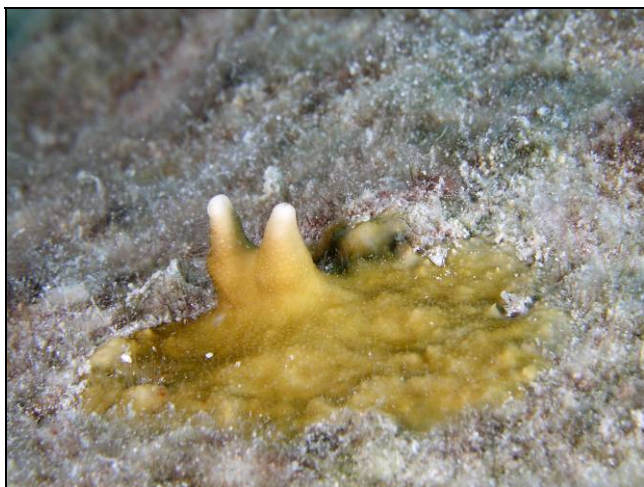
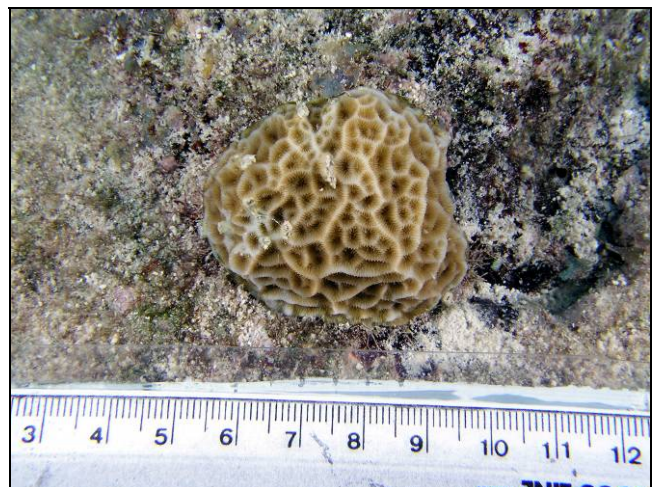
### APPENDIX 3

Photographs of benthic species surveyed on reef restoration modules during September to November 2004 monitoring event (photo credits: Jeff Anderson).
