RECLAMATION

American Recovery and Reinvestment Act (ARRA)— Urbanized Canal Inspections Status Report

**U.S. Department of the Interior
Bureau of Reclamation
Denver, Colorado**

December 2014

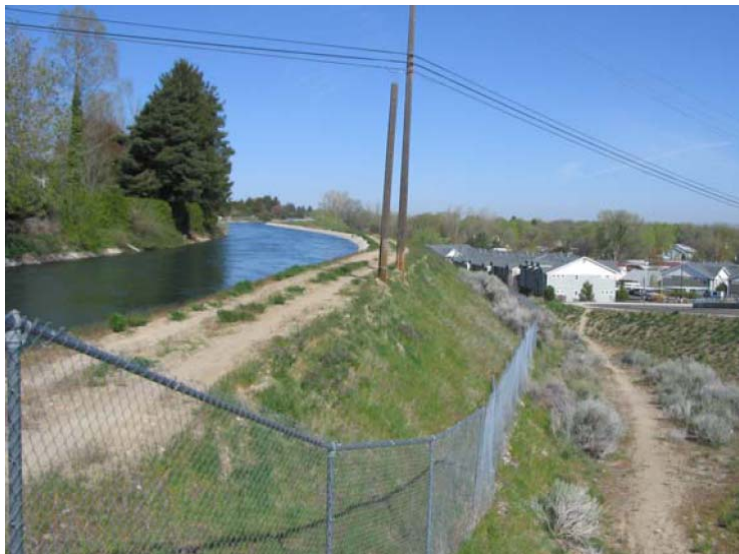
Figure 1. Urbanization near a Reclamation canal.

Over the years, increasing populations and the development and expansion of communities near the canals have resulted in the urbanization of historically agricultural areas (Figure 1). As a result, some of Reclamation’s canals pose a potential risk to urbanized areas if a failure were to occur. Reclamation identified this change and established a list of canals in urbanized areas requiring increased inspection.

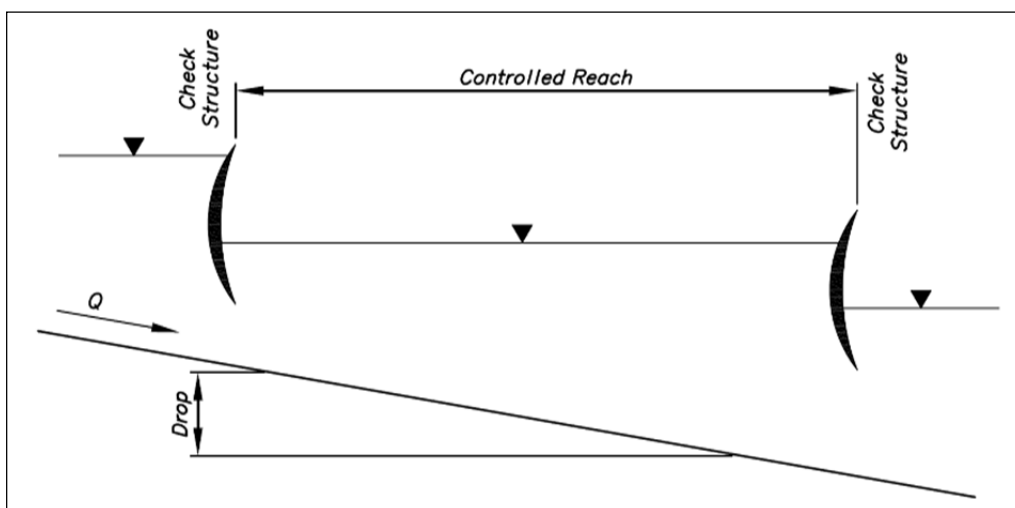
Figure 2. Controlled reach diagram.

As a result of this program under ARRA, Reclamation was able to better define specific canal reaches by determining which sections of the canal could be “controlled” from an operational standpoint. A controlled reach is that section of the canal identified by the water contained between structures, including checks, wasteways, diversion dams, etc., where the structures can be used to control or limit the amount of water to be discharged in the event of a failure. Figure 2 shows a controlled reach diagram.

Defining and inventorying canal reaches using the controlled reach approach assisted in determining canal operations, communication, and notification procedures related to emergency shutdowns, thereby reducing or limiting the extent of damages or other consequences, in the event of a canal breach. Each controlled urbanized canal reach in the inventory was assigned a unique number or controlled reach identification (CRID) number. Depending on the number of control structures in the canal, an urbanized canal could have multiple CRIDs.

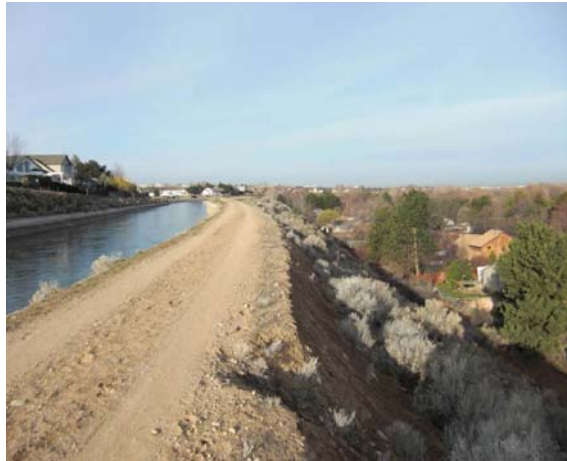
Figure 3. Urbanized canal reach.

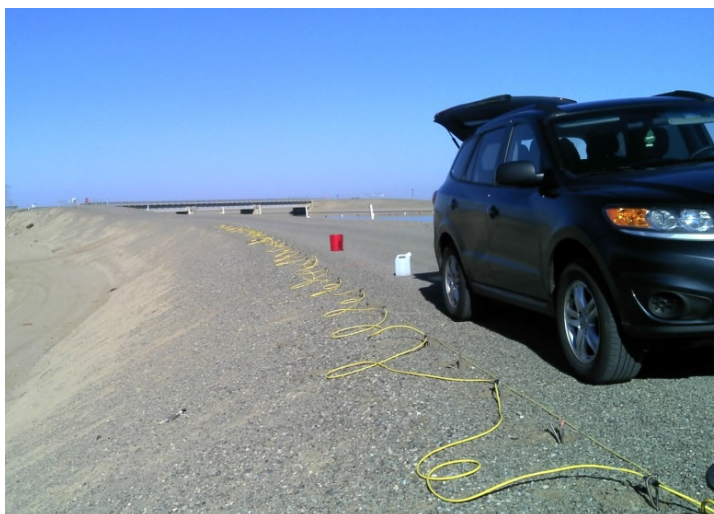
Figure 8. Collecting geophysical data on a suspected seepage area in a canal embankment.

Geophysical inspections used electrical resistivity imaging (ERI) instrumentation, and self-potential (SP) profiling along the suspected seepage areas of the canal embankments and foundations. The geophysical data were collected on the canal embankment crest—which also typically serve as the O&M road. Figure 8 shows the typical placement of ERI rods and cables for the collection of geophysical data along a suspected seepage area on a canal embankment.

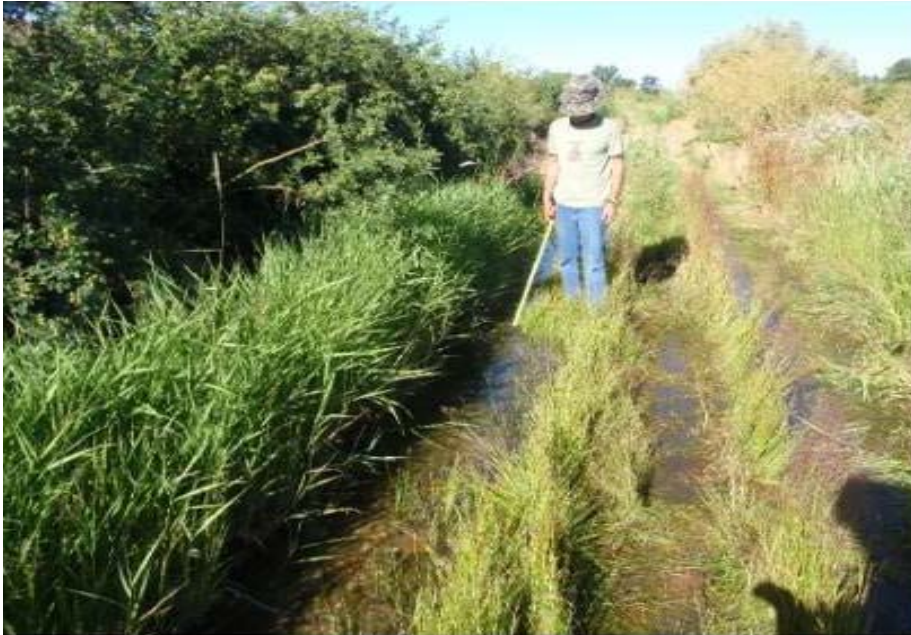
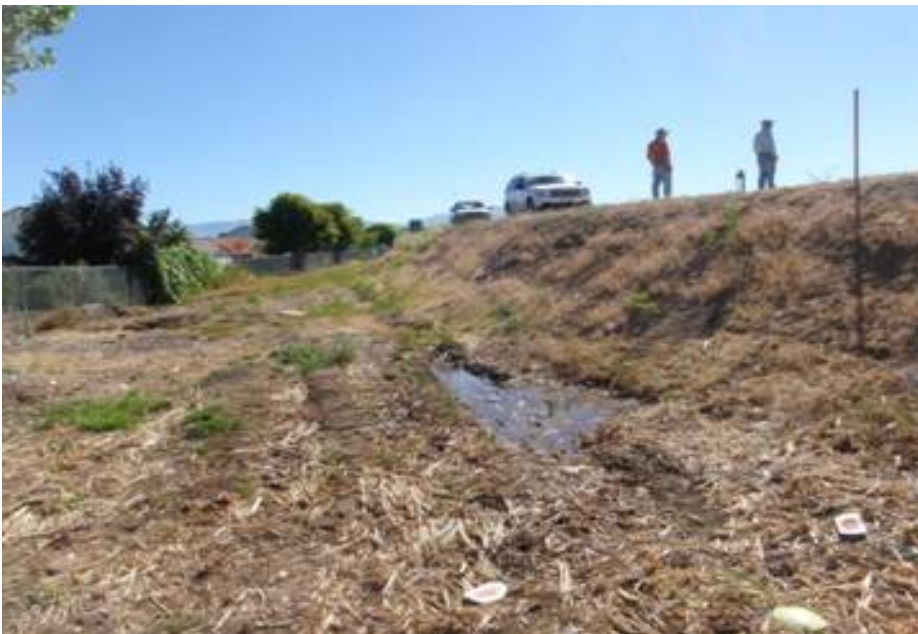
Seepage is the movement of water from the canal through the canal embankment or foundation soils (Figures 9 and 10). Seepage water flows in between the soil particles in what are known as seepage paths. If the velocity of the seepage water is great enough it can cause internal erosion or movement of soil particles with the water and result in piping, and sinkholes in the embankment.

Figure 9. Active seepage area near the outside of the canal embankment.

Figure 10. Ponded water and moist soil near toe of the canal embankment.

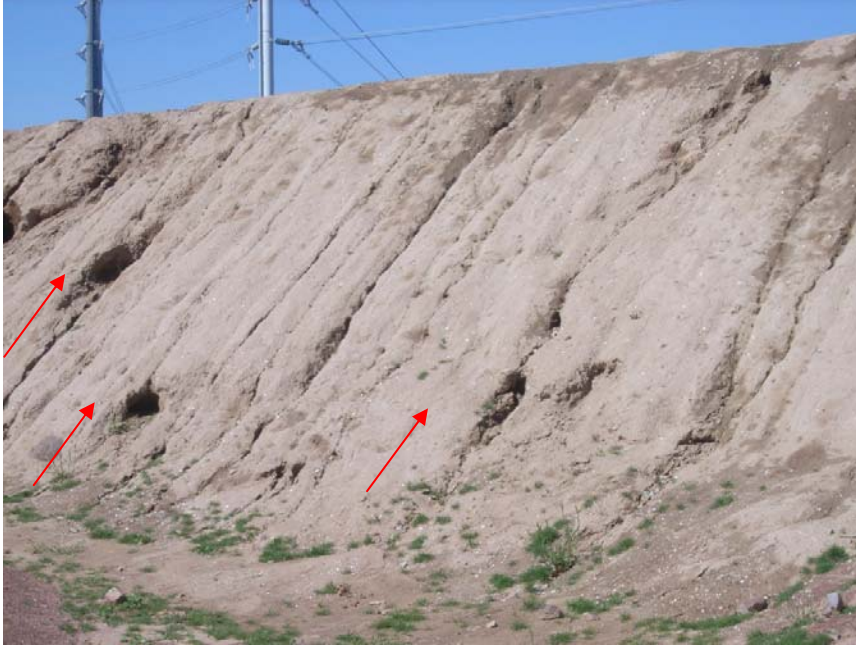
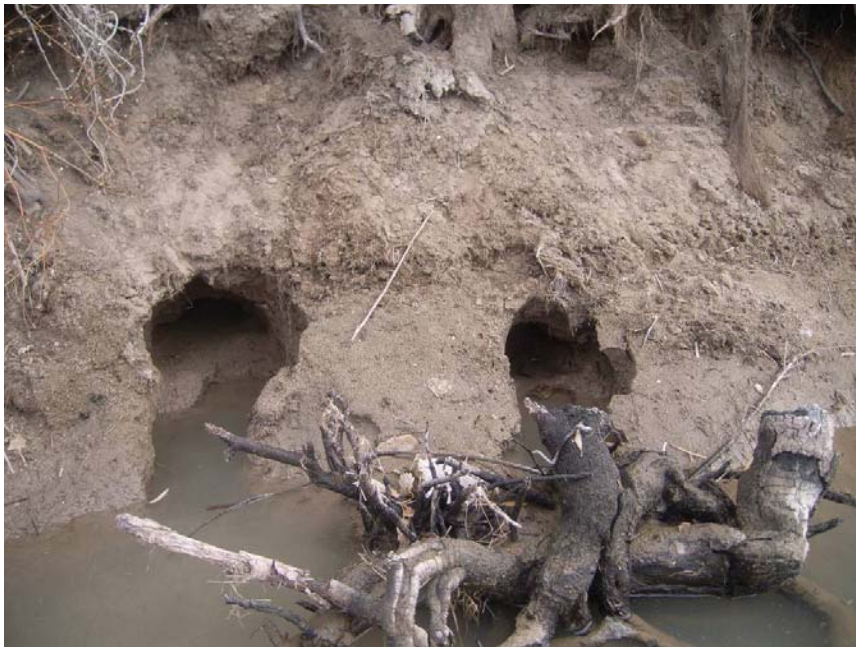
Animal burrows pose a potential threat to the integrity of canal embankments (Figures 11 and 12). Rodents that burrow through canal embankments can create a path for canal water to exit the canal through the embankment, resulting in seepage and internal erosion of the embankment.

Figure 11. Large and small diameter animal burrows on the outside of the canal embankment.

Figure 12. Large and small diameter animal burrows on the inside of the canal prism.

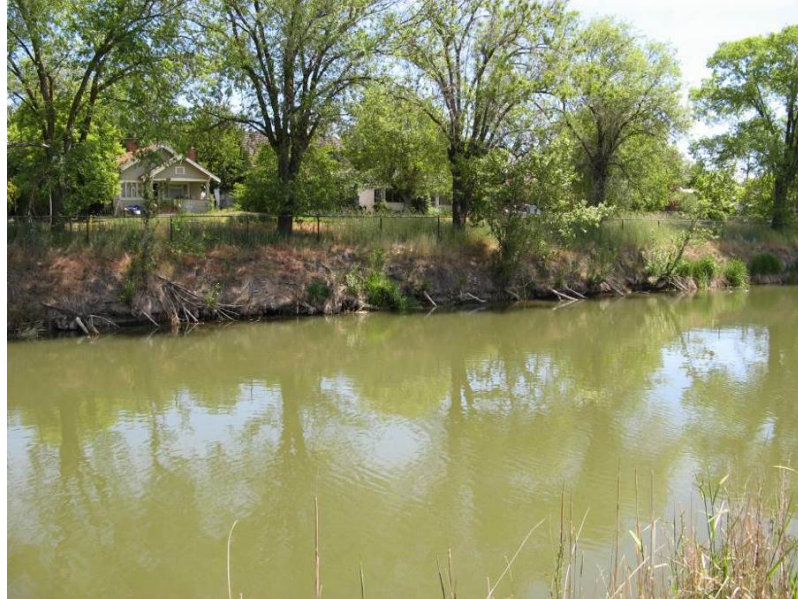
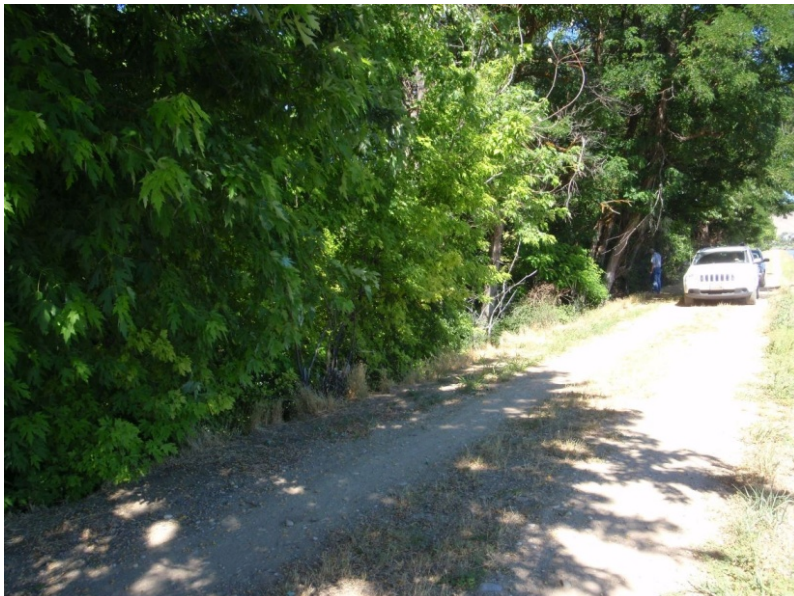
Roots from trees and woody vegetation pose a potential threat to the integrity of canal embankments (Figures 13 and 14).

Roots have the potential to loosen the compacted soils of the canal embankment. Decaying roots can create seepage paths through the embankment, which can lead to seepage and internal erosion of the embankment. In addition, excessive or dense vegetation creates inviting habitat for burrowing rodents. Further, it can obscure inspections and observations of surface conditions.

Figure 13. Trees growing on inside of canal prism; note roots.

Figure 14. Large and dense trees growing on the outside slope of the canal embankment.

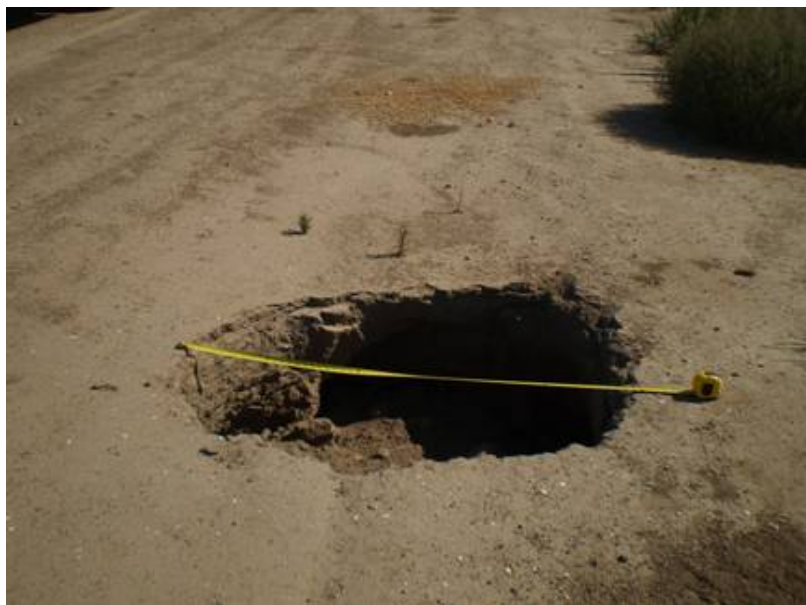
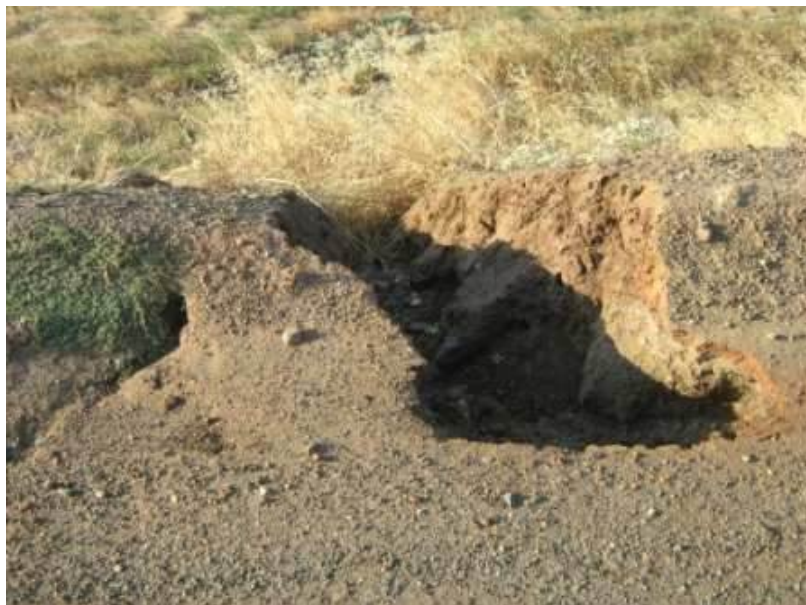
Surface erosion is the external erosion of embankment soil as a result of water or wind (Figures 15 and 16). External erosion may result from intense rain events creating voids or surface erosion on the embankment crest or slopes. Surface erosion can cause slumping or collapse of the embankment slopes.

Figure 15. Void on the crest of the canal embankment.

Figure 16. Erosion of outer slope of the canal embankment.

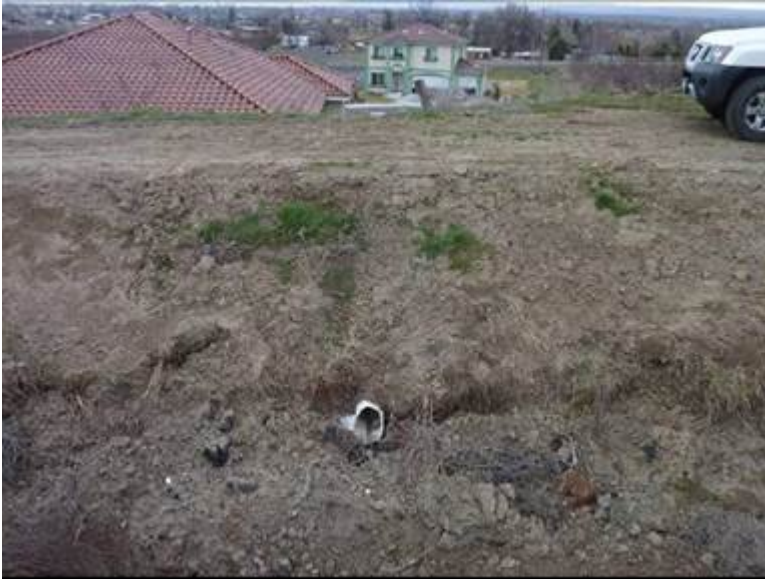
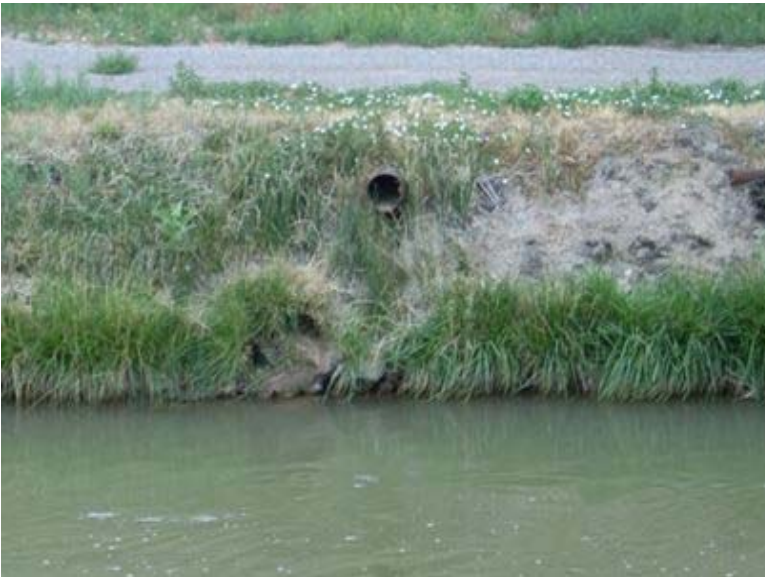
Distressed or corroding CMP and other pipes penetrating the embankment pose a potential threat to the integrity of embankments by creating a seepage path for water through the embankment (Figures 17 and 18). CMP pipes that corrode and have holes allow the water from the CMP to exit the pipe and seep along the exterior of the CMP which can result in piping and internal erosion of the embankment.

Figure 17. Pipe penetration through the canal embankment.

Figure 18. CMP pipe penetrating the canal embankment.

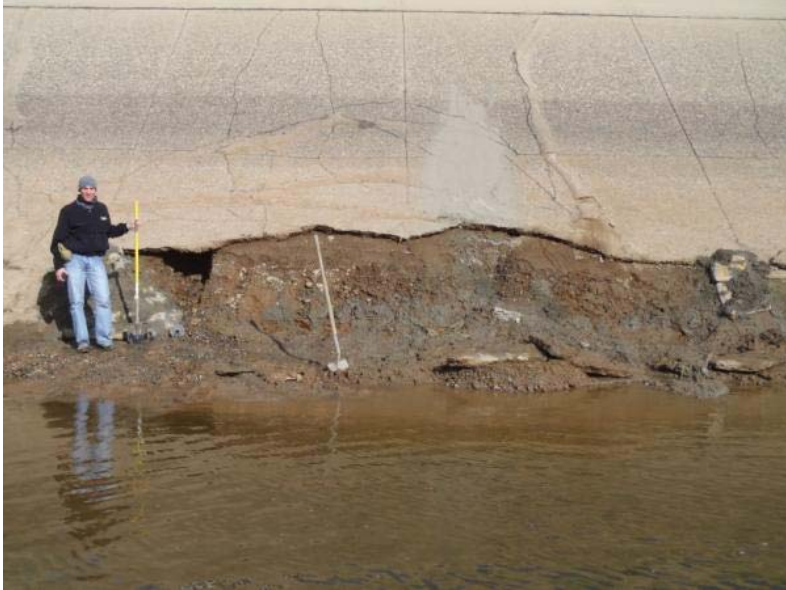
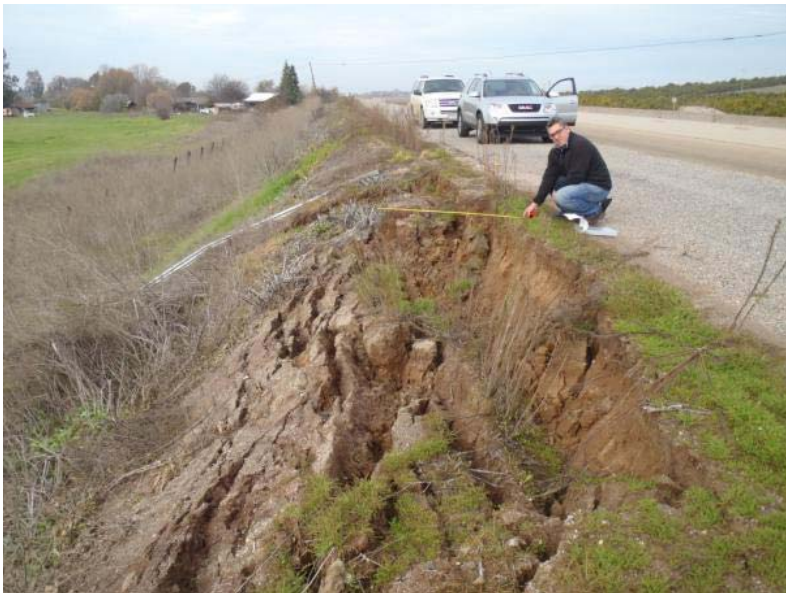
Winds resulting in waves in the canal water may result in surface erosion or sloughing on the interior slopes of the canal embankment (Figures 19 and 20). Sloughing can cause slipping and slumping of the embankment. Canal lining protects the canal from surface erosion. When canal lining is damaged, it allows water to move behind the liner and scour or erode the unprotected areas of the interior embankment slopes of the canal.

Figure 19. Distressed canal lining on the inside slope of the canal prism observed during dry inspection.

Figure 20. Sloughing of the outside slope of the canal embankment.

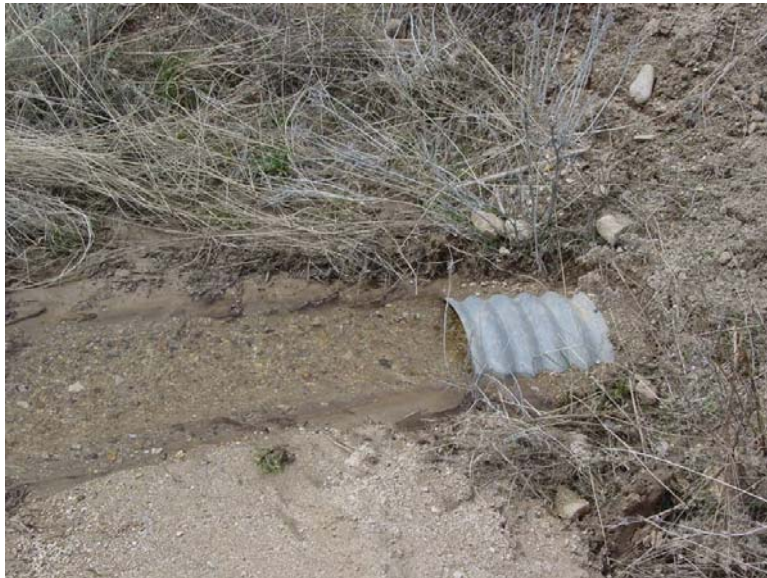
The cross drain allows drainage water to cross from the high side to the low side of the canal without interrupting the canal supply. When a cross drain becomes plugged or restricted and can no longer flow drainage water as designed, it creates the potential for the drainage water to enter the canal and not exit. During storm events, restricted cross drains can cause an excess amount of water to collect in the canal and result in overtopping.

Figure 21. Plugged corrugated metal pipe culvert that is limiting cross drainage.

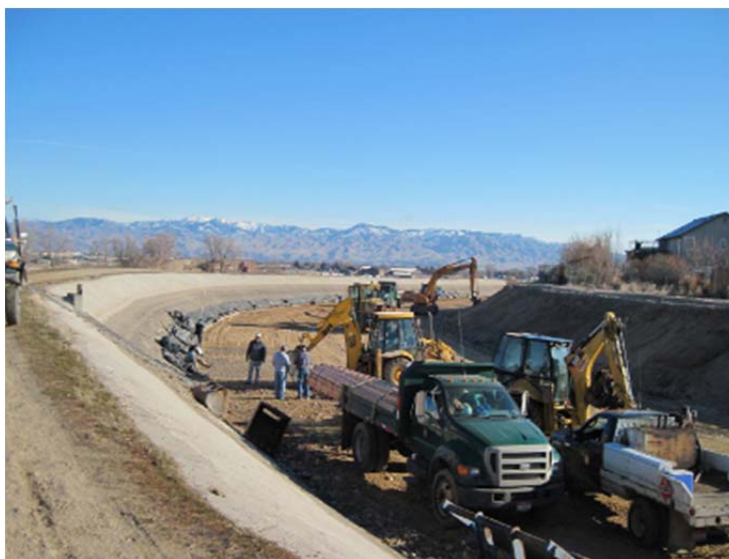
Figure 22. Operating entity performing repairs to address a seepage area.

The operating entities implement formal recommendation actions as part of their O&M on the canals. For example, during a watered up inspection, a seepage area was identified. During the next off-season, the operating entity initiated lining of the canal to mitigate the seepage. Figure 22 is a photo of the operating entity installing liner on a canal to repair a seepage area.
