# **Intake Diversion Dam Modification Lower Yellowstone Project Waters of the U.S. Delineation Report**

**U.S. Army Corps of Engineers – Omaha District**

**September 2012**

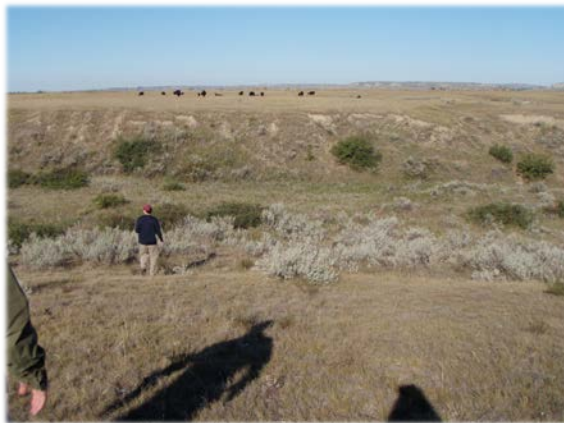
DW-1 was an incised drainageway with moderately steep banks located near the western boundary of the Waste Pile Site. A majority of DW-1 was dry at the time of investigation. DW-1 appears to drain areas south of County Road 303, collect overland flow and convey direct precipitation into the backwater of the Yellowstone River. DW-1 is described below in two sections, the upper end and the lower end. The upper end did not contain any wetlands and no evidence of an ordinary high water mark (OHWM) was present. See Photographs 1 and 2 for views of this area. Recorded upland species are listed in Table 1 below.

**Photograph 1 – View from Photo Station 1 (PS-1) facing west showing upper end of DW- (south)**

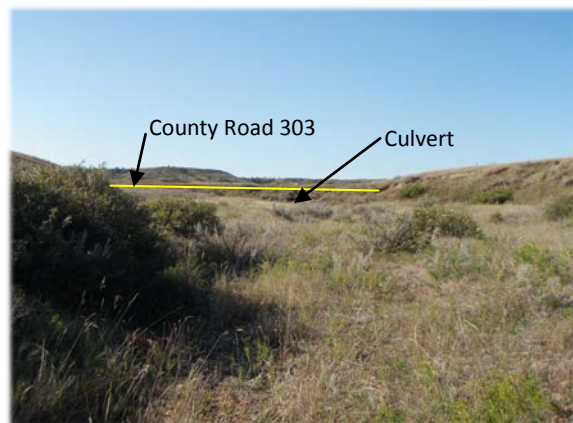
**Photograph 2 – View from west of PS-1 from within DW-1 facing upstream**

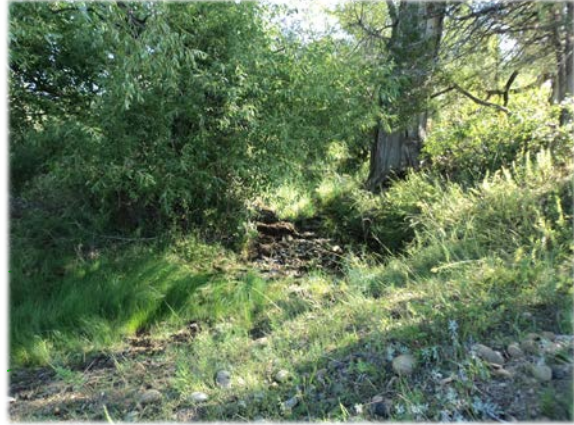
The lower end of DW-1 begins at the southern edge of a forested canopy where a seepage spring emerges from the hillside. See Photograph 3 for view of Sample point 1 (S-1), spring and wetlands (green line). The spring creates a narrow stream with gravel substrate that is approximately one- to four-inches deep and six-inches to five-feet wide. The stream flows in a northerly direction for approximately 325 feet until it dissipates and could no longer be observed. An OHWM was present near the current flow elevation.

Emergent wetlands formed a band from two inches to six feet wide around the stream. The wetlands transition to uplands where the stream dissipates. Hydrophytic trees dominate the overstory above the stream and herbaceous wetlands. Approximately 0.12 acres of Palustrine Forested Temporarily to Seasonally Flooded (PFOA/C) wetlands were surveyed at this location and are shown in green in Figure 1. See Photographs 3, 4 and 5 for views of this area. Recorded vegetation species are listed in Table 2 below.

**Photograph 3 – View of S-1 and spring within lower end of DW-1 facing southwest**

One wetland and a spring with a waterway that did not have a continuous OHWM were identified at the Waste Pile Site. Although a continuous OHWM was not observed, these features are likely regulated WUS as they connect directly to the Yellowstone River and should be avoided as a place to dump fill material. Additionally, areas within the banks of all drainageways should be avoided to the maximum extent possible. If fill must be placed in the drainageways, it should be placed in the headwaters as these areas are the flattest and fill here would most blend in with the surrounding topography. Culvert extensions would be needed if fill were placed in drainageway headwaters near the south boundary of the waste pile site so as to not hinder drainage from areas south of County Road 330.

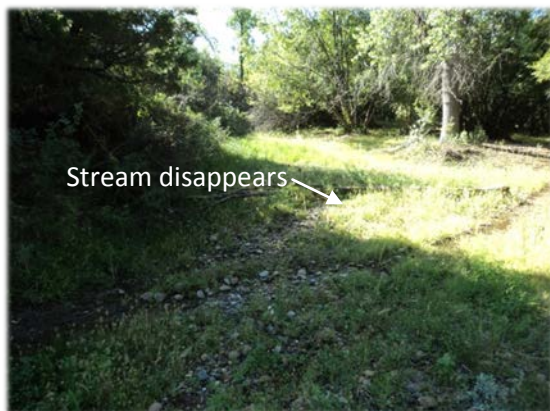
**Photograph 4 – View of area where stream and wetlands transition to upland area facing southwest**

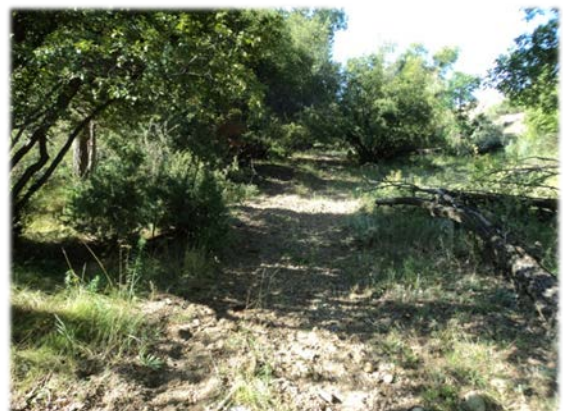
**Photograph 5 – View of upland area where stream and wetlands end facing north**

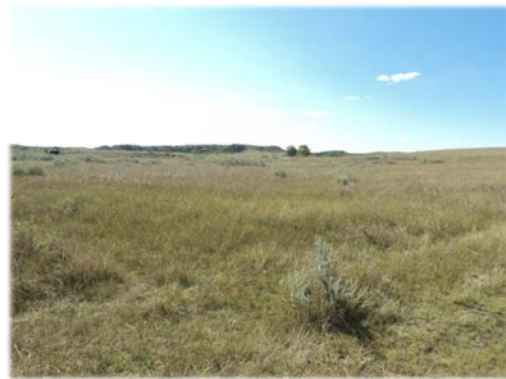
A lower flat area (B-1) between the upper ends of the banks of DW-1 and DW-2 appeared dark in a 2012 aerial photograph. Dark features on aerials may indicate wetness; therefore, a Sample point (S-2) was placed in the area to document observations. Conditions were very dry and only upland plants were identified. See Figure 1 for S-2 location and Table 3 for recorded vegetation. See Photograph 6 for a depiction of B-1 (black line).

Photograph 6 – View from S-2 of B-1 facing north

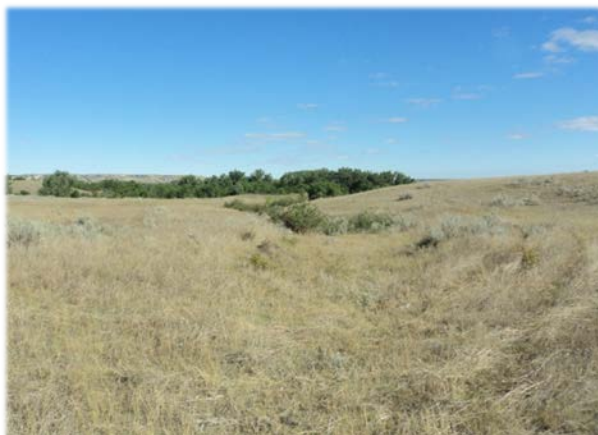
North of County Road 303 DW-2 is a grassed drainageway with gently sloping banks located near the center of the waste pile site. Near the northern boundary of the investigation area it transitions into a forested drainageway until reaching the Yellowstone River backwater. All of DW-2 was dry at the time of investigation. Similar to DW-1, DW-2 appears to drain areas south of County Road 303, collect overland flow and convey direct precipitation into the backwater of the Yellowstone River. Two Sample points (S-3 and S-4) were placed to document observations within DW-2. No hydrophytic vegetation or OHWM was present in this area. See Figure 1 for S-3 and S-4 locations and Table 4 for recorded vegetation. See Photograph 7 and 8 for depiction of DW-2.

Photograph 7 – View from S-3 facing northwest showing DW-2

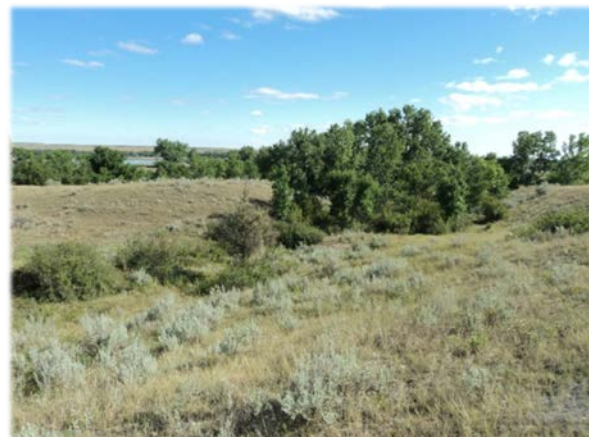
Photograph 8 – View near S-4 showing DW-2 facing northwest

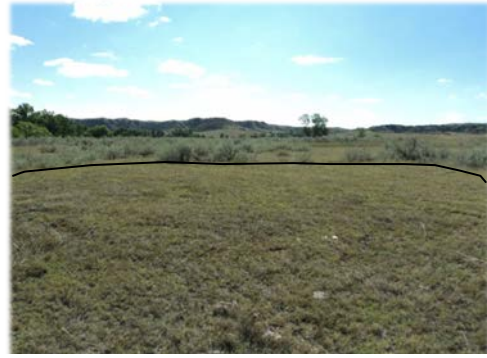
A slightly lower flat area was located west of DW-3 and appeared dark in a 2012 aerial photograph. Dark features on aerials may indicate wetness; therefore, a Sample point (S-5) was placed in the area to document observations. Conditions were very dry and only upland plants were identified. See Figure 1 for S-5 location and Table 5 for recorded vegetation. See Photograph 9 for a depiction of B-2 (foreground from black line).

**Photograph 9- View from S-5 of B-2 facing south**

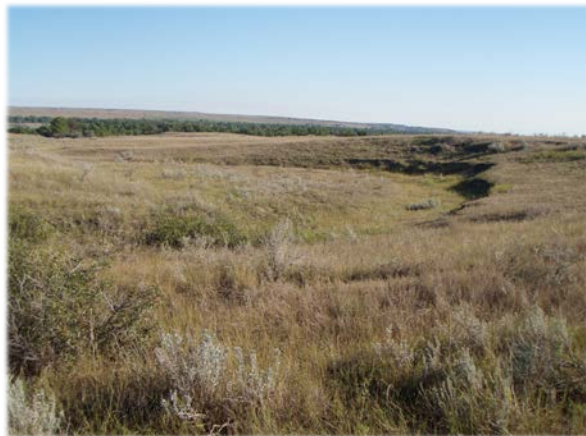
DW-3 resembles DW-2. North of County Road 303 DW-3 is a grassed drainageway with gently sloping banks located in the eastern half of the waste pile site. Near the northern boundary of the investigation area it transitions into a forested drainageway until reaching the Yellowstone River Backwater. All of DW-3 was dry at the time of investigation. It appears that DW-3 would collect overland flow and convey direct precipitation into the backwater of the Yellowstone River. Sample point 6 (S-6) was placed to document observations within DW-3. No hydrophytic vegetation or OHWM was present in this area. See Figure 1 for the location of S-6 and Table 6 for recorded vegetation. See Photograph 10 and 11 for a depiction of DW-3.

**Photograph 10 - View where DW-3 transitions from grassed to forested drainageway facing north**

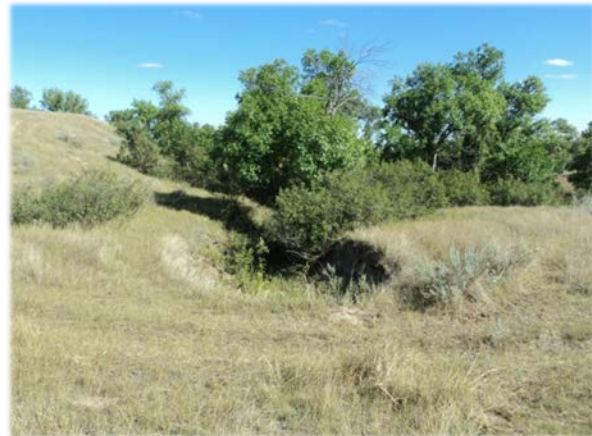
**Photograph 11 - View from south of S-5 facing north showing DW-3**

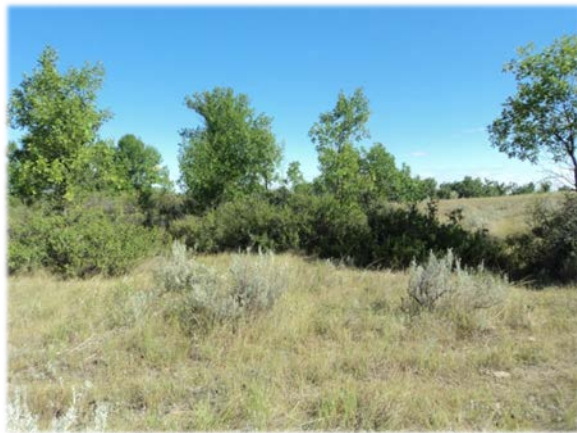
Similar to the other drainageways, DW-4 transitions from a grassed drainageway with gently sloping banks into a forested drainageway with steeper banks that connects to a backwater of the Yellowstone River. All of DW-4 was dry at the time of investigation. It appears that DW-4 would collect overland flow and convey direct precipitation into the backwater of the Yellowstone River. Sample point 7 (S-7) was placed to document observations within DW-3. *Populus deltoides* (Great Plains cottonwood) is a facultative tree (50% likelihood of being in a wetland) but was not the dominant vegetation within DW-4. No other hydrophytic species or OHWM was present in this area. See Figure 1 for the location of S-7 and Table 7 for recorded vegetation. See Photograph 12 for a depiction of DW-3 and Photograph 13 for a view from Photo Station 2 (PS-2) showing the steep drop off east of S-7 outside of the investigation limits.

**Photograph 12 - View showing S-7 facing northwest**

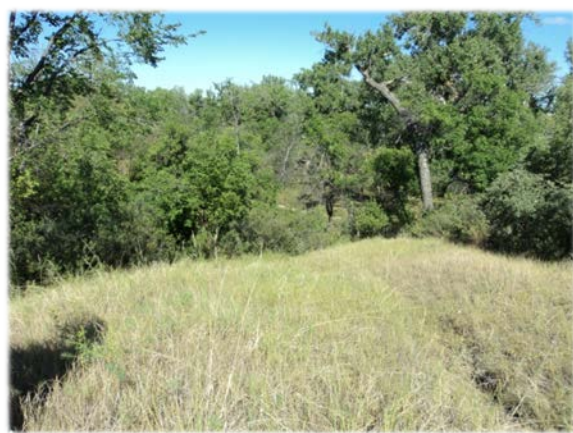
**Photograph 13 - View from PS-2 facing north showing steep drop off outside investigation area**

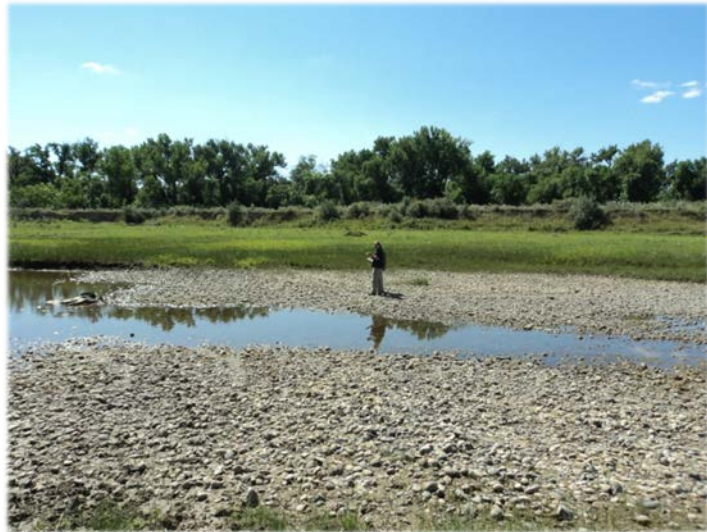
**Backwater Area A** – The NWI map classifies this area as Riverine Lower Perennial Unconsolidated Bottom Intermittently exposed (R2UBG) channel backwater. See Figure 2 for backwater location. The OHWM appeared to be along the banks as indicated by the yellow line in Photograph 14. Flow was imperceptible and the backwater appeared to be stagnant at the time of the investigation. Rock and gravel bars were present throughout the banks of the channel. Bands of fringe wetlands lie

**Photograph 14 – View of Backwater Area A from north of S-9 facing south**

adjacent to the channel and are represented by seasonal to semi-permanent herbaceous vegetation. Observations recorded at Sample point 9 (S-9) are presented in Table 8. See Photos 14 and 15 for depictions of Backwater Area A. A narrow two- to four-foot side channel was dominated by wetland vegetation and likely conveys water during high flows and functions as a wetland swale when flows are low. See green boundary line in Photo 16 for a view of this wetland swale.

Backwater Area A contains wetlands and a waterway while Backwater Area B consisted of a waterway without wetlands. Both areas would be considered jurisdictional waters of the U.S. Fill should be avoided from being placed in these locations to the maximum extent practicable. If temporary fill is placed into either backwater, then the site should be restored to pre-disturbance conditions when the activity is completed. If either area is excavated, it is likely similar wetlands would develop along the banks following construction.

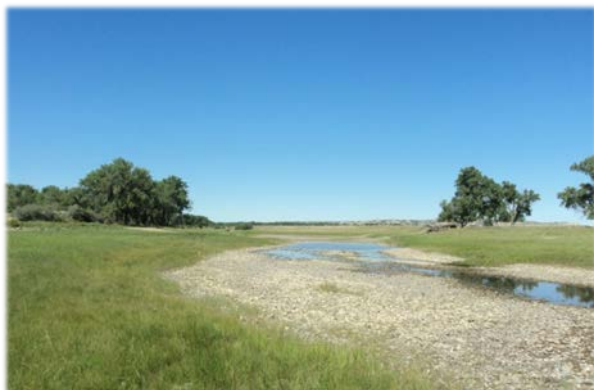
**Photograph 15 - View from S-9 showing Backwater Area A facing west**

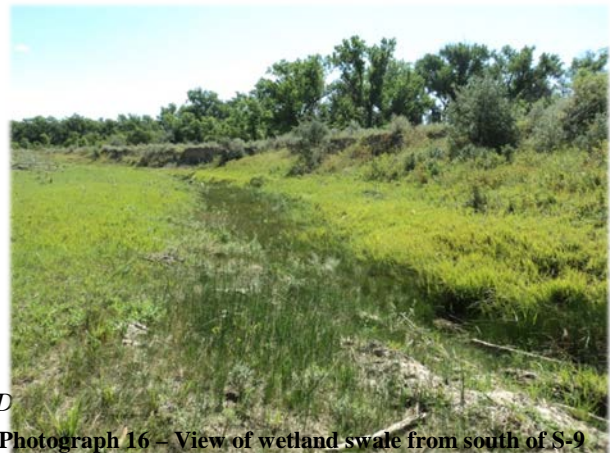
The palustrine emergent seasonally flooded (PEMC) wetlands likely fluctuate in size every year based on flow through the backwater channel. All areas have a direct connection to the Yellowstone River. Areas within the investigation area in Backwater Area A that are R2UBG and/or PEMC wetlands measure approximately 45 acres in size and are pixelated red on Figure 2. The side channel contained approximately 0.40 acres of PEMC wetlands and is shown in green on Figure 2.

**Photograph 16 – View of wetland swale from south of S-9 facing east**

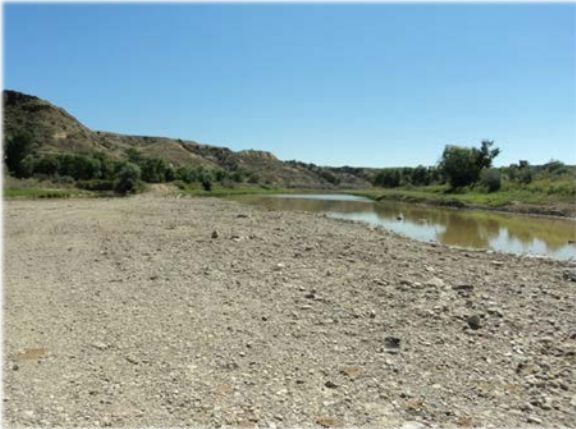
**Backwater Area B** – The NWI map classifies this area as Riverine Lower Perennial Unconsolidated Bottom Intermittently Exposed (R2UBG) channel backwater. See Figure 2 for backwater location. At the time of investigation there was very little vegetation within the area where an existing road would be improved to accommodate heavy machinery traffic. No vegetative species were recorded at Sample point 14 (S-14). Flow in the backwater was imperceptible and appeared to be stagnant. Sand and gravel were present adjacent to the open water areas. Backwater Area B connects directly to the Yellowstone River and contained approximately six acres of R2UBG habitat. See Photographs 17 and 18 below for depictions of this area.

**Photograph 17 - View of Backwater Area B from Photo Station 3 (PS-3) facing southeast**

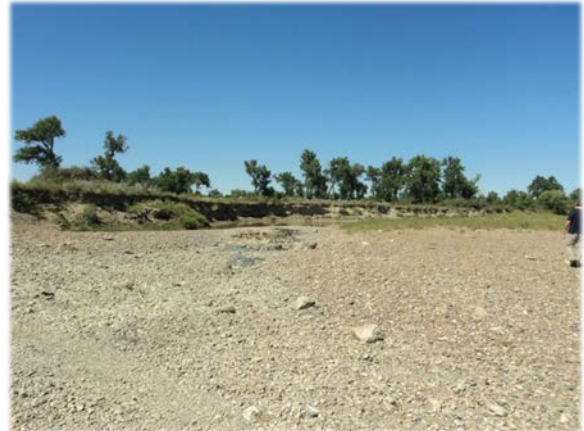
**Photograph 18- View of Backwater Area B from PS-3 facing northwest**

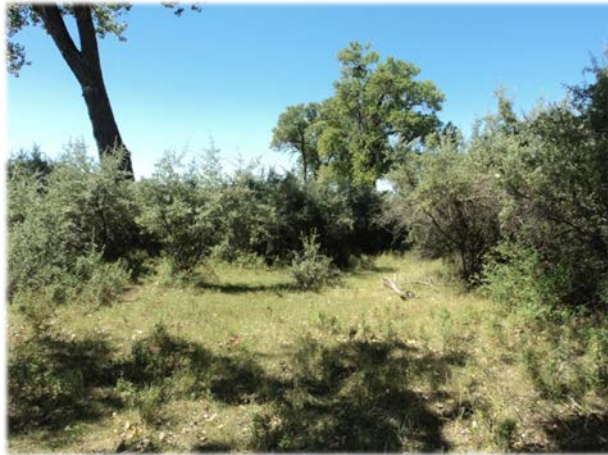
Sporadic cottonwood cover was present in patches across Joe's Island. *Populus deltoides* (Great Plains cottonwood) is a facultative tree (50% likelihood of being in a wetland) but was not the dominant vegetation within this community. Cottonwoods are approximately 75 feet tall with root systems likely as deep. These root systems probably penetrate through shallow groundwater systems which allow the cottonwoods to survive in an otherwise dry area. The understory of these areas contained upland shrubs, forbs and grasses. Leaf litter from previous growing seasons was present. See Table 9 for species identified in this area. Conditions were dry at the time of investigation. Several sample plots were placed throughout Joe's Island to document this community. Sample points S-8, S-11, S-12 and S-13 are depicted in Figure 2. No wetlands or waterways with an OHWM were identified in these areas. See Photographs 19 and 20 for typical views of the cottonwood gallery forested areas.

**Photograph 19 – View of cottonwood gallery forests near S-9 facing north**

The removal of mature cottonwood trees along the proposed bypass channel should be avoided to the maximum extent practicable. Modifying the alignment slightly and/or incorporating the trees into the bypass channel would preserve a scarce habitat in Montana and should be given consideration during the final design.

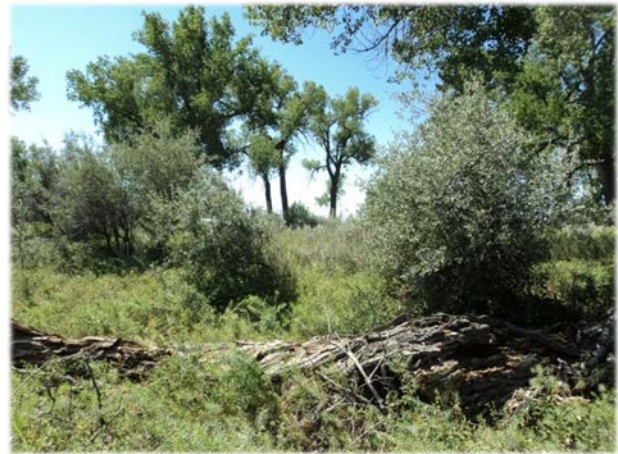
**Photograph 20 – View of cottonwood gallery forests near S-13 facing north**

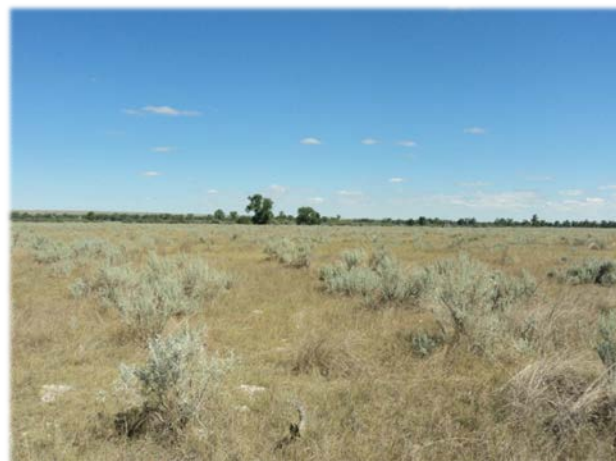
A majority of Joe’s Island is dominated by a sagebrush and crested wheatgrass shrubland community. Multiple species of sagebrush and buffaloberry dominate the shrub stratum while crested wheatgrass and leafy spurge dominate the herbaceous understory. Old meander scars and areas that looked dark on aeriels were investigated for wetlands or waterways. See Table 10 for species recorded at Sample point 10 (S-10) for typical vegetation in this

**Photograph 21 - Typical view of sagebrush and crested wheatgrass community from PS-4 facing north**

community. Conditions were dry and no wetlands or waterways with an OHWM exist. See Photo 21 for a typical view from Photo Station 4 (PS-4) of this community type.

The bypass channel would impact this community the most. Due to the availability of similar habitat on Joe’s Island, the cumulative impacts to the environment would be minor. Construction of the project would increase floodplain connectivity and increase the habitat diversity as compared to the existing monotypic habitat community.

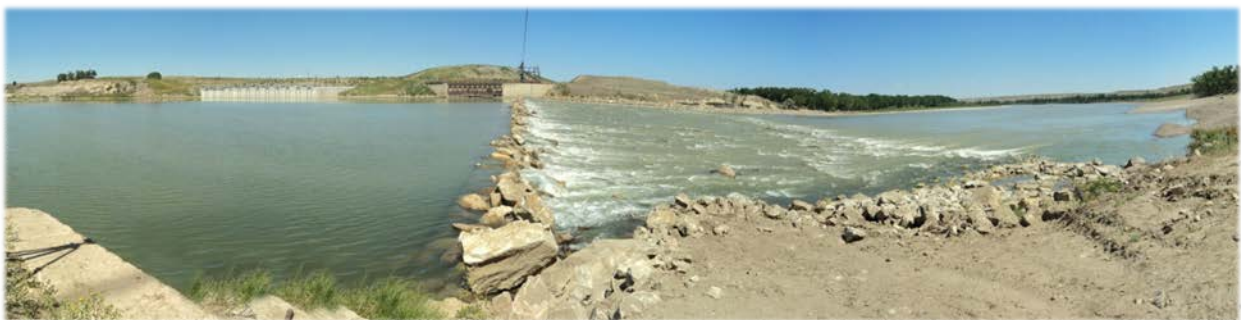
The NWI map classifies this area as a Riverine Lower Perennial Unconsolidated Bottom Permanently Flooded (R2UBH) channel. See Figure 2 for the location of the Yellowstone River. The banks ranged from steep to gradual and contained small patches of palustrine emergent seasonally flooded (PEMC) wetlands. The PEMC wetland acreage was estimated to be less than 0.05 acres and the area of potential disturbance to R2UBH river habitat is approximately one acre. See Table 11 for species identified along banks of the Yellowstone River and Photograph 22 for a panoramic view of this area.

**Photograph 22 - View of Intake Dam from right descending bank of the Yellowstone River facing north**

The Yellowstone River is a waterway with small patches of emergent wetlands along the shoreline. Both habitats would be considered jurisdictional waters of the U.S. Fill should be avoided from being placed in these locations to the maximum extent practicable. If temporary or permanent fill is placed into the river, than environmental conditions should be restored to a pre-disturbed state when the activity is completed.

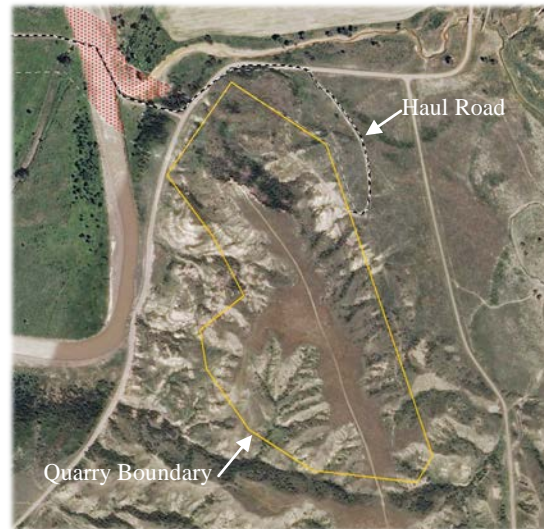
**Figure 3. Quarry site**

The desktop investigation indicated that this area likely did not contain wetlands or waterways. The quarry is on private land and permission was not obtained prior to the investigation, so investigators could not verify desktop findings in the field. Excavating material from here for construction on Joe’s Island and the Waste Pile Site should not impact any waters of the U.S. at this site. No avoidance or minimization techniques are recommended regarding sensitive habitats for Area 3. See Figure 3 for an aerial view of this location.
