Navajo Operations Environmental Impact Statement Water Quality Resource Report

*Western Colorado Area Office
Durango, Colorado
March 2002*

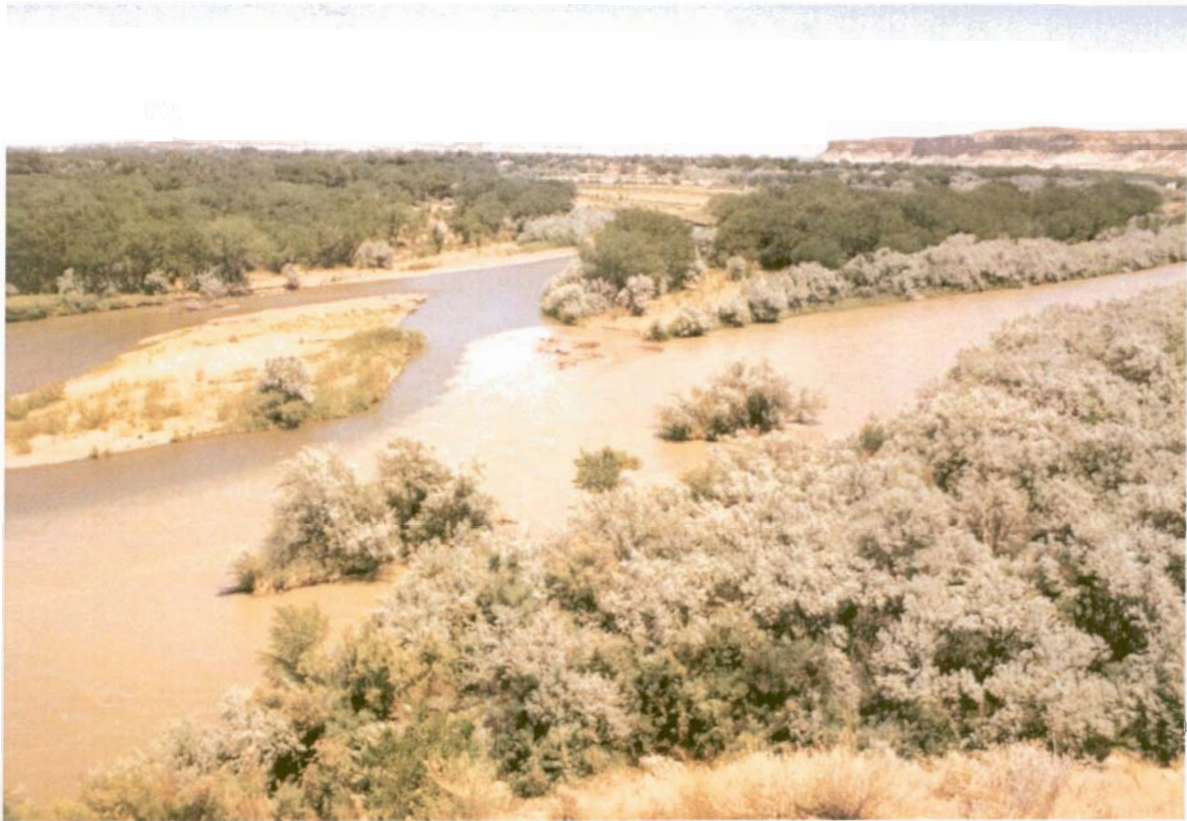
cover photograph - Confluence of the Animas and San Juan Rivers on June 6, 2000 during high flow release from Navajo Reservoir
