4.0 CONSULTATION AND COORDINATION

The following list summarizes the agencies contacted during the preparation of the Yuma, Arizona Welcome Center Parking Lot EA.

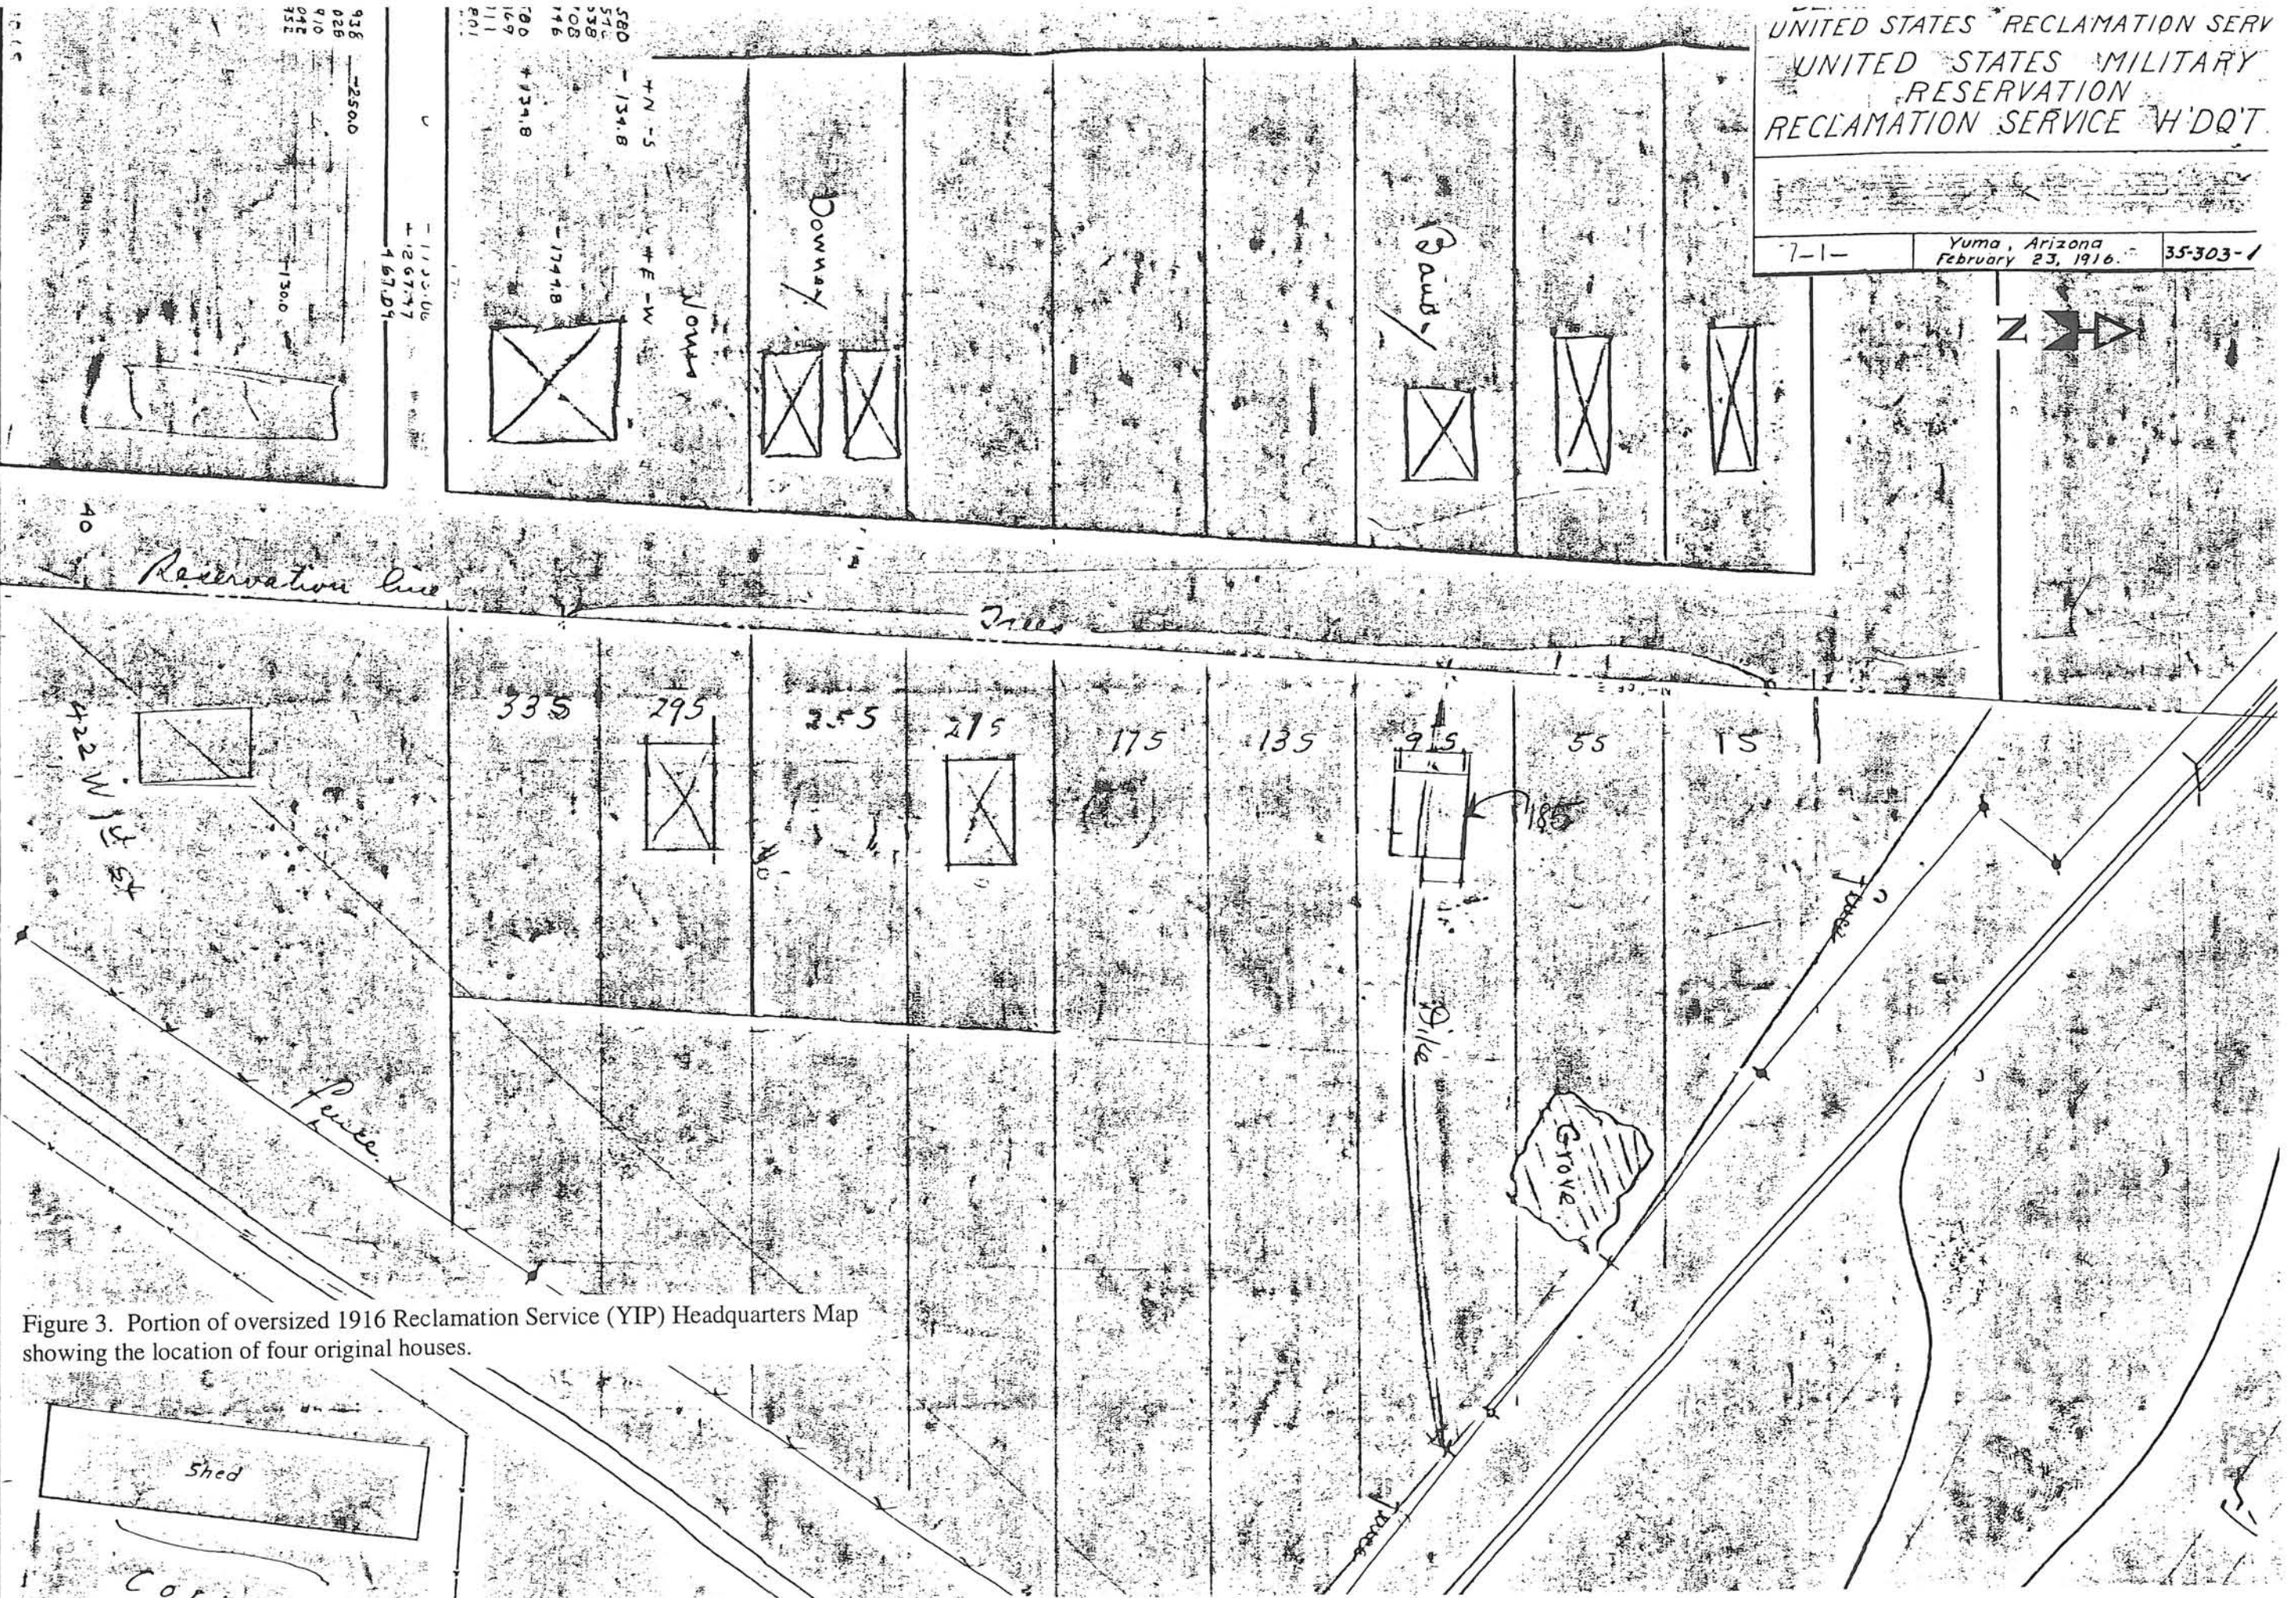
Figure 3. Portion of oversized 1916 Reclamation Service (YIP) Headquarters Map showing the location of four original houses.

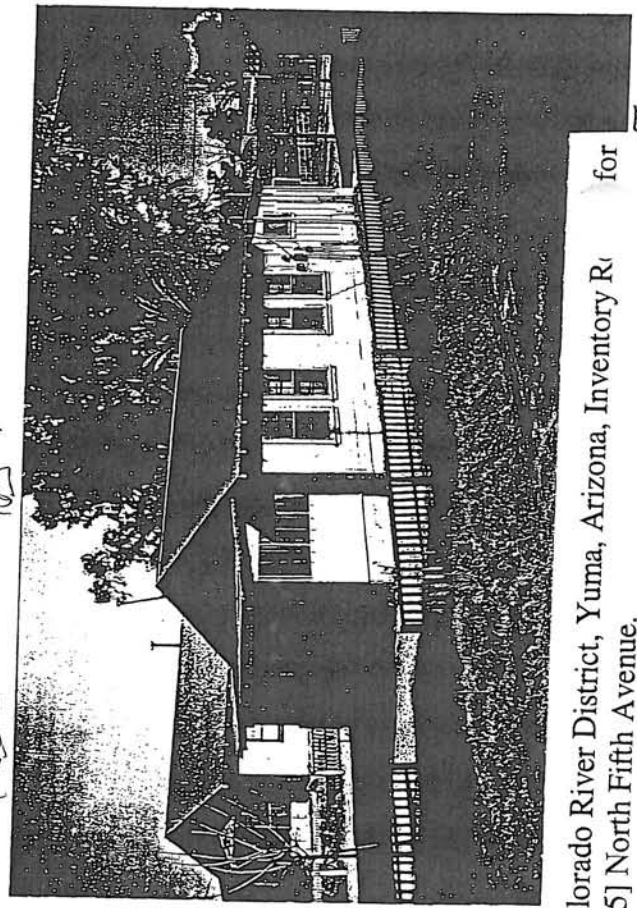
Figure 6 Over Colorado River District, Yuma, Arizona, Inventory R- for residence -- 115 [165] North Fifth Avenue.

Constructed on the Reservation Division of the old Yuma Project in 1918 by Government forces at a total cost of \$1,168.02, and moved to the present address and remodeled by Government forces from O & M funds in 1946. House is wood-frame construction, foundation and footings are concrete; wood floors; exterior walls are wood drop-siding; interior walls are wallboard or sheetrock; windows are wood double-hung; roof is covered with asphalt-roll roofing; screened porch across front of house; a shed-type addition on rear of house; kitchen and bathroom are outdated; single garage on same lot; quarters are substandard in construction and general condition.

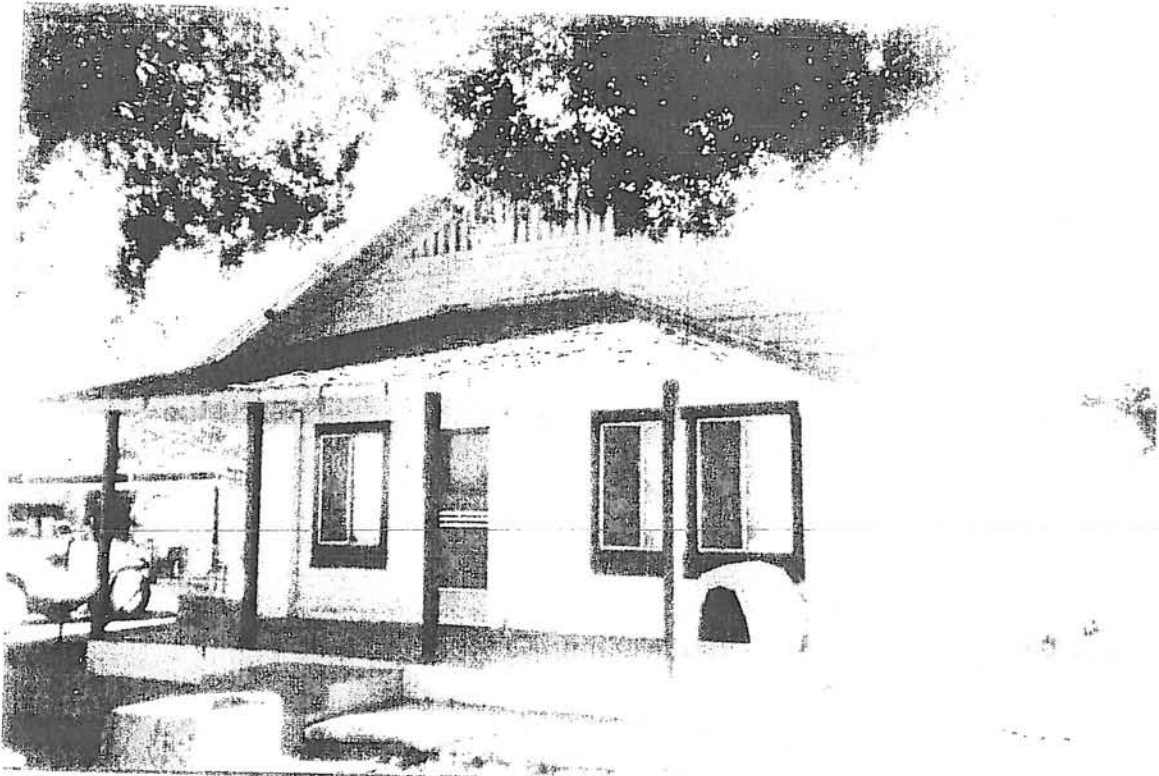
Residence at 185 W. Fifth Ave, Yuma, Arizona. View of west (front) and south facades.

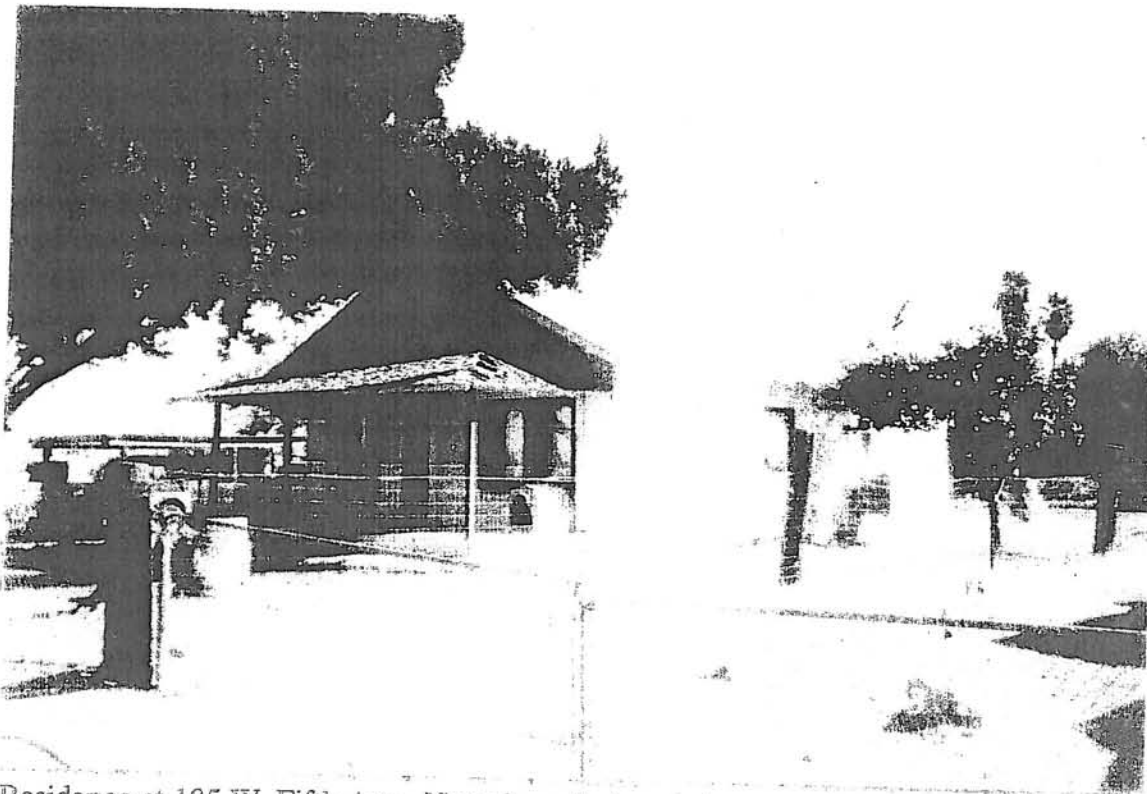
Residence at 185 W. Fifth Ave. Note the rolled asphalt on south-facing portion of roof.

Fair to good (some problems apparent). Describe: The original wooden shake roof shingles were removed from the south portion of the roof and those remaining are old and curled up around the edges. Consequently, past roof leakage is suspected.

Roof: Front gabled, low pitch roof. The north half of the roof and half-gabled (shed) roof over the front porch retain the original wood shake shingles; the south half has been replaced with rolled asphalt roofing.

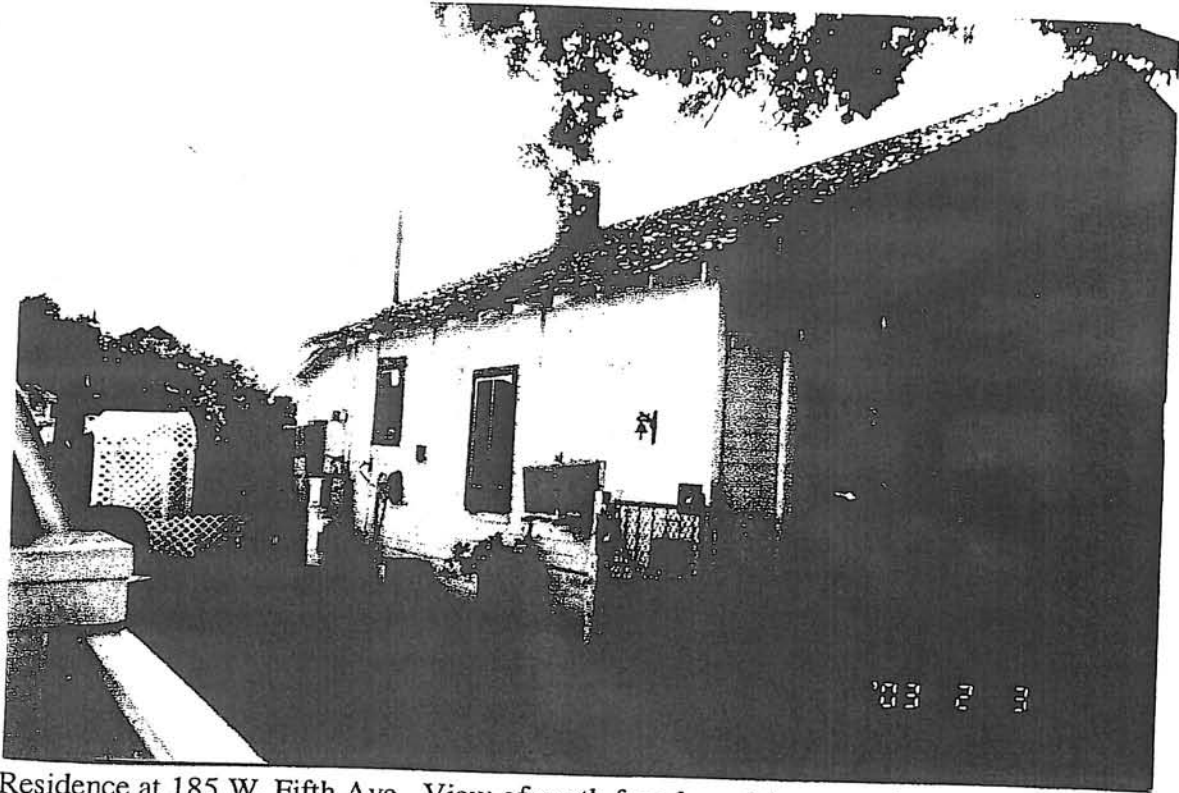
Residence at 185 W. Fifth Ave. View of north façade and front porch. Note boarded-up window holding air conditioner and wood shingles on north portion of roof.

The house has been altered in several ways: A former rear porch has been closed in and the original windows have been replaced with aluminum frame, sliding windows. An air conditioner has been installed in a north-facing window and the opening has been boarded up around it.

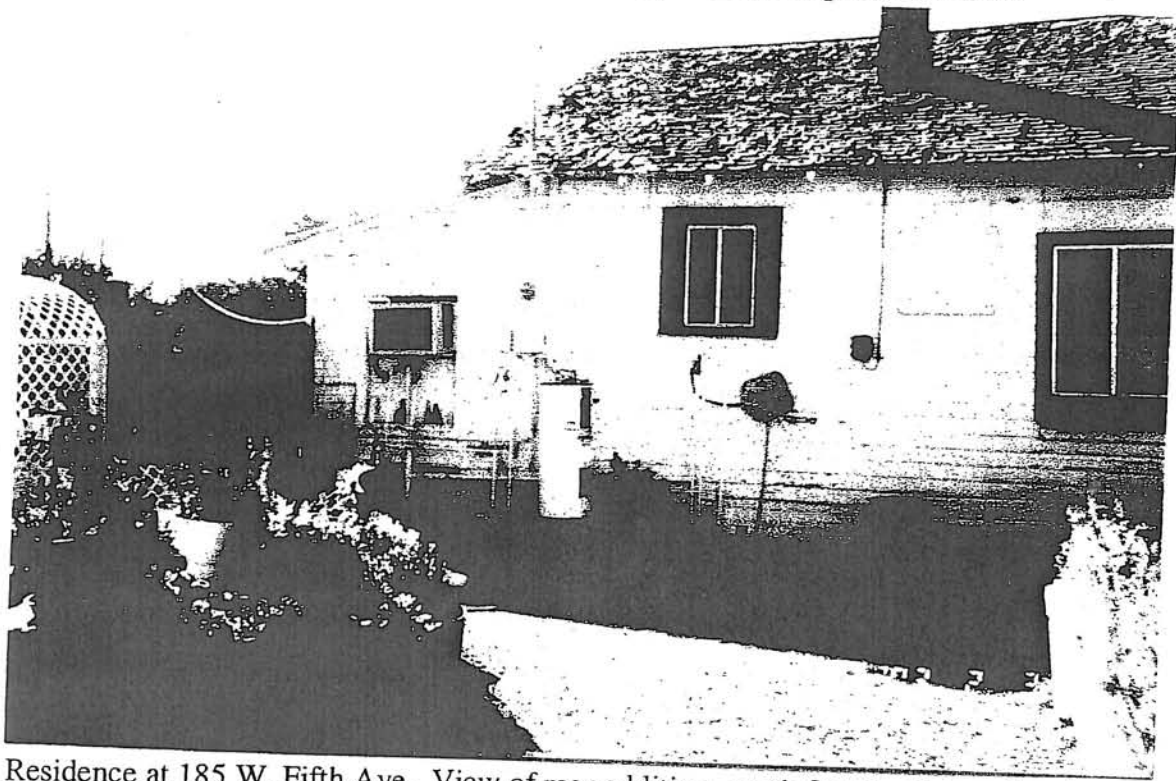
Residence at 185 W. Fifth Ave. View of rear addition, north façade. Note refitted aluminum windows.

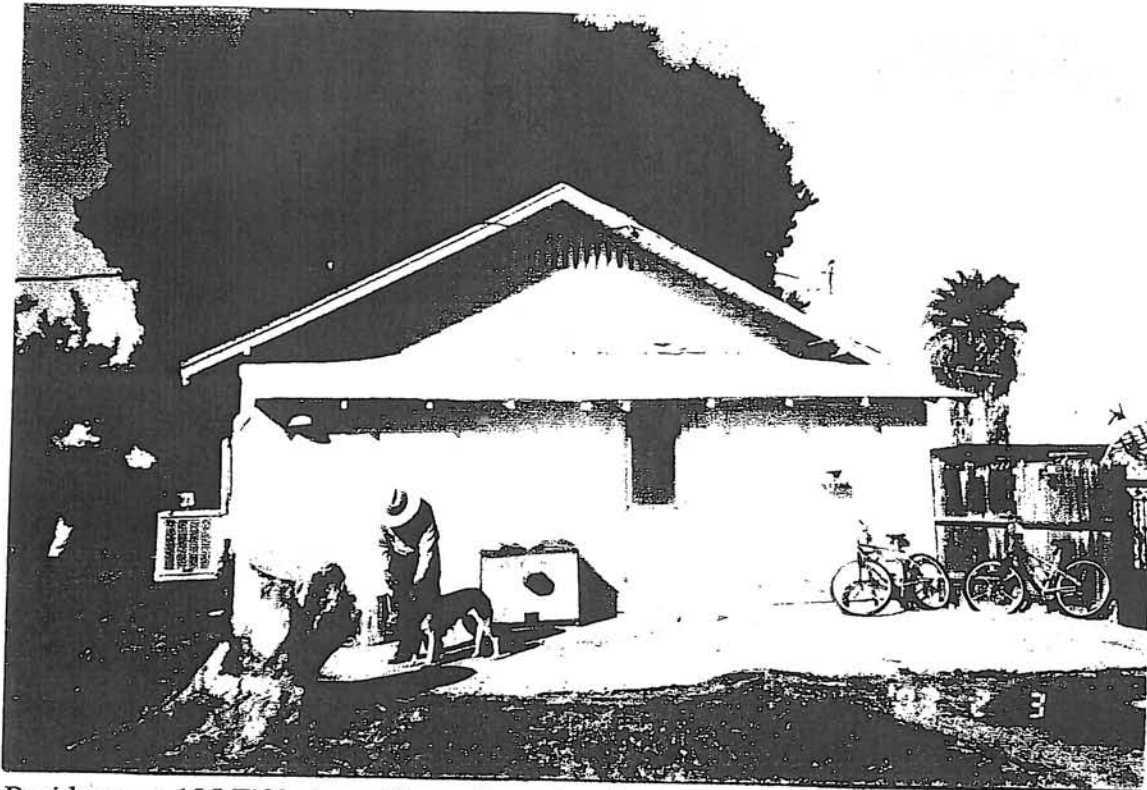
Residence at 185 Fifth Ave. View of east facade showing addition in rear of house (possibly a closed-in porch).

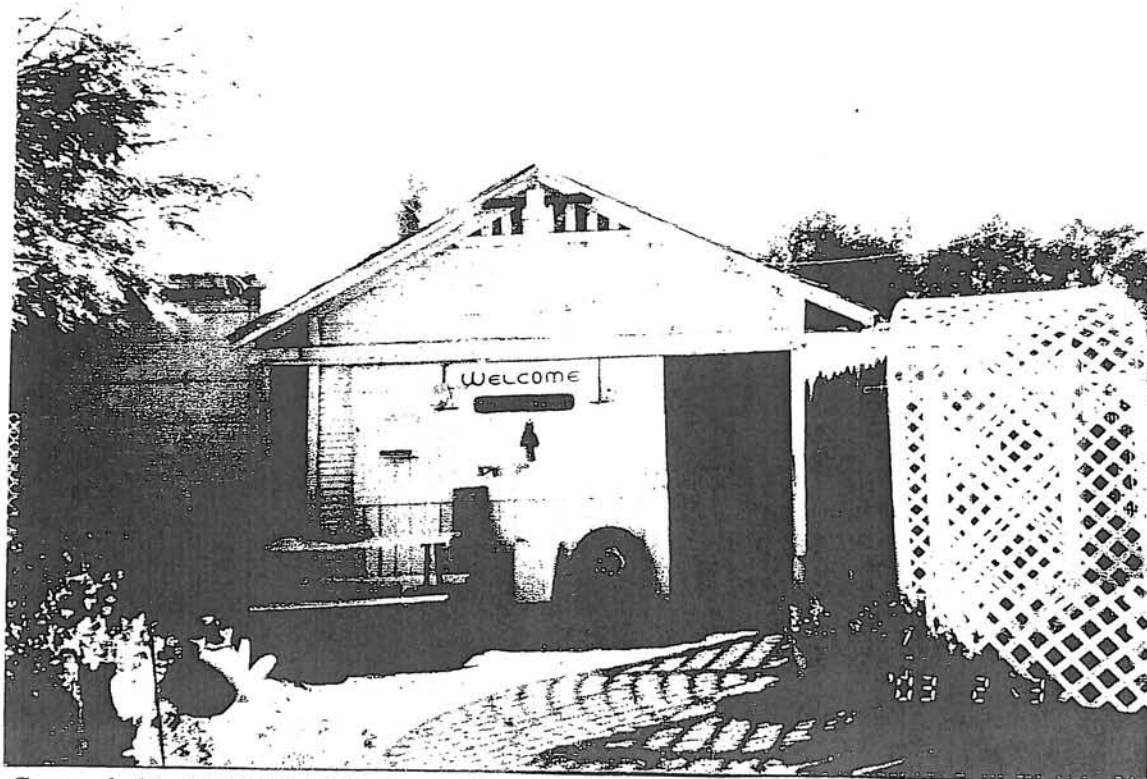
Garage behind 185 W. Fifth Ave. Note sliding wood double door.

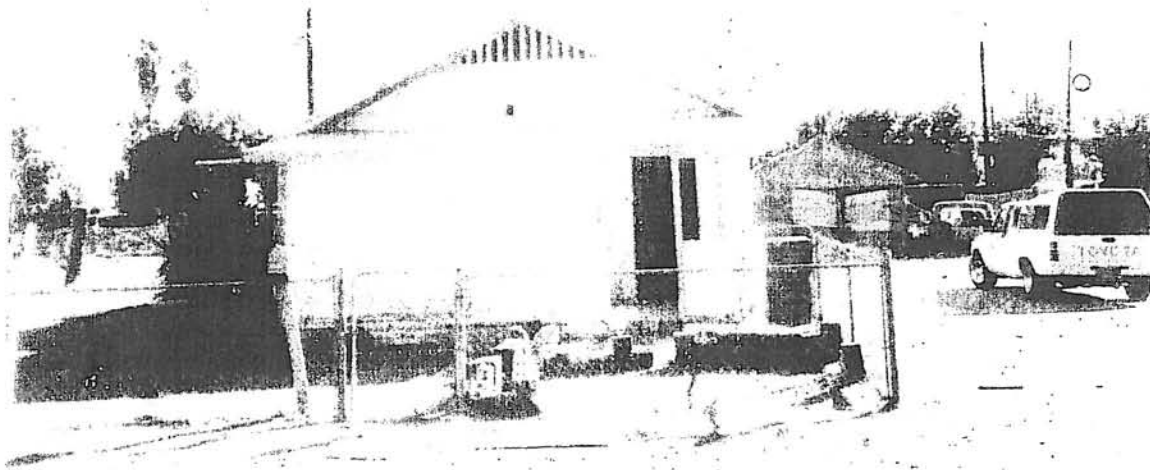
West (front) façade of residence at 165 W. Fifth Ave. Note enclosed porch.

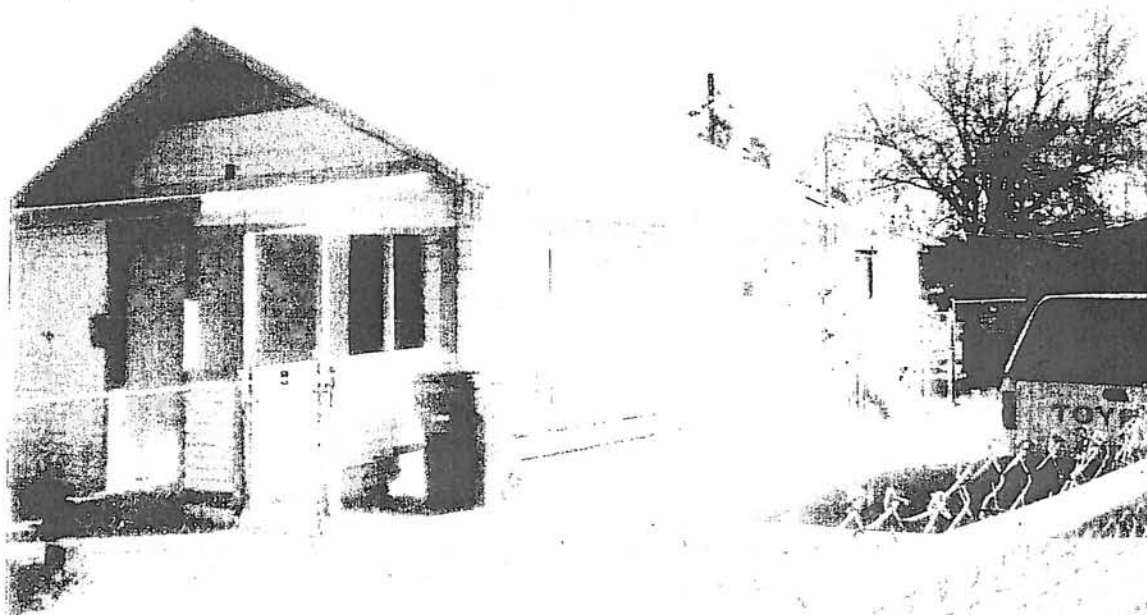
Porch and south façade of residence at 165 W. Fifth Ave. Note boarded-up window with air-conditioner, rolled asphalt roof, and rear addition.

The house has been altered in several ways: The front and rear porches have been closed in and the original windows have been replaced with aluminum frame, sliding windows. An air conditioner has been installed in a north-facing window and the opening has been boarded up around it. The roof covering is not original.

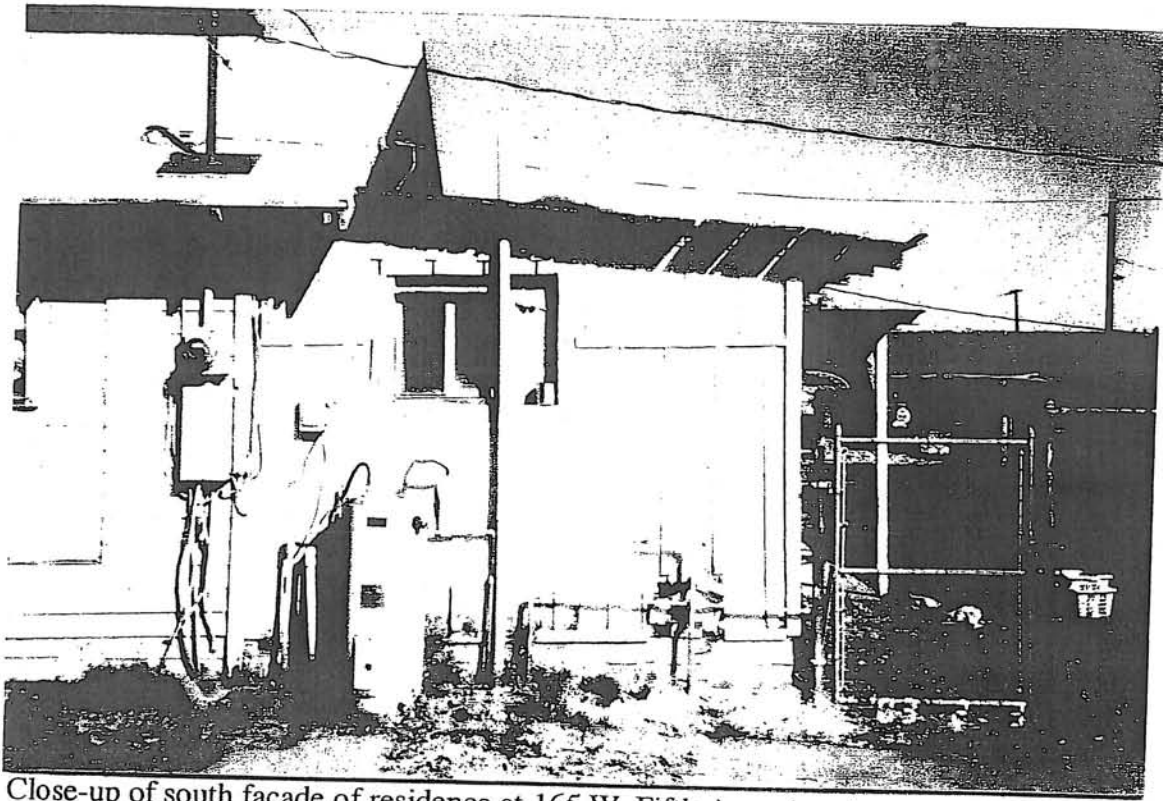
Close-up of south façade of residence at 165 W. Fifth Ave. showing rear addition with vertical plank siding.

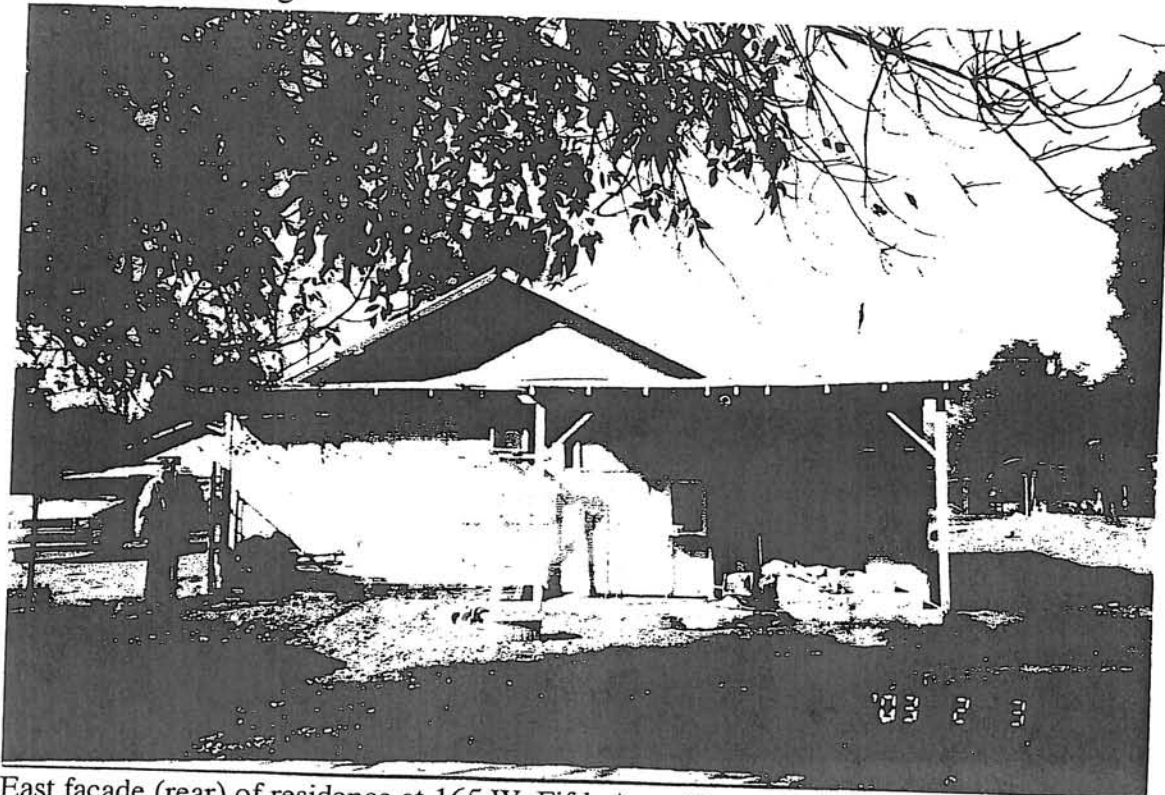
East façade (rear) of residence at 165 W. Fifth Ave. Note small covered patio and sliding door.

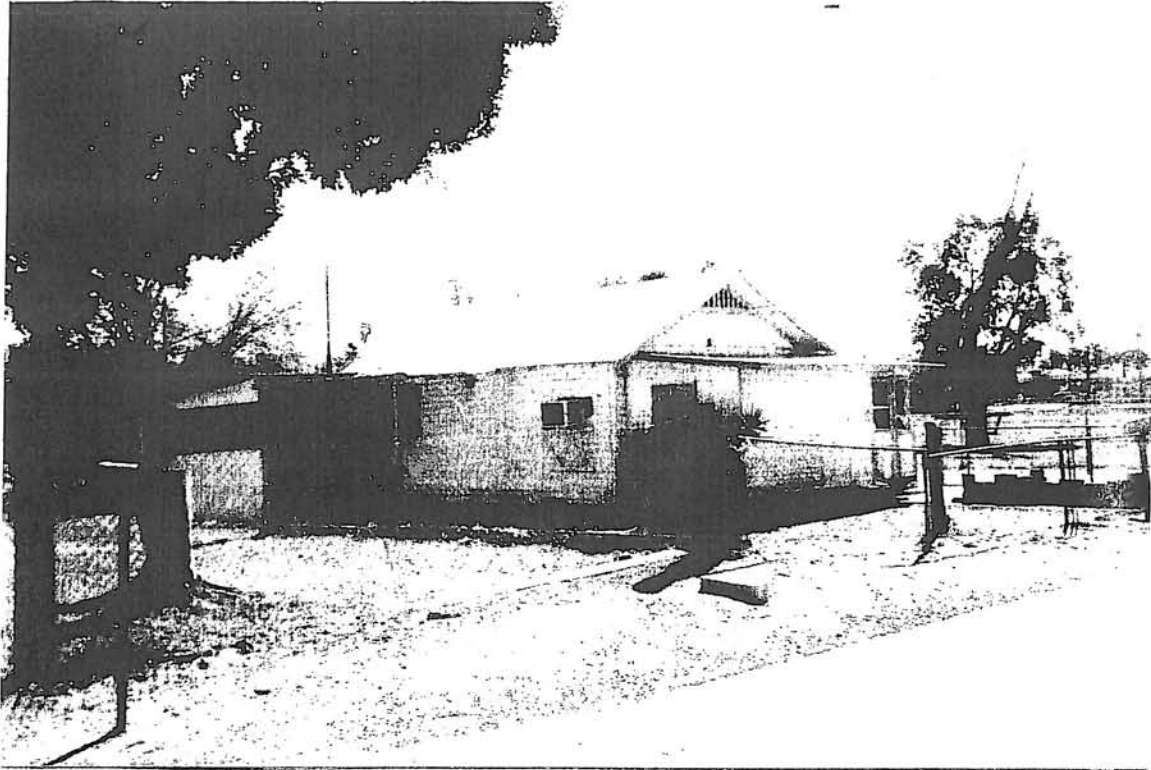
North façade and west-facing enclosed porch at 165 W. Fifth Ave. Rear addition extends 8-feet north of original walls; north window boarded up to enclose air conditioner.

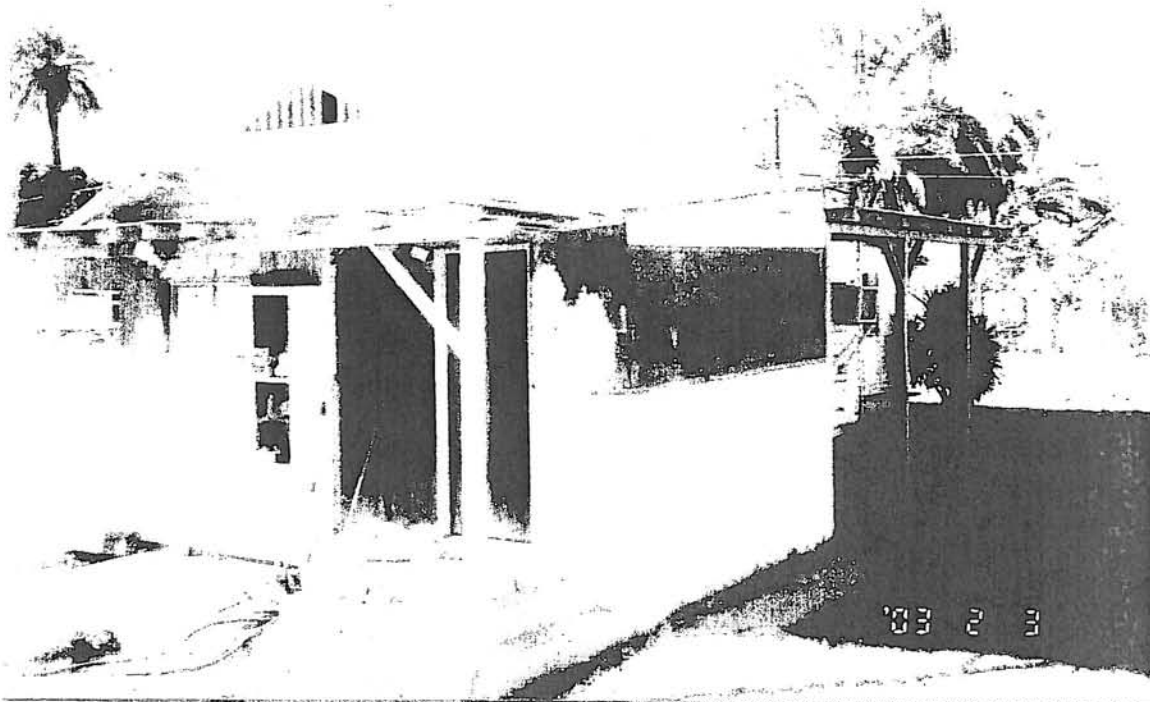
View of rear addition (northeast corner) of residence at 165 W. Fifth Ave.

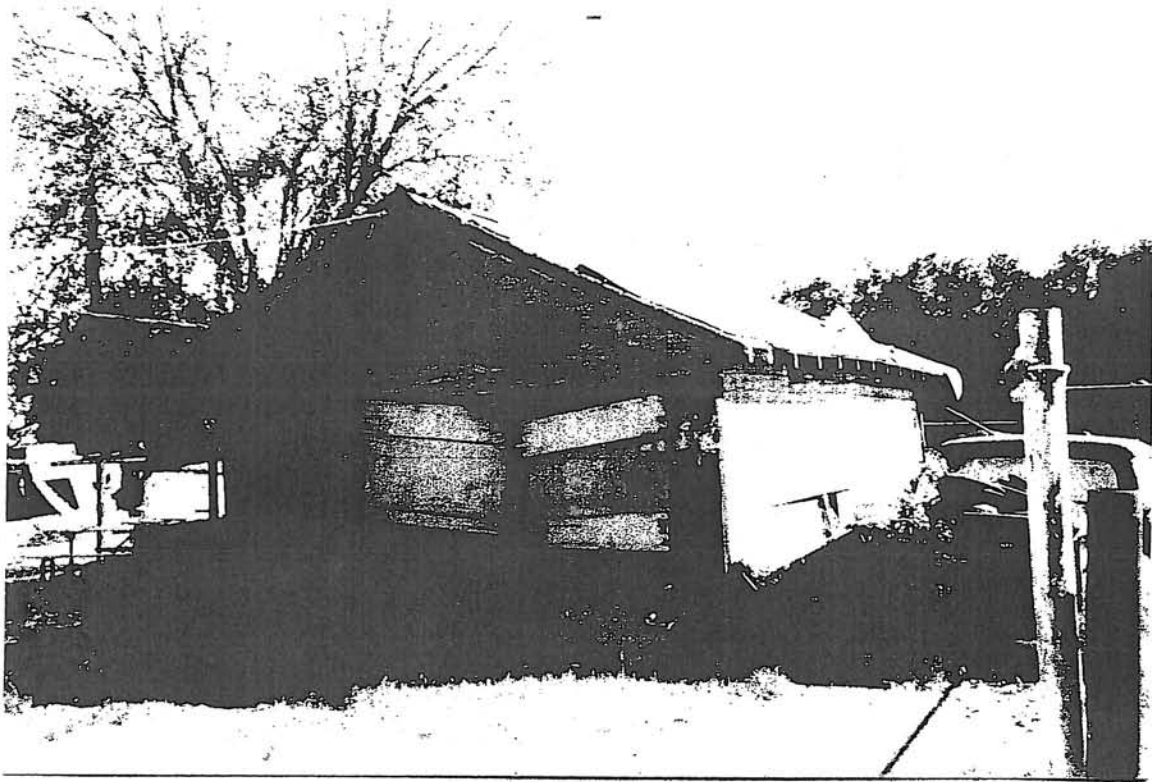
West-facing garage with double doors behind the residence at 165 W. Fifth Ave.

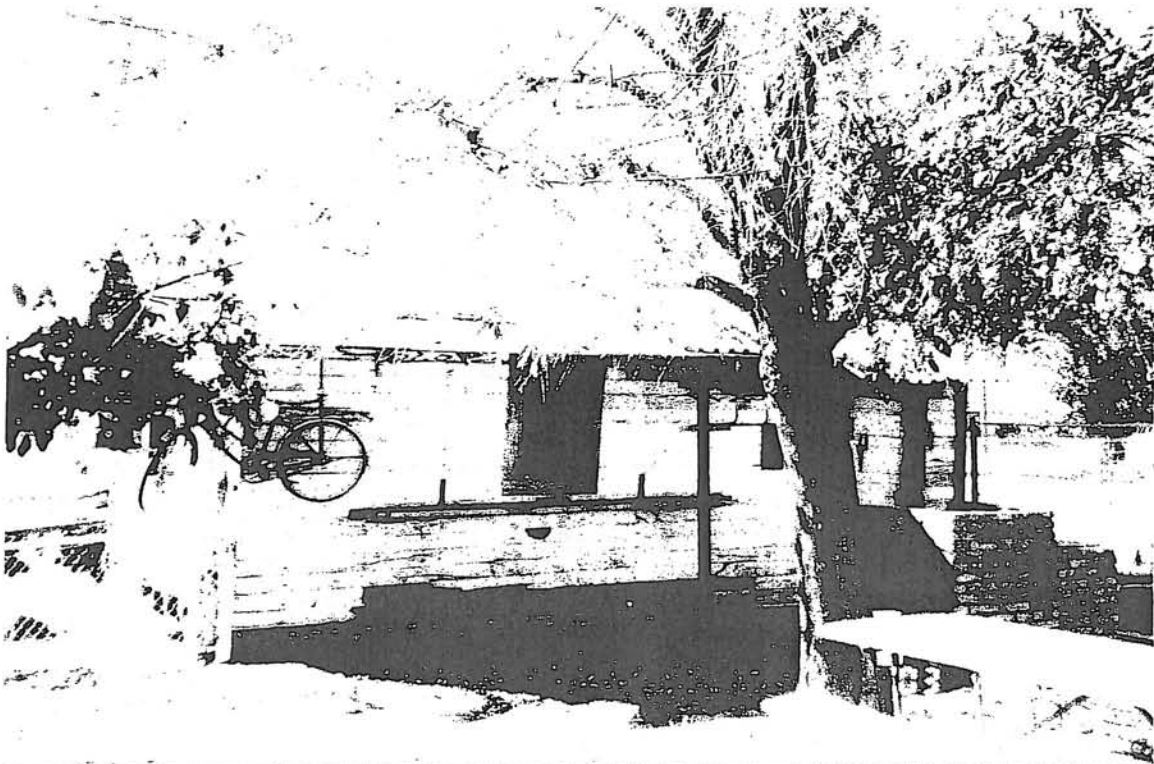
North exterior wall of garage at 165 W. Fifth Ave. Note missing siding and rolled asphalt roof.

Condition: The house and garage are in poor condition. The original siding is missing or rotted in several locations around the base of the house and the few replacement slats are ill-fitting. The window openings on the south exposure have been enlarged to accommodate aluminum windows that are much larger than the originals. The double doors of the garage have missing slats and sag in the middle and the roofing is loose in many areas.
