## **Evaluation of New Obstruction Lighting Techniques to Reduce Avian Fatalities**

May 2012

DOT/FAA/TC-TN12/9

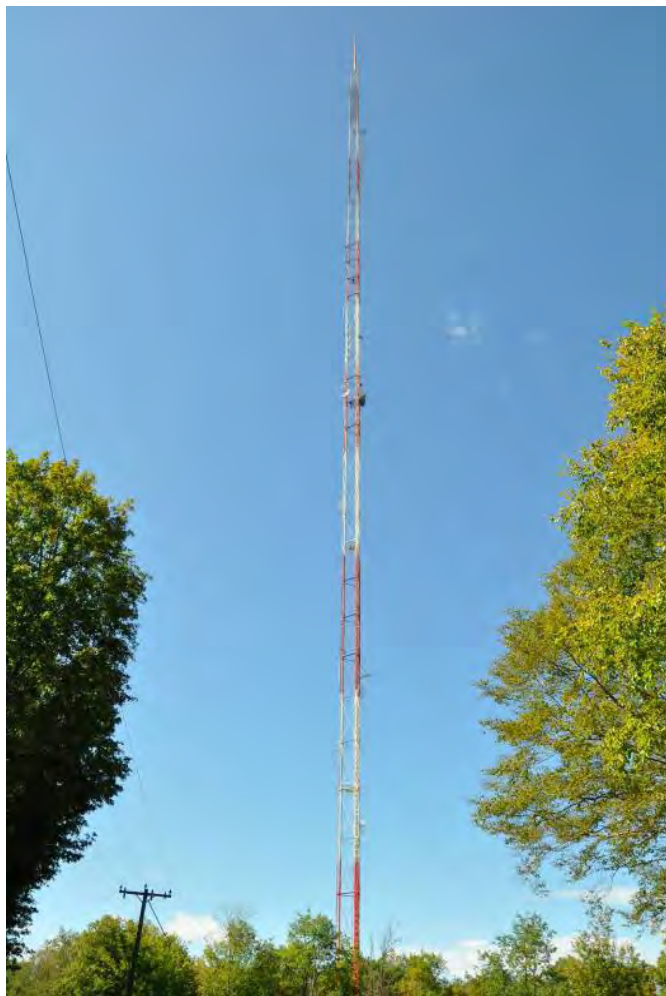
Figure 1. The WPBN Tower, Harrietta, Michigan

One structure included in this study was a television transmission tower located near Harrietta, MI, which is about 31 miles east of Lake Michigan and about 15 miles to the west of Cadillac, MI. The tower is owned by WPBN, a television station based in Traverse City, MI. It stands 1130 ft above ground level (AGL), with the tip of the tower at 2549 ft above mean sea level (see

figure 1). The tower is indicated on the Green Bay Sectional Aeronautical Chart, shown in figure 2. The tower is painted in alternating bands of aviation orange and white as required by the FAA, and has 18 guy wires that support the tower (see figure 3). The tower, constructed in 1961, was the focus of a 1962 bird mortality study conducted by Dr. Larry Caldwell from Central Michigan University [4]. This study concluded that the tower was directly in the path of a major migratory flyway that hundreds of thousands of birds traveled during each migration season. Between 1962 and 1972, researchers found 2192 dead birds at the base of the tower, with the highest single night count of 692 dead birds found on September 23, 1964 [5]. In 1991, after several years of negotiation, a Special Use Permit was issued to WPBN to allow for the lighting to be switched to a nonstandard nighttime configuration in which the normally steady-burning red L-810 lights were programmed to flash simultaneously with the brighter red L-864 flashing lights.

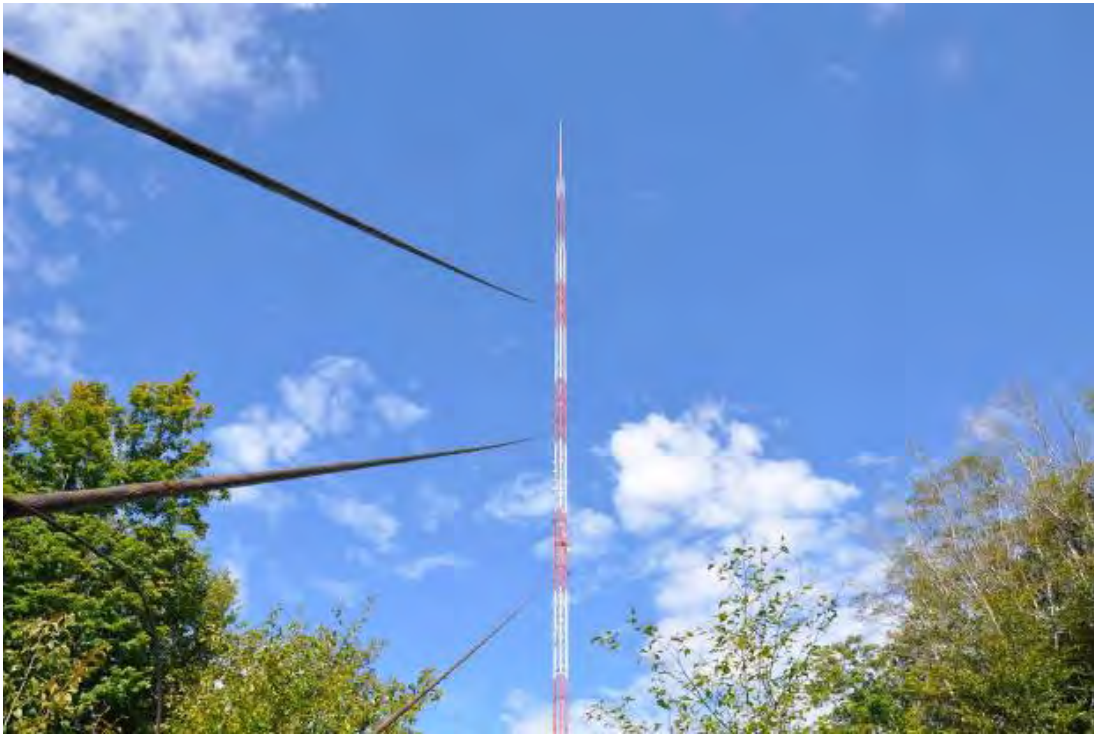
Figure 3. Guy Wires Supporting the WPBN Tower

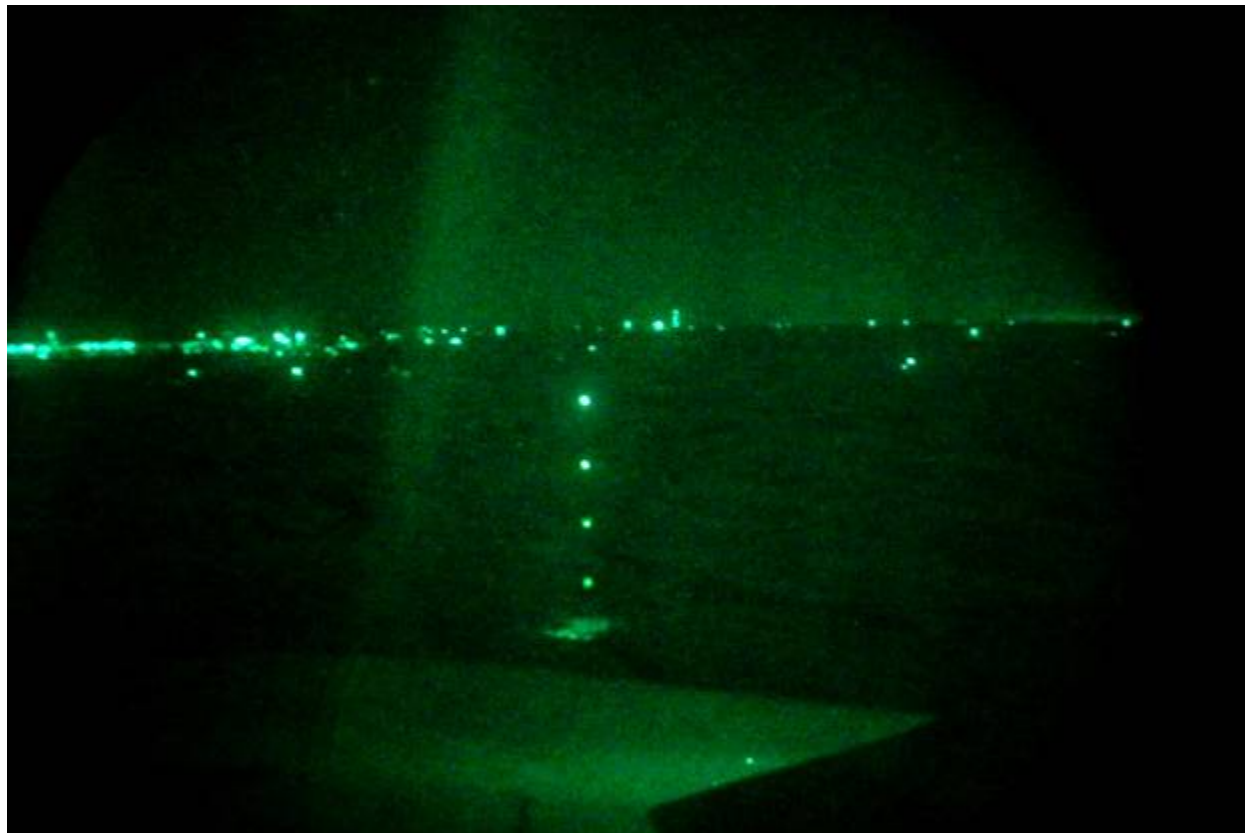
Figure 9. View of the WPBN Tower Without L-810s Through a Night Vision Scope

The researchers also took video of the tower through a night vision scope to verify how the tower looked without the L-810s. As noted in the June 2, 2010, evaluation, there was sufficient light for the night vision scope to detect the tower without creating any distractions or problems for the user. Figure 9 shows an image of the WPBN tower without the L-810s, as observed

through the night vision scope. Note how the L-864s are still very prominent in figure 9, just as they are in figure 7. The L-864s provided the most prominent light source for the night vision scope; therefore, omitting the L-810s did not adversely affect the presentation. At the conclusion of the evaluation, the L-810s were turned back on and restored to their pre-evaluation settings.

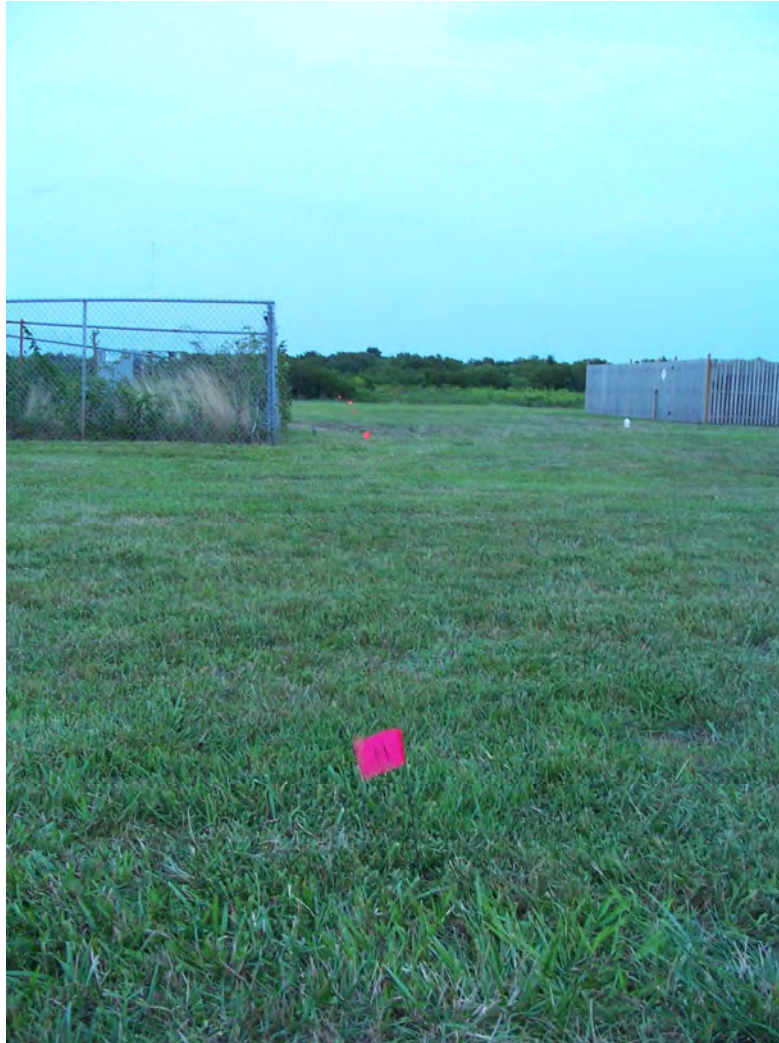
Figure 3. A Cape May, NJ United States Coast Guard Rescue-21 tower was the focus of a study on avian collisions in May and September 2008 and 2009. Flags were systematically placed within the search area to facilitate methodical searches for avian carcasses.

The tower was searched 7-26 May and 11-30 September, 2008 and 7-26 May and 11-30 September, 2009. After onsite training, the technicians arrived at the tower as early in the day as possible in an effort to prevent diurnal and crepuscular scavengers from removing carcasses. Using flagged, straight-line transects, the technicians walked at a rate of 45-60 m per min and searched for carcasses within 5 m on either side of each transect (Fig. 3, Gehring et al. 2007, Erickson et al. 2003). Transects covered a circular area under the tower with a radius of 90% of the height of the tower. Bird carcasses were placed in plastic bags, and the following data were recorded: tower identification number, date, closest transect, distance from tower, azimuth to the tower, estimated number of days since death, and observer's name. Once bagged and labeled, carcasses were frozen for later identification and verification of species. I maintained the appropriate USFWS and New Jersey Department of Environmental Protection- Division of Fish and Wildlife permits for collection of bird carcasses.

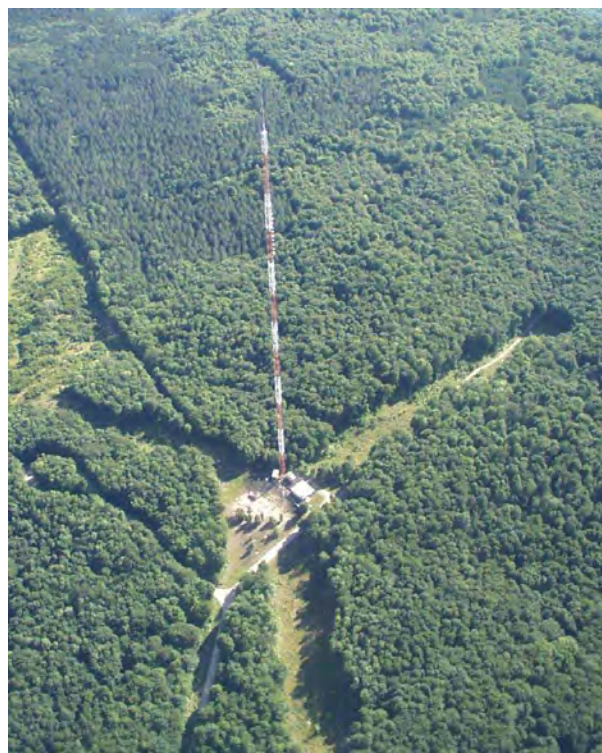
Figure 5. Seven communication towers located throughout the lower Peninsula of Michigan were included in a study of avian collisions (six each season). The areas under these towers were simultaneously and systematically searched for bird carcasses during 20 consecutive mornings surrounding the peak of songbird migration in the spring and fall 2008 and 2009 to compare the relationships between avian fatalities and tower lighting systems.

Research was conducted at 6 communication towers distributed throughout the lower peninsula of Michigan, USA. Towers > 277 m AGL were selected based on granted access by tower owners, existing tower lighting systems, and their dispersion throughout the study area (Fig. 5). Towers located within 1.6 km of an extensively-lit area (e.g., large urban area) or within a tower farm (additional communication tower(s) within 0.81 km) were not included in the study. This procedure prevented a situation where communication tower lights might be less visible to birds or “washed-out” due to sky glow in the surrounding areas (Caldwell and Wallace 1966). I was granted access to two towers lit at night with red blinking lights (L-864) combined with red non-blinking lights (L-810), three towers lit at night only with white strobes (L-865) and no non-

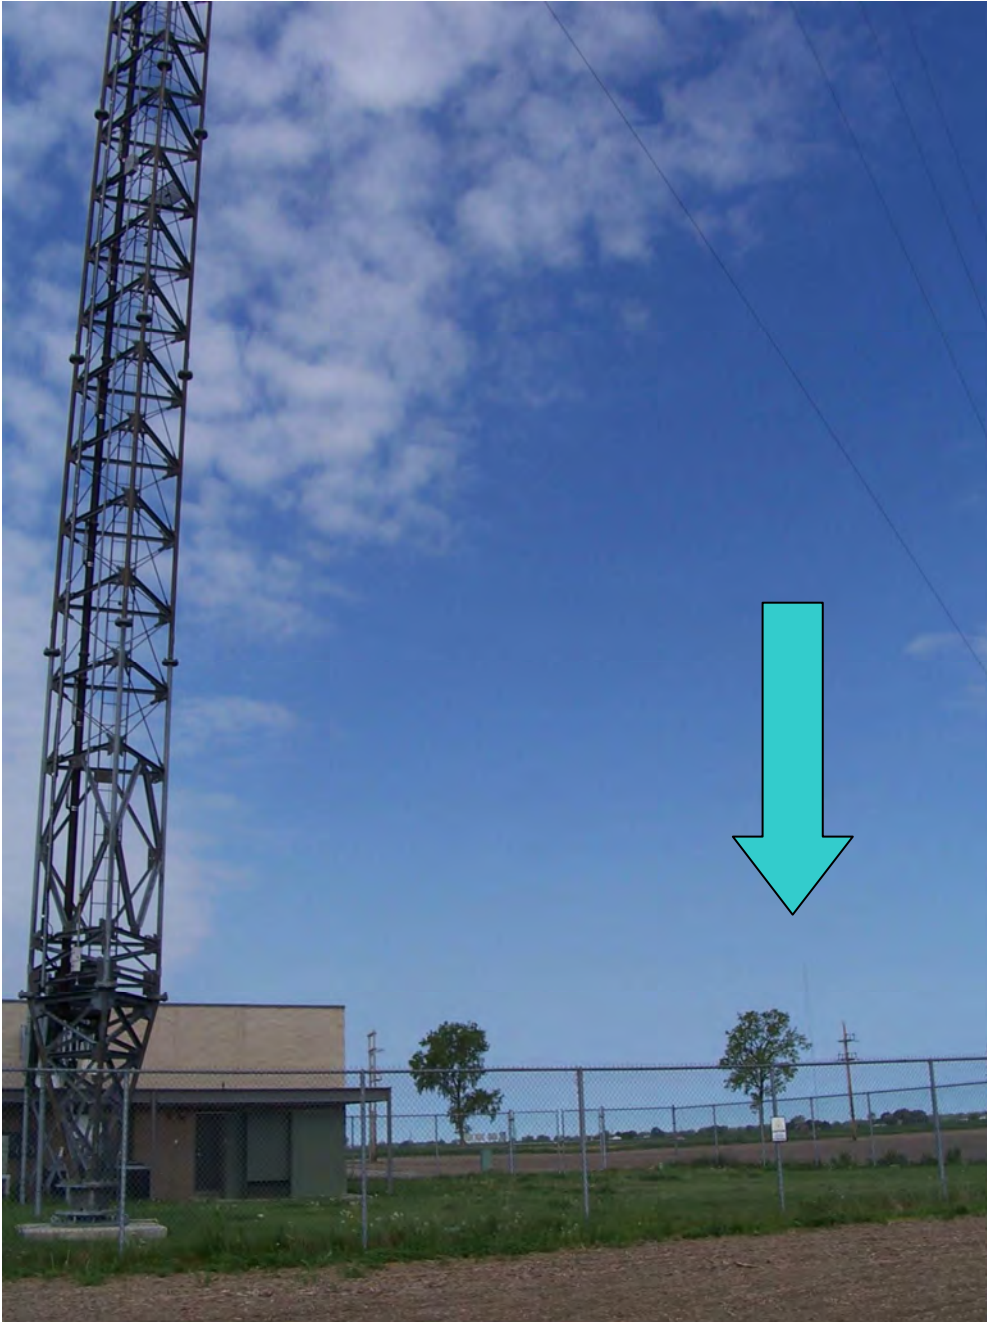
Figure 9. Communication tower lighting systems were compared at 2 Michigan towers > 277 m Above Ground Level that were separated by 1.25 miles. The areas under these towers were simultaneously and systematically searched for bird carcasses during 20 consecutive mornings surrounding the peak of songbird migration in the spring 2009 to compare the relationships between avian fatalities and tower lighting systems. The tower delineated by the blue arrow was lit with white strobe lights and was involved in 2 avian fatalities, while the more proximate tower was lit with non-blinking and blinking red lights and was involved in 33 avian fatalities.

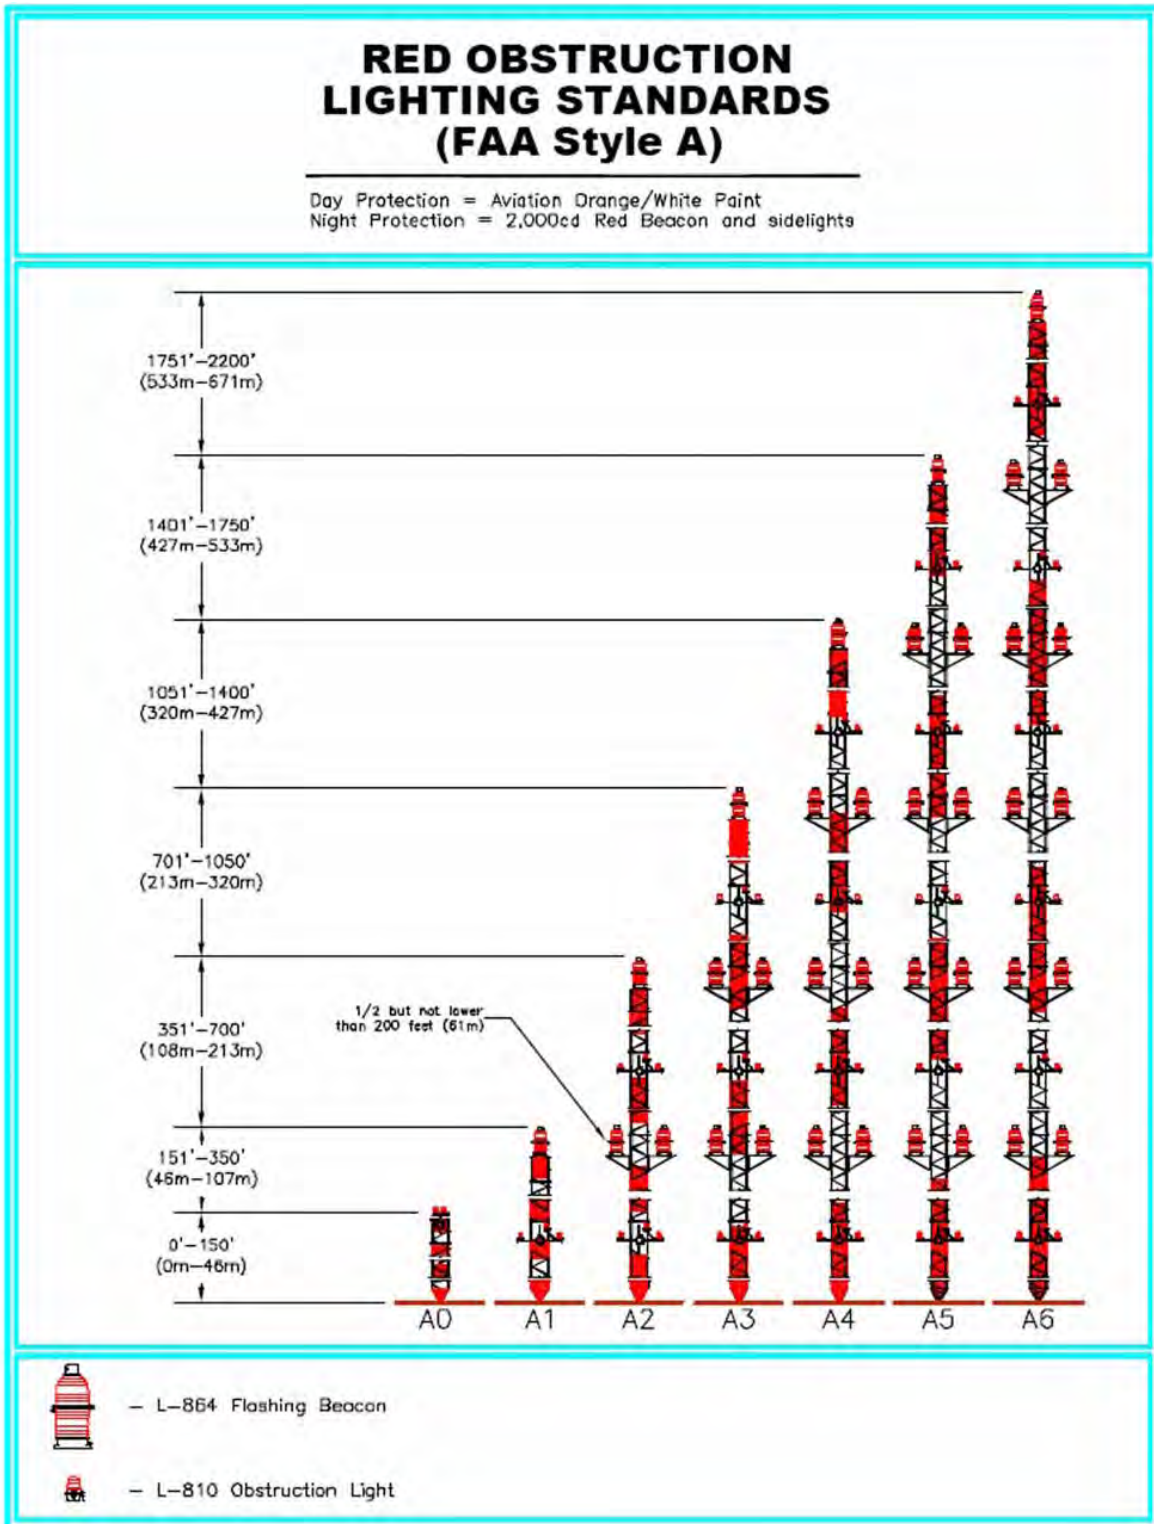
Figure B-1. The Federal Aviation Administration Style A Lighting Configuration

- FAA Styles A/F (figures B-1 and B-6)—a combination of steady-burning red L-810 and flashing red L-864 light fixtures on a tower approximately 1000 ft high.
- FAA Styles B/C (figures B-2 and B-3)—a series of high-intensity white strobe lights on a tower approximately 1200 ft high. Figure 4 shows this tower with the white lights illuminated.
- FAA Style E (figure B-5)—a combination of steady-burning red L-810 and a flashing red L-864 light fixtures on a cellular phone tower approximately 300 ft high.

FAA LIGHTING STYLE A, RED OBSTRUCTION LIGHTING STANDARDS (as shown in figure B-1). Lighting style A is the preferred lighting configuration, as it incorporates alternating bands of aviation orange and white paint for day protection and a combination of red flashing L-864 beacons and steady-burning L-810 sidelights for night protection. For this particular lighting scheme (figure B-1), the required lighting configurations are divided into seven categories that are based on the height of the tower structure. These categories are designated A-0 through A-6, with A-0 being the lowest. The categories for towers higher than 351 ft (A-2 through A-6) have similar requirements, with additional sets or levels of L-864s and L-810s added as the height of the tower increases.

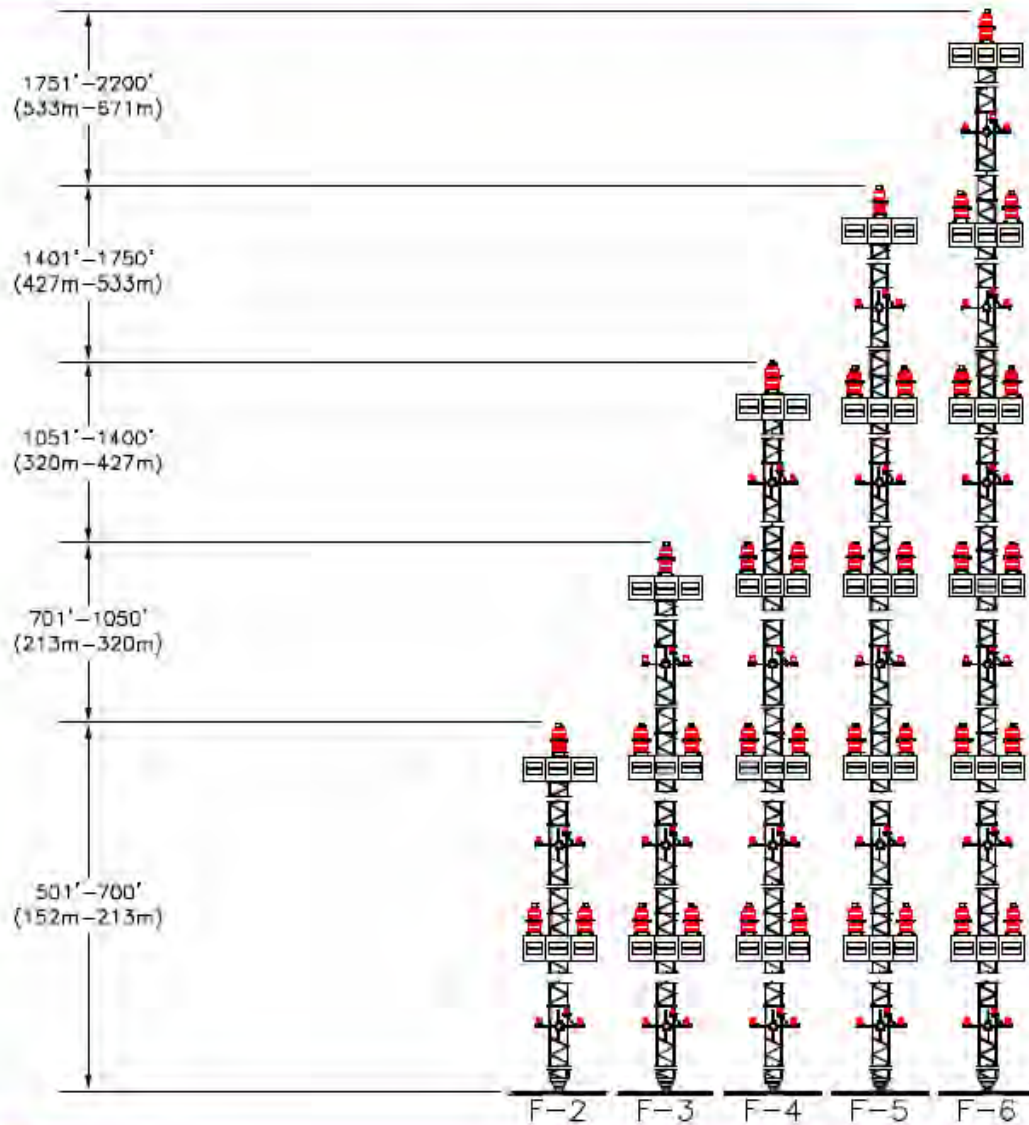
# DUAL HIGH INTENSITY OBSTRUCTION LIGHTING STANDARDS (FAA Style F)

Day Protection = 200,000cd White Strobe  
 Twilight Protection = 20,000cd White Strobe  
 Night Protection = 2,000cd Red Beacon and sidelights

Figure B-6. The Federal Aviation Administration Style F Lighting Configuration

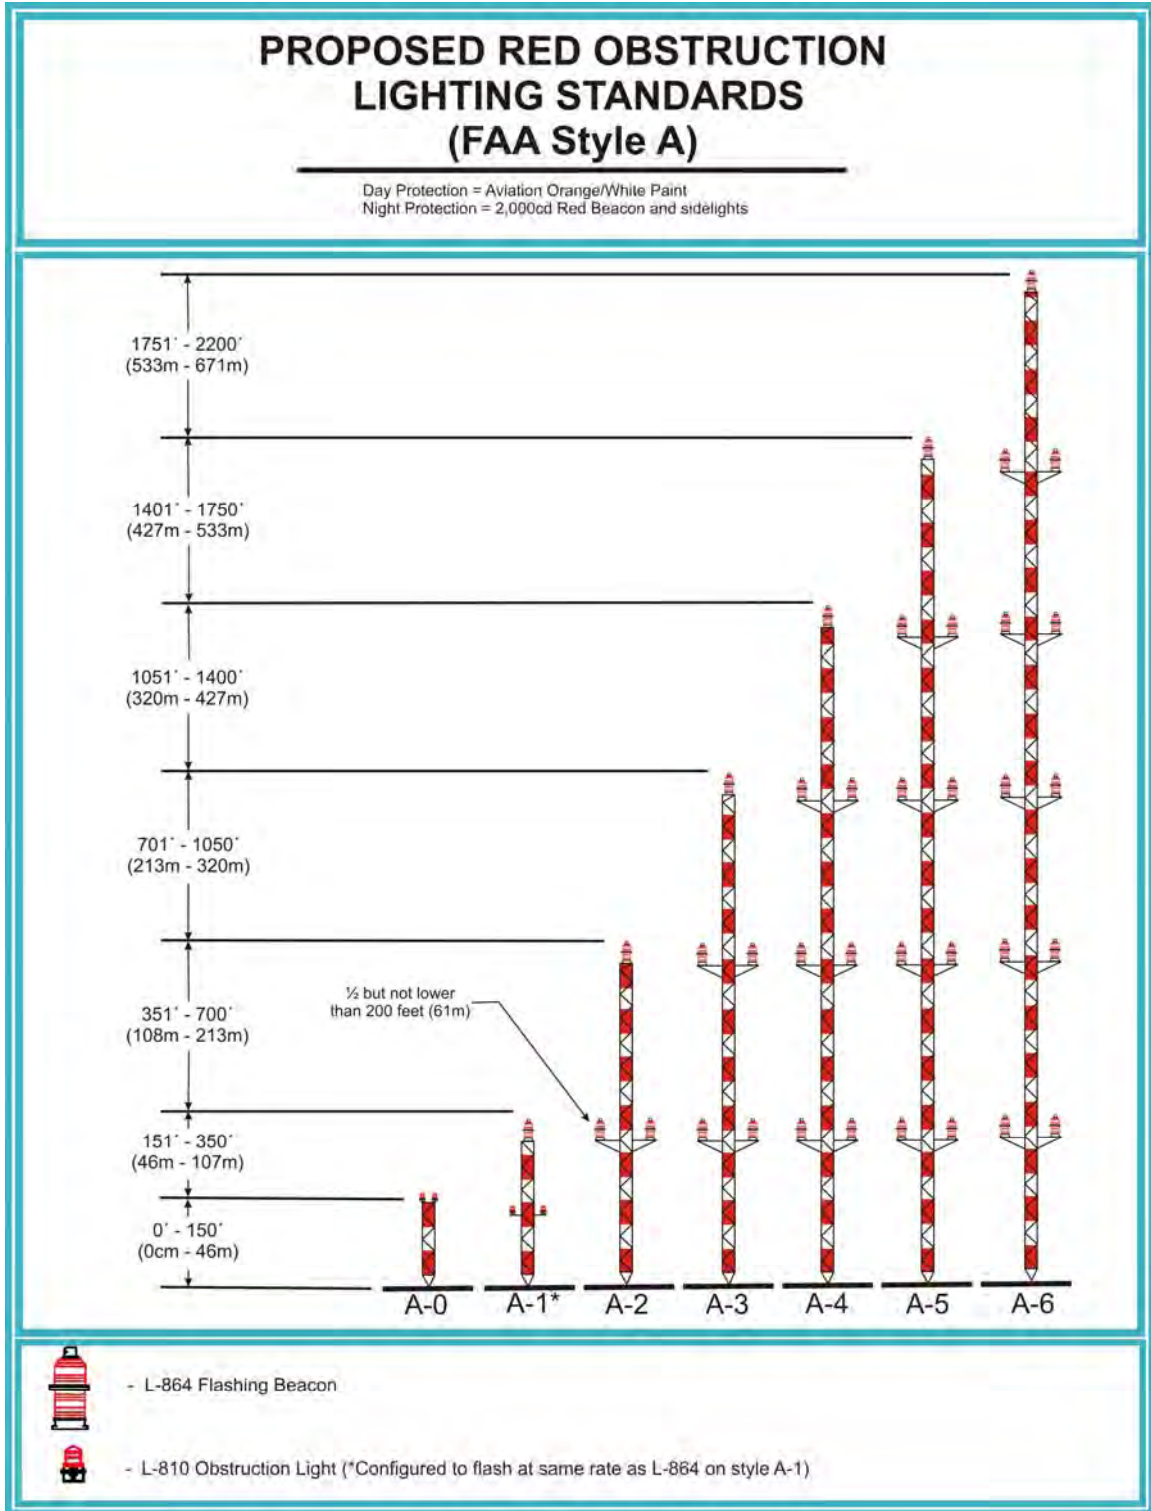
Figure C-1. Proposed Federal Aviation Administration Style A Lighting Configuration

The researchers recommend option 1 because it makes use of the fixtures that are already there and would only require minor rewiring to connect the light circuits together to make the L-810s flash with the L-864. The FAA would be required to modify the standard for the L-810 to include the provision that it can be flashed at the same rate and duration as the L-864.
