San Juan River Water Quality before, during and after the Gold King Mine Spill

U.S. Department of the Interior
Bureau of Reclamation
Technical Service Center
Denver, Colorado

June 2016

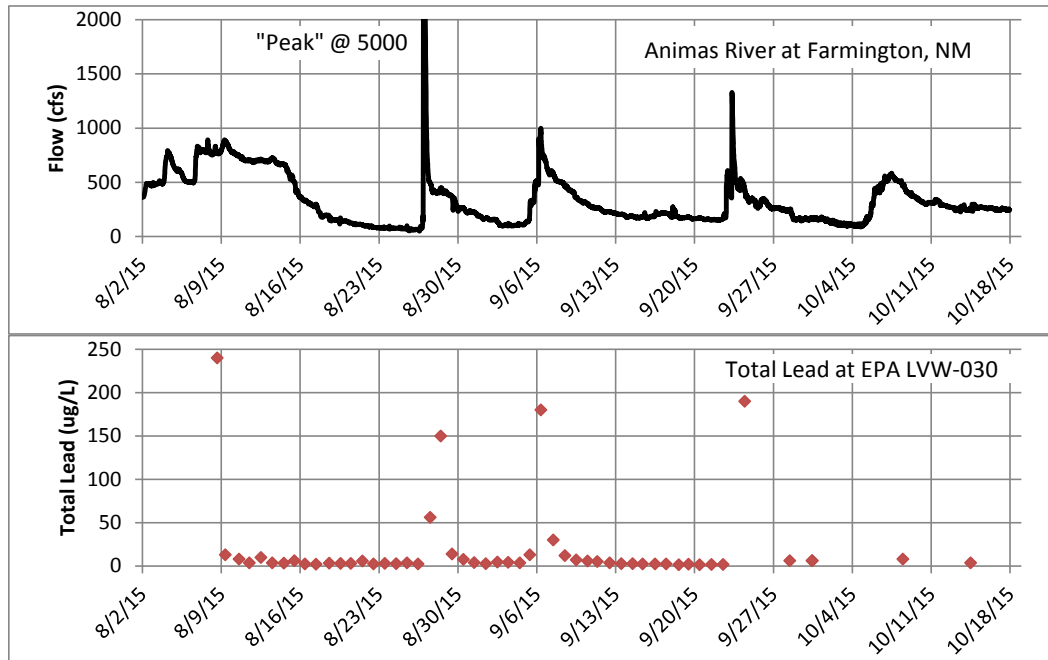
Figure ES-1. Flow in the Animas River at Farmington, NM and total lead concentration at the EPA LVW-030 sampling site 22 miles upstream from the Hogback Site.

Reclamation observed a small increase in the concentration of total inorganic species (i.e., aluminum, arsenic, iron, lead, and silver among others) at the Hogback Site from August 7 to August 9, 2015, which corresponded to the estimated arrival of the drainage plume. The EPA continued almost daily sampling at a site several miles upstream from the Hogback Site through mid-October. At this site, significant increases in metals were observed at three discrete times after the spill event on August 27, September 6, and September 24, 2015, where the total concentration of multiple metals increased concomitantly (Figure ES-1). During these events, concentrations of both dissolved and total

The observed concentration increases were compared to the historical dataset (USGS) at the Hogback Site prior to the Gold King Mine spill and found a similar trend. Several historical samples exhibited similar increases in metal concentrations that correspond with flow increases in the Animas River, but these increases were not observed during spring snow run-off in April-June 2014. These results suggest that the observed concentration increases after the Gold King Mine spill cannot be fully attributed to the spill as similar historical trends were observed, and the relationship between flow and metal concentration is complex.

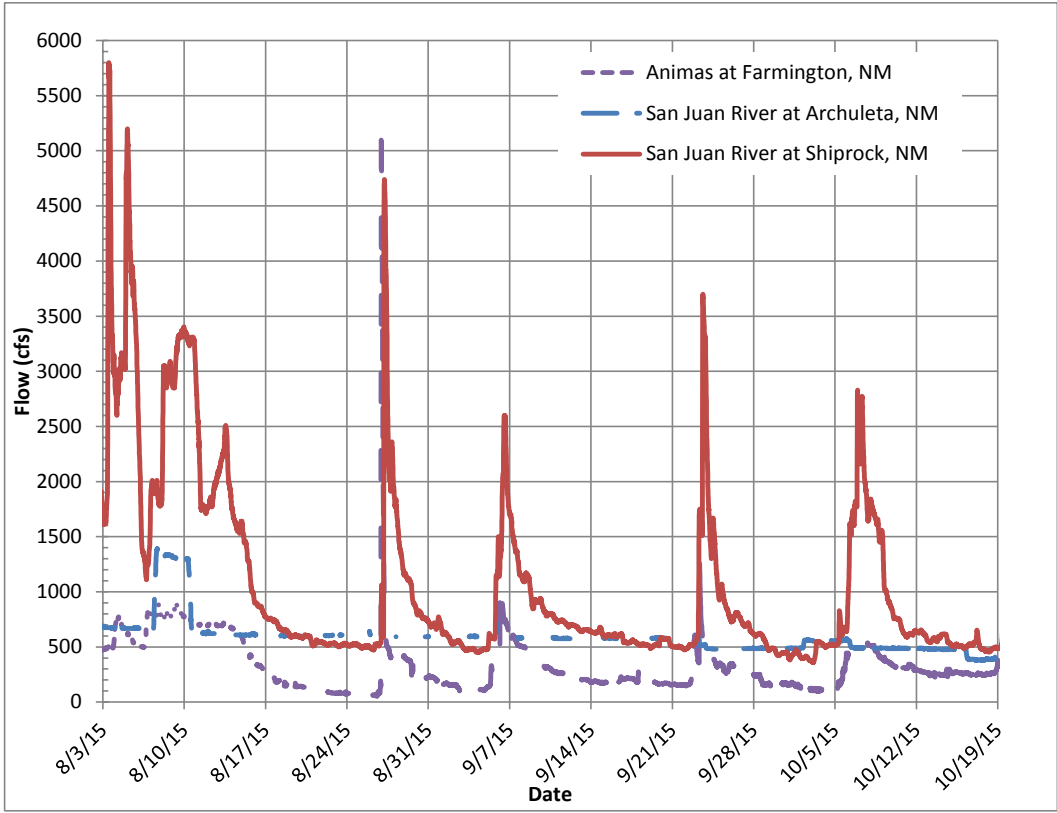
Figure 2: River flows above and below the confluence of the Animas and San Juan Rivers in July-September 2015. Some data was marked provisional by USGS at the time of report preparation.

Rain events in the two months following the spill have a large impact of the watershed hydrology. After the spill, the sharp increases in flow observed in Figure 2 were caused by three significant precipitation events in Southwest Colorado on August 28, September 6 and September 24, 2015, as shown in Figure 3, Figure A- 1, Figure A- 2.

While the Reclamation Hogback and EPA SJHB Sites stopped sampling after the third week of August, the EPA continued to collect and analyze samples from the EPA LVW-030 Site through mid-October. These results suggest that the effects of metal loading in the watershed extend beyond the passing of the mine drainage plume. Significant spikes in metal concentrations were measured at the EPA LVW-030 Site on 8/28/15, 9/6/15 and 9/24/15. In general, these increases are greater than those observed on August 8-9 right after the approximate date the plume reached the San Juan River. These increases in concentration correspond with periods where the Animas River and San Juan River flow rates increased significantly over a short period of time due to a rain event in the watershed. Recall that Figure 2 shows the hydrograph for the Animas River in Farmington

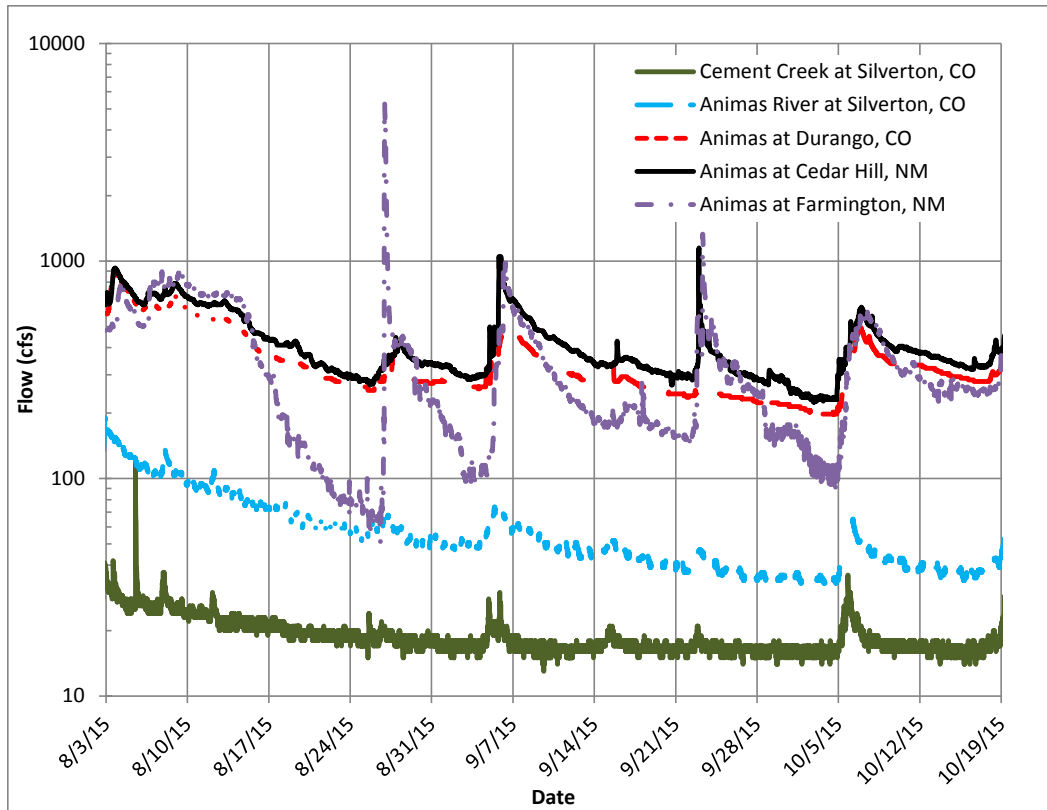
Figure 4. Flows in Cement Creek and at various points in the Animas River during 2015. Some data was marked provisional by USGS at the time of report preparation.

Mine drainage from Gold King Mine entered Cement Creek before flowing into the Animas River. Figure 4 shows flows at various points along the Animas River relative to Cement Creek and attests to the size of the Animas River watershed. Flows in Cement Creek and the Animas River at Silverton, CO are small compared to monitoring locations lower in the watershed. During rain events, small fluctuations are recorded in Silverton but the largest fluctuations are observed in northern New Mexico.

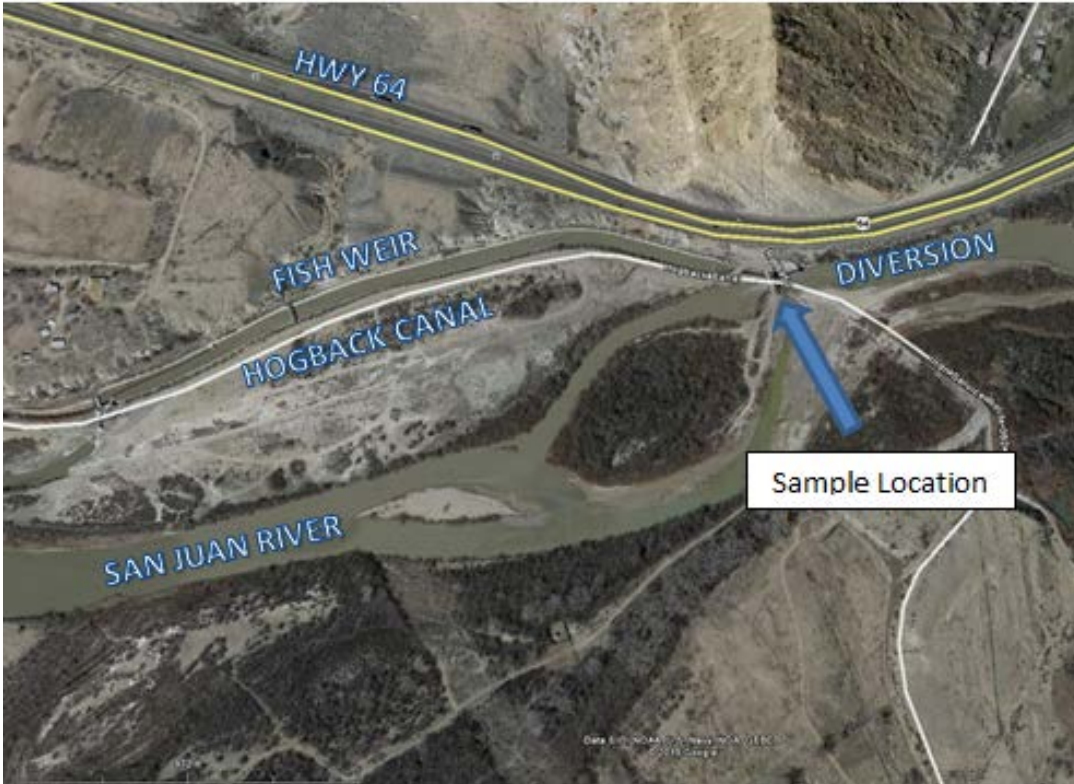
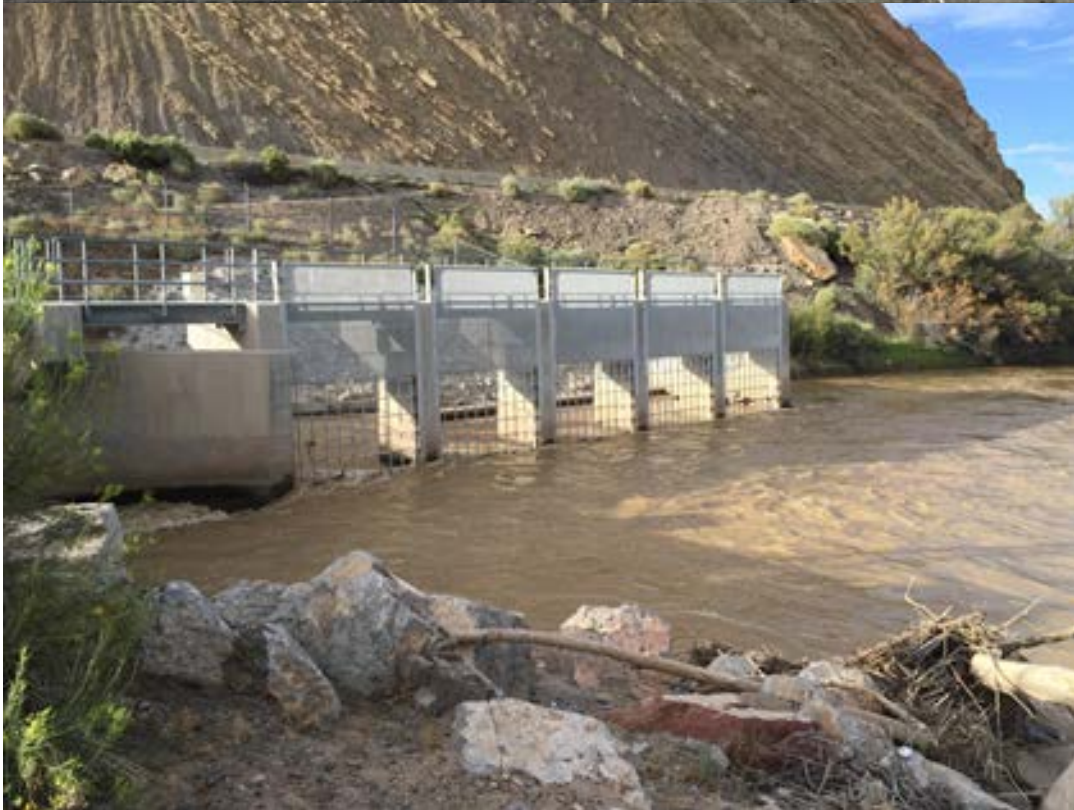
Figure 6. Sampling location for samples collected by BOR at the Hogback Diversion Channel.

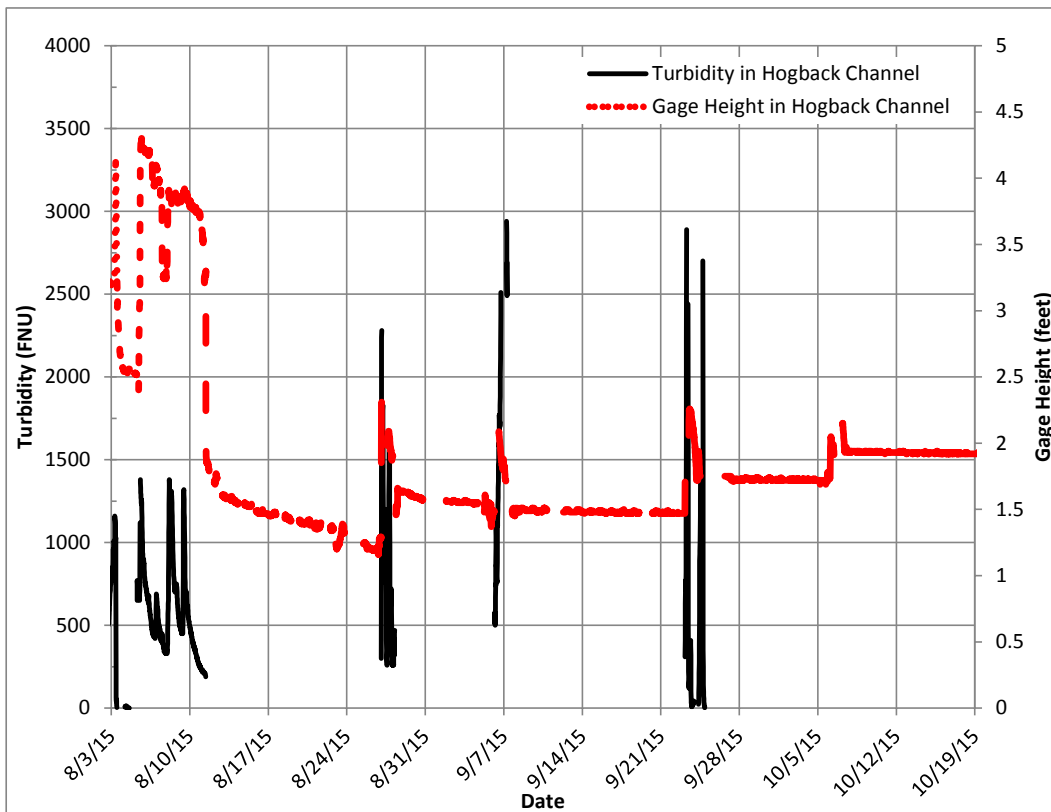
Figure 7. Relationship between gauge height and turbidity at BOR SJHB Site in late 2015.¹⁴ Some data in figure is still provisional. Upper range for turbidimeter is 3000 FNU. Some data was marked provisional by USGS at the time of report preparation.

Increases in gage height and turbidity in the channel were observed as shown in Figure 7. Gauge height is presented in Figure 7, because flow data is not available past August 19. The USGS site states that the relationship between gage height and discharge is, “being developed or revised”. The dates of these turbidity spikes correspond with significant precipitation events in the area that caused rapid flow increases in the Animas River (Figure 2 and Figure 3). While the data in Figure 7 must be interpreted in the context of the diversion gates being closed, they do show a relationship between increases in river flow and turbidity. Turbidity increases can be a surrogate measure for increases in suspended material in the San Juan River.

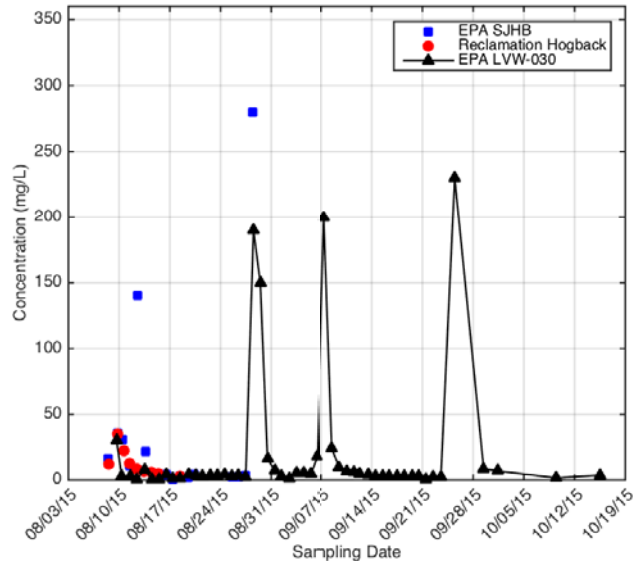
Total Iron

Figure 9. Total iron measured in micrograms per liter from the three sampling locations. No EPA data prior to August 2015 is available at the Reclamation Hogback Site.

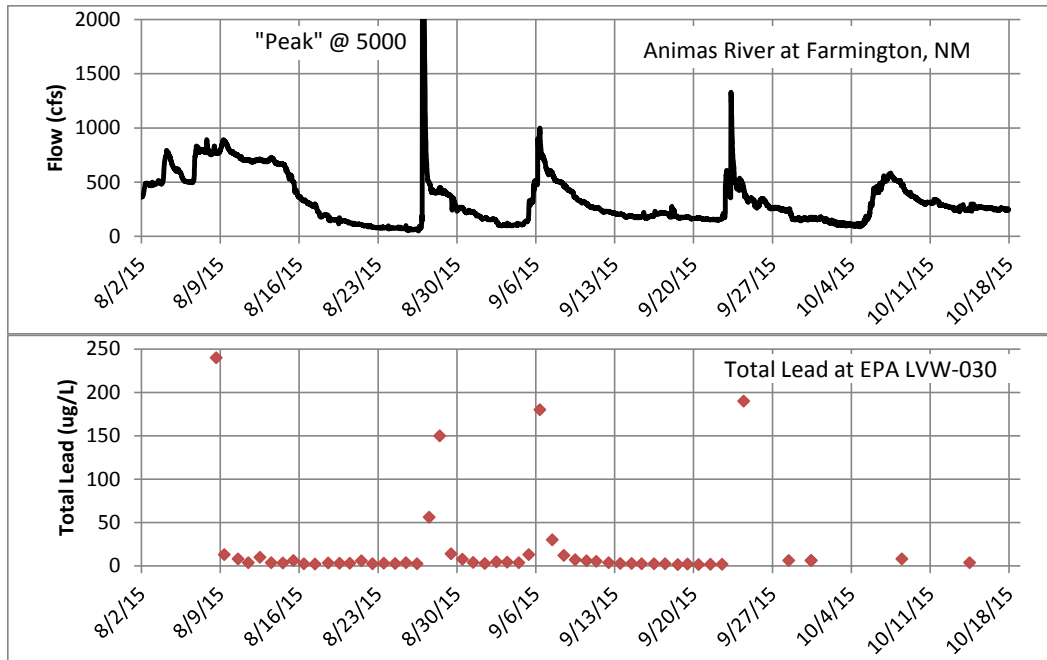
Figure 10. Hydrograph of the Animas River compared against total lead concentrations at EPA LVW-030. USGS data flow data was marked provisional at the time of report preparation.

(before the confluence with the San Juan River) and the San Juan River at Shiprock, NM between August and mid-October 2015. The occurrence of increased metal concentrations aligns with periods of high flows as illustrated for lead in Figure 10. There is roughly a one-day lag time between the rise in the Animas River flow and observed increases in metals at the EPA LVW-030 Site. Precipitation data from the National Weather Service also show large precipitation events during this time in Southwest Colorado and Northwest New Mexico corresponding to river flow increases (Figure 3, Figure A- 1 and Figure A- 2).

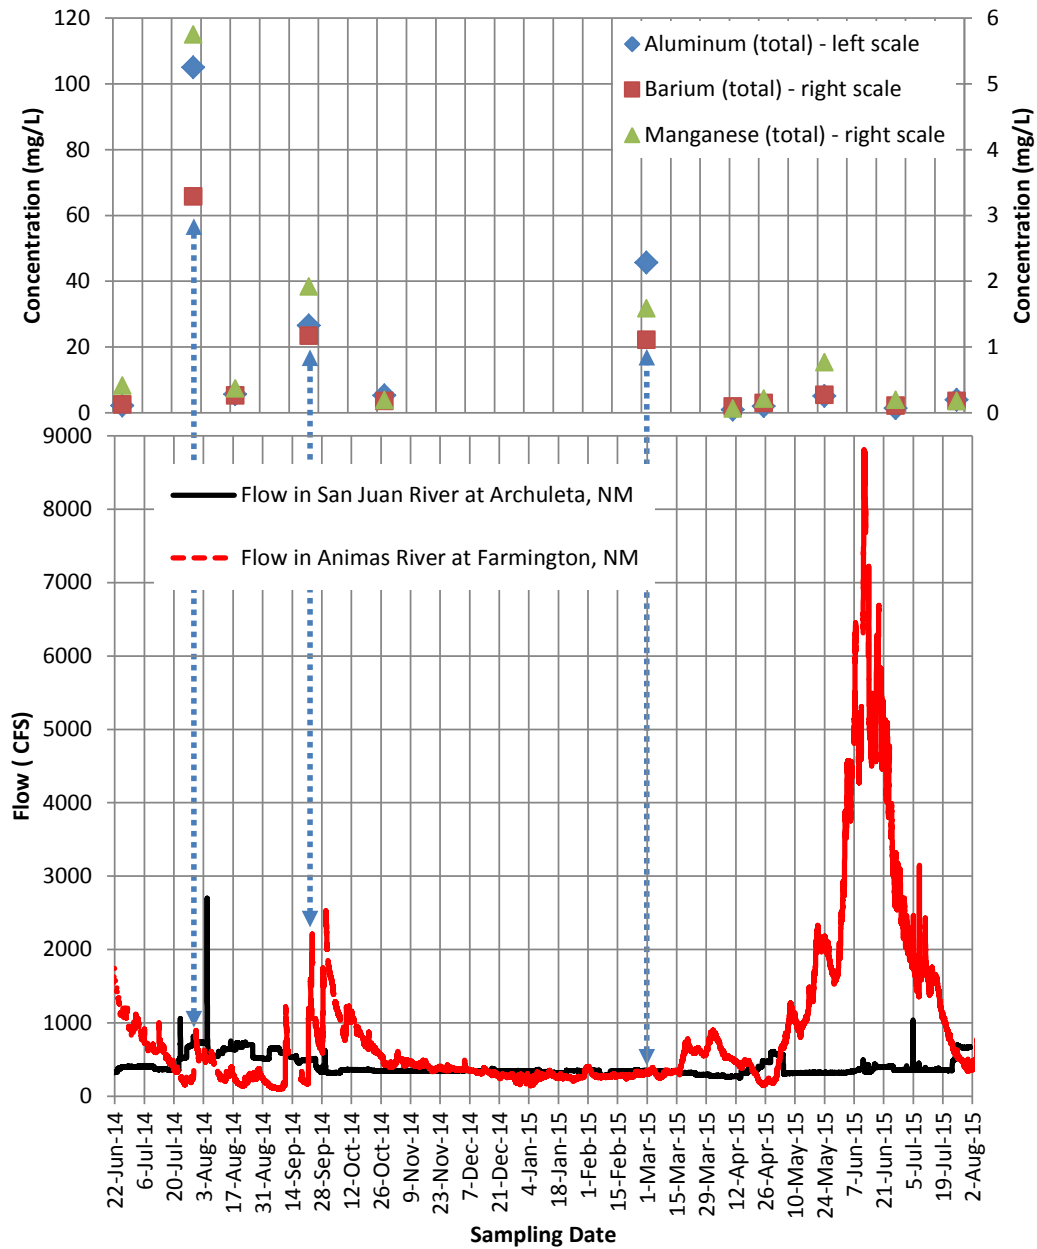
Figure 14. Relationship between flow in the Animas River and select total metal concentrations prior to the Gold King Mine spill. Metal concentrations were measured at the Hogback Site by USGS.

The relationship between flow in the Animas River and total metal concentrations in the San Juan River is complex and not mutually exclusive. While an increase in San Juan River metal concentration is often accompanied by an increase in Animas River flow, the opposite is not necessarily true (i.e., an increase in flow yielding an increase in metals) as shown in Figure 14. Elevated metal concentrations observed in 7/2014, 9/2014 and 3/2015 were accompanied by a

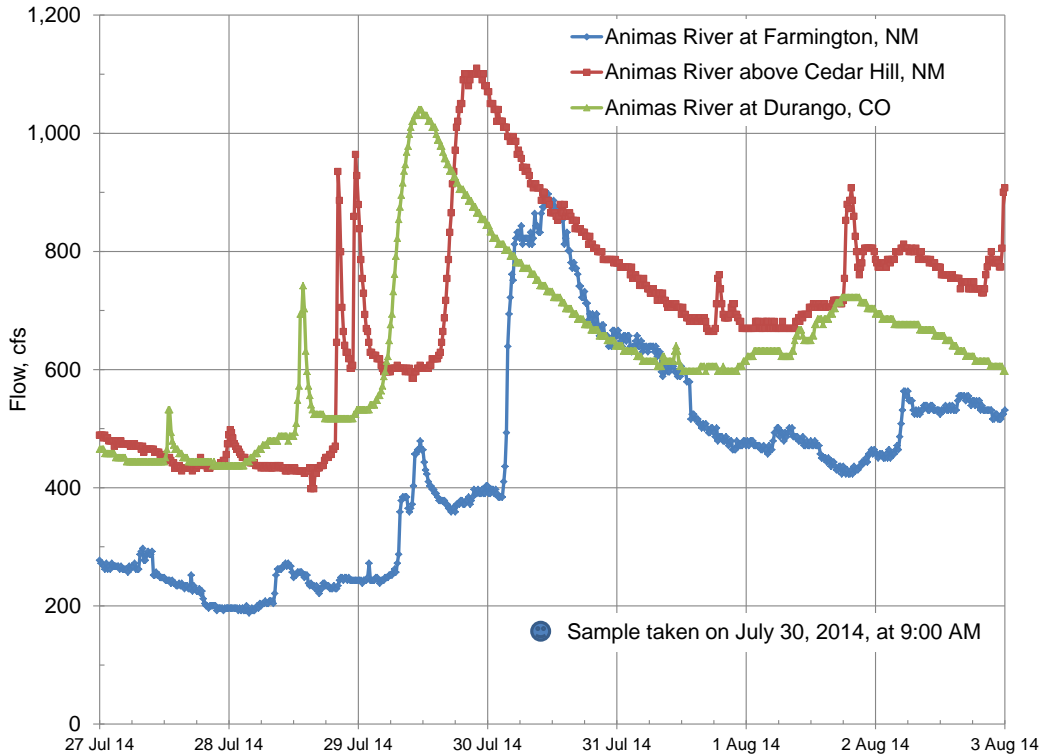
Figure 15. Hydrographs along Animas River during the days preceding and following the July 30, 2014 water quality analysis. Marker indicates time of sampling event.

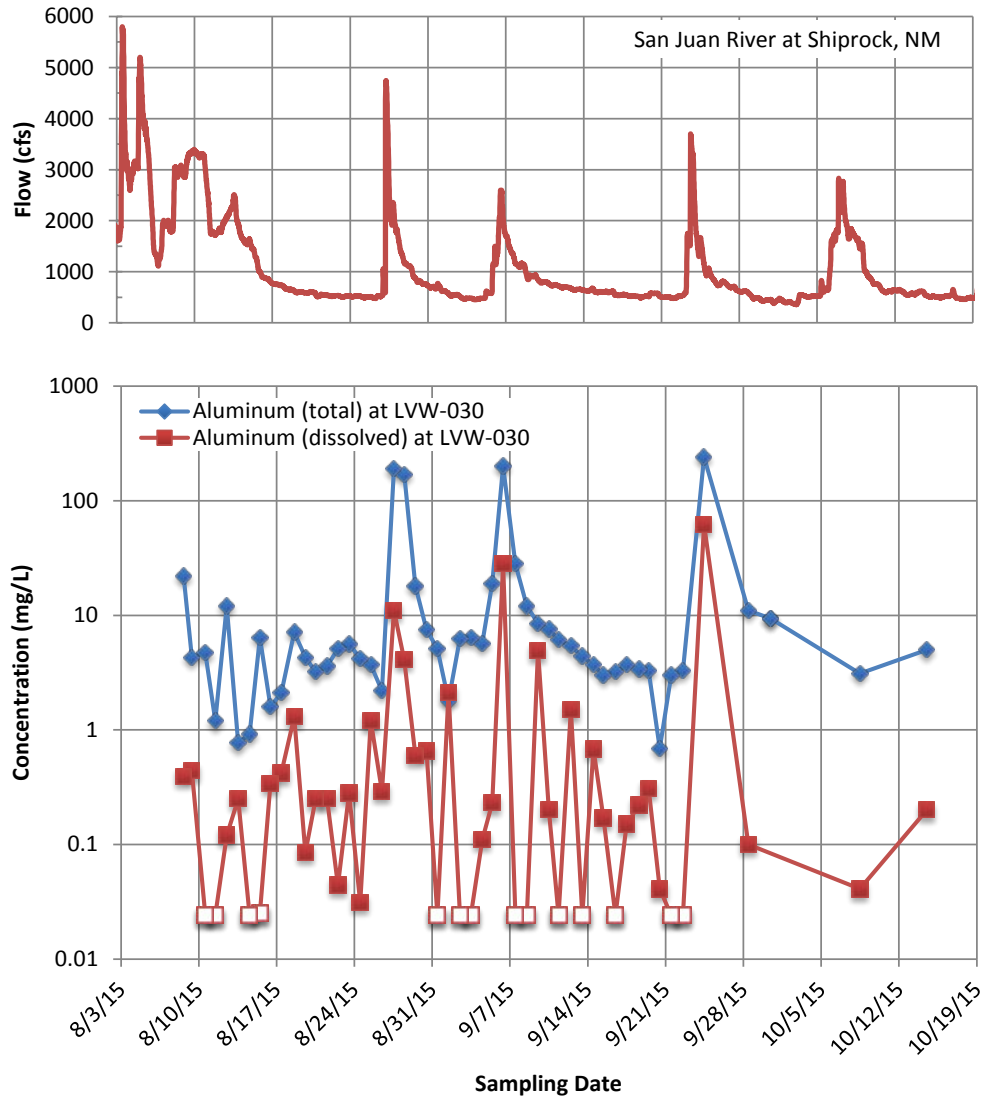
Figure 16. Distribution of aluminum between suspended and dissolved forms during August-October 2015. Unfilled markers indicate data plotted at the MRL. USGS flow data was marked provisional at the time of report preparation.

Based on the trends observed in Figure 16, the distribution of dissolved and particulate metals were compared further by focusing on the peaks following precipitation events. During these events, most of the metals detected were in the form of particulate matter rather than dissolved species with the exception of two analytes (Figure 17). Molybdenum and potassium were primarily found in the dissolved phase although molybdenum concentrations were near the detection limit and did not show the same concentration spikes as other compounds (Figure A- 16). Another observed trend is that the later sampling date (9/24/15) had a relatively larger proportion of the analytes found in the dissolved phase relative to particulate material. In isolated events, both arsenic and selenium were measured as nearly 50% dissolved.

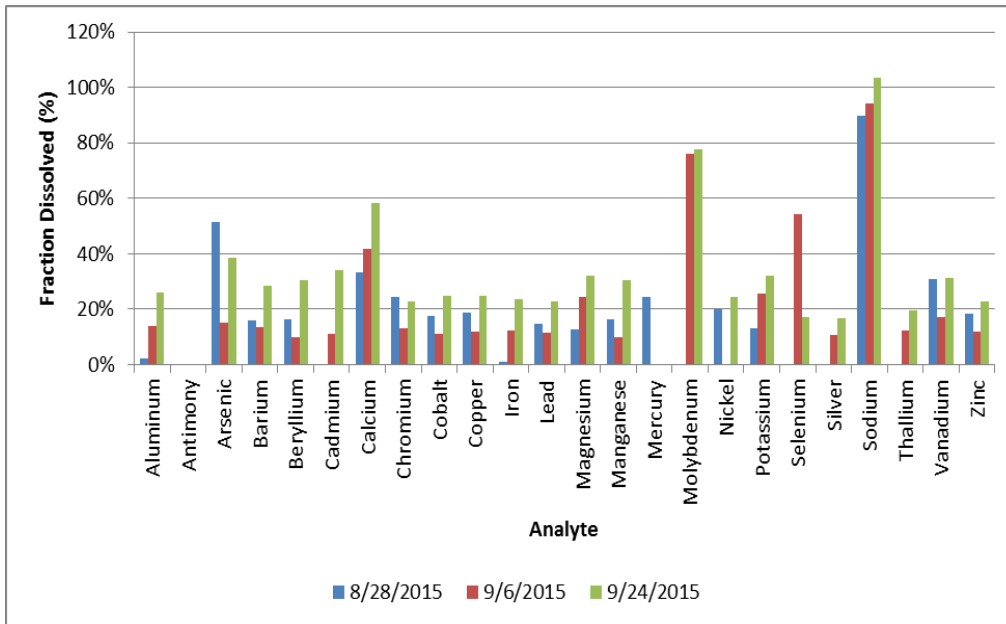
Figure 17. Fraction of analyte measured in the dissolved phase compared to the total recoverable metals during peak flow events at the EPA LVW-030 Site.

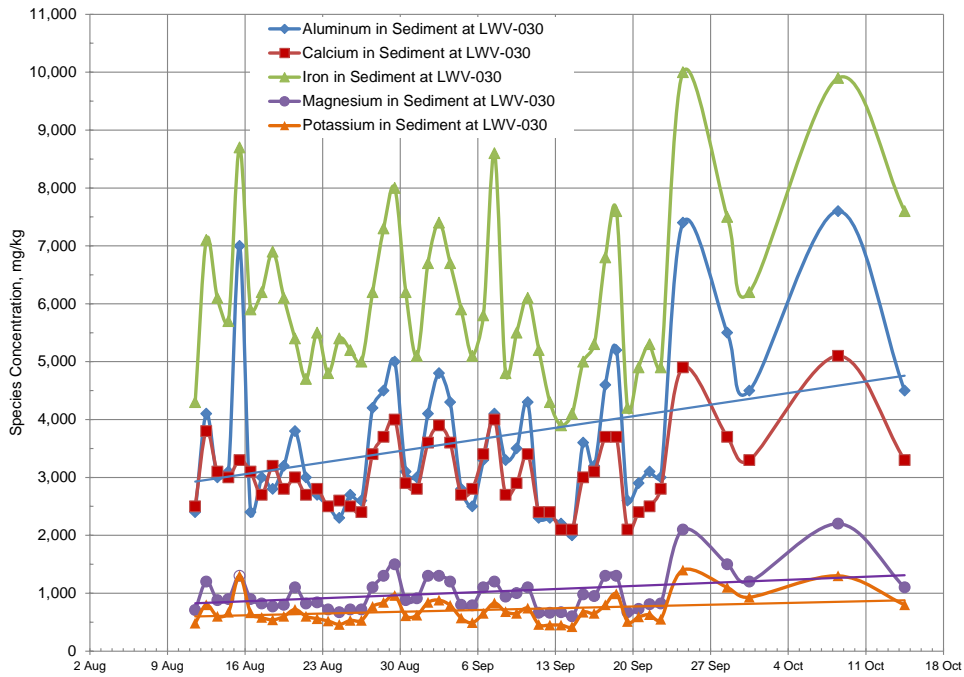
Figure 18. Aluminum, calcium, iron, magnesium and potassium sediment concentrations at EPA LVW-030 in 2015.

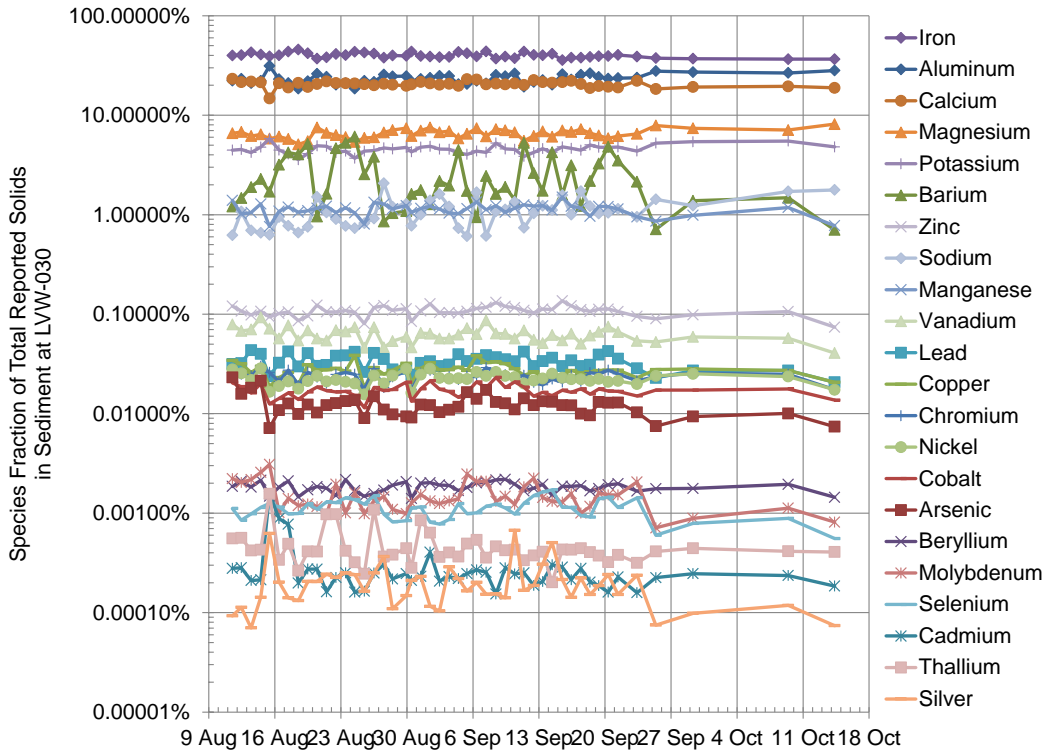
Figure 19. Relative abundance of total recoverable metals in sediment sampled from the LVW-030 Site between August and October 2015.

Temporal variations in the relative abundance of total recoverable metals at the LVW-030 Site were compared and found no significant trends as shown in Figure 19. In general, sediment was comprised predominantly of iron, aluminum and calcium with all other metals present at less than 10%. In the absence of any temporal trends, it appears that the precipitation events that increase suspended solids have little effect on both the sediment concentration and composition at a single sampling point.

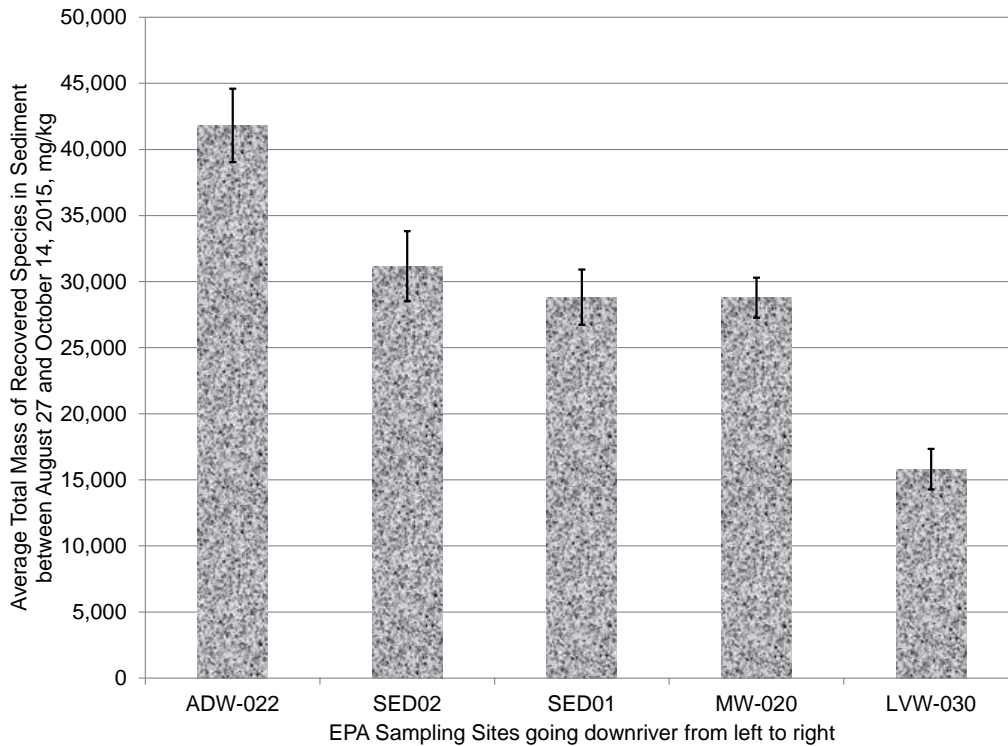
Figure 20. Mass of total recoverable metal at select sites along the Animas and San Juan Rivers. Error bars represent 95% confidence intervals.

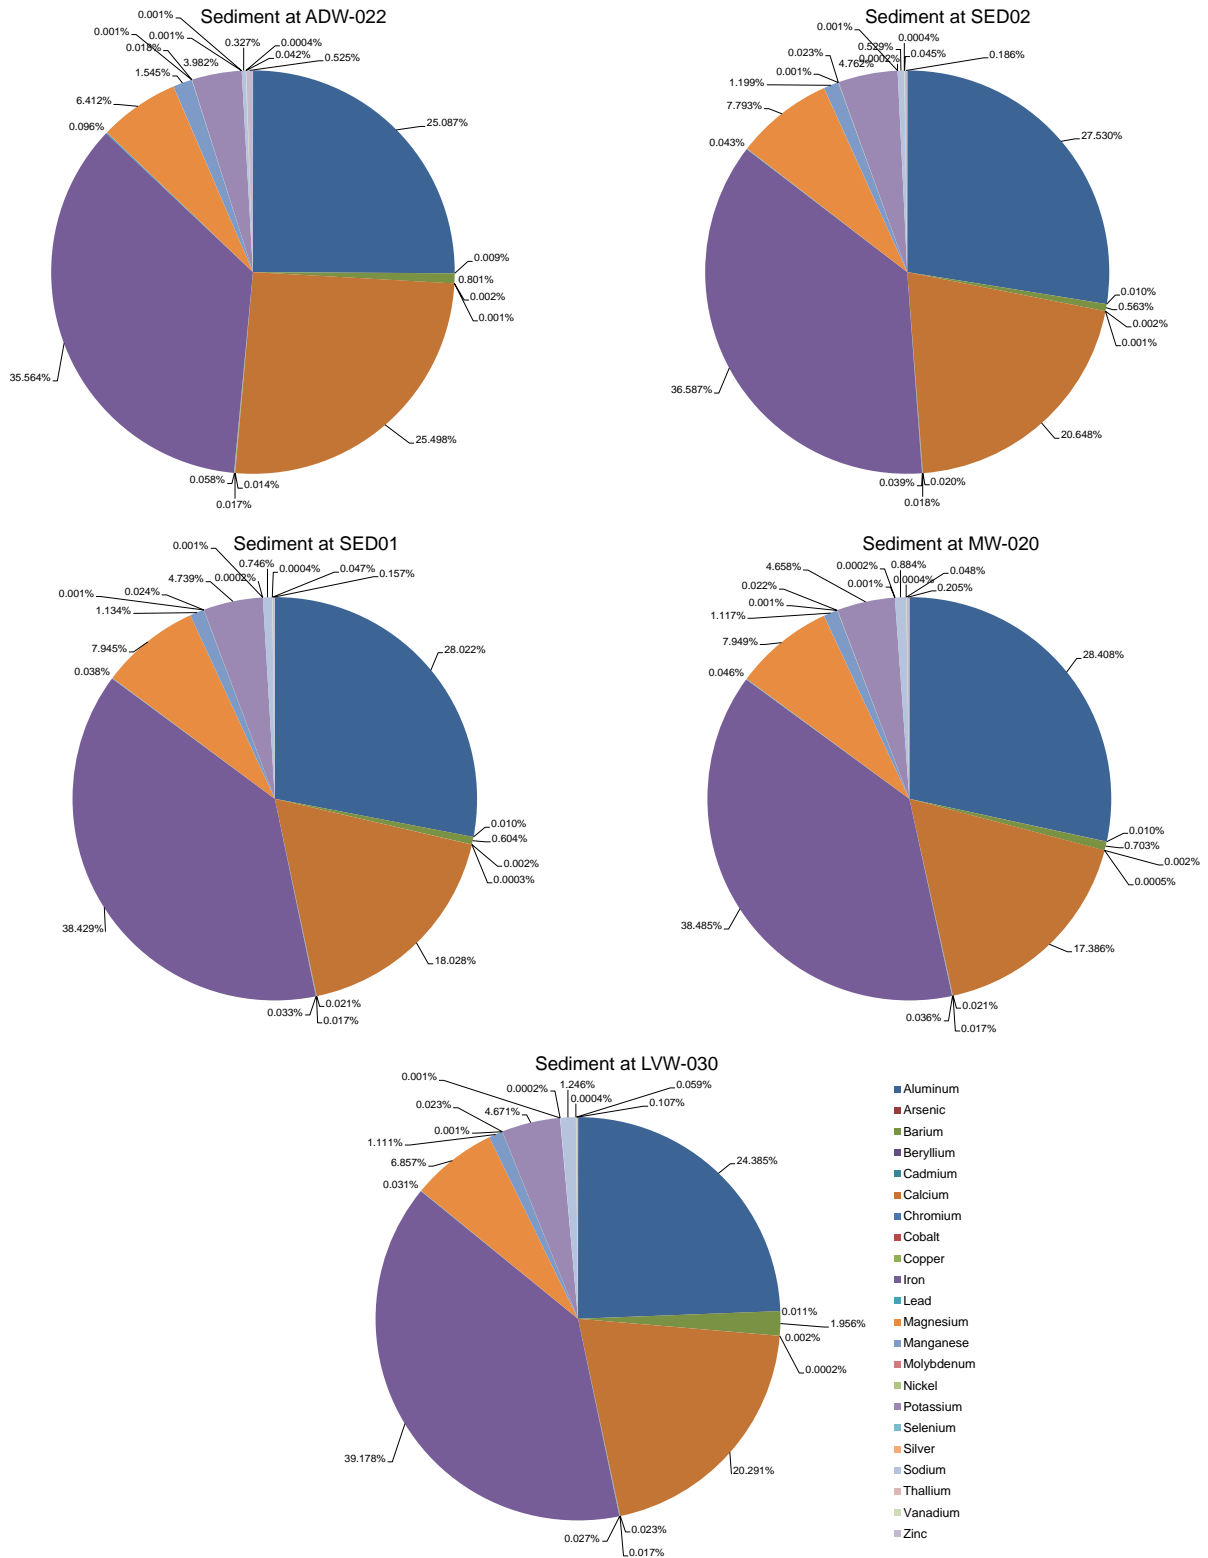
Figure 21. Distribution of total recoverable metals at each sampling location.

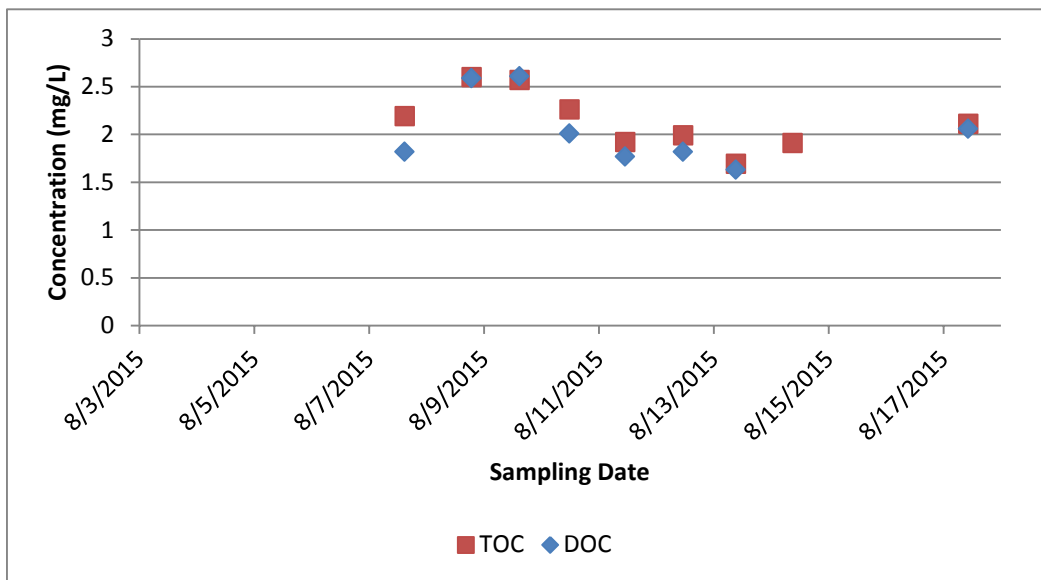
Figure 22. TOC and DOC at the Hogback Site following the Gold King Mine spill collected by Reclamation.

Total organic carbon (TOC) and dissolved organic carbon (DOC) were measured at the Hogback Site both historically by USGS and immediately following the spill by Reclamation. Figure 22 shows that both TOC and DOC increased about 0.5 mg/L from August 7th to August 9th, 2015. By August 11th, both TOC and DOC returned to concentrations similar to those observed on August 7th. Water quality data from the Gold King Mine adit does not report organic carbon concentrations (Table 3), so it cannot be concluded whether this fluctuation in organic carbon is due to the spill or other processes within the watershed. There were precipitation events in the Animas watershed during the same period of time, which may have increased carbon transport to the rivers, independent of events at the mine. Since the TOC and DOC concentrations are similar, nearly all the carbon in the samples was in the dissolved form rather than particulate form, suggesting that the large transport of sediment and colloidal material in the watershed is largely inorganic in nature. Since no samples collected during the precipitation events in late August and September were analyzed for organic carbon, more data are needed to better understand the relationship between sediment transport and organic matter concentrations at the Hogback Site.

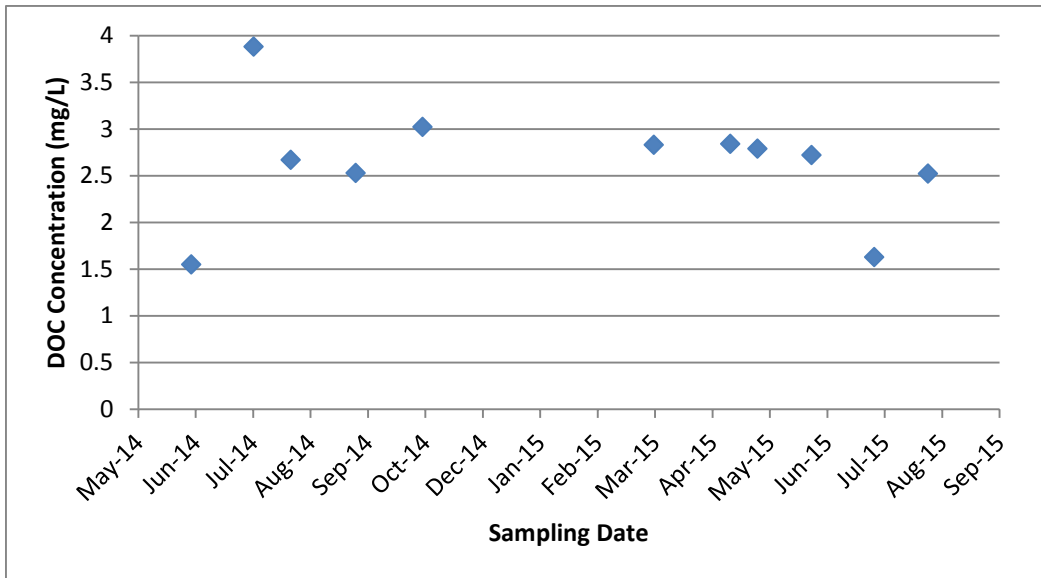
Figure 23. Historical DOC concentrations measured at the Hogback Site prior to the Gold King Mine Spill collected and analyzed by USGS.

Compared to historical values, the DOC concentrations in August 2015 were similar to historic values. Figure 23 shows that most samples collected had concentrations between 2.5 mg/L and 3 mg/L, which are slightly higher than concentrations observed in August 2015. If anything, the formation of iron and aluminum hydroxide colloids in the river may have acted to lower dissolved organic matter concentrations through adsorption mechanisms, similar to coagulation in a water treatment plant.

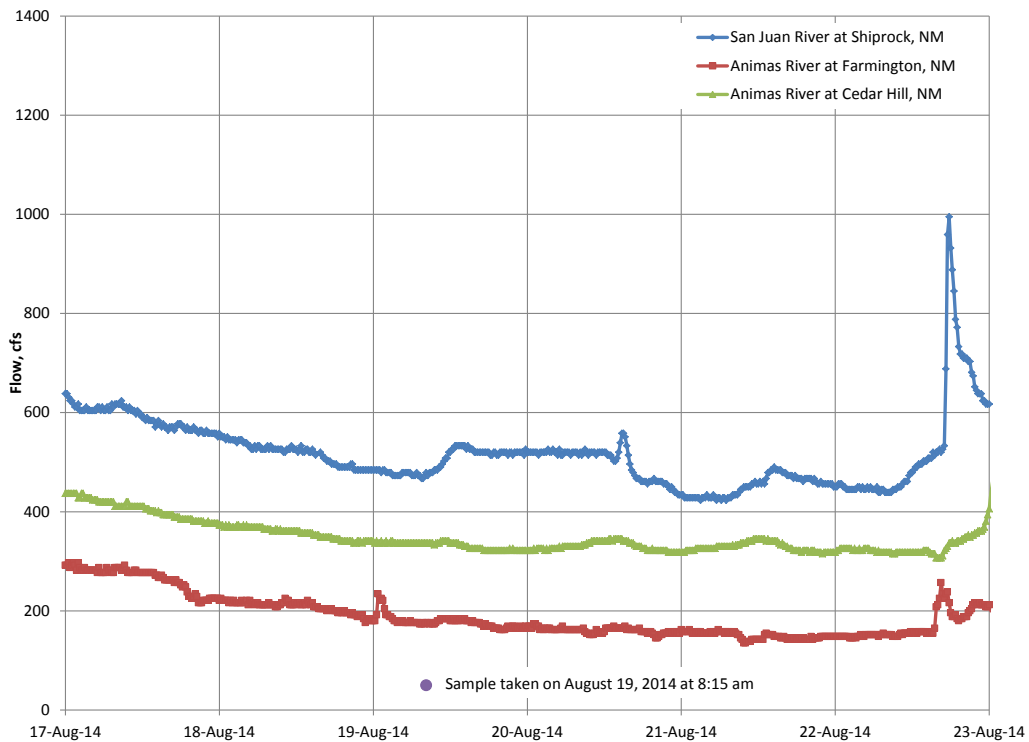
Figure A- 26. Hydrographs along Animas River during the days preceding and following the August 19, 2014 water quality analysis. Marker indicates time of sampling event.
