**Navajo Unit Operations
January 27, 2009
Coordination Meeting**

U.S. Department of the Interior
Bureau of Reclamation

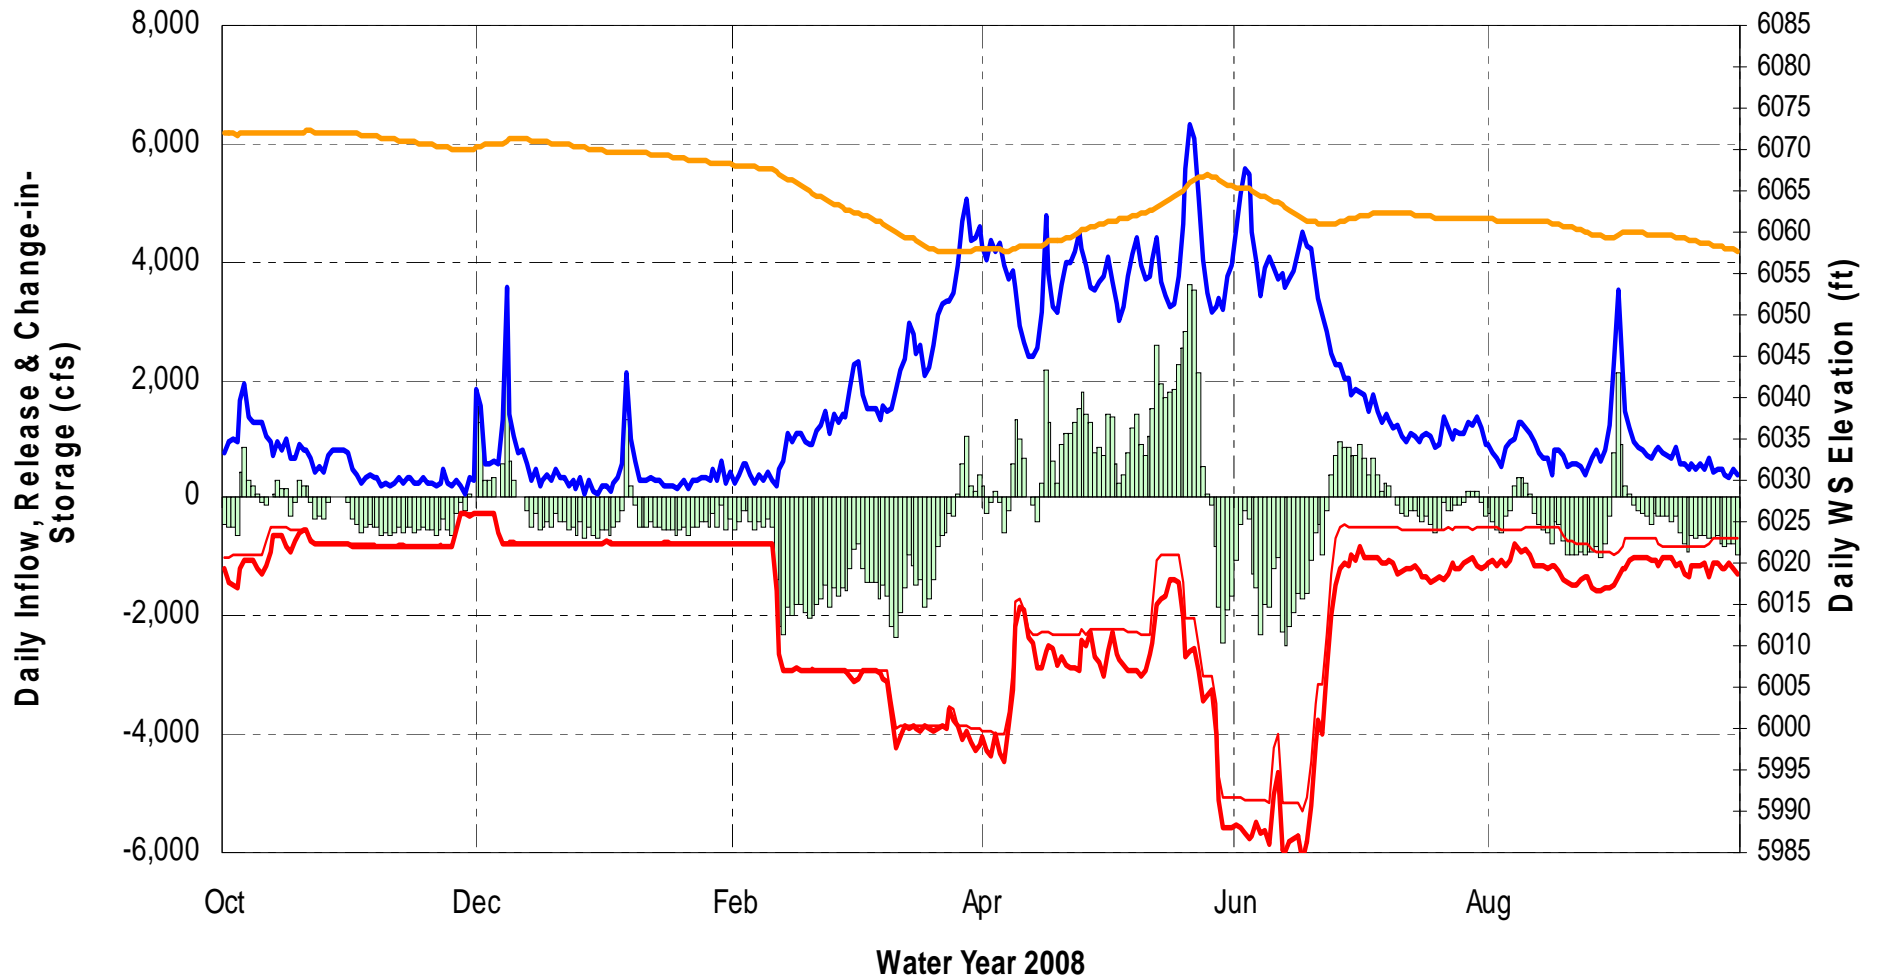
Review of 2008 Operations

Change-in-Storage (cfs)
 Total Release (cfs)
 Inflow (cfs)
 River Release (cfs)
 WS Elevation

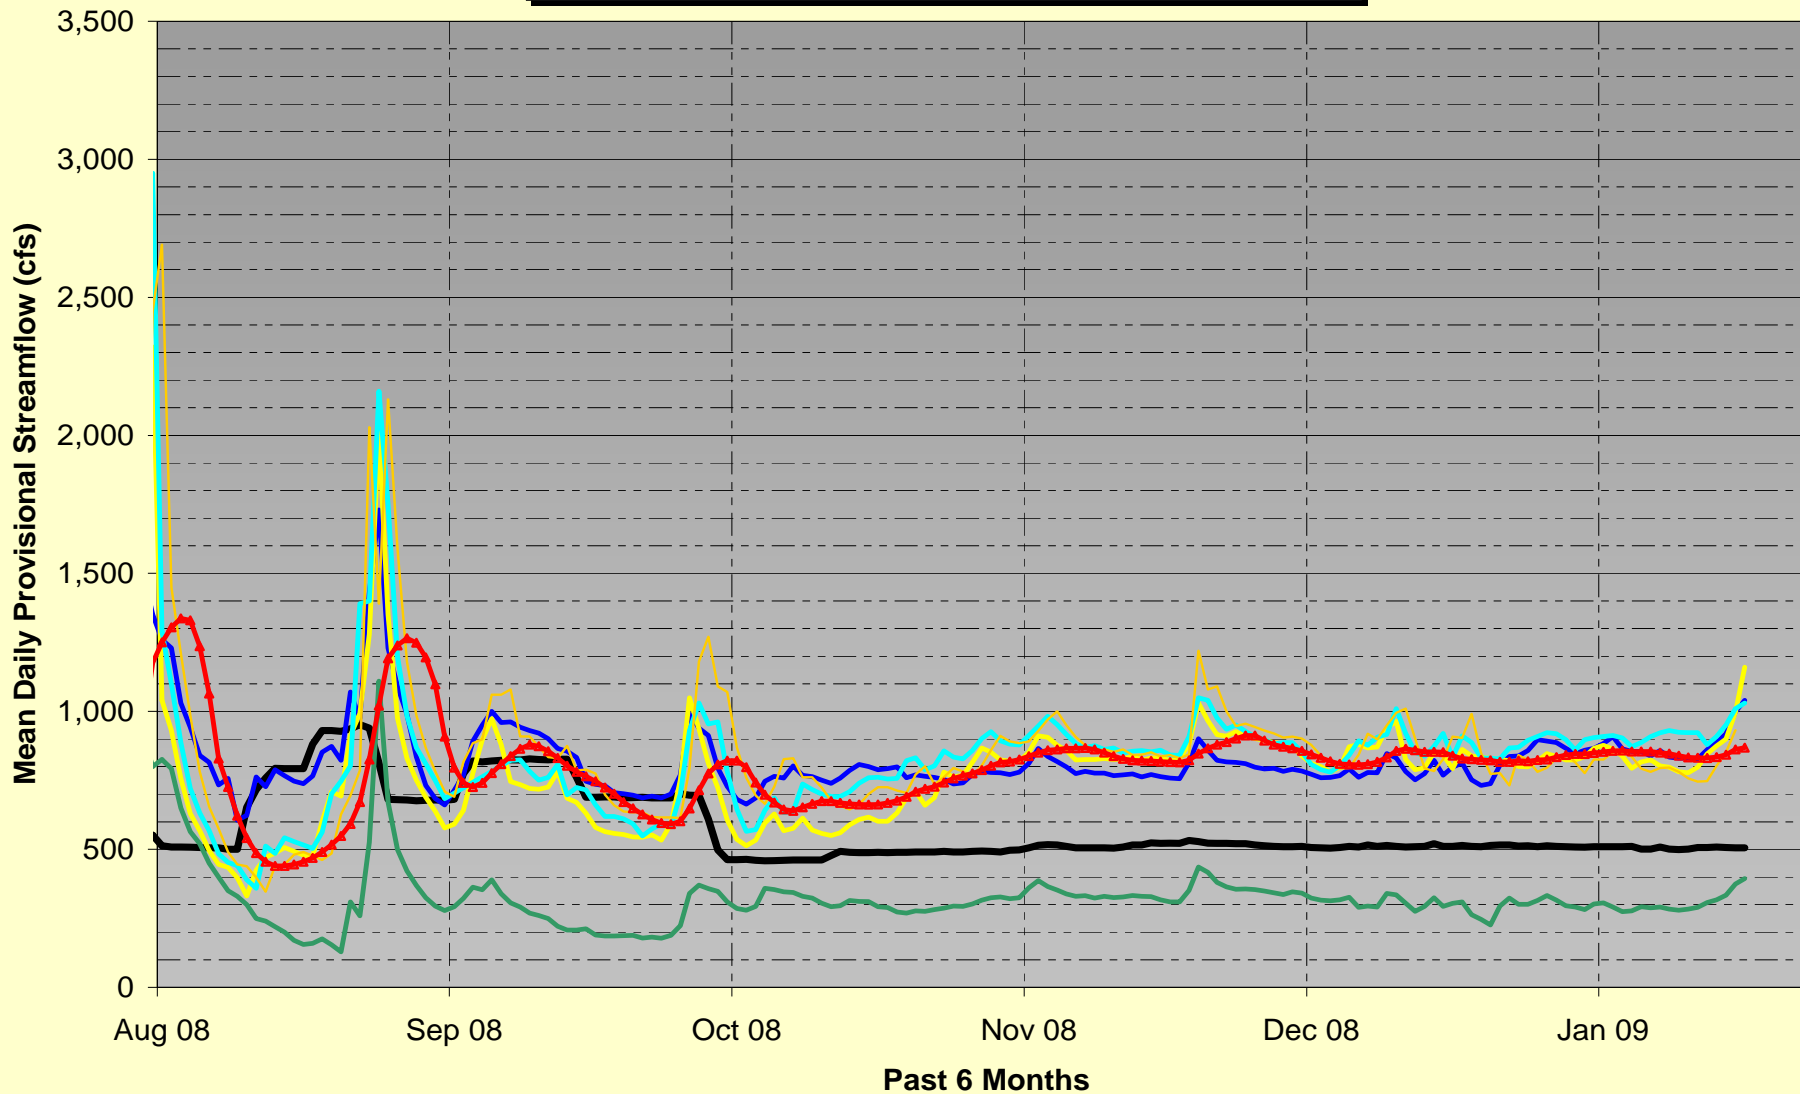
USGS PROVISIONAL MEAN DAILY STEAMFLOW SAN JUAN RIVER STATIONS

— SJR Archuleta — SJR Farmington — SJR Shiprock — SJR Four Corners — SJR Bluff — Animas Farmington — MIN 7DMM

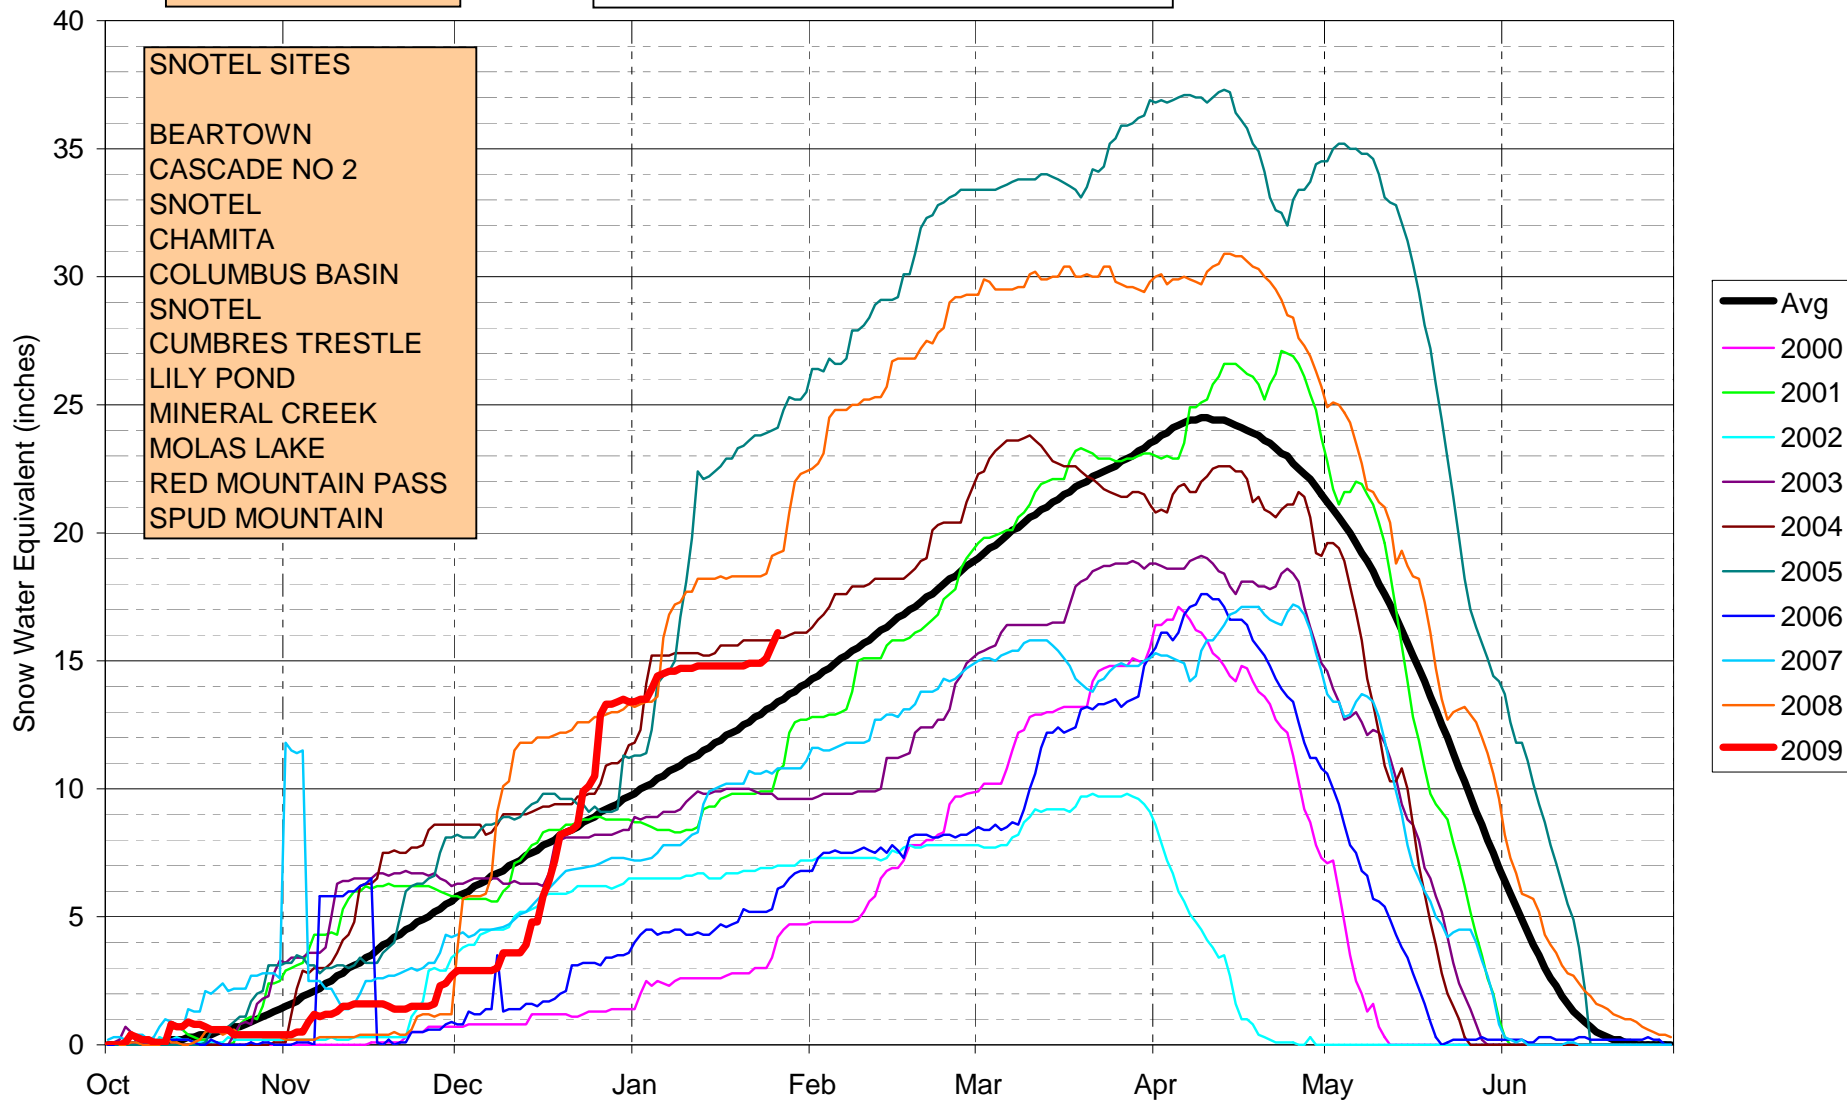
San Juan Basin Multiple Station Snotel Plot

January 26, 2009

Current Snowpack is $(16.1/13.1) = 123\%$ of Average

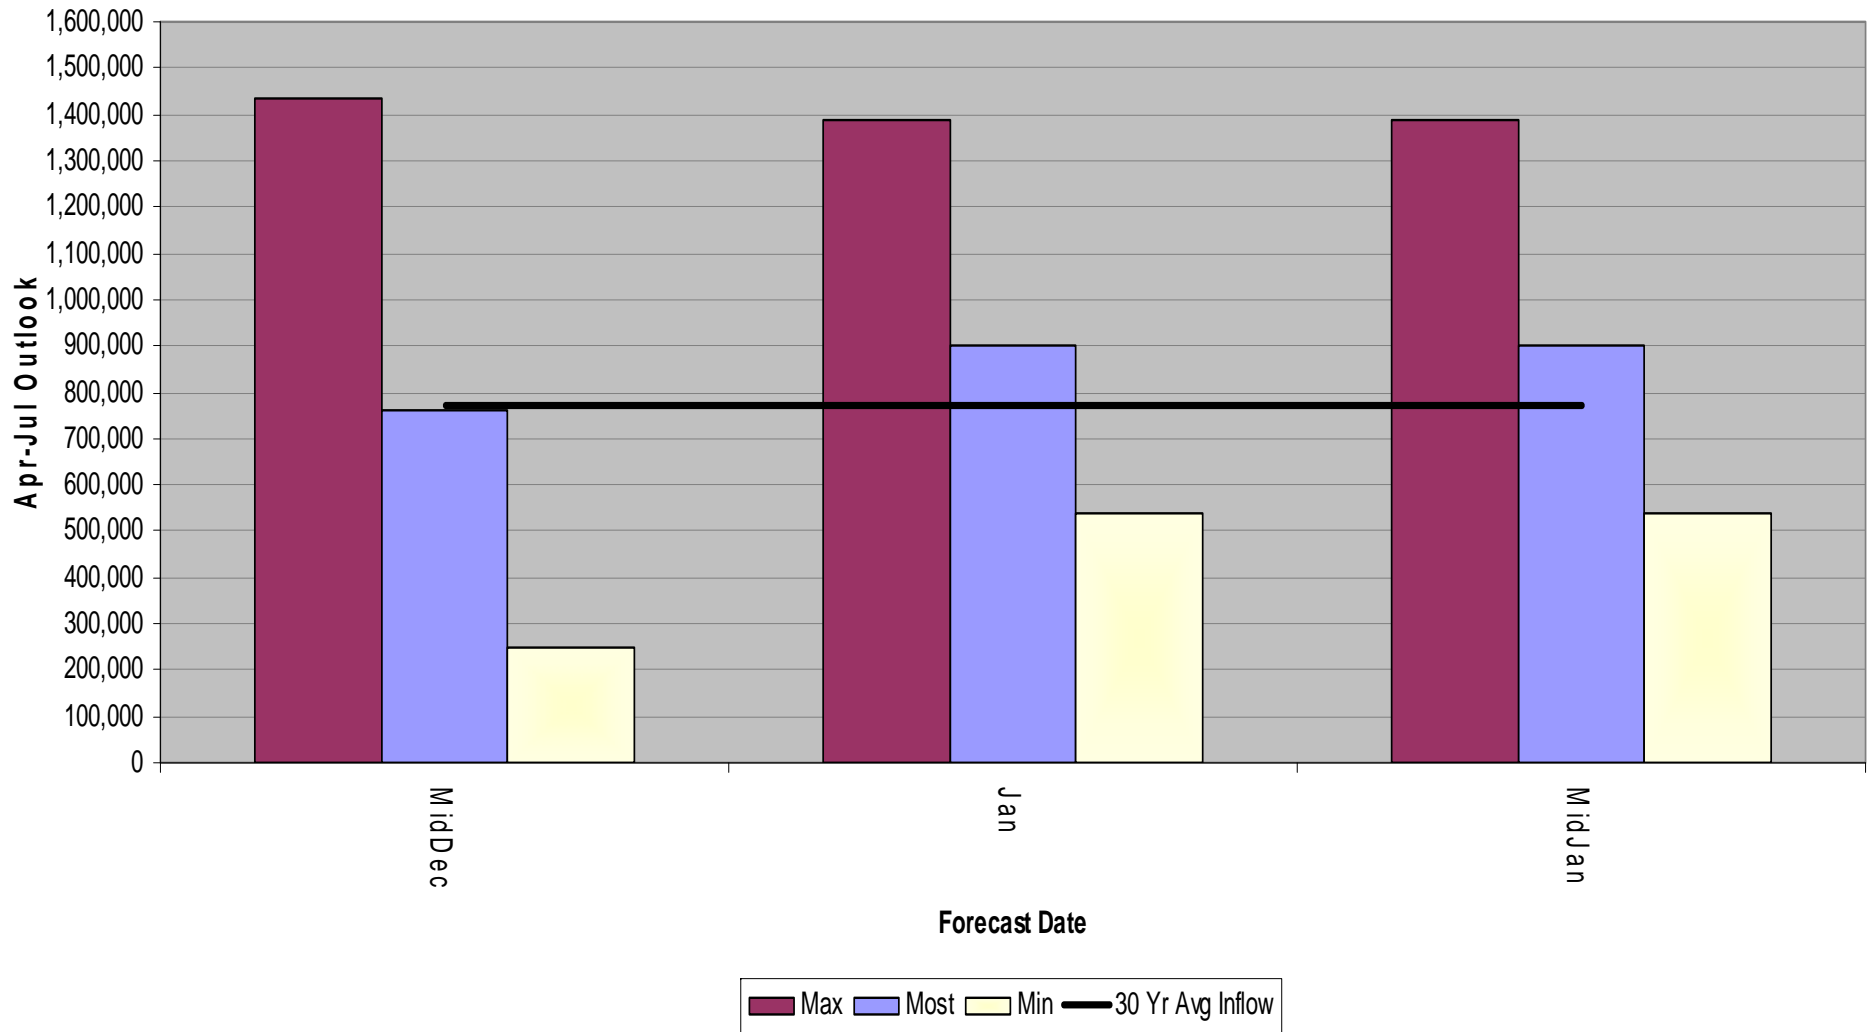
WY2009 CBRFC - Navajo Reservoir Most, Max and Min Inflow Forecasts (acre-feet)

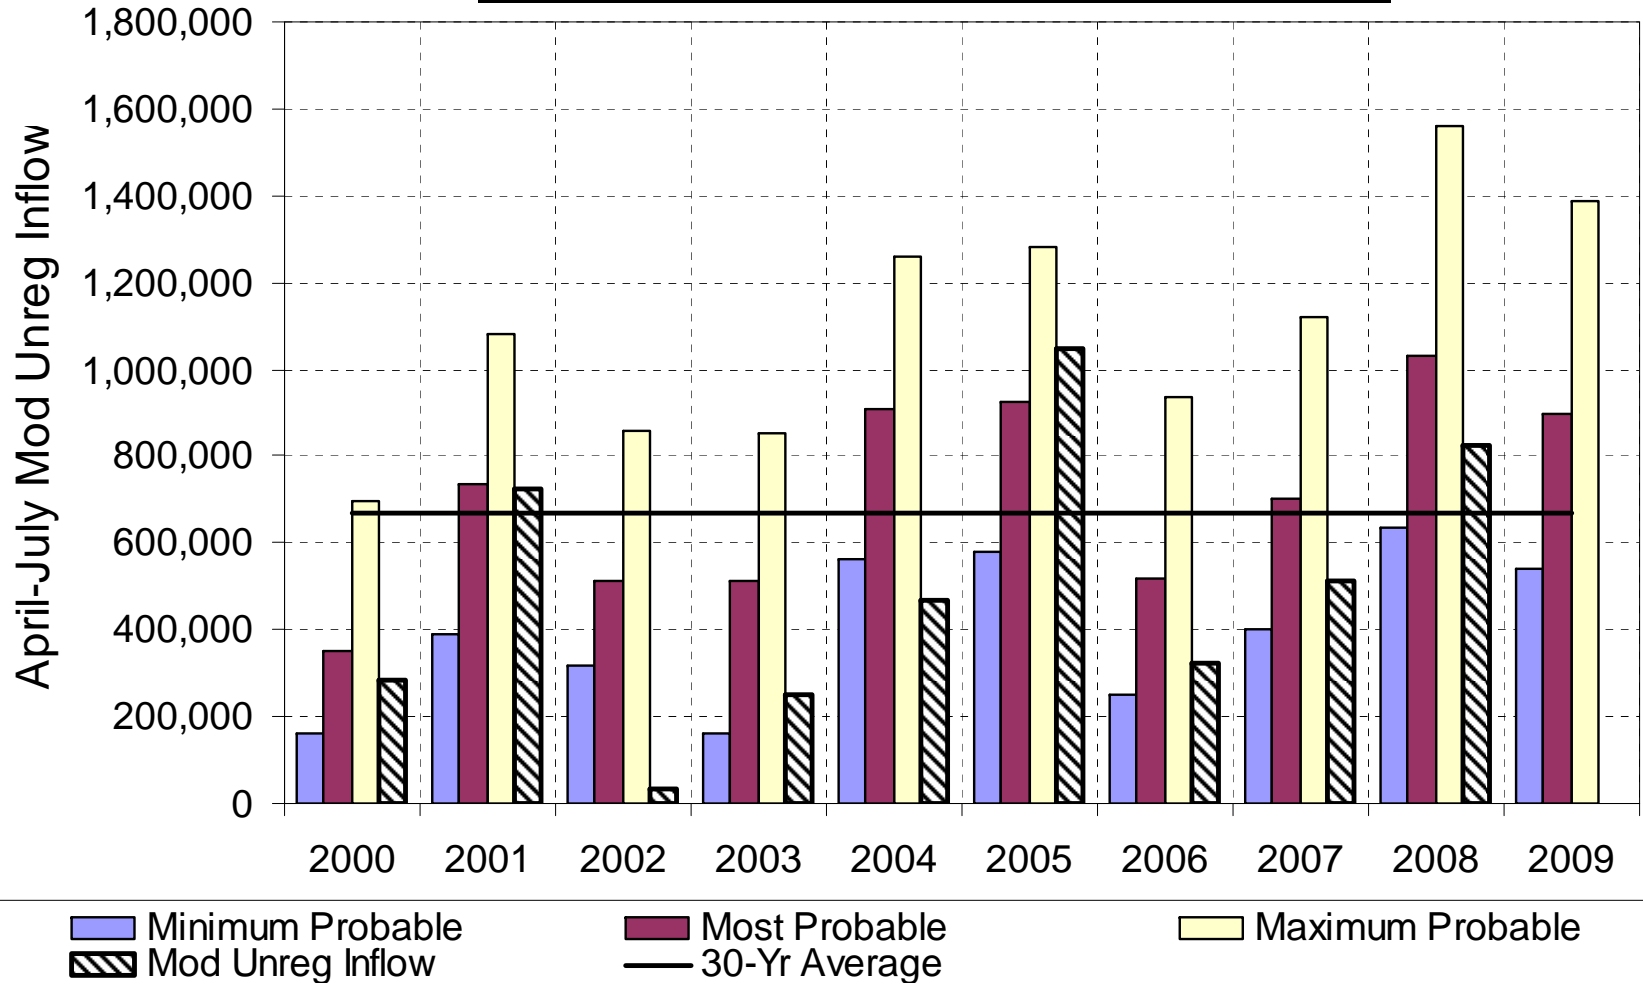
April-July Mod Unreg Forecast from January
 VS
 Actual Mod Unreg Inflow

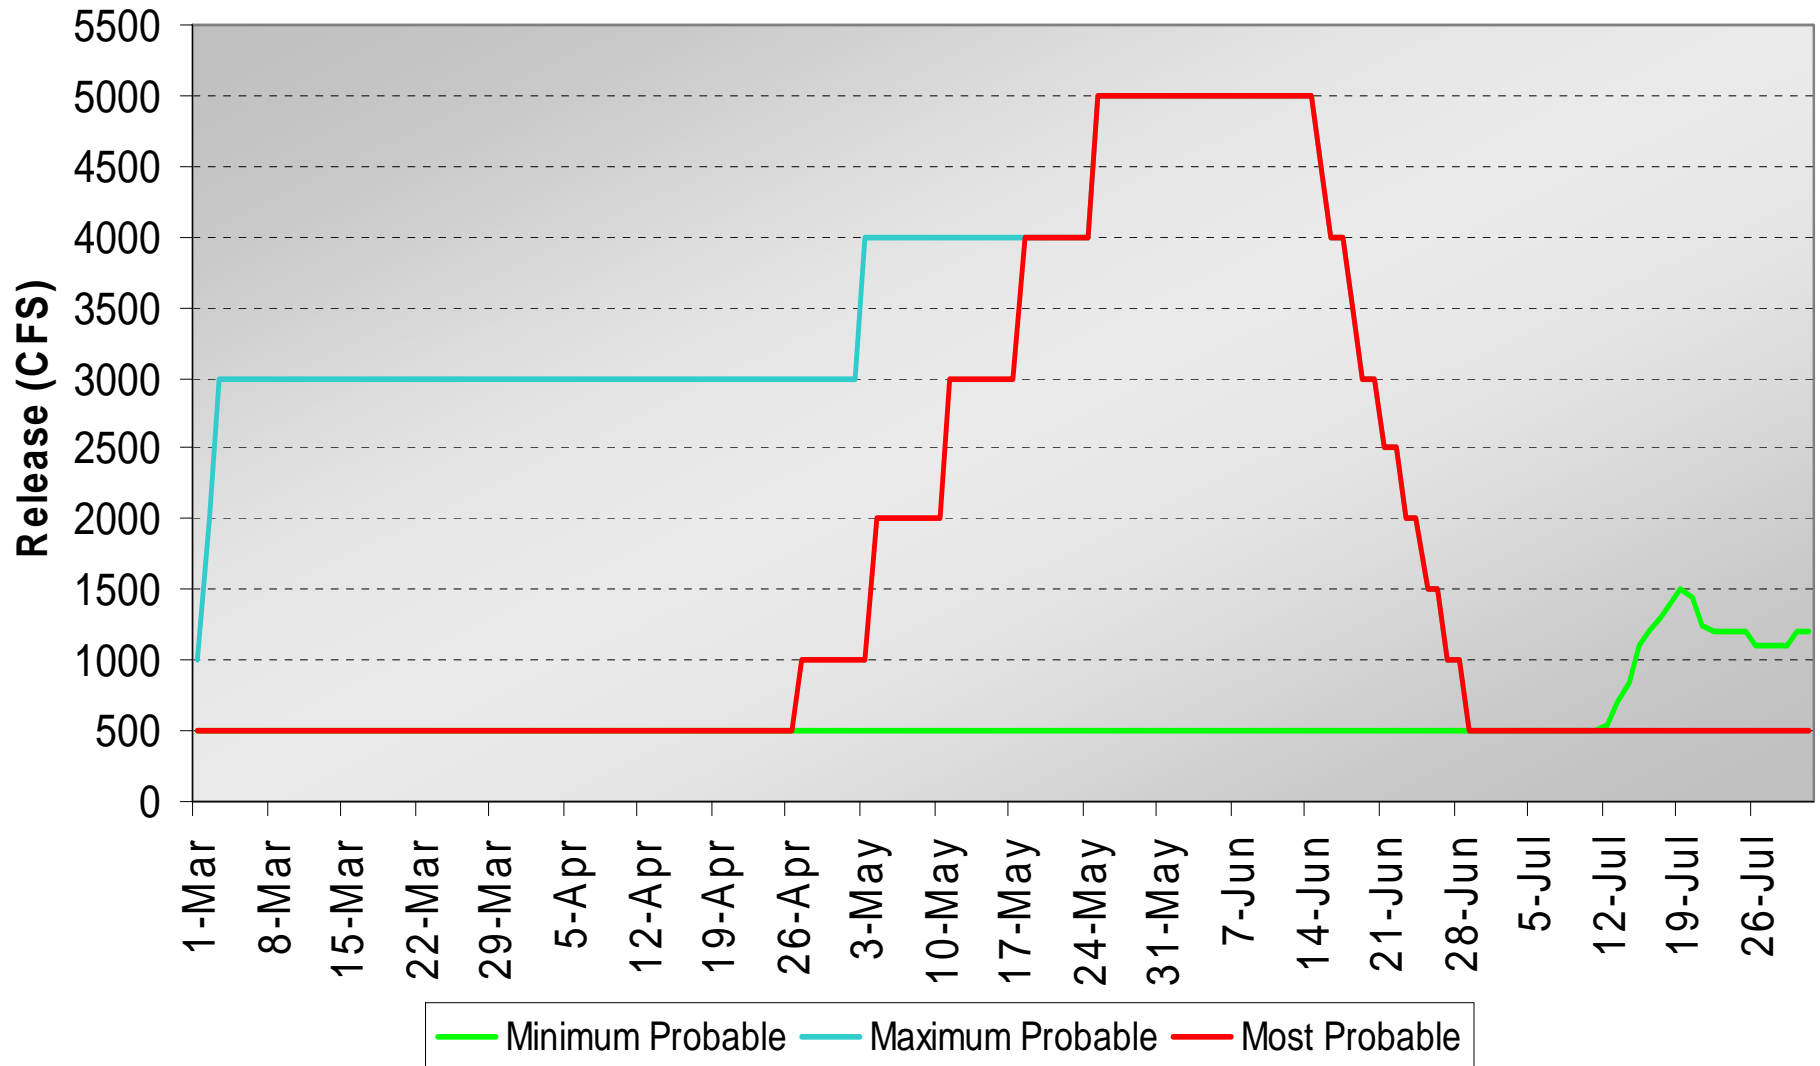
Spring Peak Hydrographs for WY2009 as of the January Mid Month Forecast

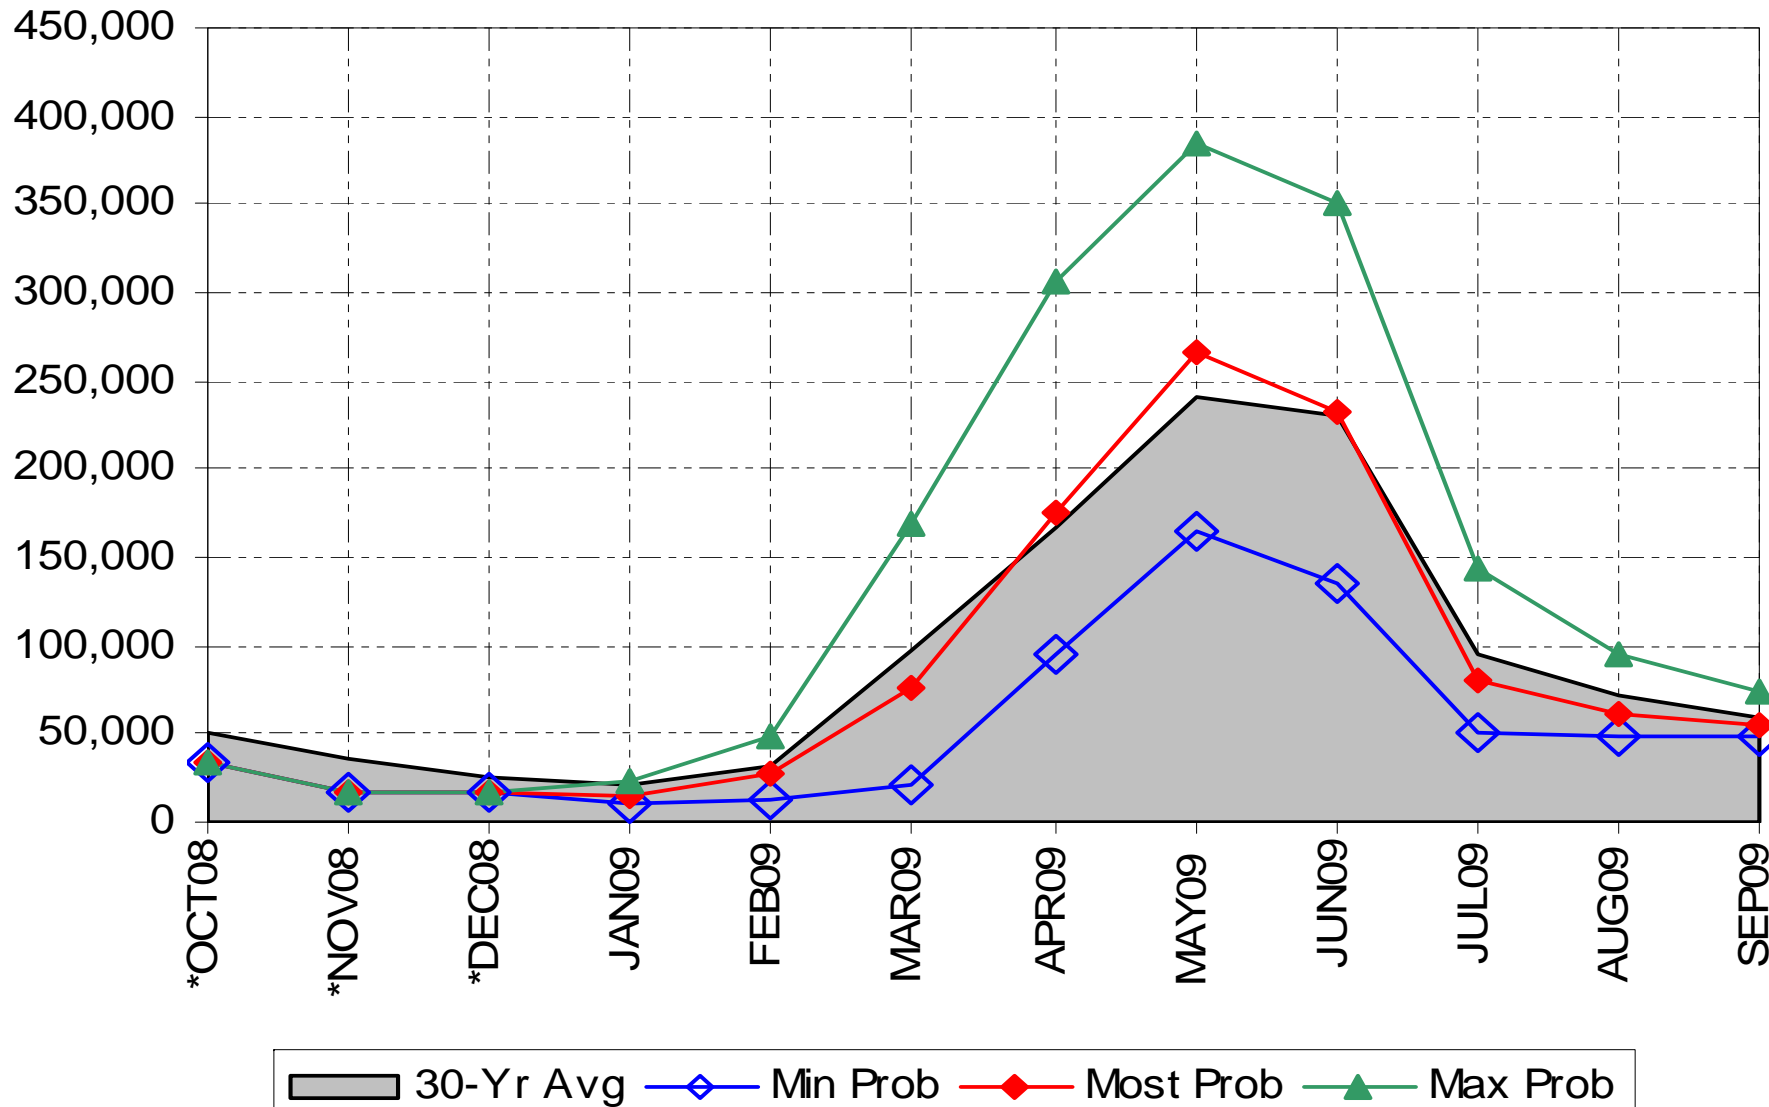
Inflow (af) as of January 2009 Mid Month Forecast

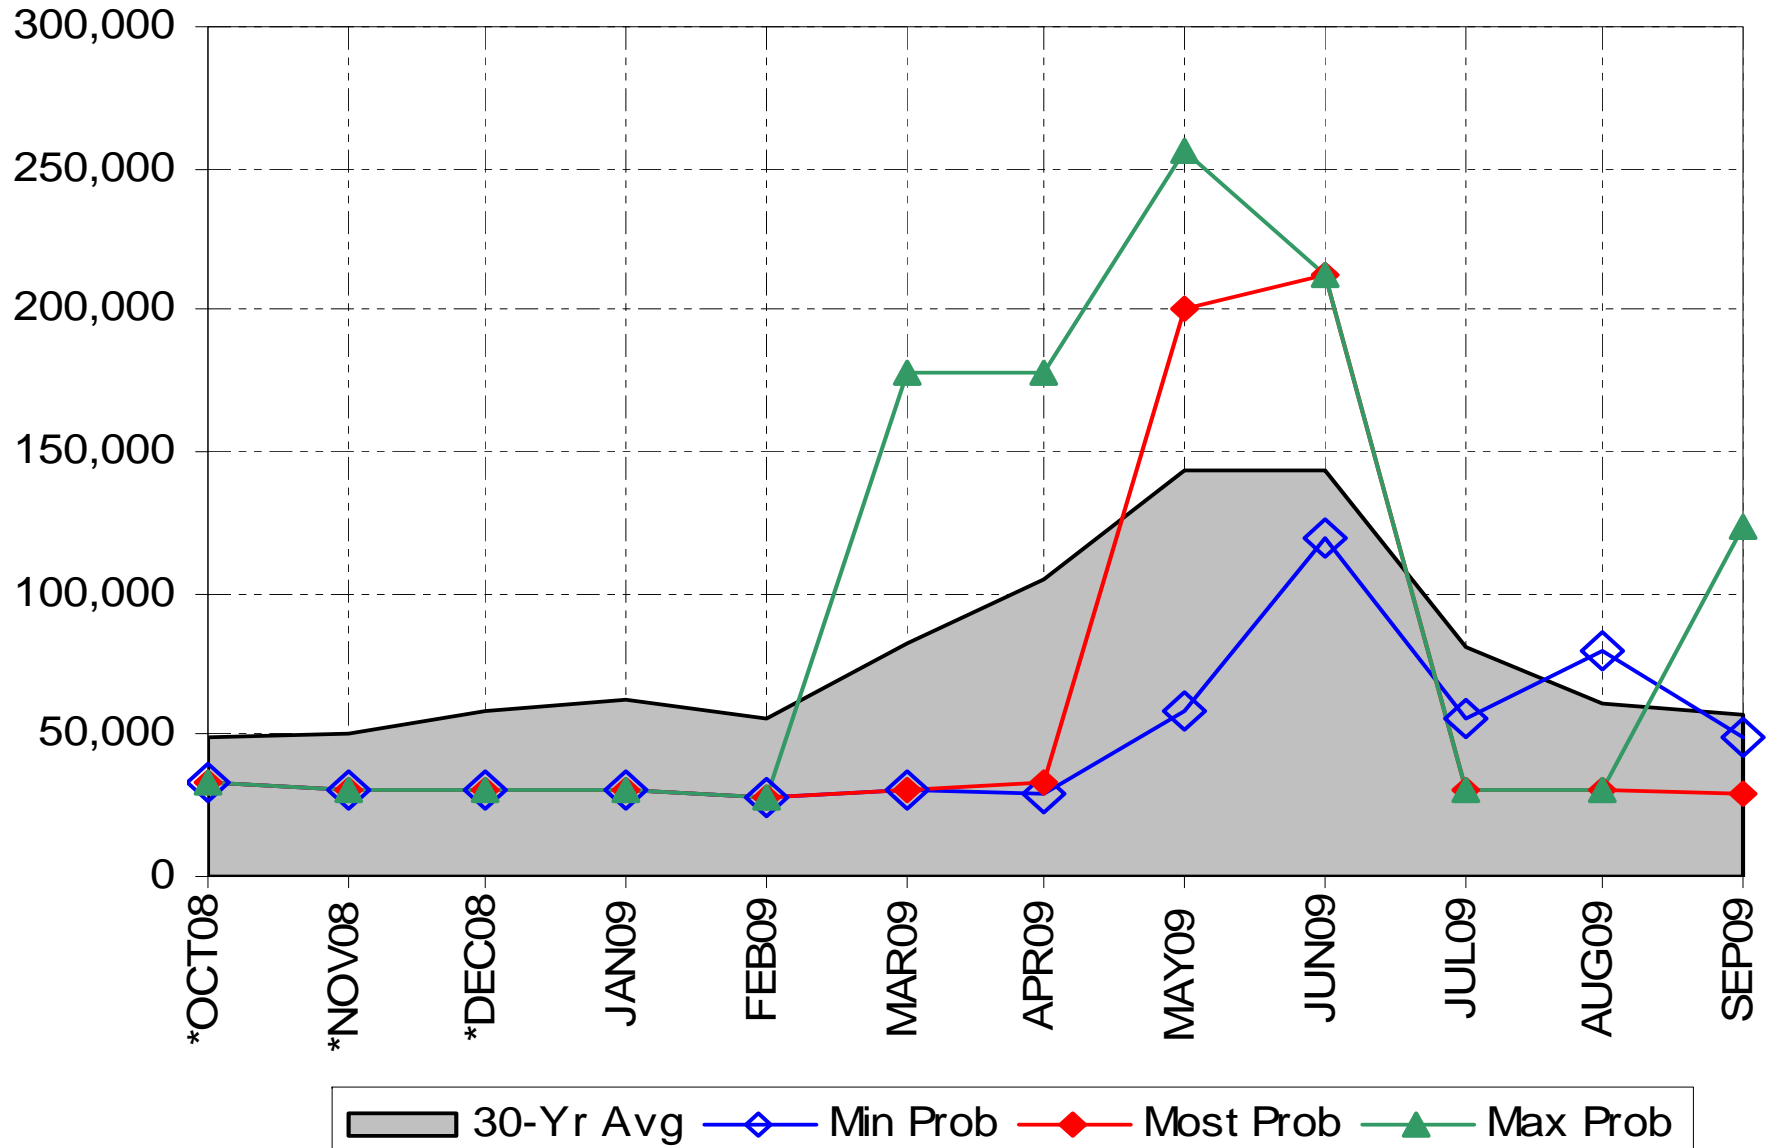
Release (af) as of January 2009 Mid Month Forecast

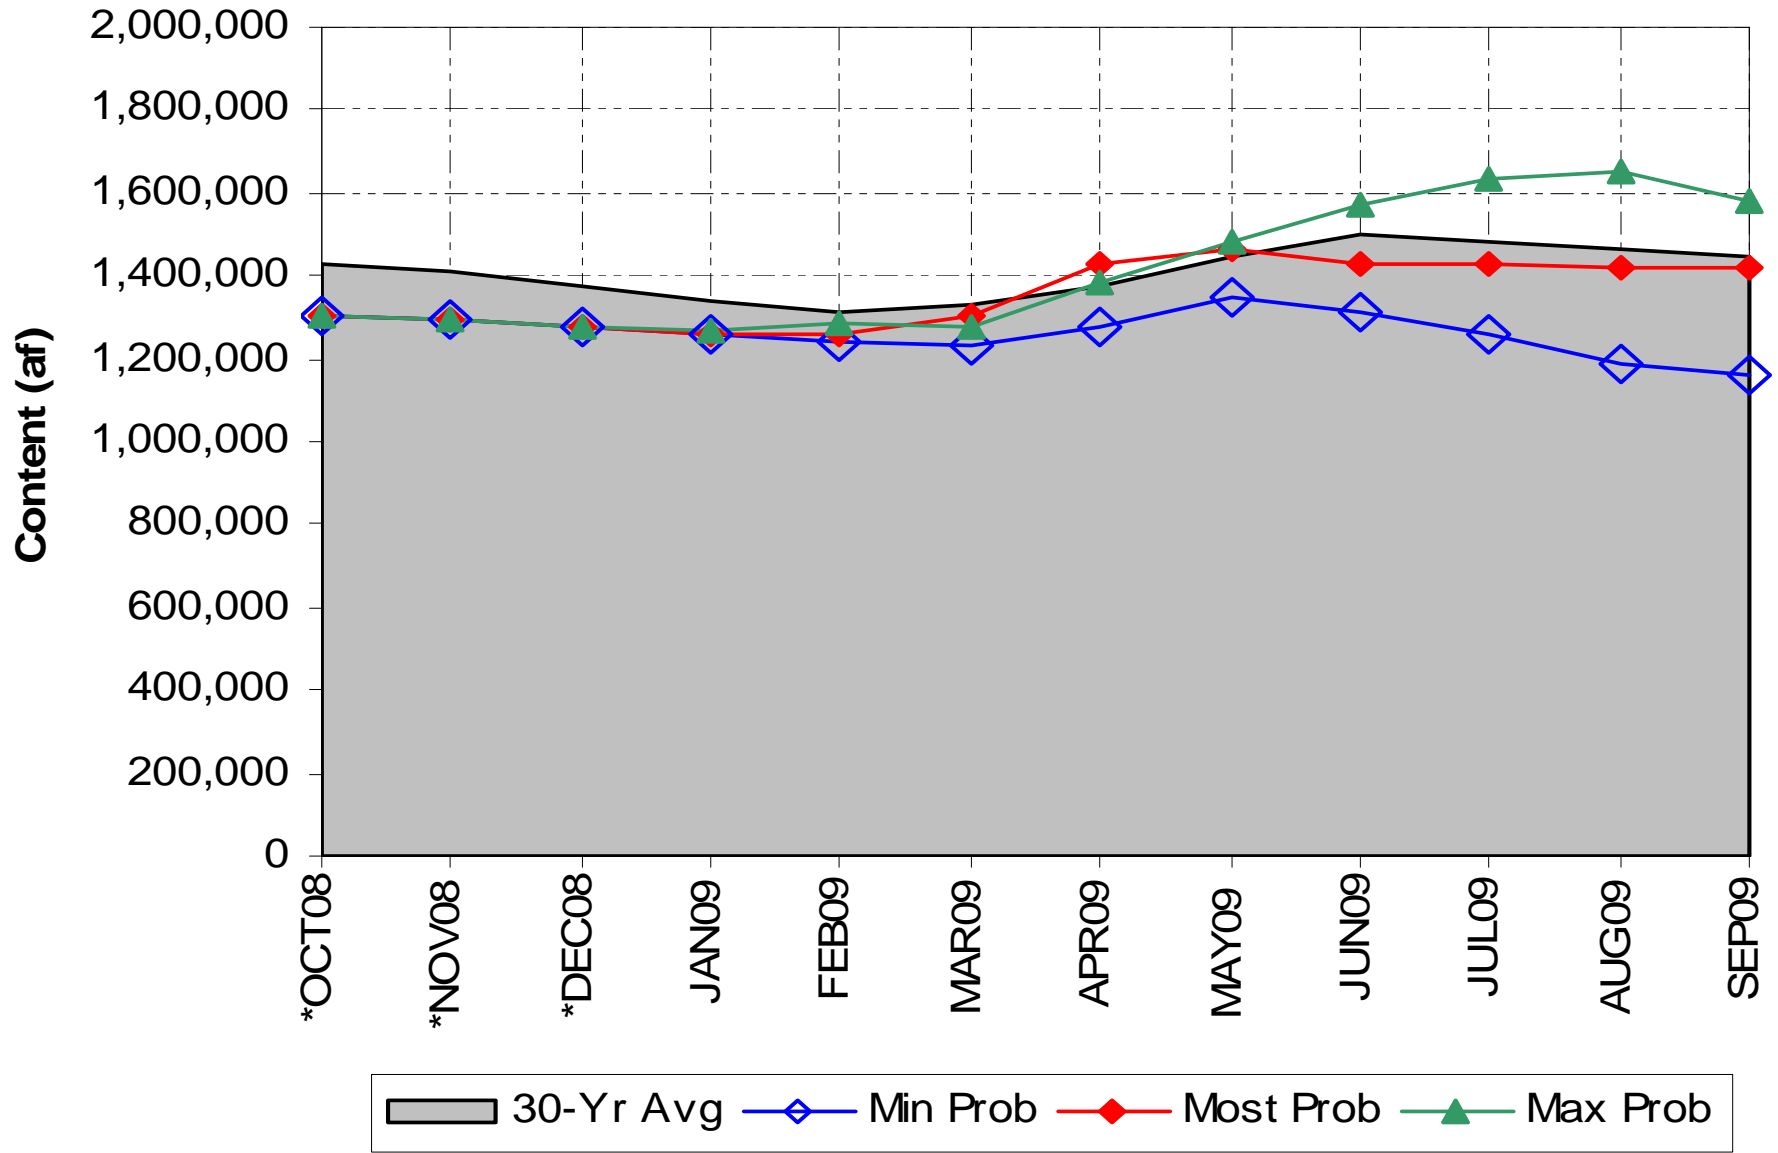
Content (af) as of January 2009 Mid Month Forecast

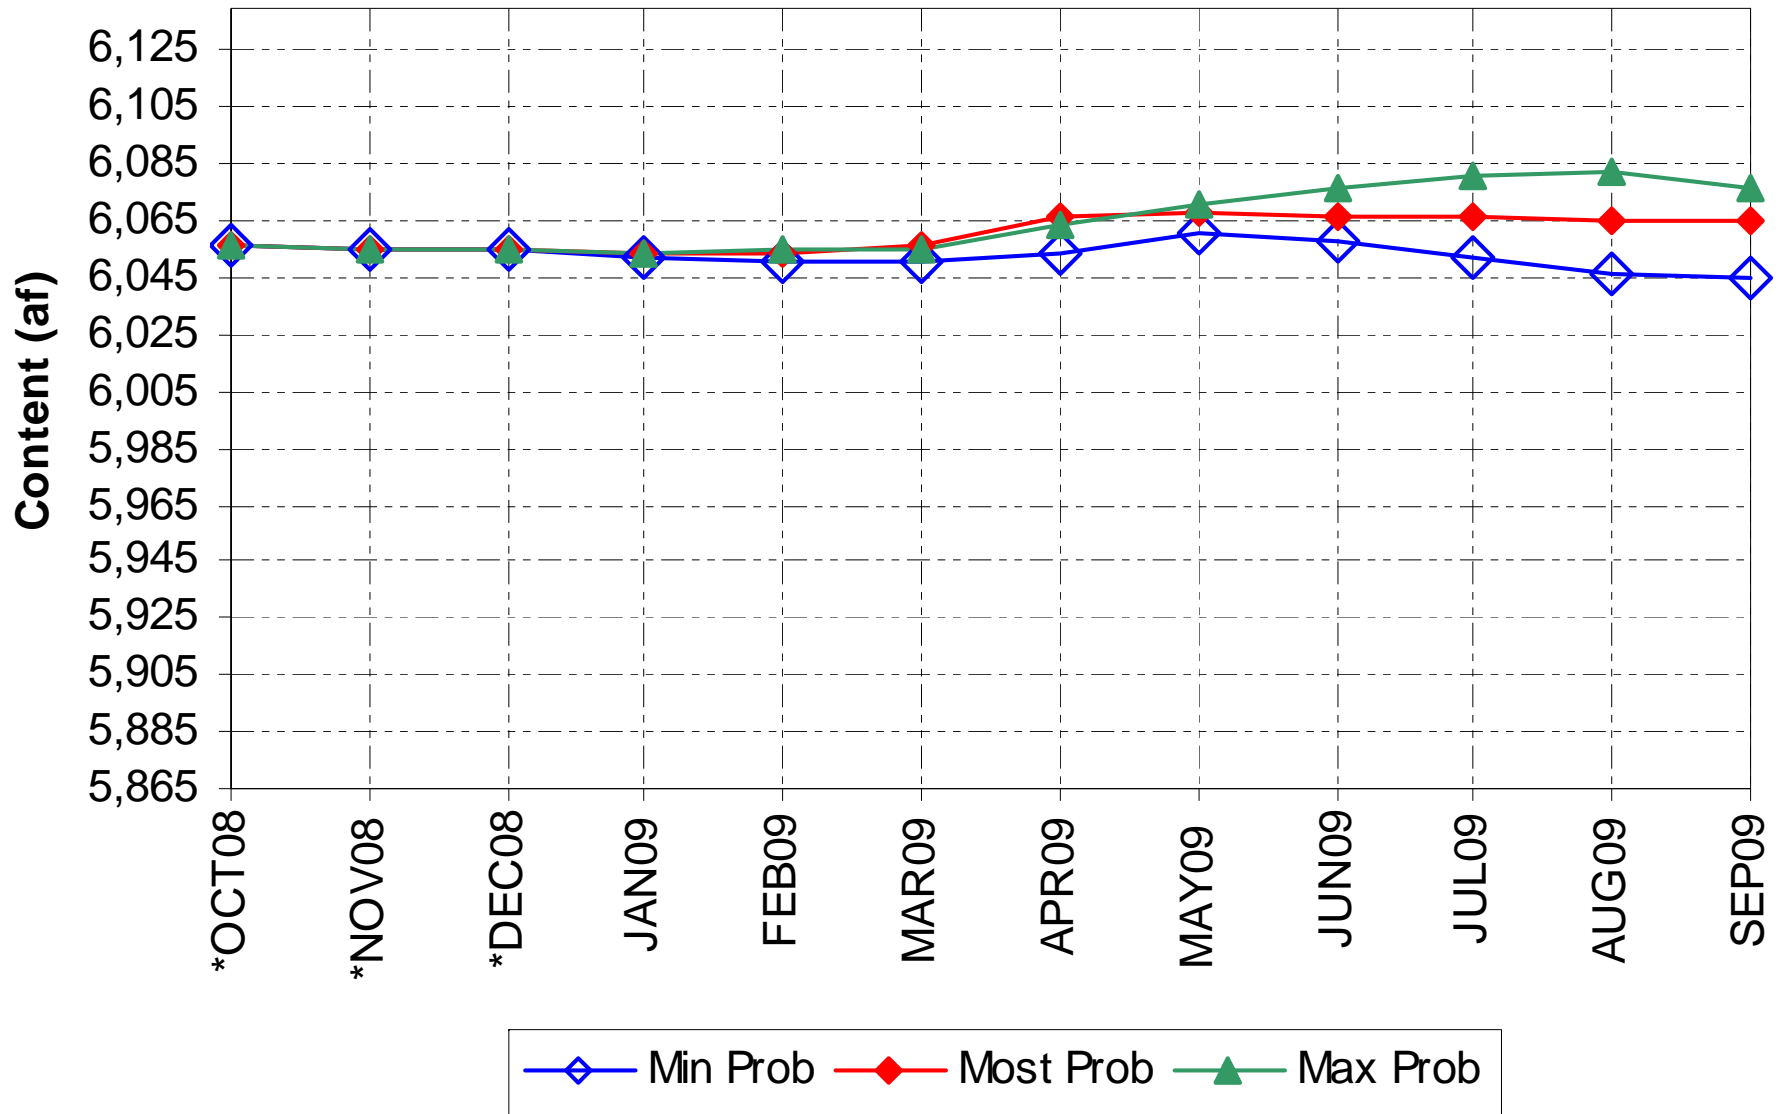
Elevation as of January 2009 Mid Month Forecast

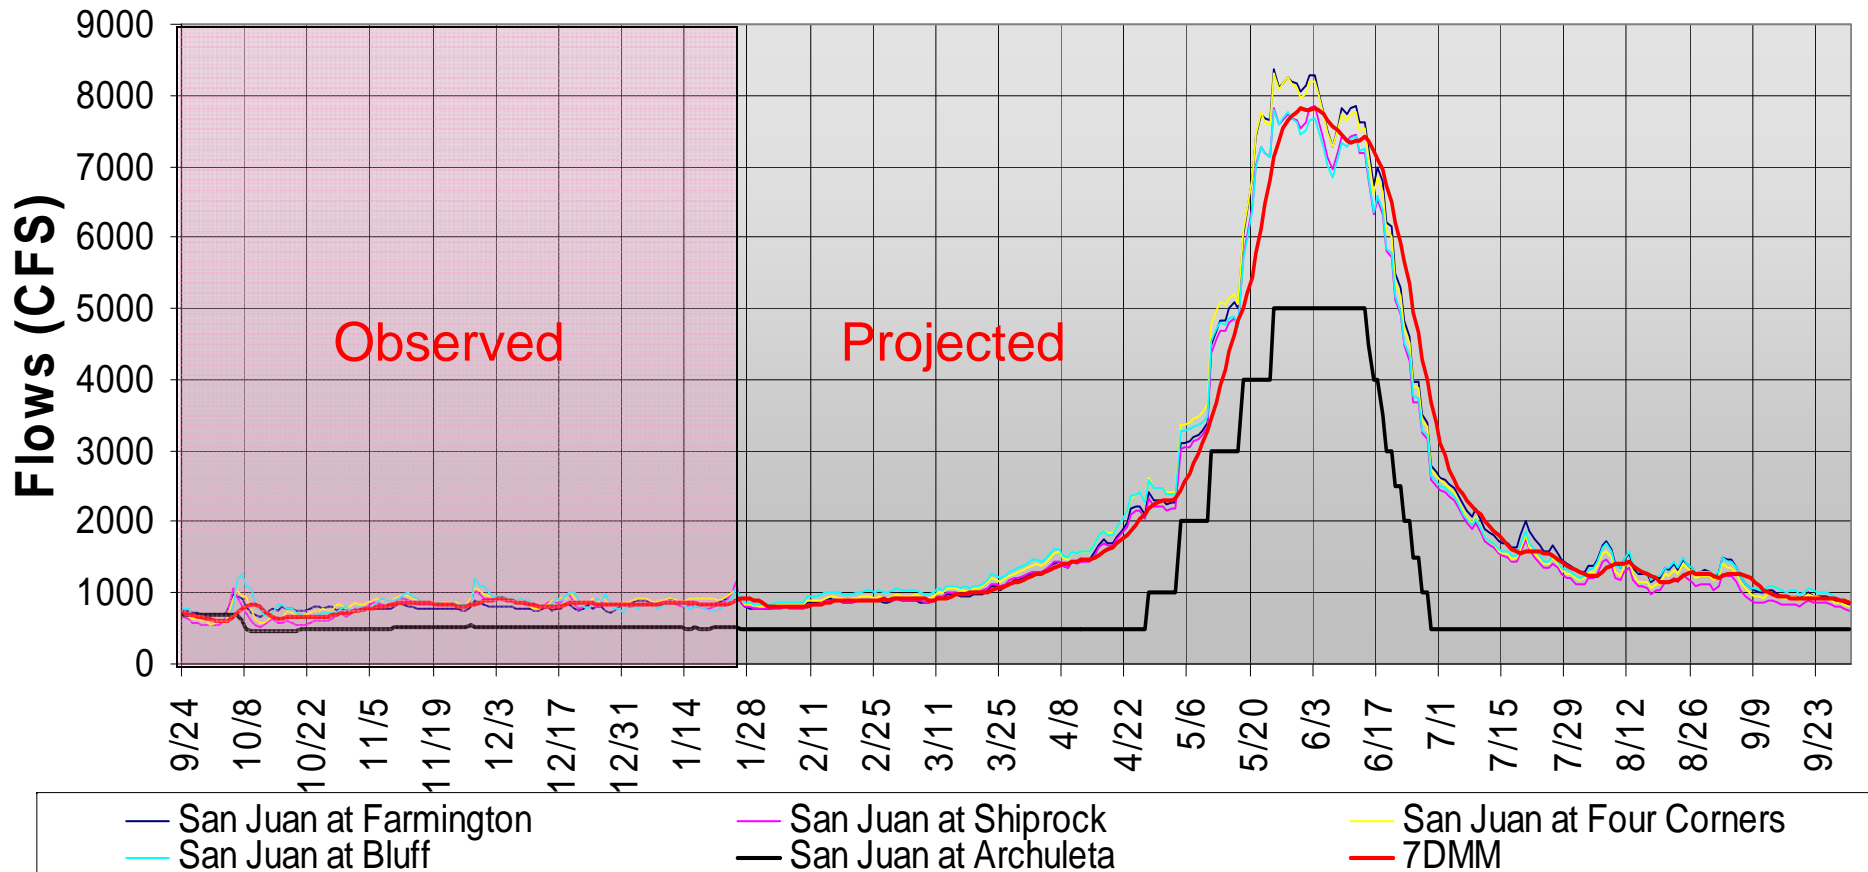
San Juan River Downstream Flows

San Juan Flows based on Most Probable Navajo Release
and Animas @ Farmington Flows as of 1/26/2009

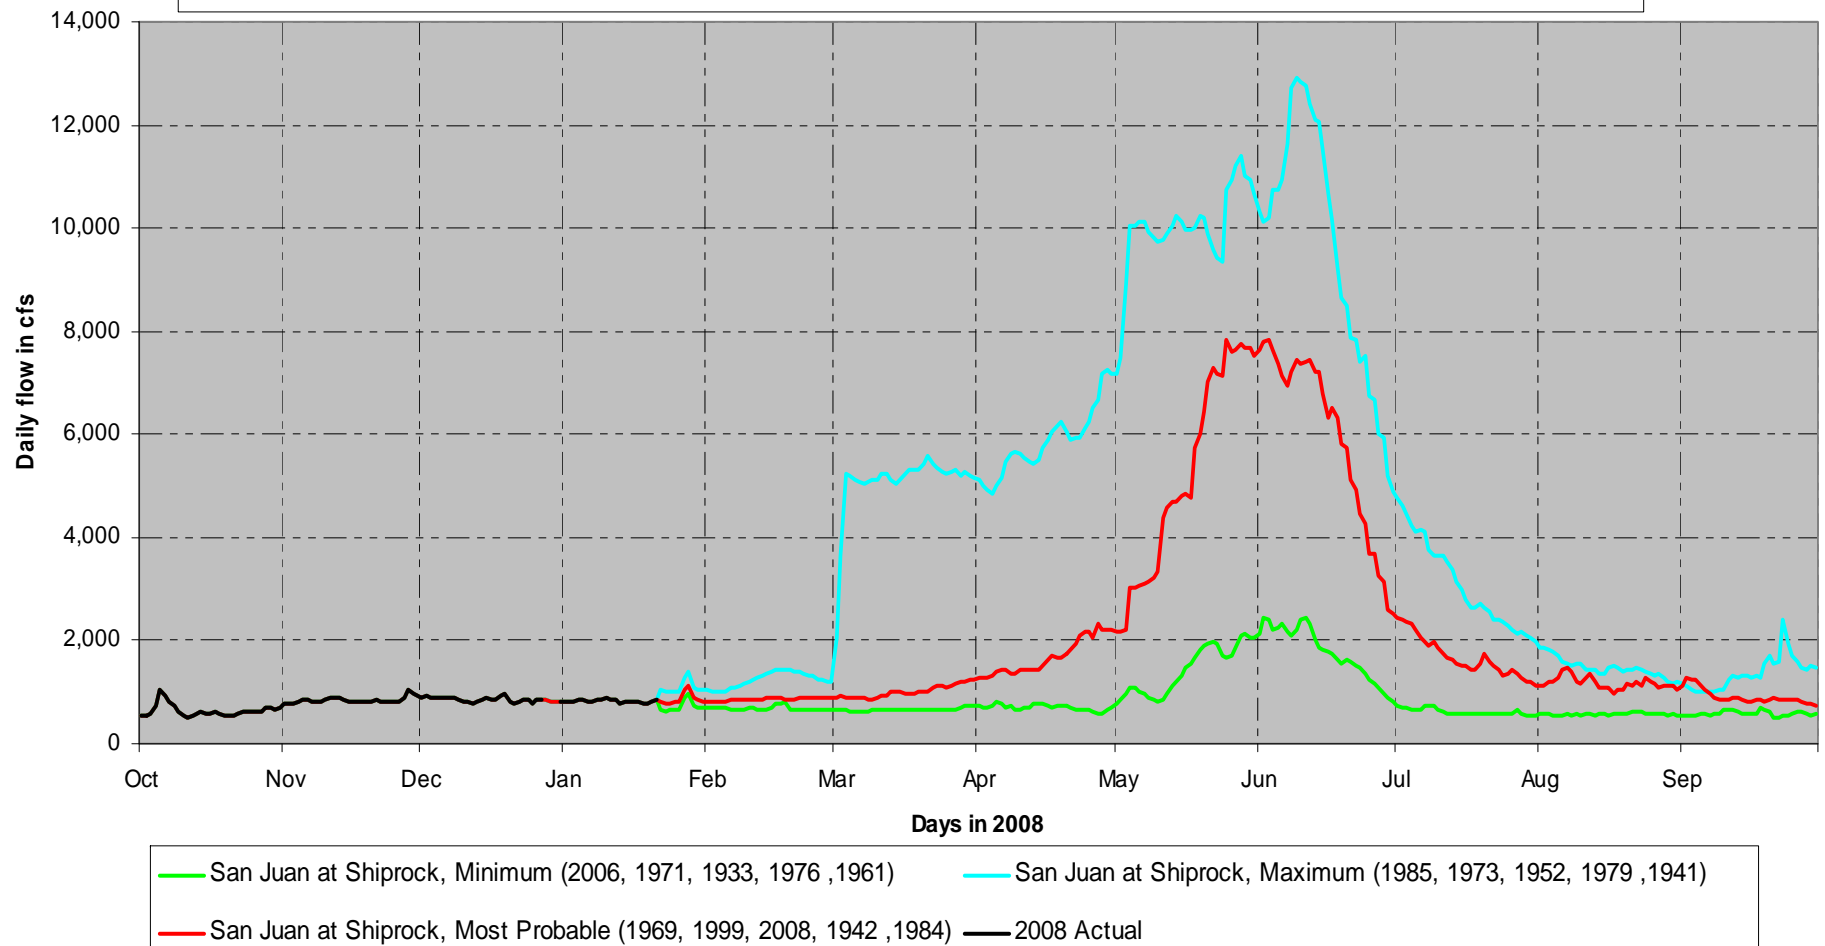
San Juan River at Shiprock

Based on the Jan Mid Month Forecast , Estimate of the San Juan River at Shiprock, Representative Daily Historic Flows
