**Navajo Unit Operations
January 27, 2009
Coordination Meeting**

U.S. Department of the Interior
Bureau of Reclamation

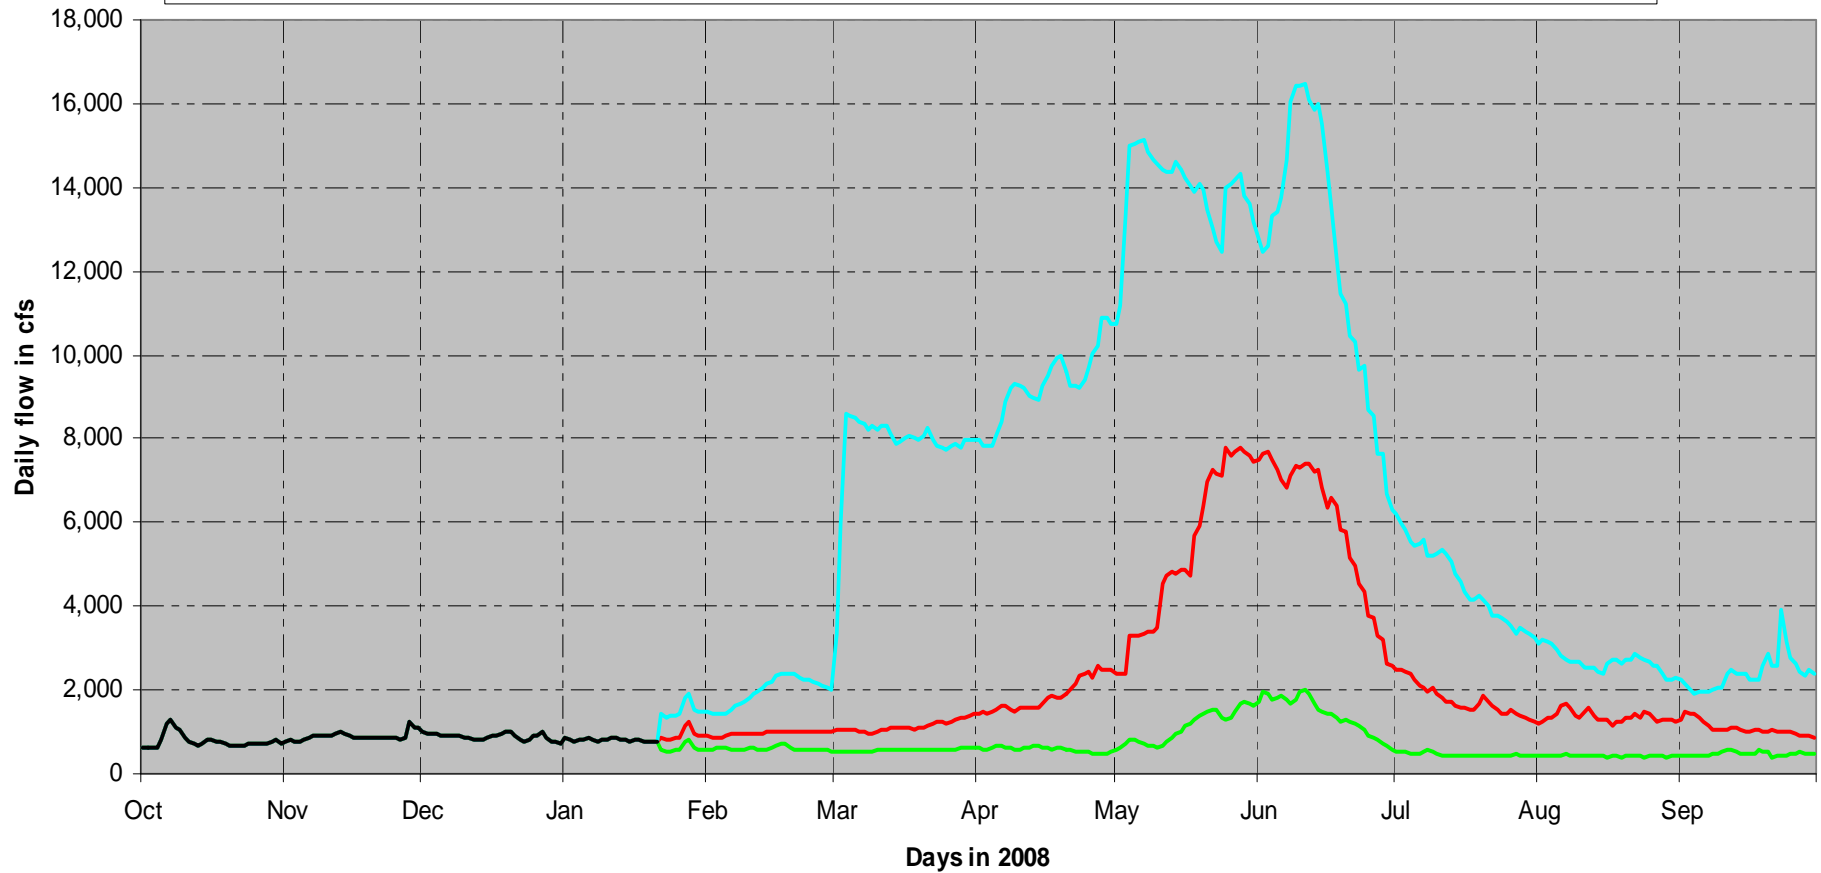
San Juan River at Bluff

Based on the Jan Mid Month Forecast , Estimate of the San Juan River at Bluff, Representative Daily Historic Flows

San Juan at Bluff, Minimum (2006, 1971, 1933, 1976 ,1961)

San Juan at Bluff, Most Probable (1969, 1999, 2008, 1942 ,1984)

San Juan at Bluff, Maximum (1985, 1973, 1952, 1979 ,1941)

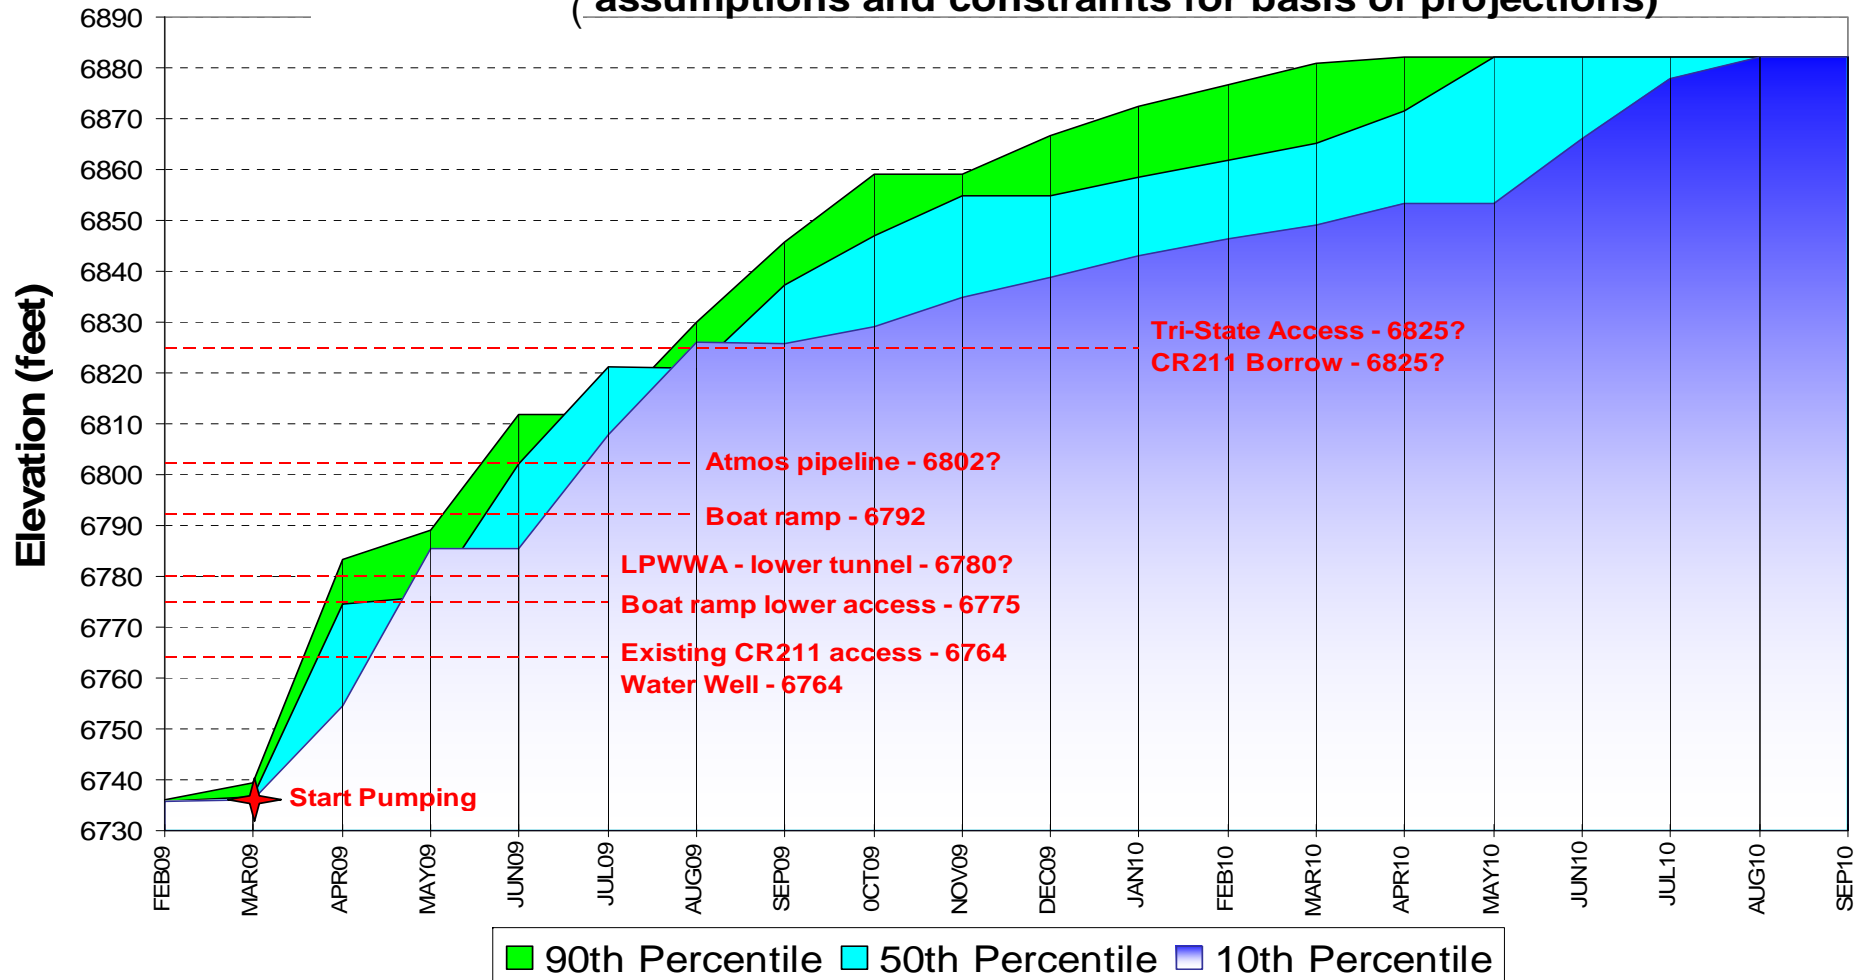
Projected First Fill Schedule
 based on the January 09 Final Forecast
 (assumptions and constraints for basis of projections)

- The project is 66% complete
- Testing of pumps to begin soon
- First Fill is scheduled to begin March 1st, 2009
- Navajo Nation Municipal Pipeline is currently under construction
