Wetland Delineation Report

Proposed 2011-2012 Dry Gulch Irrigation Company Hancock and State Road Lateral Salinity Reduction Projects (Duchesne and Uintah Counties, Utah)

November 2011

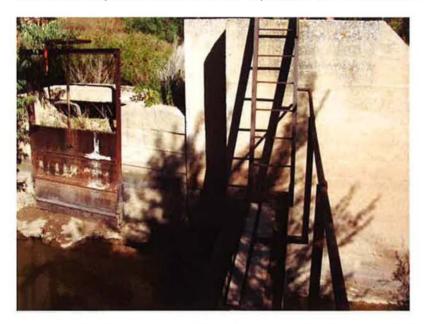
Photo 1: This is the existing diversion structure at Cottonwood Creek (left bank) that corresponds with the northwest beginning of the State Road Canal. This diversion structure would be modified to divert waters into the proposed settling basin. The proposed settling basin would supply the proposed State Road piping system.

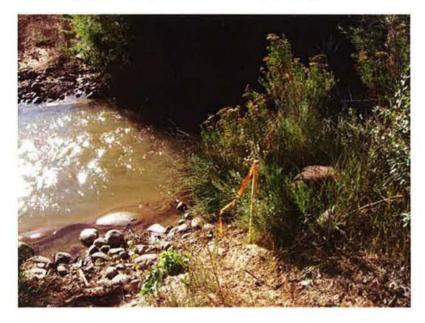
Photo 2: This photo captures the ordinary high water mark (OHWM) stake positioned along Cottonwood Creek (left bank) at ford crossing, downstream of diversion illustrated in photo # 1.

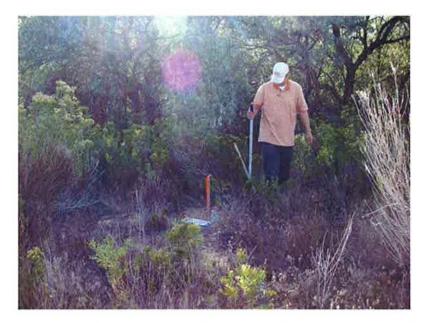
Photo 3: Soil test pit (STP) #1 is located approximately 30 feet landward of the left bank of Cottonwood Creek. This upland STP is located along the proposed overflow pipeline alignment stemming from the proposed settling basin. A rabbit-brush / sage brush community dominates this area.

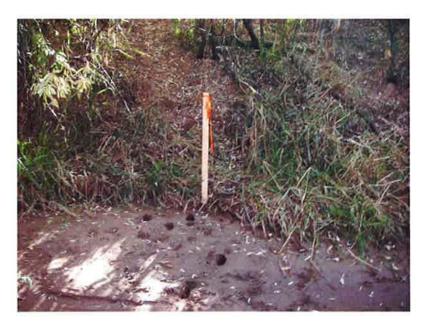
Photo 4: View of an OHWM stake along the existing alignment of the State Road Canal, located approximately 100 feet downstream of the diversion illustrated in photo #1.

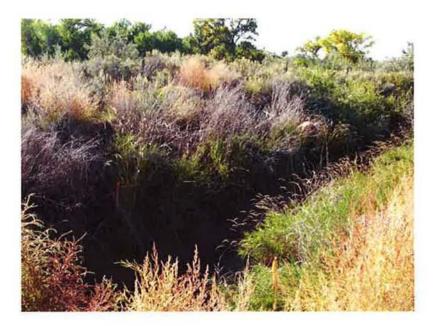
Photo 6: This photo captures the OHWM stakes placed along State Road Canal, located approximately 0.75 miles downstream of the diversion (Photo # 1).

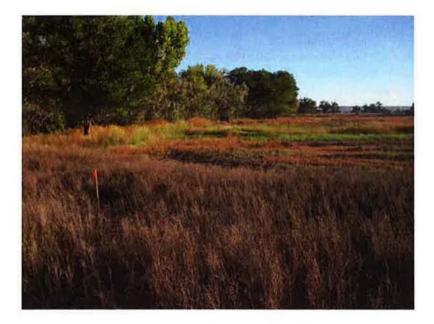
Photo 7: This upland area, represented by STP #2, is situated in a flat, cultivated field; landward of the right bank of the existing State Road Canal.

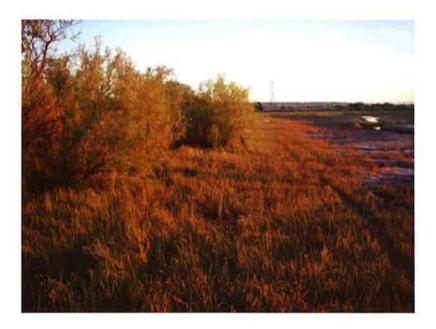
Photo 8: This photo captures STP #3, located near the southeast end of the project area correlated to the proposed piping alignment of State Road Canal. On the right side of the photo, there is a salt flat, which is within a flood irrigated wasteway.

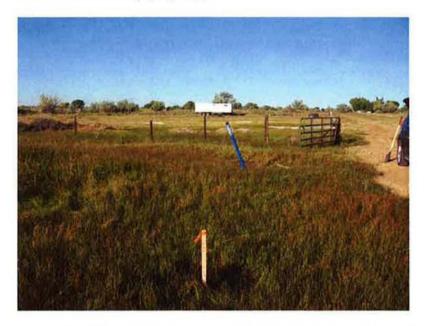
Photo 10: This photo captures STP #4, located within a flood irrigated wet meadow. The herbaceous vegetative community here is dominated by Baltic rush, salt grass and foxtail barley. This area is actively grazed by livestock. The white box trailer in the photo background marks the location of the proposed new settling pond.

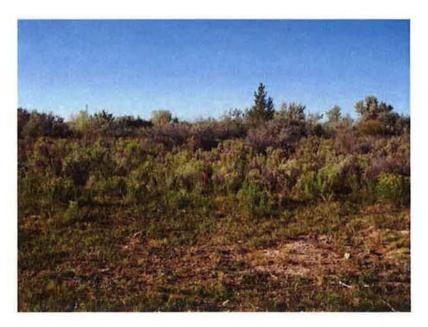
Photo 11: In the center of this photo, a wooden stake with orange flagging marks STP #5, which is located approximately 30 feet landward of the right bank of the Pole Line/Martin Lateral, along 2000 South. This STP was established to help define with wetland transition between STP # 4 and # 5.

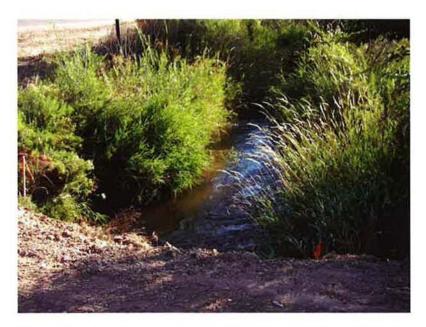
Photo 12: This photo captures the outflow of the Martin Lateral at a drive crossing. The new Hancock piping alignment crosses the Martin Lateral at this location and then heads northeasterly. The wooden stakes with the orange flagging mark the OHWM. The vegetative community is dominated by reed canary grass; at this proposed crossing, no woody vegetation would be cleared.

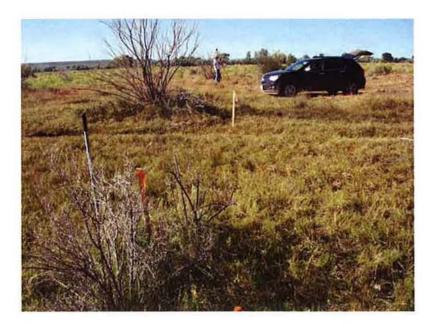
This wetland data point is paired with upland STP #6 to define the limits of the "sloped" wetland tailout extents, situated below the bass pond (see photos # 13 through # 16). All three of the wetland parameters were fulfilled at STP # 7. Hydrophytic vegetation structure was dominated by cattails, salt grass, Baltic rush, and foxtail barley. The wetland hydrology was evidenced by the presence of saturation in the upper 12 inches of the STP. Hydric soil was indicated by a hydrogen sulfide smell in the upper profile as well as the presence of a gleyed sandy matrix observed from 3-18 inches in the STP. This wetland area is managed under a cooperative agreement with the local NRCS field office; recently, the NRCS has planted some trees in planting tubes within and adjacent to the identified sloped wetland.

Photo 13: Looking southwesterly, this photo captures the established transect containing STPs # 6 and # 7, and wetland boundary (WB) stake. At this location, the dominant hydrophytic species is salt grass.

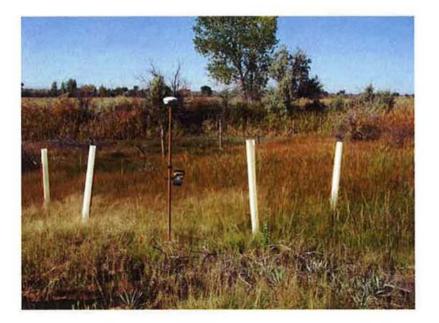
Photo 15: Looking southwest along the proposed piping alignment, this photo captures the location of the wetland boundary, located on the northeastern end of Bass pond sloped wetland tail-out.

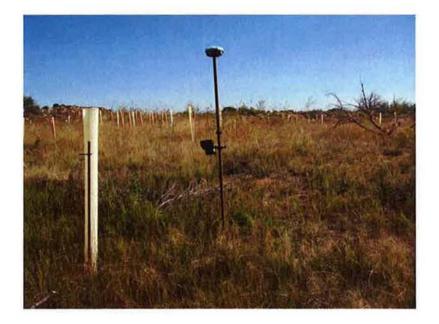
Photo 16: This photo is the inverse of photo # 15. Looking northeasterly, this photo captures the wetland boundary location (and evident topography shift) of the identified sloped wetland (tailout) stemming down-gradient of the Bass Pond.

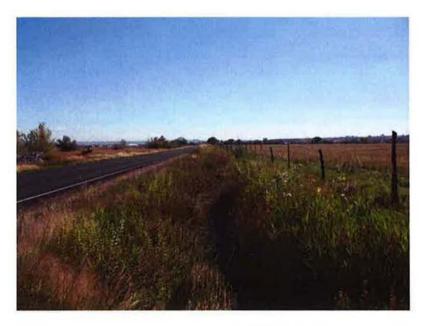
Photo 17: This photo captures the Martin Lateral along 2000 South, east of 4000 West. The proposed piping alignment is located in this existing/established irrigation ditchline. Post piping installation, a roadside swale would be cut into this area to handle roadway stormwater and irrigation run-off waters.

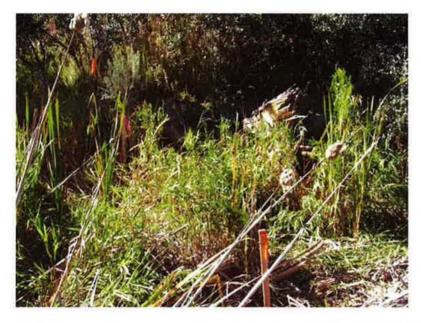
Photo 18: Looking westerly, this photo captures the transect containing STPs # 8 and # 9 as well as the wetland boundary stakes, located at a crossing of an un-named gulch. STPs are marked with lath and orange flagging; whereas, wetland boundary locations are marked with lath and pink flagging.

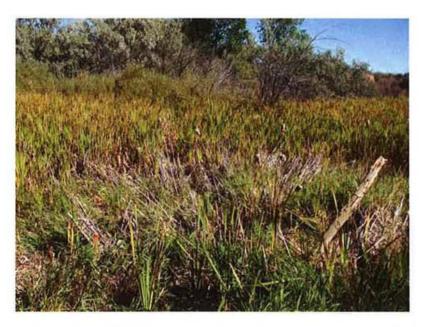
Photo 19: Looking easterly, this photo is the inverse of photo # 18. The proposed piping alignment does cross perpendicularly through this un-named gulch. The un-named gulch is characterized as a sloped wetland, dominated by cattails.

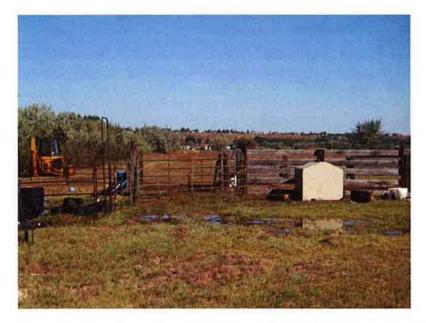
Photo 20: This photo captures a corral that is located at the transition from an upland area to a wetland area. The wetland area is an irrigation induced wet meadow (see photo 21).

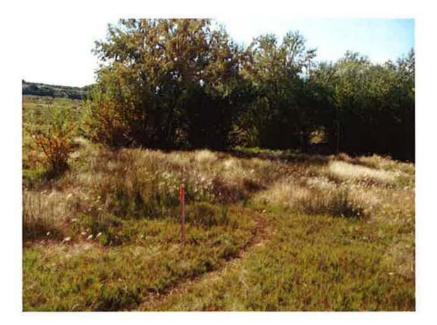
Photo 21: In the center of this photo illustrates STP #10, located in a flood irrigated wet meadow. Salt grass, Baltic rush, foxtail barley and sparsely scattered Russian olives dominate the vegetative community of this wet meadow. This wet meadow is grazed by livestock.

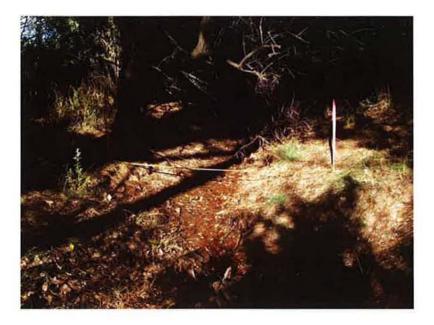
Photo 23: This photo captures an ephemeral drainage crossing along the Hancock piping alignment, where the channel width (OHWM to OHWM) is 9.25'.

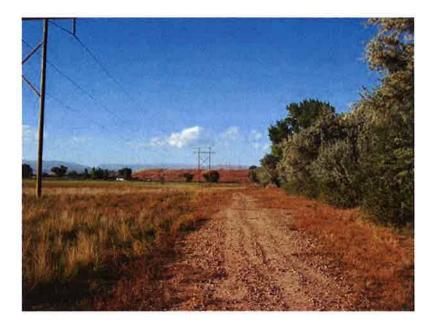
Photo 24: Looking northerly at a segment of the proposed Hancock alignment, where the piping alignment is situated within this gravel utility service road footprint.

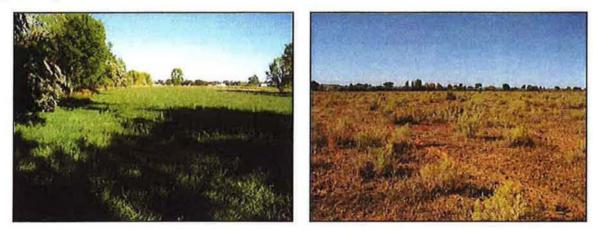
The photos below illustrate the project action area from two different vantage locations. The left photo was taken near the middle of the proposed State Road pipe alignment; at this location, the new alignment is situated along the edge of an alfalfa field. The right photo was taken looking southwest, along the proposed Hancock Phase 1 alignment, toward the intersection of Pole Line Road/2000 South and 5000 West; uncultivated areas in the project

action area are dominated by sparse sagebrush communities like this one. This particular area is grazed by several horses.
