700 bar Hydrogen Dispenser Hose Reliability Improvement

**National Renewable Energy Laboratory
DOE 2016 Annual Merit Review
June 9, 2016**

**Project ID
PD100**

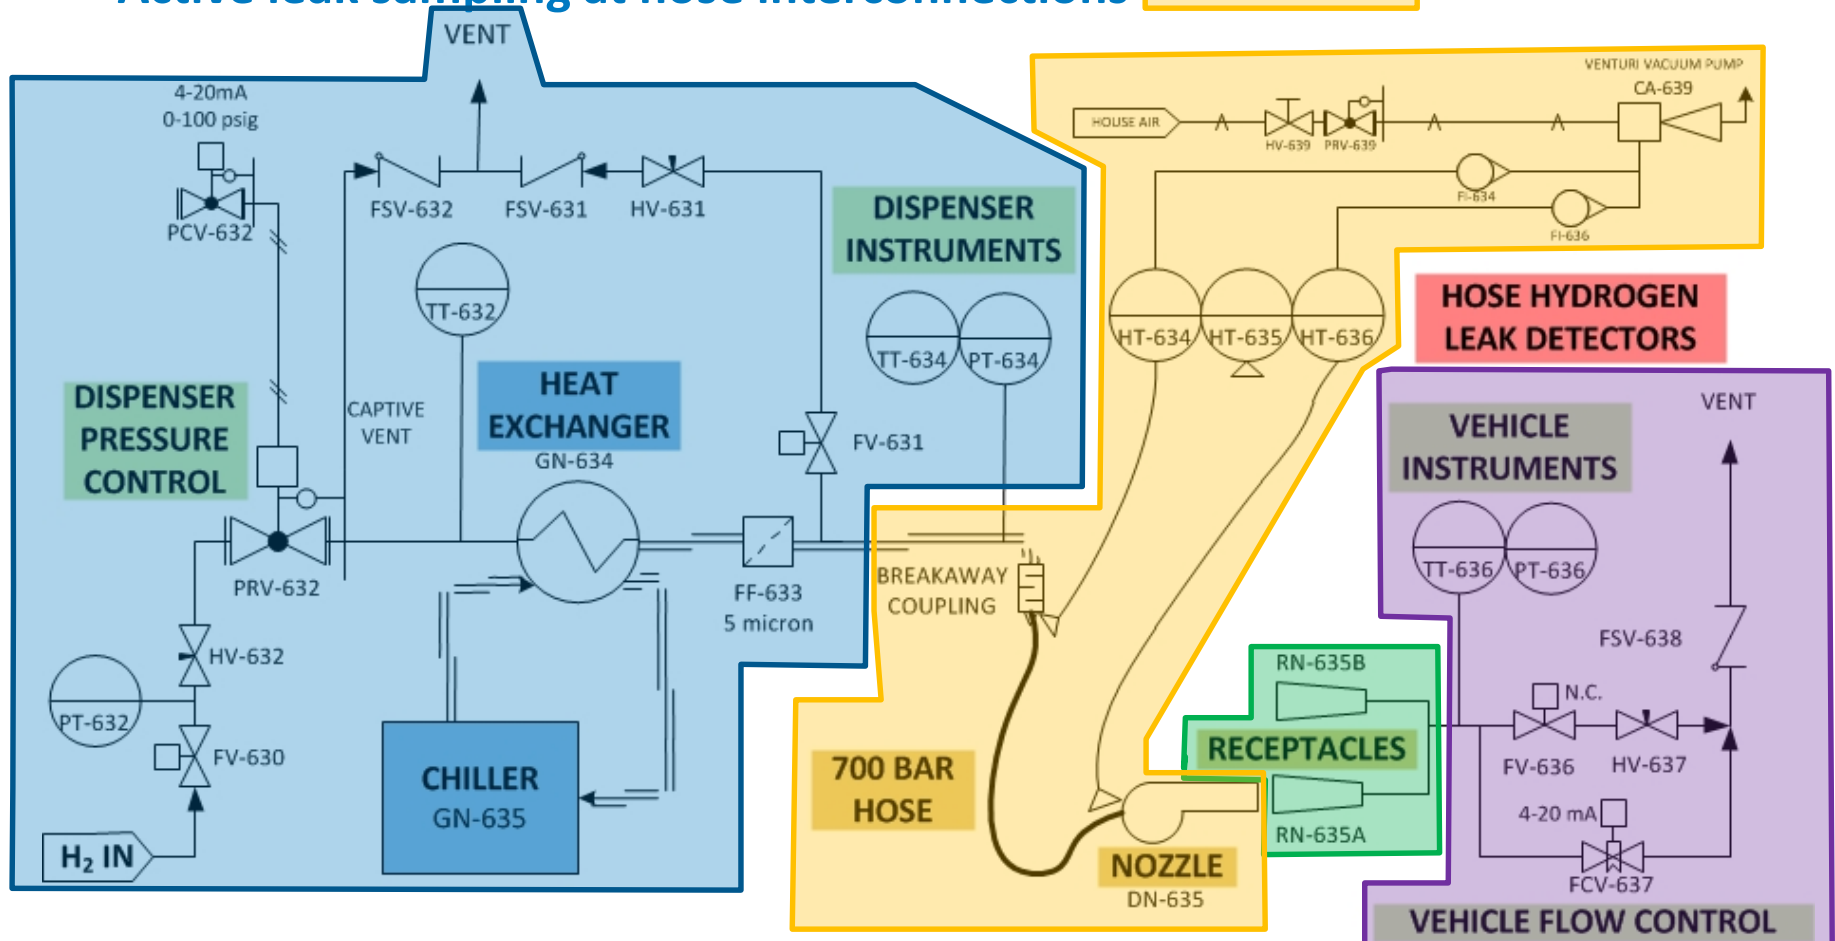
Approach – Hose Test Stand System Design

- ‘Dispenser’ subsystem based on commercial dispensers
- Redundant receptacles to give greater path options
- Tankless flow control for low-mass, pre-cooled cycles
- Active leak sampling at hose interconnections

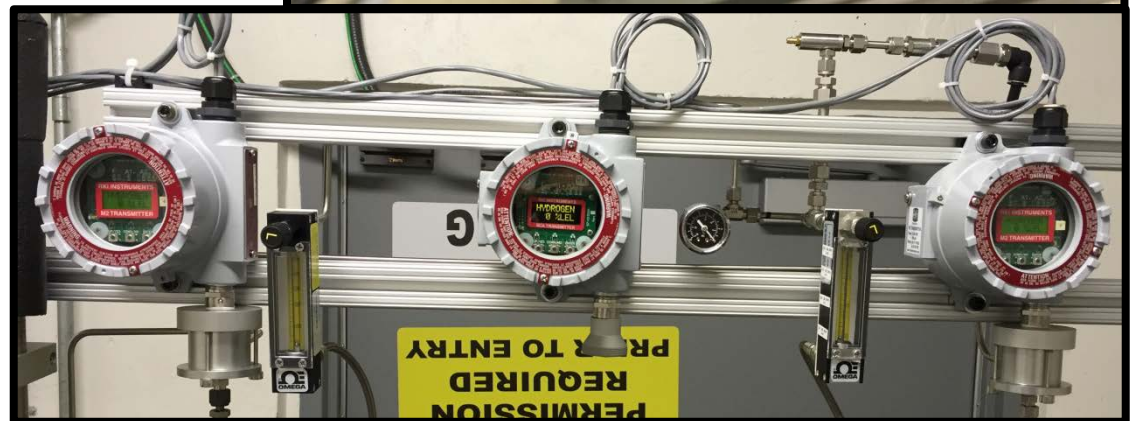
Approach – Hose Leak Detection

- Vacuum pump sampling system installed on crimp fittings
- Constant flow 400 mL/min around hose crimp fittings through hydrogen detectors

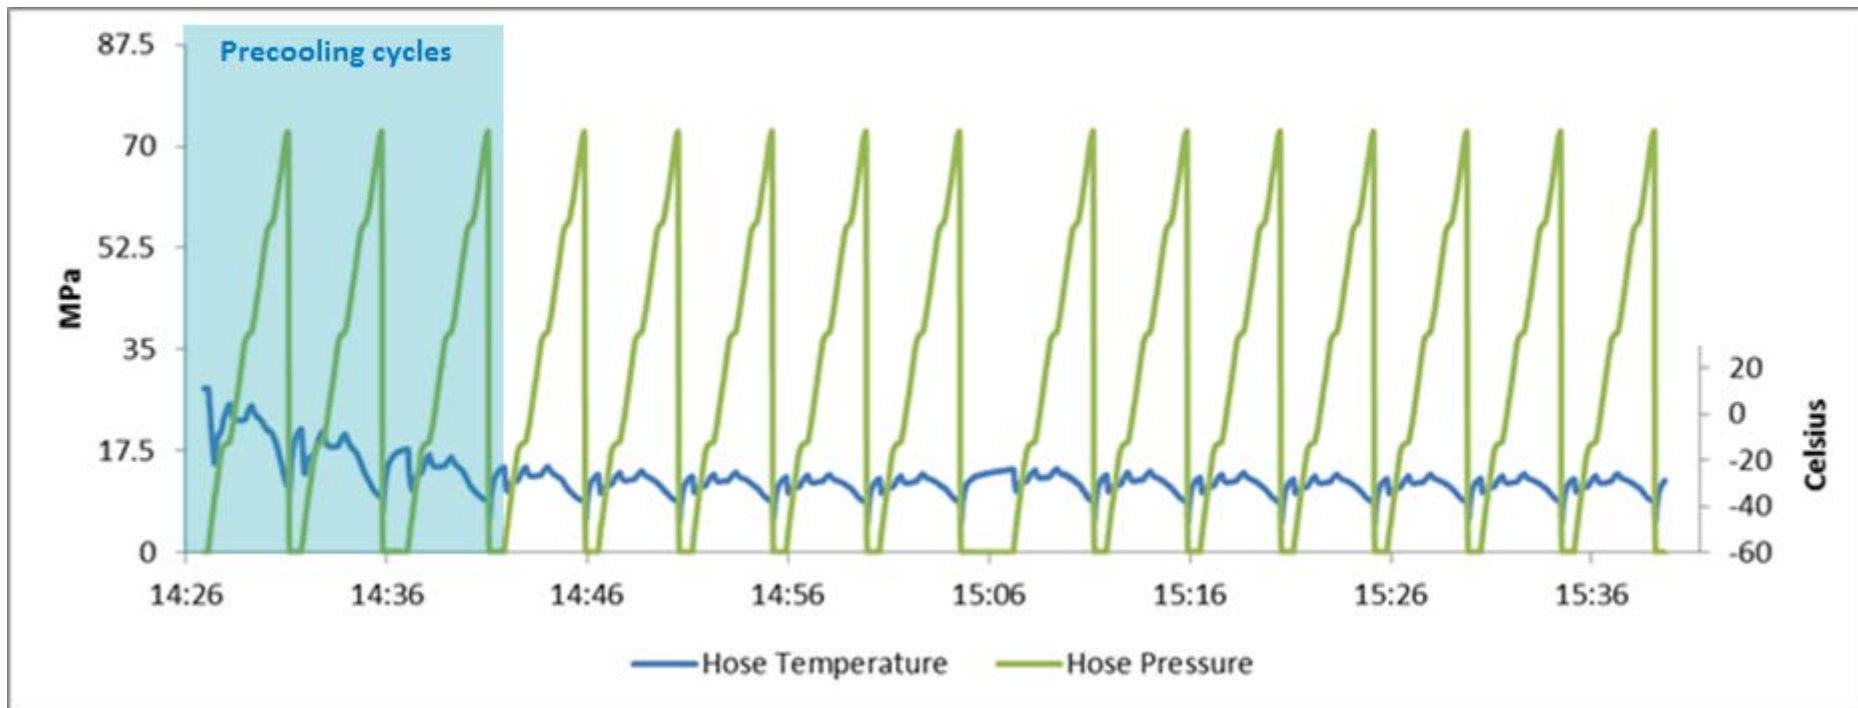
Progress – Sample of a Cycle Set

Start of a cycle set with initial temp 10 C (set continues →)

Average mass H2 consumed per cycle	57 grams
Average fill time (inc. leak checks)	4 min 2 sec
Average non-fueling time (return to dispenser)	46 sec

- Successful repetition of tankless filling keeping hose inner liner cold
- Regular breaks in fueling provide thermal shock

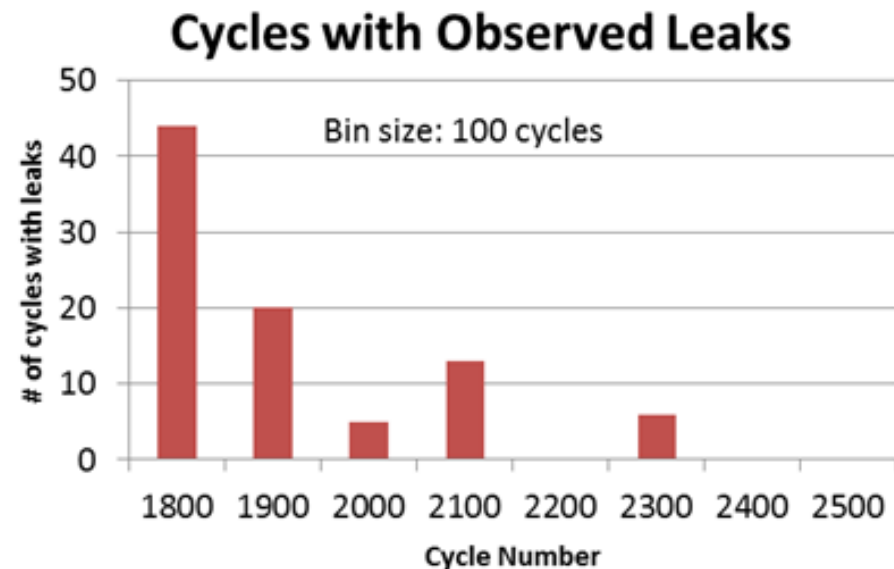
Progress – Hose Fitting Leak Detection

- Hose leak active detector system mounted on dispenser hose end started registering leaks at Cycle 1856
- Nozzle hose end registered leaks at Cycle 3033
- Leak tended to develop after several chilled cycles and persist through multiple cycles with little day-to-day consistency
- Small amount H₂ released
 - ~1 milligram H₂ through detector per cycle (400ml/min)
 - Hose is not considered failed

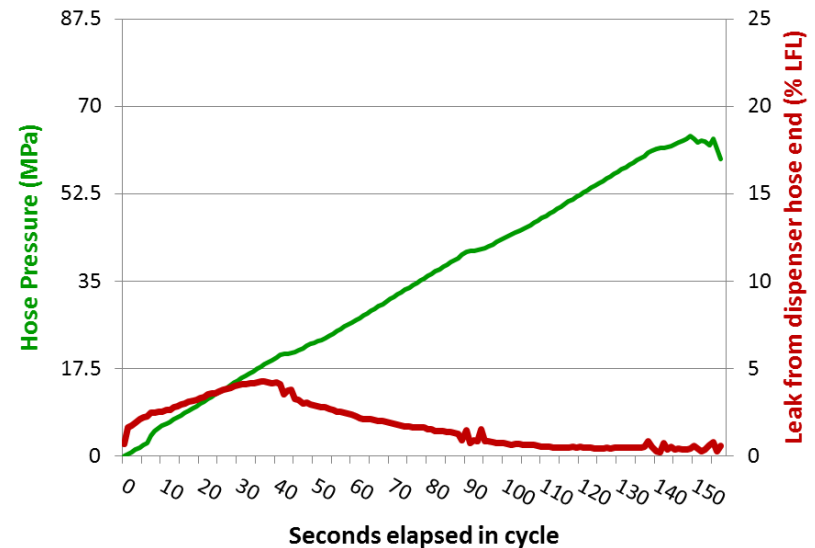
Averaged Leak Rates for Cycles 1855 to 1920

- Leak appears to mainly occur upon hose depressurization, motion after hose gets very cold
- Often leaks over consecutive cycles
- Can stop leaking after cycle paused
- No clear pattern identified yet

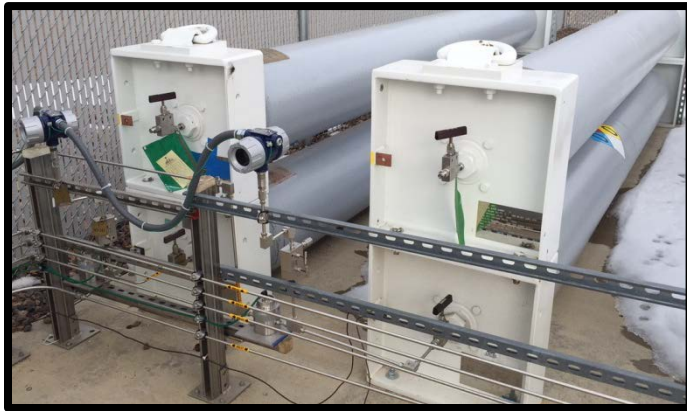
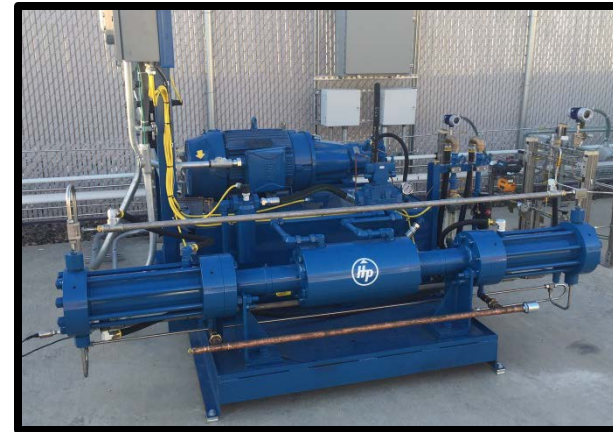
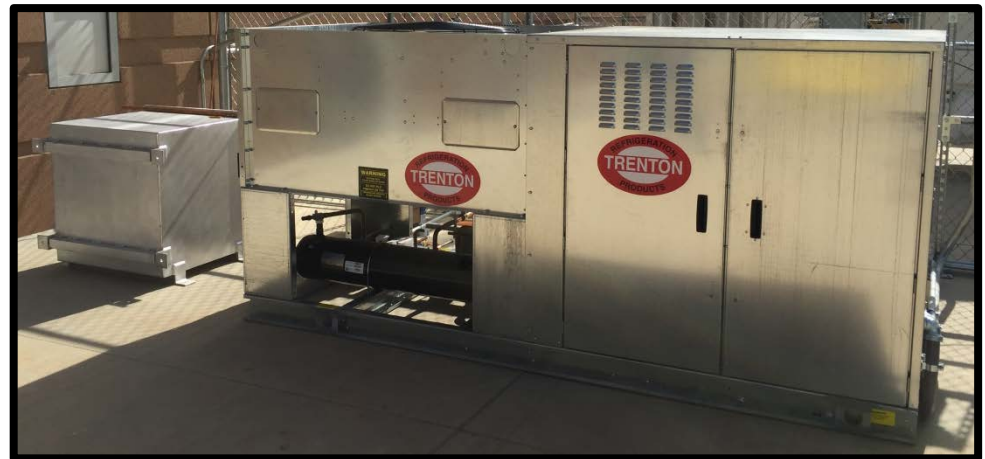
Progress – Station Upgrades

- Additional high pressure storage tanks – 32 kg @ 875 bar (Total 60 kg)
- High pressure compressor – up to 20 kg/hr to 875 bar

- 16 hp chiller and heat exchanger – will provide -40°C at hose with higher flow
- Together, the station upgrades allow for increased cycle rate, higher target pressure, higher flow rates and less downtime due to shared projects

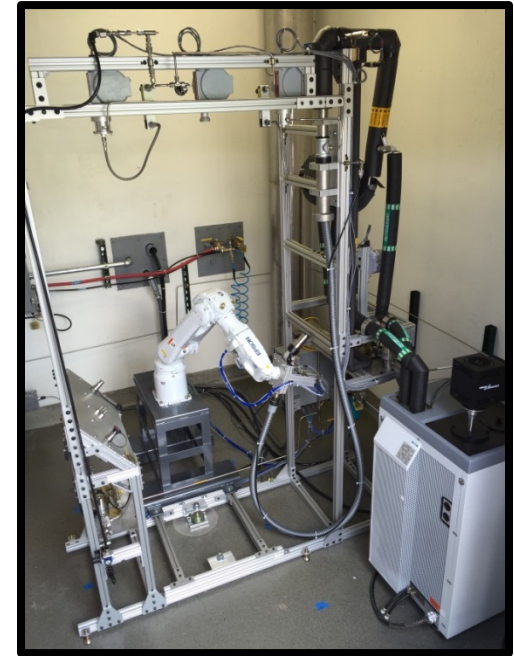
Approach – Mechanical Bending/Twisting

- **Epson six-axis robot installed and programmed with realistic human motions from ‘dispenser’ to receptacles – total distance ~3 feet**
- **Double receptacle system to provide options for greater randomization of paths from dispenser**
- **High repeatability, over torque tripping capability, anchored frame and calibration help reduce stresses on nozzle and receptacle**
 - Focus on crimped hose end connections and their ability to remain sealed under bending/twisting stress while cold.
 - Nozzle and other components are replaced as needed if they wear out.

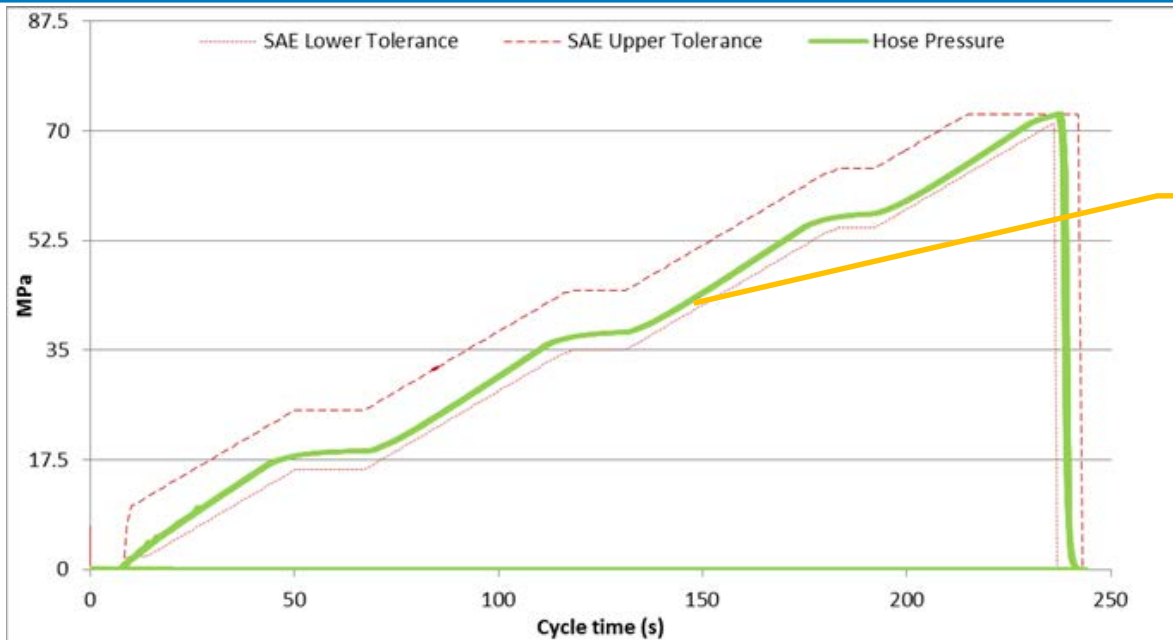
Progress – Sample of a Cycle Set

Set of 15 cycles has high repeatability and remains within specified cycle tolerance at all times

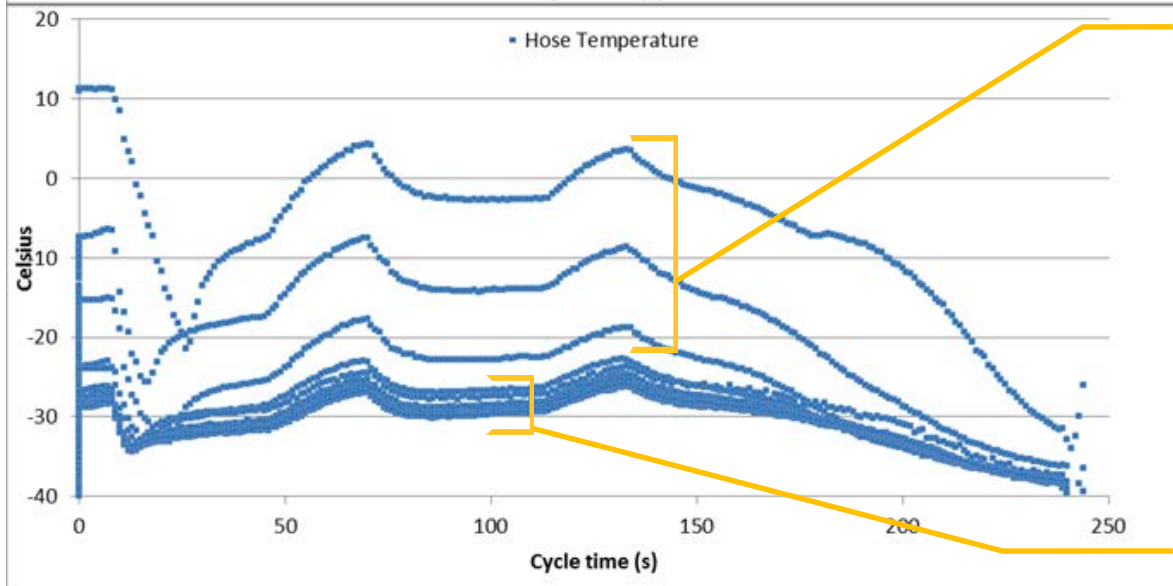
First 3 cycles:
Average hose temp -17.5 C

Next 12 cycles (and beyond)
Average hose temp -30.5 C
