Hydrogen Component Validation

Danny Terlip
National Renewable Energy Laboratory
7 June 2016

Project ID #TV019

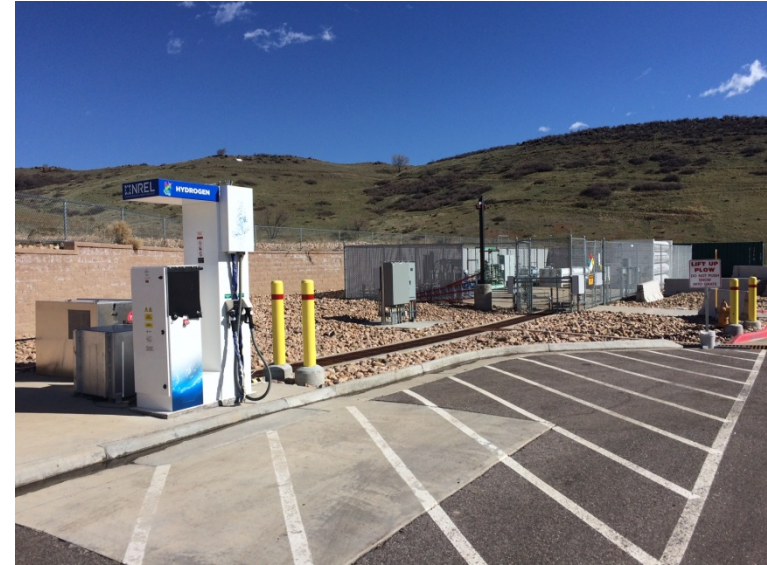
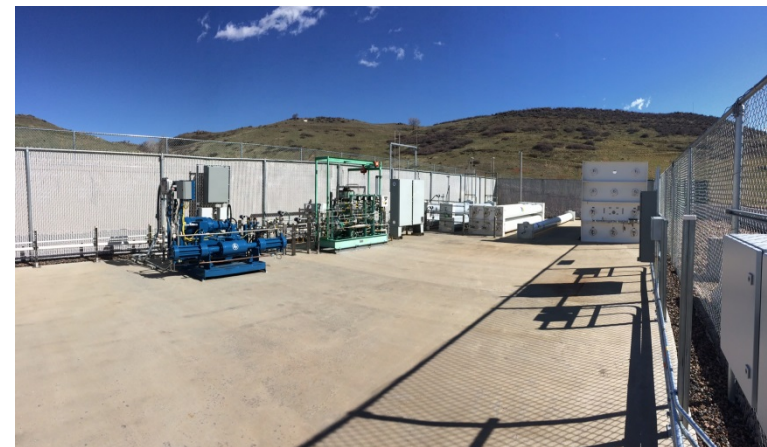
- **Leverage current DOE projects at the Hydrogen Infrastructure Testing and Research Facility (HITRF) at NREL**
 - 700 bar station configured similar to a retail station
 - No retail customer base allows for research space
 - Unfettered access to components
 - Current projects generate data useful to this project
- **Leverage NREL hydrogen program**
 - Material Data Screening tools and fuel cell research
 - FCEV filling using SAE J2601 T40 protocol
 - NFCTEC Composite Data Products (CDPs)
 - Safety Codes and Standards group

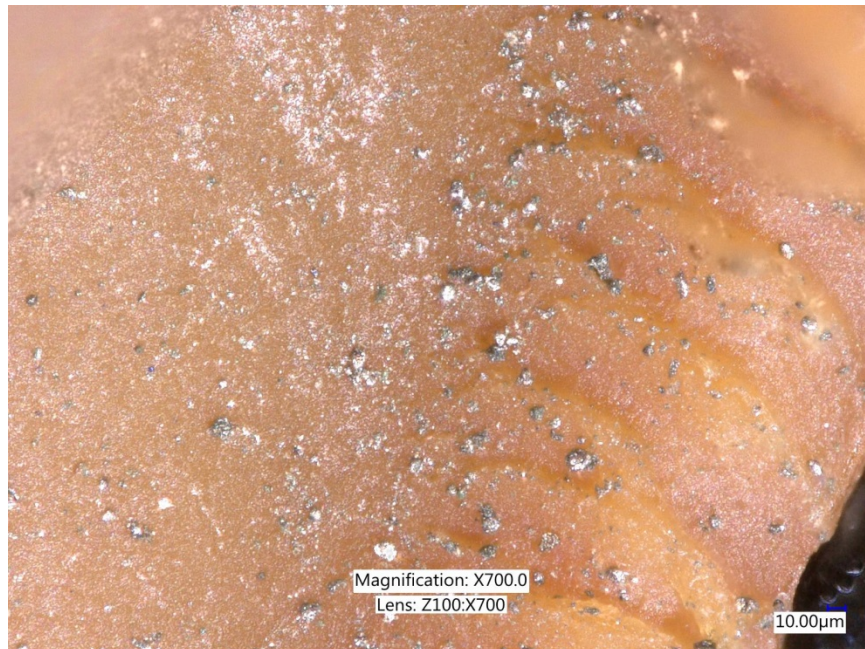
Seat material from a valve exposed to pre-cooled hydrogen. Metal flakes visible near fracture.

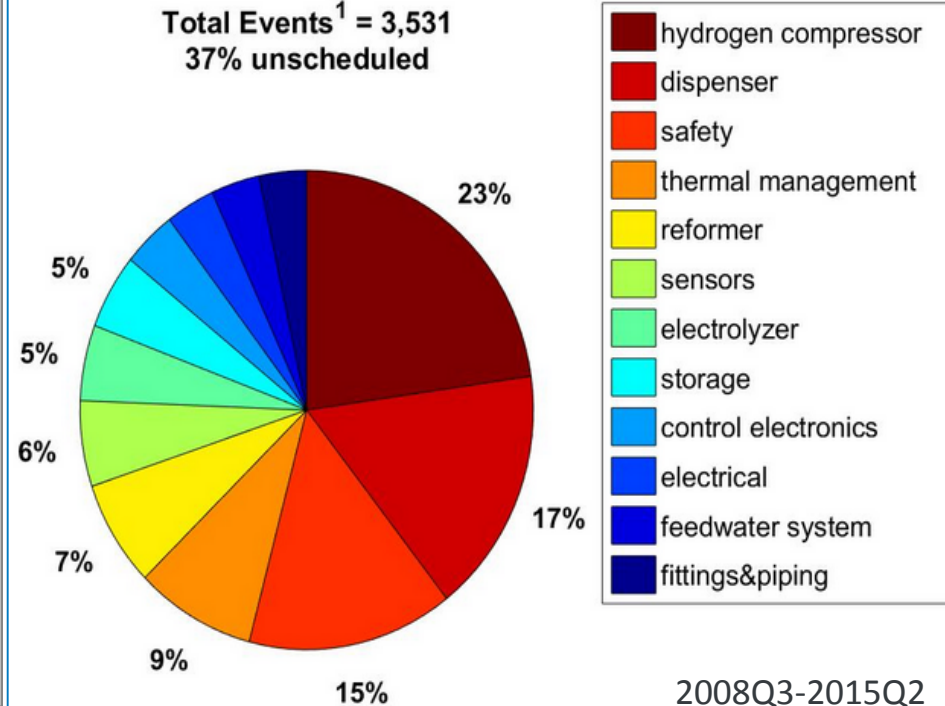
Maintenance Events

Total Events¹ = 3,531
37% unscheduled

The HITRF is a research station that focuses on component research rather than servicing FCEV customers, yet **compressors** and **dispensers** remain major maintenance burdens

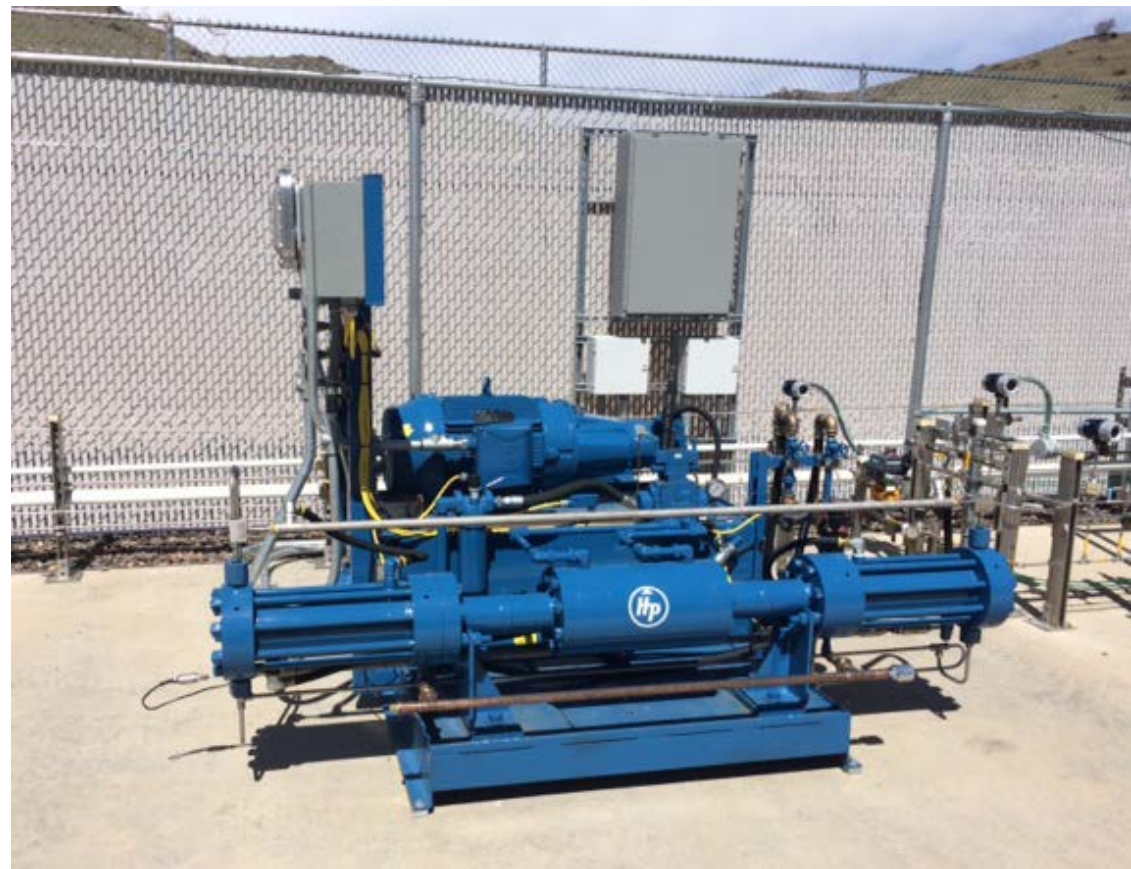
• Linear Piston 900 Bar Compressor Installation

Specification	Value
Inlet Range	12.1-41.3 MPa
Max Discharge	96.5 MPa
Capacity (35 MPa)	140 SCFM
Stages	1
Motor Power	40 hp
Compressor Weight	4,500 lbs

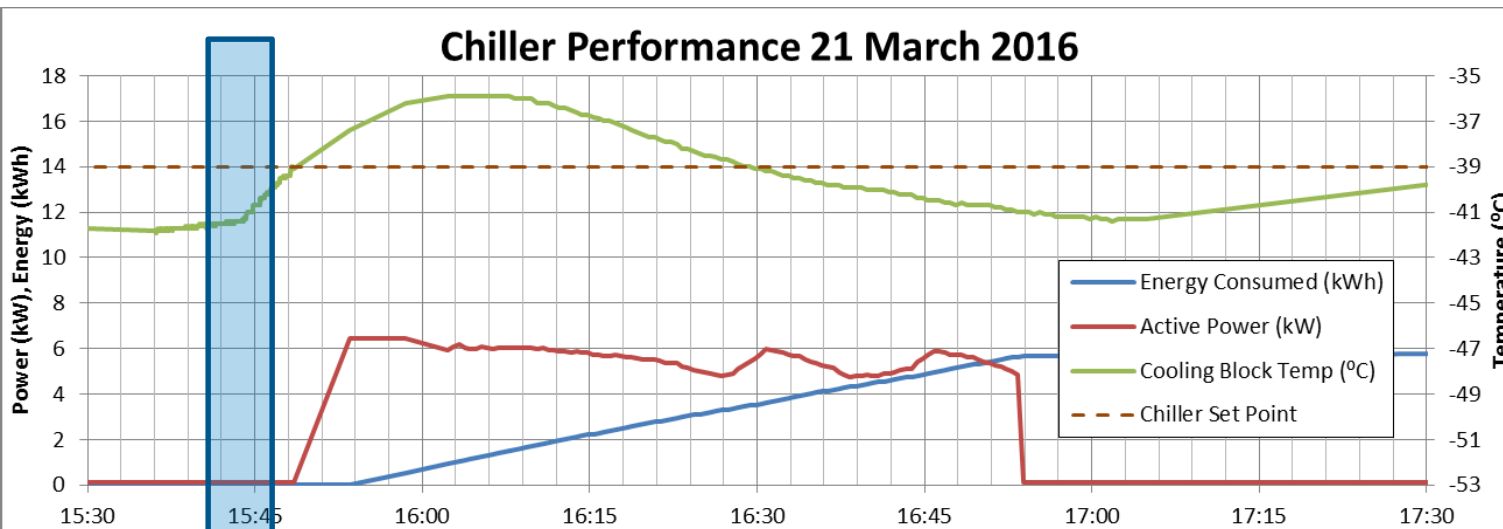
Full Recovery
6.0 kWh
58.9 min
6.46 kW _{max}

Data critical to improve modeling accuracy and benchmarking (see PD104 - Elgowainy)
