Subject: Issuance of Findings of Violation and Order for Compliance for NPDES Permit Violations

Exhibit 1  
Marisco, Ltd.  
NPDES Permit No. HI0021786  
Drydock Cycling Effluent Limitation Violations  
April 2007 – November 2008

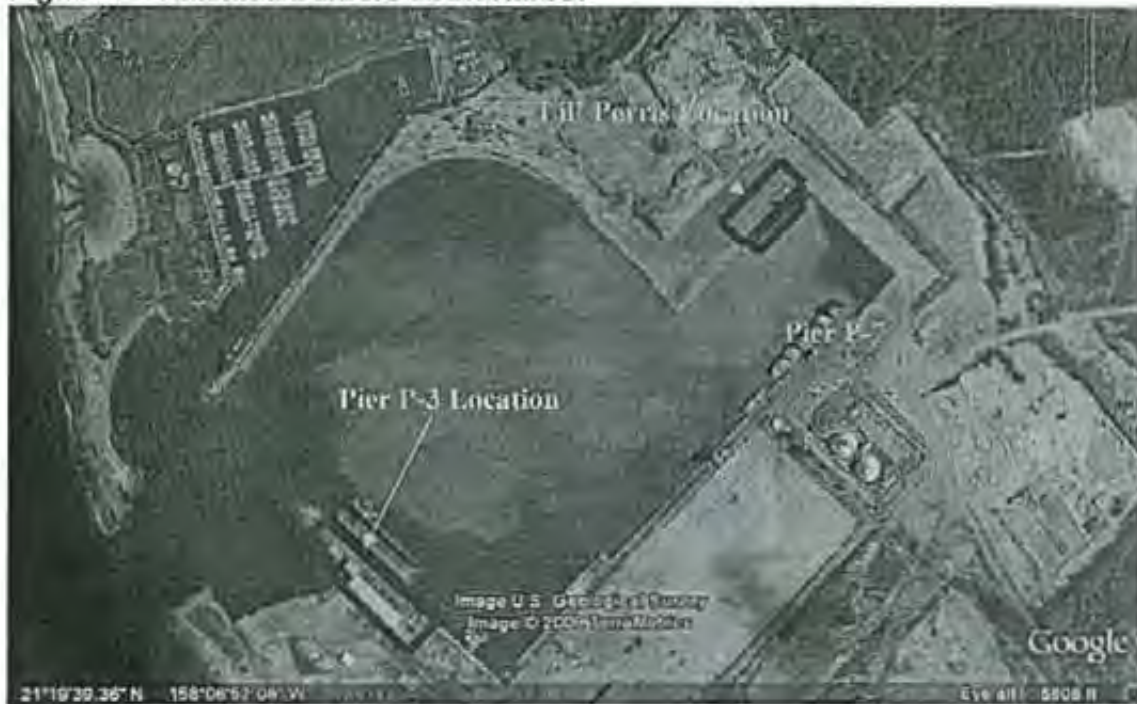
**Figure 1 – Kalealoha Barbers Point Harbor**

Figure 1 provides an overview map of the Barbers Point Harbor and the two Marisco, LTD operations.

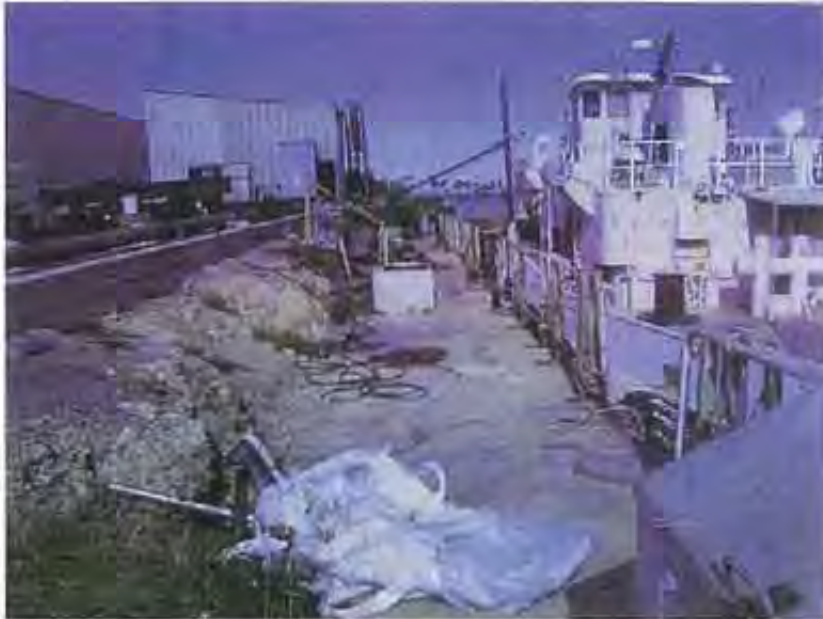
Photo 1: This photograph provides an overview of the dock, beyond the containment berm and on the edge of the water. This photograph is taken facing northwest. This area appeared to be used mostly as a walk way to the docked vessels, however observations during the inspection suggest that at a minimum, temporary or short-term storage of materials, including petroleum products, occurs at this location.

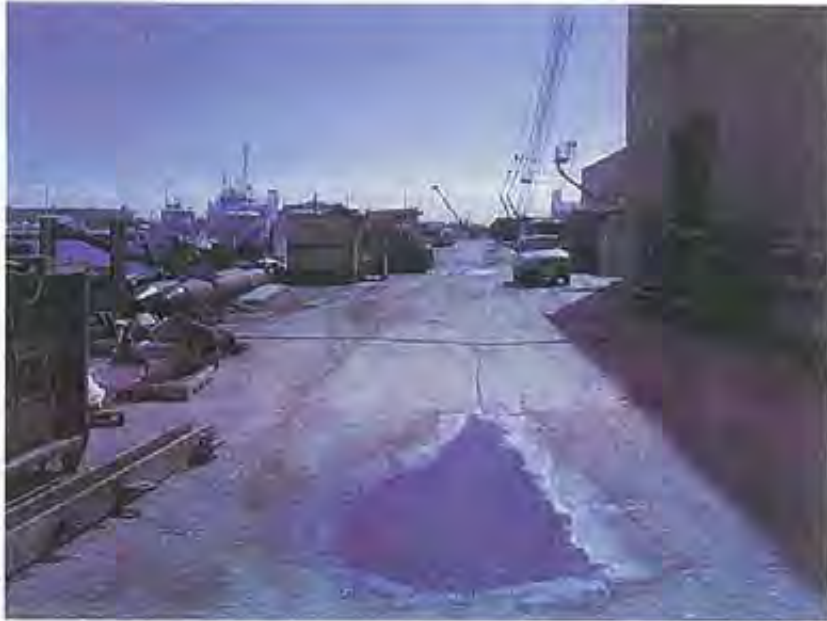
Photo 2: This photograph provides an overview of the main yard from approximately 3/4ths of the way down the southeast side. The Facility representative stated that most of the rainfall that occurs on-site is collected in the middle of the yard in three dry wells. The Facility representative was unsure of the volume of the dry wells. The gradient of the concreted area does suggest that the majority of the rainfall would drain toward the center of the main yard and into the dry wells. However, the gradient of the main yard near the bermed area was not apparent, and evidence of flow through gaps in the berm were observed during the inspection.

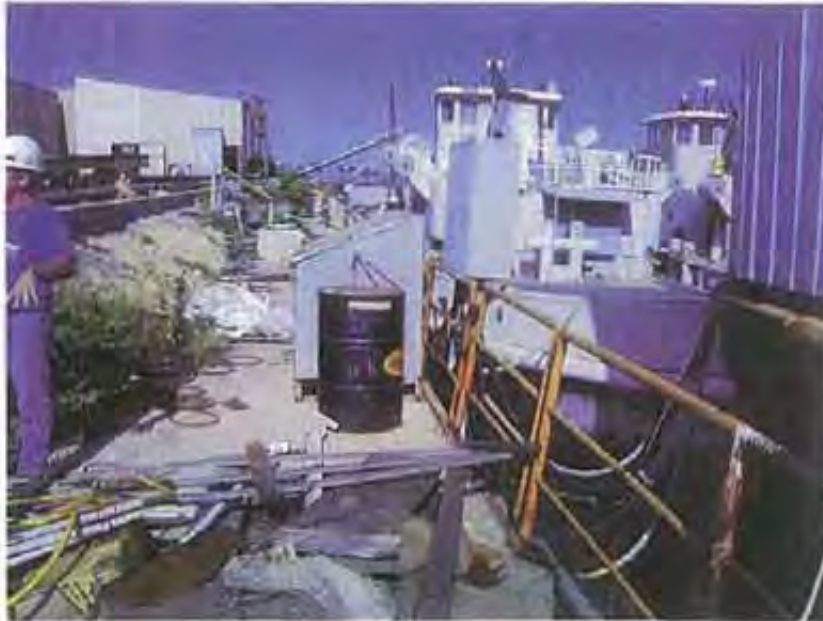
**Photo 3:** This photograph provides an overview of the dock, beyond the containment berm on the edge of the water, slightly further back than Photo 1. A 55-gallon drum of engine oil was observed on-site, exposed to potential rain fall, adjacent to the receiving water, and without secondary containment.

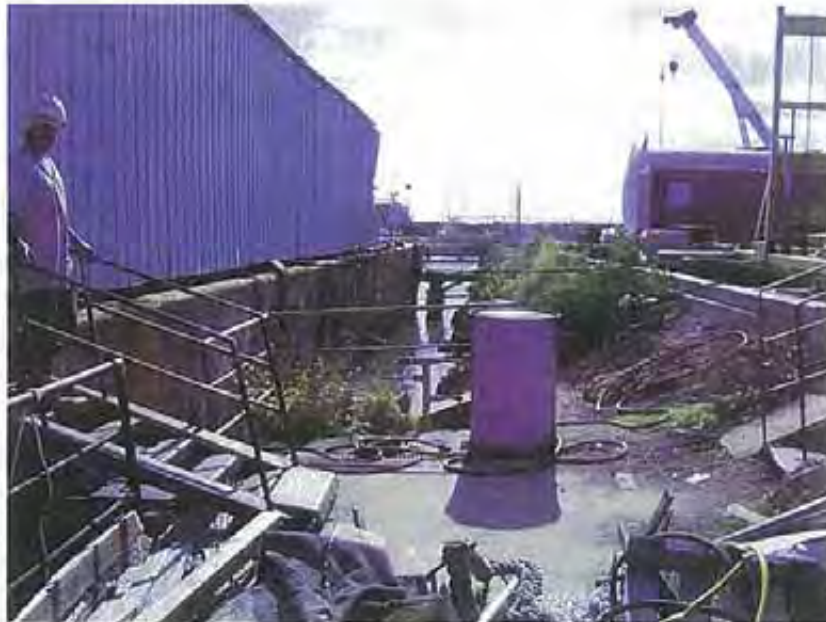
Photo 4: This photograph provides an overview of the dock, beyond the containment berm on the edge of the water, between the "Working Barge" and "JR's Area". This photograph is taken facing southeast. The 55-gallon drum pictured above is a spill kit.

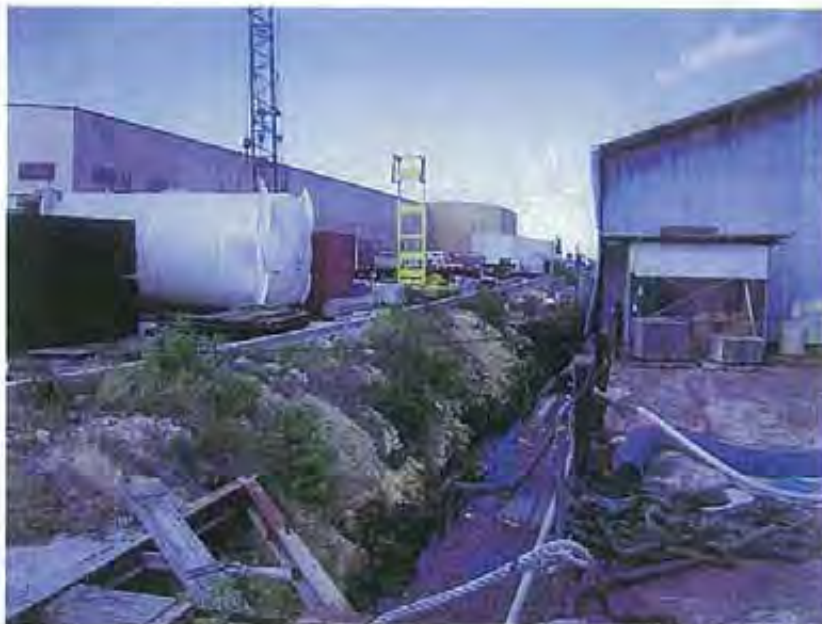
Photo 5: This photo was taken from the on-site "work barge", and depicts the drop-off from the bermed areas of the Facility directly into the receiving water. This is typical of the area referred to as "JR's Area" (area pictured above), and the portion of the main yard at the northwest end of the Facility, beyond the dockside walk way.

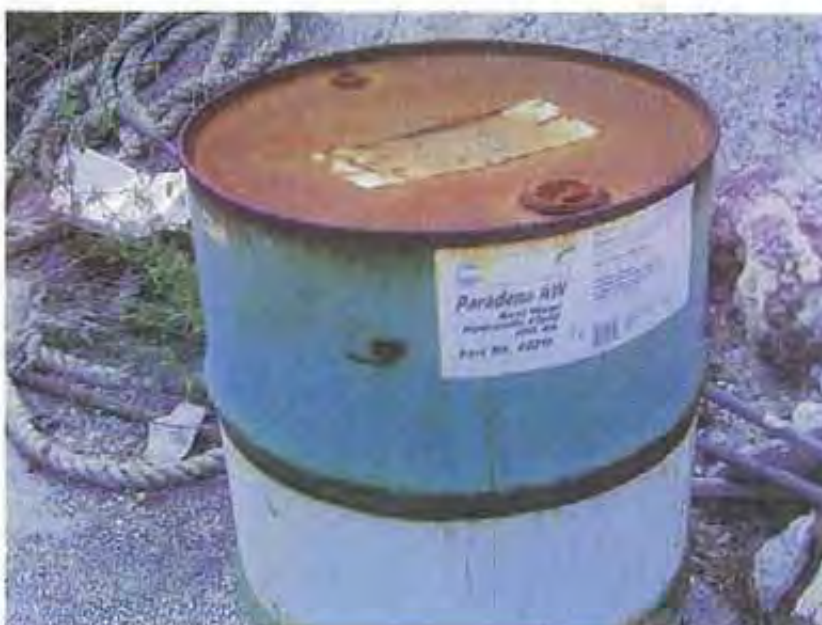
Photo 6: A 55-gallon drum of hydraulic fluid was observed on-site, adjacent to the receiving water, without secondary containment.

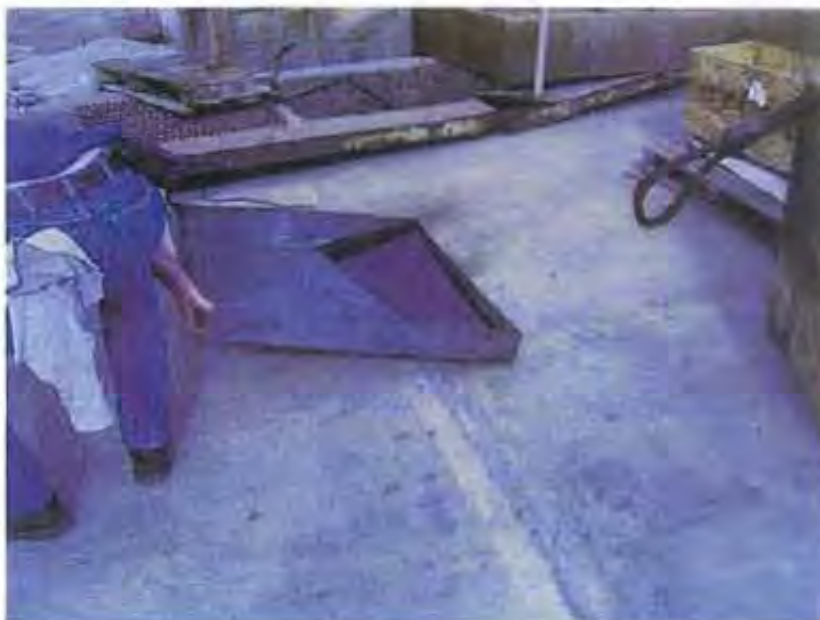
Photo 7: Unidentified liquid contained in a "make-shift" drip pan, resembling other petroleum products observed on-site, in the main yard adjacent to the berm surrounding the main yard.

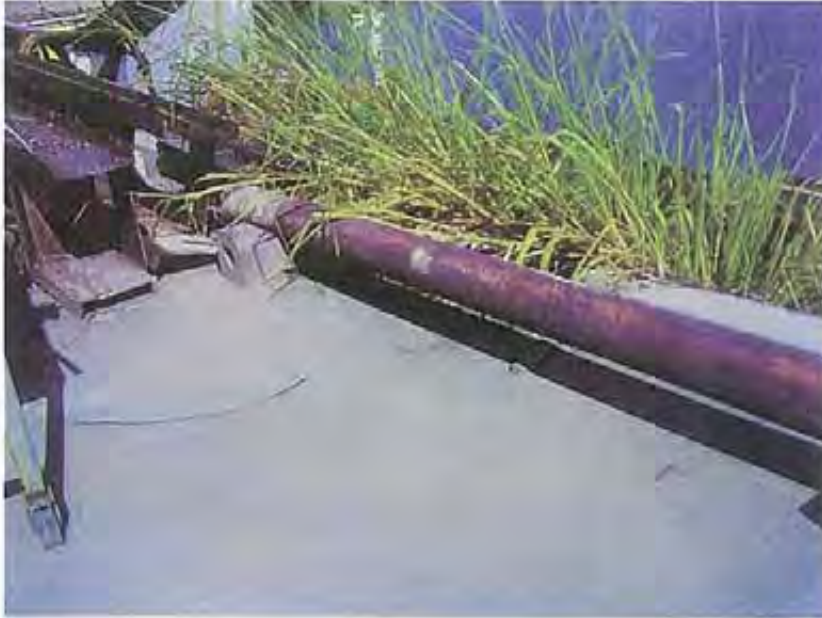
Photo 8: A break in the berm for the main yard.

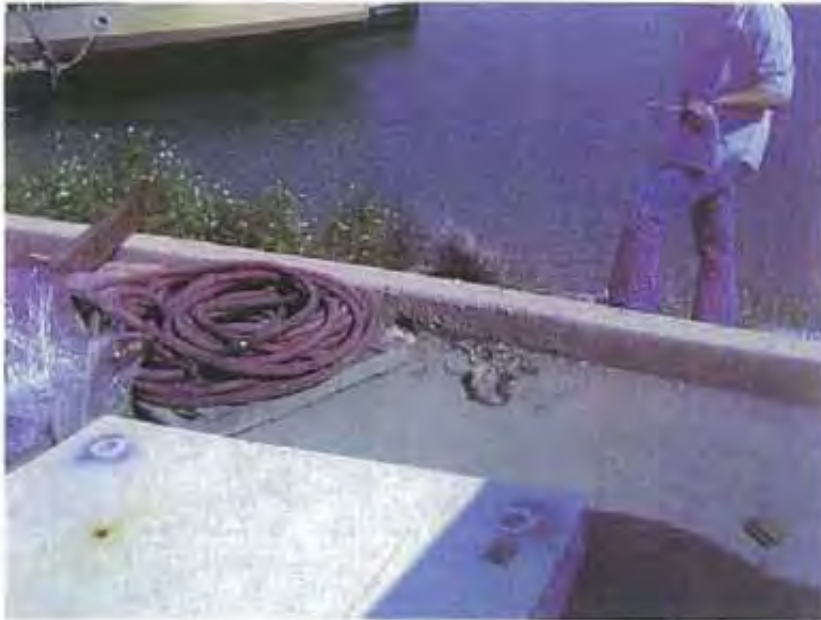
Photo 10: A drainage hole in the berm of the main yard, down gradient of the pallet of used batteries.

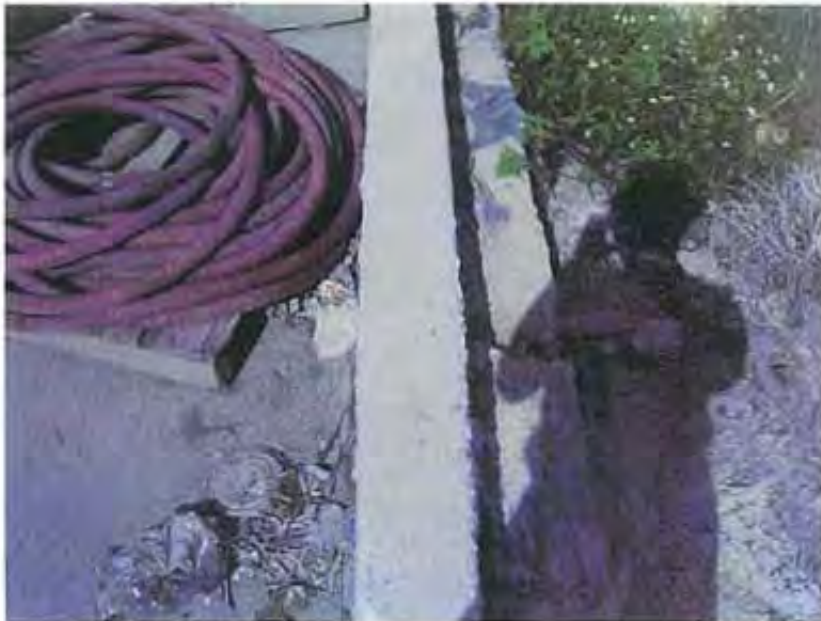
Photo 11: Debris and silt were observed around the drainage hole in the berm. Signs of erosion were observed on the water's side of the berm, indicating that discharges from this drainage hole have occurred. Flow through this discharge location would flow down the bank and directly into the receiving water.

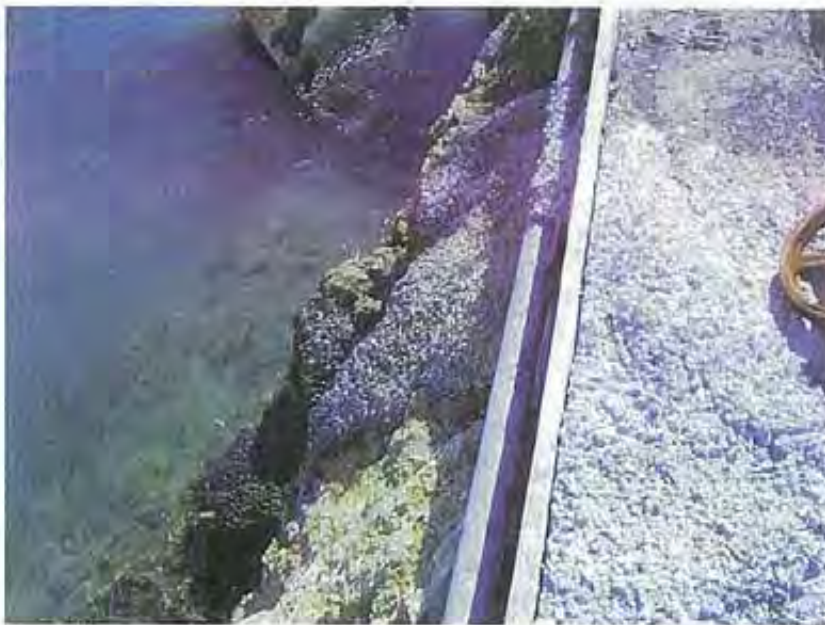
- c. The Discharger had recently concreted portions of the main yard, JR's area, and the storage area behind (northeast of) the metal working building. The inspectors noted that concrete had not been properly contained, including in some cases overflowing into the receiving water;

Photo 12: An ongoing construction project was observed on-site. Evidence of concrete spillage into the receiving water was observed on-site.

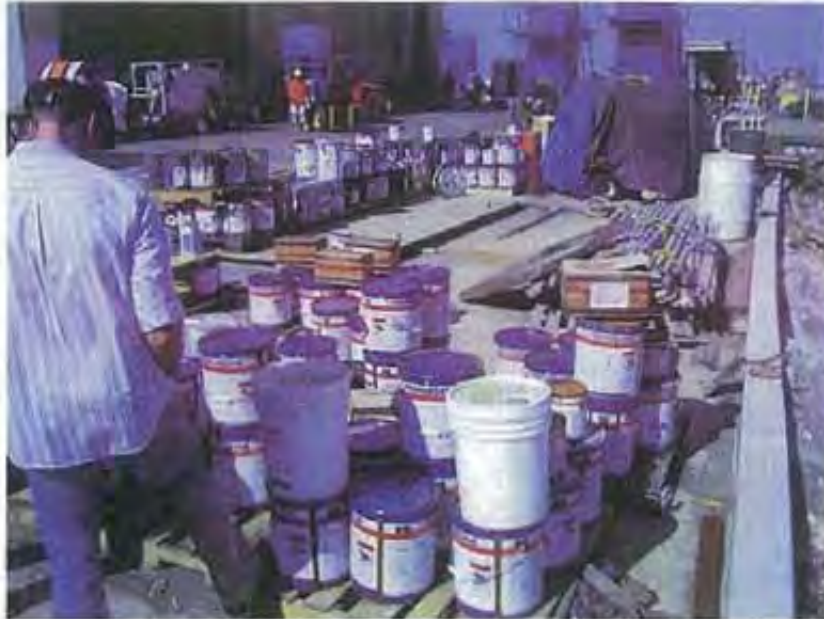
Photo 14: Large quantity of buckets of paint and paint thinner were observed in the yard, uncovered and without secondary containment. The Facility representative stated that this was a temporary measure while they cleaned out their paint storage lockers.

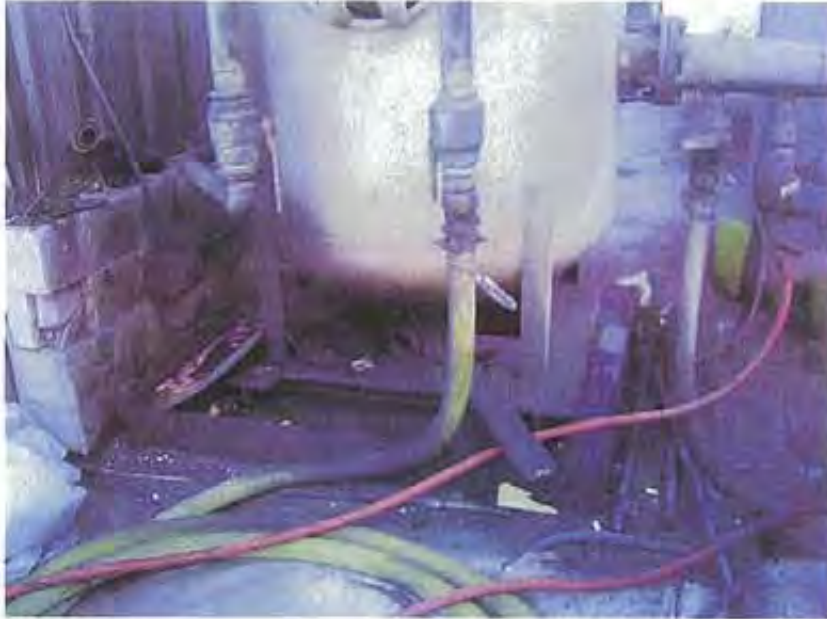
Photo 16: A drip pan for an air receiver located beside the metal working building full of a mixture of oil and condensate was observed. The drip pan was uncovered, exposed to potential rain fall, and without additional containment.

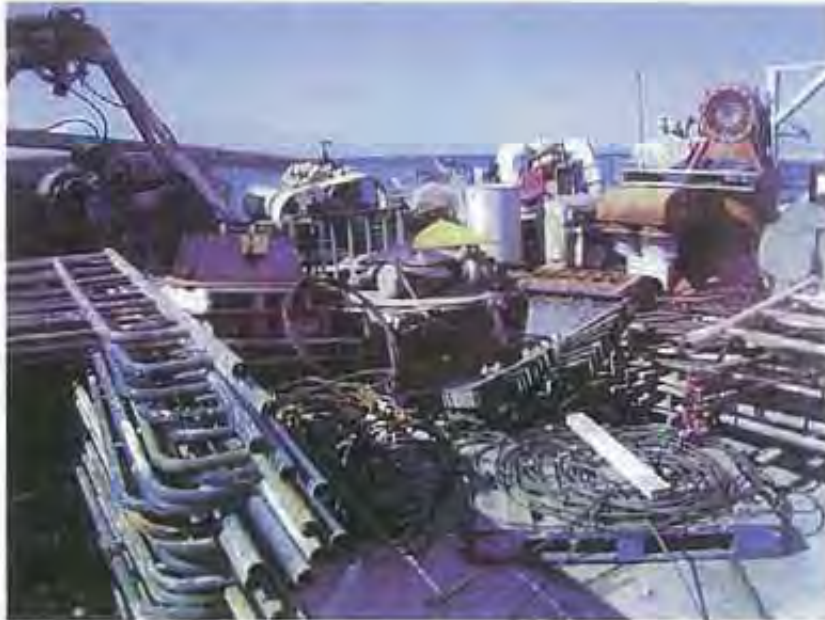
Photo 18: Material storage on the northwest end of the main yard. Engines, pumps, and other equipment were observed in this area.

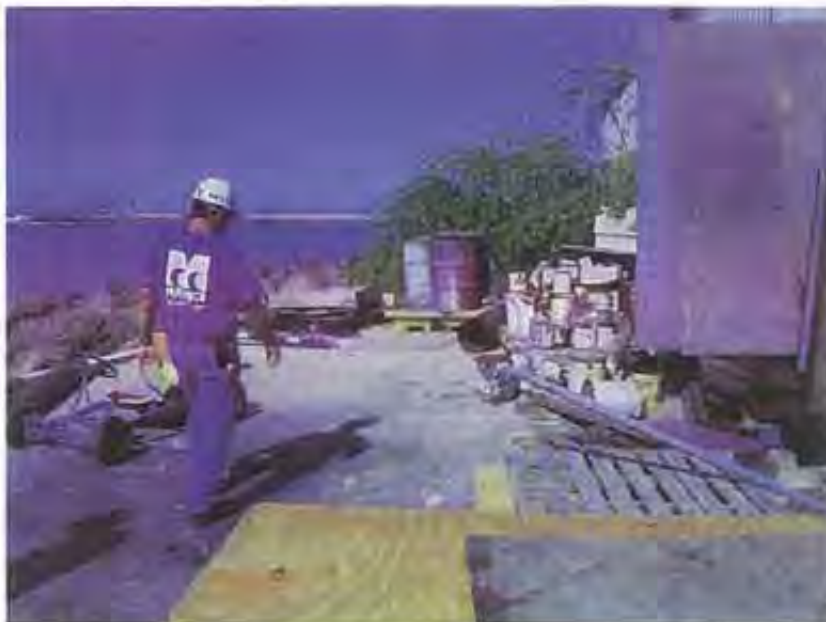
Photo 19: An area northwest of the main yard, behind the metal working building appears to be used for material storage. Materials stored in this area include paint, zinc anodes, and 55-gallon drums. This area does have a containment berm, which directs all storm water to a storm water discharge location pictured in Photo Nos. 23 and 24. A pallet of paint cans was observed stored on-site, exposed to potential rainfall, and in the direct drainage area to a storm water outfall.

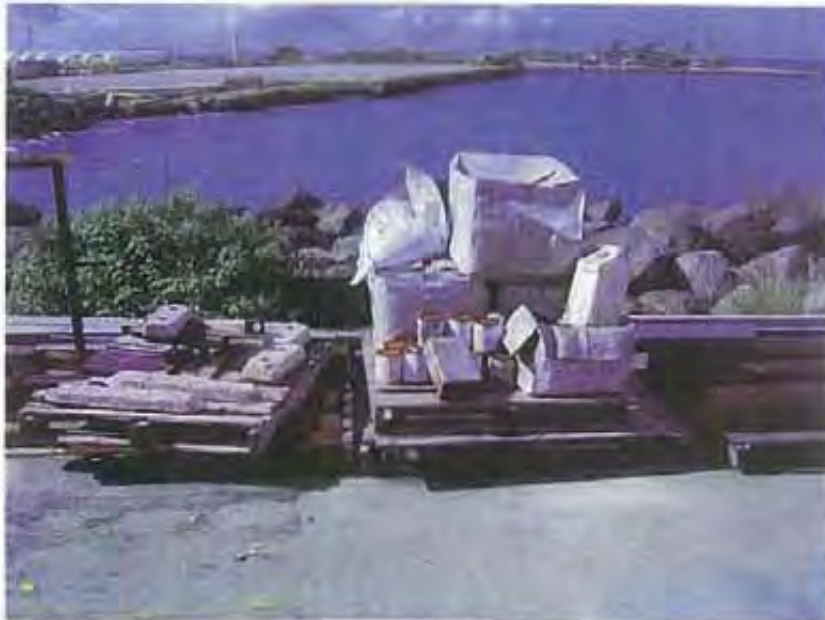
**Photo 20:** Additional cans of paint and zinc anodes were observed stored behind the metal working building, southwest of the main yard, exposed to potential rainfall and in the direct drainage area to a storm water outfall.

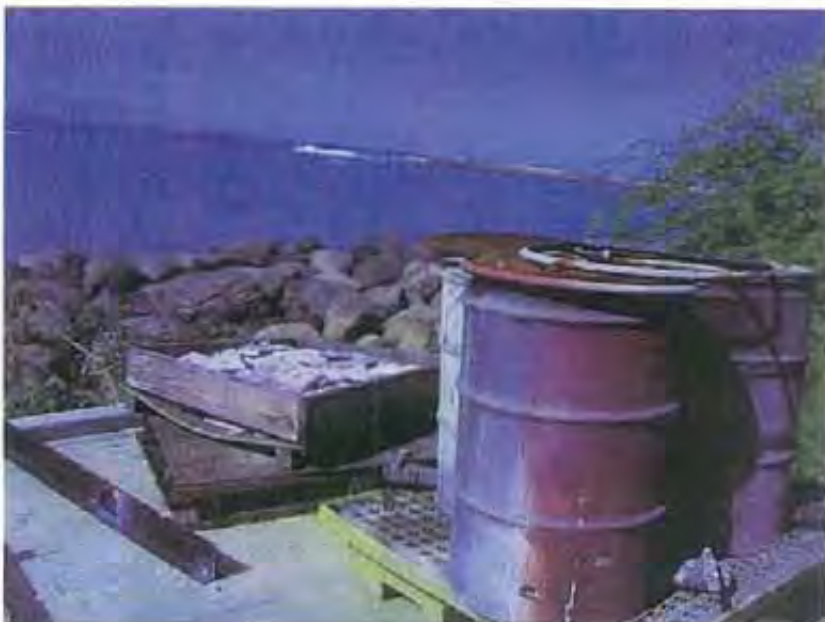
**Photo 21:** A wooden box of old zinc anodes were observed stored in the area behind the metal working building, exposed to potential rain fall and in the direct drainage area for a nearby storm water discharge location.

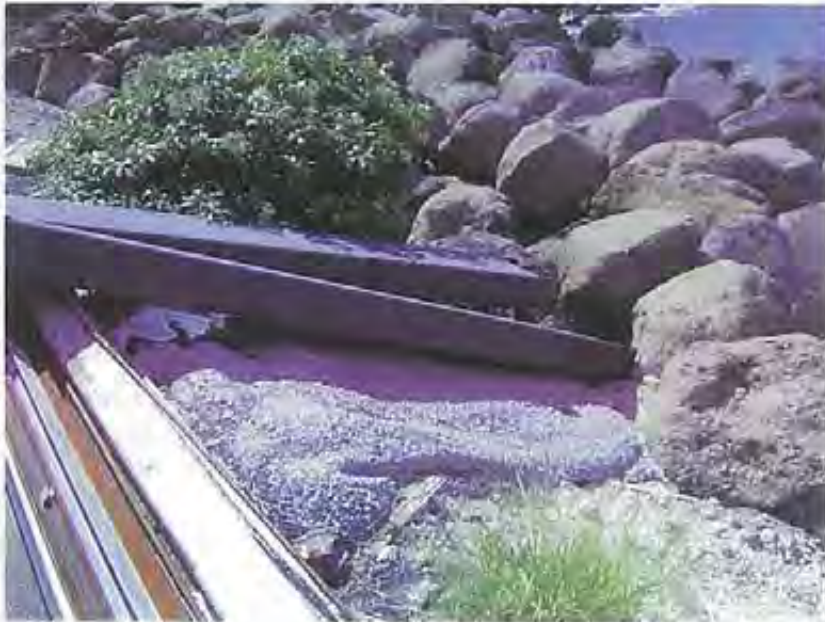
Photo 22: Evidence of concrete spillage from an on-site construction activity (possibly the construction of the concreted area itself or the berm) toward the receiving water. It is unclear if any of the concrete actually entered the receiving water. However this photo demonstrates a lack of effective best management practices utilized for the construction project by the Discharger this close to the edge of the receiving water.

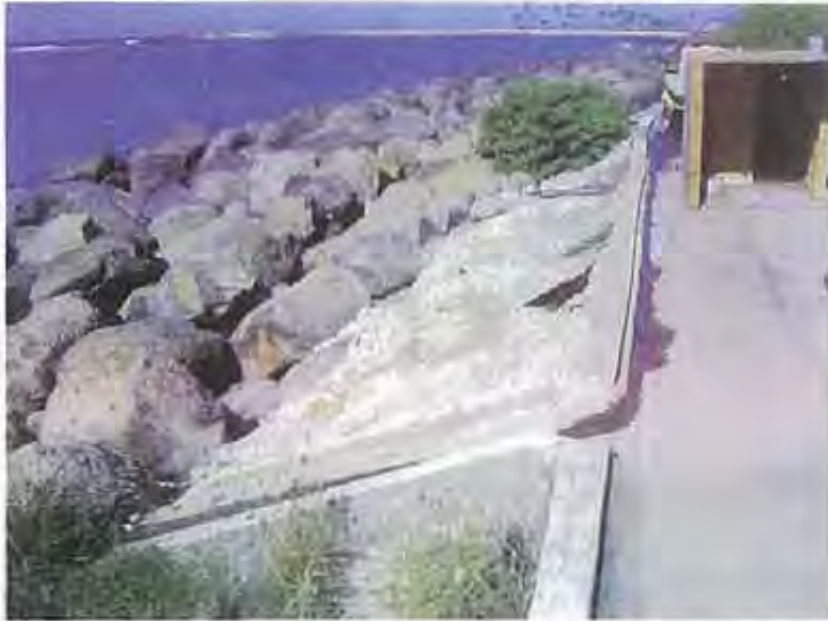
Photo 23: During the inspection, a storm water discharge location for the concrete area behind the metal working building was observed. Zinc anodes and paint cans are stored in this location. In addition, two dogs were observed chained in this area. Later in the day, a worker was observed hosing down the area toward the storm water outfall. Wash water runoff is visible discharging down the outfall.

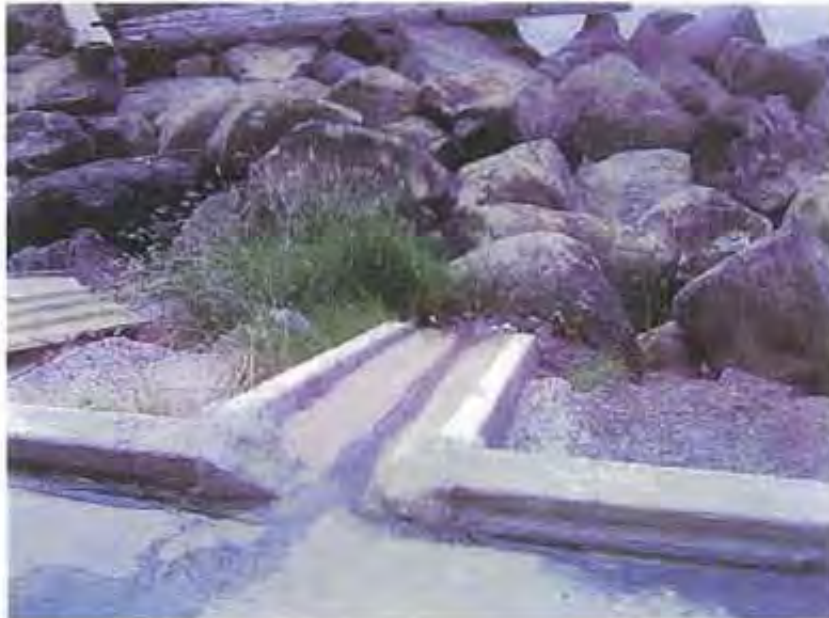
Photo 24: Another photograph of the storm water outfall for the area behind the metal working building. Wash water runoff is visible discharging down the outfall.

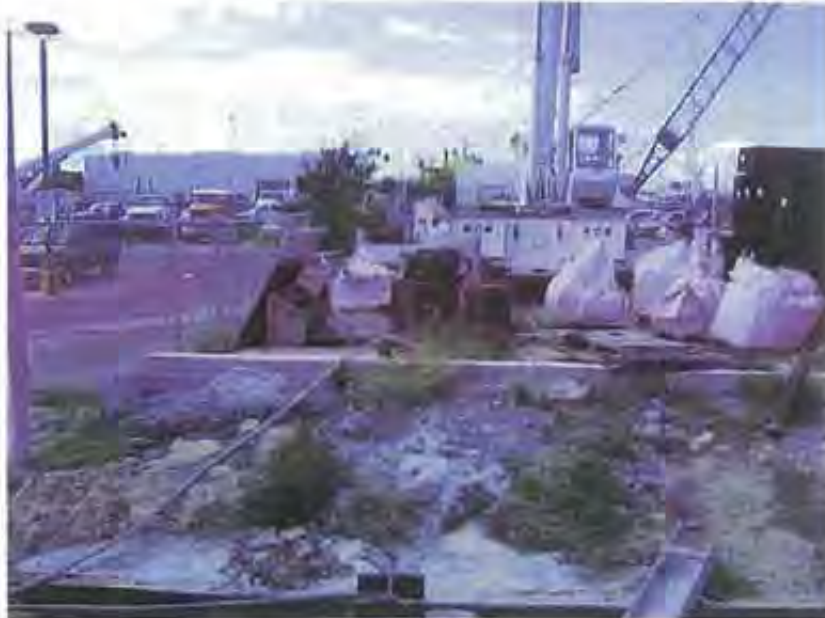
Photo 25: A view from the on-site working barge of the storage area at the southeast end of the main yard. This area was referred to by the Facility representative as "JR's Area". This area has a berm, with identified discharge locations (at the south end of the berm or left side of the photograph, and a gap in the berm to the right where the photograph cuts off). Materials observed stored in this location include used sand blasting grit, heavy equipment, petroleum products, and paint waste (what appeared to be a mixture of paint and paint thinner).

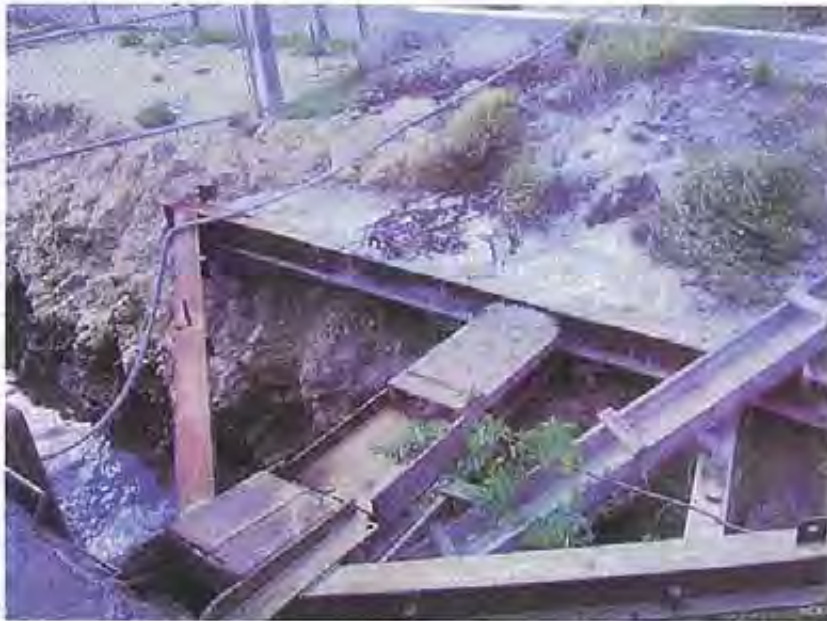
Photo 26: Evidence of concrete spillage from an on-site construction activity (possibly the construction of the concreted area itself or the berm) toward the receiving water. It is unclear if any of the concrete actually entered the receiving water, although concrete observed on the very edge of the metal frame work would indicate that it did. However this photo demonstrates a lack of effective best management practices utilized for the construction project by the Discharger this close to the edge of the receiving water.

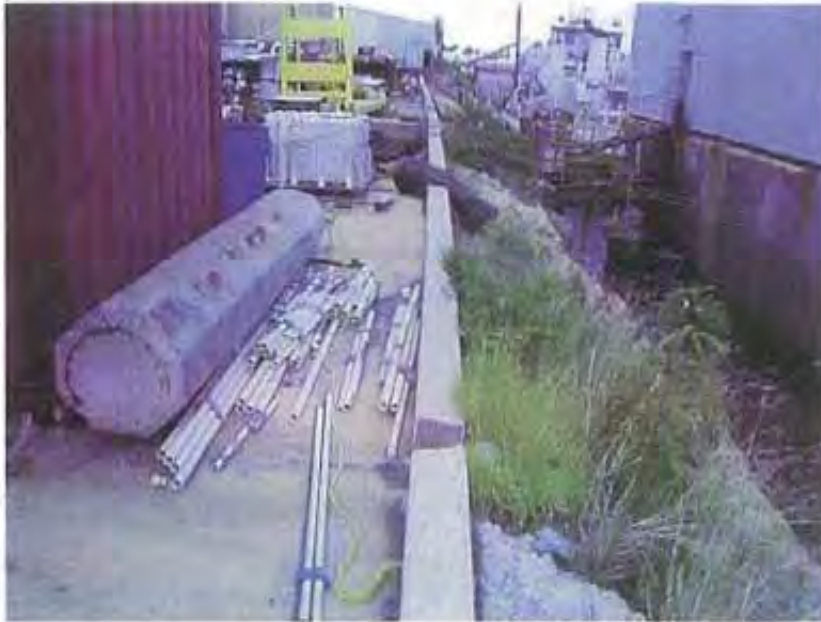
Photo 27: A gap in the berm surrounding JR's area. Discharges through this gap would flow down the bank and directly into the receiving water.

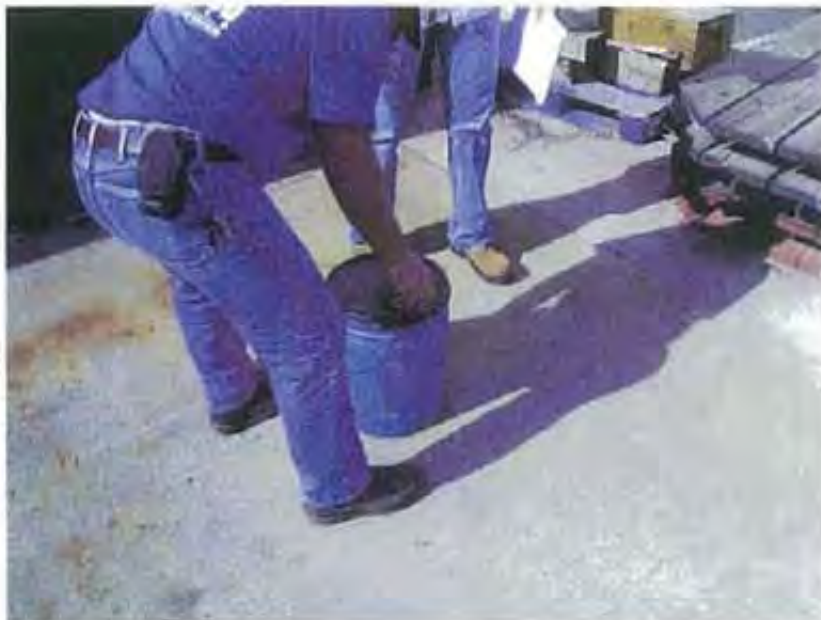
Photo 28: This photograph shows a 5-gallon bucket of motor oil (as identified by the Facility representative) in "JR's Area", without secondary containment.

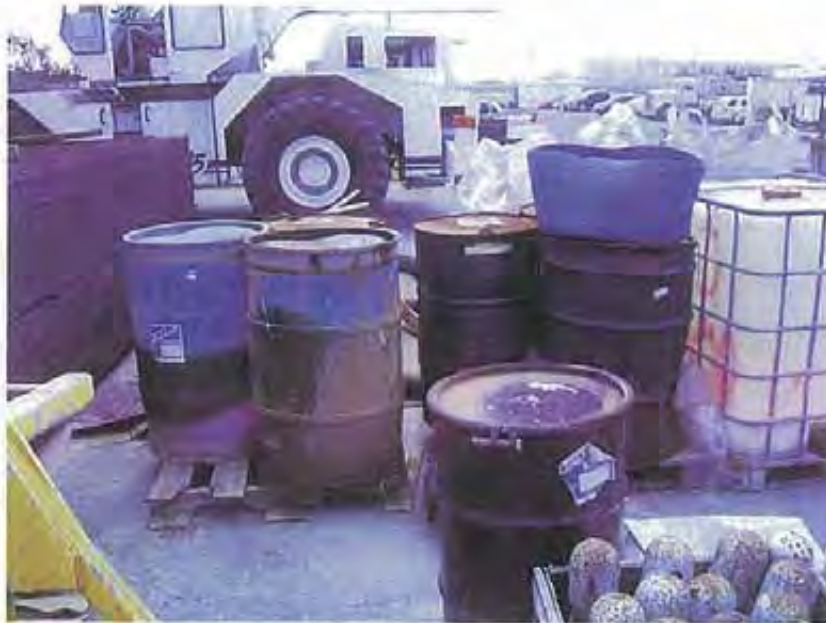
Photo 29: Three of the 55-gallon drums pictured (and labeled) above appeared to contain petroleum products, including motor oil and diesel fuel. These drums are not in a contained area, do not have secondary containment, and are exposed to potential rain fall.

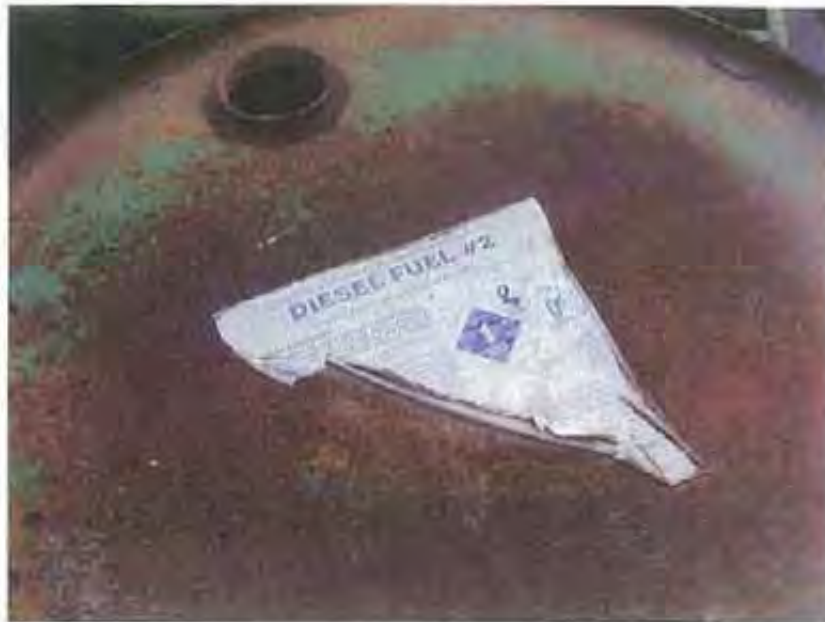
Photo 31: One of the three drums referenced above.

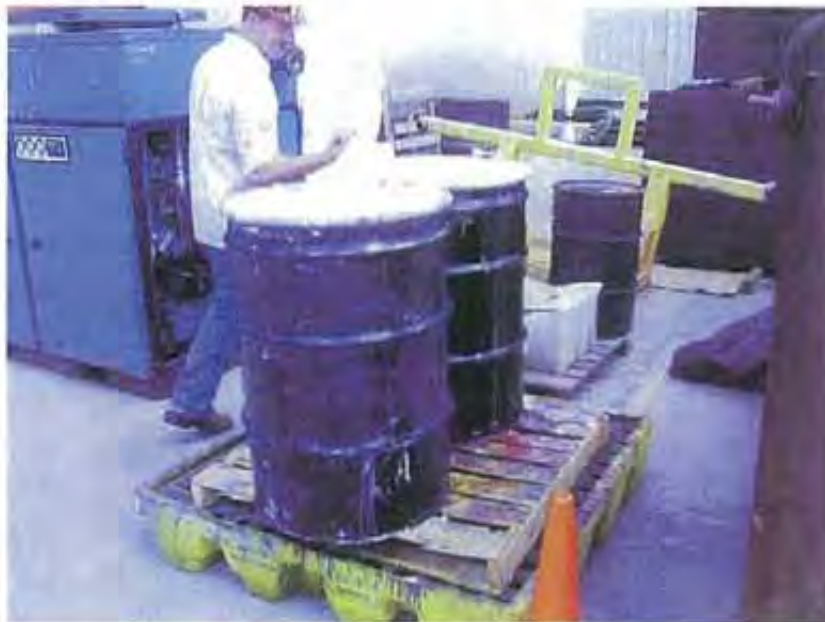
Photo 32: Two 55-gallon drums of "paint related waste" (as described by the Facility representative), which appeared to be a mixture of paint and paint thinner were stored on a secondary containment pallet, in "JR's Area", outside the designated hazardous waste storage area. The drum pictured above was opened by the Discharger at the inspector's request (as shown in Photo 31). One of the drums was hanging over the edge of the containment pallet.

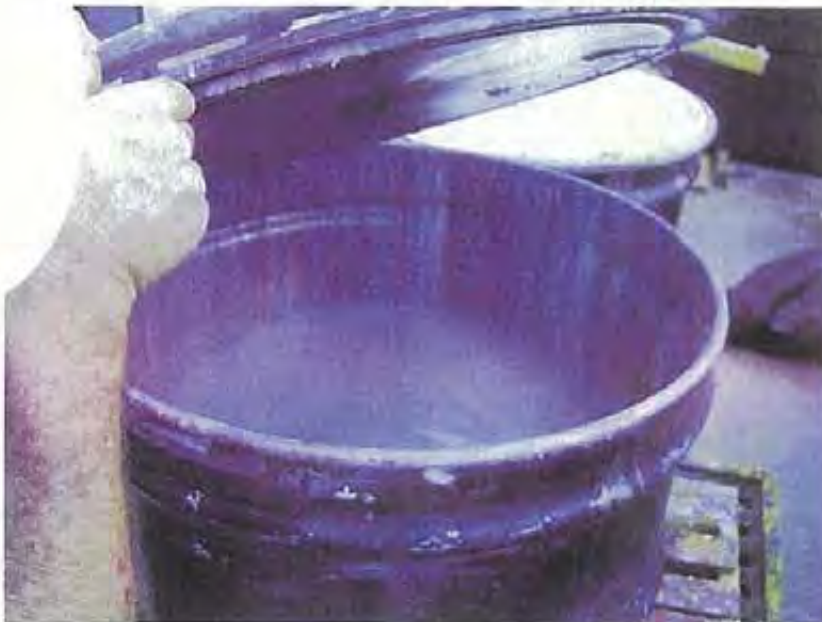
Photo 33: A photograph of the substance inside one of the two 55-gallon drums described in Photo 32. The drum pictured above was opened by the Discharger at the inspector's request.

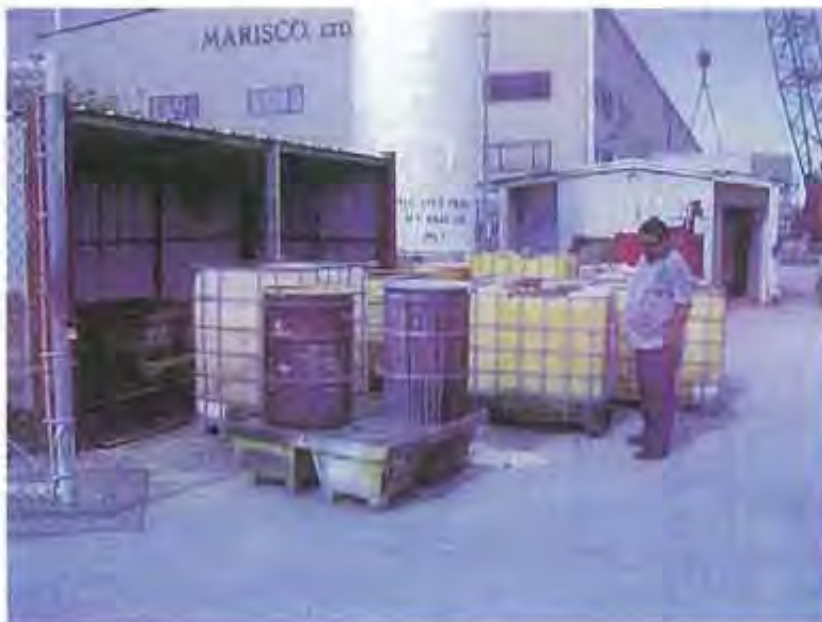
Photo 34: Hazardous waste storage area located adjacent to the main yard entrance of the Facility. Additional drums of paint related waste is shown above, outside the hazardous waste containment area. The white tote has been filled with diesel fuel and is inappropriately labeled as flocculent. Approximately 11 totes were observed in the area, outside any containment area, with residual liquid.

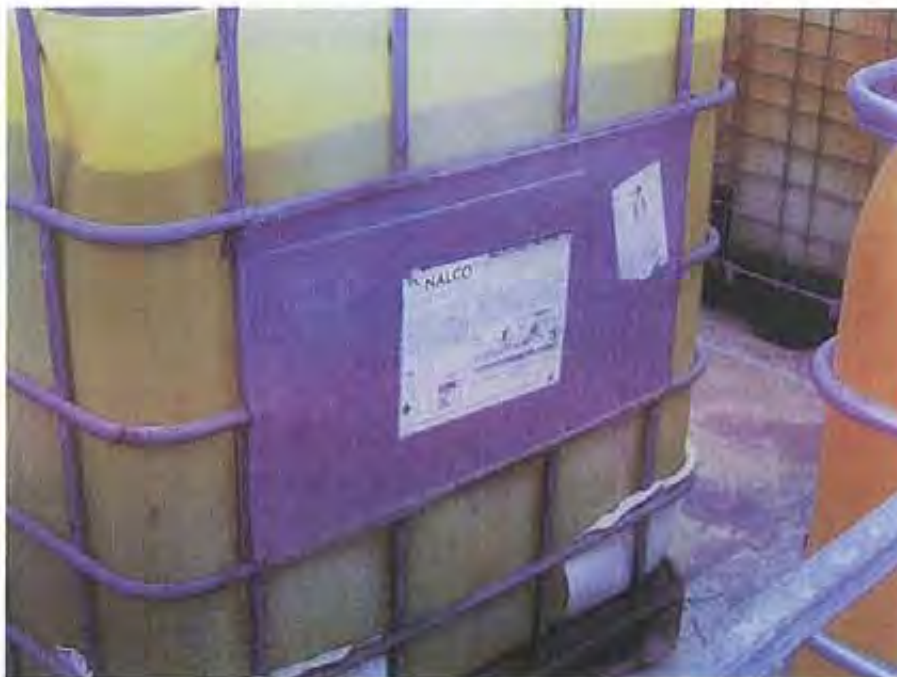
Photo 35: A tote originally used for flocculent was being used to store diesel fuel, without secondary containment. The tote was labeled as flocculent.

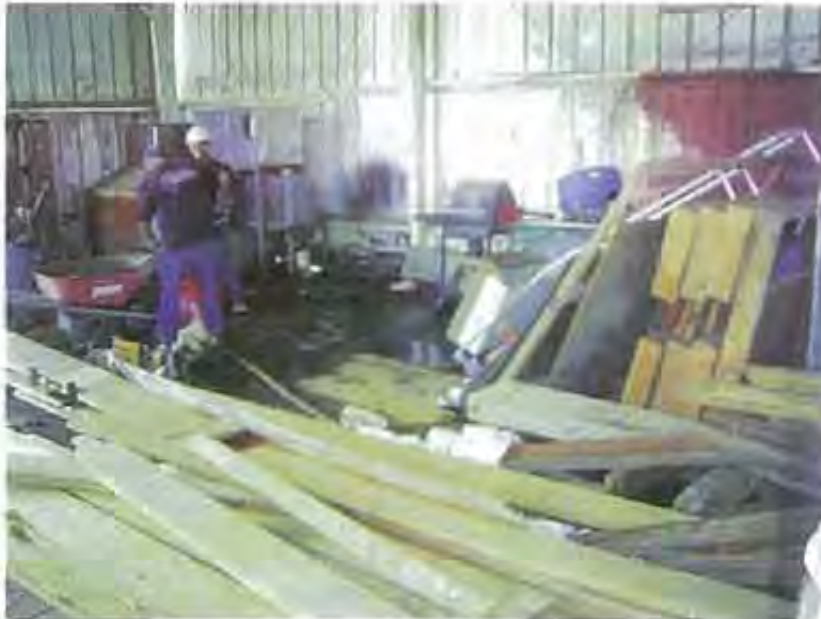
- d. Two workers were observed mixing cement on the work barge. Wet cement was observed on the ground of the work barge. Runoff from the cement mixing was observed running under the wall and down the side of the work barge into the receiving water;

Photo 37: Two workers were observed mixing cement on the work barge. Wet cement was observed on the ground of the work barge. Runoff from the cement mixing was observed running under the wall and down the side of the work barge into the receiving water, as shown in Photo No. 39.

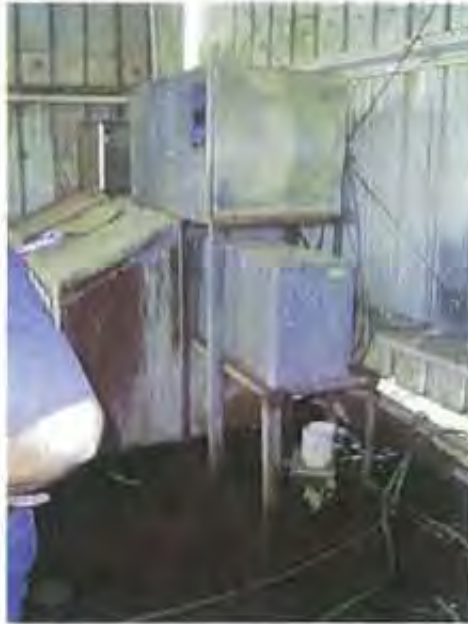
Photo 38: A closer photograph of the runoff from the cement mixing going under the wall of the work barge. Further, the Facility representative stated that condensate from the ice maker discharges under the wall and over the side of the work barge as well.

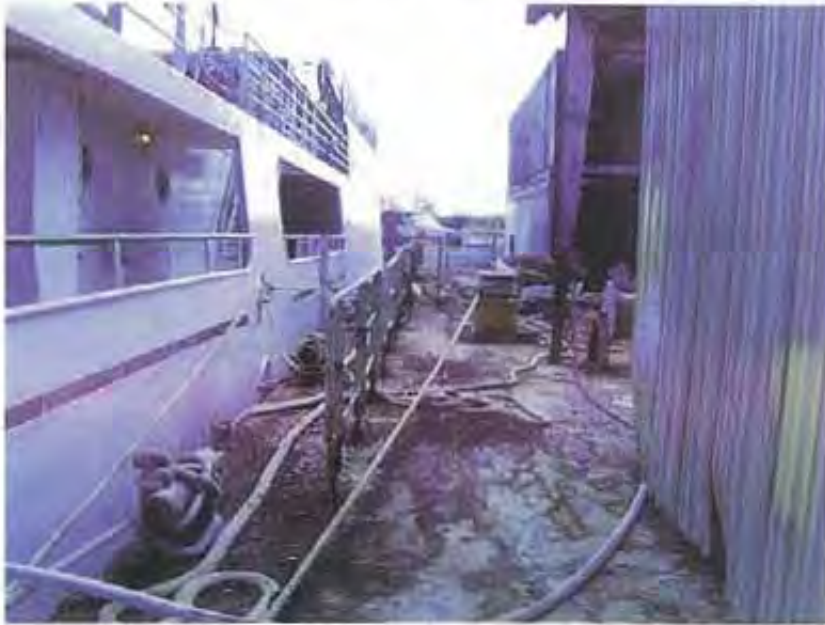
**Photo 40:** The floor of the work barge was covered in general debris and rust chips/dust, exposed to potential storm water runoff.

15. By APRIL 15, 2009 Marisco shall properly clean the deck of the support work barge of rust chips/dust that has a potential to discharge into Kalaeloa Barbers Point Harbor, as noted in the Inspection report, photo 40.

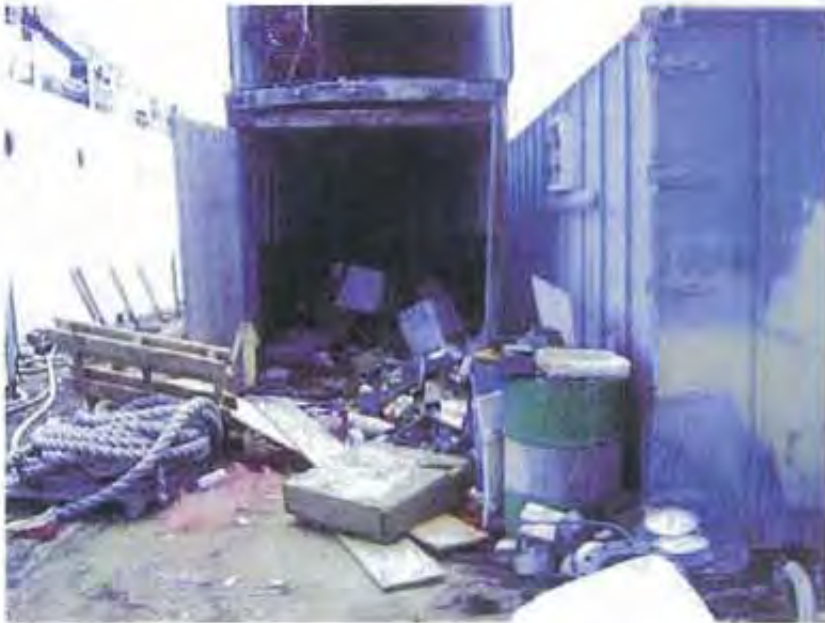
**Photo 41:** Debris and materials scattered on the floor of the work barge outside a storage shed. Two 55-gallon drums of oil were observed on the deck of work barge, without secondary containment.

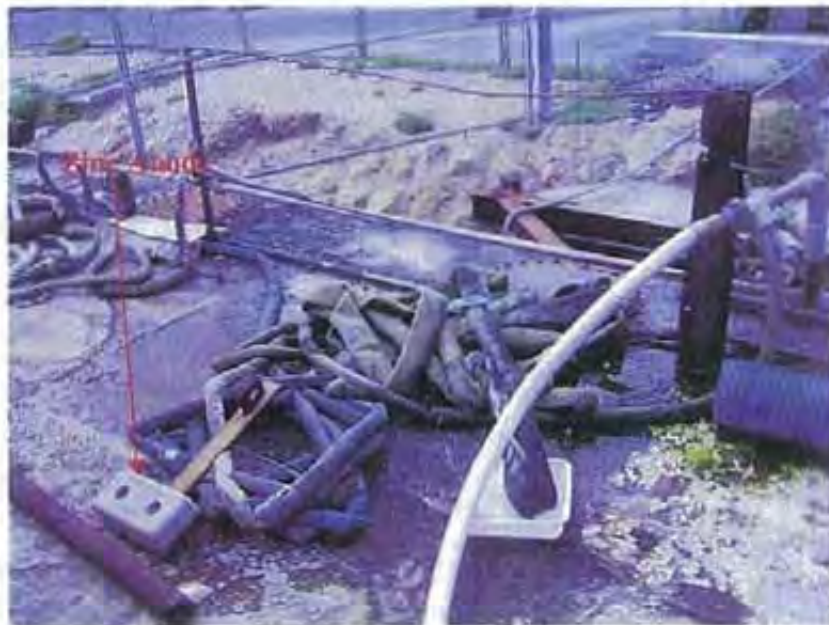
Photo 43: These water lines are used to supply the workers with potable water as they work on-board vessels. The line/hose hook ups were observed leaking and draining over the edge of the work barge. Also pictured above is a zinc anode on the deck of the work barge, near the draining water.

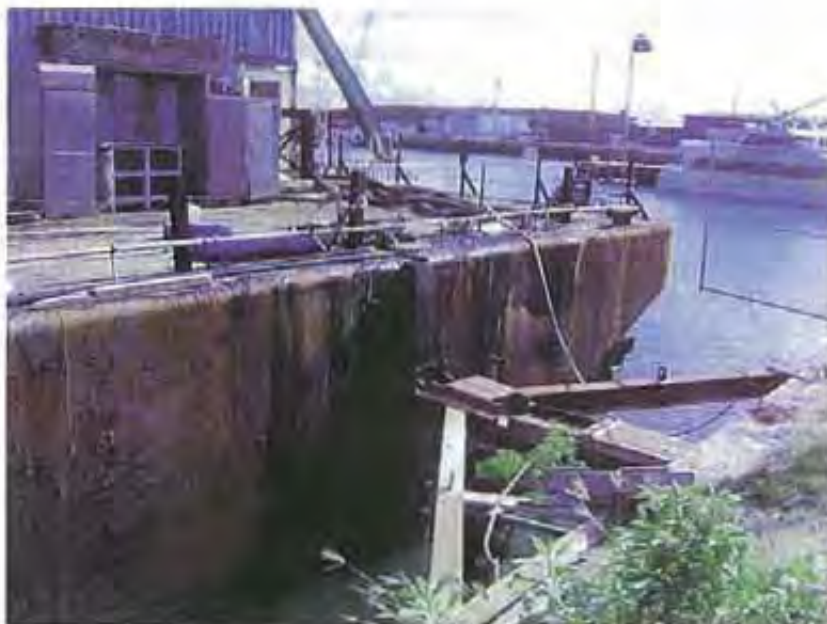
Photo 44: Potable water from hoses on the work barge was observed flowing over the deck and into the receiving water.

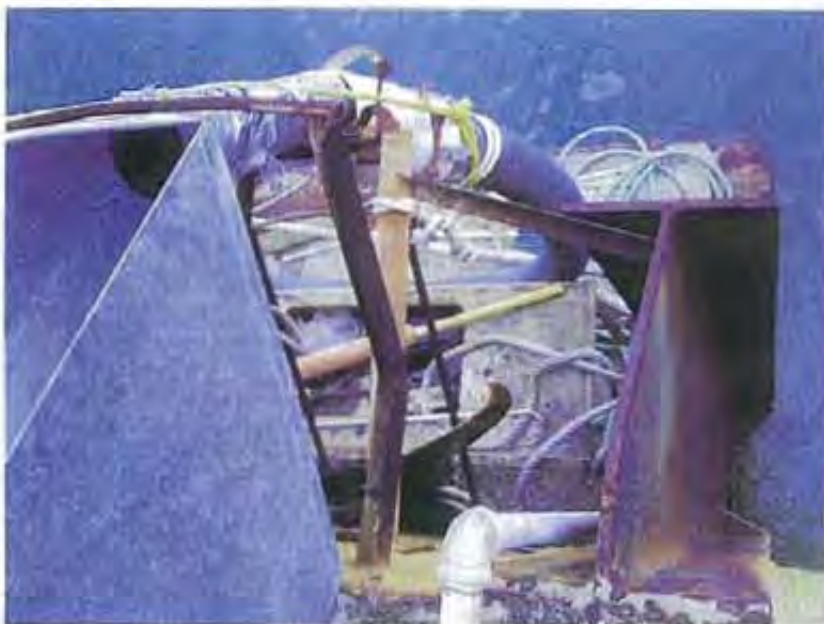
- e. A sink was observed on the stern of the work barge. The Facility representative stated that the sink was used for washing hands and cleaning fish and that he believed that the sink discharges directly into the harbor below; and

Photo 45: A sink was observed on the stern of the work barge. The Facility representative stated that he believes the sink discharges directly into the harbor below. The Facility representative stated that the sink is used for washing hands and cleaning fish. Due to the location of the sink, it was not possible to confirm the discharge location of the sink.
