Subject: Issuance of Findings of Violation and Order for Compliance for NPDES Permit Violations

Exhibit 1  
Marisco, Ltd.  
NPDES Permit No. HI0021786  
Drydock Cycling Effluent Limitation Violations  
April 2007 – November 2008

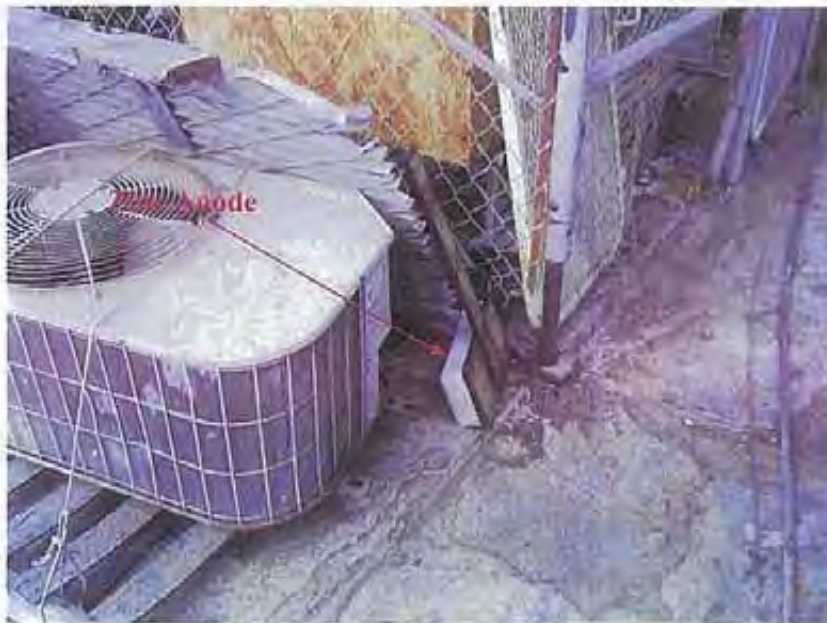
Photo 46: Another zinc anode observed on the deck of the work barge, exposed to potential storm water runoff.

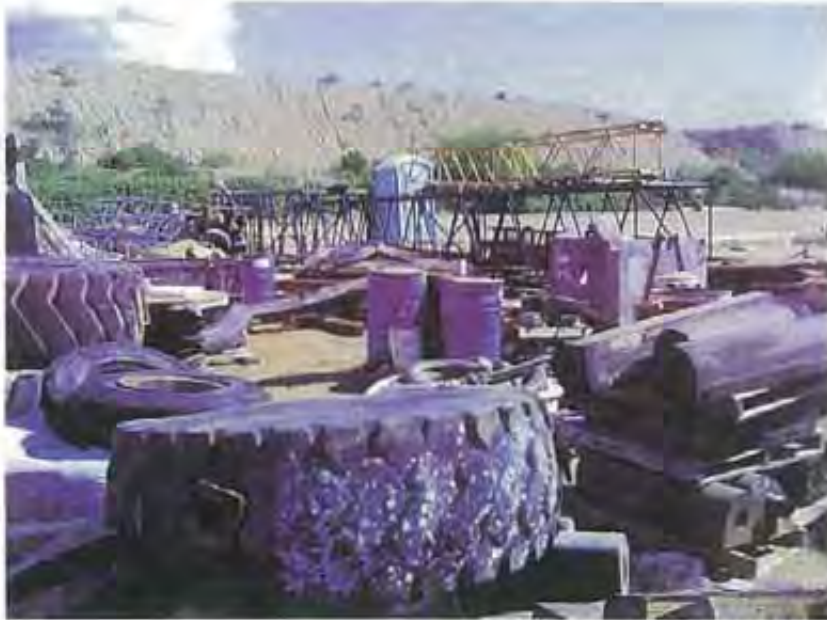
Photo 47: The photograph above is an overview of the northeast portion of the shore side staging area for the Lil' Parris dry dock. This area is used by the Discharger for storing materials for work performed on the dry dock. Materials stored in this area include scrap metal, old tires, cables, and machinery. Other materials are stored on-site in covered sheds.

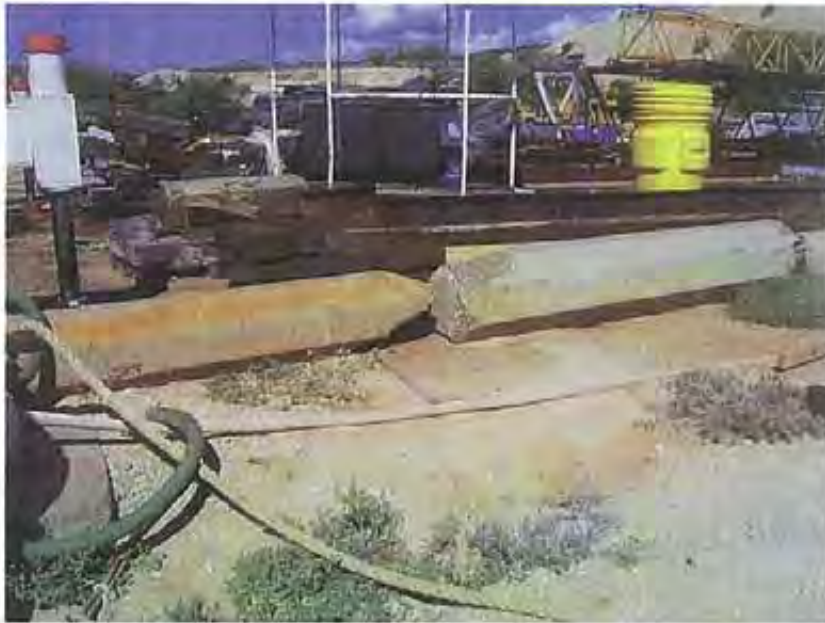
Photo 48: The shore side staging area for the Lil' Perris dry dock has a berm built from cement pillars. Plastic sheeting has been laid down against the pillars and covered with dirt, however the plastic sheeting has torn away in most areas and gaps are prevalent along the entire berm.

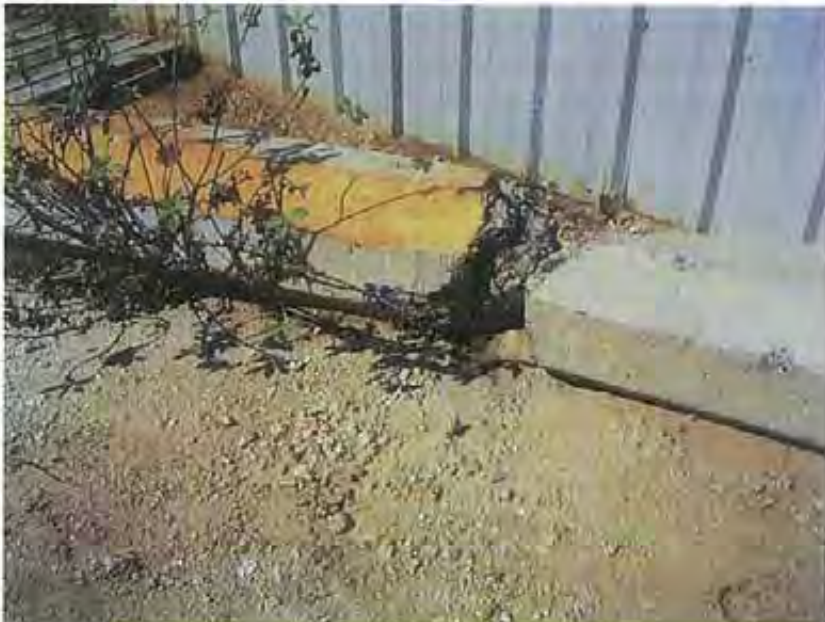
Photo 49: One of the gaps in the berm surrounding the shore side staging area for the Lil' Perris dry dock.

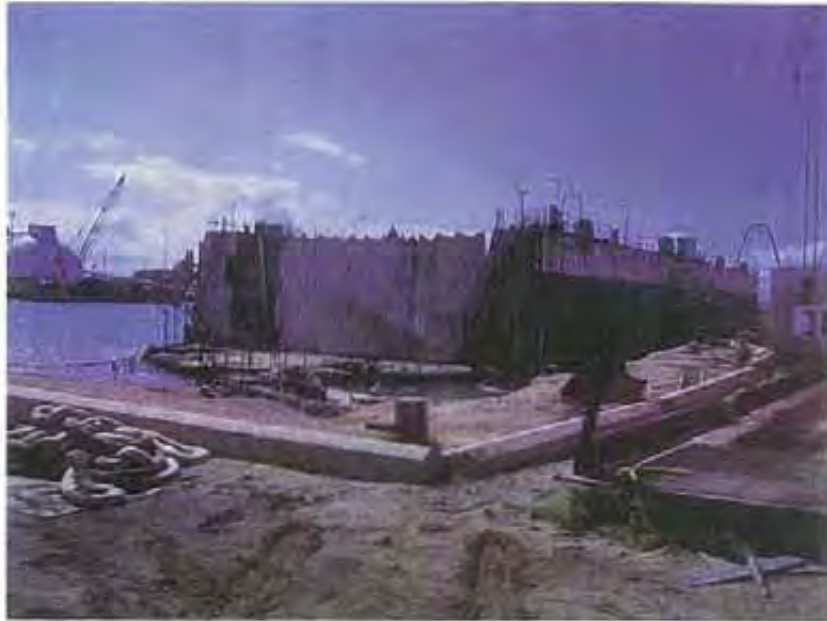
Photo 50: An overview of the Lil' Perris dry dock and the berm structure.

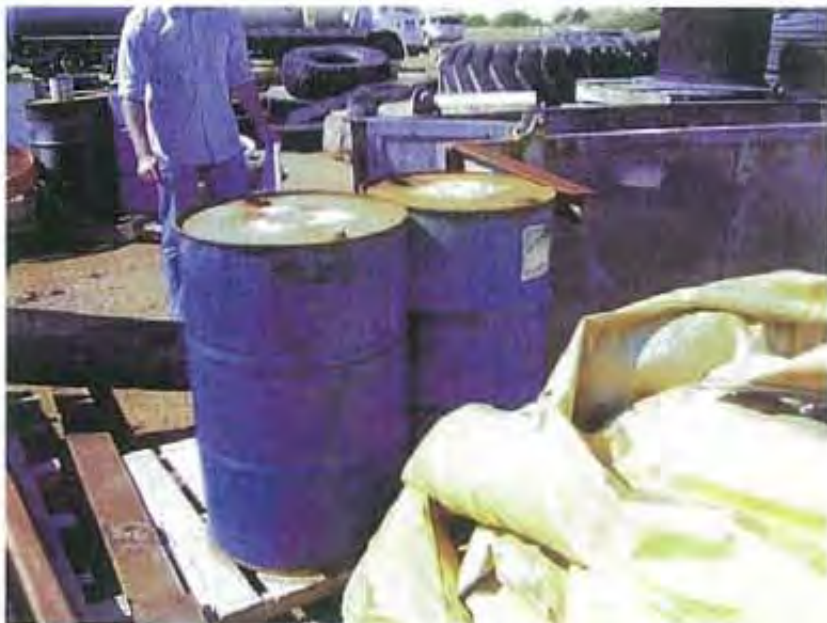
- i. Two 55-gallon drums of used oil were observed stored without secondary containment on the shore side staging area beside the dry dock, inconsistent with Part B.2.j of the permit which states, "The Permittee shall maintain land-based operations in a clean and orderly manner and implement measures to prevent pollutants from contacting storm water runoff." Further, this condition is not consistent with land-based operation BMPs of the Discharger's BMP Plan (p. 8), which states that spill pallets will be on-site and used;

Photo 51: Two 55-gallon drums of used oil were observed stored without secondary containment on the shore side staging area beside the Lil' Perris dry dock.

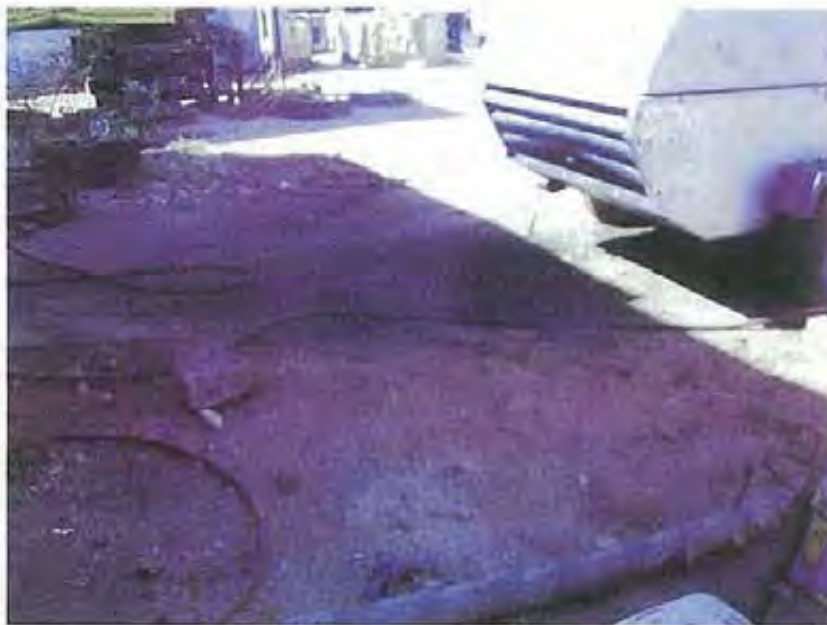
Photo 52: Staining of the ground by exhaust from an on-site air compressor.

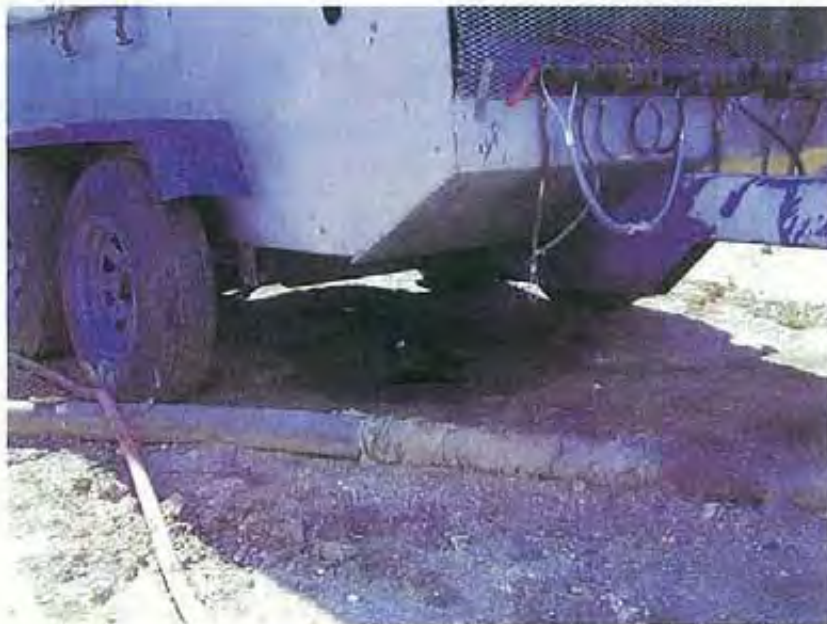
- ii. A mixture of oil and condensate was observed dripping directly on the ground from an air compressor on the shore side staging area beside the dry dock, inconsistent with Part B.2.j of the permit;

Photo 53: A mixture of oil and condensate dripping from the above pictured air compressor.

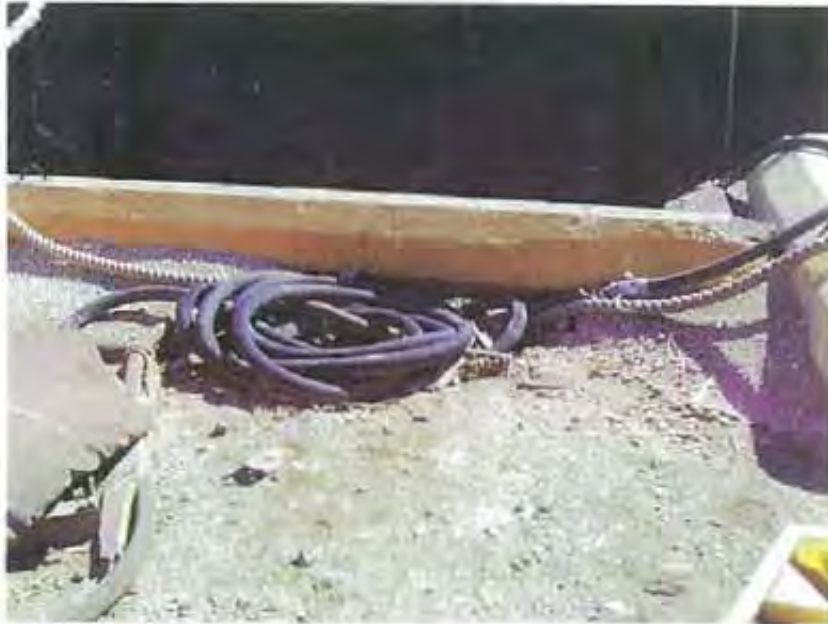
Photo 54: Another gap developed through erosion in the berm.

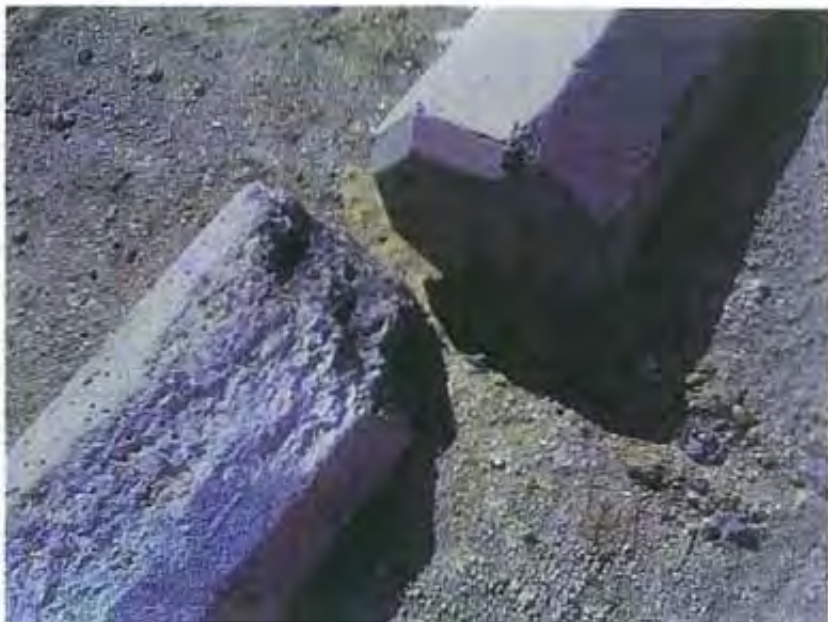
Photo 55: Another gap in the berm.

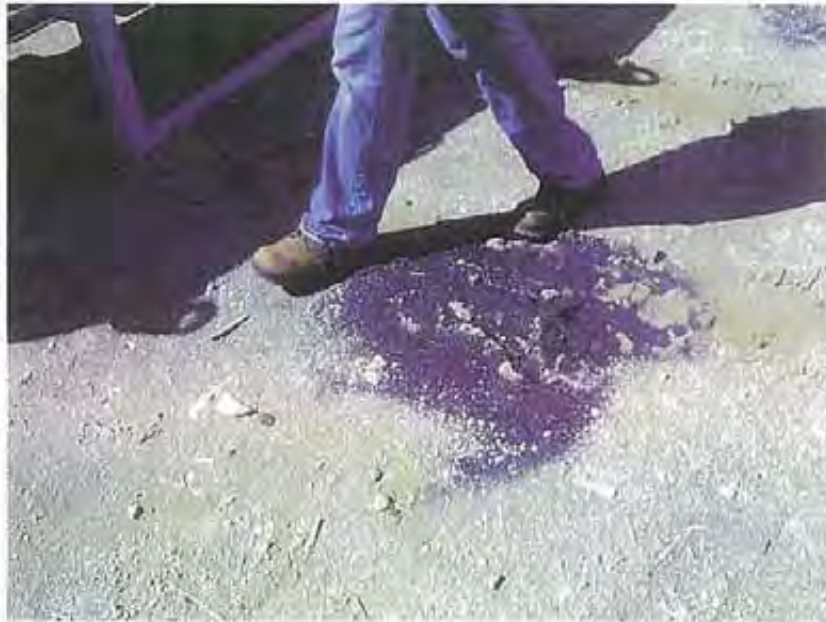
- iii. Sand blasting grit was observed spilled on the ground, shore side of the dry dock and multiple bags of fresh sand blasting grit were observed stored on-site without cover, inconsistent with Part B.2.j of the permit and with the land-based operation BMPs of the Marisco's BMP Plan, which states that sand blast grit [new or spent] will be covered; and

Photo 56: Sand blasting grit was observed on the ground, exposed to potential storm water runoff.

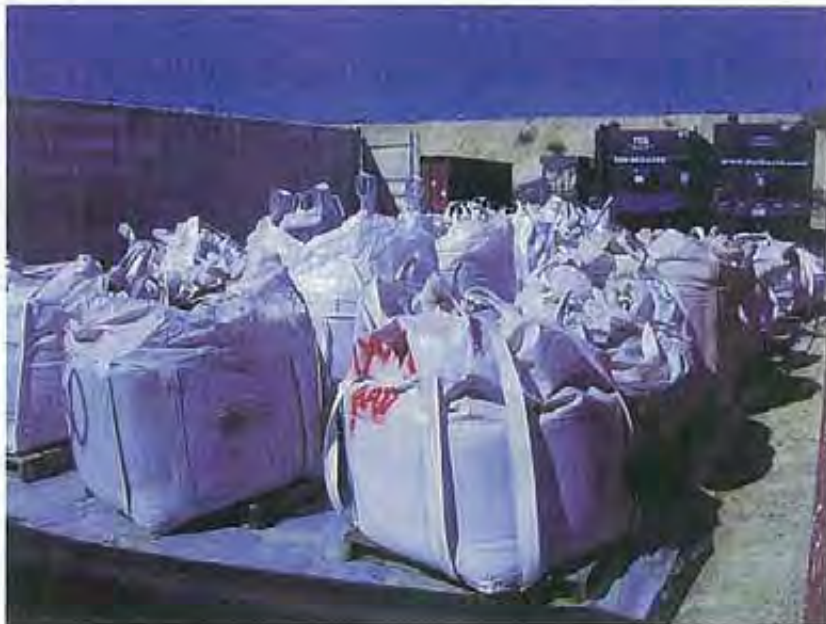
Photo 57: Sandblast grit stored on-site, un-covered.

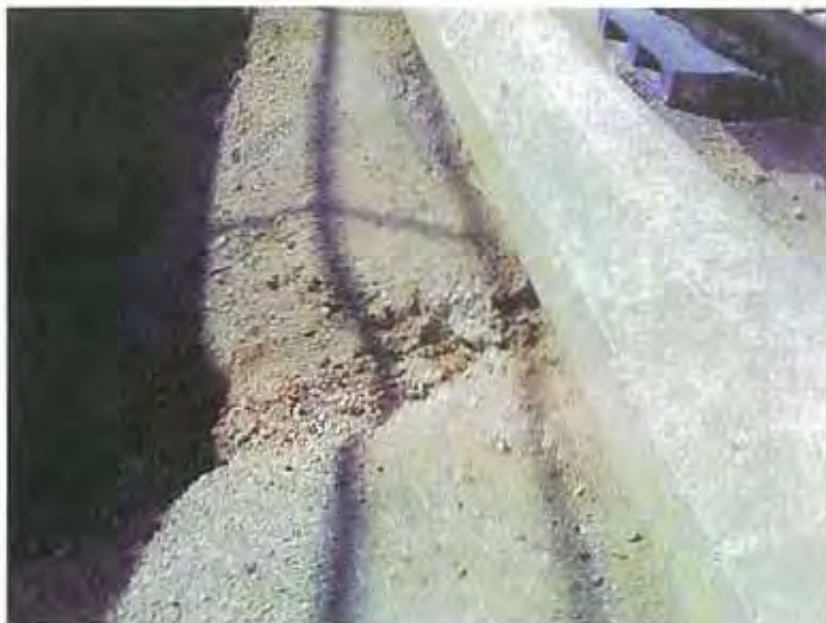
Photo 58: Another gap in the berm.

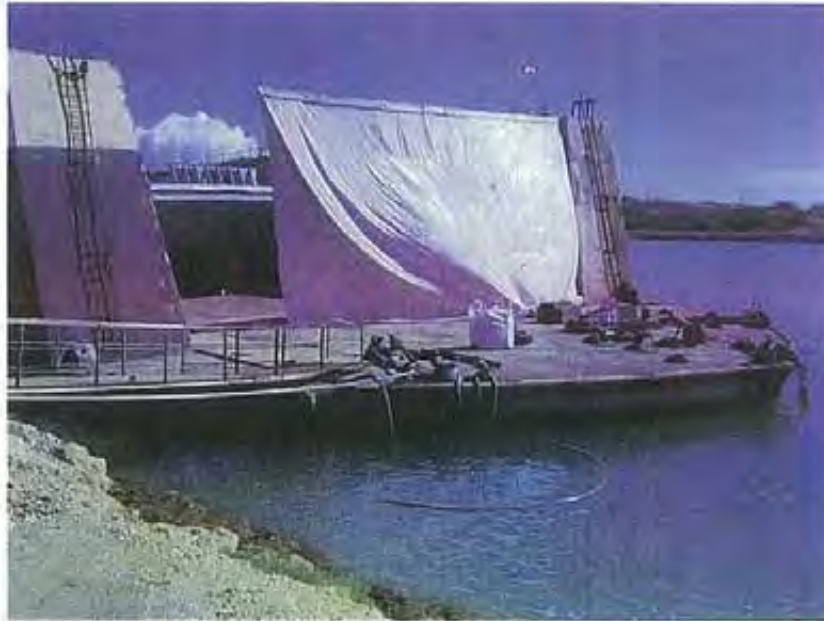
Breaches of the berm surrounding the shore side area next to the dry dock were observed down the entire length of the berm (Photo Nos. 49, 54, 55, and 58). In addition, the deck of the dry dock was observed to not have a berm (Photo No. 59). The Facility representative stated that the berm around the deck of the dry dock had been removed.

- d. The dry dock does not have any structural BMPs, such as a berm (Photo No. 59) to contain potential discharges from washing/cleaning activities. The Discharger's BMP Plan states, under low pressure/low volume cleaning, and ultra-high pressure water blasting (pages 4 and 5), that a 4" inch berm is on the forward and after ends of the dry dock to contain any liquids generated on-site. The Facility representative further stated that temporary berms or containment BMPs are not set up on the dry dock.

Photo 59: An overview of the Lil' Parris dry dock facing northeast.

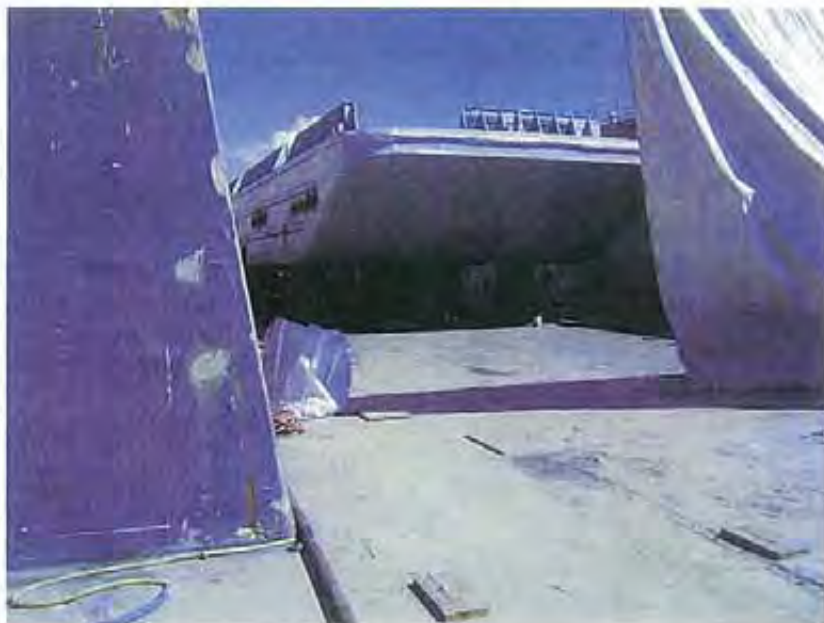
Photo 60: A vessel was docked in the Lil' Parris dry dock on the date of the inspection. Work on the vessel was not performed in the presence of the inspector; however work on the vessel had occurred early in the day.

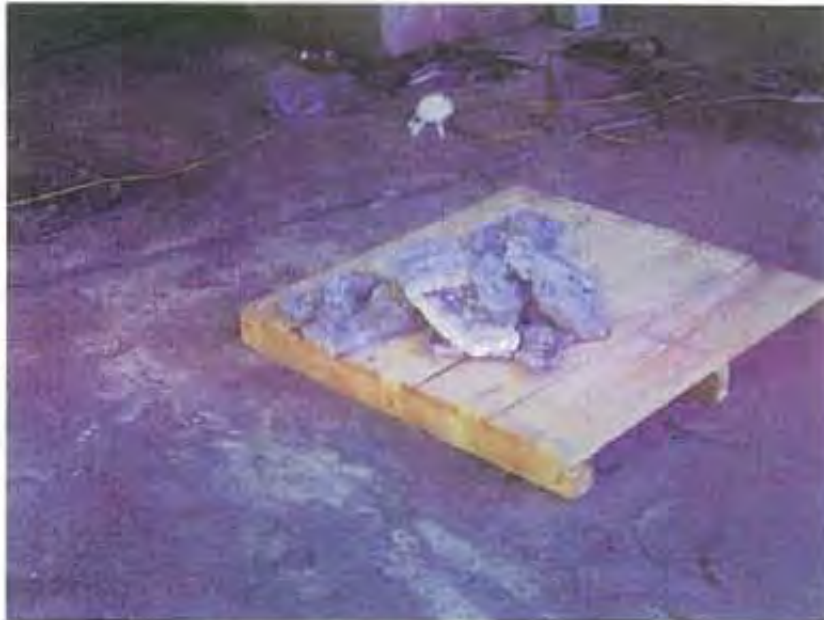
Photo 61: Zinc anodes were observed stored on the dry dock, uncovered and exposed to potential rain fall.

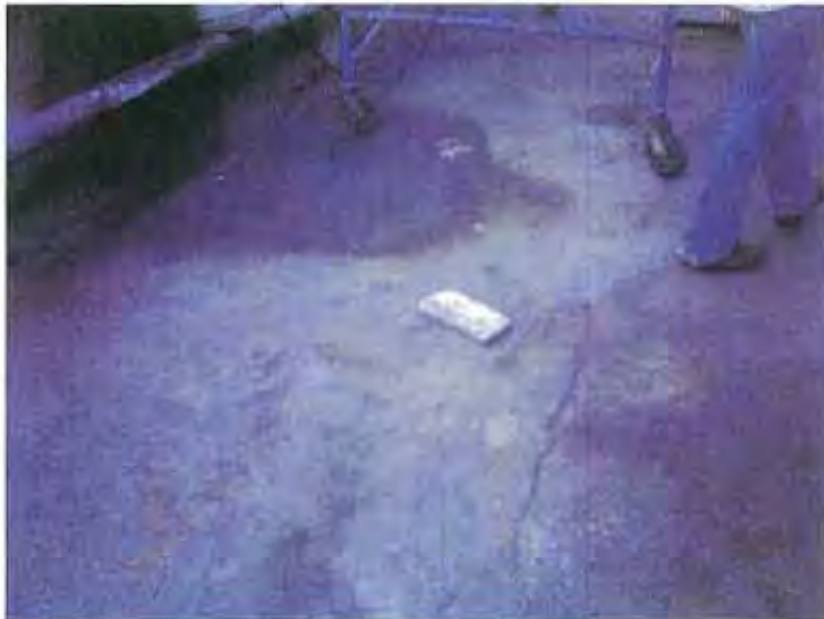
Photo 62: A zinc anode was observed on the floor of the dry dock, exposed to potential storm water runoff.
