*Identification of Historic Properties
within the Area of Potential Effects for
Tenaska Brownsville Partners'
Tenaska Brownsville Generating Station,
Cameron County, Texas*

**Cultural Resources Assessment
(CRA) –Tenaska Brownsville
Generating Station – Transmission
Interconnect Line**

**Tenaska Brownsville Partners, LLC
Cameron County, Texas**

December 18, 2013

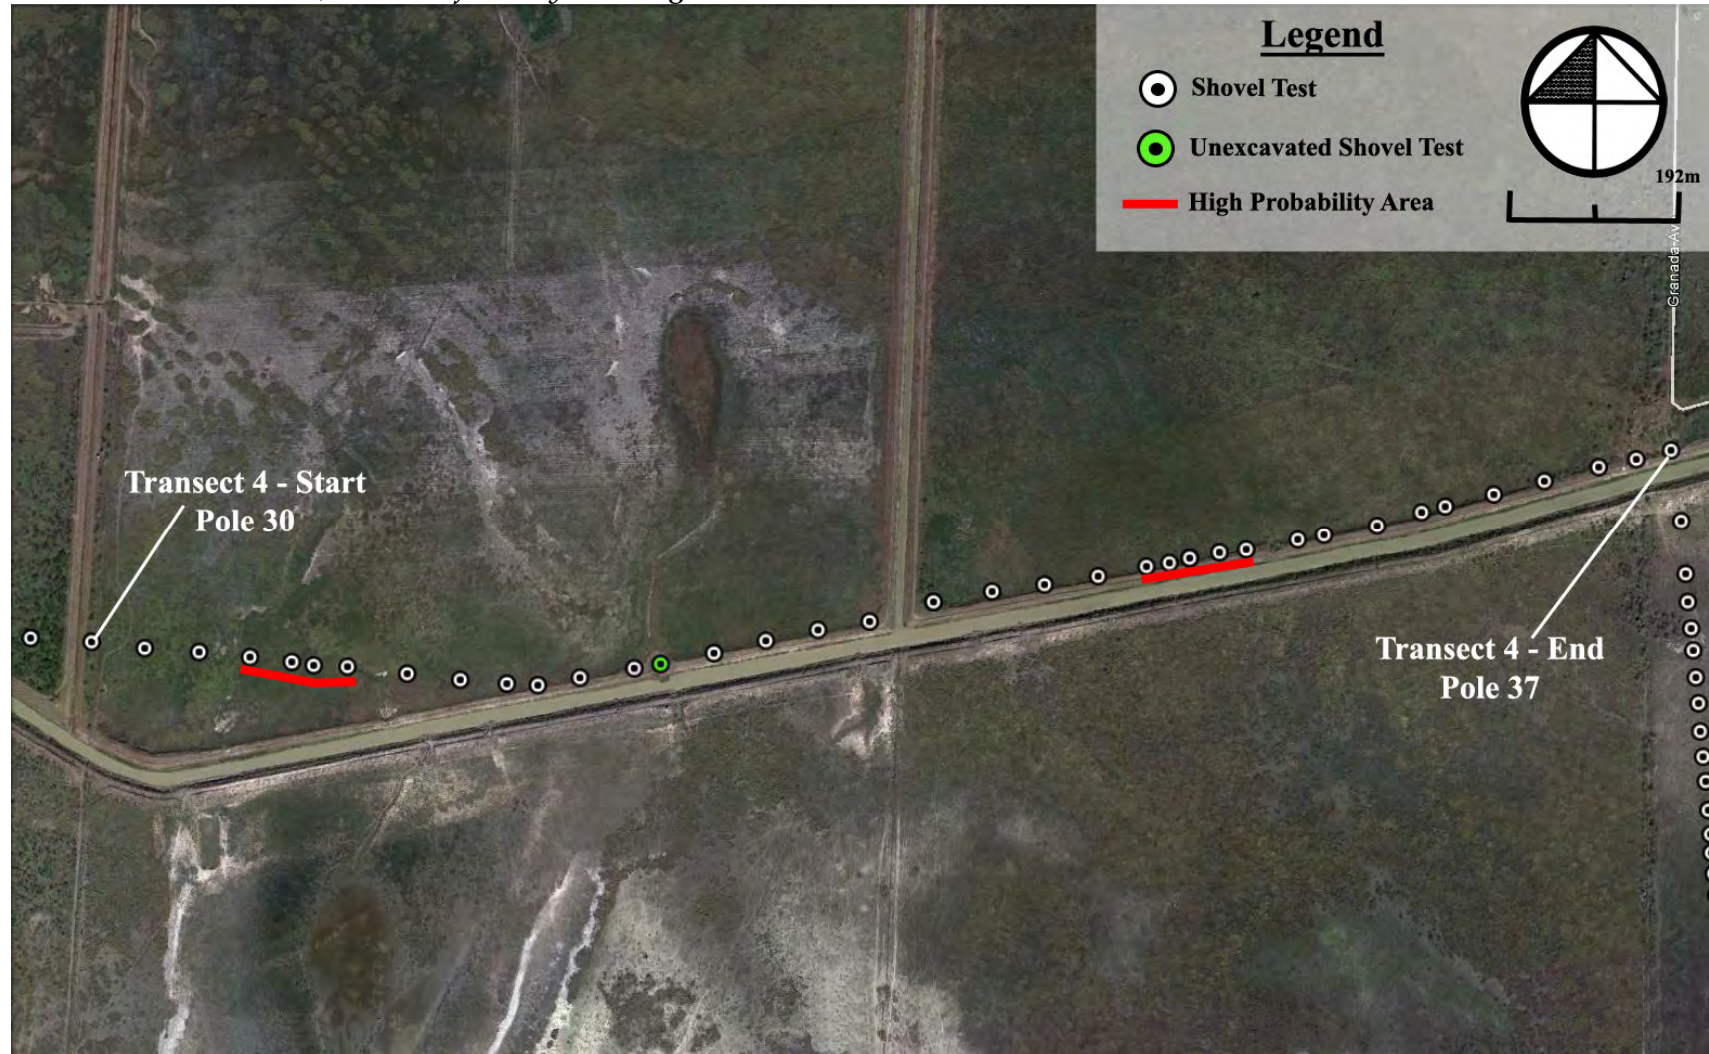
FIGURE 3-4: Transect 4, Results of Survey Showing Shovel Test and Unexcavated Shovel Test Locations

Transect 4 consists of the eastern-most 1.14 miles (1.83 km) of the east-west section (Figure 3-4). Two small high probability areas are within this transect and a total of 37 shovel tests were excavated. Seven high probability areas are included in Transect 5 (Figure 3-5 and 3-6). A total of 146 shovel tests were dug along the 3.83-mile (6.2 km) transect. Transect 6 was located within a heavily disturbed pipeline ROW and no shovel tests were excavated. The last transect terminates at the Loma Alta Substation (Figure 3-7) and eighteen of nineteen planned shovel tests were completed.

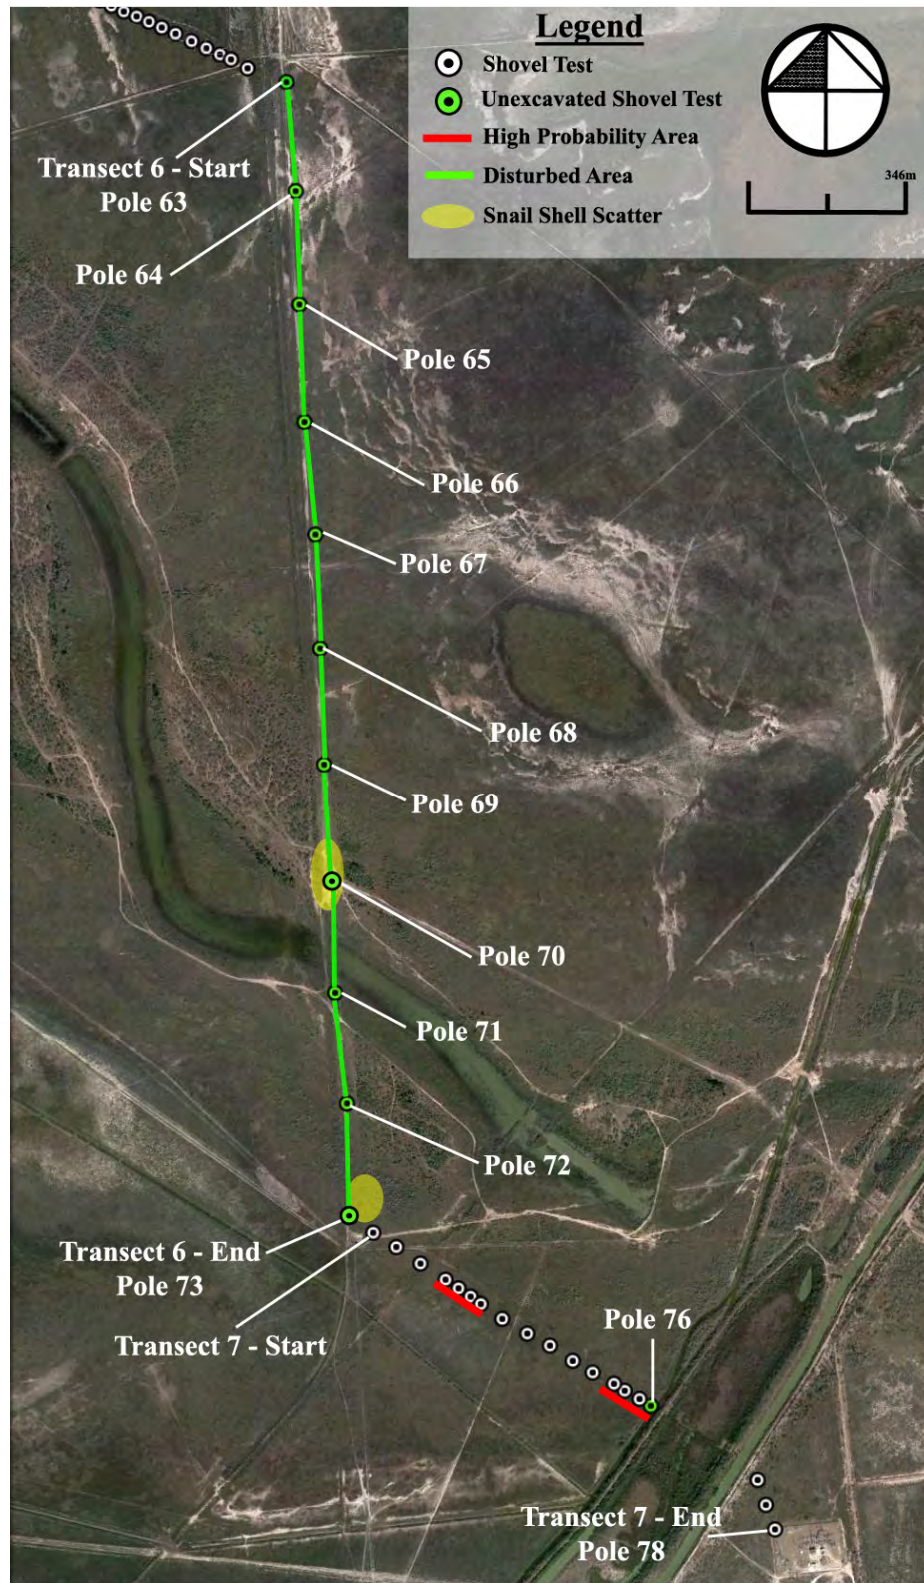
FIGURE 3-7: Transects 6 and 7, Results of Survey Showing Shovel Test and Unexcavated Shovel Test Locations

0.9-mile (1.4 km) segment of Transect 1 that started at the first western turn was located within the disturbance of the canal levee and no shovel tests or metal detection were performed in this segment (Figure 3-7). Surveyors could not safely and adequately access a 0.60-mile (1 km) segment within Transect 3 due to intensely thick thorny brush and cacti; additional work is recommended for this area (see Section 3.2.5). In the vast majority of shovel tests, natural soil profiles matching NCRS soil maps were encountered.

Two areas containing snail shells were observed along the disturbed Transect 6 corridor (see Figure 3-7, above). The shells were observed eroding out of disturbed cut banks; however, visual inspection did not reveal any culturally modified material in these areas.

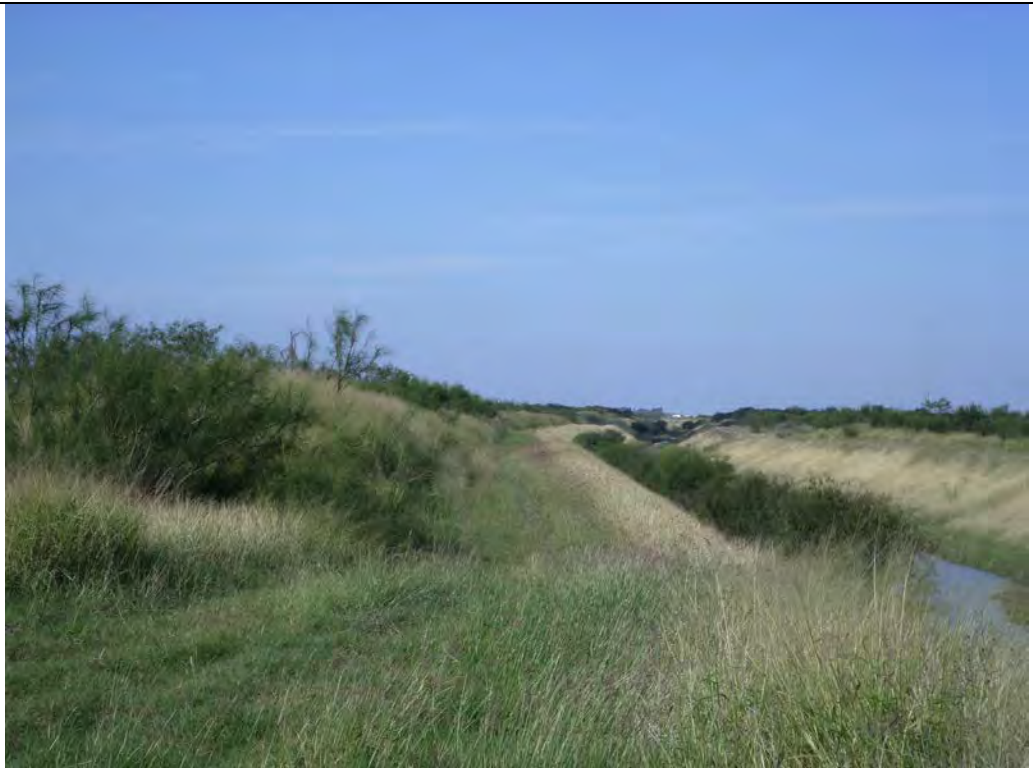
Date:
10/28/13

Description: Transect
1 Segment 3, located
entirely within
disturbed levee
context. Photo taken
at eastern end of
Segment 3 near where
the line crosses the
canal.

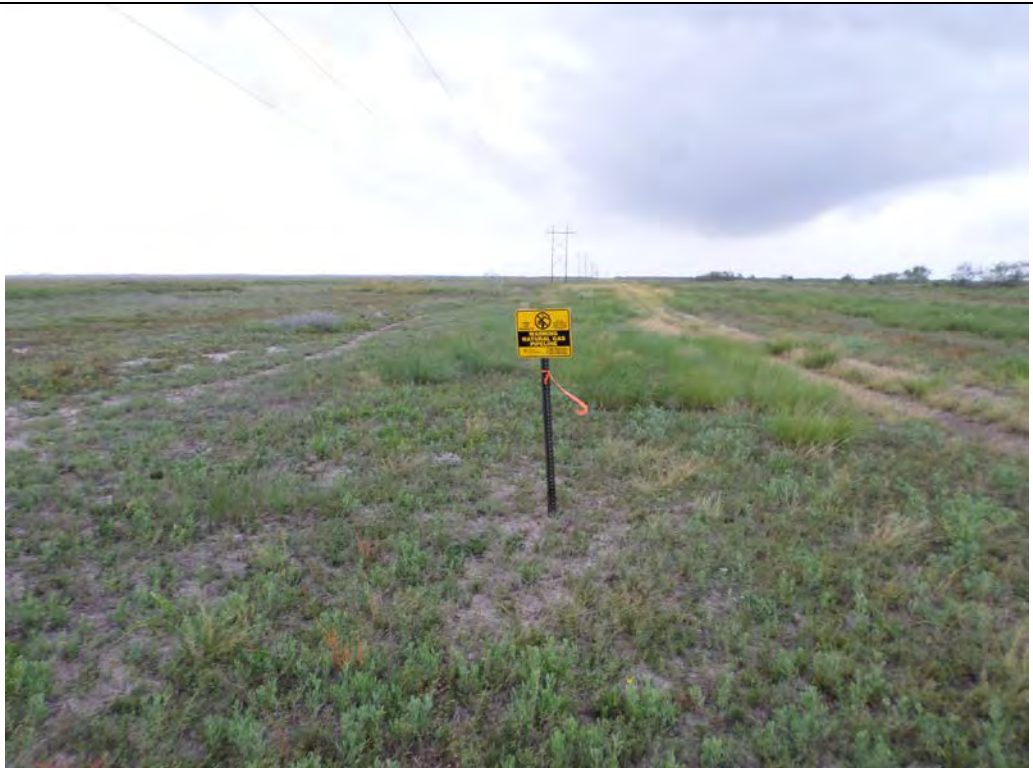
Photo No.
22

Description: From
Pole Location 63,
looking south along
disturbed section of
project. Start of
pedestrian recon area.

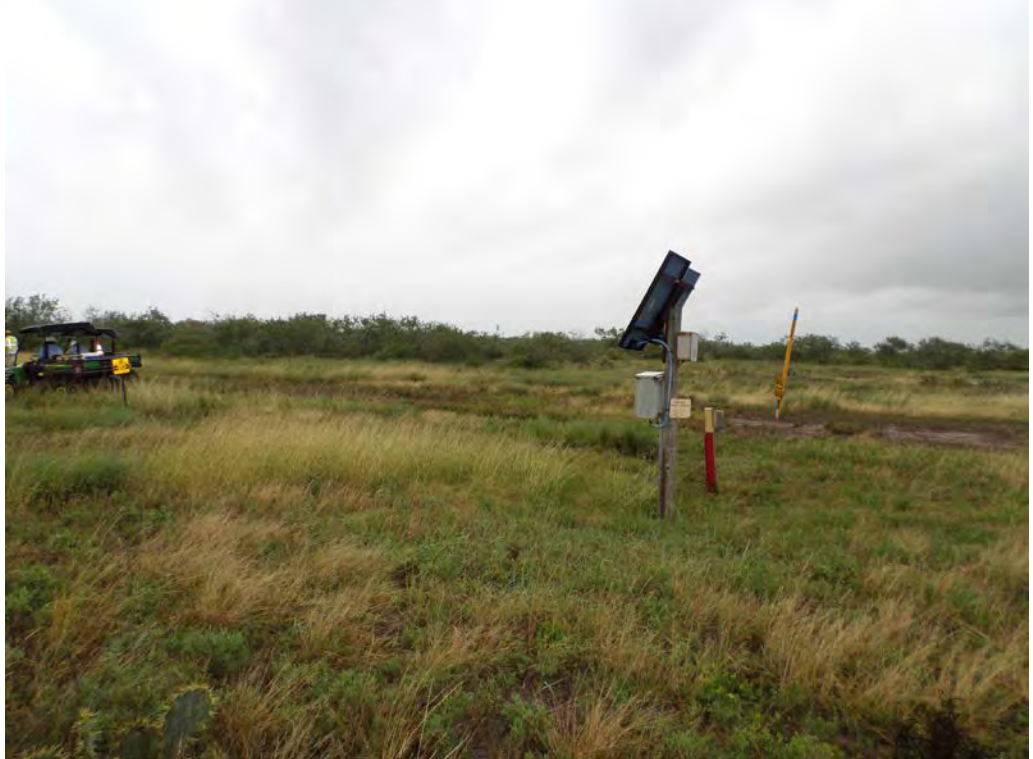
Description: Pipeline
markers and
monitoring station in
disturbed portion of
project area

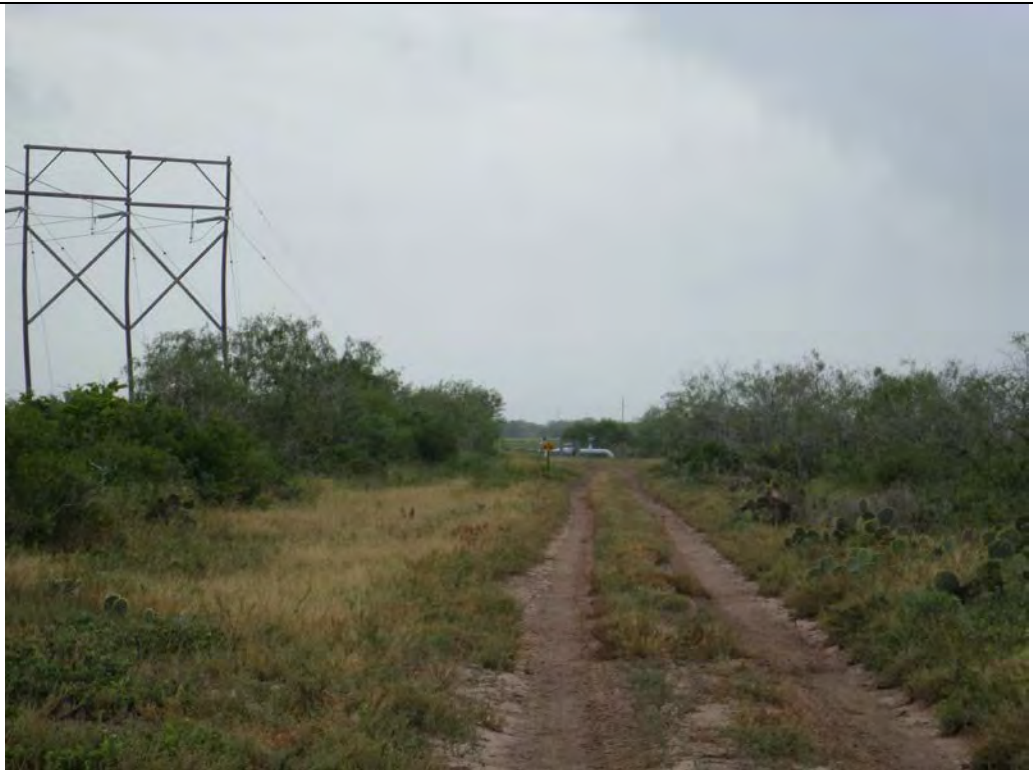
Photo No.
26

Description: Pipeline
Station in ROW near
Pole 73

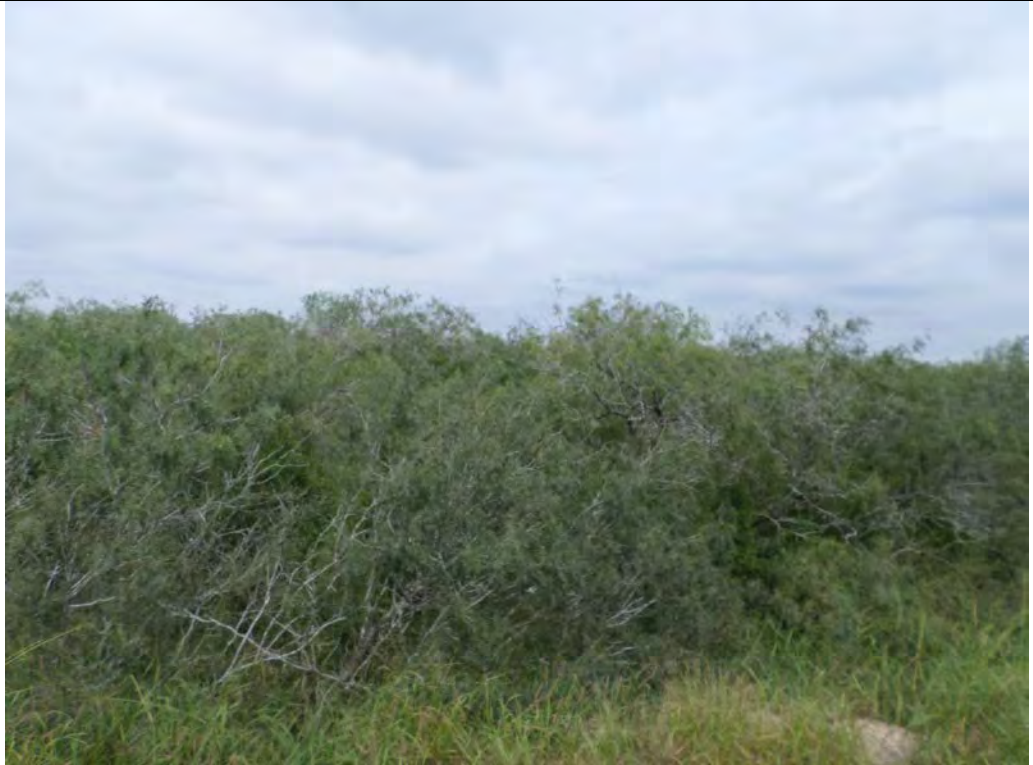
Photo No.
34

Description: Dense
Vegetation between
Poles 23 and 29.
Photo taken from top
of levee to the south
of vegetation.
Vegetation is taller
than levee (10+ foot
tall levee).

Because no archeological sites were identified within the direct impact area, construction of the Transmission Line ROW is unlikely to have an adverse effect on archeological historic properties. However, due to access constraints along a 0.60-mile (1 km) long portion of Transect 3, additional work is recommended in this area. Additionally, ERM recommends deeper testing by hand-augering at pole locations within paleochannels to identify buried paleosols. This work would be completed prior to the start of the transmission line construction and concluded in an addendum report.
