Measure Guideline: Internal Insulation of Masonry Walls

J.F. Straube, K. Ueno, and C.J. Schumacher
Building Science Corporation

July 2012

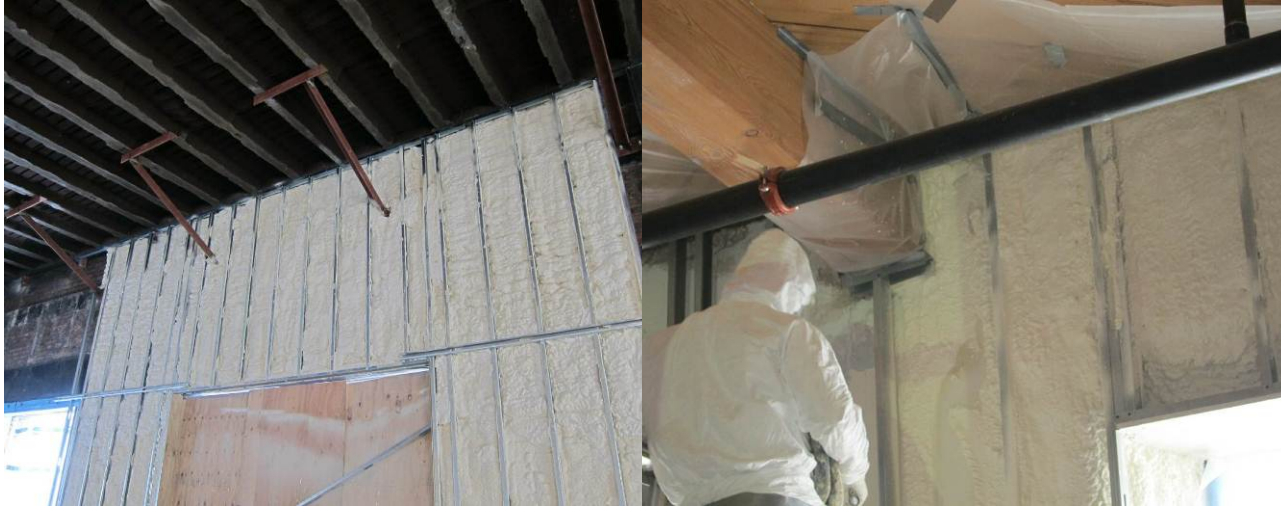
Figure 8. Various retrofit installations of interior spray foam insulation on mass masonry

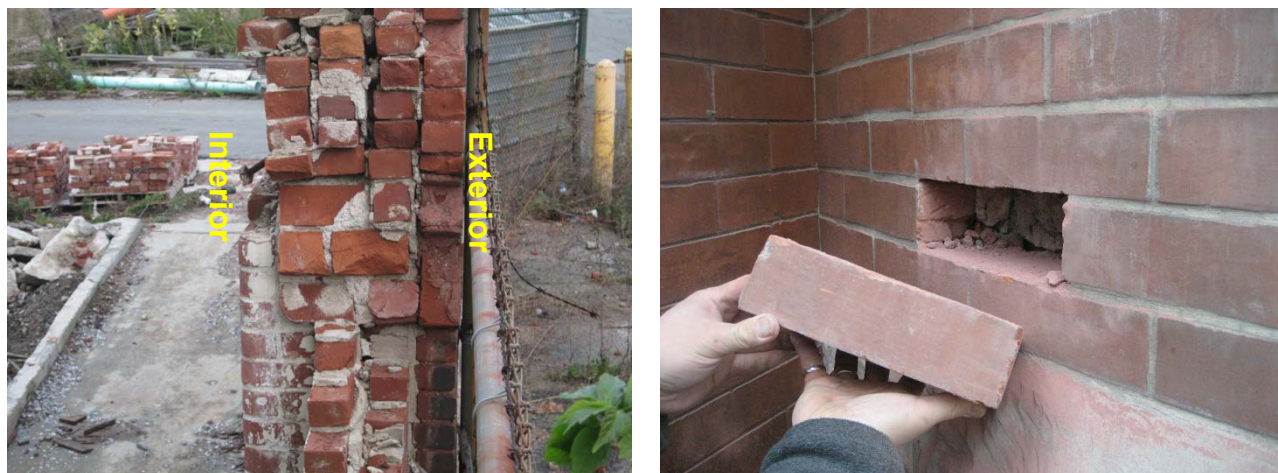
The wall assemblies described as solid masonry may in fact contain many hollow spaces (Figure 14). Voids, sometimes full-height, sometimes story height, and sometimes only 16–24 in. high are often found between layers of masonry. These voids act as capillary breaks, and may allow water to accumulate or concentrate, as they are invariably not intentionally drained.

Figure 14. Voids commonly found between wythes of brick in masonry walls

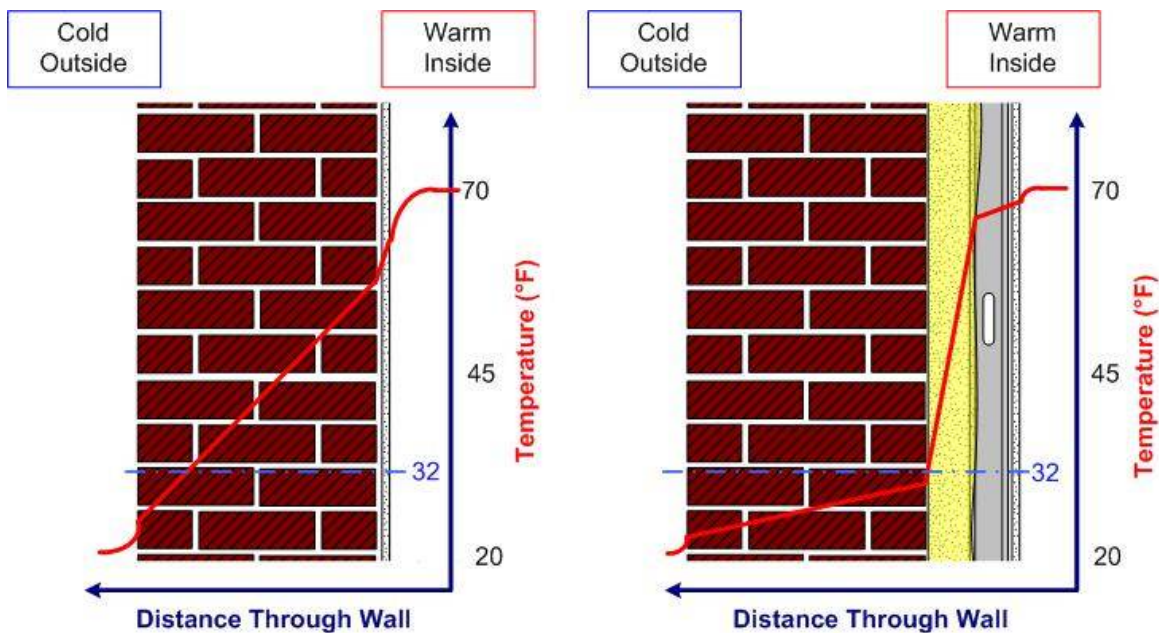
The biggest changes occur at the inside face of the masonry wall. Before the retrofit, the assembly experienced moderate temperatures close to interior conditions (Figure 15, left). After the retrofit, the inside face will experience much colder temperatures and often wetter conditions (Figure 15, right). With just modest levels of insulation, the interior face of the masonry can regularly experience freezing temperatures. Hence, the concern is whether there is a potential for FT damage created by the retrofit.

Figure 15. Left: Pre-retrofit temperature gradients through wall; Right: post-retrofit temperature gradients through wall

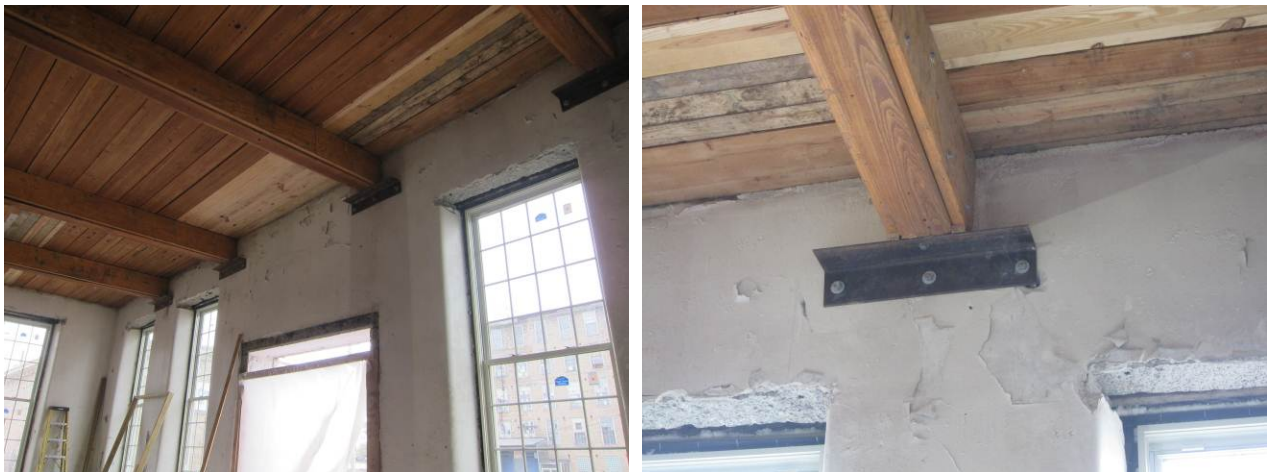
Embedded wood timbers are a common embedded element with durability concerns. A number of solutions are being pursued, including borate injections into the wood, metal wedges next to the member (to provide passive heat flow), active heating, or construction of a load-bearing structure inside the masonry (Figure 16), and cutting off the end of the beam.

Figure 16. Steel angle bolted to masonry to transfer load out of beam pocket

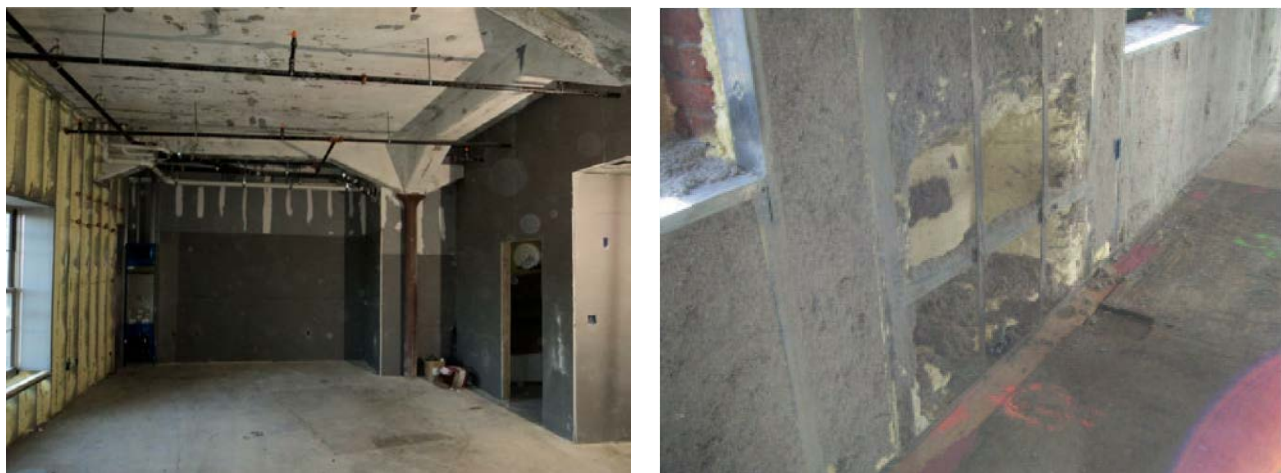
The examples shown below in Figure 23 use steel framing with damp spray cellulose insulation, inboard of 2 PCF ccSPF insulation. There is significant thermal bridging through the steel studs, which diminishes the value of the cavity insulation.

Figure 23. Hybrid spray foam/damp spray cellulose assembly (steel stud not recommended)

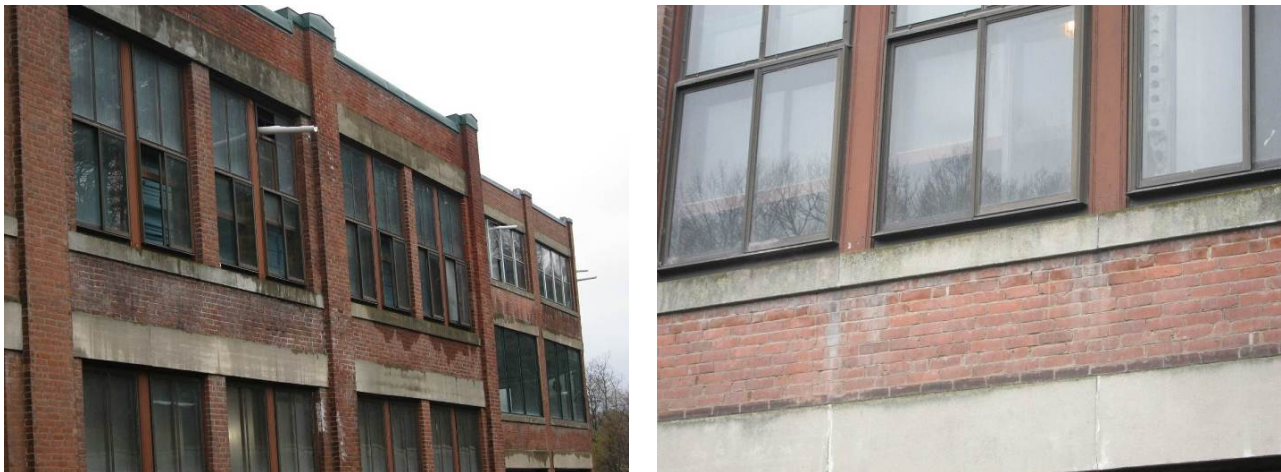
Windows and doors are nonabsorbent, and hence shed all the rainwater (wind-driven rain) that strikes them. The shapes of windows and doors also tend to concentrate water, especially at the lower corners (Figure 29). To maximize durability, a critical requirement is to avoid concentration of rainwater surface drainage, and to encourage the shedding of water away from the face of the building.

Figure 29. Improper drainage off window faces, and staining at window sill grout joints

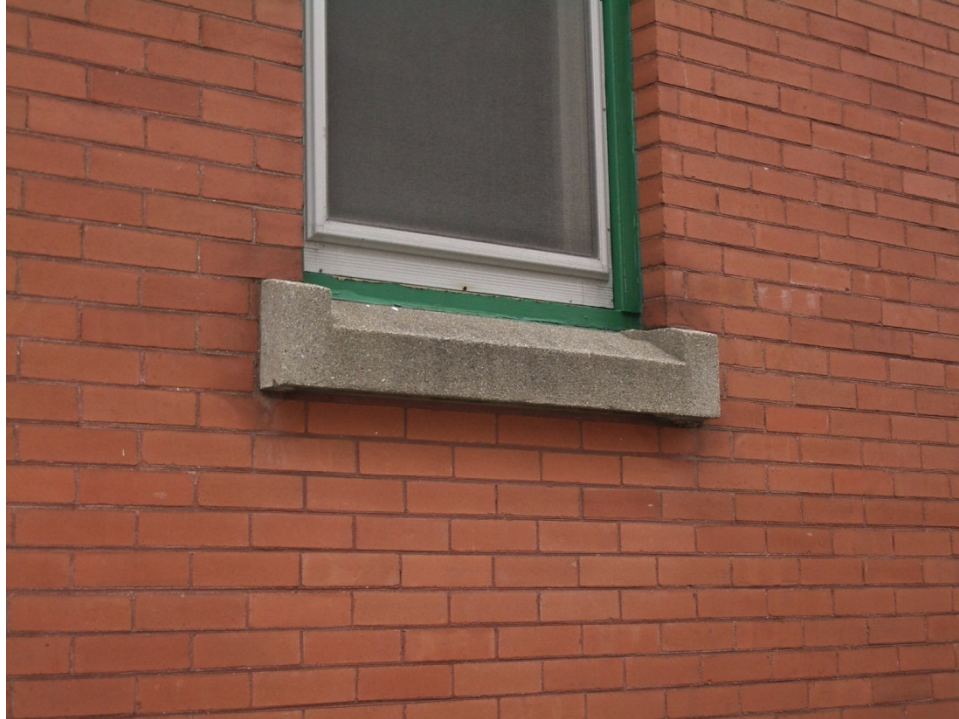
Figure 32. A high performance window sill, exhibiting end dams, steep slope, large projection, jamb extensions, and drip edge

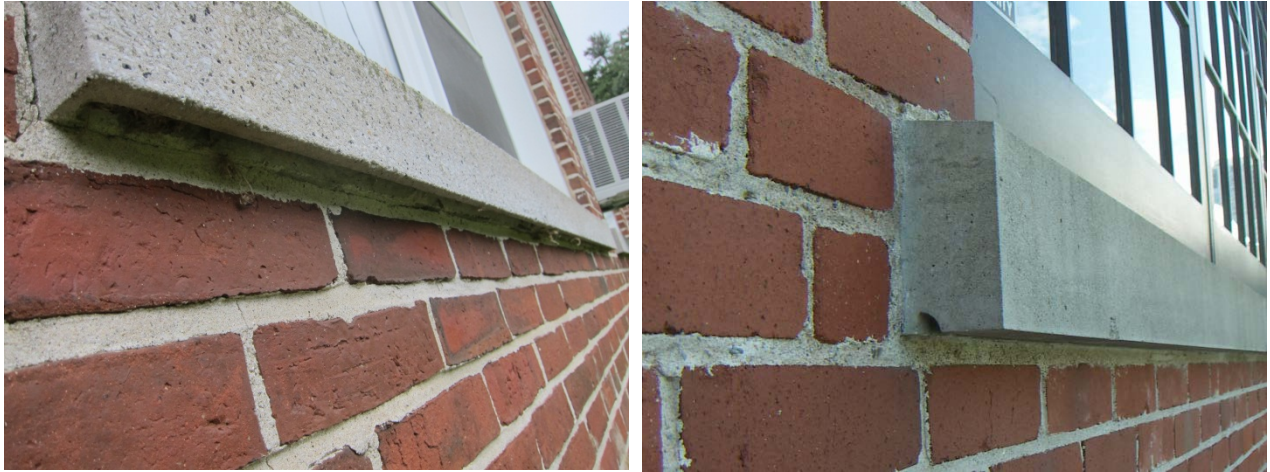
Many existing precast window sills have drip edge details built in to their undersides, as shown in Figure 36. These types of details typically provide excellent performance and durability.

Figure 36. Precast window sill drip edge details

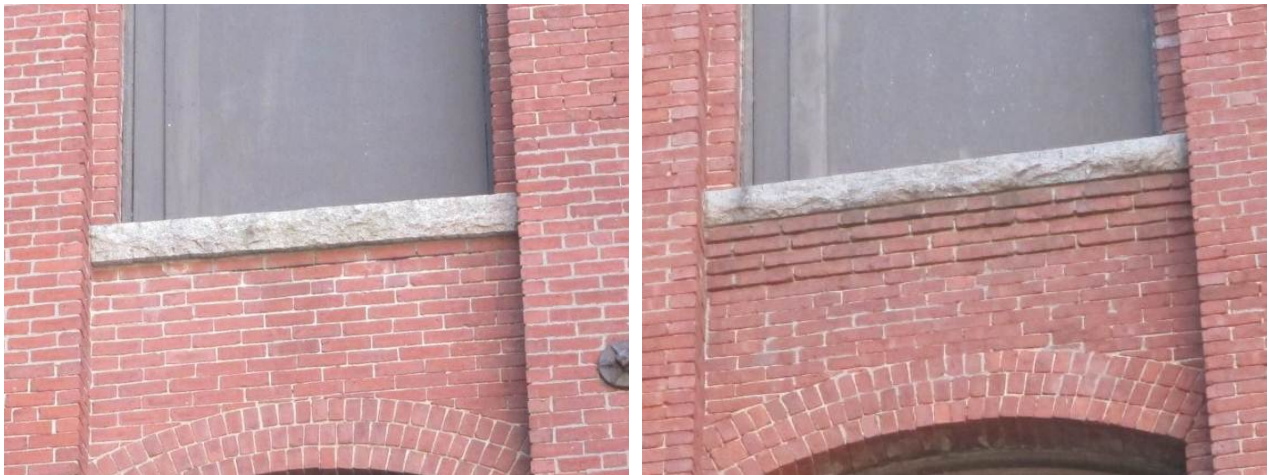
Informative patterns of water deposition can be seen in this building with granite sills: some of the sills have no corbeling below them (Figure 37, left); others have a brick corbel detail (Figure 37, right). Staining and mortar erosion was more severe at the corbeled detail (right), as the water draining from the sill is more likely to run onto the brick below from surface tension, as opposed to dripping free from the noncorbeled sill “lip” (left). This shows the importance of a projecting overhang at the sill.

Figure 37. Left: Window sill without brick corbeling (left); Right: Window sill with brick corbeling, showing different mortar erosion patterns

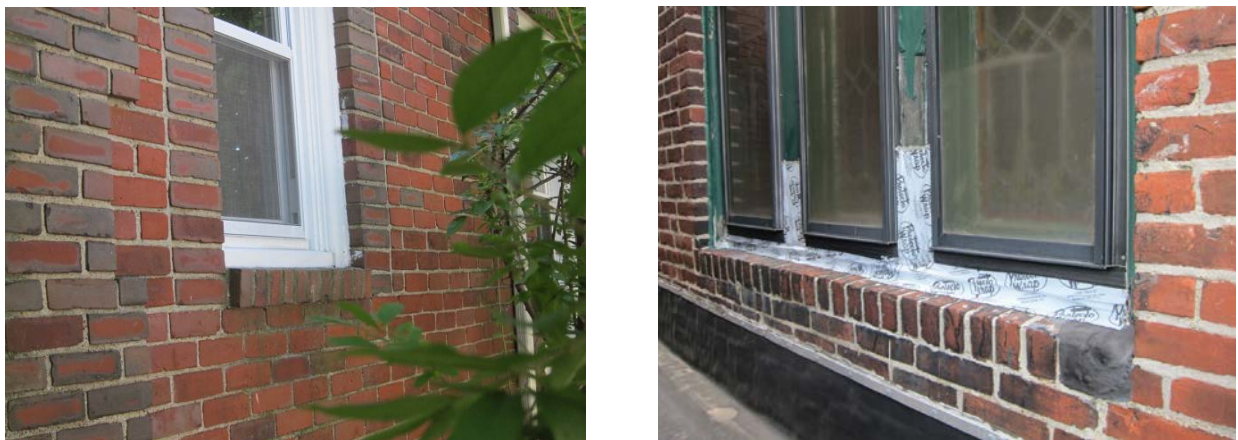
Another problematic sill detail is the rowlock brick sill (Figure 39). Recommended construction details for a rowlock sill are provided by BIA (2005). Rowlock sills are more vulnerable than the previously described stone or cast sills, as they are composed of individual bricks with mortar joints, which will be a source of water leakage.

Figure 39. Rowlock window sill examples

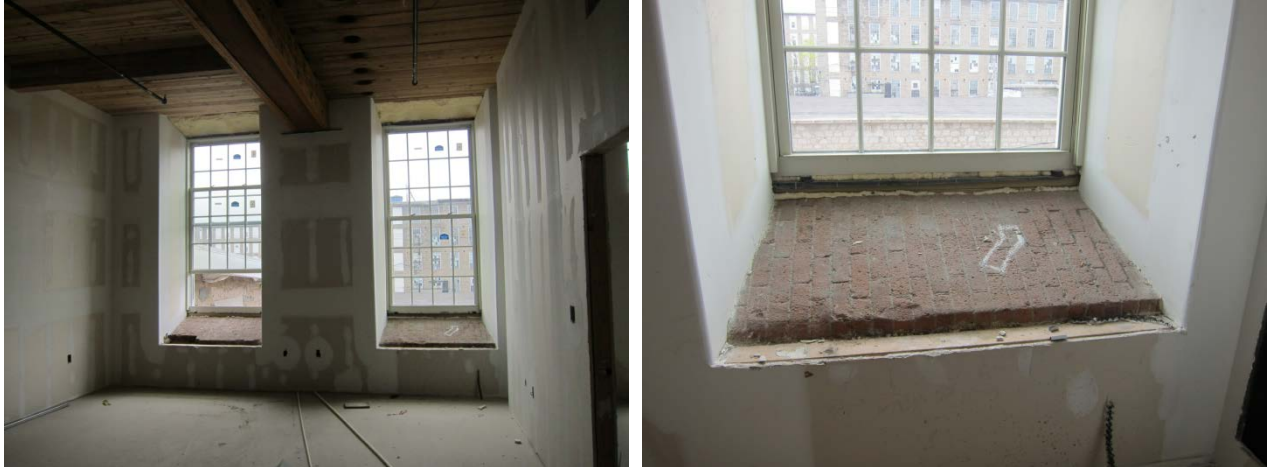
This installation had to meet historic preservation requirements; therefore, the brick sill was left exposed as a historic detail (see Figure 48). This is not recommended, because of poor energy performance, potential condensation issues, and possible comfort complaints (occupant “seeing” a larger cold radiative surface).

Figure 48. Gypsum board at window openings with tapered jamb detail (sill left uninsulated; not recommended)

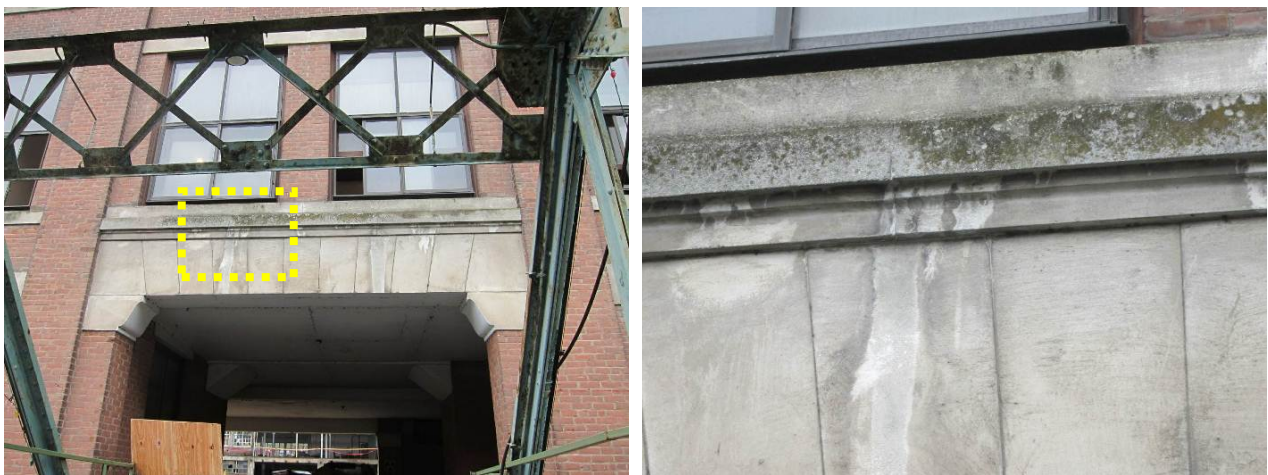
Figure 49. Staining on decorative arch coping stones, concentrations at joints

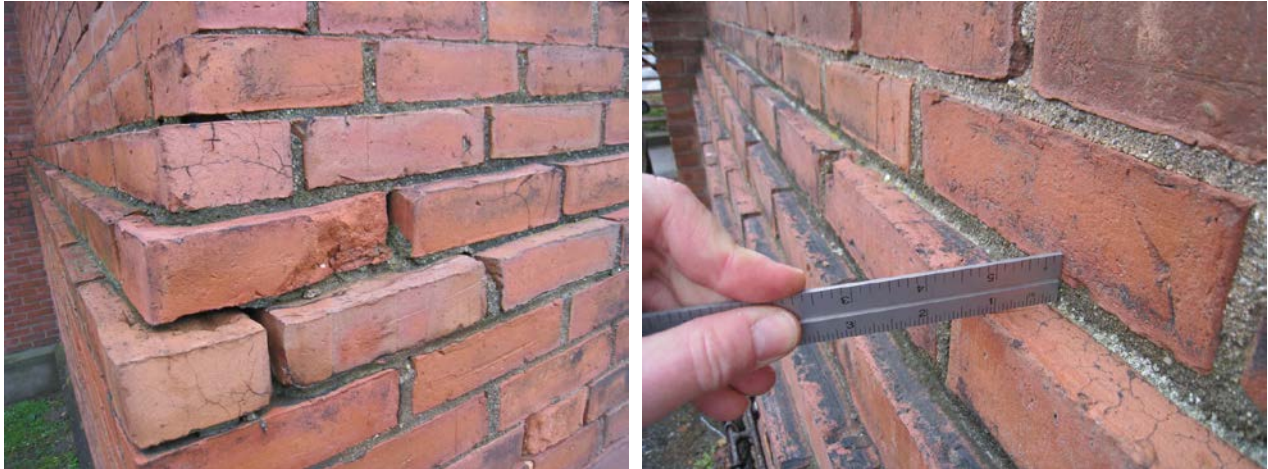
Figure 50. Steps in brickwork, and related cracking/FT damage

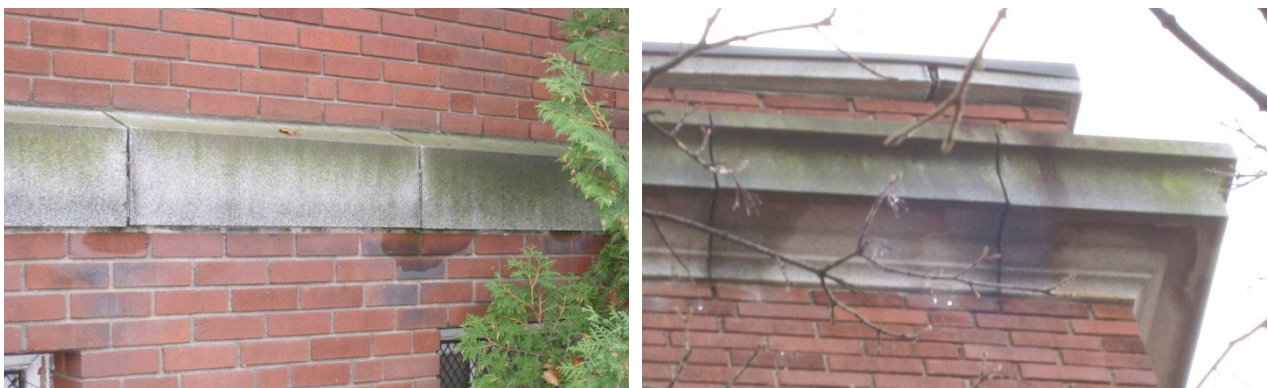
Figure 51. Water concentration at stone belt and cornice joints

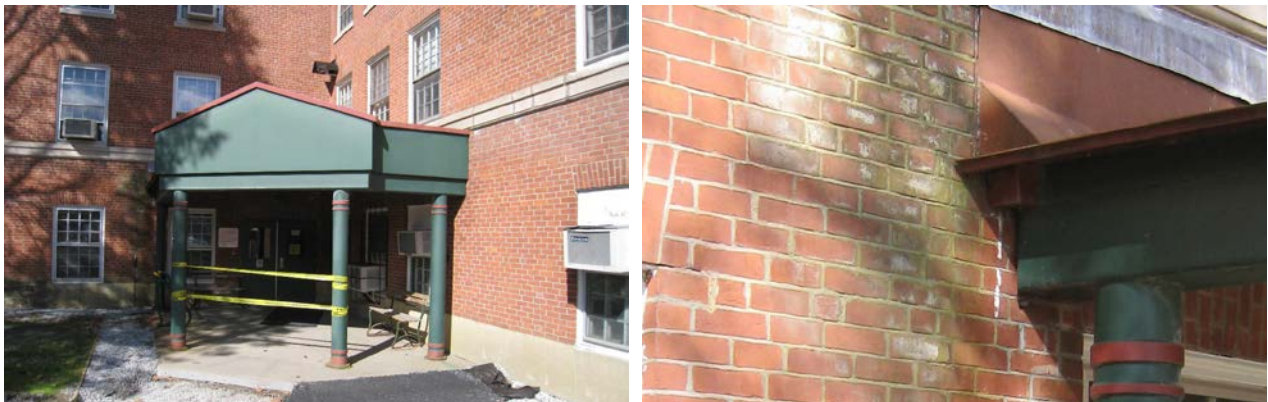
Figure 53. Left: Retrofit roof over entrance; Right: Water runoff concentration at roof-wall interface

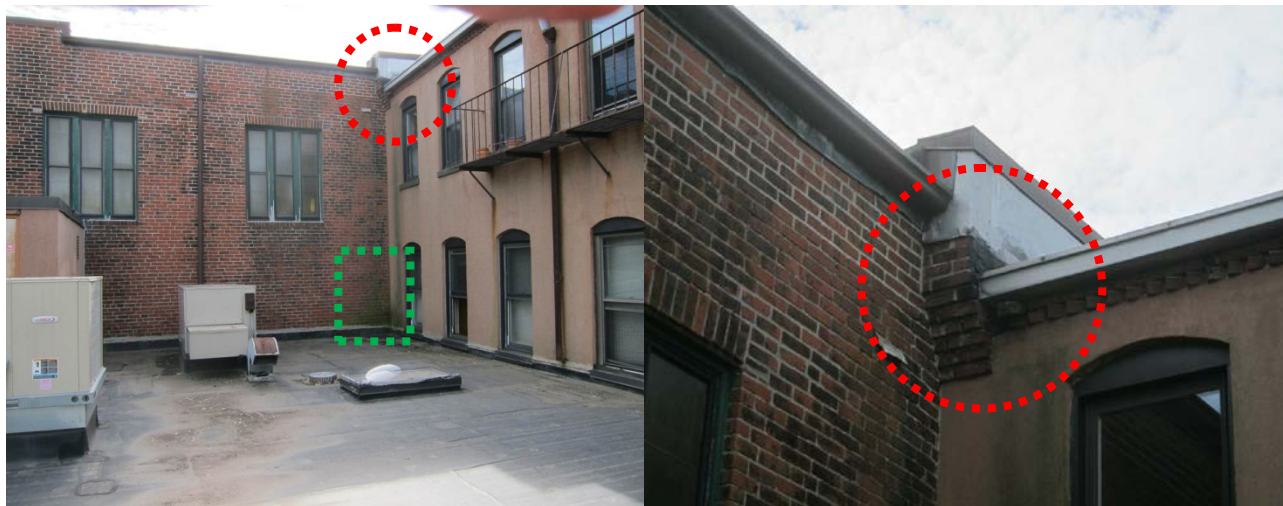
Figure 55. Water runoff concentration at roof-wall interface (kickout flashing required)

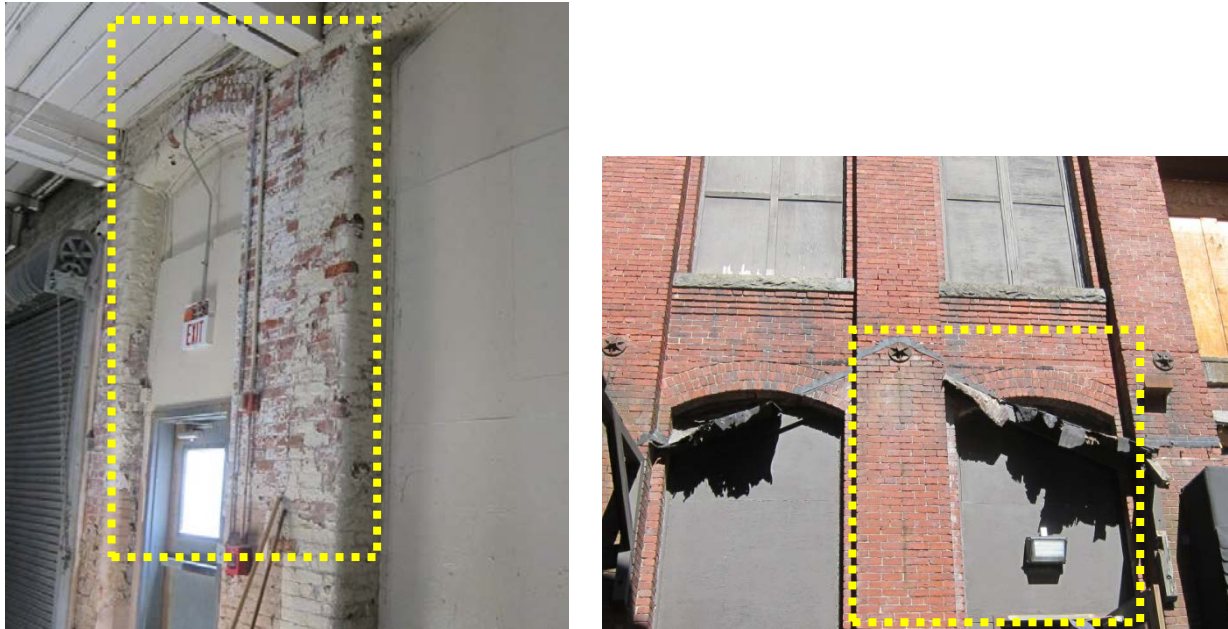
Figure 56. Left: Interior paint/parging delamination; Right: Exterior conditions for comparison

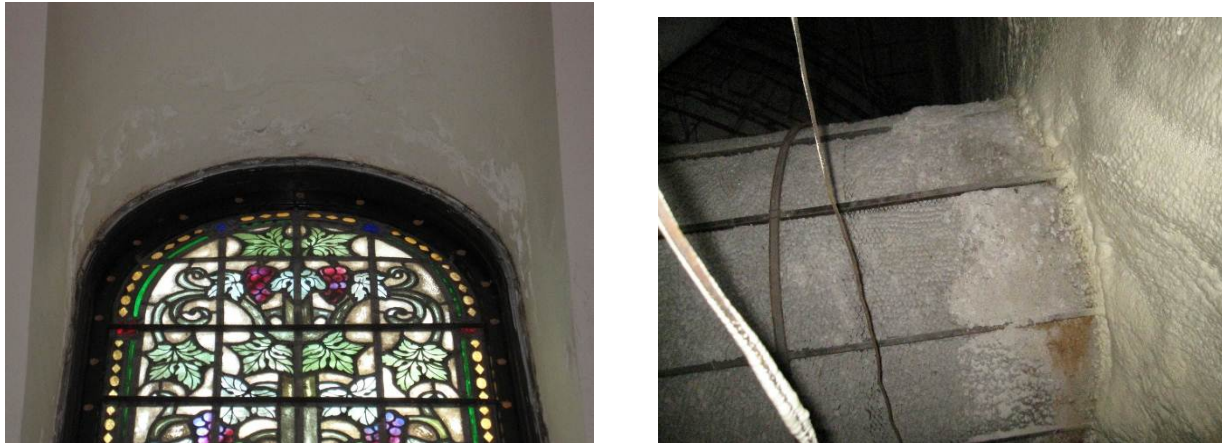
Figure 58. Moisture issues at chapel windows

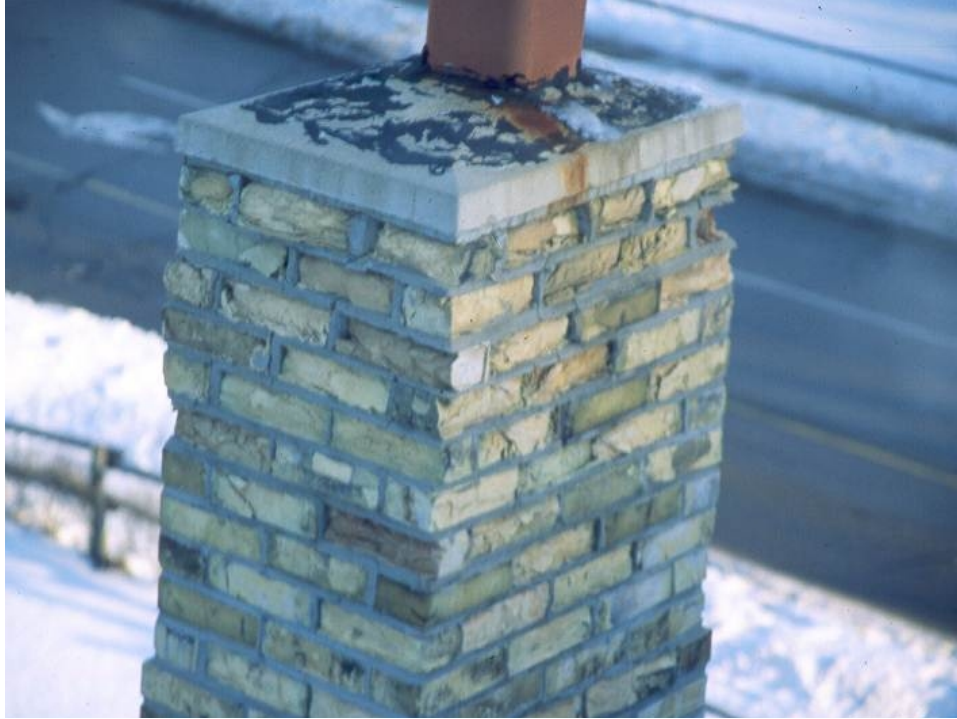
Figure 59. Severe FT damage at existing chimney; lack of projecting cap with drip edge

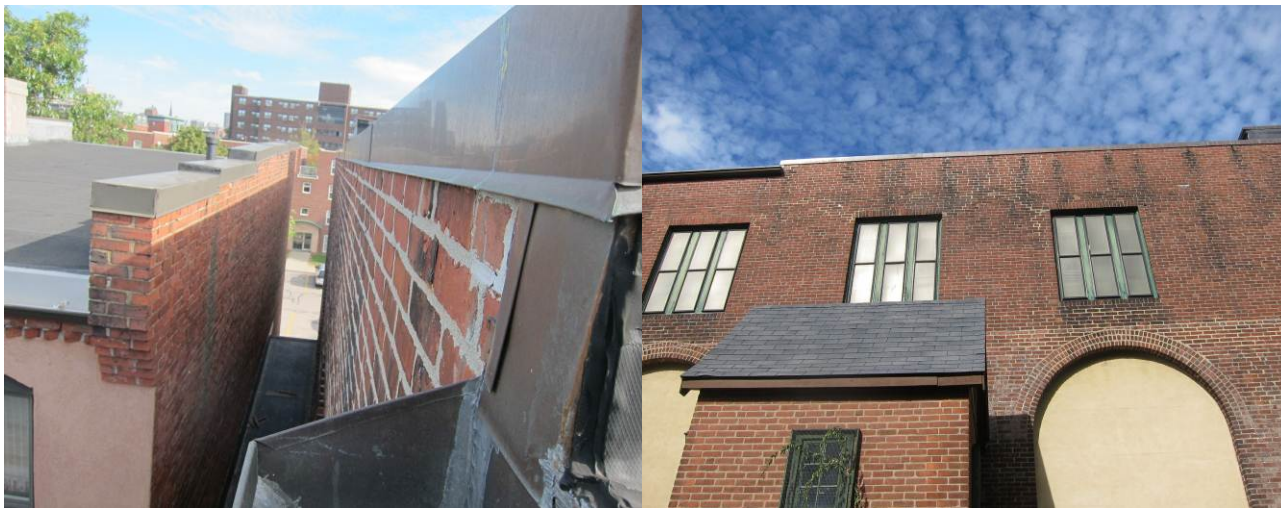
Figure 60. Coping detail and runoff staining at joints of previous coping design

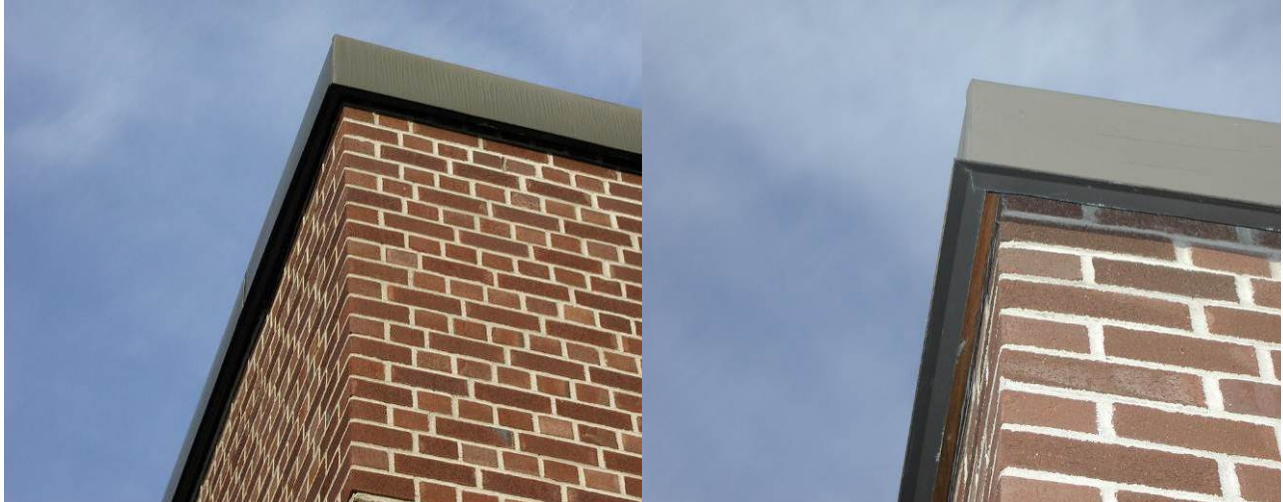
Figure 62. Improved drip edge overhang at coping

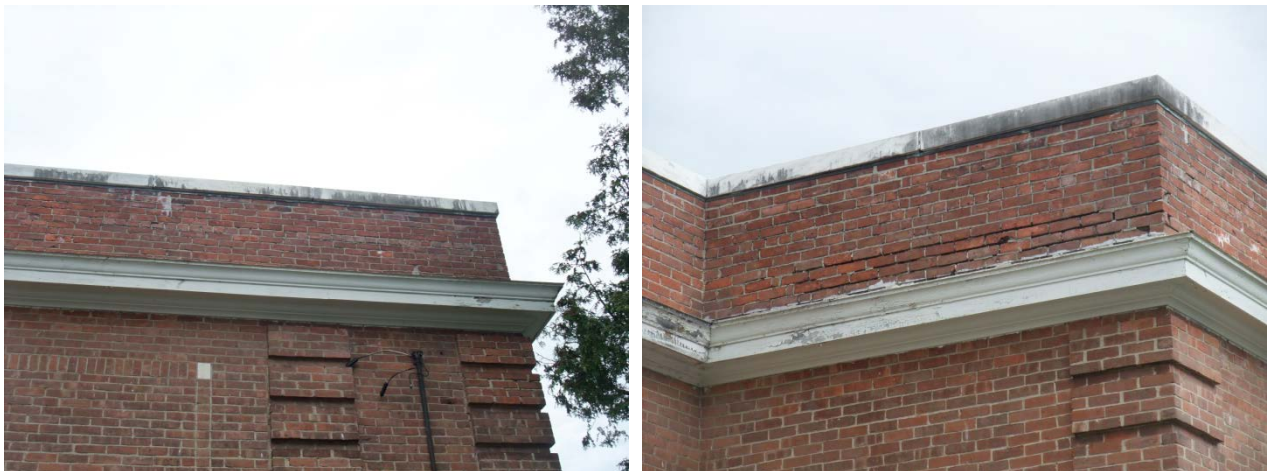
Figure 63. Stone parapet cap, with joints in stone coping

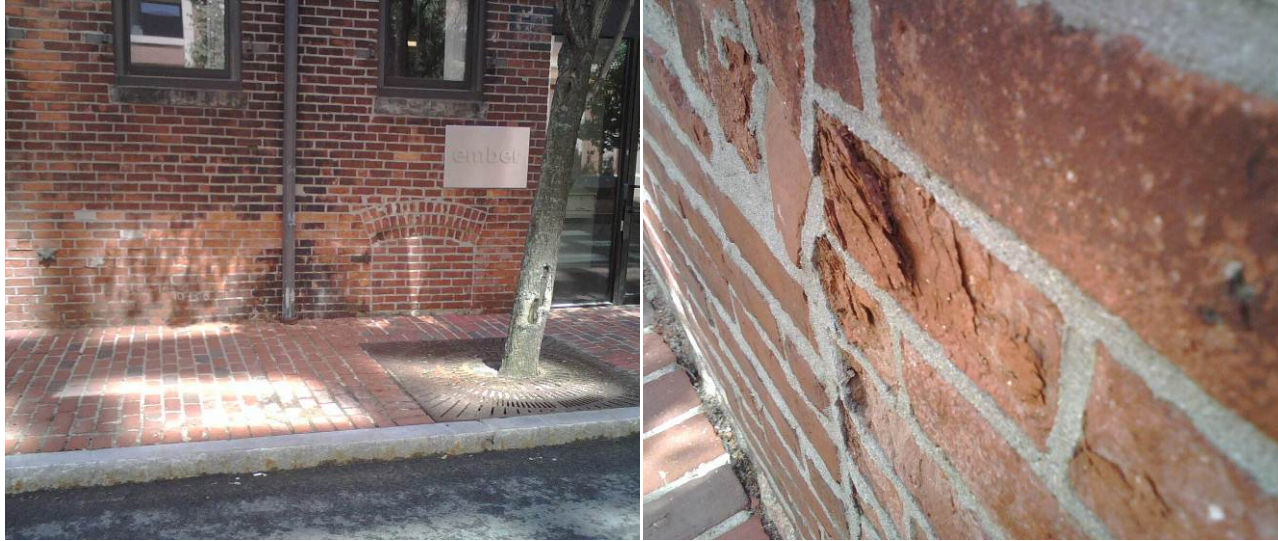
Figure 65. Left: FT damage at downspout disconnection; Right: delamination of brick

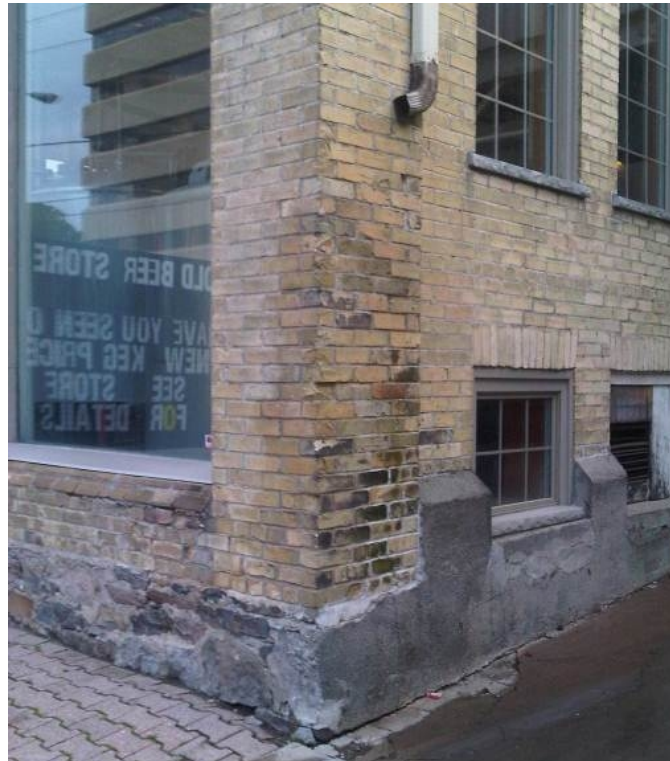
Figure 66. Disconnected downspout and related damage to masonry

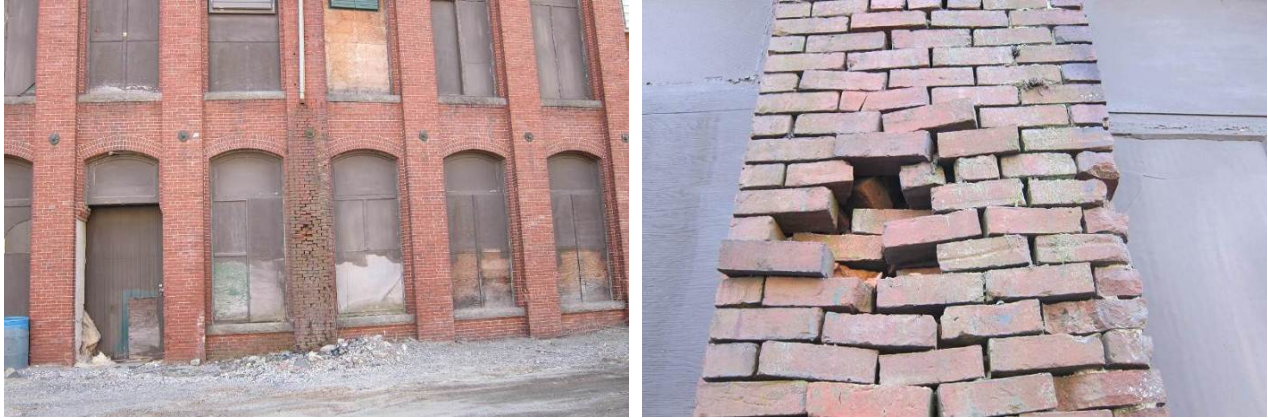
Figure 67. Left: Damaged pilaster at downspout; Right: Severe mortar erosion

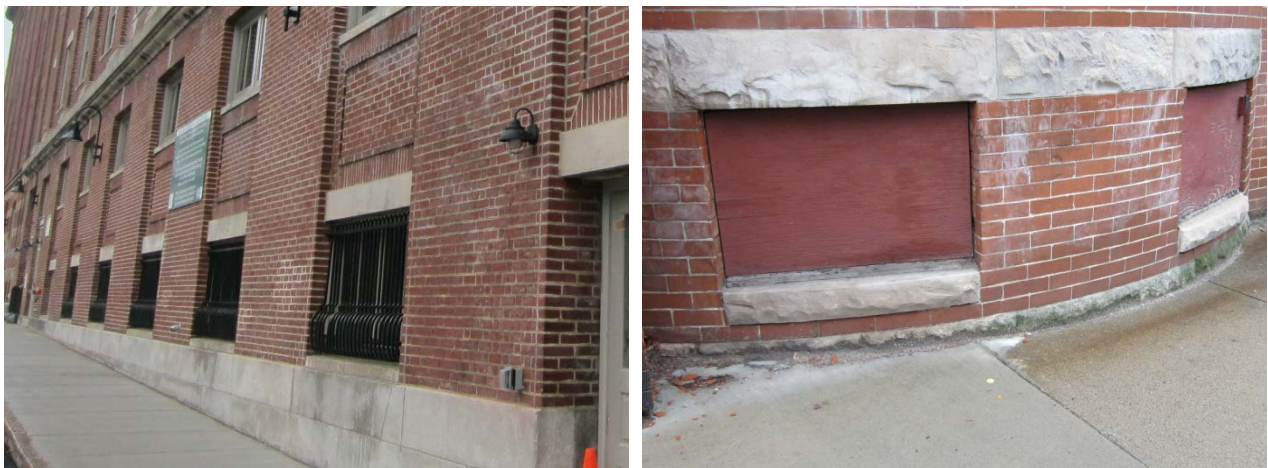
Figure 68. Common masonry wall assembly with non-porous stone at grade

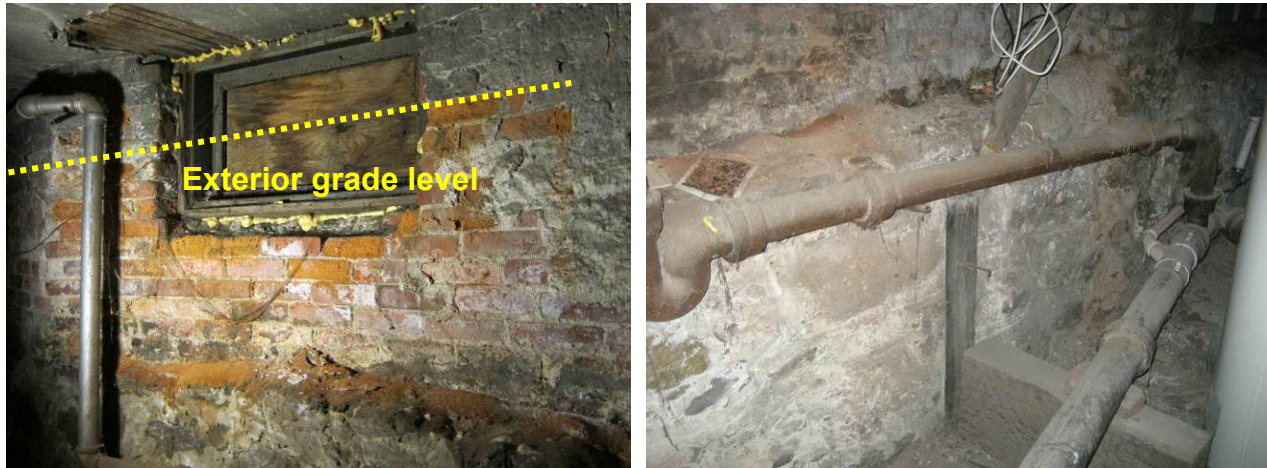
Figure 69. Left: Severe subfluorescence and spalling at basement window; Right: Stone shelf below grade

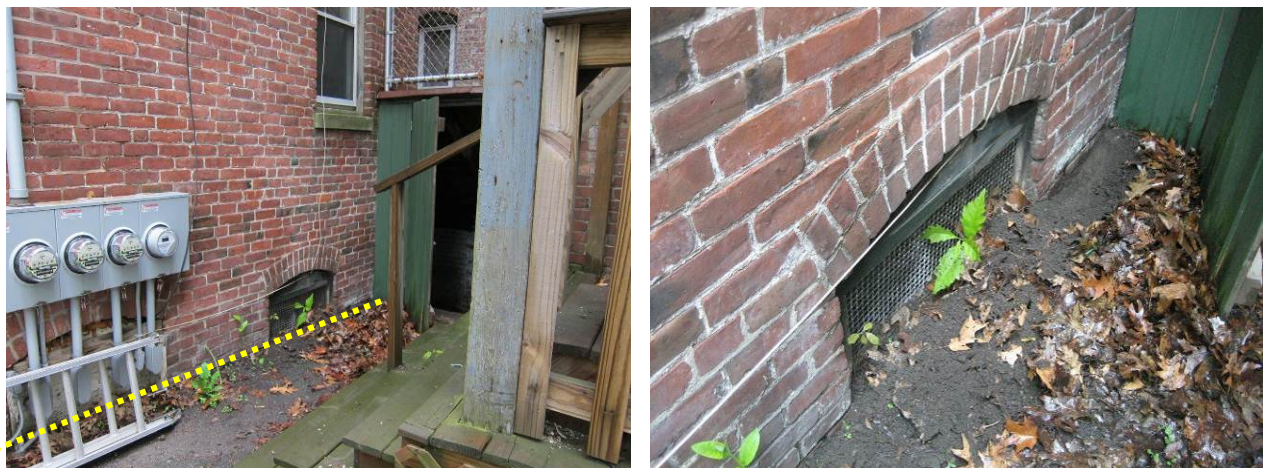
Figure 70. Left: Rear wall near subfluorescence damage visible in basement; Right: Buried window

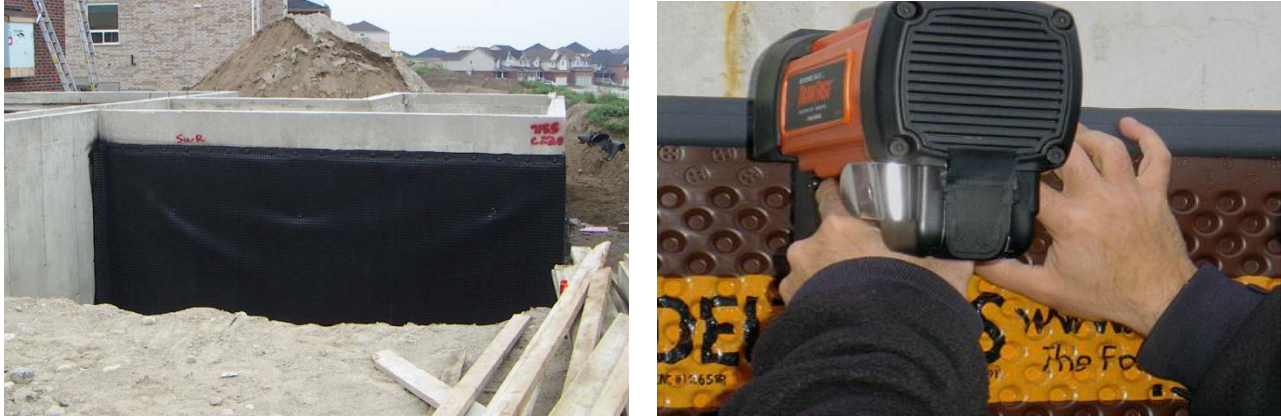
Figure 73. Air gap membrane below grade and top closure strip

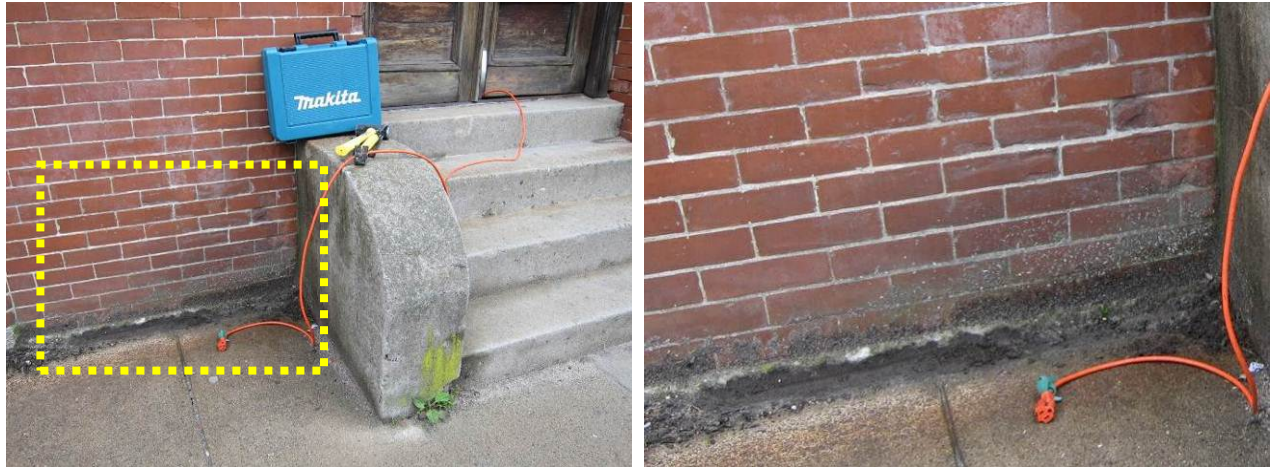
Figure 75. Brick condition adjacent to front steps, splashback evident

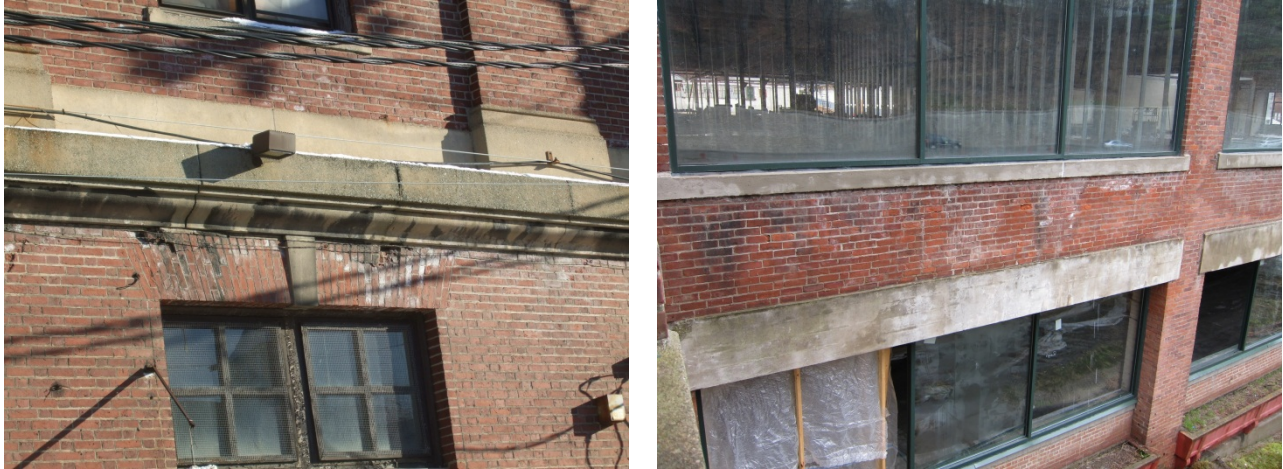
Figure 83. Exterior details that demonstrate FT damage in existing masonry buildings

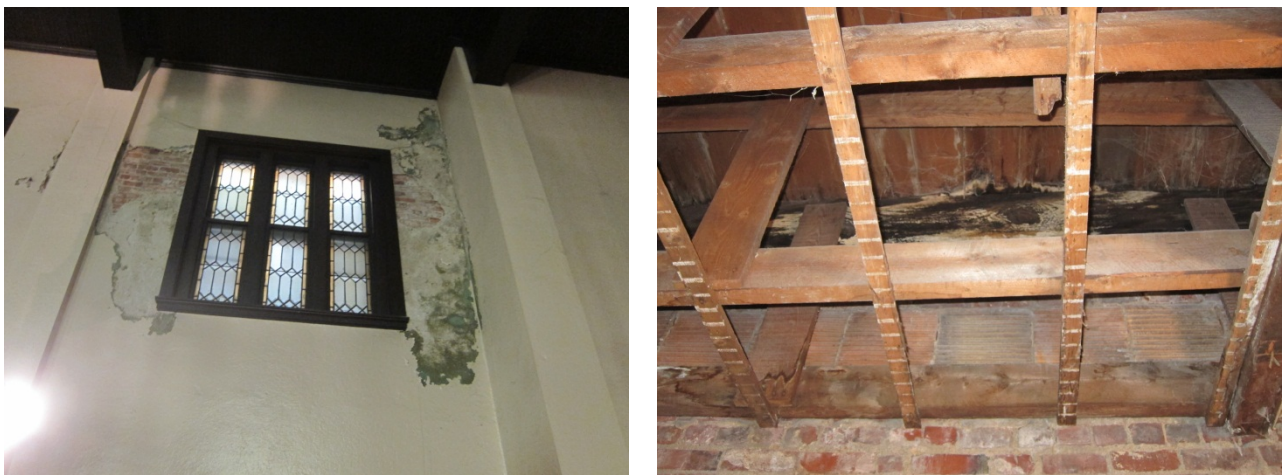
Figure 84. Interior details showing previous moisture issues at window and roof-wall interface

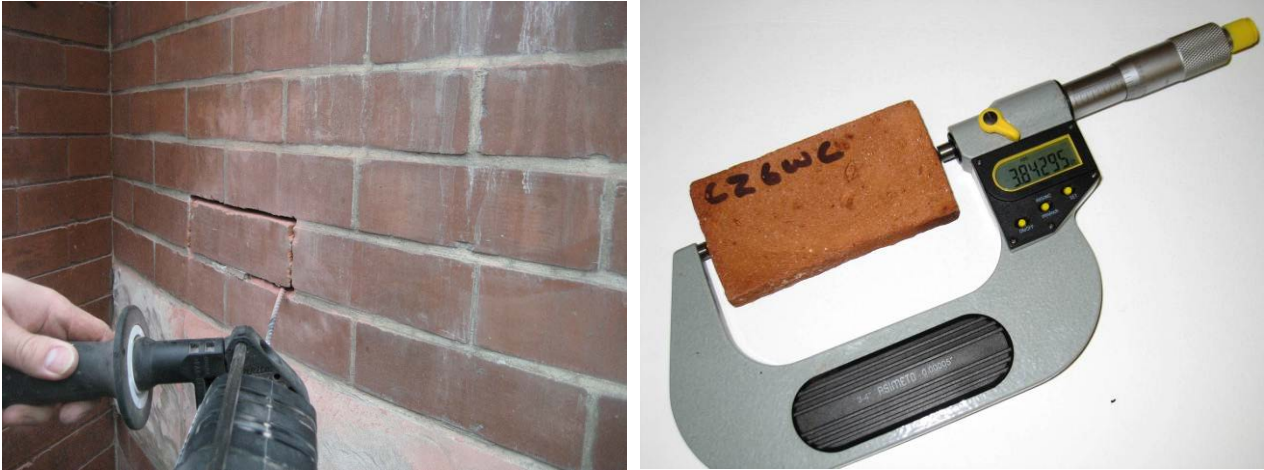
Figure 88. Left: Removal of brick sample; Right: dilatometry (dimensional change) measurements

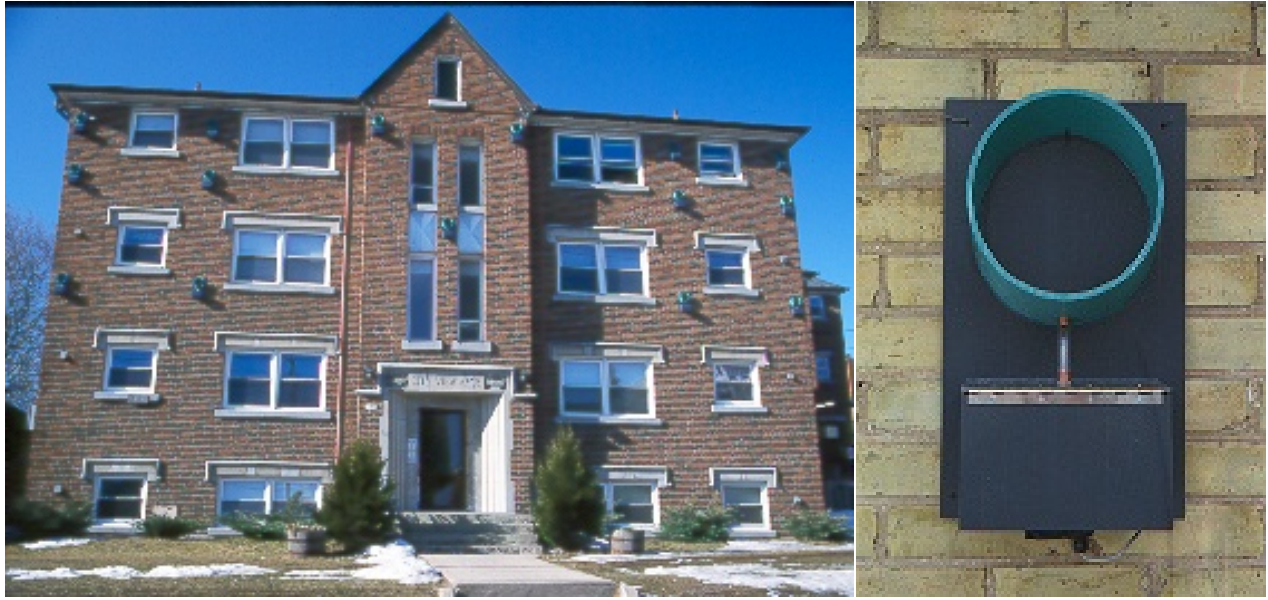
Figure 91. Instrumented occupied building (Waterloo, Ontario) with driving rain gauges
