Restoring Salmonid Aquatic/Riparian Habitat: A Strategic Plan for the Downeast Maine DPS Rivers

Project SHARE

Restoring Salmonid Aquatic/Riparian Habitat:

A Strategic Plan for the Downeast Maine DPS Rivers

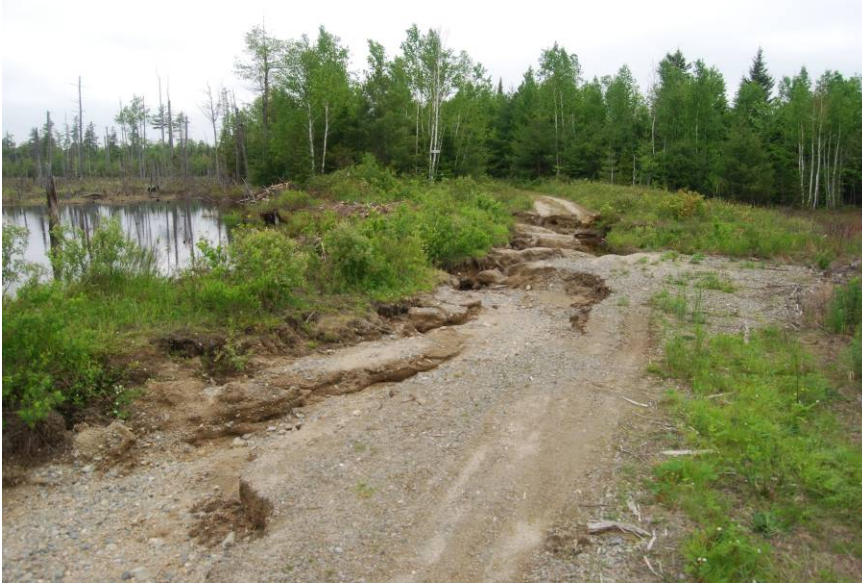
Figure 1. Non-point source sedimentation in the Machias River watershed.

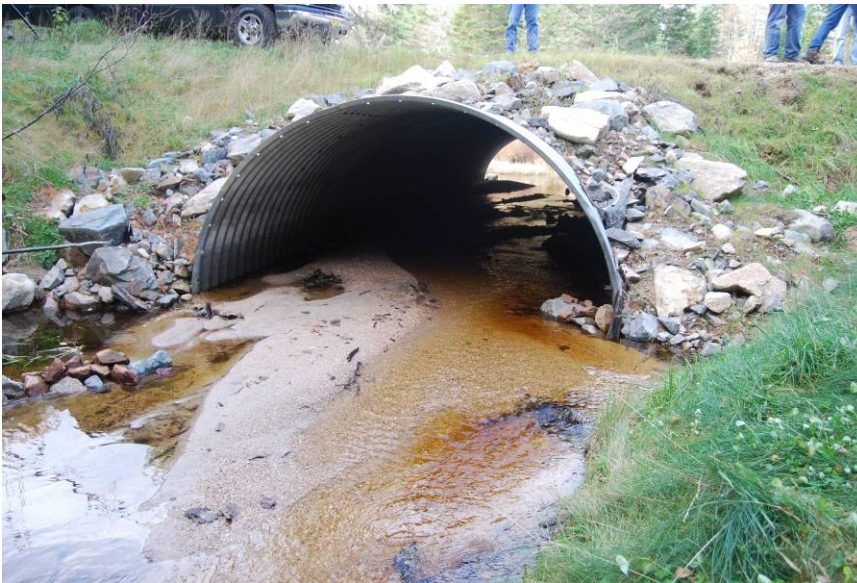
Figure 2. Stream connectivity restored at road/stream crossing by replacing traditional round culvert with open-bottom arch culvert.

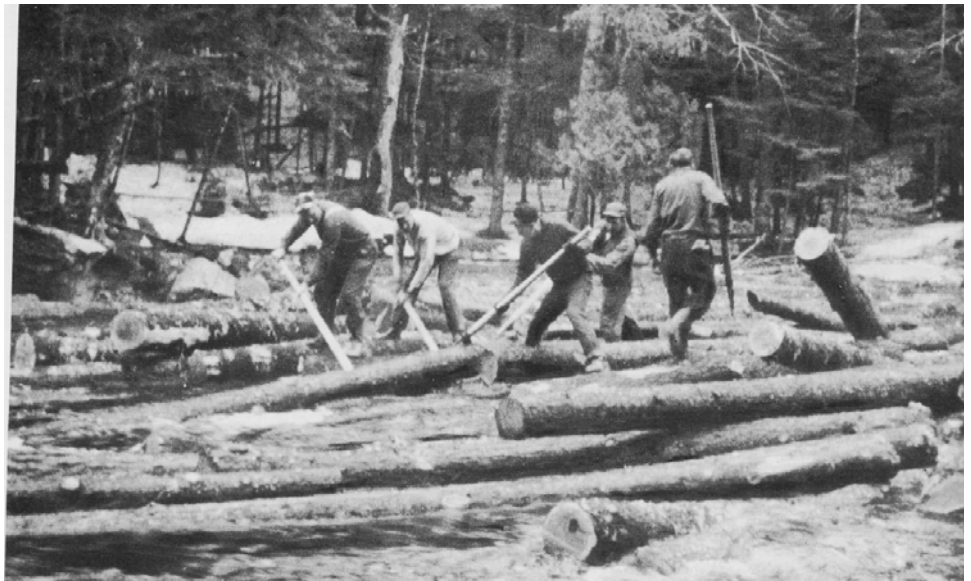
Figure 5. Picture of Crews breaking up a log jam at Grover Pitch “The Pit” on Old Stream with Poles and Peaveys (1965). Photo from (Anonymous 1966).

and after spring ice breakup, log drives on streams swollen with melting snow and early season rains carried enormous volumes of wood to downstream mills. Dams were used on many headwater lakes to store water, raise levels, and regulate outflow. On smaller streams, “splash” dams were built to store water (and energy) for the drive. These splash dams were deliberately breached by releasing blocks, removing a key log, or setting off a well-placed charge of black powder, sending a torrent of water and logs downstream (Irland 1999, Verry 1986, Williams 1976). The log and pulpwood drives must have had a devastating impact on stream-channel stability and aquatic habitat quality in some stream and river reaches. At the mills, booms that were used to capture and store logs also fouled the water and riverbeds with tannins, loose bark, and “sinkers.” In addition, mill waste and sawdust were commonly discarded directly into rivers (National Research Council 2004).

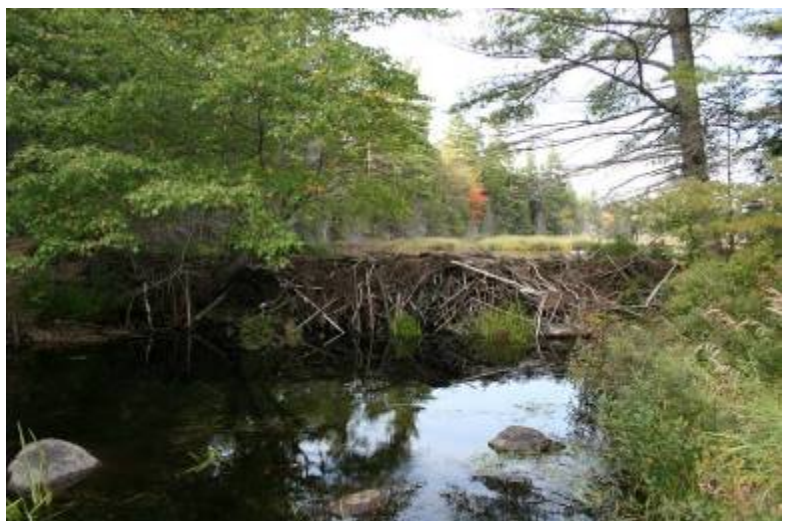
Figure 8. Looking upstream to fish barrier beaver dam built on top of remnant log drive dam just above 1st Lake Old Stream (Oct. 2007). Photo by Scott Craig

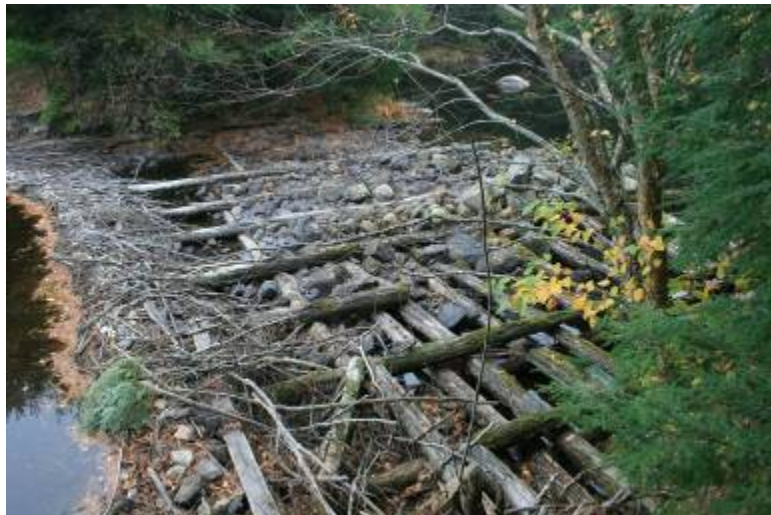
Figure 9. Remnant Dam at the outlet of Fourth Machias Lake. This structure is not in the State or National Dam Database. Picture is looking north across river. (Oct 2007) Photo by Scott Craig

Although dams on main-stems and major tributaries on the Downeast DPS rivers have been breached and no longer present a threat to passage of Atlantic salmon, there may be a legacy of instream channel alterations remaining on the landscape. Oral history interviews and review of historic references document the location of numerous dam sites on the Downeast rivers that were principally used during the era of log drives and water powered mills (Appendix I).

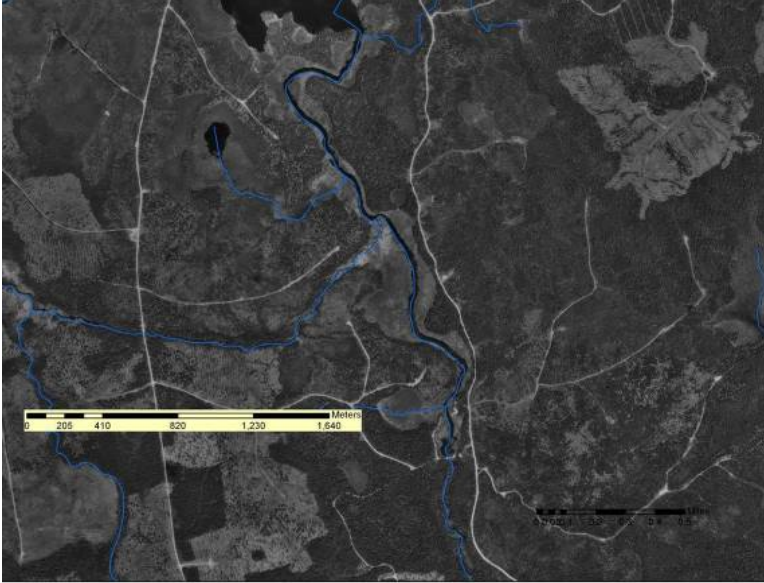
Figure 10. Aerial photography of Canaan Dam to 1st Lake Old Stream utilized May 1996 gray scale images. Over-widened channel and outline of historic reservoir are apparent in the aerial photography decades after the dam was removed.

Preliminary investigation of aerial photography and ground-truthing several historic sites suggest that impacts to the river channel are still apparent. Remnant hydraulic checks and stream channel evolution through partially-breached remnant reservoirs may be an explanation for a number of the "back water" channel reaches that are apparent on the landscape. While the impact of remnant dams on stream channels may not be a threat to fish passage, they appear to be a constraint on other aspects of stream connectivity including: channel bank full width, water depth, current velocity, sediment and nutrient transport. The ecological impacts of remnant dams and historic dam removals do not appear to be documented. Therefore, we will attempt to draw inferences from impacts of dams and present day dam removals.

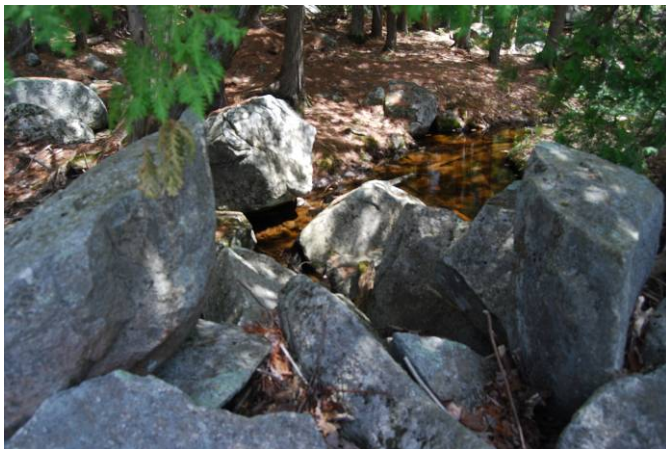
Figure 14. Boulders blocking side channel of Machias River.

general, there appeared to be a paucity of spawning-sized substrates and, when present, cobbles and gravels were embedded. Past timber harvest activities appear to have significantly disrupted pool-riffle sequences on this reach of the Machias River, simplified instream habitat, and likely contributed to population decreases of Atlantic salmon over time. By comparison, the geomorphology and habitat of the Crooked River above its confluence with the mainstem Machias River upstream of Route 9 differed with respect to channel structure and habitat quality. The channel bed exhibited better representation of all substrate size classes, and pool-riffle sequences appeared to be much more regular and predictable than those on the Machias River. These basic building blocks of aquatic habitat are essential in supporting an assemblage of species and life stages, riparian vegetation that influences channel shape and position, and interactions between the stream channel and adjacent floodplain. In addition, the group observed a former side channel along the left bank of the river just downstream of the Route 9 bridge that had been blocked off by a line of boulders placed at the upstream inlet (Figure 14).

These practices were commonly employed by log drivers to prohibit logs from being lost down side channels or providing secondary flow paths that could lead to the formation of logjams.”

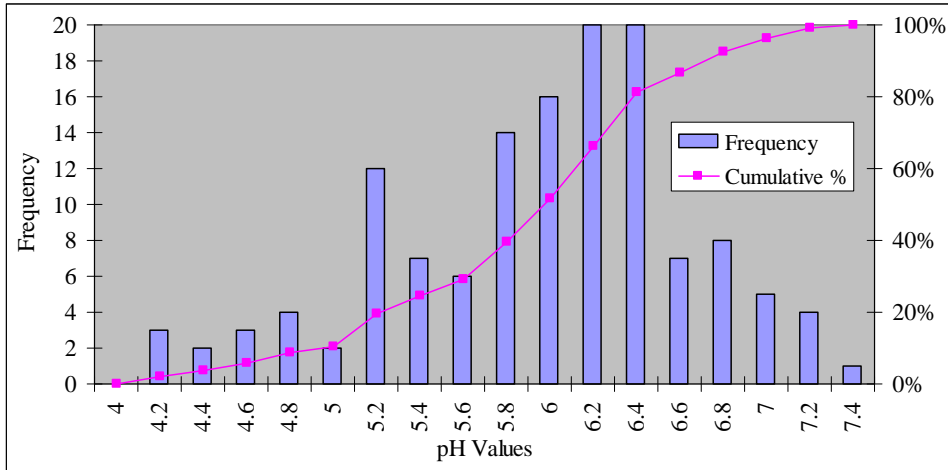
Figure 18. Distribution of pH measurements taken at 134 MEFRO upper headwater electrofishing sites in the Narraguagus, Machias, and East Machias Rivers. Fish were not observed at pH values < 4.7

The lowest pH value where fish were observed was 4.7. Brook trout appear to be least sensitive

to pH as they were the only species to occur at values below 5 (pH). See figure 17 for distribution of all pH data (n=134).

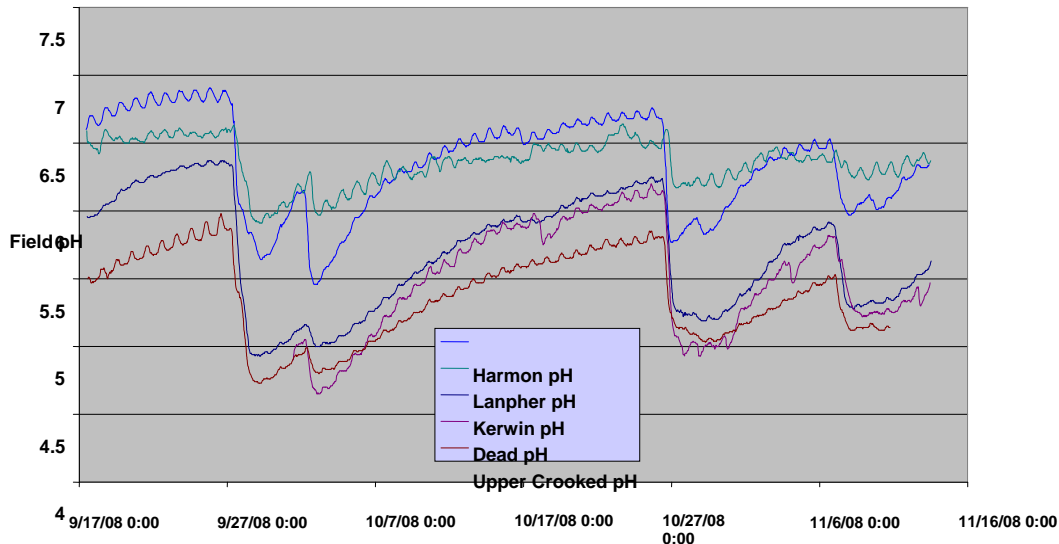
Figure 19. Continuous recording data sondes Fall 2008

Continuous recording data sondes placed in several tributaries Downeast document that pH depressions last several weeks following high water storm events (Figure 19). Patterns of pH depression are similar between tributaries; however there is a distinct variation in the range of pH between tributaries. We believe the range of pH for a tributary is directly linked to bedrock geology and its contribution to buffer capacity. Given the extent of documentation of low pH and elevated monometric aluminum in headwater tributaries within restoration focus areas in the Machias River and the duration of pH depressions, we believe mitigation of pH-related water chemistry is a priority action for watershed assessment and restoration.
