**FINAL  
INTEGRATED  
FEASIBILITY REPORT  
AND  
ENVIRONMENTAL IMPACT STATEMENT  
COASTAL STORM DAMAGE REDUCTION**

**BOGUE BANKS, CARTERET COUNTY  
NORTH CAROLINA**

**APPENDIX E  
ARCHAEOLOGICAL SURVEY**

***An Archaeological Remote Sensing Survey of Bogue Banks  
Offshore Borrow Areas, Carteret County, North Carolina***

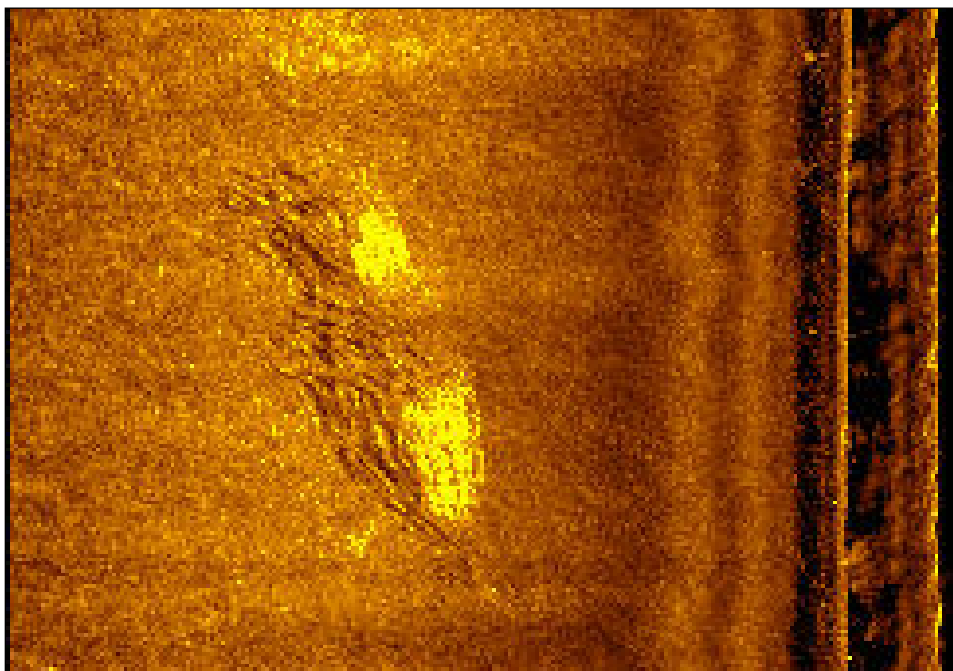
Side Scan Sonar Image of a Possible Shipwreck Borrow Area Q2

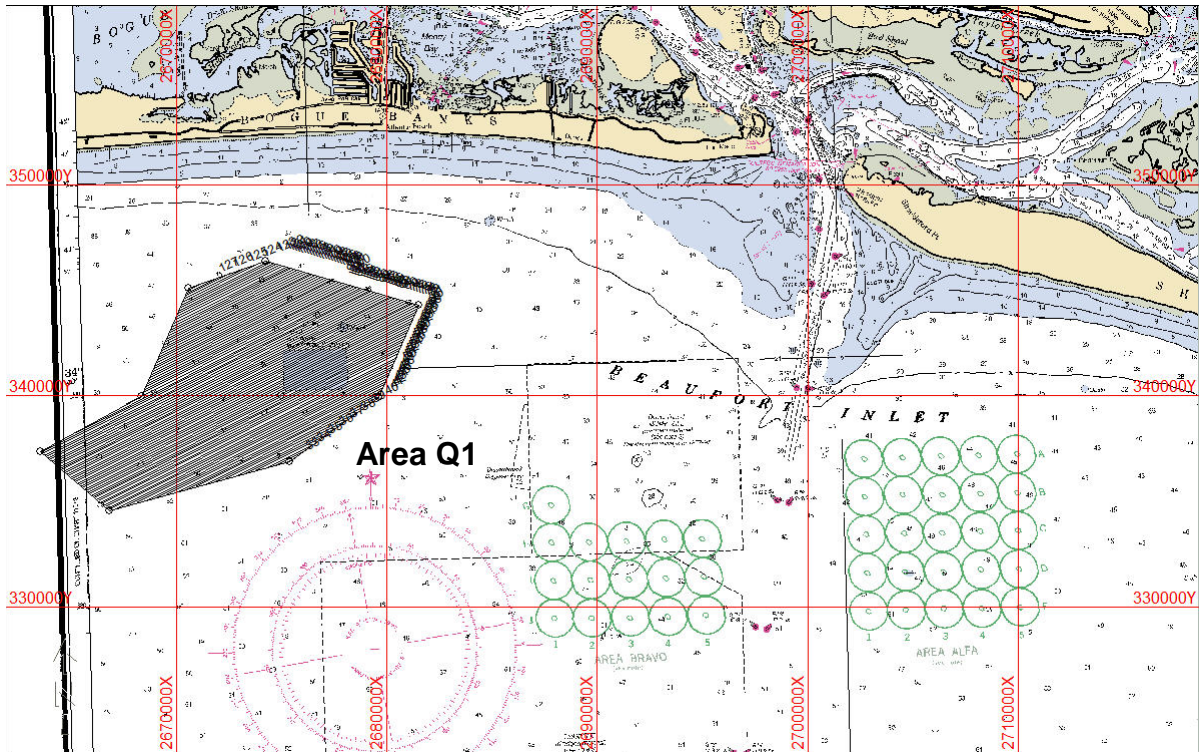
Figure 3. Borrow Area Q1.

The Borrow Area Q1 survey consisted of 127 lines @ 100ft/30m spacing, totaling more than 1,119,998 linear ft/302 nautical miles with water depths of 45 to 50 ft.

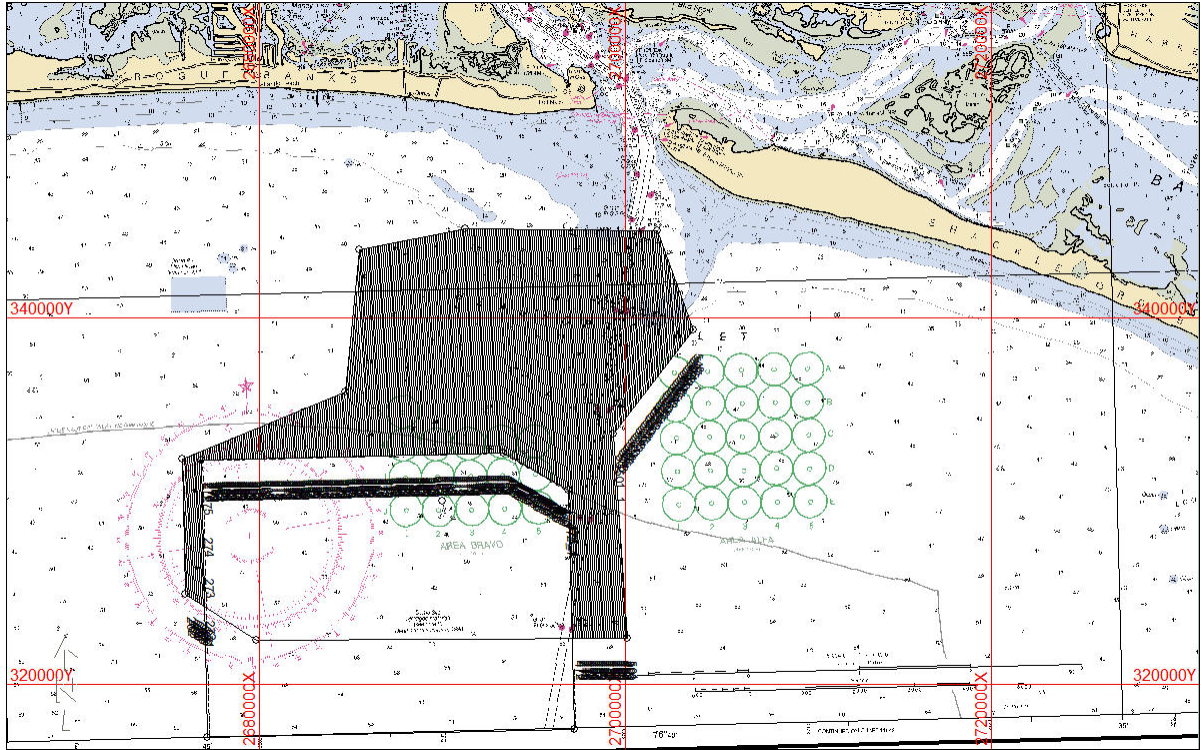
Figure 4. Borrow Area Q2.

The Borrow Area Q2 survey consisted of 480 lines @ 65ft/20m spacing, totaling 4,001,421 linear ft/658 nautical miles with water depths of 15 to 53 ft.

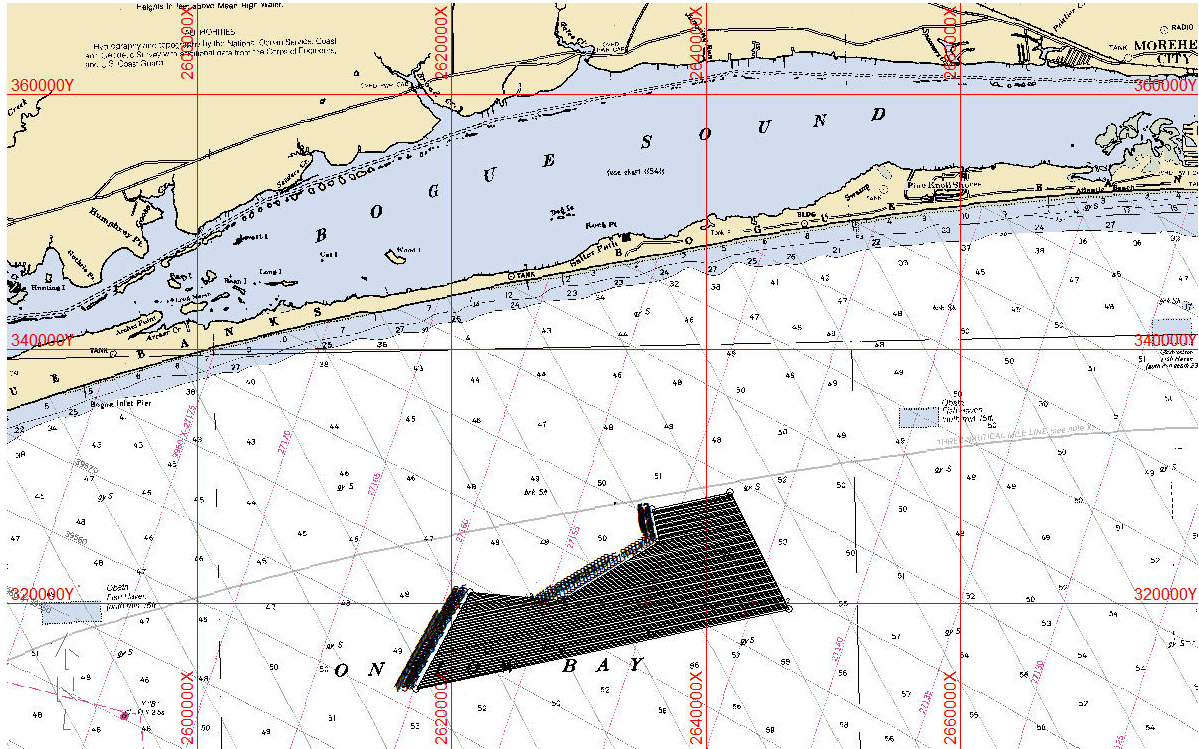
Figure 5. Borrow Area U.

The Borrow Area U survey consisted of 141 lines @ 100ft/30m spacing, totaling 1,839,554 linear ft/302 nautical miles with water depths of 51 to 57 ft.

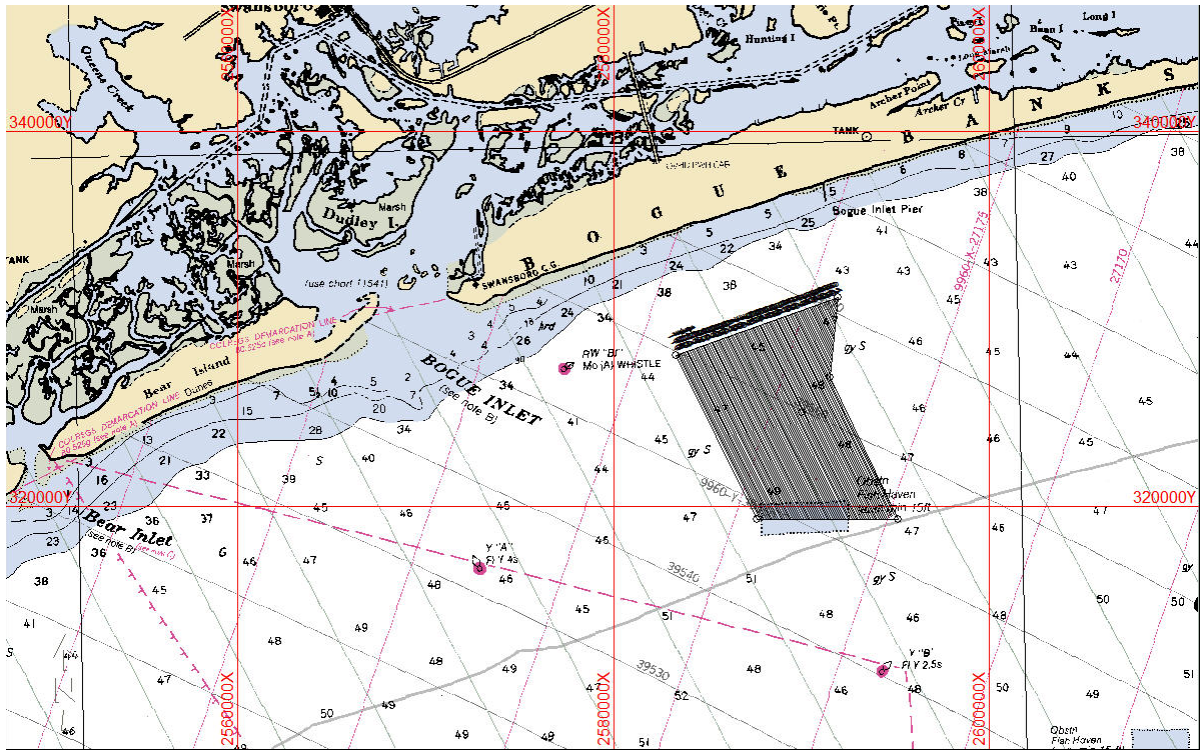
Figure 6. Borrow Area Y.

The Borrow Area Y survey consisted of 111 lines @ 100ft/30m spacing, totaling 795,834 linear ft/131 nautical miles with water depths of 44 to 49 ft.

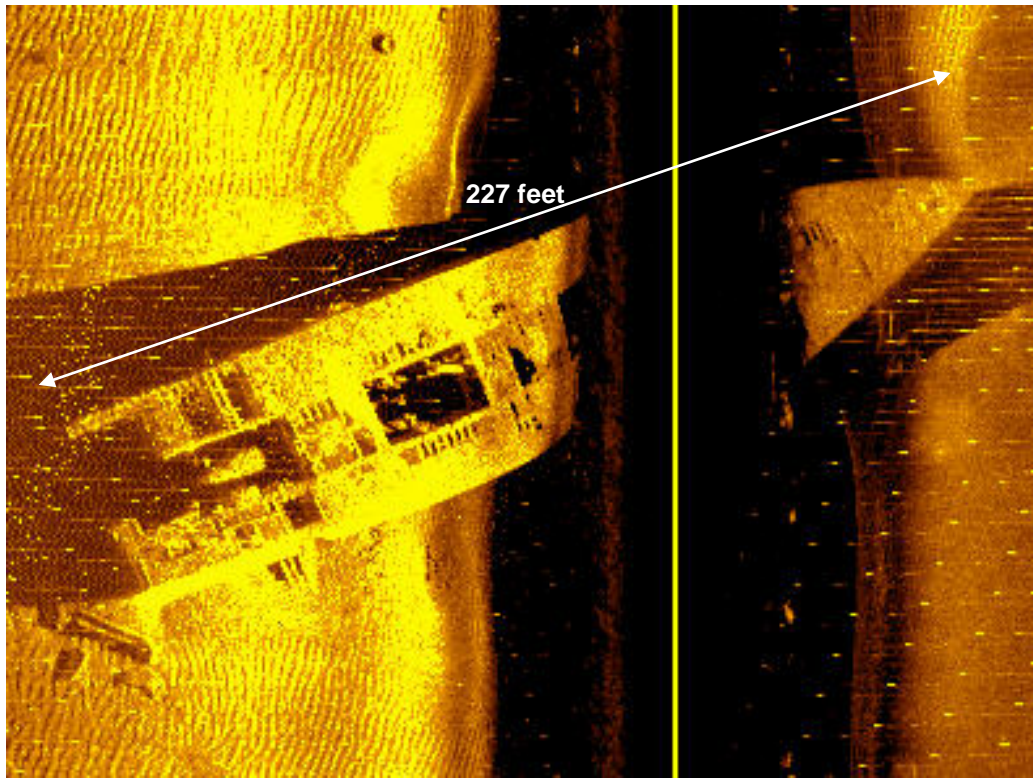
Although there were numerous magnetic and acoustic target signatures in Borrow Area Q1 none were found to be associated with historic submerged cultural resources. All target signatures were associated with a variety of purposely sunken vessels, craft, tires and debris associated with the North Carolina Division of Marine Fisheries – Atlantic Beach Reef AR-315 (Figures 7, 8, 9, 10, and 11).

Figure 8. AR-315 Liberty Ship *Theodore Parker*.

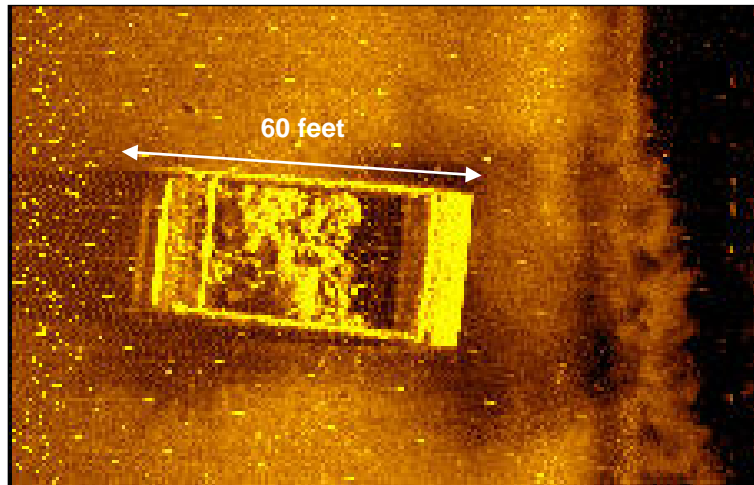
Figure 9. AR-315 Lash Barge.

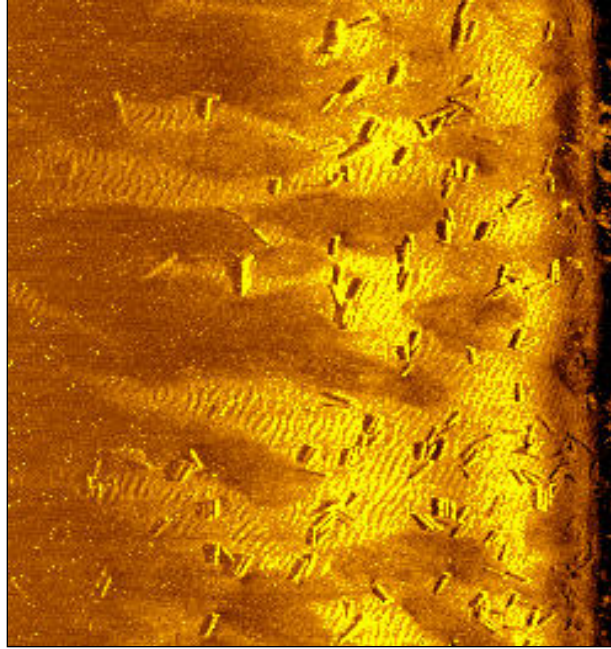
Figure 10. AR-315 Concrete Pipe.

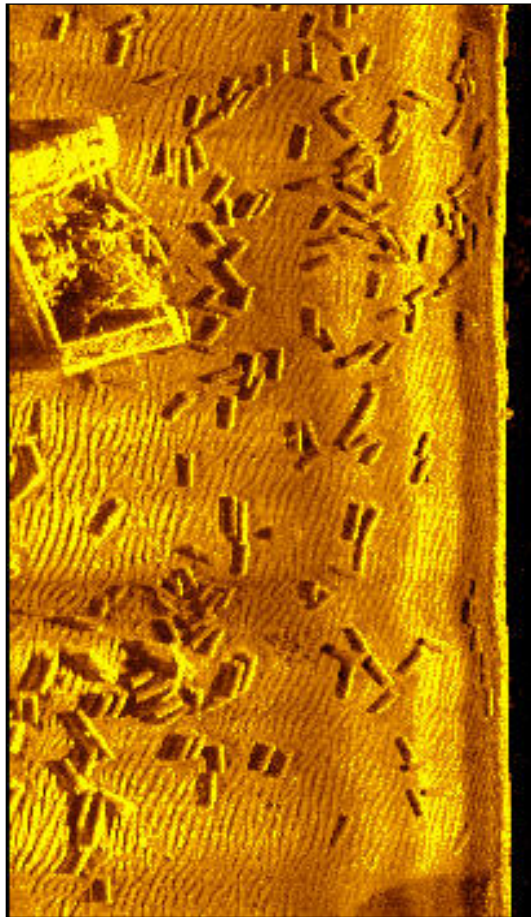
Figure 11. AR-315 Concrete Pipe and Lash Barge.

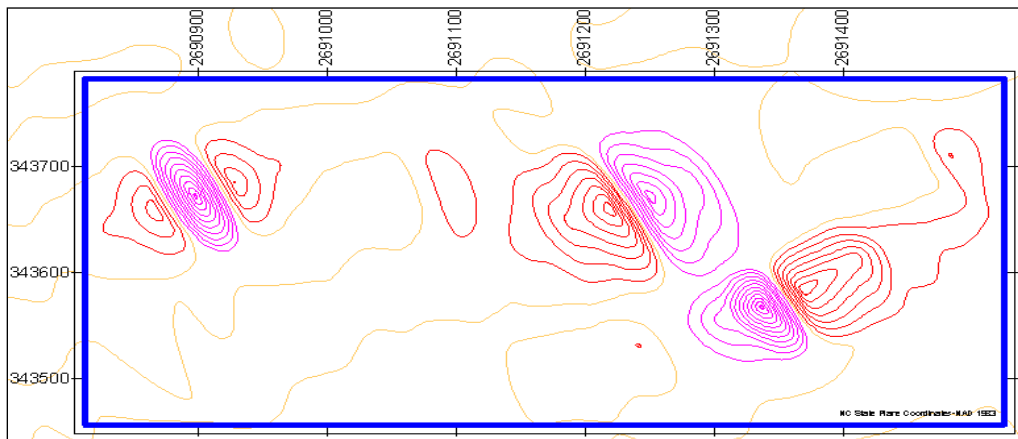
Figure 12. Target Cluster Q2-1 Magnetic Contour Signature.

Target Cluster Q2-1 consisted of at least three dipolar magnetic anomalies on three survey lines with a maximum magnetic intensity of 18 nT. No acoustic target signature was identified in association with the magnetic anomalies. The low intensity, proximity, and characteristics of the targets signatures suggest they may be related.

The characteristics of the cluster suggest that there are at least three single source objects with similar magnetic characteristics or one linear object such as a wire rope over 300 feet in length. The nature of the target cluster suggests it has little potential to be associated with a significant cultural resource. No additional underwater archaeological investigations are recommended (Figure 12).

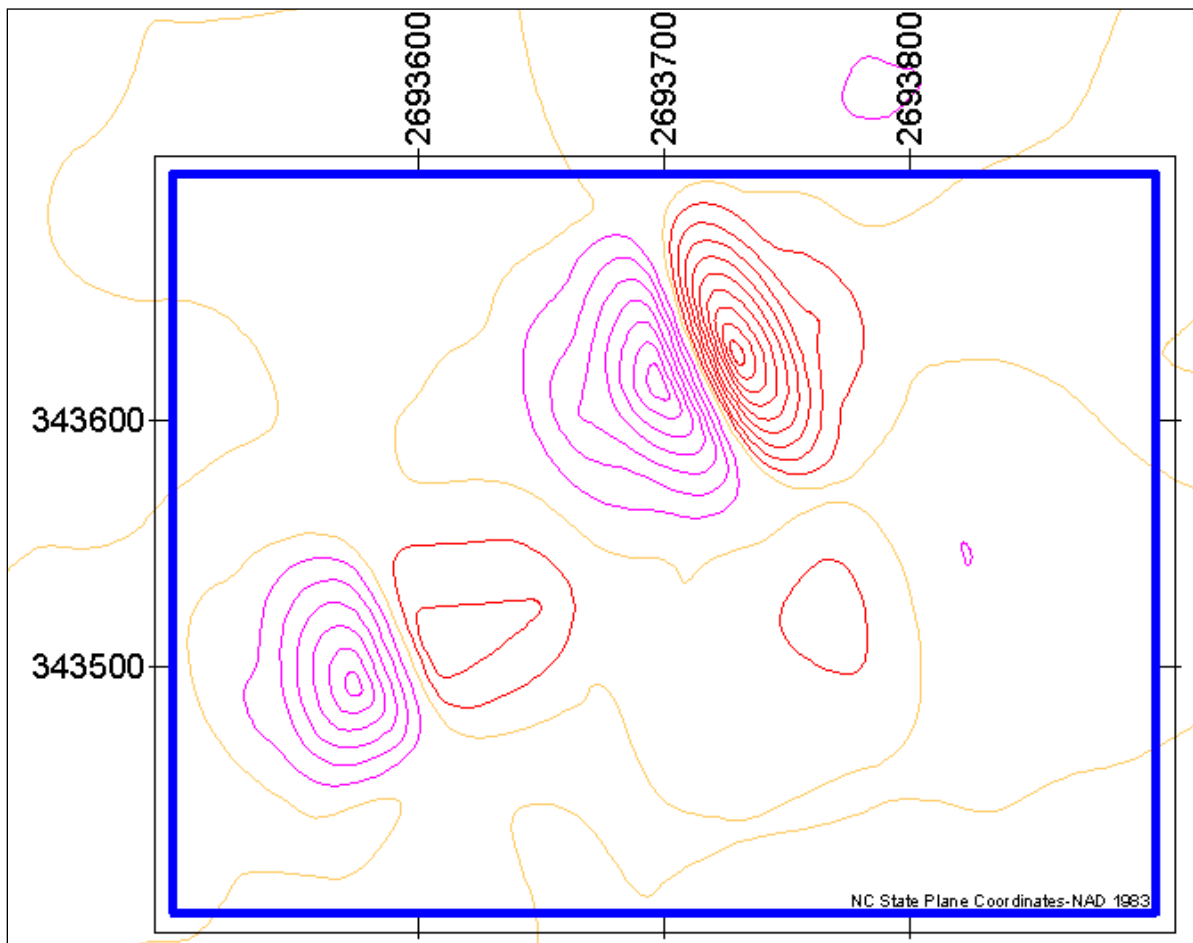
Figure 14. Target Cluster Q2-2 Magnetic Contour Signature.

Target Cluster Q2-2 consisted of at least two dipolar magnetic anomalies on three survey lines with a maximum magnetic intensity of 15 nT. No acoustic target signature was identified in association with the magnetic anomalies. The low intensity, proximity, and characteristics of the targets' signatures suggest they may be related.

The characteristics of the cluster suggest that there are at least two single source objects with similar magnetic characteristics or one linear object such as a wire rope over 200 feet in length. The nature of the target cluster suggests it has little potential to be associated with a significant cultural resource. No additional underwater archaeological investigations are recommended (Figure 14).

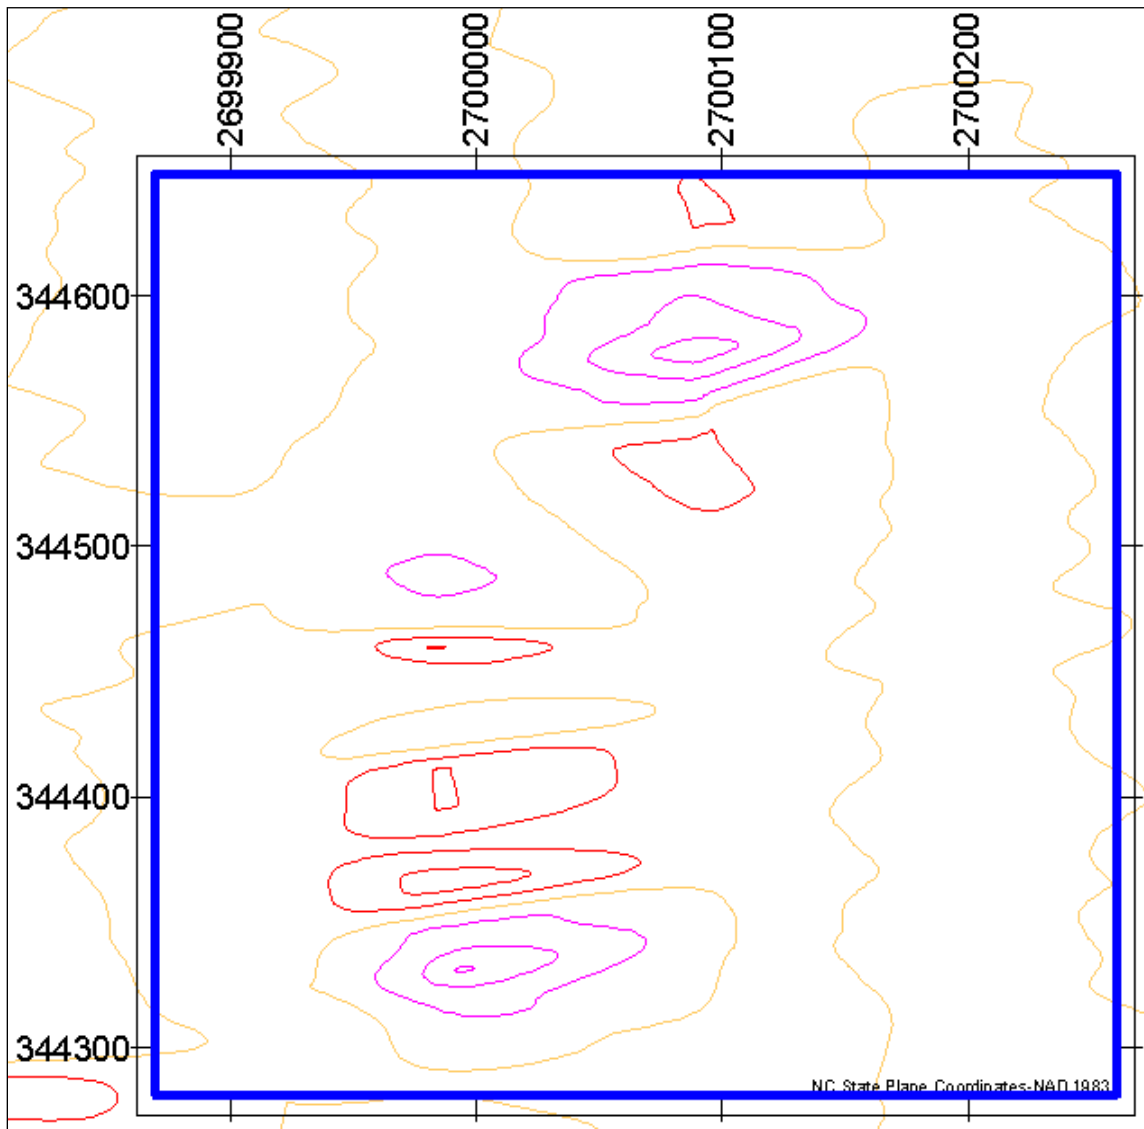
Figure 17. Target Cluster Q2-5 Magnetic Contour Signature.

Target Cluster Q2-5 consisted of at least three dipolar magnetic anomalies on two survey lines with a maximum magnetic intensity of 5 nT. No acoustic target signature was identified in association with the magnetic anomalies. The low intensity, proximity, and characteristics of the targets' signatures suggest they may be related.

The characteristics of the cluster suggest that there are at least three single source objects with similar magnetic characteristics or one linear object such as a wire rope over 300 feet in length. The nature of the target cluster suggests it has little potential to be associated with a significant cultural resource. No additional underwater archaeological investigations are recommended (Figure 17).

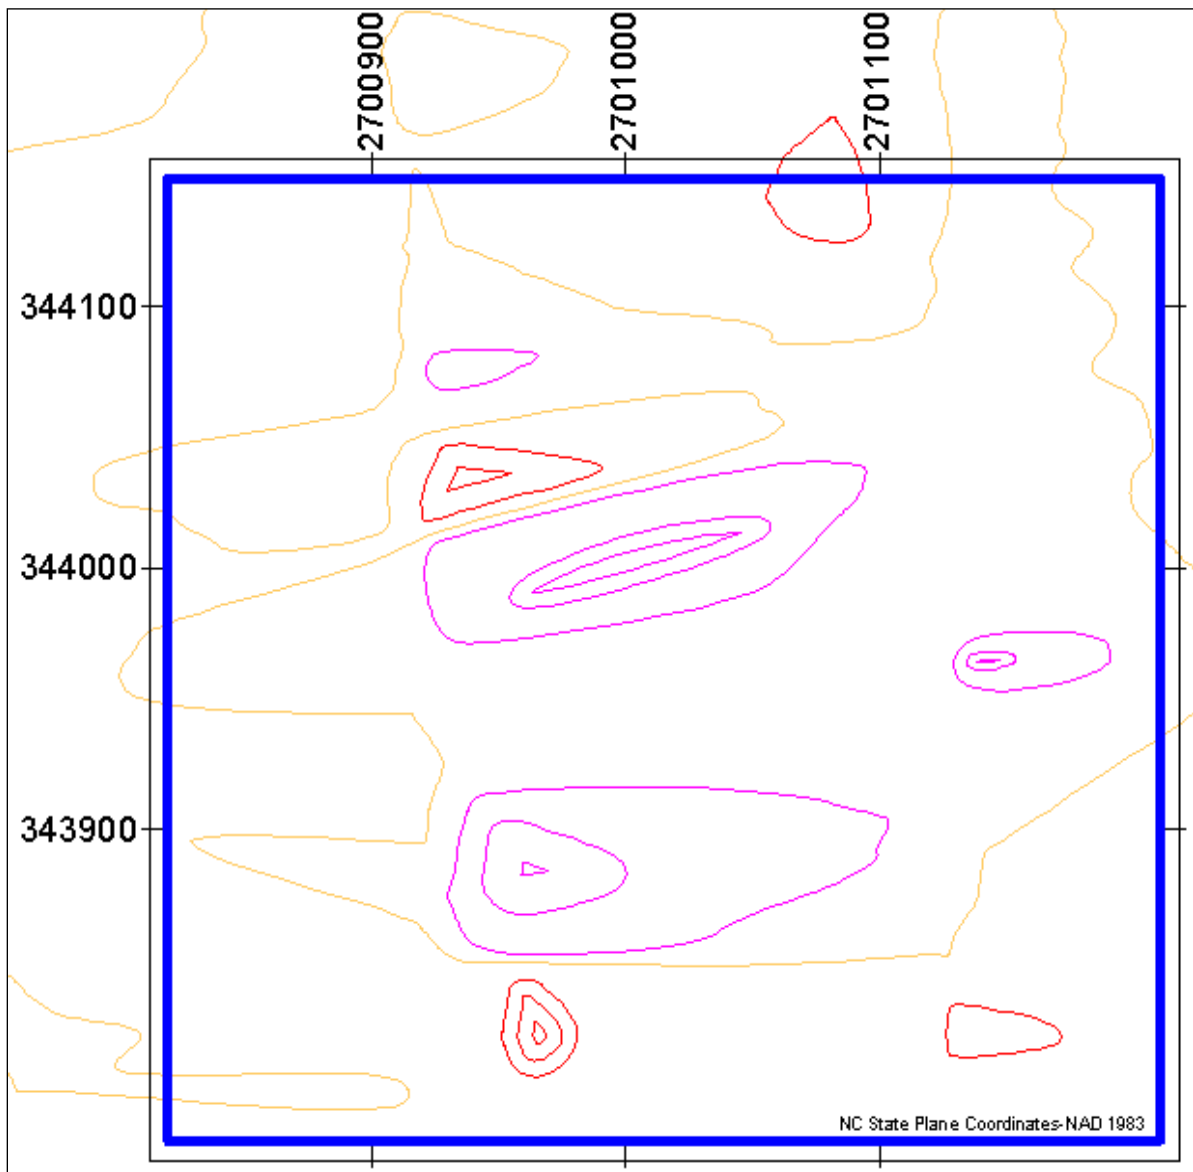
Figure 18. Target Cluster Q2-6 Magnetic Contour Signature.

Target Cluster Q2-6 consisted of at least two dipolar magnetic anomalies on two survey lines with a maximum magnetic intensity of 6 nT. A sonar image of 150 – foot long wire rope and 4 by 4 foot block buoy sinker was identified in association with the magnetic anomaly.

No additional underwater archaeological investigations are recommended (Figure 18 and 19).

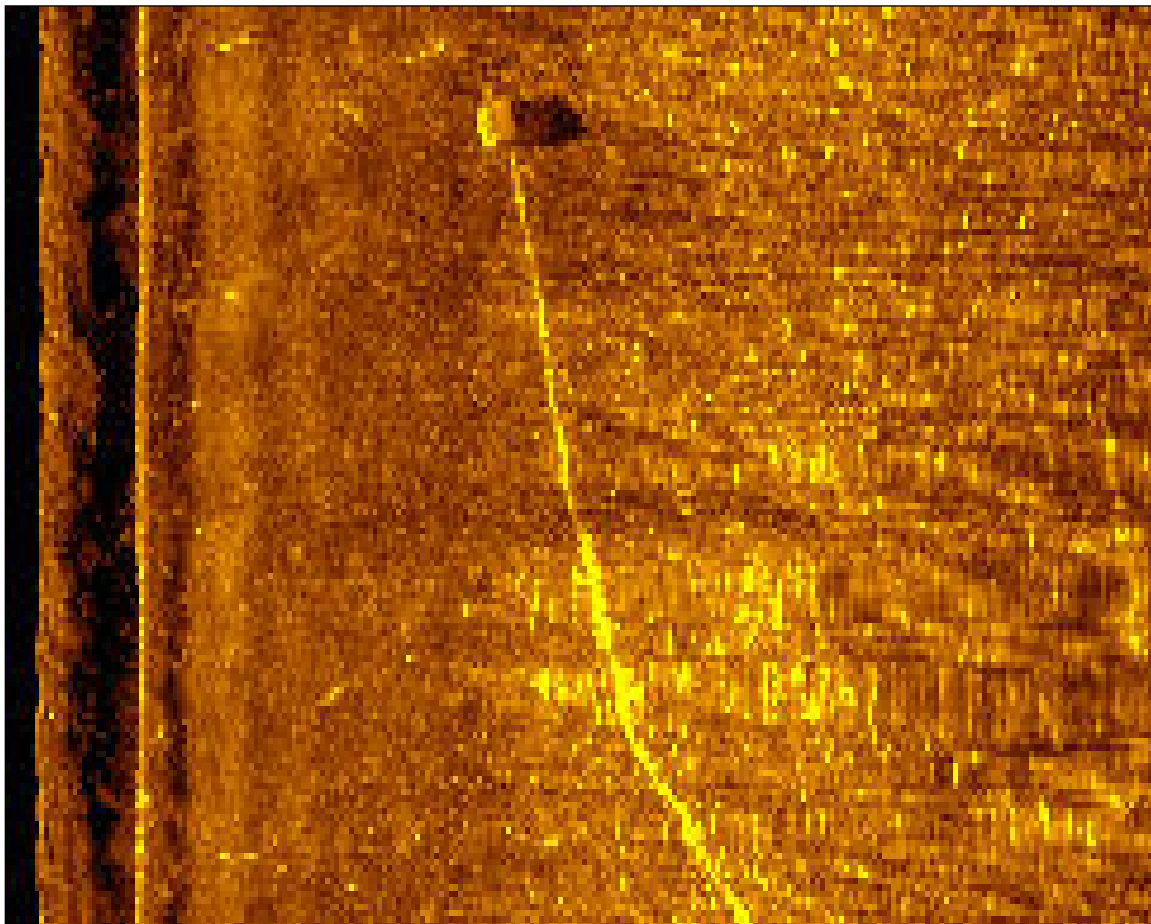
Figure 19. Acoustic Target Signature Q2-6.

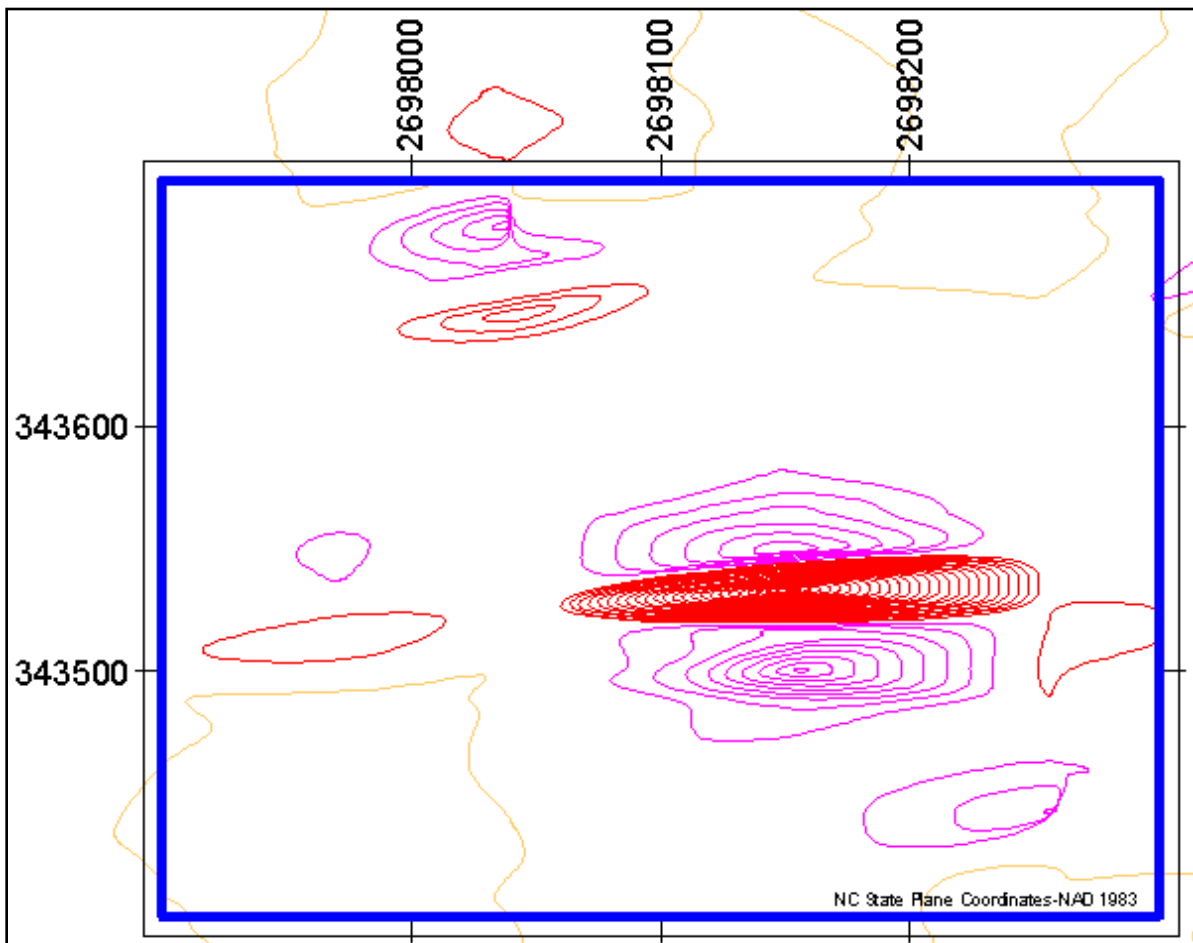
Figure 21. Target Cluster Q2-8 Magnetic Contour Signature.

Target Cluster Q2-8 consisted of at least three dipolar magnetic anomalies on three survey lines with a maximum magnetic intensity of 33 nT. The low intensity, proximity, and characteristics of the targets signatures suggest they may be related.

The characteristics of the cluster suggest that there are at least two single source objects with similar magnetic characteristics or one linear object such as a wire rope over 150 feet in length. The nature of the target cluster suggests it has little potential to be associated with a significant cultural resource. No additional underwater archaeological investigations are recommended (Figure 21).

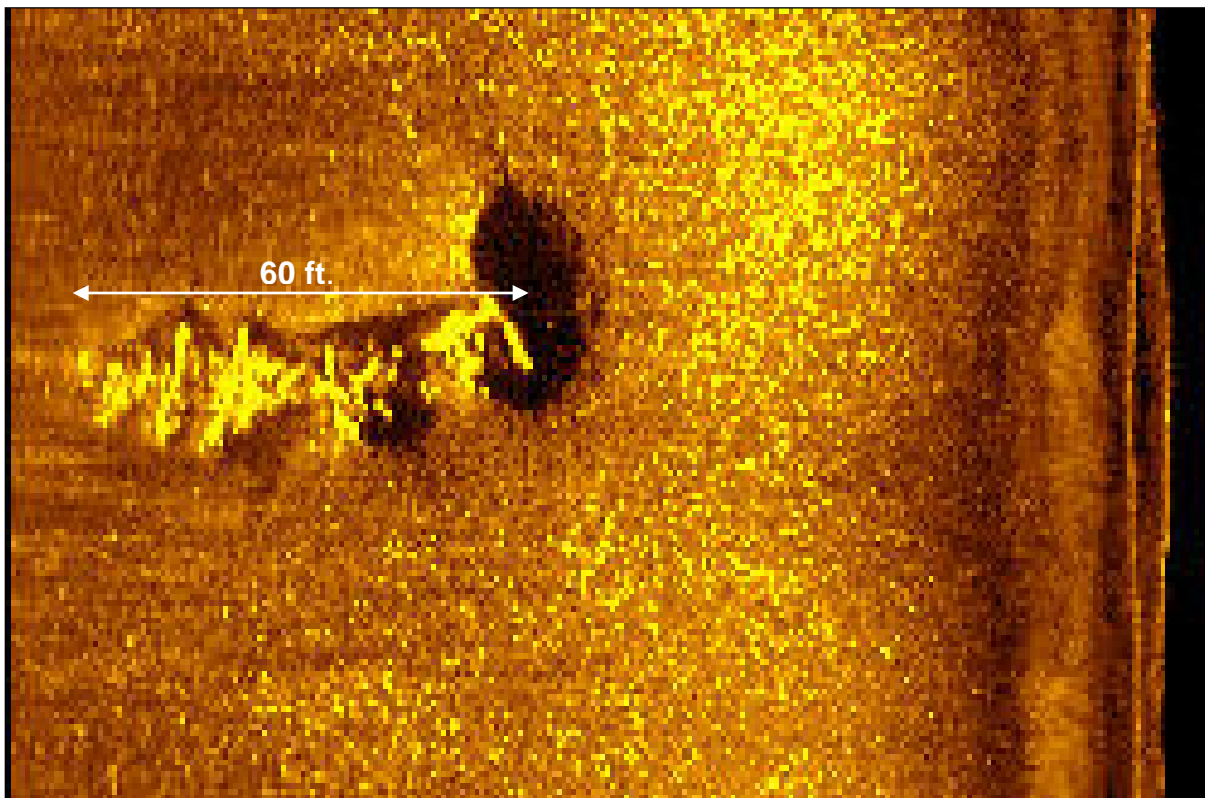
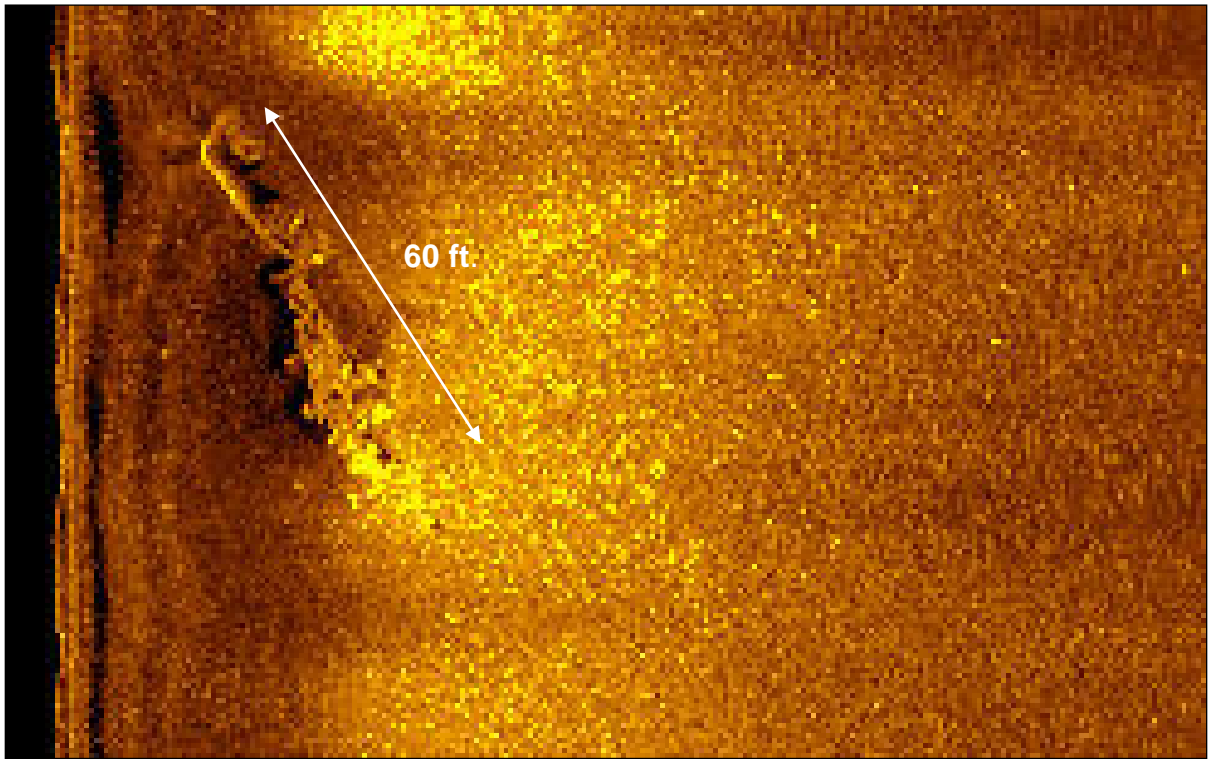
Figure 23. Acoustic image of Target Q2-9.

Figure 24. Acoustic image of Target Q2-9.

The target has the potential to be associated with a significant cultural resource. An underwater investigation to identify the nature of the material producing the magnetic signature is recommended. If underwater investigations are not an option, a no impact buffer zone should be created around the target signature. The no-impact zone should include an area at least 900 feet in diameter around the target coordinates (Figures 22, 23, and 24).

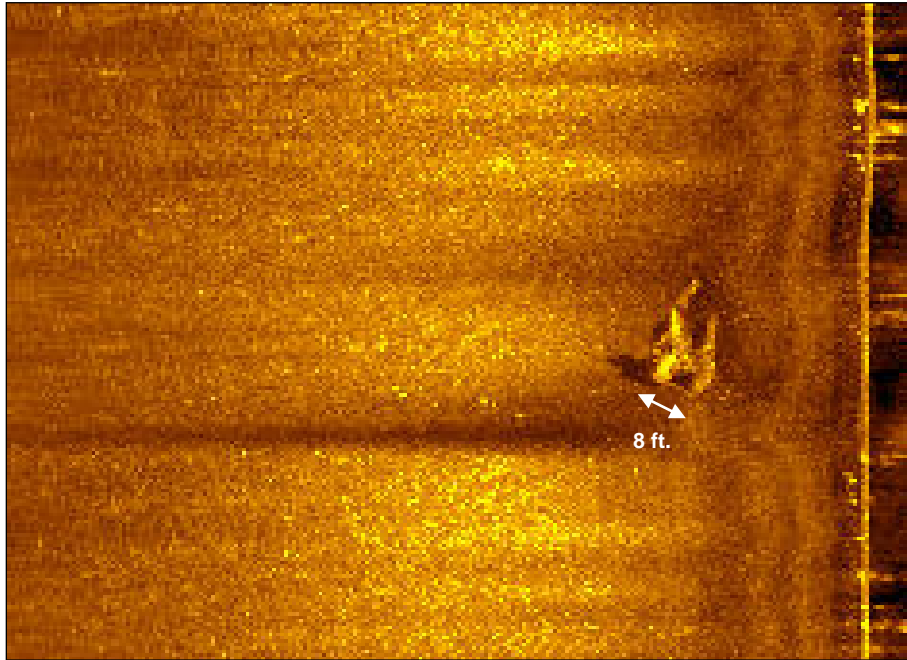
and although it may be associated with a large modern anchor it may also be associated with historic material such as steam machinery. An underwater investigation to identify the nature of the material producing the magnetic and acoustic signatures is recommended. If underwater investigations are not an option, a no impact buffer zone should be created around the target signature. The no-impact zone should include an area at least 200 feet in diameter around the target coordinates (Figure 28 and 29).

Figure 29. Sonar image associated with Q2-13.

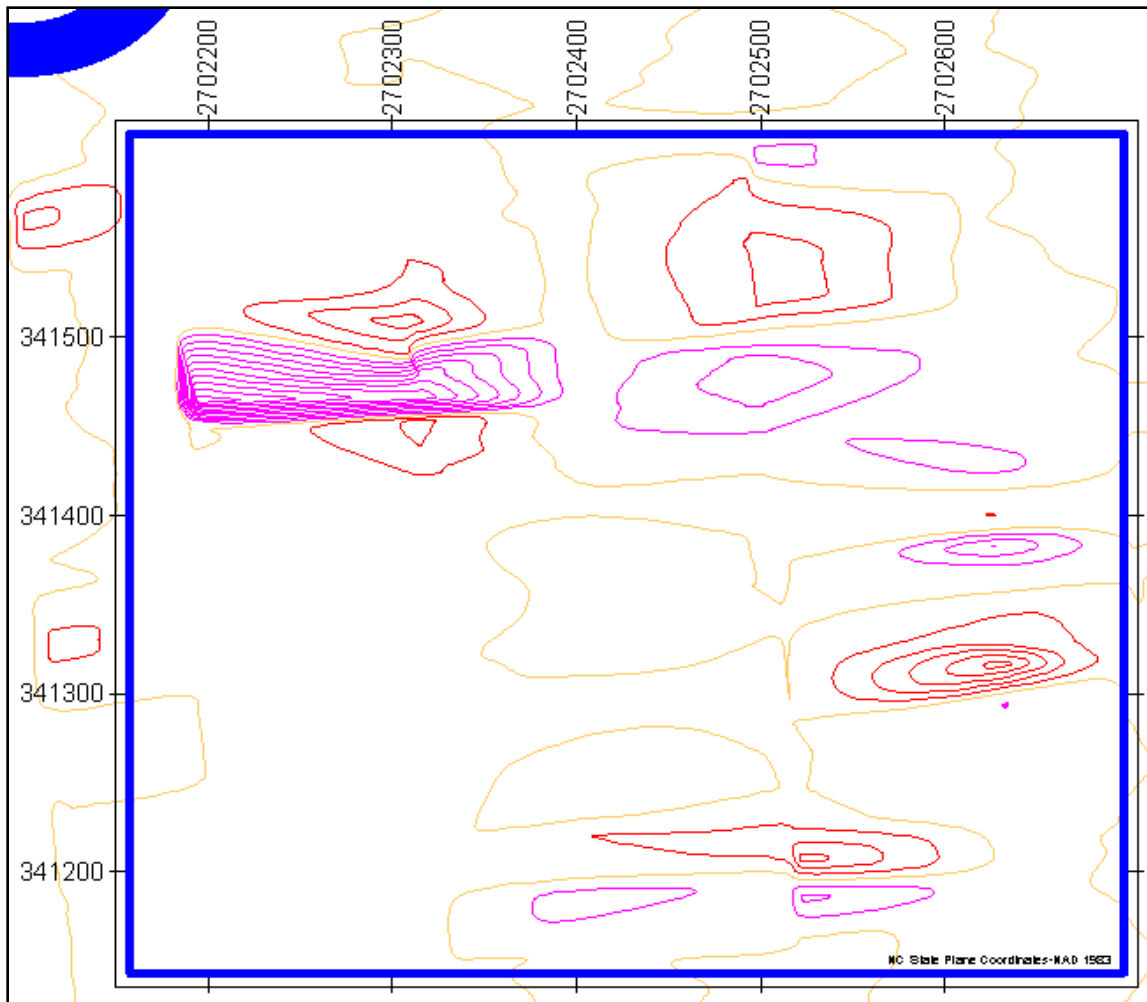
Figure 30. Target Cluster Q2-14 Magnetic Contour Signature.

Target Cluster Q2-14 consisted of multi-component and dipolar magnetic anomalies on four survey lines with a maximum magnetic intensity of 15 nT. No acoustic target signature was identified in association with the magnetic anomalies. The low intensity, proximity, and characteristics of the targets' signatures suggest they may be related.

The characteristics of the cluster suggest the material producing the magnetic signature is a linear object such as a wire rope over 300 feet in length. The nature of the target cluster suggests it has little potential to be associated with a significant cultural resource. No additional underwater archaeological investigations are recommended (Figure 30).

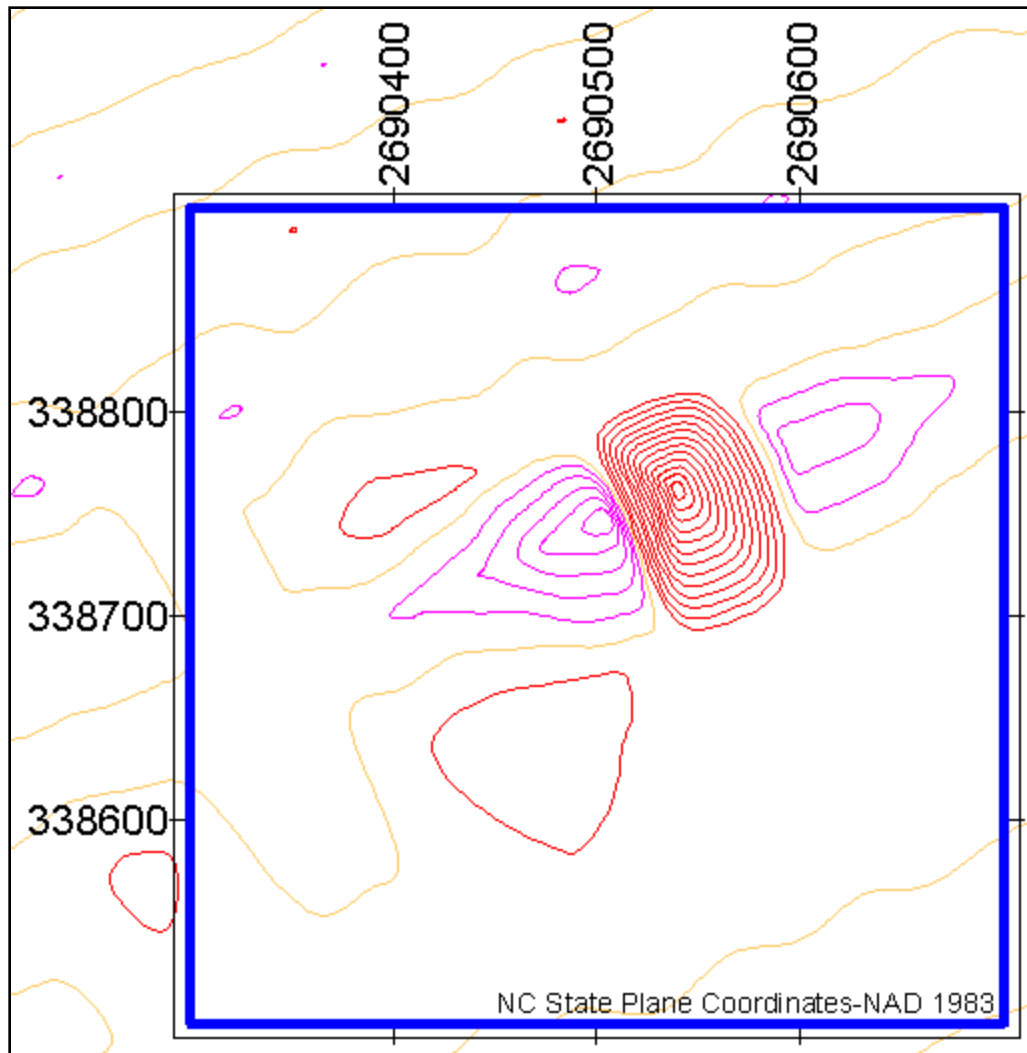
Figure 34. Target Q2-18 Magnetic Contour Signature.

Target Q2-18 consisted of relatively small multi-component anomaly on two survey lines with a maximum magnetic intensity of 18 nT. No acoustic target signature was identified in association with the magnetic anomalies.

The characteristics of the target signature is created by a single source object with similar magnetic characteristics or one linear object such as a wire rope over 200 feet in length. The nature of the target suggests it has little potential to be associated with a significant cultural resource. No additional underwater archaeological investigations are recommended (Figure 34).

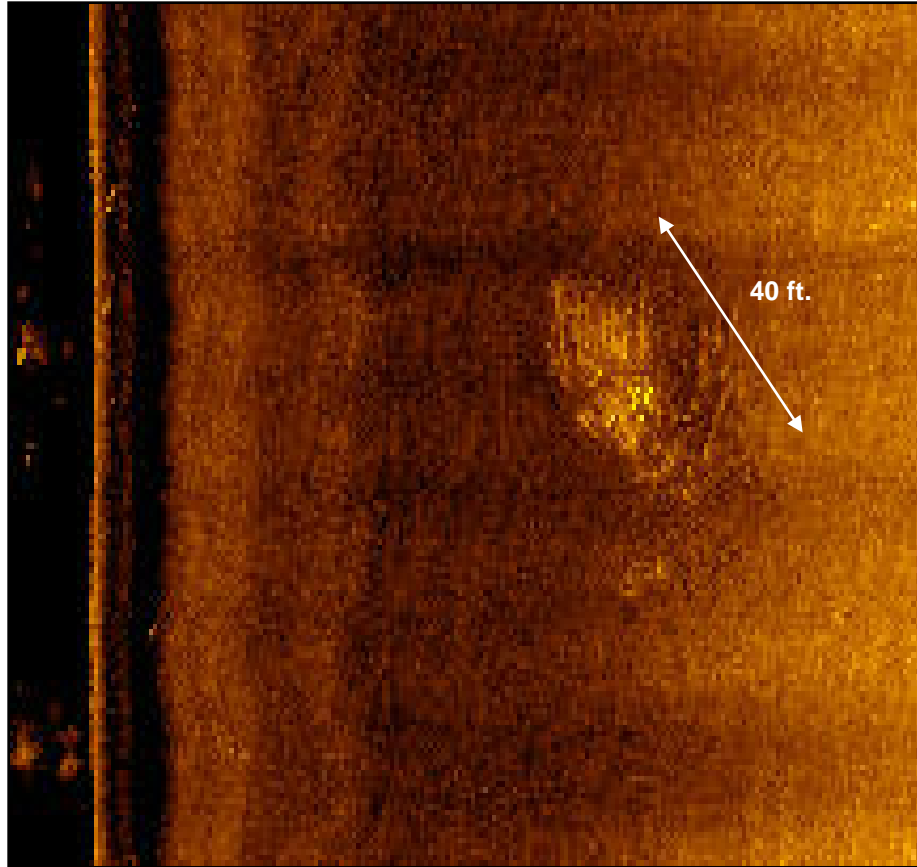
The characteristics of the target strongly suggest that the target is a shipwreck site. An underwater investigation to identify the nature of the material producing the magnetic signature is recommended. If underwater investigations are not an option, a no impact buffer zone should be created around the target signature. The no-impact zone should include an area at least 400 feet in diameter around the target coordinates (Figure 41).

Figure 42. Target 25 - Acoustic Target Signature.

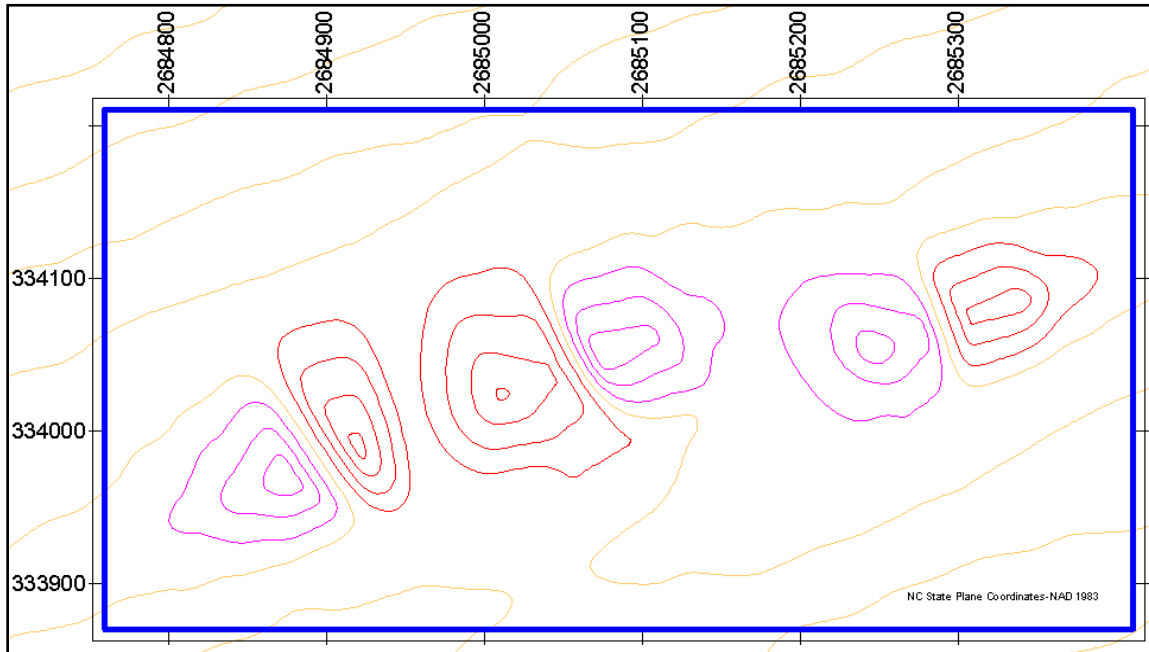
Figure 43. Target Cluster Q2-26 Magnetic Contour Signature.

Target Cluster Q2-26 consisted of three low intensity dipolar anomalies on two survey lines with a maximum magnetic intensity of 7 nT. No acoustic target signature was identified in association with the magnetic anomalies.

The characteristics of the cluster suggest that the material producing the low intensity anomalies is over 400 feet in length and linear. The target is most likely wire rope and has low potential to be associated with a significant submerged cultural resource. No additional investigations are recommended (Figure 43).

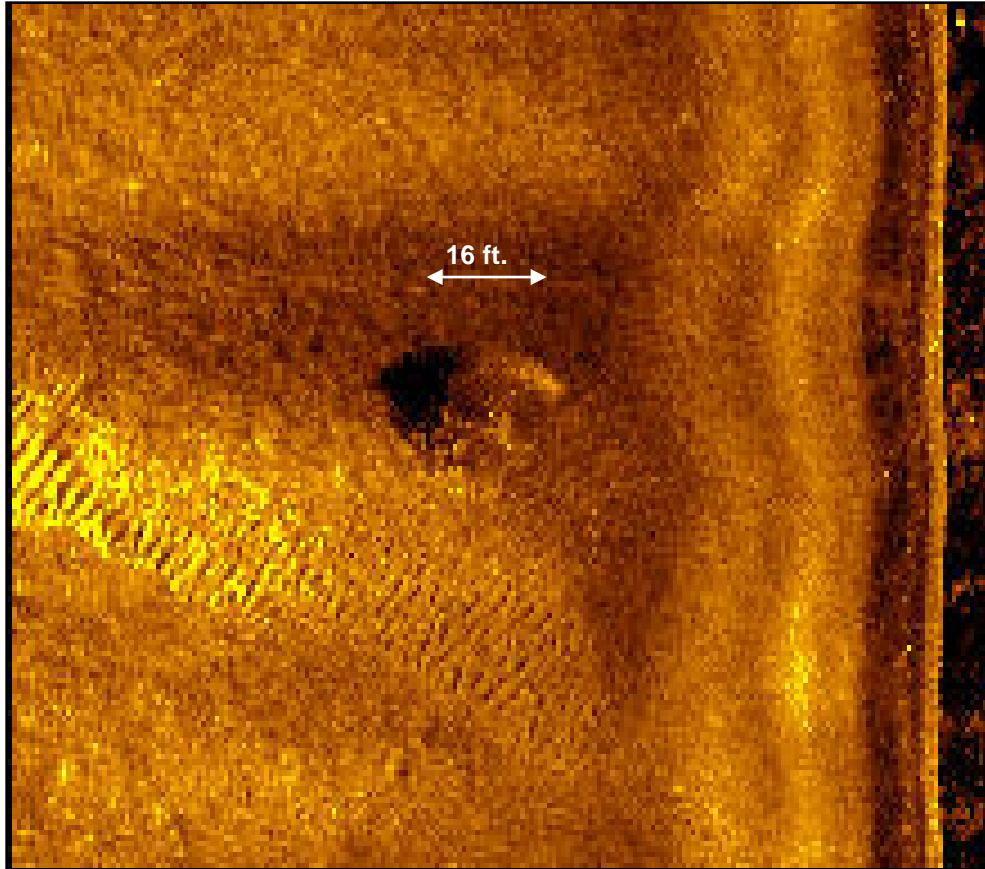
Target Q2-27 had no magnetic signature. The acoustic image suggested the target was a disk or dome-shaped object 16 feet in diameter with associated structural mountings still attached. The object appears to be of modern origin.

Figure 44. Target 27 – Acoustic Target Signature.

The nature of the target suggests it has little potential to be associated with a significant cultural resource. No additional underwater archaeological investigations or mitigation are recommended (Figure 44).
