**FINAL  
INTEGRATED  
FEASIBILITY REPORT  
AND  
ENVIRONMENTAL IMPACT STATEMENT  
COASTAL STORM DAMAGE REDUCTION**

**BOGUE BANKS, CARTERET COUNTY  
NORTH CAROLINA**

**APPENDIX E  
ARCHAEOLOGICAL SURVEY**

***An Archaeological Remote Sensing Survey of Bogue Banks  
Offshore Borrow Areas, Carteret County, North Carolina***

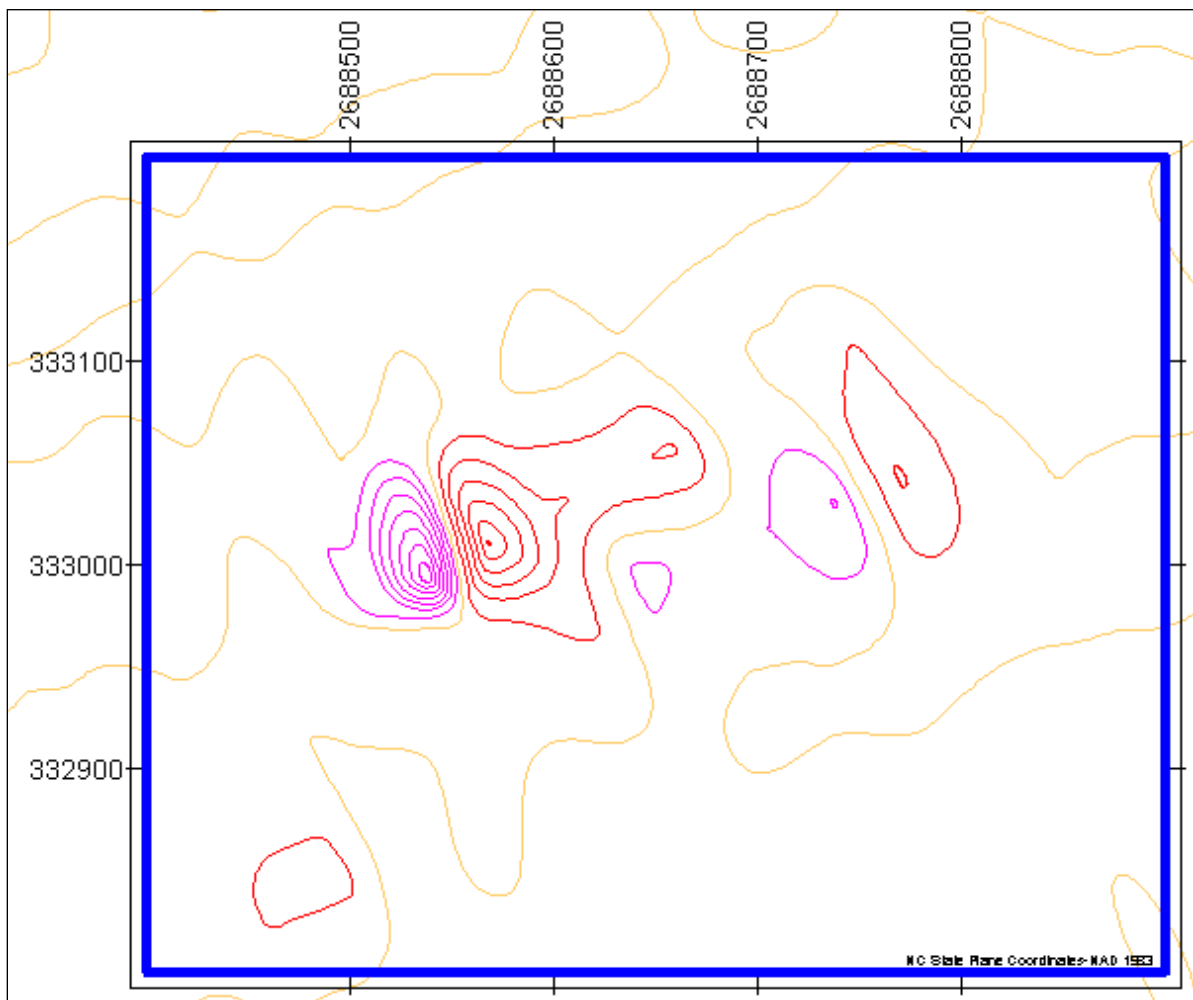
Figure 46. Target Cluster Q2-29 Magnetic Contour Signature.

Target Cluster Q2-29 consisted of two low intensity dipolar anomalies on two survey lines with a maximum magnetic intensity of 12 nT. No acoustic target signature was identified in association with the magnetic anomalies.

The characteristics of the cluster suggest that the material producing the low intensity anomalies is over 300 feet in length and linear. The target is most likely wire rope and has low potential to be associated with a significant submerged cultural resource. No additional investigations are recommended (Figure 46).

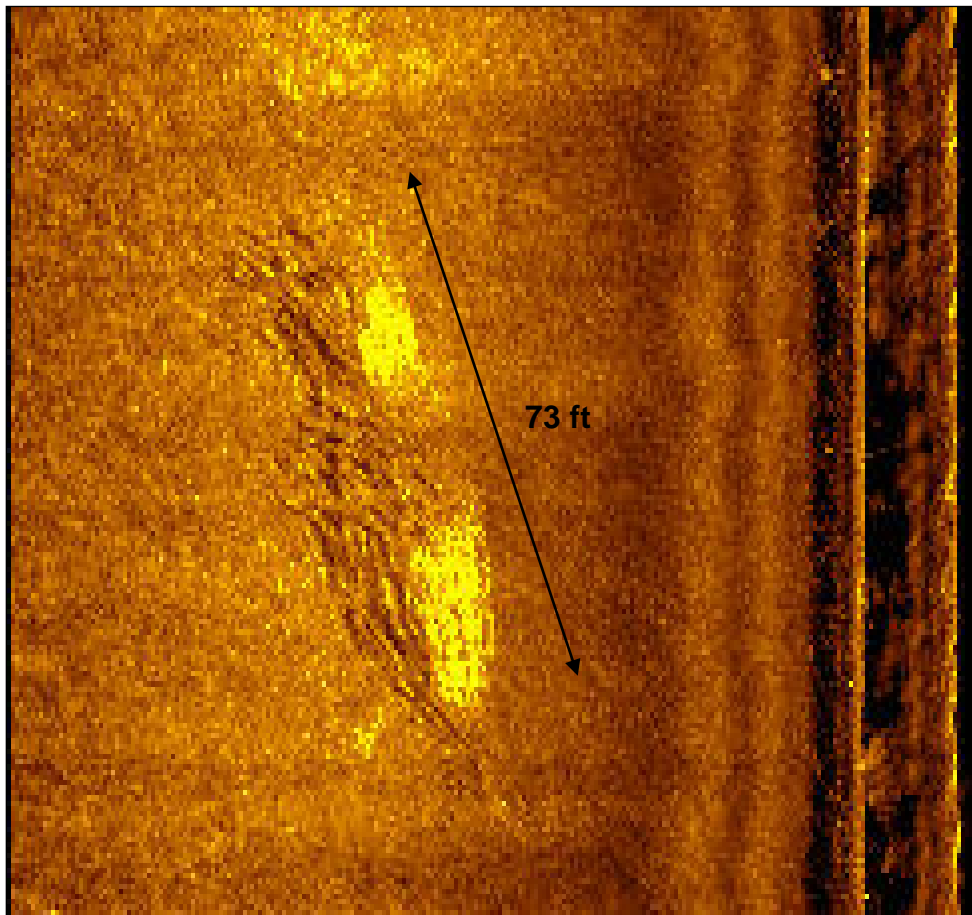
Figure 48. Target 30 – Acoustic Target Signature.

The target has the potential to be associated with a significant cultural resource. An underwater investigation to identify the nature of the material producing the magnetic signature is recommended. If underwater investigations are not an option, a no impact buffer zone should be created around the target signature. The no-impact zone should include an area at least 700 feet in diameter around the target coordinates (Figures 47 and 48).

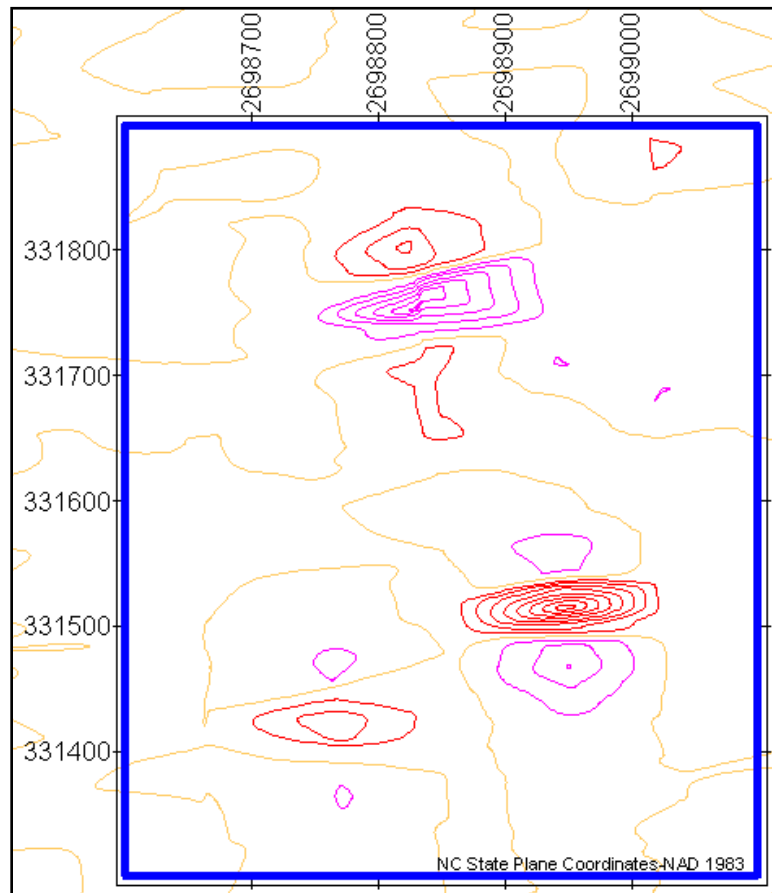
Figure 51. Target Cluster Q2-33 Magnetic Contour Signature.

Target Cluster Q2-33 consisted of at least three multi-component magnetic anomalies on four survey lines with a maximum magnetic intensity of 11 nT. Sonar images associated with the site show a single object approximately 8 feet wide and a second circular object a short distance away. The acoustic image has characteristics that suggest the object is a large modern anchor. No additional investigations or mitigation is recommended (51 and 52).

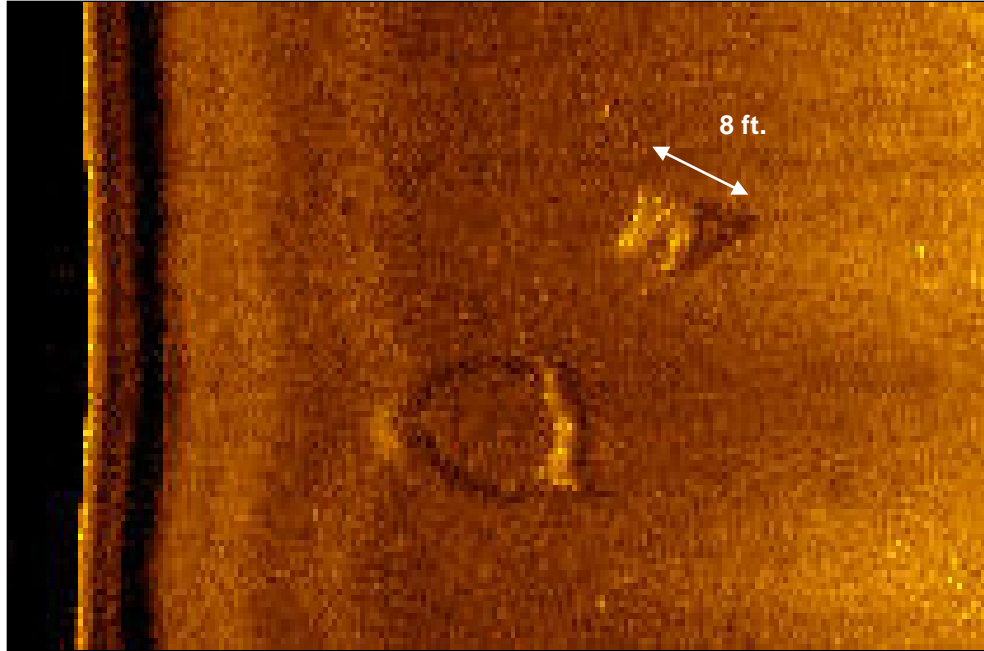
Figure 52. Target 33 - Acoustic Target Signature.

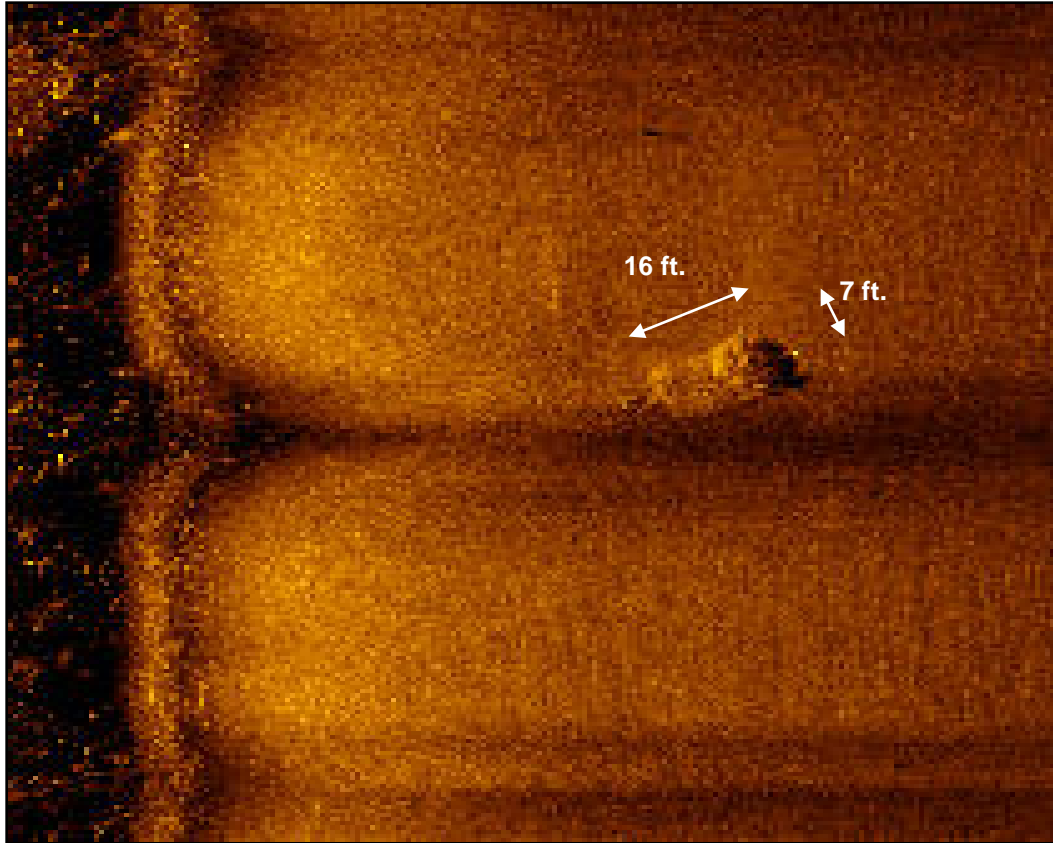
Only one magnetic anomaly with an associated acoustic signature was identified in Borrow Area Y. It has been recommended for additional investigations or avoidance. In contrast, hundreds of magnetic anomalies were identified within Borrow Area Q2. Many of these magnetic anomalies are isolated low intensity targets with little potential to be associated with a significant submerged cultural resource. Some of the magnetic anomalies are clustered together suggesting they may be related and could be associated with the scattered remains of historic shipwrecks. These were grouped into target clusters.

Figure 56. Target Y-1 Acoustic Target Signature.

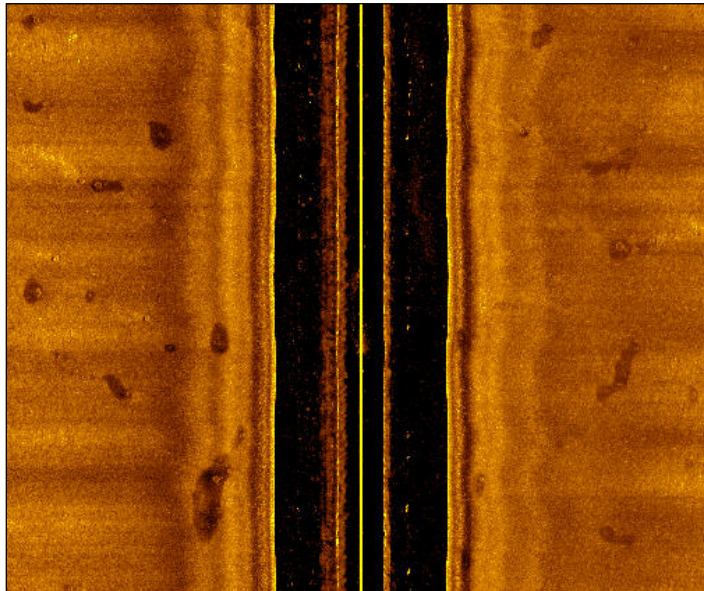
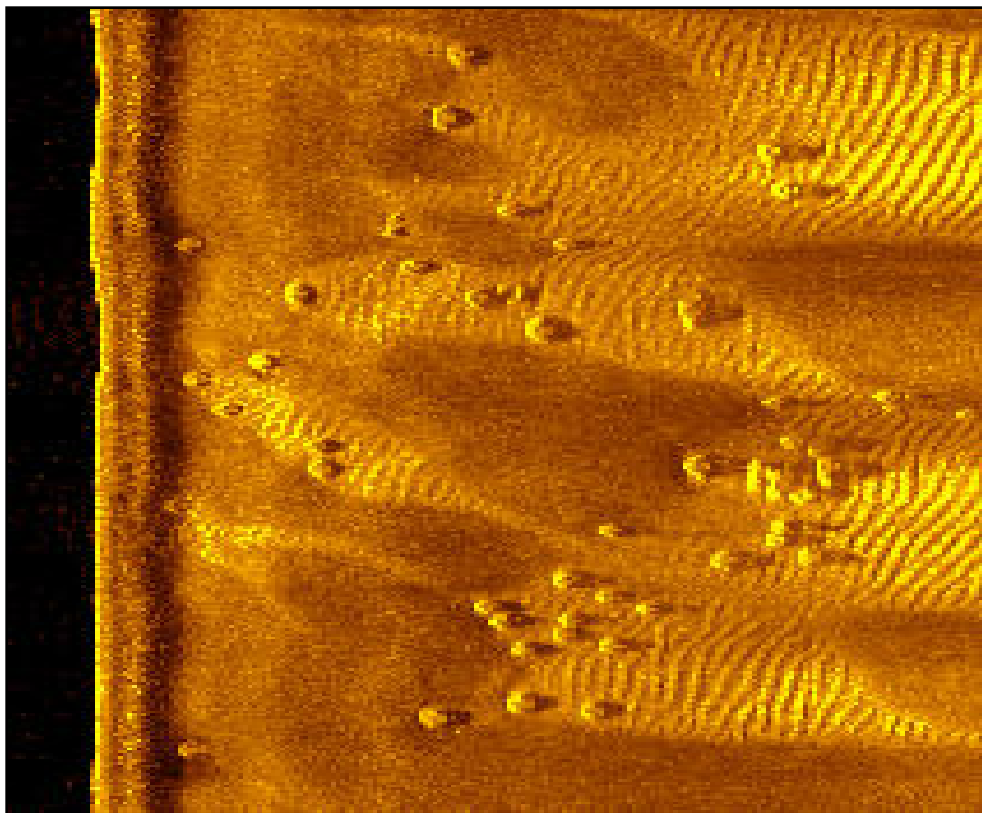
Figure 58. Example of Tire Scatter Borrow Area Q1.

Figure 59. Example of Tire Scatter Borrow Area Q1.

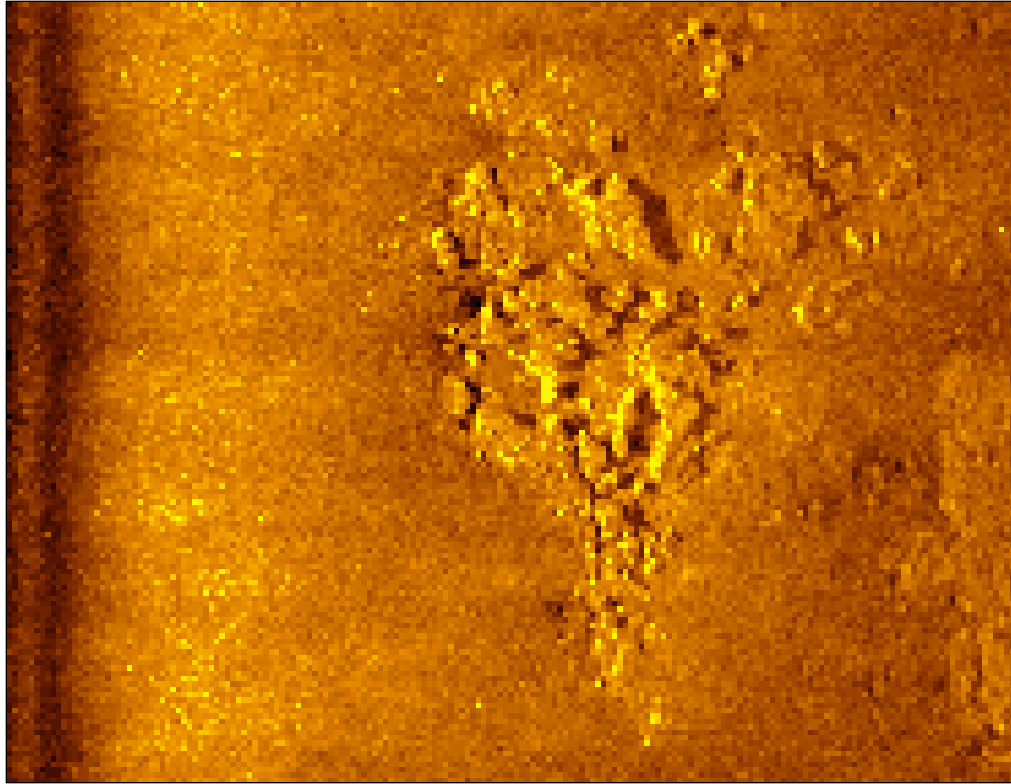
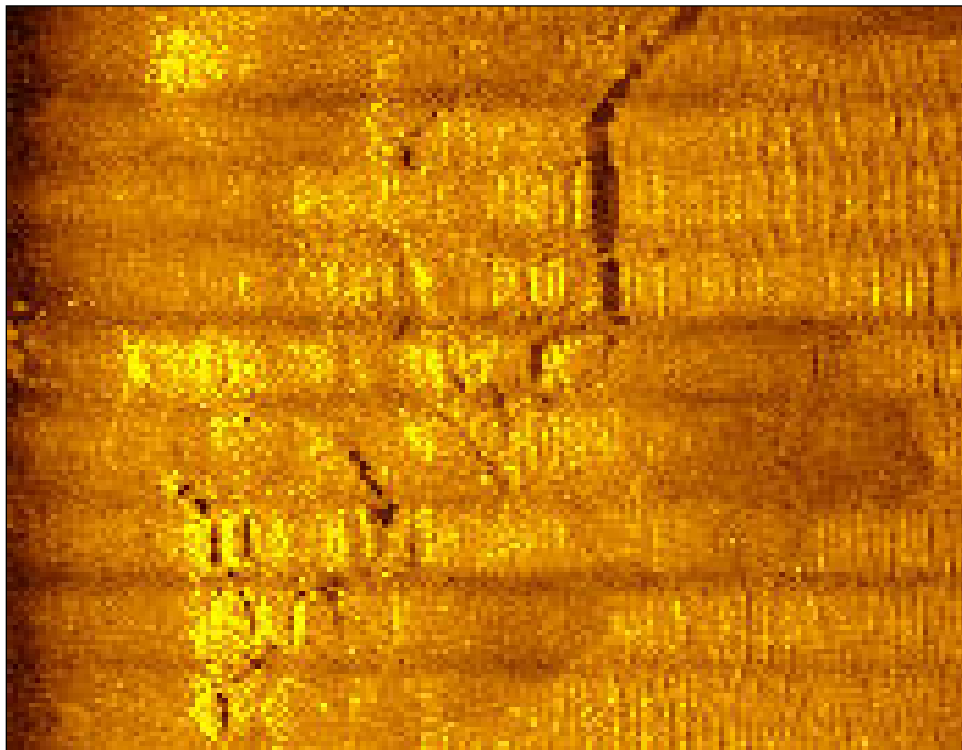
Figure 63. Example of Hard Bottom Borrow Area U.

Figure 64. Example of Hard Bottom Borrow Area U.

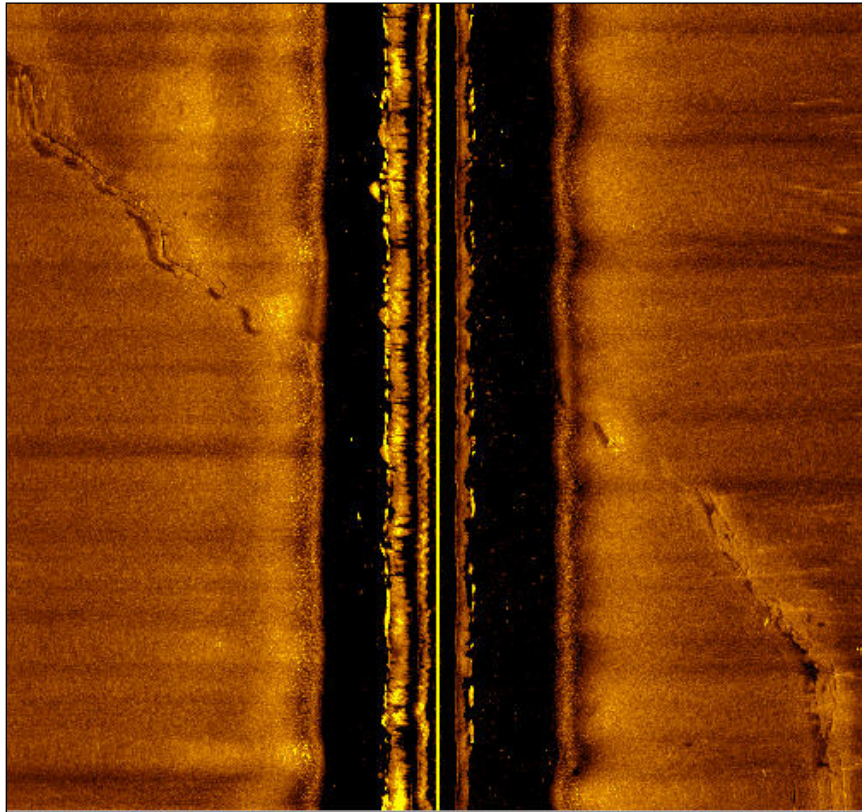
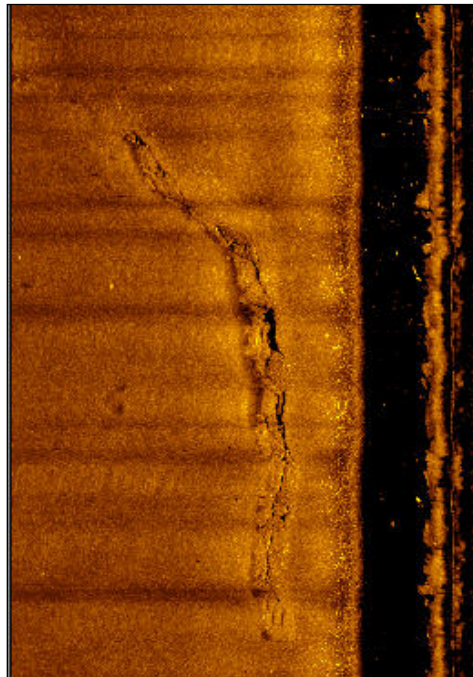
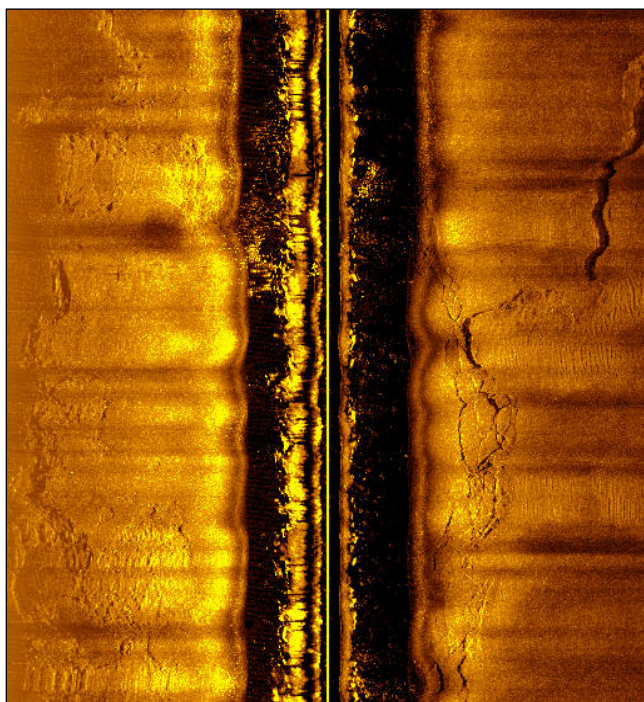
Figure 65. Example of Hard Bottom Borrow Area Y.

Figure 66. Example of Hard Bottom Borrow Area Y.

Figure 67. Example of Hard Bottom Borrow Area Y.

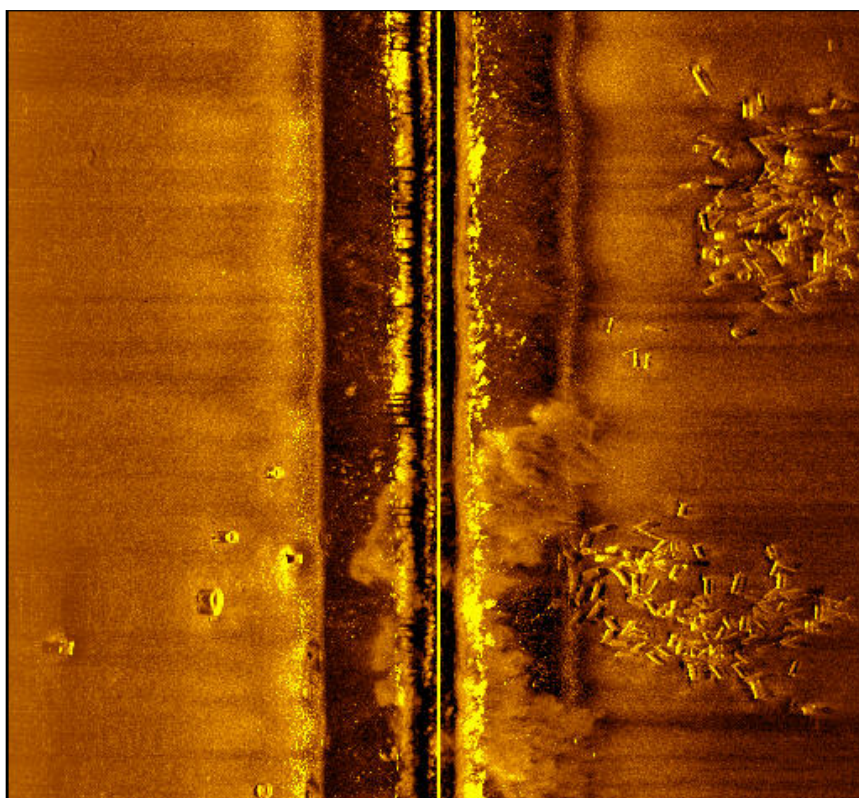
Figure 68. Artificial Reef Material located just south of Borrow Area Y.
