Building America Case Study Technology Solutions for New and Existing Homes

Preventing Thermal Bypass

Sarasota Springs, Florida

Air Sealing and Alignment of Air and Thermal Barriers Required to Prevent Bypass

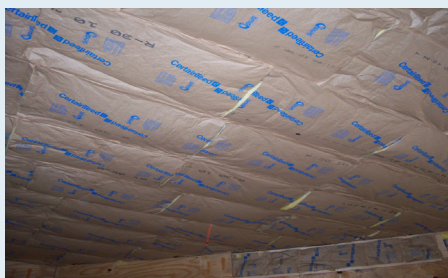
Right

EPA's Thermal Bypass Checklist requires alignment between the thermal and air barriers. One technique is to staple the insulation to the joist faces as shown in the picture below.

Both insulation methods do a good job of avoiding gaps from ill-fitting pieces.

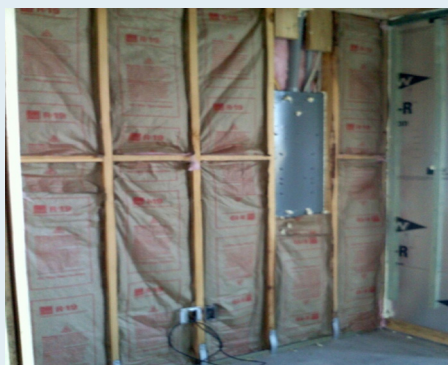
Wrong

In the picture below, inset stapling of batt insulation to the sides of studs leaves gaps between the thermal barrier (insulation) and the air barrier (drywall). These gaps create cold spots on walls and pathways for air currents that pull air through leaks in air barriers.
