# Chapter 8 Protecting Infrastructure: Costs and Impacts

## Infrastructure Adaptation

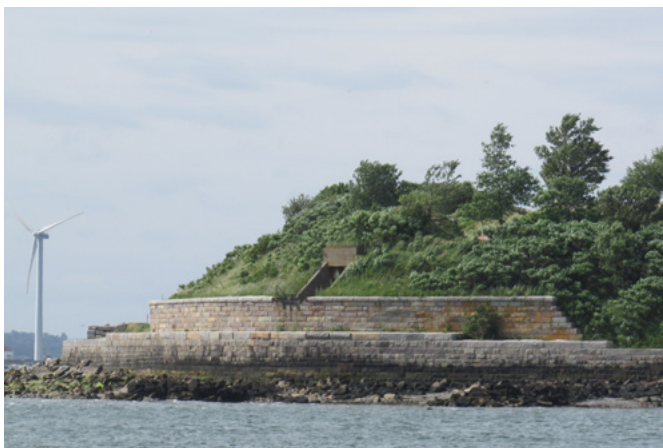
Figure 8.2. A seawall protects Fort Warren on Georges Island at Boston Harbor Islands National Recreation Area. Photograph by NPS.

Seawalls (figure 8.2) are onshore, shore-parallel structures built along open coasts with the primary purpose of protecting the resource behind the seawall from wave action. They are commonly constructed with a vertical, stepped, or curved face using stone, steel, concrete, or wood (Benoit et al. 2007).

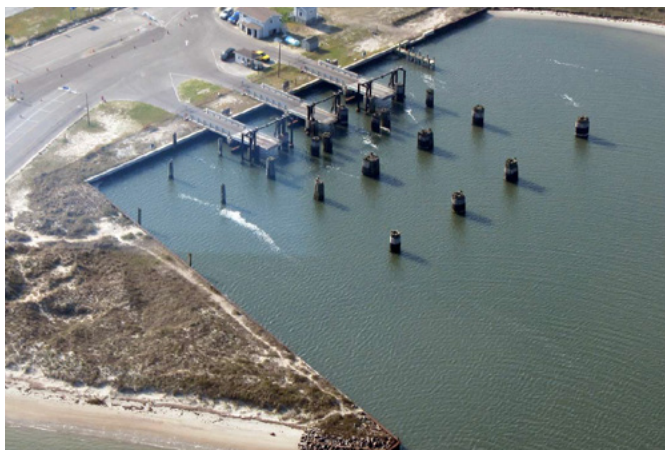
Figure 8.3A. Bulkheads at the Hatteras Island ferry landing on Ocracoke Island, NC. Photograph by NPS.

Bulkheads (figure 8.3) are vertical structures or partitions, usually running parallel to the shoreline on sheltered coasts, for the purpose of retaining upland soils while providing protection from wave action and erosion. Bulkheads are commonly rock-filled timber cribs and gabions, steel/composite sheet pile, concrete blocks, or armorstone units (Coburn, Griffith, and Young 2010). They can be freestanding or can have a series of tiebacks for stability (Benoit et al. 2007).

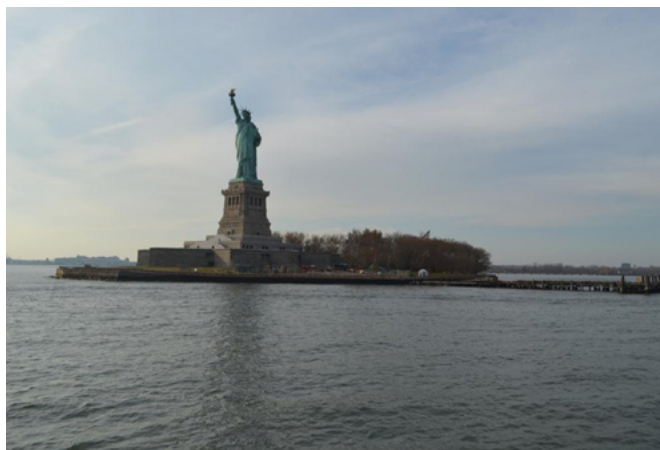
Figure 8.3B. Bulkheads protect Liberty Island. Photograph by NPS.

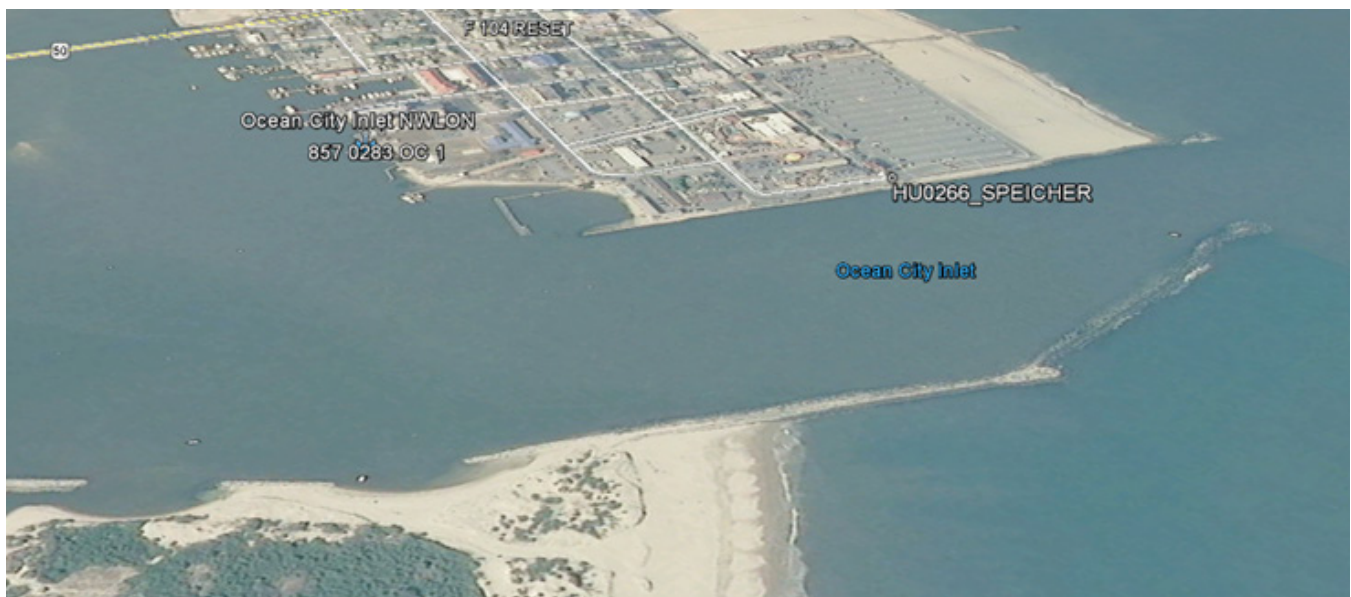
Figure 8.4. Ocean City Inlet jetty and breakwaters on the north end of Assateague Island National Seashore in 2011. Photograph by NPS.

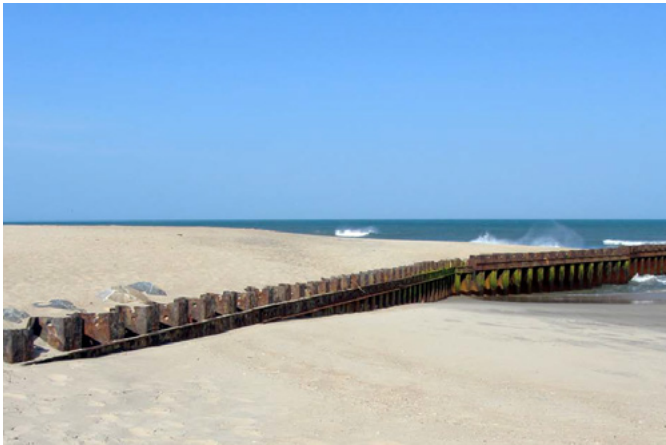
Figure 8.5. Steel sheet-pile groin at the former location of the Cape Hatteras Lighthouse. Photograph by NPS.

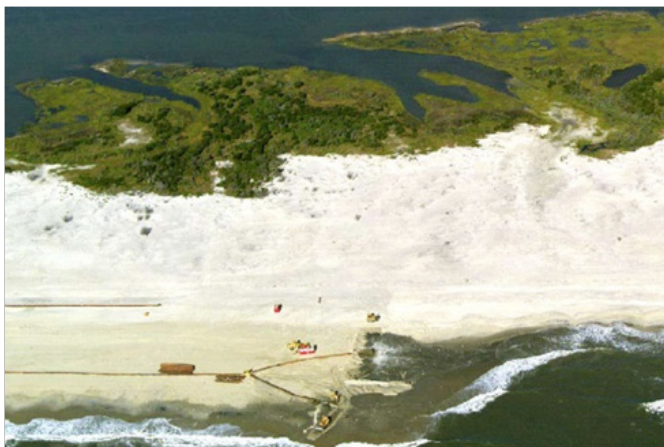
Figure 8.6. Beach nourishment at Assateague Island National Seashore in 2002 added sediment and widened the beach. Photograph by NPS.

Beach nourishment, also referred to as renourishment or replenishment, is the placement of sand onto beaches or within the nearshore (figure 8.6). Sand is obtained from an outside source; it is commonly dredged from an offshore location and pumped via pipelines directly onto the beach or dumped from a hopper dredge into the nearshore, or in some cases it is trucked from an inland source and dumped onto the lower beach. Nourishment replaces sand that is lost because of coastal erosion and can temporarily widen a narrow beach. Many times this process is used to mitigate erosion caused by hard structures such as groins and seawalls. The placement of sand on the beach increases the distance between vulnerable infrastructure and wave energy, which in some cases can help mitigate and postpone damage to infrastructure and property from coastal hazards. Berms may also be built when sand is added to replace dune function; they absorb wave energy before the water reaches infrastructure behind the dunes, and they serve as a sand source to nourish the beach. Dunes may be stabilized by planting vegetation and erecting sand fencing, which is described in the following section. The NPS [Reference Manual 39-2: Beach Nourishment Guidance](#) provides guidelines and best management practices for implementing beach nourishment projects where they have been deemed necessary and consistent with NPS management policies (Dallas, Eshleman, and Beavers 2012).

- 1. Assateague Island, Maryland (2002)**  
A one-time beach nourishment event widened the beach by 100 ft (30 m) in the area between 1.2 and 7.5 mi (2 and 12.5 km) south of the Ocean City Inlet (figure 8.6). The sediment was dredged from Great Gull Bank, in offshore Maryland State waters, and placed just seaward of the mean high water line to replace about 15% of the sand captured by the Ocean City Inlet since 1934 (USACE 1998). This effort cost \$13.2 million.  
*Total Volume: 1,832,000 yd<sup>3</sup> (1.4 million m<sup>3</sup>)*  
*Approximate cost: \$7/yd<sup>3</sup> (\$9.42/m<sup>3</sup>)*

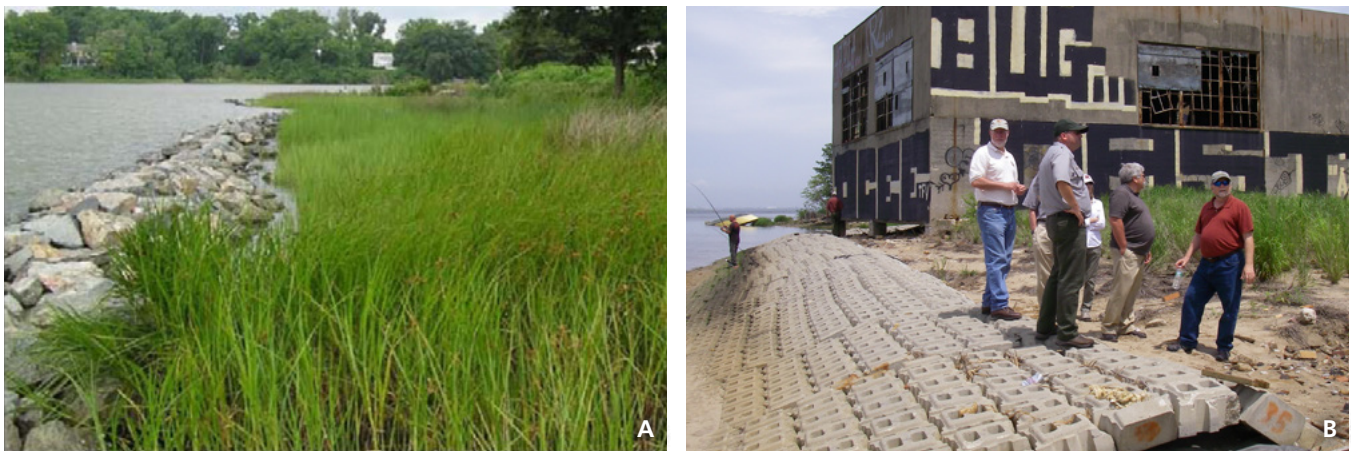
Figure 8.7. Examples of hybrid approaches to living shorelines. *Notes: (a) This hybrid approach to a living shoreline uses natural and nature-based features by combining a planted marsh with a rock sill. Photograph from Bilcovic and Mitchell (2011). (b) The vegetation component of this hybrid approach at GATE was unsuccessful, leaving only shoreline armoring. Photograph by NPS.*

Nature-based features, also known as hybrid techniques (figure 8.7), incorporate both nonstructural components and structural approaches (e.g., rock sill, breakwater). They have sometimes been referred to as “living shorelines,” a misnomer because the living component can be used as a façade to build what is functionally a hardened shoreline. An example is the combination of plantings with edging (e.g., geotextile tubes, oyster reef) or rock sills to hold the toe of the existing slope in place (see Schupp, Beavers, and Caffrey 2015, “[Case Study 3: Shell Mound Sites Threatened by Sea Level Rise and Erosion](#)”). Sills are low edges that protect marsh grass fringe by breaking approaching waves. Breaks in the sills allow fauna to cross through the barrier. Building a sill system requires encroachment beyond the shoreline. Sand may be added with marsh grass plantings to provide stability and will be necessary at sites with a wind fetch that exceeds 0.5 mi (0.8 km). Creating this system changes existing habitat; the eroding bank, narrow beach and nearshore are converted to a stable bank, marsh and stone sill (Benoit et al. 2007).

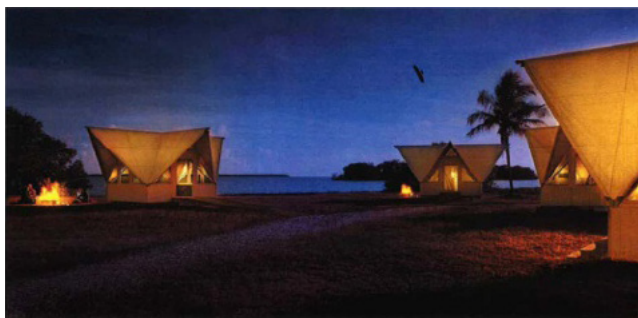
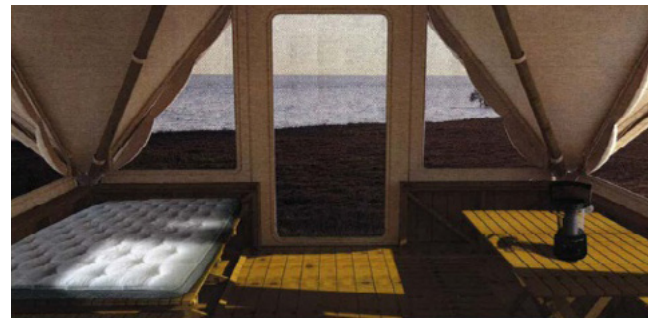
Figure 8.9. Visitor facilities have been redesigned at Everglades National Park; the new eco-tents are designed to be portable and can be moved in advance of storms. Images by NPS.

Adapting the design of a structure is another way to protect a structure, or the function of a structure, in place (figure 8.9). Design options for existing infrastructure include elevating the structure, elevating systems within the structure, or waterproofing mechanical systems (as described in “Chapter 9 Lessons Learned from Hurricane Sandy”). New construction design may include elements such as sacrificial construction that is expected to be destroyed during an event, but will minimize clean up or hazards. Historic infrastructure may now be insufficient

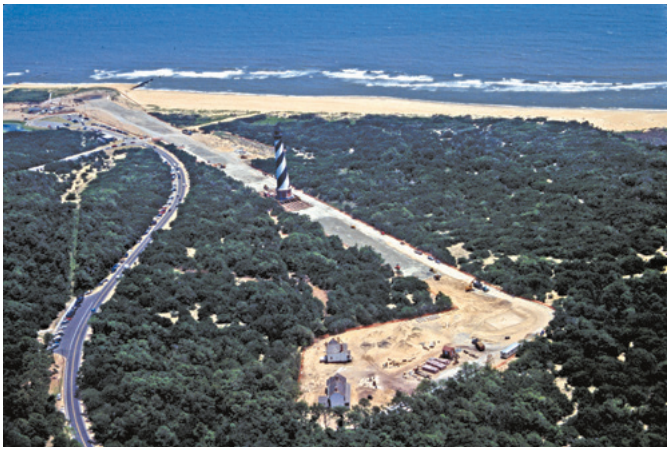
Figure 8.10. In this example of relocation and retreat, the Cape Hatteras lighthouse was moved inland using a railway. Photograph by NPS.

Structure relocation is the strategy of transporting a structure from a vulnerable area and placing it in a more stable location (figure 8.10). This can reduce structure vulnerability to threats, such as undermining caused by shoreline erosion, damage from wave impact, boring by marine organisms, and sea level rise. A structure can be moved as a whole or in parts using a flat-bed truck or temporary rails. The transport distance can vary, but most examples of relocation have been less than 500 feet inland from the original location. Infrastructure can also be replaced by structures that are designed to be moved landward to a new site, usually once or twice away from an eroding shoreline, or by portable structures that are moved off site seasonally or ahead of a storm and then returned (see Schupp, Beavers, and Caffrey 2015, “[Case Study 16 Relocating Visitor Facilities Threatened by Accelerated Erosion](#)”). Relocation should also consider the vulnerability of the new site to climate change.
