Chapter 9 Lessons Learned from Hurricane Sandy

Contributing Authors: Amanda Babson, Rebecca Beavers, Mike Eissenberg, Mary Foley, Tim Hudson, and Courtney Schupp

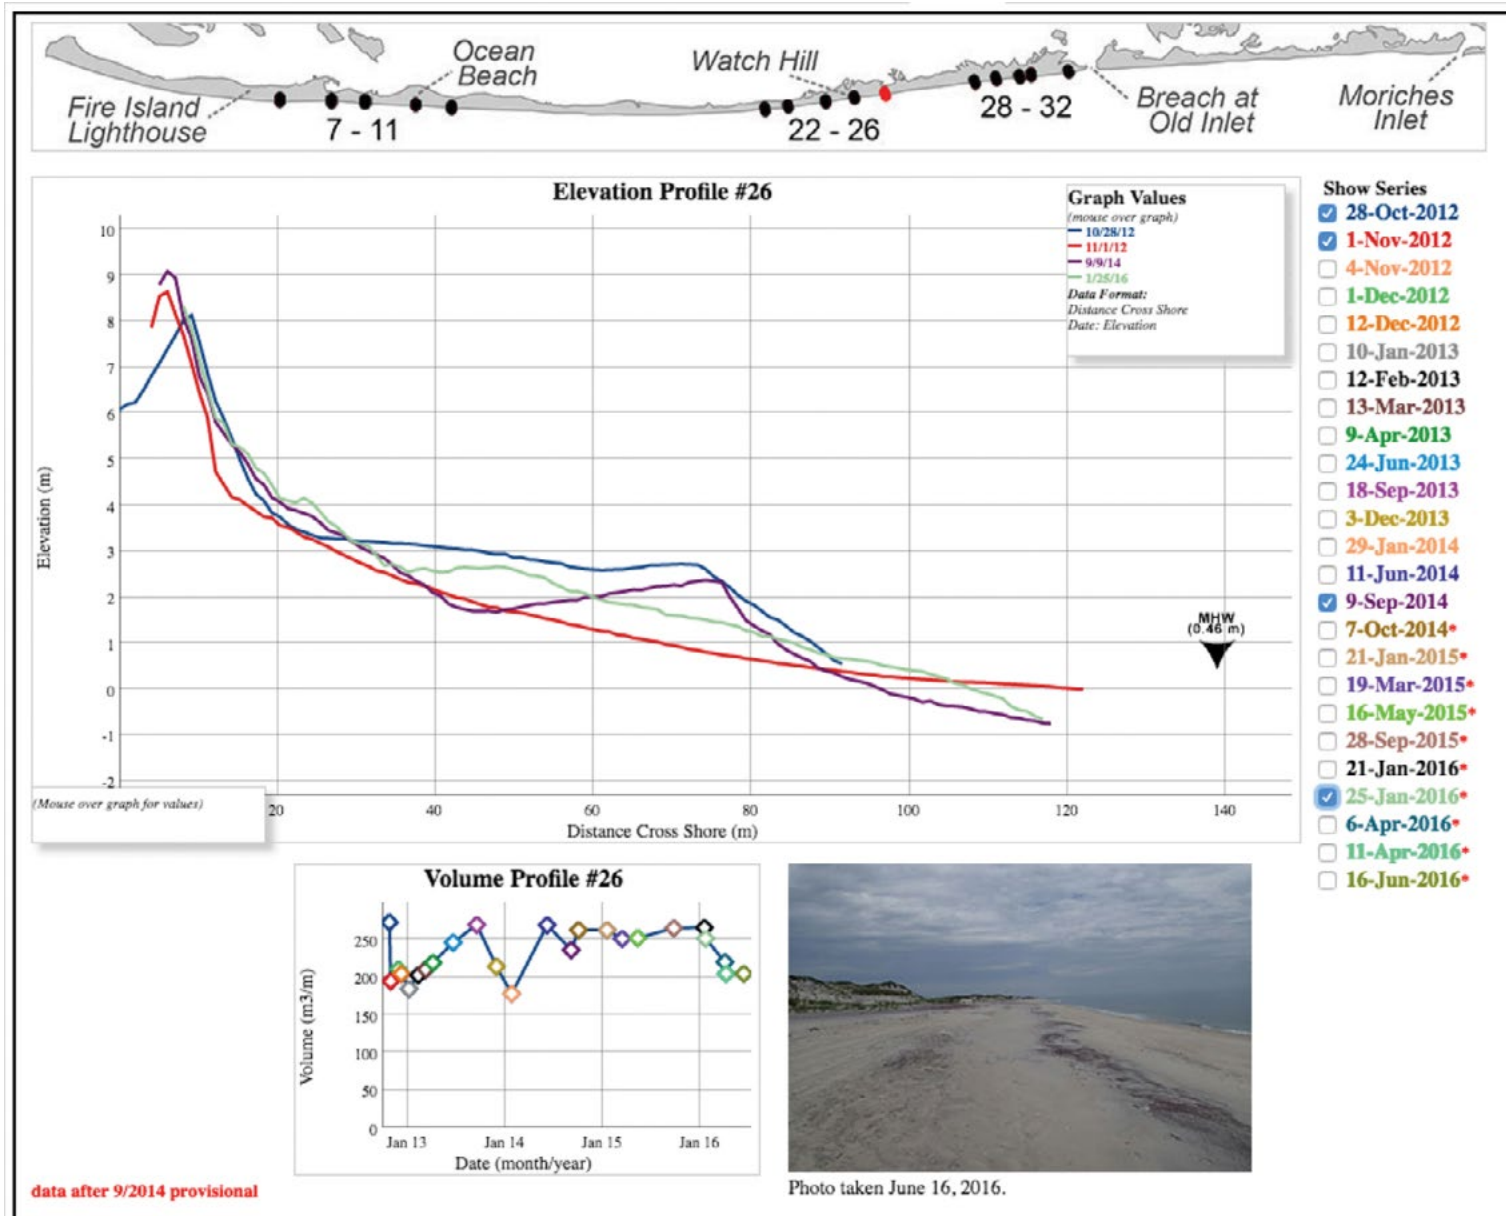
Figure 9.3. Beach profiles at FIIS before and after Hurricane Sandy. Note: Shore-perpendicular elevation profiles of Fire Island, New York, capture the initial impact of Hurricane Sandy and the ongoing recovery of the beach system. Surveys were performed one day prior to Hurricane Sandy landfall in October 2012, within three days after the storm (in November 2012), in September 2014 and in January 2016. Profile elevation data were collected at 0.5 second intervals using an Ashtech Z-Xtreme GPS surveying instrument and post-processed using positional data from a base receiver to achieve sub-decimeter accuracies. This figure and additional data are available from <http://coastal.er.usgs.gov/fire-island/research/sandy/beach-profiles.html>. Figure from Hapke (2014).

At FIIS, a comparison of pre-and post-Hurricane Sandy US Geological Survey (USGS) beach profiles showed substantial changes in beach volume due to the hurricane, but that as of September 2014, the beach was growing steadily and approaching pre-Hurricane Sandy conditions in some locations, likely because the sand remained within the littoral system in the nearshore area (Hapke et al. 2014) (figure 9.3). Significant impacts to natural resources resulted from debris floating onto beaches and salt marsh habitat.

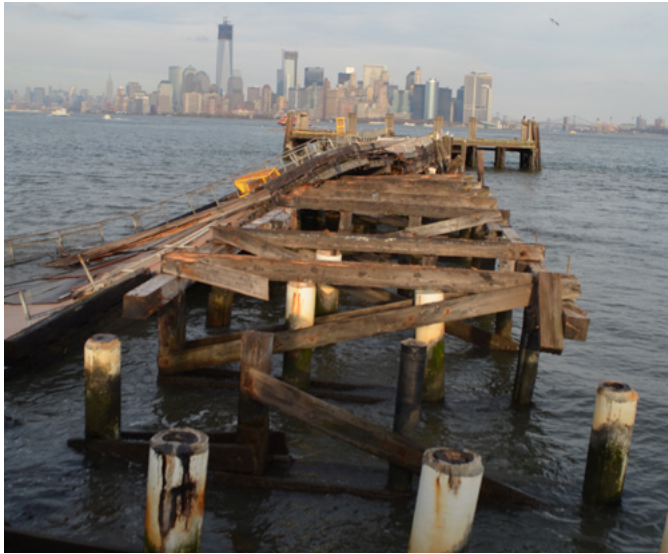
Figure 9.4. Photo from Liberty Island of damaged dock access. Photograph by Rebecca Beavers, NPS.

accommodate rising water levels. The design changes that were incorporated included design-to-fail connection points between the dock sections to isolate damage and improved connections where the docks are fixed to the piles to improve survival (figure 9.4).

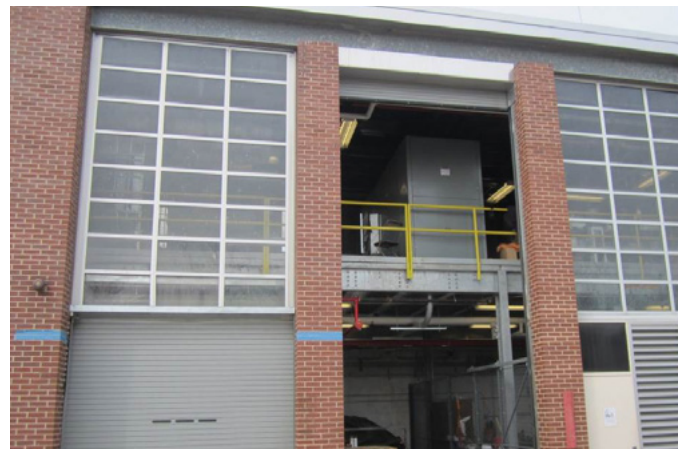
Figure 9.5. Photo of elevated platform in maintenance building on Liberty Island.

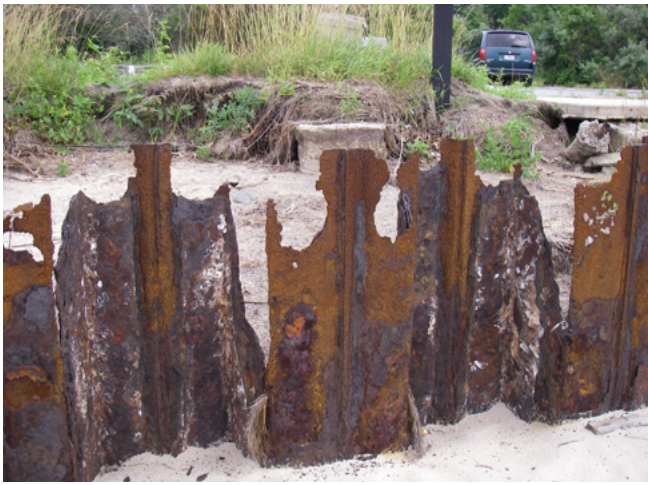
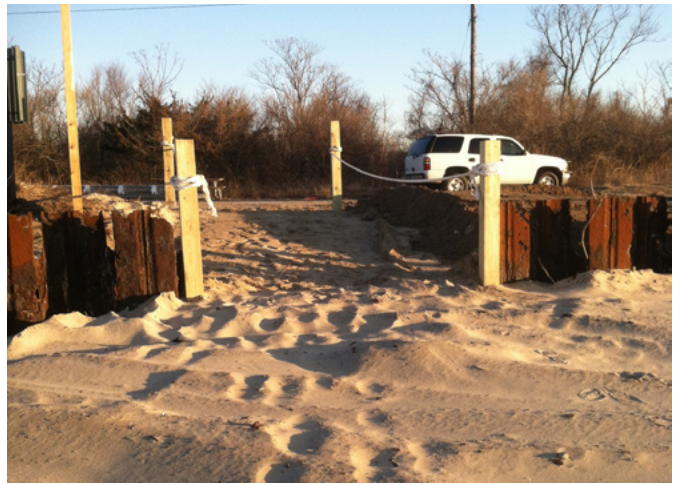
Figure 9.8. Photos of Aviation road bulkhead (left) and area where section was removed (right). *Note: Planned removal of the Aviation road bulkhead to allow shoreline migration was delayed and only a section was removed initially for safe access. Removal of the bulkhead is now proceeding.*
