# Coastal Adaptation Strategies: Case Studies

National Park Service Report 2015

Edited by Courtney A. Schupp<sup>1</sup>, Rebecca L. Beavers<sup>1</sup>, and Maria A. Caffrey<sup>2</sup>

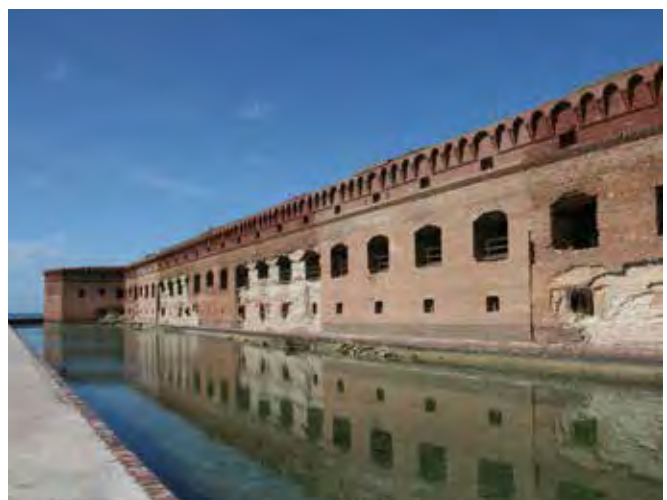
Fort Jefferson needs repairs to its front and moat wall.  
Image credit: Kelly Clark, NPS.

brick, with six sides and three tiers. It is surrounded by a 21 m (70 ft) wide wet moat that is separated from the open waters of the Gulf of Mexico by a masonry wall, formally called the counterscarp. The counterscarp sits approximately 2 m (6 ft) above the low water line and 1 m (3 ft) above high tide. The moat and counterscarp were designed to keep would-be attackers at bay and to provide a structural first line of defense for the fort against the sea.

Throughout the architecture of the fort, there are iron components embedded within the masonry that served various functions, including water collection, supports for catwalks, and, most importantly, protection against enemy fire. In this salt water environment, the wrought-iron has rusted and expanded, pushing the brick apart and causing serious structural damage to Fort Jefferson's exterior scarp walls; large sections of the fort walls have collapsed into the moat.

The moat wall surrounding the fort also needs repairs in many places. Because it is an integral part of the site design and protects the fort from wave forces, it also protects the investment in stabilization of the fronts.

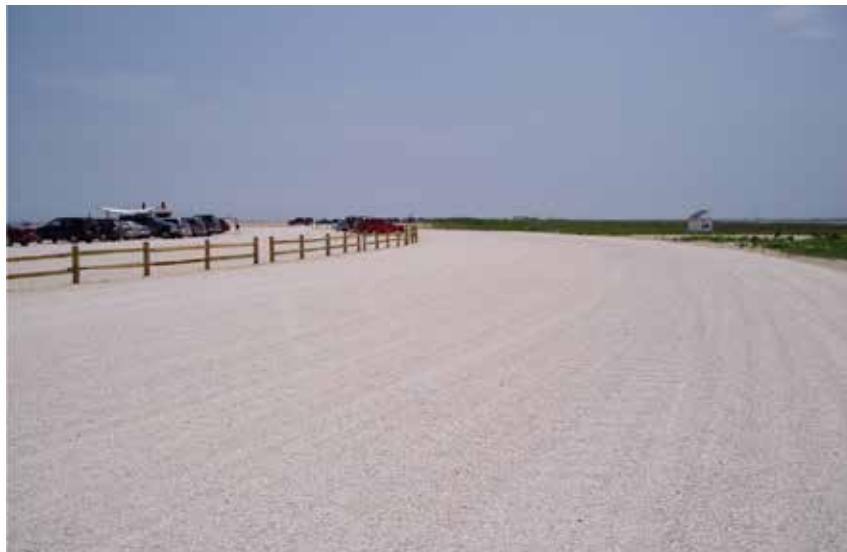
The Virginia visitor parking lot is constructed with native materials including clay and clamshell that can be reused in post-storm repairs. Image credit: Ish Ennis, NPS.

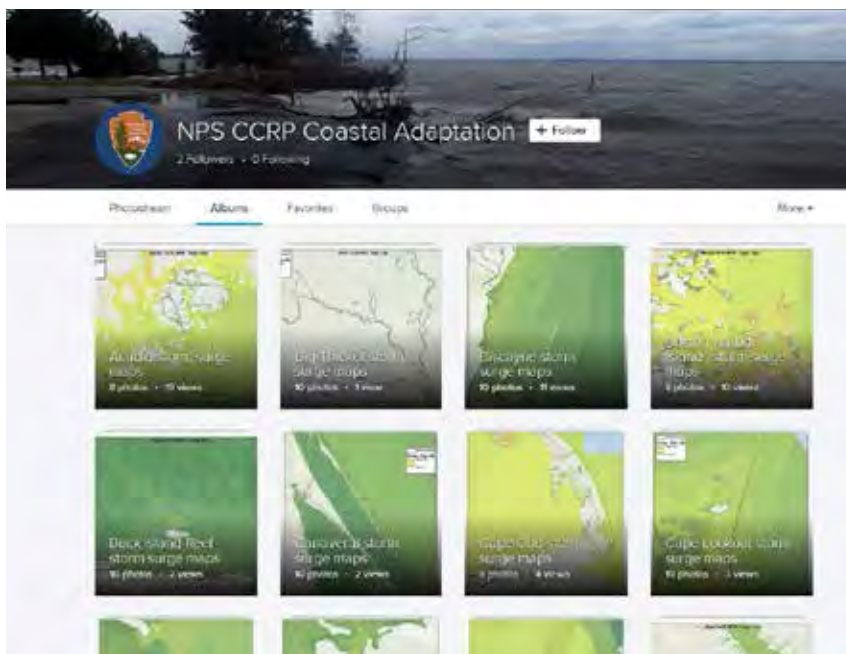
Storm surge maps completed for the parks (available at <https://www.flickr.com/photos/125040673@N03/sets/>). Image credit: NPS.

NOAA Sea, Lake and Overland Surges from Hurricanes (SLOSH) model data have already been incorporated into 34 foundation documents, 9 state of the parks reports, and various assistance requests (e.g., Gulf Islands National Seashore, Acadia National Park, Assateague Island National Seashore, Boston Harbor Islands National Recreation Area, Colonial National Historical Park, Gateway National Recreation Area, Fire Island National Seashore, and Statue of Liberty National Monument). Individual sea level change and storm surge projections for each park will be released in a full report during the NPS Centennial Celebration in fiscal year 2016. Interim products that have been supplied to the parks as part of foundation documents or state of the parks reports can be found at <https://irma.nps.gov>. Sea level change and storm surge data will be featured in the park atlas and as a separate interactive website. In the meantime, storm surge maps are already available at <https://www.flickr.com/photos/125040673@N03/sets/>.
