*Summary Report and Lessons Learned*

# The Response to the Misawa Dock on the Washington Coast

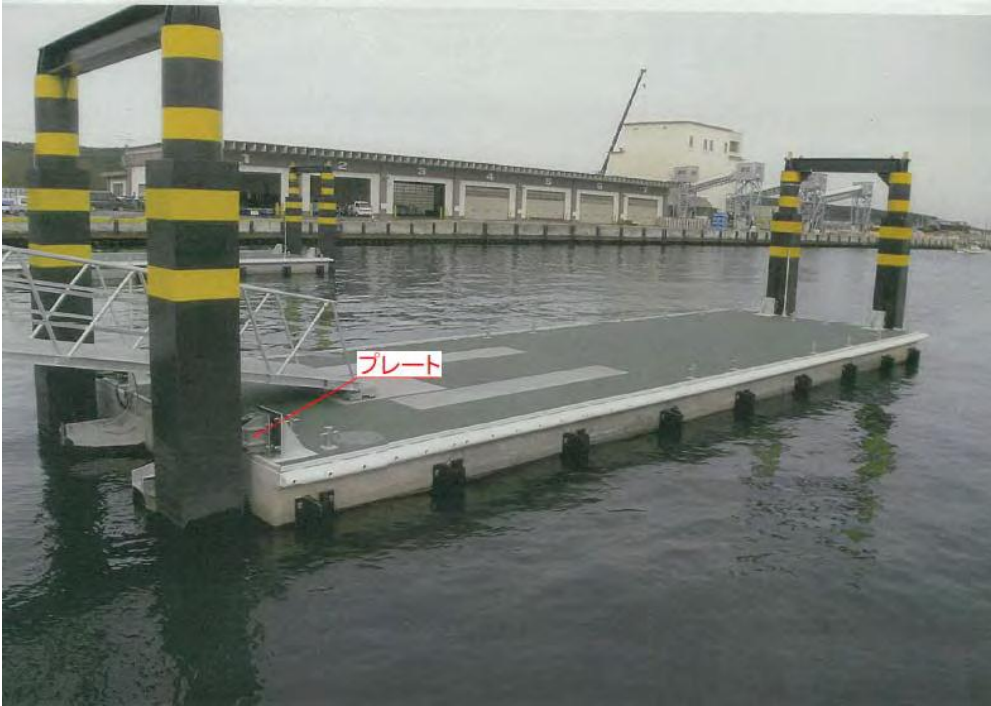
**Figure 1:** One of floating docks at the port of Misawa (Photo: Port of Misawa)

The March 11, 2011 earthquake and tsunami in the Tohoku region of Japan claimed nearly 19,000 human lives, injured 6,000 people, and inflicted severe damage on the local communities and infrastructure. Japan's Ministry of the Environment estimates that approximately 5 million tons of debris washed out to sea, of which 1.5 million tons remained afloat initially, while the rest sunk near shore. The floating debris was comprised of a variety of items from the devastated communities and infrastructure, including wood, plastic items, fishing gear, vessels, and four large docks from the fishing port of Misawa in northeastern Japan (Figure 1).

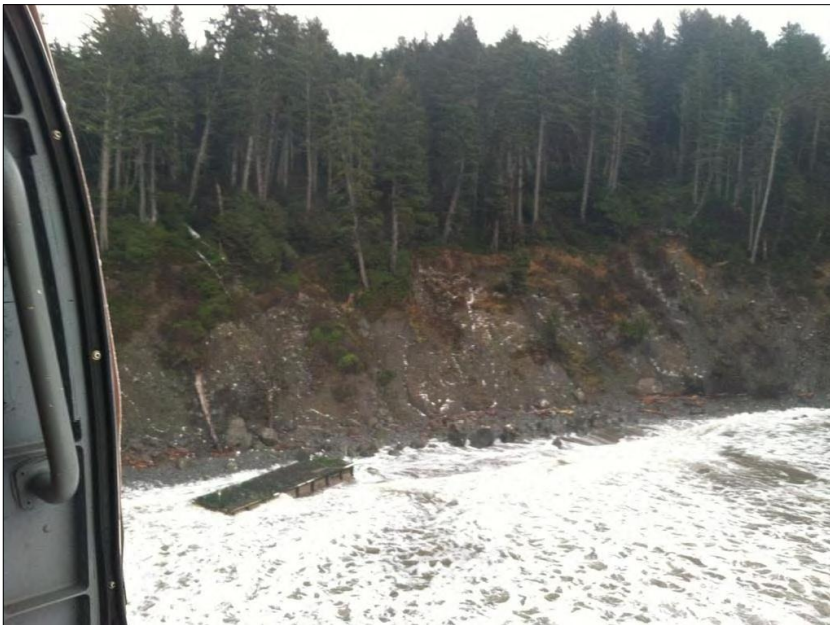
**Figure 4:** Dock found by USCG on December. 18 (Photo: USCG)

Finding the floating object, suspected to be one of the lost docks from Misawa, was a first priority. NOAA Office of Response and Restoration (OR&R) conducted its first General NOAA Operational Modeling Environment (GNOME) model run and trajectory analysis on the night of December 14 and forwarded results to USCG. The next day, USCG flight crew, braving stormy weather conditions and poor visibility, conducted a search but was unable to locate the dock. Over the next few days NOAA and USCG worked closely on trajectory modeling (Figure 3), flight search areas, and flight paths. USCG flight crews conducted additional overflights on December 16, 17, and 18, locating the dock on Tuesday, December 18, aground on the shore at 1430h, at 47° 47.721 N, 124° 28.943 W, one mile due east of Alexander Island (Figure 4), within the boundary of Olympic National Park (ONP) and OCNMS (Figure 5).

The dock was found by USCG overflight on December 18, which initiated the second phase of response. On December 19, the state set up an Incident Command Post (ICP) at the University of Washington’s Olympic Natural Resources Center in Forks, a facility with lab space suitable for initial processing of suspected AIS found on the dock.

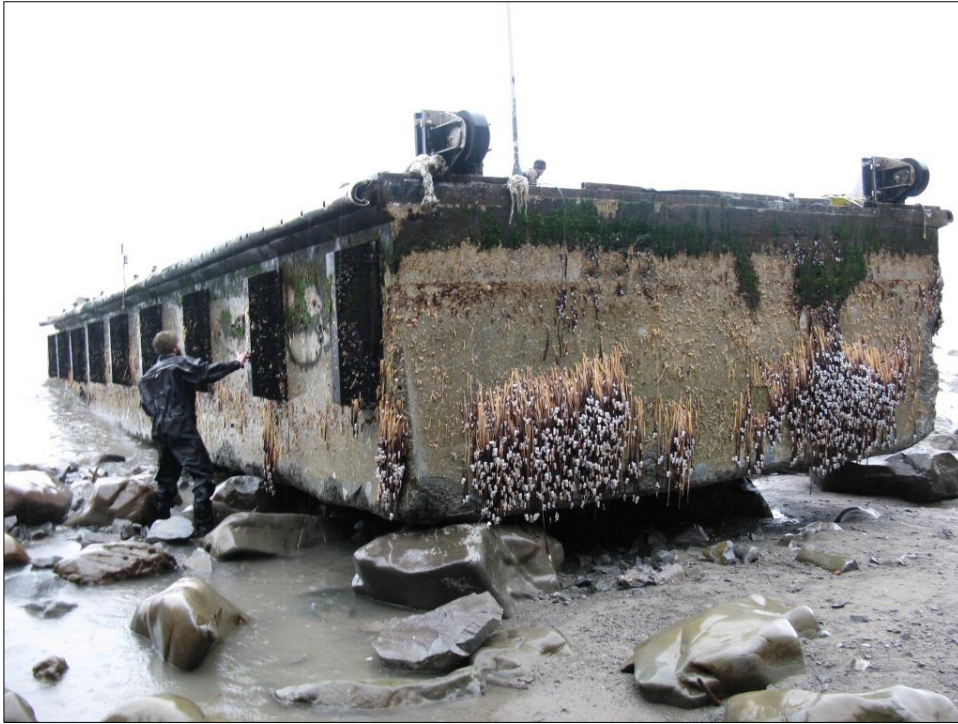
**Figure 6:** The dock on December 21th, 2012, perpendicular to the shoreline. (Photo: WDFW)

- **Overall characterization:** The team took numerous photos of the dock (Figure 6), assessed its overall condition, and measured its dimensions, which were identical to the dock that beached in Oregon. This dock suffered significant damage and was found in much worse condition than the Oregon dock. Some damage seemed to have occurred some time ago, and some was recent. Considering the location of the dock, nearby sheared and broken rocks, and the fact that the

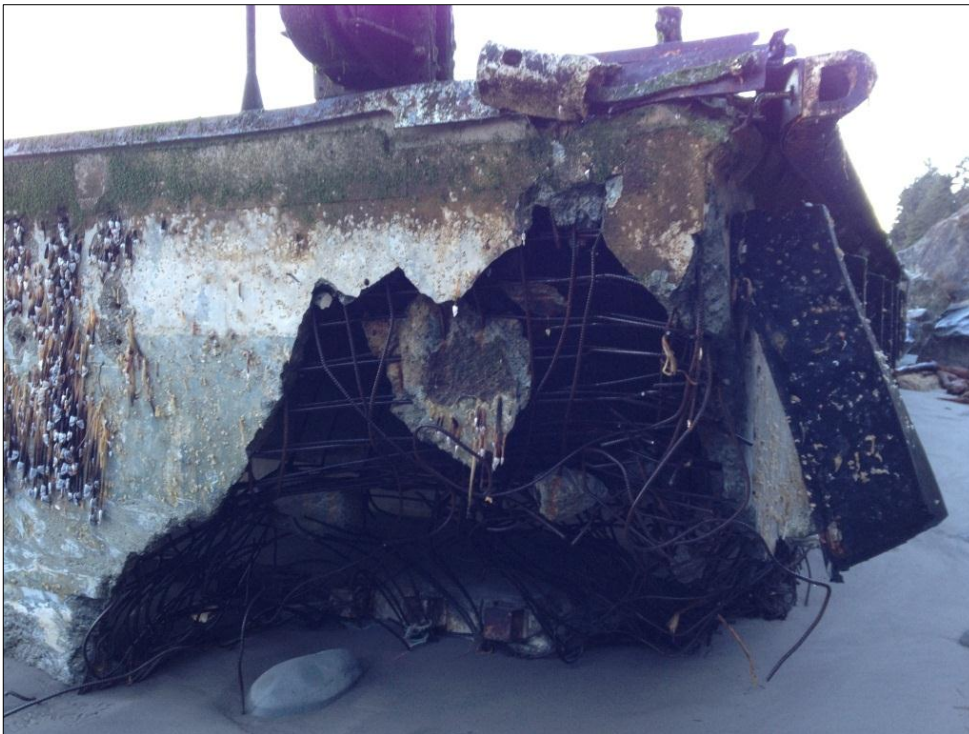
**Figure 7:** Dock on January 3<sup>rd</sup>, 2013, now parallel to the shoreline. Severe damage is visible. (Photo: NPS)

dock seemed to have moved since being spotted by USCG and even since the previous day, the dock was clearly mobile (Figure 7).

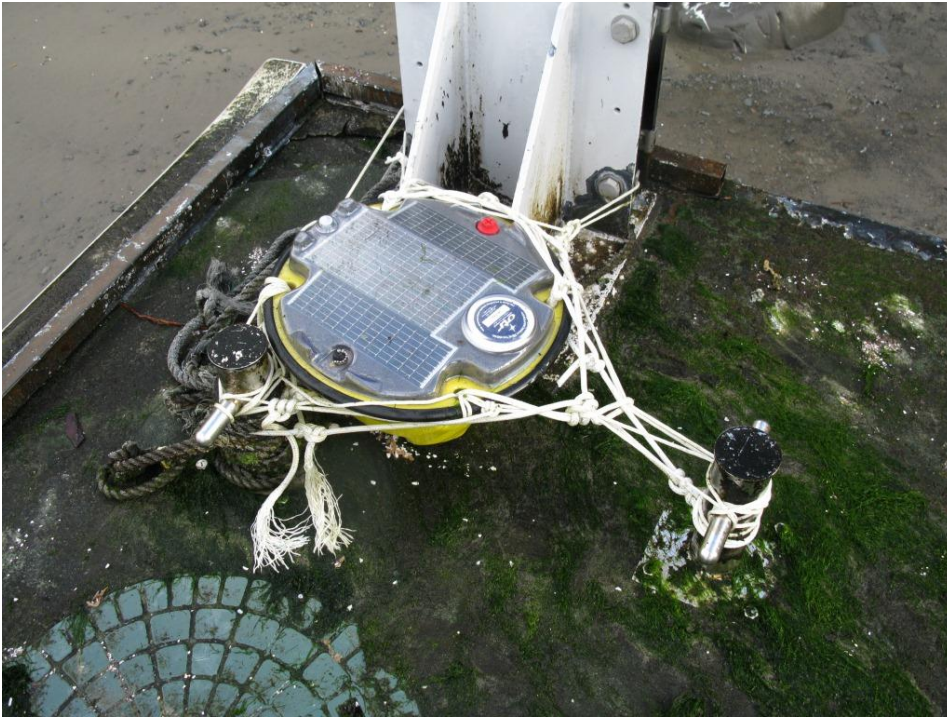
**Figure 8:** The tracking buoy is attached to the dock (Photo: WDFW)

- **Tracking buoy:** The team secured and activated a tracking buoy to the dock's deck (Figure 8).
- **Aquatic Invasive Species:** The team assessed the abundance and distribution of AIS on the dock and collected numerous samples of organisms.
- **Radiation assessment:** Samples were taken from the dock to be analyzed for radiation.
- **Confirmation of dock origin:** The team looked for a plaque or other identifying markers on the dock, but was not able to find one. The team took photos of what appeared to be Japanese writing on dock parts. These photos were shared with the General Consulate of Japan in Seattle, and the Consulate initiated the confirmation process.

In the first visit to the grounded dock, the team secured a NOAA tracking buoy to the deck of the dock and activated it. This was done to ensure that the location of the dock was known at all times, especially if it refloated, a remote possibility. The buoy transmitted GPS locations twice a day via email received by NOAA and several agencies.

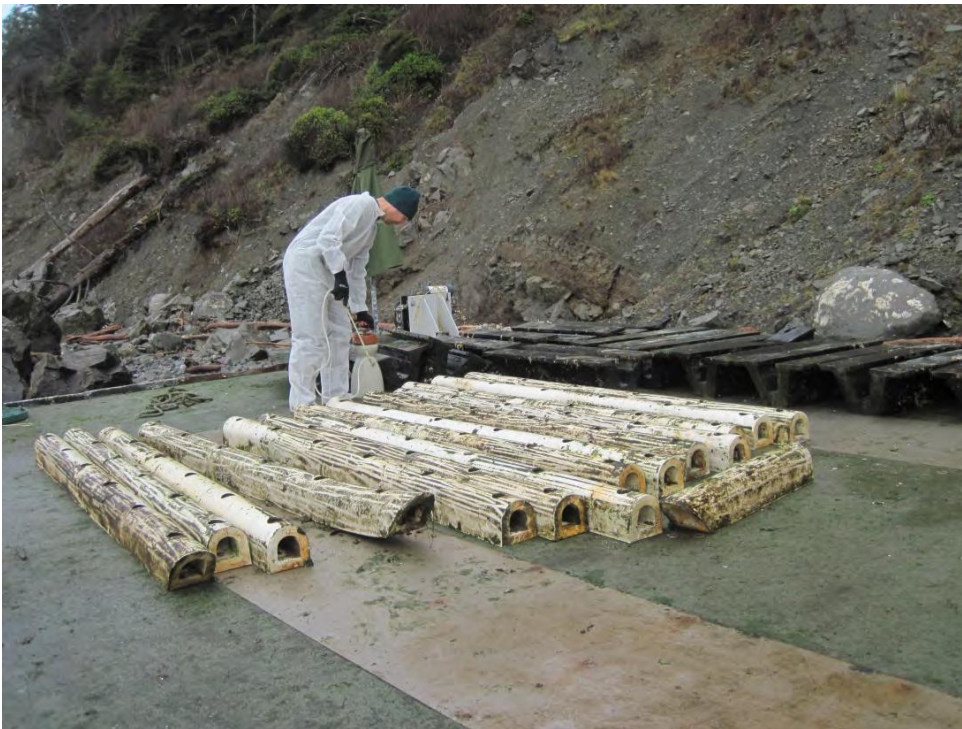
**Figure 9:** AIS cleanup. Judicious use of bleach on removed fenders and bumpers on Jan 3 (Photo: NPS)

On January 3 and 4, 2013, the team revisited the dock and cleaned the remaining growth from the dock. By then, even more growth had been stripped from the dock by surf action. Cleanup was done by scraping visible growth on the sides and deck of the dock, hauling 400 lbs. of biota up the bluff and away from water access, and sterilizing the surface with a bleach solution, used sparingly and under a permit from OCNMS. Vertical and horizontal bumpers, providing shelter to living organisms, were removed, cleaned, and stored in the hold of the dock (Figure 9). The team estimated that 99% of the visible growth had been removed, and additional AIS remediation efforts at this stage were no longer necessary.

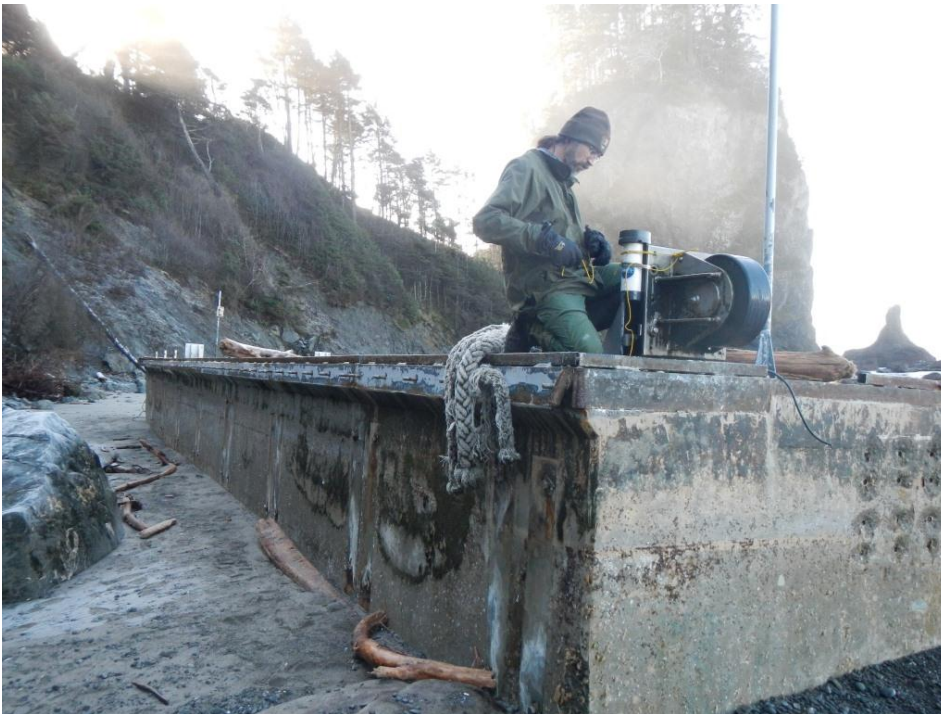
**Figure 11:** Repositioning the PMEL beacon on the dock on Jan 17 (Photo: NOAA)

After a few days, the charge of the solar-rechargeable batteries on the buoy was decreasing, and there was concern that the buoy would stop transmitting. Therefore, an additional beacon was secured from NOAA PMEL and attached to the dock on January 4 (Figure 11). Fortunately, both the tracking buoy and the PMEL beacon continued to transmit daily, and for several weeks, all involved entities were updated daily on the location of the dock, which remained essentially the same (Figure 12).

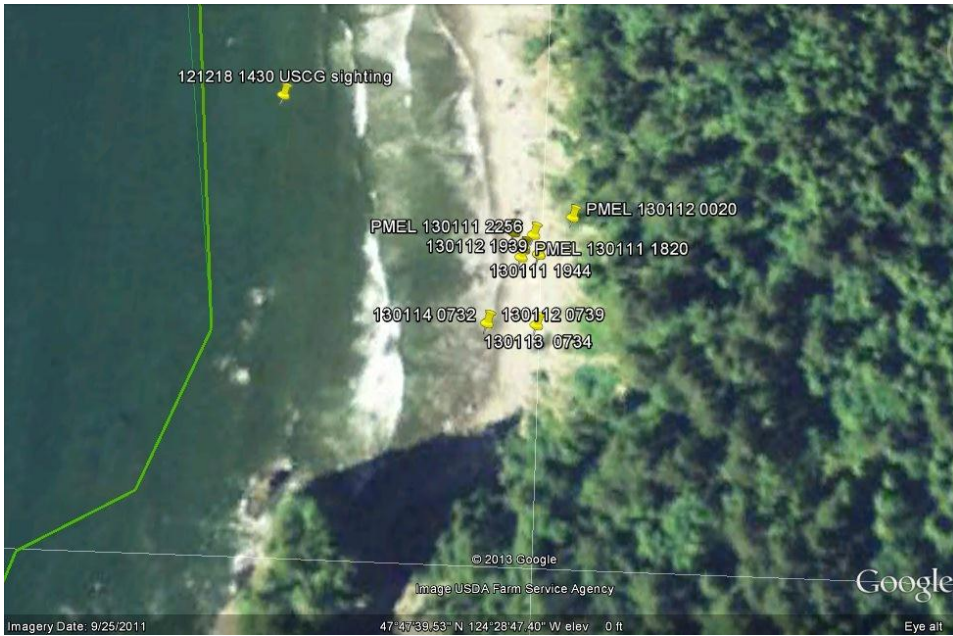
**Figure 11:** Google map with dock locations (Image: NOAA)

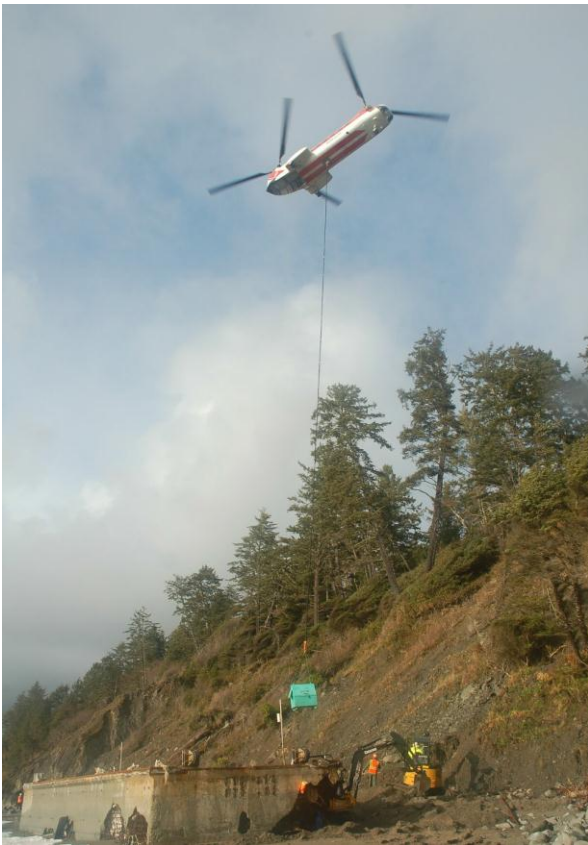
**Figure 12:** Mobilization of equipment with the Vertol helicopter (Photo: The Undersea Company)

Dock removal began on March 16 with the mobilization by the heavy lift Vertol helicopter of equipment, two mini excavators, and fuel (Figure 12). The mini excavators built a berm approximately 10 ft high on the inland side of the dock (Figure 13) to store equipment and supplies safely above high tide. The heavy lift helicopter demobilized that day. During the next week the crew used two mini excavators, three concrete saws, and a variety of smaller tools to cut the concrete parts of the dock (Figure 14), remove the foamed plastic, and fly foamed plastic pieces out using the Jet Ranger helicopter to fly foamed plastic (Figure 15). A Huey helicopter with 3,000 lb lift capacity was used to fly out pieces of concrete.

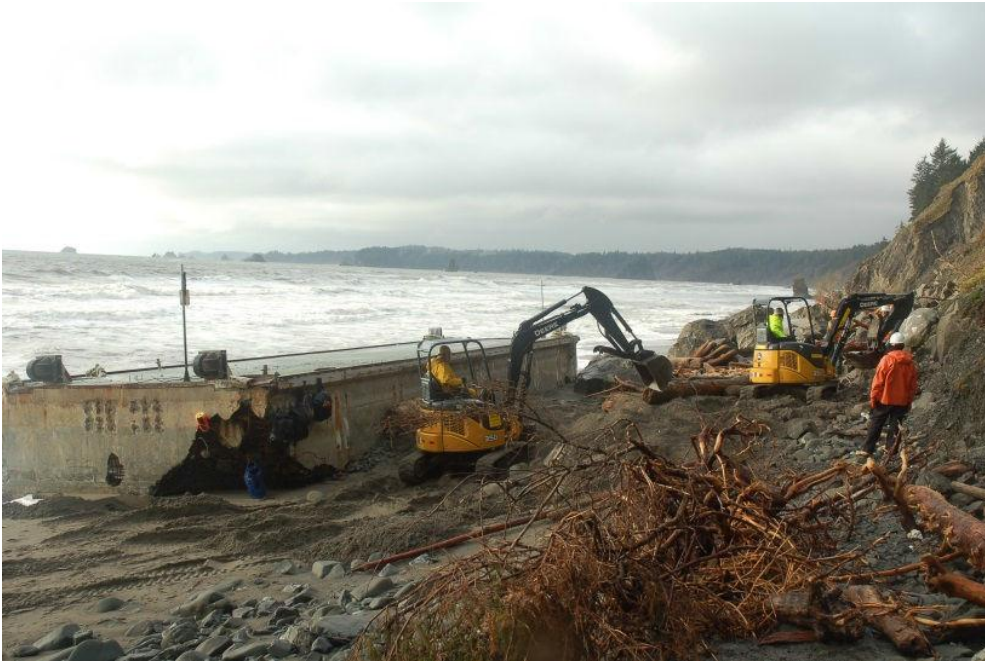
**Figure 13:** Mini excavators constructing the berm (Photo: The Undersea Company)

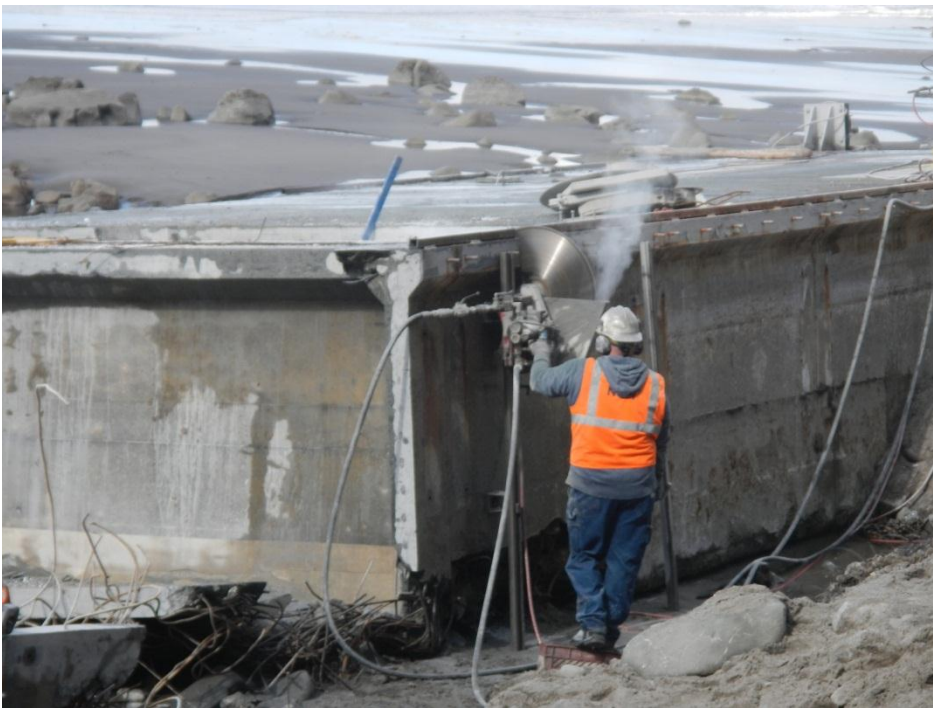
**Figure 14:** Cutting the dock with a concrete circular saw (Photo: NOAA)

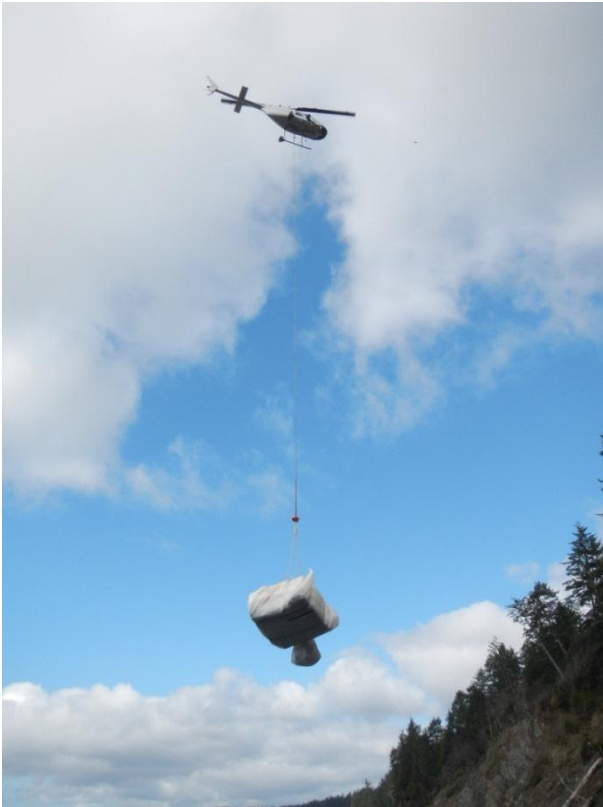
**Figure 15:** Removal of foamed plastic with the Jet Ranger (Photo: NOAA)

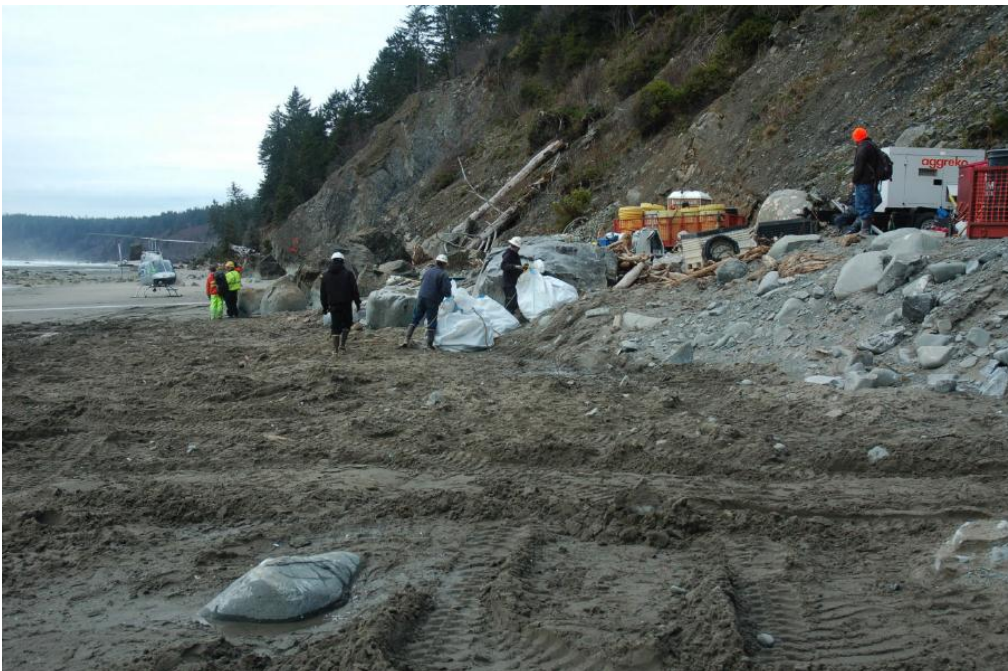
**Figure 16:** Site cleanup after dock removal is completed (Photo: The Undersea Company)

The weather cooperated for the most part. Except for one stormy day on March 20 when operations were halted and work was uninterrupted from sunrise to sunset on most days. OCNMS and ONP staff monitored the work every day throughout the removal operations, and on March 24, they inspected the site and verified that the removal had been completed satisfactorily (Figure 16). The contractor then demobilized the equipment and supplies, using the Vertol helicopter. All the dock debris from the landing site was transported to the Forks landfill, where the contractor confirmed that the majority of the debris would be recycled. By March 26, all removal operations were completed, and the contractor and all equipment had been demobilized.
