NOAA Abandoned and Derelict Vessel Case Study

Dead Horse Bay Vessel Removal (NY)

Contributor: Lisa Scheppeke, American Littoral Society

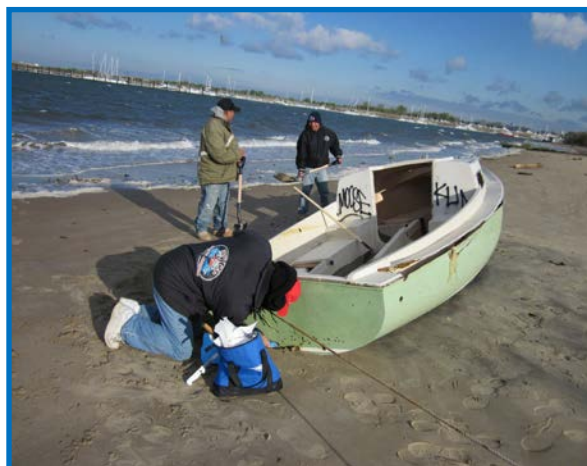
Incident: Boat found on shoreline

Vessel type: Sailboat

Hull material: Fiberglass

Length: 18 ft.

History: Boat was found washed up on the shoreline and the origin or owner is not known.

Removal Methods: The boat was patched and ultimately towed to a marina where it was removed from the water via a hydraulic lift.

Vessel removal summary: The boat was patched and towed from the beach to the marina for disposal.
