Work Task E2: Beal Lake Native Fish

Location: Reach 3, Arizona, Havasu NWR, ½ mile east of River Mile 237

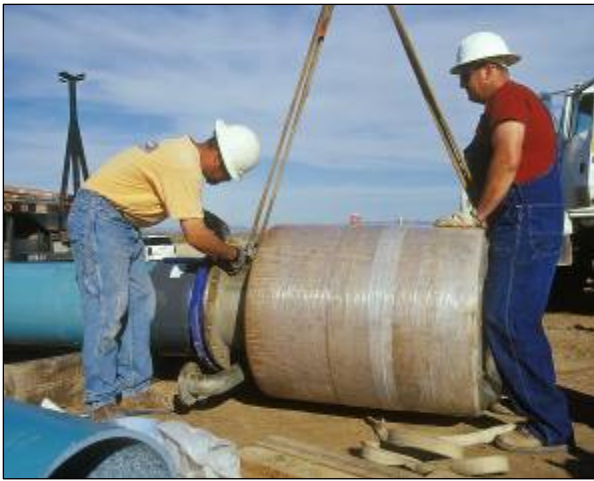
Figure E2a: Assembling the wedge-wire fish screen system.

A cylindrical wedge-wire screen system was installed in spring 2005. The system consists of three 18” diameter PVC pipes installed through the existing rock structure with cylindrical wedge-wire screens installed on each end of the pipes using standard flange connections. An additional 18” pipe was installed which could be screened at a later date if capacity was deemed insufficient. This essentially means that each pipe and screen combination will represent an independent system. An in-line valve was installed in each pipe to allow the pipe to be closed when necessary (i.e., repair or replacement of screens, etc.).

The screens were custom fabricated and purchased from Johnson Screens. The screens are approximately three feet in diameter and approximately three feet long. They are constructed of Z-Alloy, an anti-biofouling nickel-copper alloy developed by Johnson Screens, and are equipped

with an internal diffuser and 3" air backwash system. The screen slot size is 0.6 mm and each screen has a capacity of 1,500 gallons per minute.

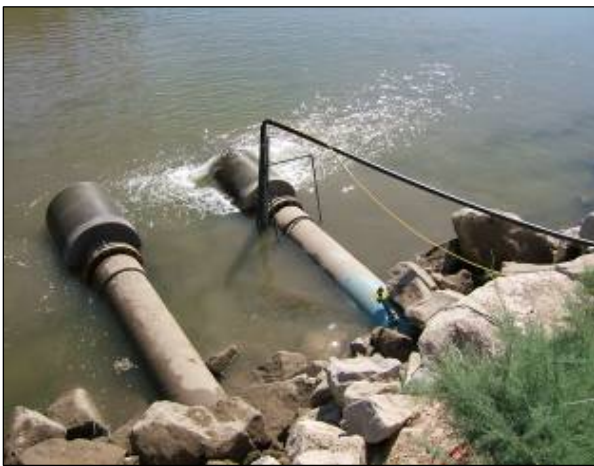
Figure E2b: In situ hydraulic testing of the wedge-wire screens.

The screen system was evaluated after installation to determine the effectiveness and efficiency of the system with respect to screening capabilities, hydraulic performance, and maintenance requirements. This also included a test of the screens' internal backwash systems. The testing involved three independent sampling events during different seasonal conditions and over a number of different flow scenarios. In addition, continuously sampling water level sensors were installed to provide remotely accessible data to assess future screen performance.

Results indicate that the screen system is more than adequate to provide water to balance evaporative losses in Beal Lake. Results also suggest that the system has relatively low maintenance requirements, best handled through regular low-tech cleaning of the screens. Based on the exceptional performance of the contracted services for these evaluations, Phase 2, evaluation of the screen system's biological exclusion capabilities, would be funded in FY06.

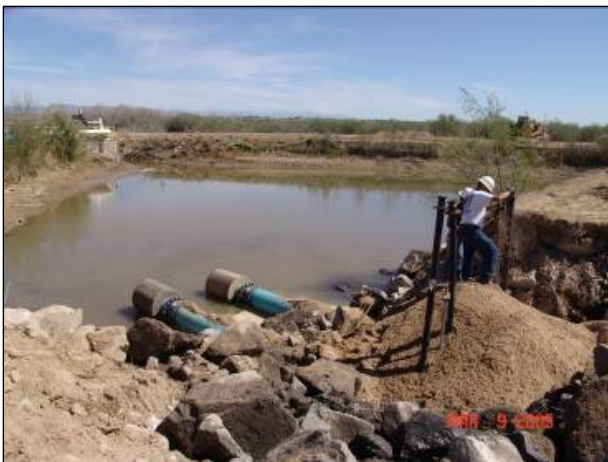
Figure E2c: Installation of the wedge-wire fish screen system.
