Native Riparian Species Seeding Demonstration Project In the Colorado River Delta

Karen Schlatter
Sonoran Institute
January 26, 2012

COLORADO RIVER RIPARIAN RESTORATION SITE NETWORK

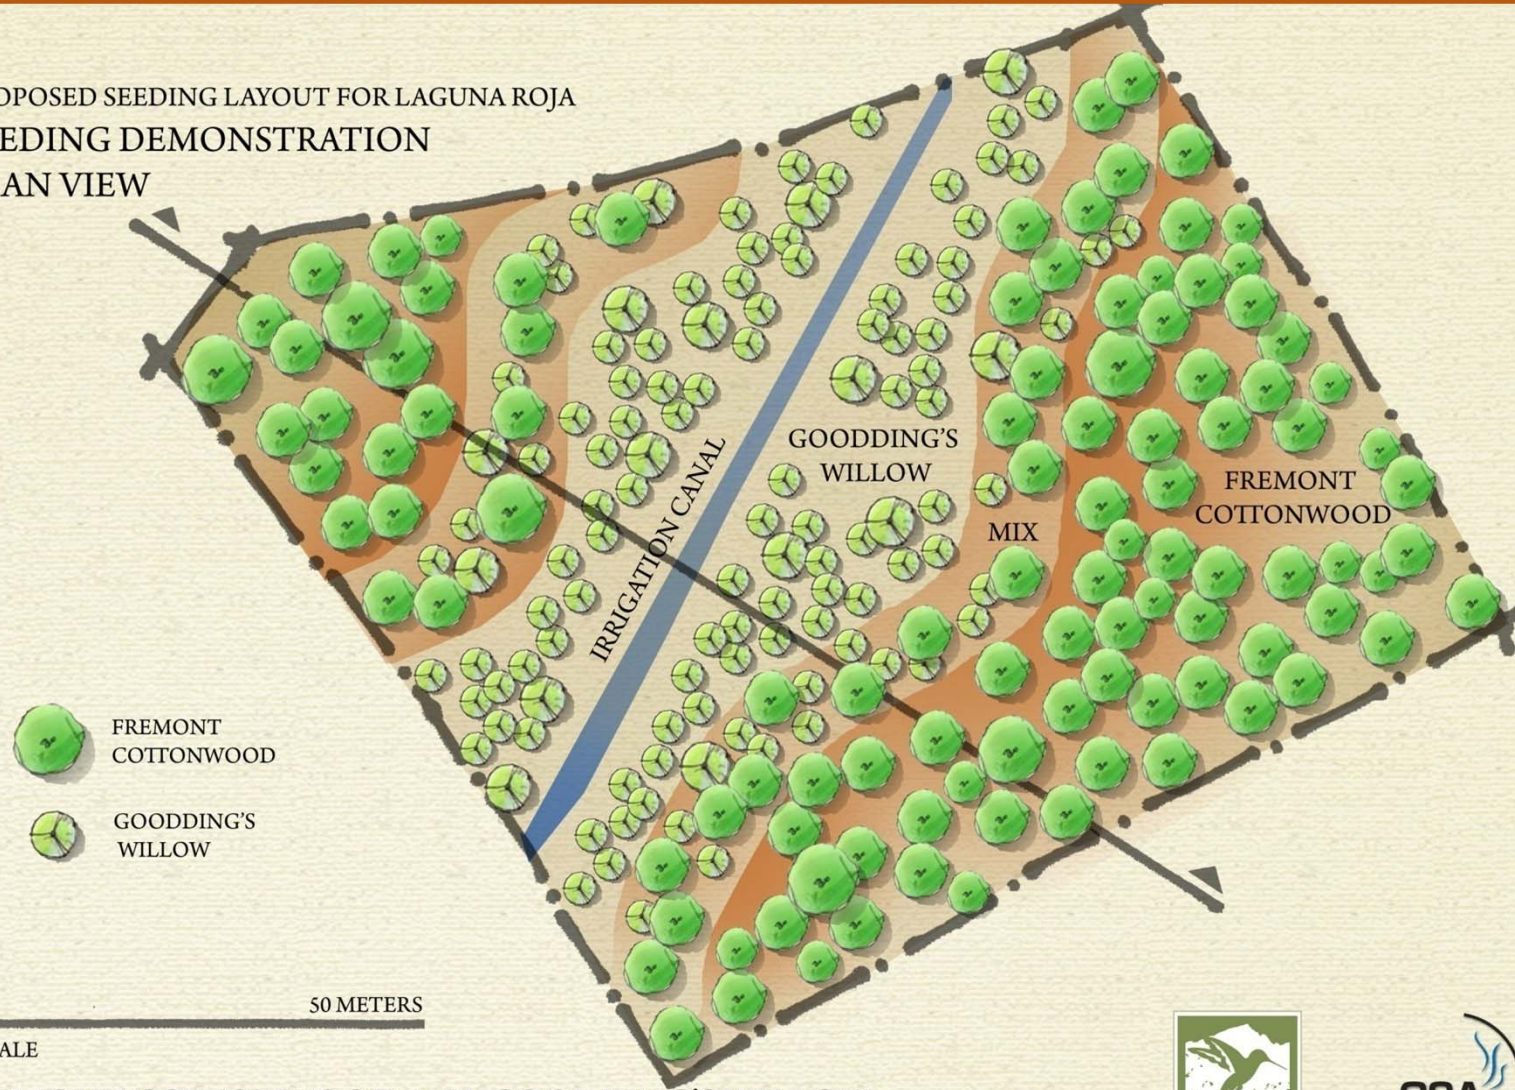
PROPOSED SEEDING LAYOUT FOR LAGUNA ROJA
SEEDING DEMONSTRATION
PLAN VIEW

FREMONT COTTONWOOD AND GOODDING'S WILLOW
HYDROSEEDING DEMONSTRATION

- Desired tree density: 5 trees per square meter or ~20,000 trees per acre
- Species layout: Gooding's willow nearest to irrigation canal; Fremont cottonwood furthest from canal; mixed cottonwood and willow in area between
- Used tree establishment rate of 1% and 10% respectively for Gooding's willow and Fremont cottonwood (GSA 2008, 2009) to determine seeding rate

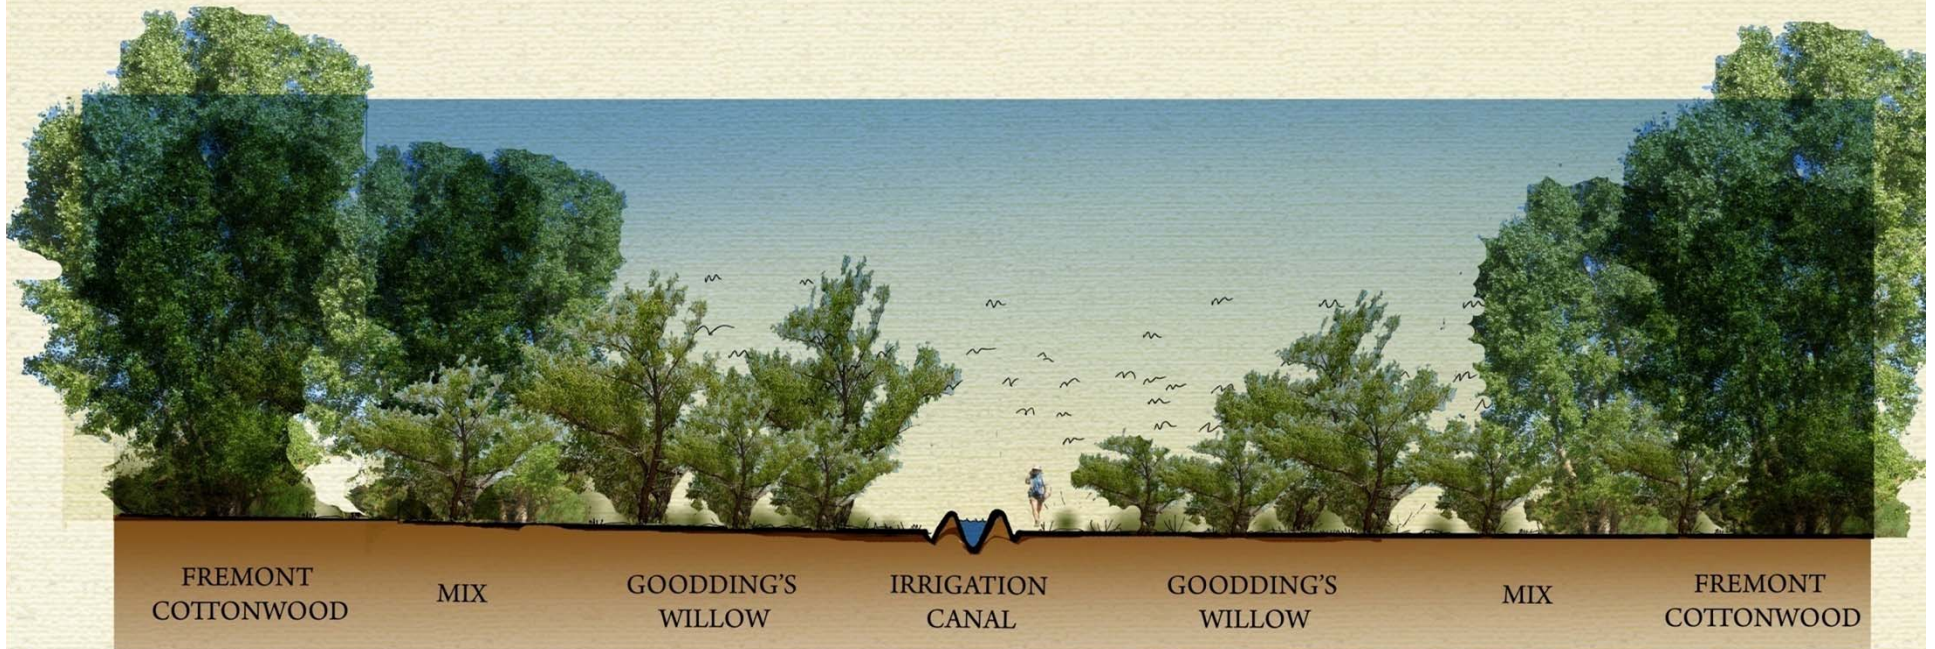
PROPOSED SEEDING LAYOUT FOR LAGUNA ROJA
SEEDING DEMONSTRATION
SECTION VIEW

FREMONT COTTONWOOD AND GOODDING'S WILLOW
HYDROSEEDING DEMONSTRATION

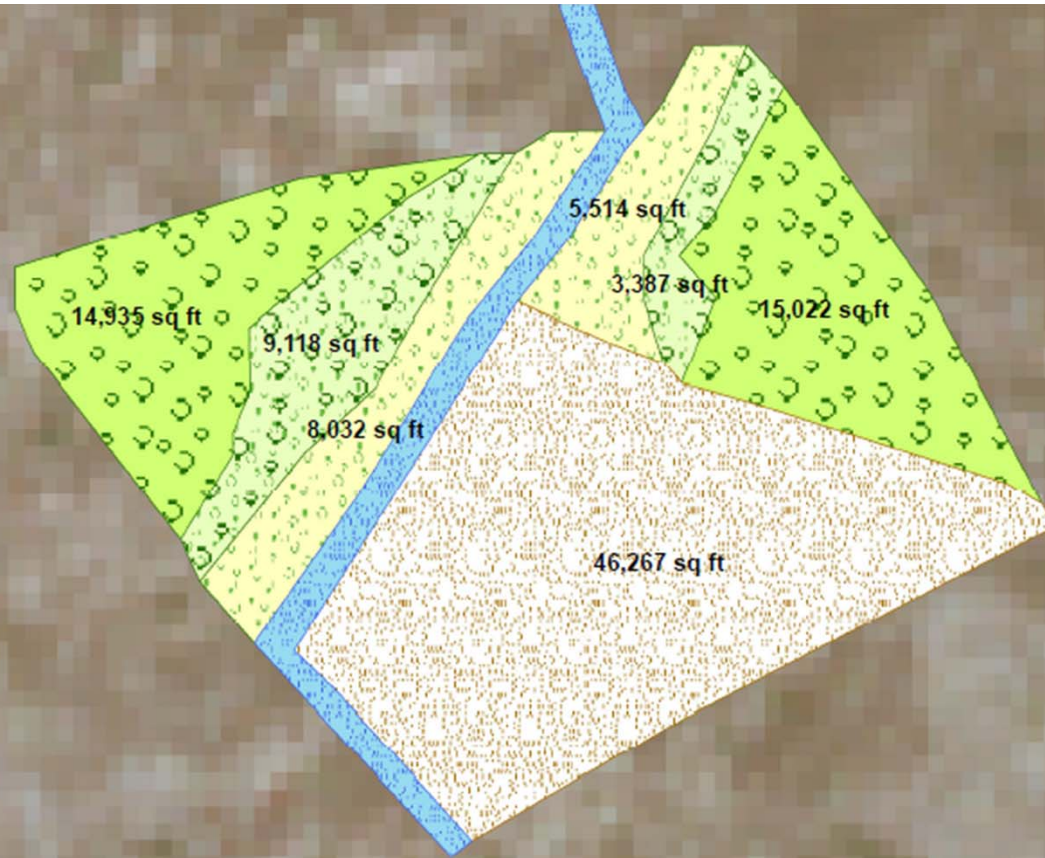
Demonstration project seeding layout - 2011
