# Environmental Assessment Sheep Creek Irrigation Company Cedar Hollow Lateral Salinity Control Project

PRO-EA-13-001

Provo Area Office Provo, Utah Upper Colorado Region

Daggett County, Utah and Sweetwater County, Wyoming Upper Colorado Region Provo Area Office Provo, Utah

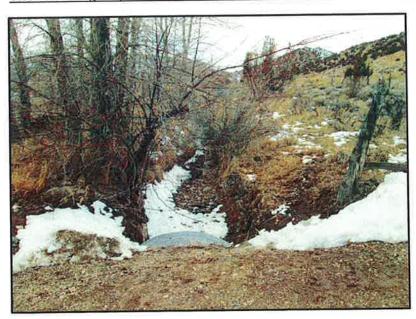
Photo 1: Looking at the Cedar Hollow lateral in mid-March, outside of the irrigation season. The channel is generally dry outside of the irrigation season. Scattered Russian olives, coyote willow, and cottonwoods have recruited along the banks of the lateral.

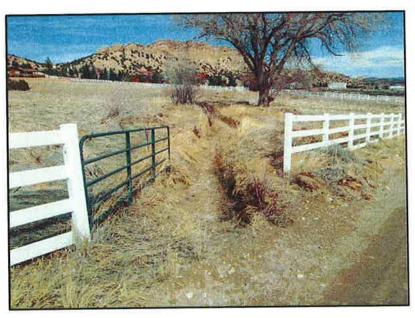
Photo 2: Another mid-March look at the lateral, outside of the irrigation season. Mixtures of reed canary grass, Garrison meadow foxtail, and smooth brome dominate the herbaceous structure along the banks of the lateral.

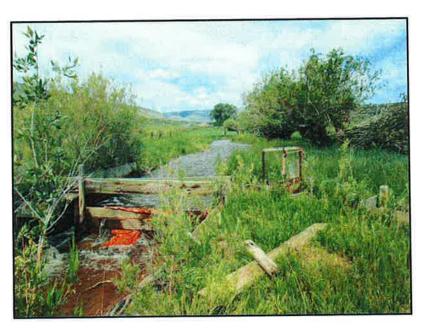
Photo 3: Looking upstream (westerly) at the existing diversion structure that feeds the Cedar Hollow lateral from Birch Spring Draw. This structure is planned to be replaced within the same footprint.

The existing diversion structure at the start of the project would be replaced with a new structure. The new diversion structure would include a screening structure to prevent debris from entering the pipeline. The main pipeline would have splitter boxes to deliver water to individual farms. Gates and valves would be installed to allow operators to better control the allocation of water along this system. This

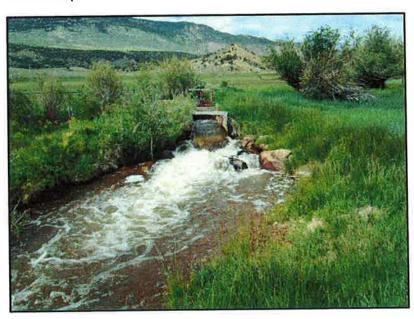
Photo 4: Stemming from the diversion structure (Photo #3) this photo illustrates the start of the Cedar Hollow lateral.

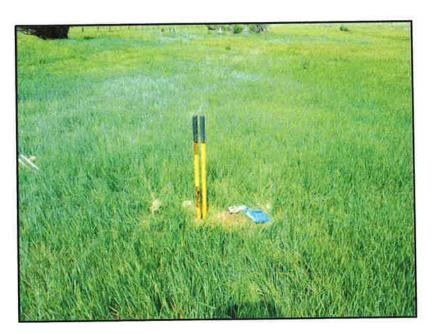
Photo 5: Soil Test Pit (STP) #1 is an upland location and is situated 55 feet landward (north) of the inlet structure, on the left bank.

These paired STPs are located inland of the OHWM of the left bank of the Cedar Hollow lateral. These STPs were established perpendicular to the inlet structure where water is diverted from Birch Spring Creek. STP #1 and STP #2 were located 55 feet and 80 feet north of the inlet structure respectively. STP #1 represents the typical upland setting with vegetation that included quackgrass, whitetop, alfalfa, and mountain brome. Saturation was observed at a depth of 23 inches. STP #2 characterizes a spring fed swale that parallels Birch Spring Creek in close proximity to the inlet structure. This emergent swale also receives tail water from adjacent irrigation practices. STP #2 meets all three of the wetland criteria. The water table was observed at a depth of 4 inches, and the vegetation was composed entirely of either OBL or FACW species. The vegetation at STP #2 included Garrison creeping meadow foxtail, soft-stem bulrush, Nebraska sedge, and Baltic rush.

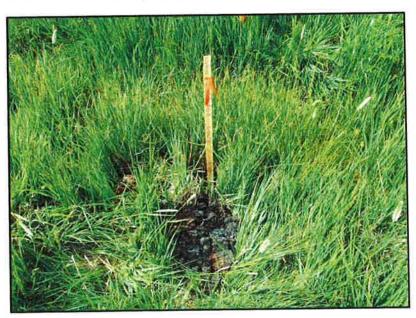
Photo 6: STP #2 is a wetland location that is paired with STP #1. STP #2 is located 80 feet landward (north) of the inlet structure, on the left bank.

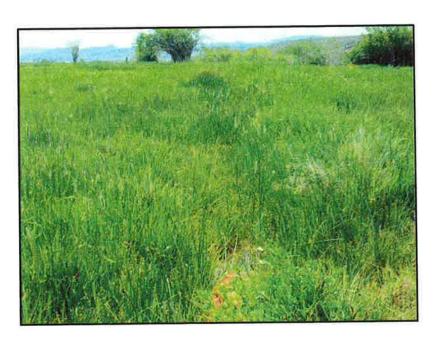
Photo 7: View of the emergent wetland that is situated adjacent/parallel to Birch Spring Draw immediately north of the inlet structure. A mixture of Garrison meadow foxtail, Nebraska sedge, Baltic rush and soft-stem bulrush dominates this wetland area.

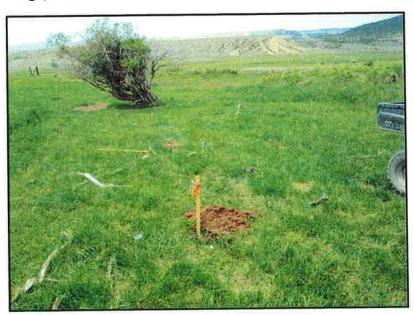
Photo 8: STP #3 is an upland location that is 91 feet north of a depressional wetland/stock pond. This STP is located halfway between the lateral and the depressional wetland. STP #3 was dug at a low topography break along the anticipated pipeline alignment.

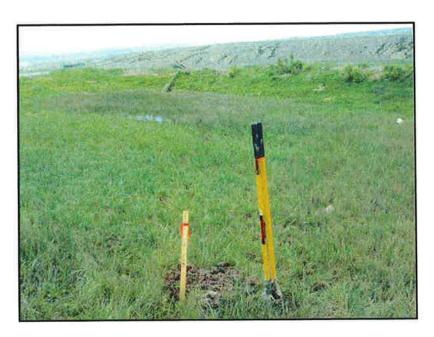
Photo 9: STP #4 is a depressional wetland. This STP is 9 feet within the wetland boundary and is paired with STP #3. Common spike-rush dominates this wetland area.

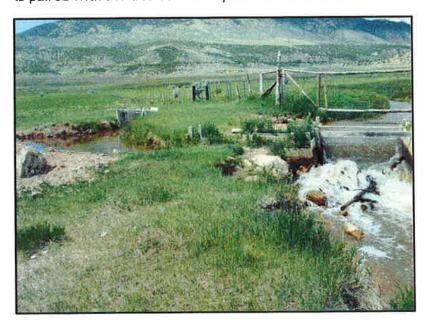
Photo 10: View of the stock pond next to Birch Spring Draw. Water is piped from this stock pond into the wetland area illustrated in Photo 9.

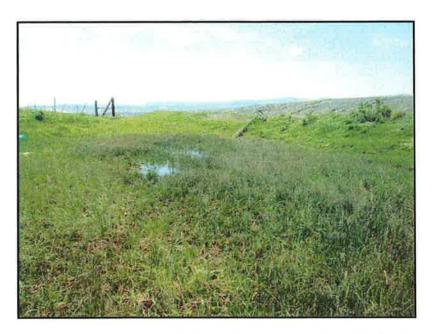
Photo 11: Another view of the wetland captured by STP #4. A manmade dike constructed along the southern side impounds the water in this wetland.

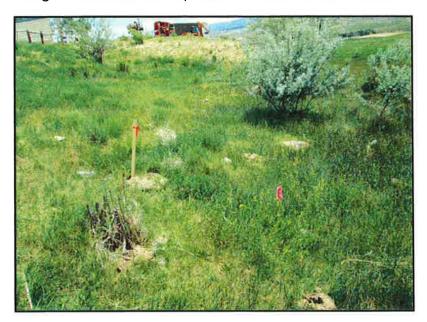
Photo 12: STP #5 is marked with the lathe and orange flagging. STP #5 is an upland location on the northeast side of habitat replacement site. Ant hills were observed between STP #5 and the wetland boundary (pink pinned flag).

This pair of STPs were established along a transect linked to the sloped wetland that is contained within the habitat replacement site. STP #5 was characterized as an upland setting. STP #5 was dry to a depth of 20 inches and no redox features were encountered in the soil profile. The vegetative community at STP #5 included rabbitbrush, greasewood, Russian olive, alfalfa, whitetop, orchard grass, mountain brome, quackgrass, Dyer's woad, and common plantain. At STP #6 the vegetation was dominated by OBL and FACW species such as Baltic rush, seaside arrow-grass, poison hemlock, and water sedge. The water table was encountered at a depth of 7 inches and the presence of a hydrogen sulfide odor indicated that hydric soils were present.

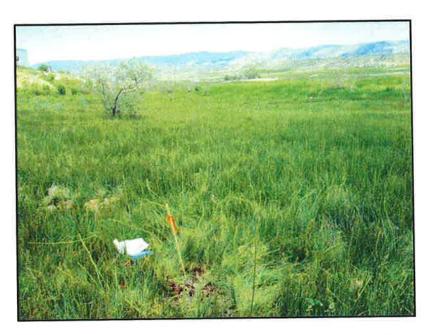
Photo 13: STP #6 captures the sloped wetland feature within the habitat replacement site. The wetland component of habitat replacement site is dominated by Baltic rush, seaside arrow grass, and scattered Russian olives.

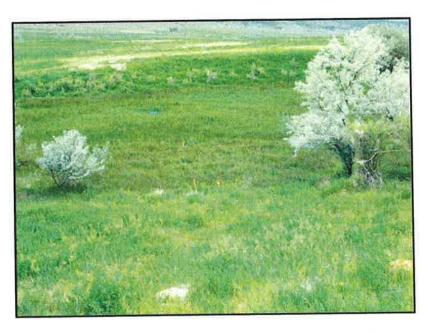
Photo 14: A perpendicular view looking along transect #3, which contains STP #5 and #6. The habitat replacement site contains a sloped wetland feature.

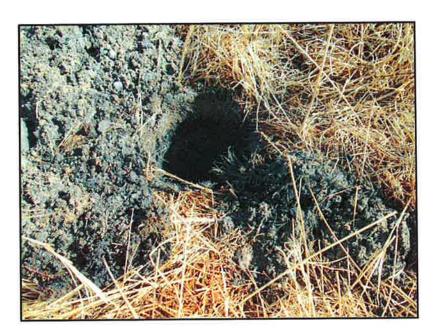
Photo 15: Looking at STP #7, which is a wetland pit, nearest to the eastern terminus of the project footprint. STP #7 helps to identify a sloped wetland feature located near the overflow pipe alignment option #2. The water table was located at a depth of 10 inches at STP #7.

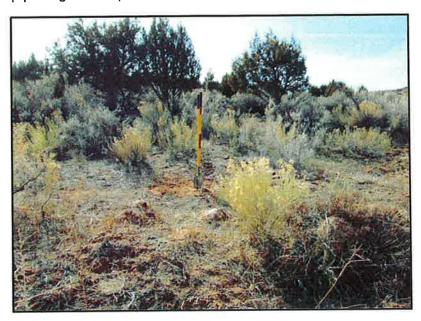
Photo 16: Looking at STP #8, which is the upland pit that is paired with STP #7. This upland area contains scattered tall sage brush, rabbit-brush, junipers and greasewood.

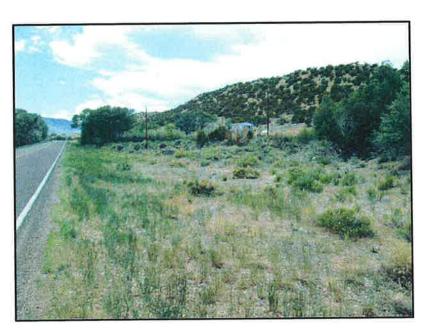
Photo 19: Looking at staging area #4; this photo was taken from the eastern corner looking westerly, along Hwy 43. This upland area is dominated by crested wheatgrass, mountain brome, quackgrass, rabbit-brush, and tall sagebrush.

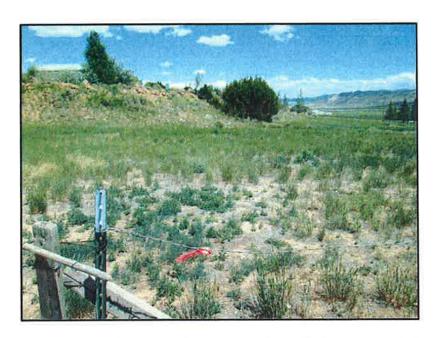
Photo 21: Looking at staging area #6, from 4<sup>th</sup> East St., easterly along the new pipeline alignment. This is the southeast corner of the staging area. This area was previously used as a dump site for the Town of Manila. The area is dominated by crested wheatgrass and cheatgrass. The entire staging area is an upland site.

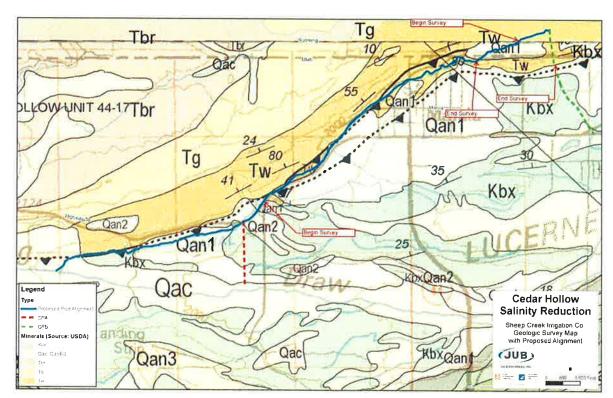
**Figure 1.** Geologic map showing canal lateral (blue line). Abbreviations of geologic formations and unit descriptions are provided in Table 1. Geologic Map from Sprinkle (2006).

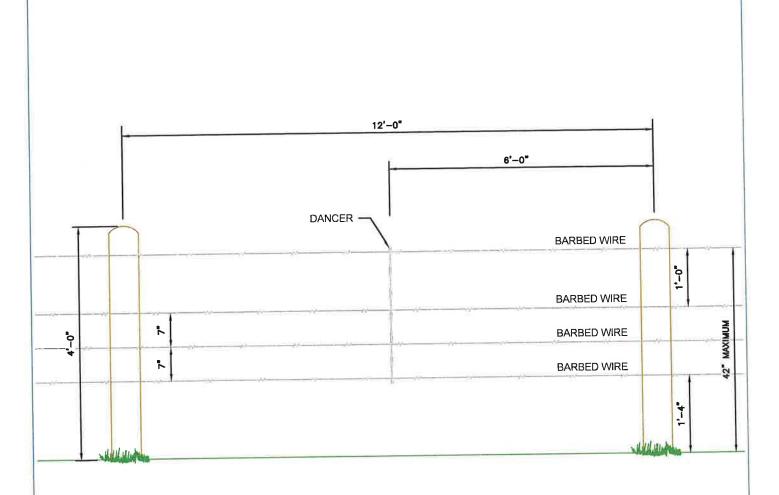
SHEEP CREEK IRRIGATION COMPANY
HABITAT REPLACEMENT PLAN
TYPICAL PERIMETER FENCE (4-WIRE) DESIGN

NOTE: TYPICAL FENCE DESIGN MODELED FROM HANOPHY'S (2009) IDEAL WILDLIFE - FRIENDLY FENCE DETAIL.

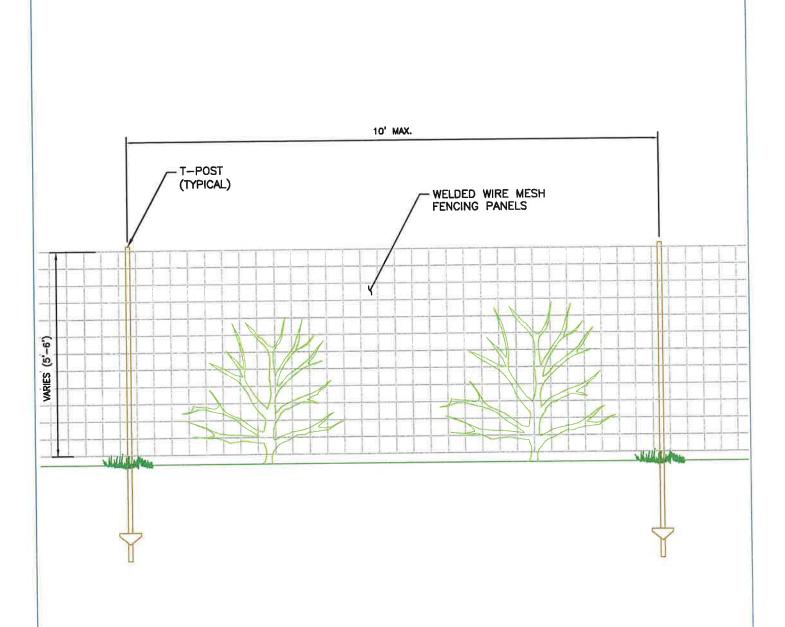
SHEEP CREEK IRRIGATION COMPANY
HABITAT REPLACEMENT PLAN
TYPICAL EXCLUSIONARY FENCE DESIGN

NOTE: TYPICAL FENCE DESIGN YIELDS PANELS WITH WIRE DIAMETER (3-6mm) AND MESH (50-80mm x 50-80mm).

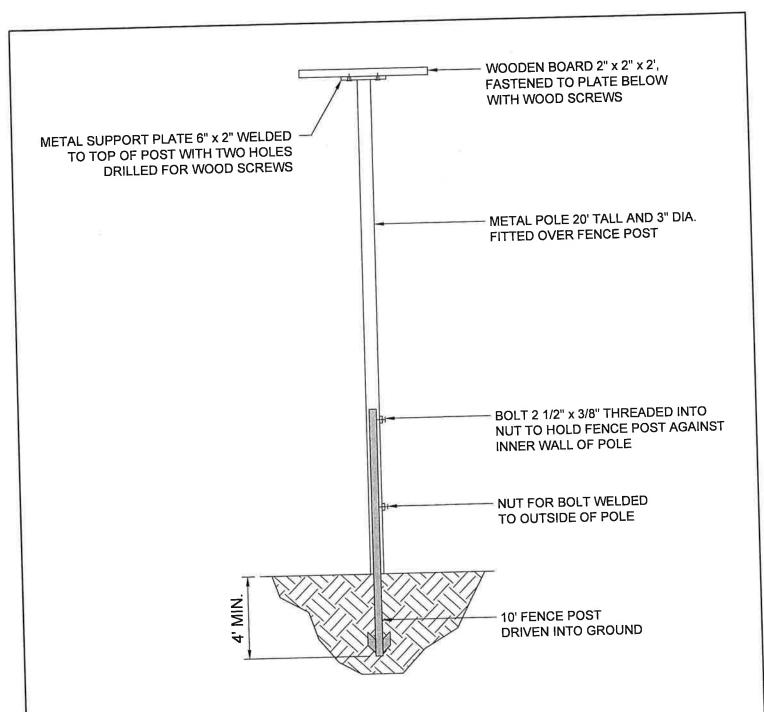
- PERCH SHOULD BE ASSEMBLED IN A WORKSHOP ACCORDING TO THIS DIAGRAM. THE 2' LENGTH OF 2" x 2" UNTREATED PINE BOARD SHOULD BE BOLTED TO THE 6" PIECE OF FLAT METAL THAT HAS BEEN ARC WELDED TO ONE END OF THE METAL POLE. TWO HOLES 1/2" IN DIAMETER SHOULD BE DRILLED IN THE POLE APPROXIMATELY 18" AND 48" FROM THE BOTTOM. NUTS FOR THE 2 1/2" x 3/8" BOLTS SHOULD BE ARC WELDED TO THE OUTSIDE OF THE POLE IN ALIGNMENT WITH THESE HOLES.

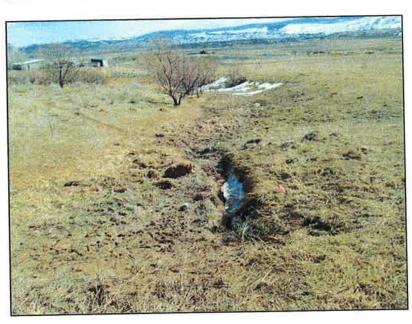
Photo 1: This photo illustrates the North West corner of the Habitat Replacement Site (HRS). An existing 6" overflow pipe, stemming from the stock/irrigation pond toward the north, enters the HRS at this location.

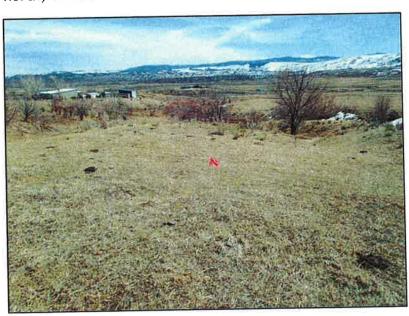
Photo 2: This photo illustrates the north central look of the HRS. All of the trees in the foreground are Russian olives. Approximately 300 Russian olive trees are planned to be removed from this site. The perching pole will be installed 100 feet from this pink flag.

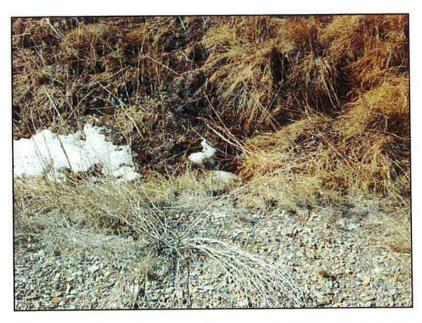
Photo 6: This photo shows the 12-inch outlet pipe that is located at the south end of the HRS. This pipe traverses through Bennion Lane. No modifications are proposed to this pipe.
