Re: Vision 2020 – Final Report  
Contract No. R10PC80497  
TCG Project No.: 10124

# Evaluation of an Industry Suggested Protocol for Measuring the Performance of Reinforcing Steel Corrosion Mitigation Technologies for Concrete Repairs

**Bureau of Reclamation**

**TCG Project No. 10124**

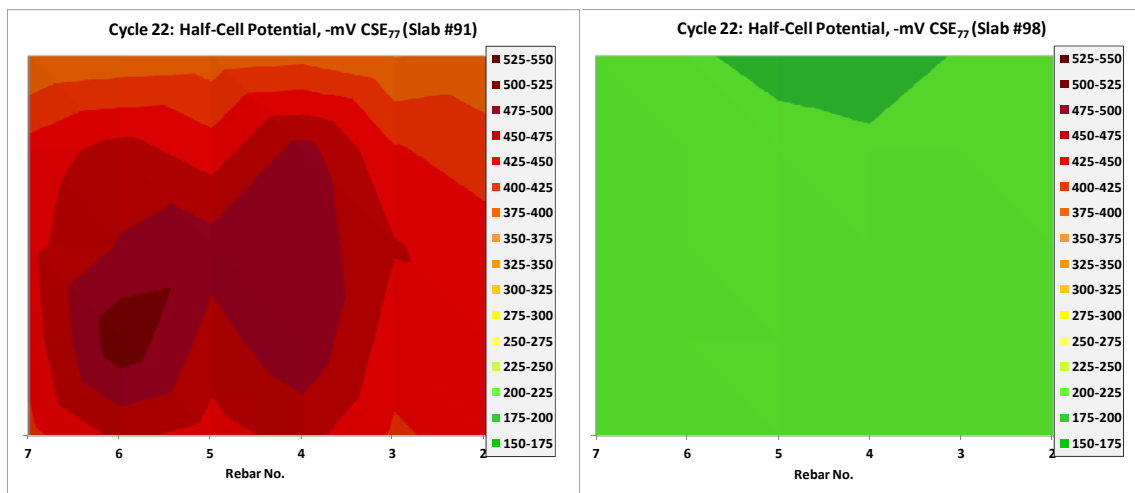
Figure 6 - Corrosion potential maps of slabs. Slab on the left is a control that has a high corrosion rate, and several sharp contours (color gradations). Slab on the right was treated with silane and is passive.

Figure 6 shows a comparison between a control slab and one treated with silane. The reduction of contours and more positive corrosion potentials in the silane treated slab are indicative of passive behavior, whereas the control slab shows steep contours and highly negative potentials associated with high corrosion rates.

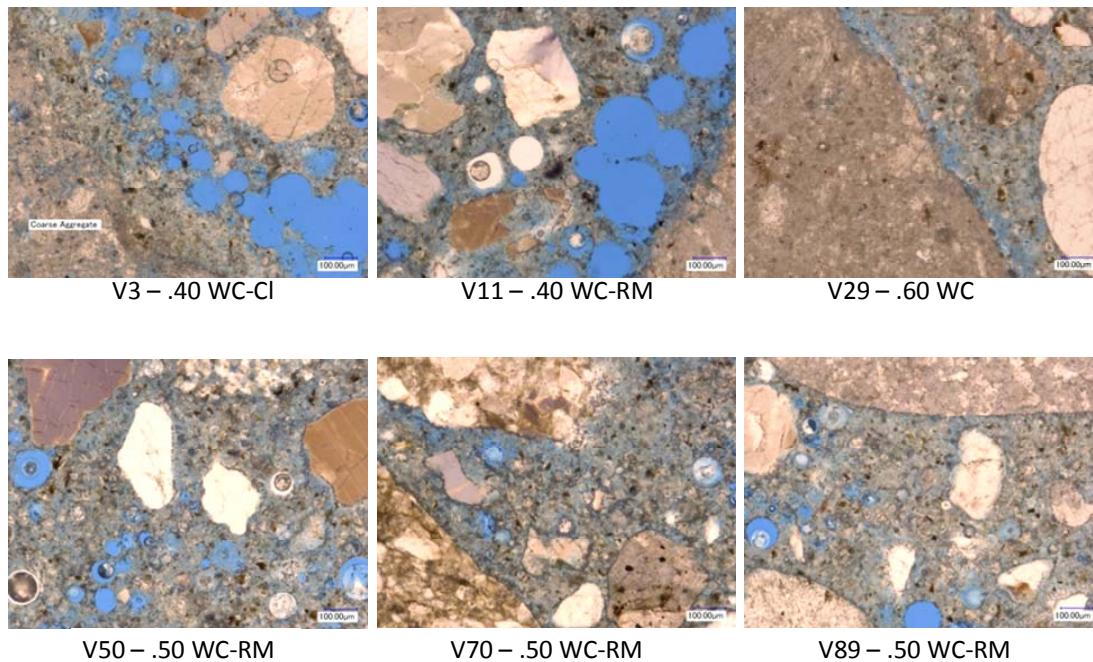
**Figure 4 – Thin section analysis of concrete batches, where blue represents porous areas, the w/c=0.40 concrete the air void shapes are clearly visible. Slab 50 is from Batch #3, Slab 70 from Batch #4 and Slab 89 from Batch #5**

The reduced times to corrosion and more porous structure found are in agreement with the rapid chloride permeability results for Batch 1 versus the other mixtures. Though Batch 1 can't be used to represent a low permeability concrete, it can be used to show the effect of a higher permeable concrete. As expected increasing the permeability of the concrete does reduce the time to corrosion initiation, as discussed in the following section.

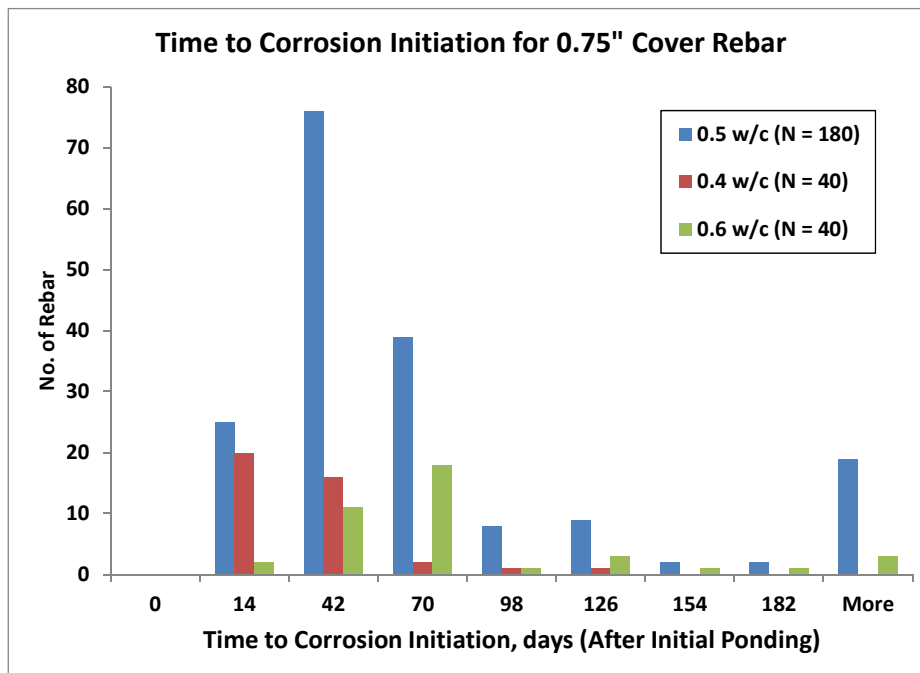
**Figure 7 – Histogram of Time to Corrosion Initiation for 0.75-inch Cover Rebar**

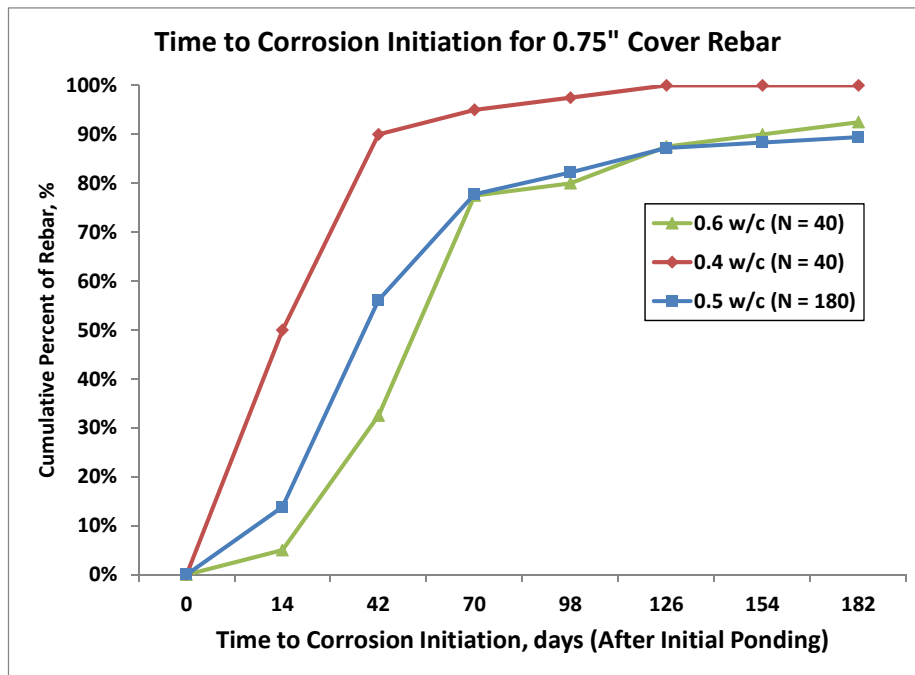
Figure 8 – Cumulative Distribution of Time to Corrosion Initiation for 0.75-inch Cover Rebar

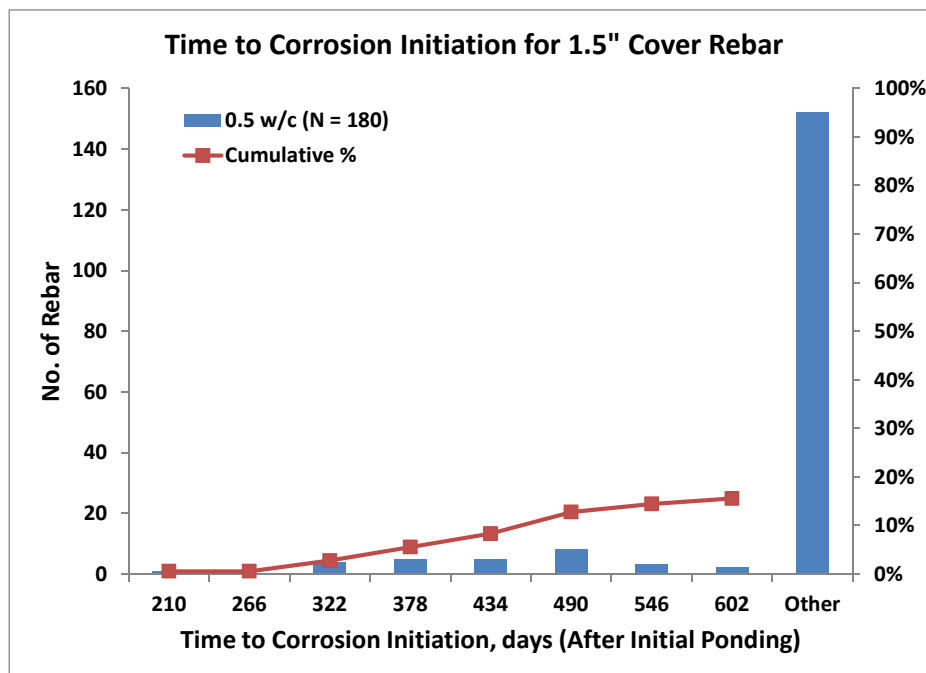
Figure 9 – Histogram and Cumulative Distribution of Time to Corrosion Initiation for 1.5-inch Cover Rebar

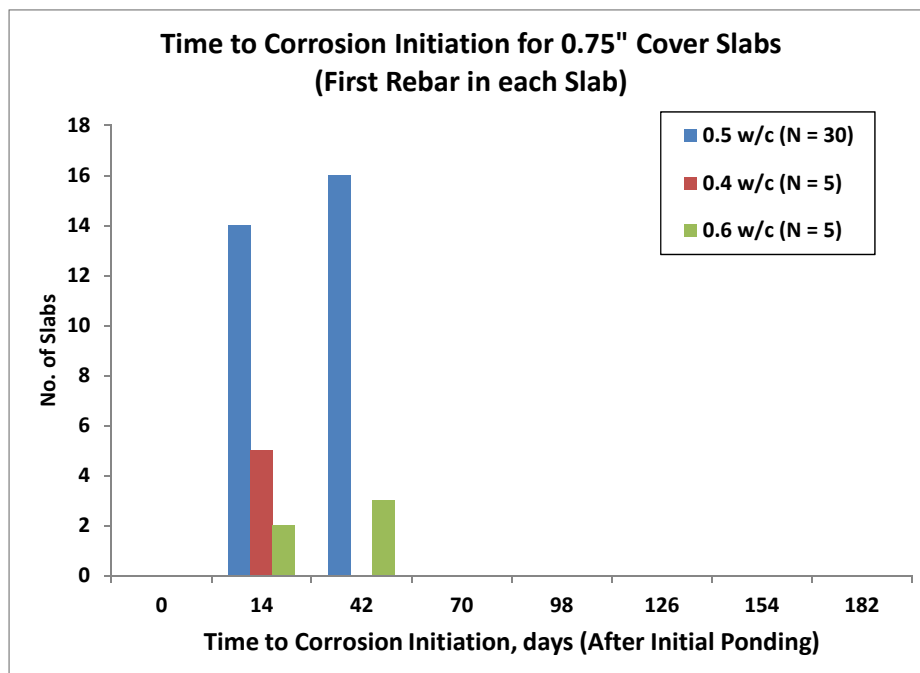
**Figure 10 – Distribution of time to corrosion initiation for first rebar in 0.75-inch cover slabs**

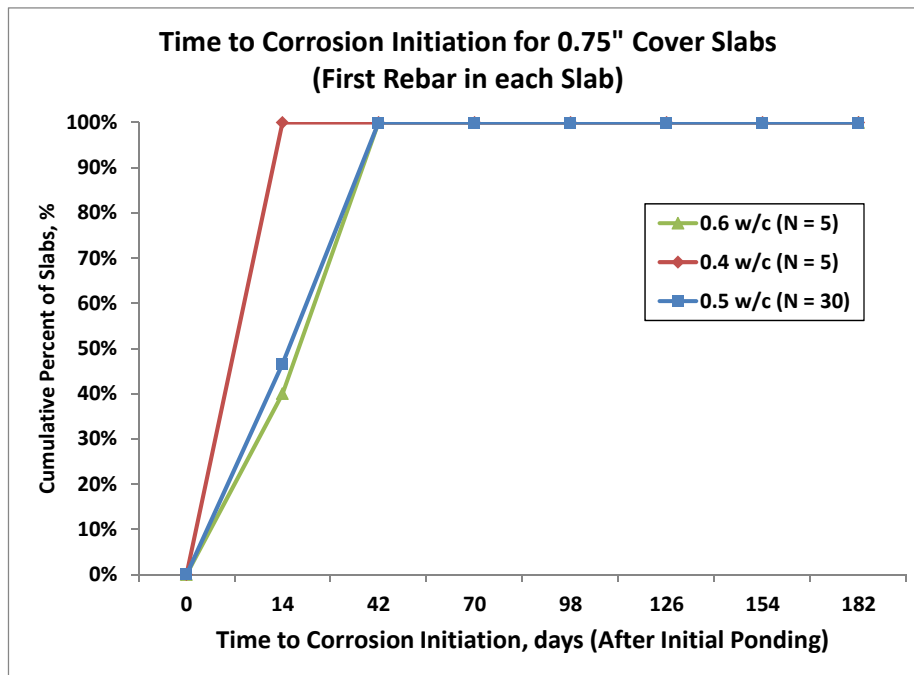
Figure 11 – Cumulative distribution of time to corrosion initiation for first rebar in 0.75-inch cover slabs

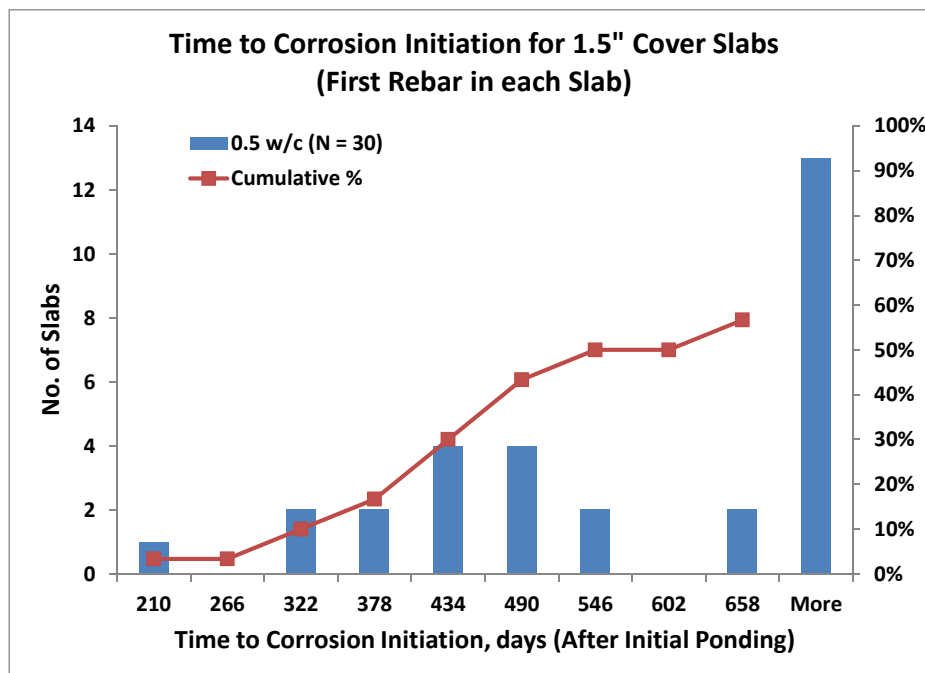
Figure 12 – Distribution of time to corrosion initiation for first rebar in 1.5-inch cover slabs

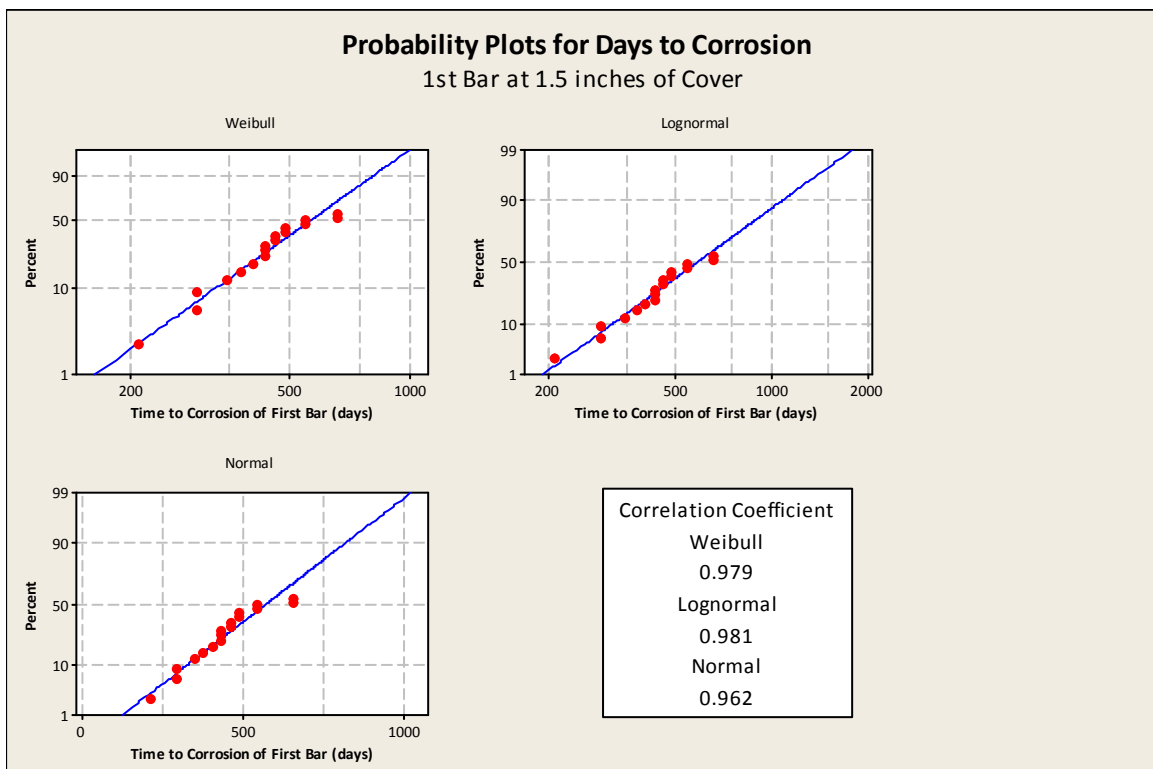
**Figure 13 – Estimate of time to corrosion initiation distributions for first rebar in 1.5-inch cover slabs**

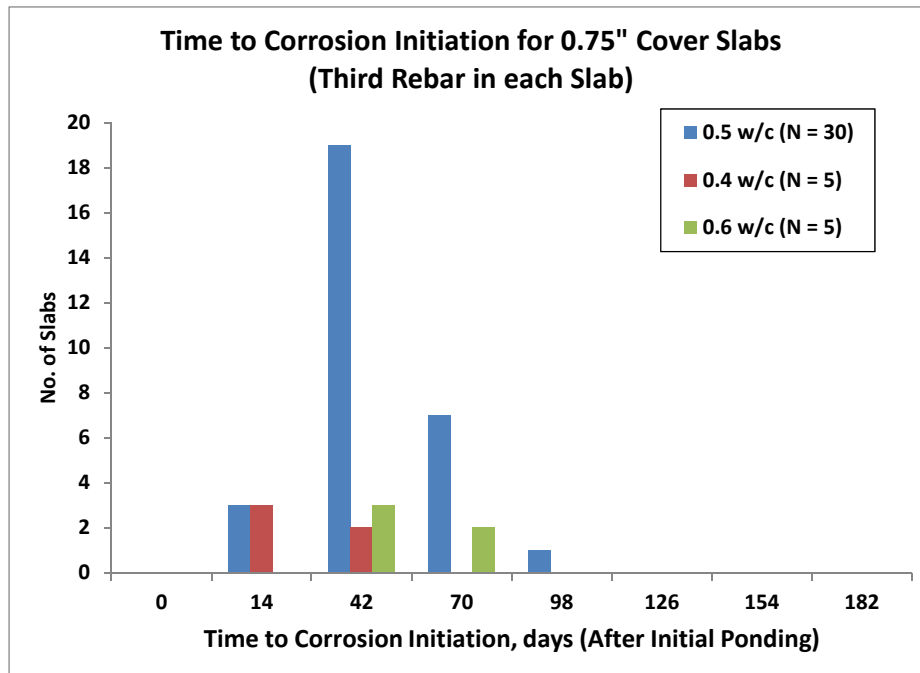
Figure 14 – Distribution of time to corrosion initiation for third rebar in 0.75-inch cover slabs

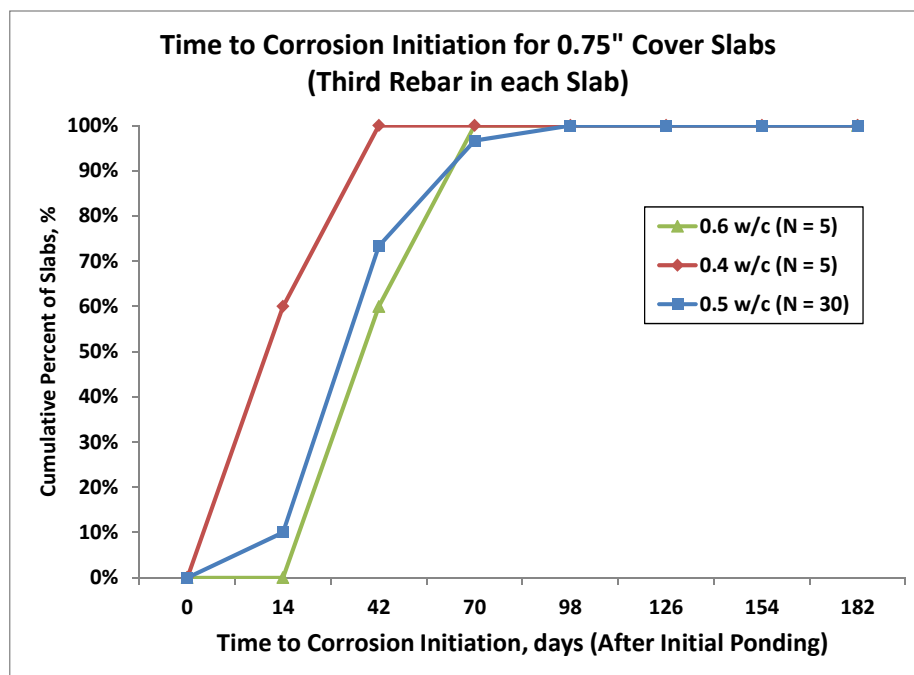
Figure 15 - Cumulative distribution of time to corrosion initiation for third rebar in 0.75-inch cover slabs

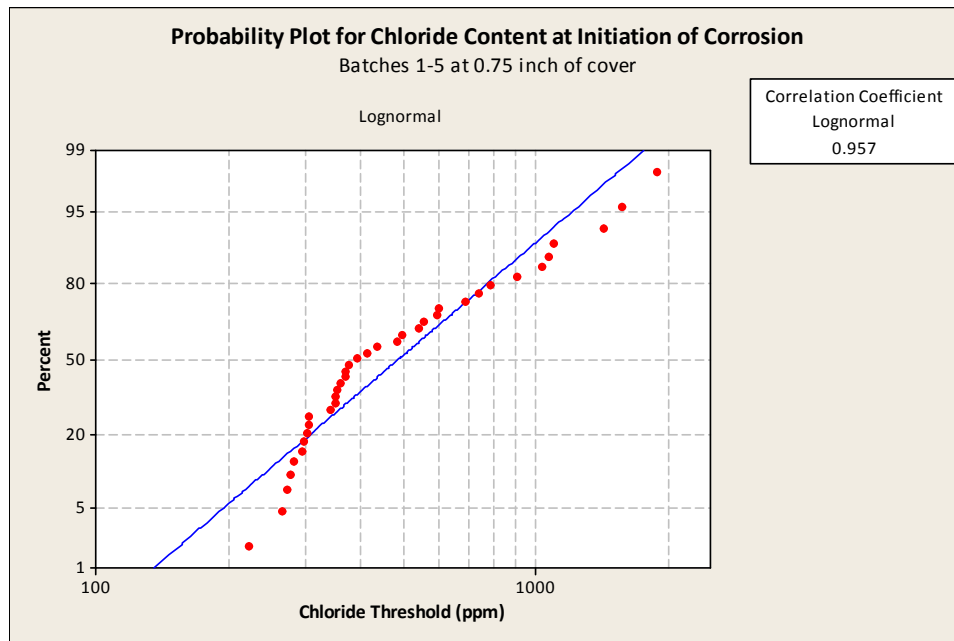
Figure 16 – Chloride threshold distribution (Batches 1-5, 0.40-0.60 w/c, 0.75-inch cover)

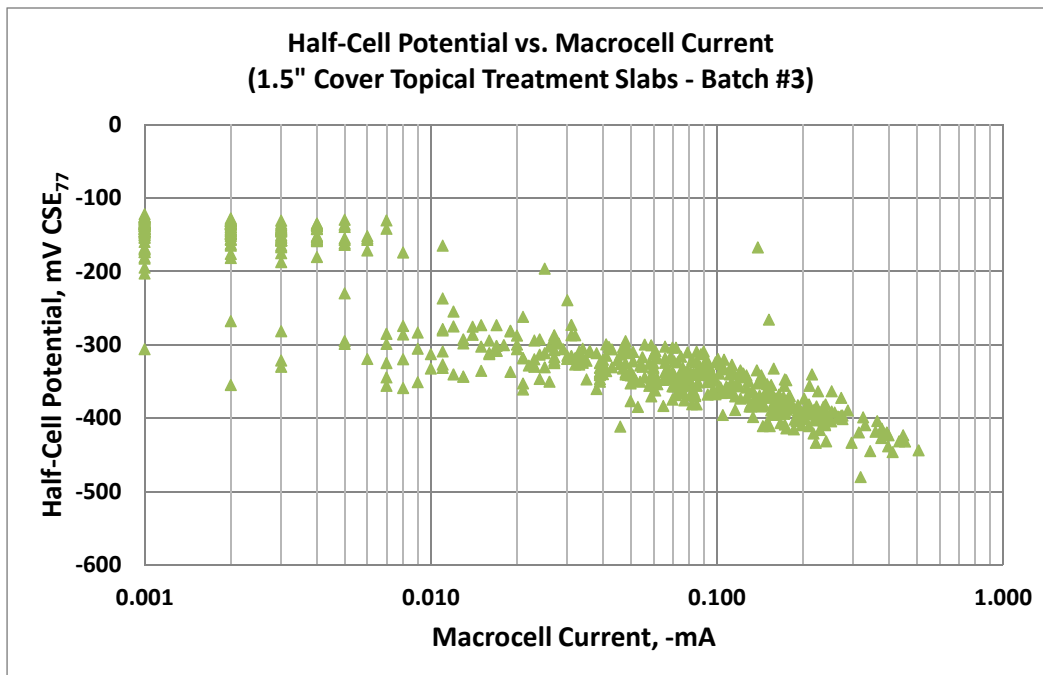
Figure 17 – Semi-Log plot of macrocell current vs. half-cell potential as a function of time (1.5-inch cover, Batch #3)

The corrosion initiation definition for this project was evaluated by plotting the half-cell potential as a function of current on a semi-log scale for all measurements. Figure 17 through Figure 19 provide the plots for Batches #3-5 for 1.5-inch cover slabs. In all batches the data becomes linear once active corrosion starts, typically around a half-cell potential of -300 mV CSE<sub>77</sub> and macrocell current above 0.030 mA.

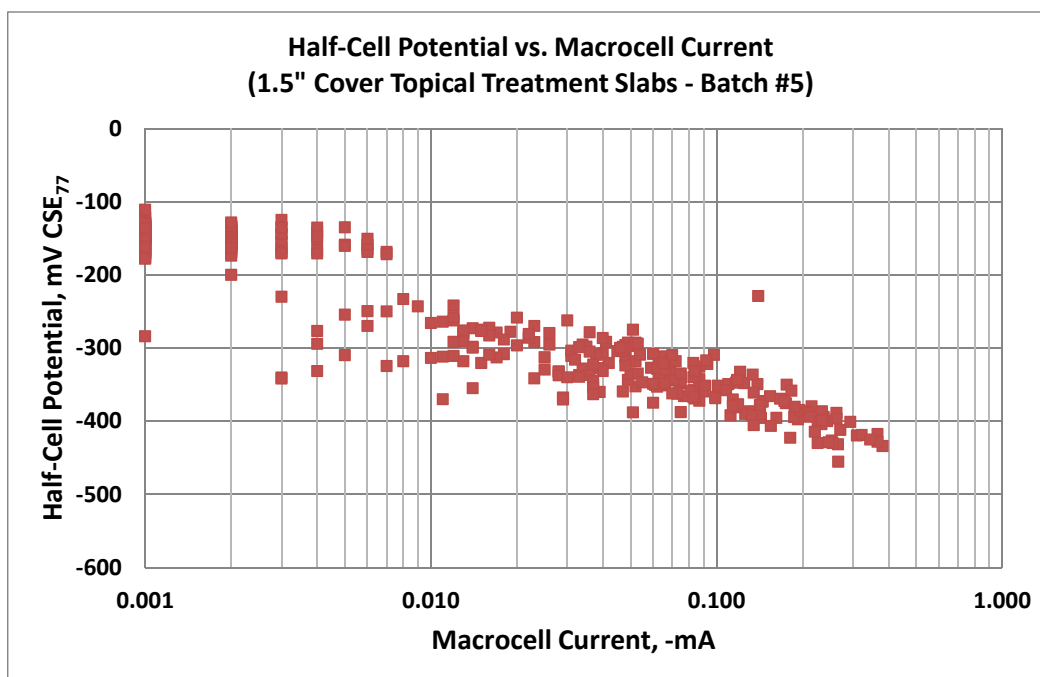
Figure 19 - Semi-Log plot of macrocell current vs. half-cell potential as a function of time (1.5-inch cover, Batch #5)

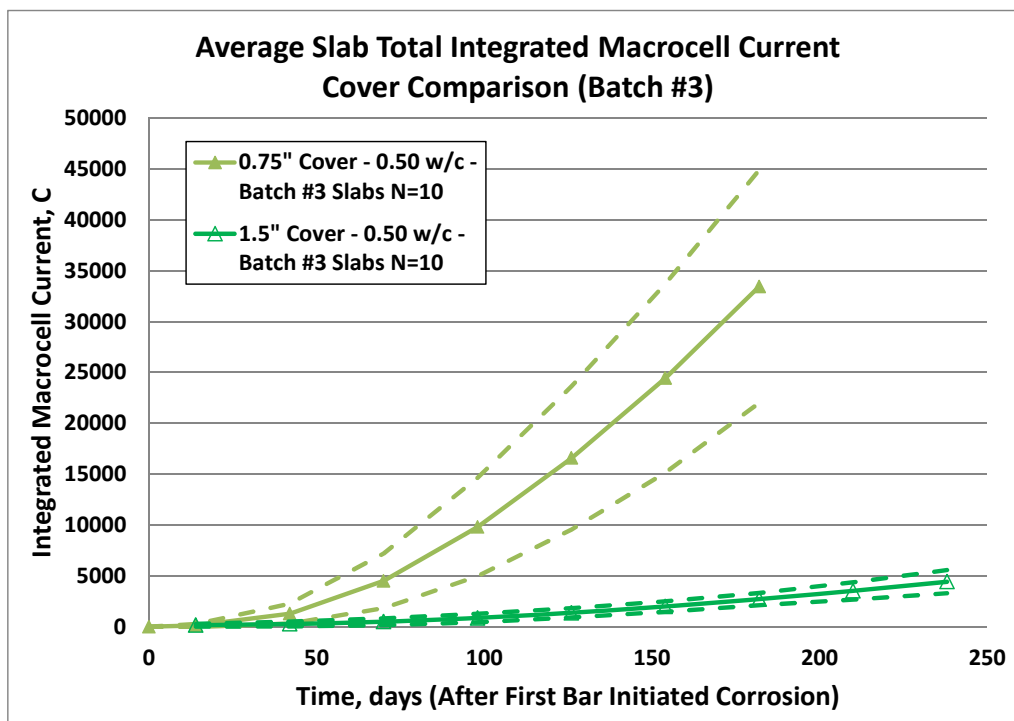
**Figure 22 – Corrosion rate as a function of time for both concrete covers in Batch #3 (data shown is after corrosion has initiated)**

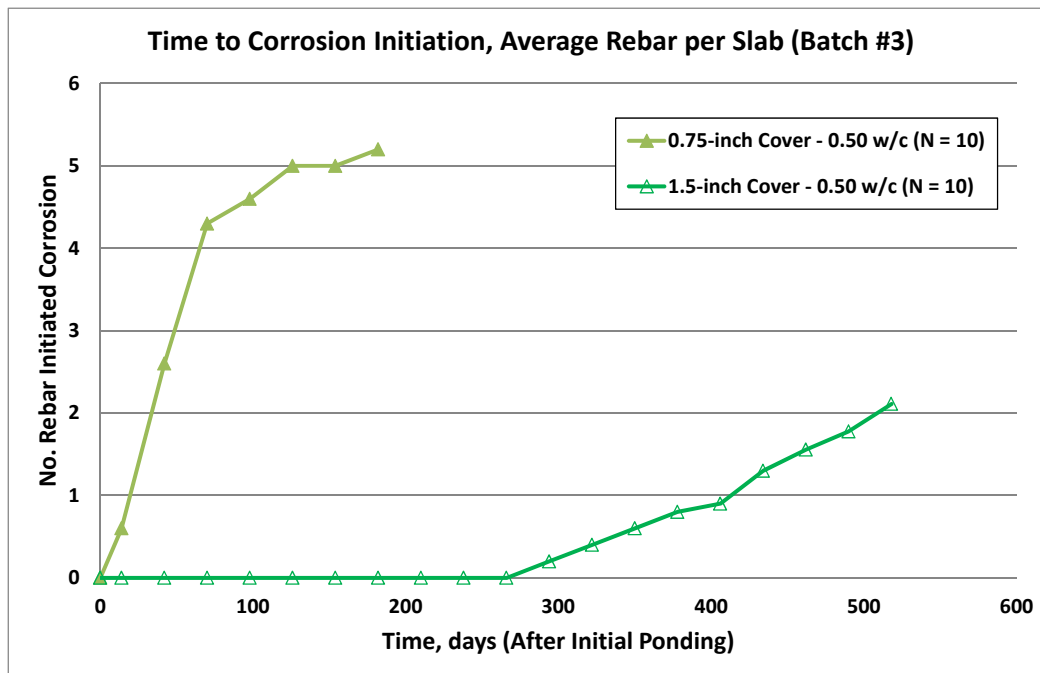
Figure 23 - Average number of rebar corroding (initiated) per slab as a function of time comparing cover depth in Batch #3 slabs

The slower corrosion rates measured in slabs with deeper cover can be attributed to a slower buildup of chloride at the rebar. Figure 23 displays the average number of rebar that have initiated corrosion per slab is much less in 1.5-inch cover slabs.

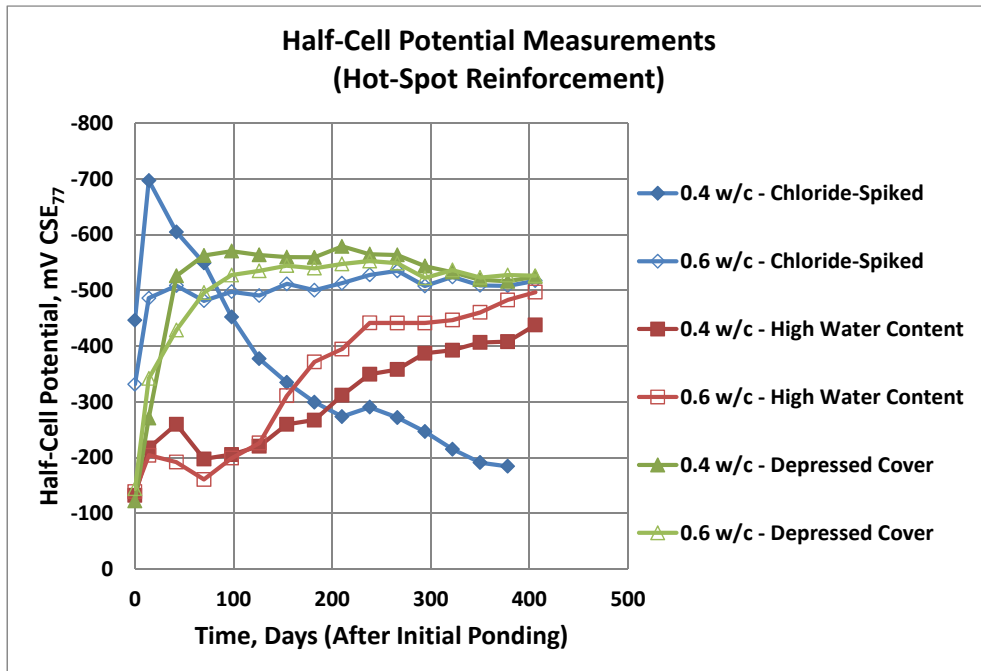
Figure 24 - Average half-cell potential as a function of time (hotspot rebar, 1.5-inch cover)

The following plots provide the average half-cell potential (Figure 24) and integrated current (Figure 25) for individual rebar as a function of time. Each plot is the average of 20 bars, i.e. 2 per slab, 5 slabs per batch. Data is shown up to approximately 400 days of testing (~15 ponding cycles). At this time the hotspots were disconnected when it became apparent that the hotspots may be cathodically protecting rebar outside the hotspot by throwing positive current to the main rebar.

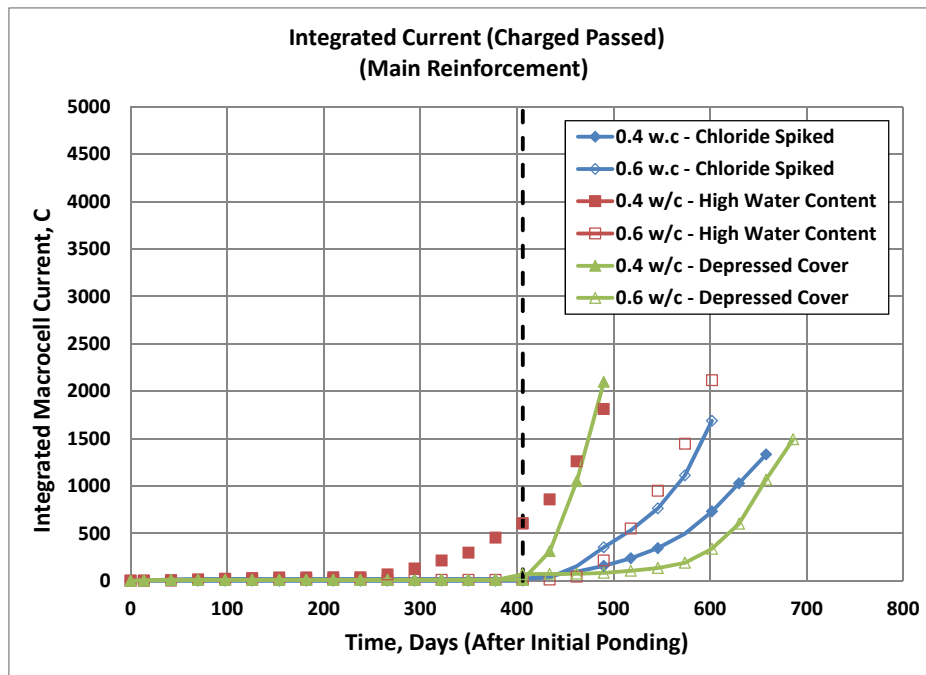
Figure 26 – Average integrated current as a function of time (main rebar, 1.5-inch cover)

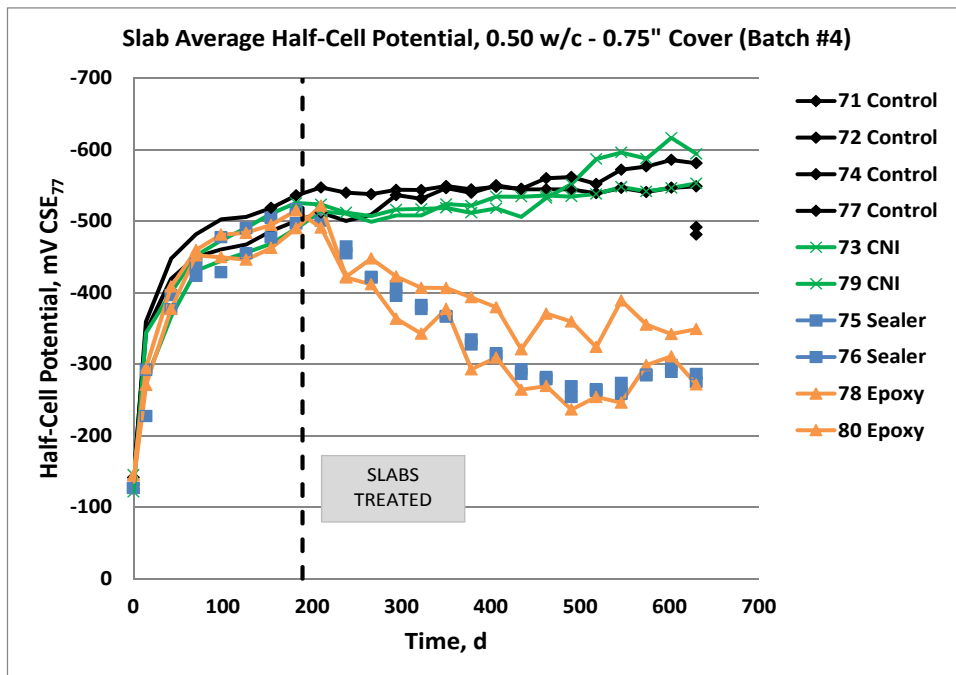
Figure 29 - Slab average half-cell potential as a function of time (Individual slabs, Batch #4, 0.50 w/c, 0.75-inch cover)

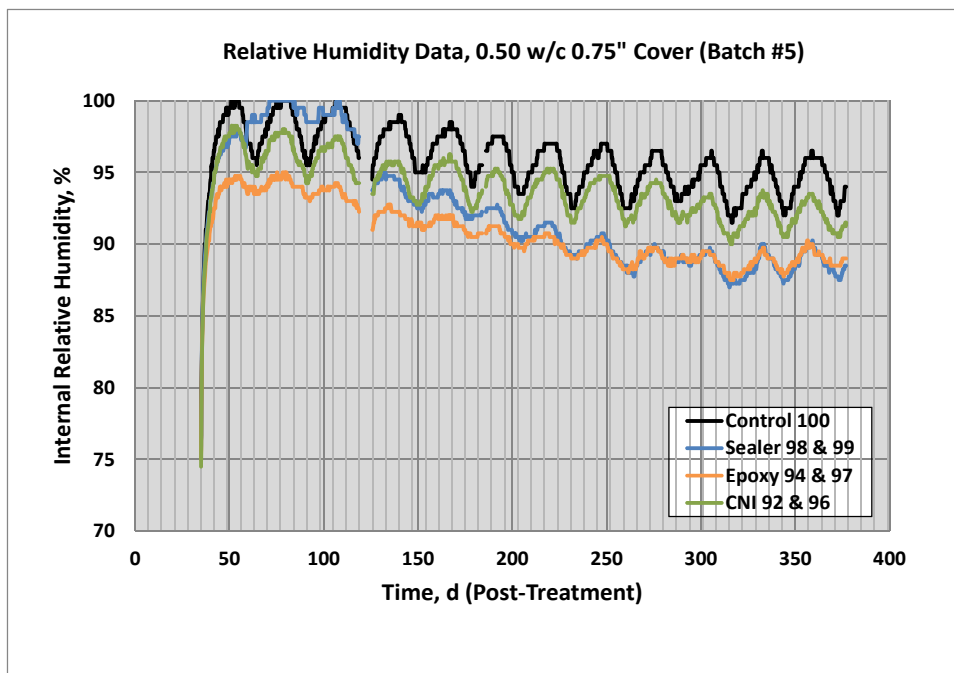
Figure 38 - Relative humidity as a function of time (Batch #5, 0.50 w/c, 0.75-inch cover)

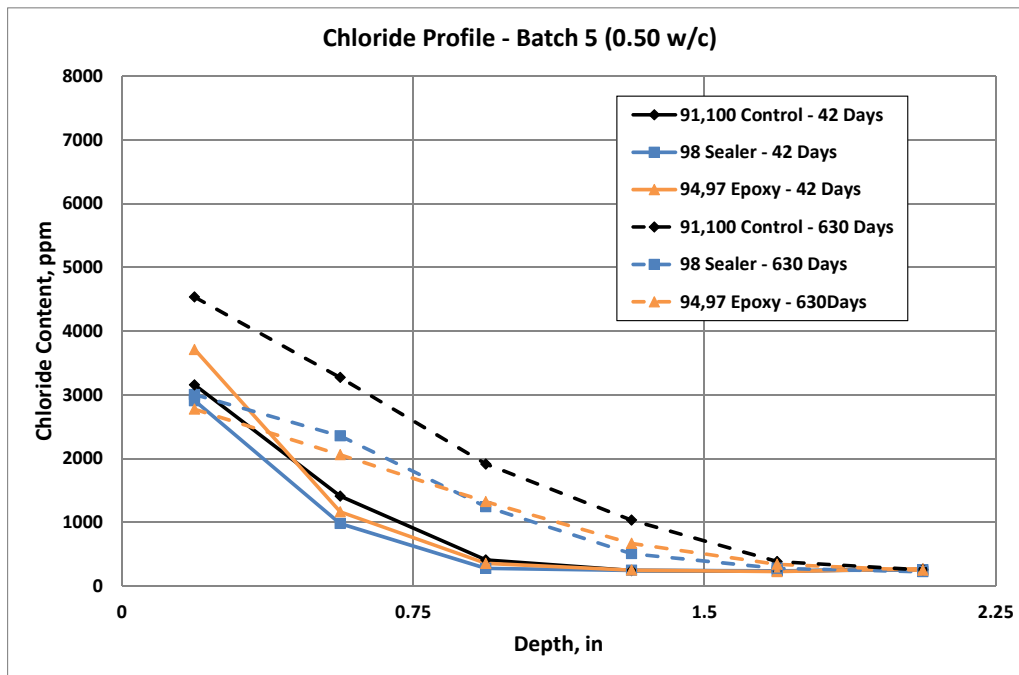
Figure 39 – Chloride profiles at two time periods, 42 days (prior to treatment) and 630 days (end of testing) for selected Batch #5 control, sealer, and epoxy treated slabs

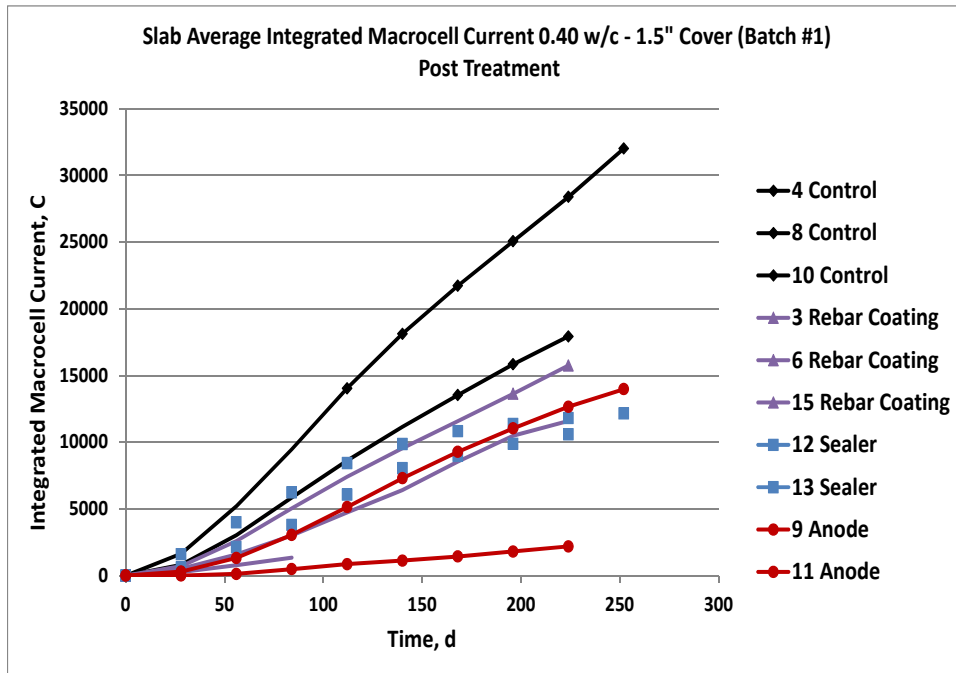
Figure 40 - Slab total integrated current as a function of time  
(Individual slabs, Batch #1, 0.40 w/c, 1.5-inch cover)

Note: The integrated current results provided in Figure 40 and Figure 41 for test specimens containing galvanic anodes are comprised of data from four rebars, instead of six (two half-length rebars excluded). The half-cell potential measurements provided in Figure 42 through Figure 44 were measured with the galvanic anode disconnected, typically for 4 to 24 hours, allowing the rebar to depolarize prior to measuring.

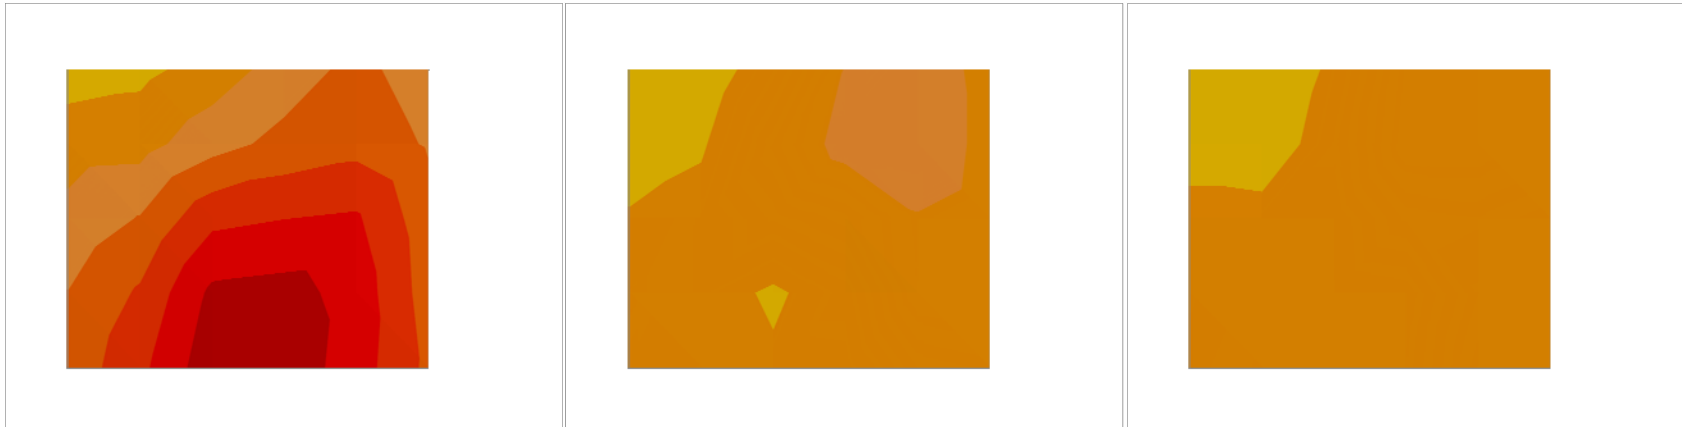
**Figure 43 - Half-cell potential mapping over time, prior to repair, after 5 ponding cycles, and after 8 ponding cycles (Rebar Coating)**

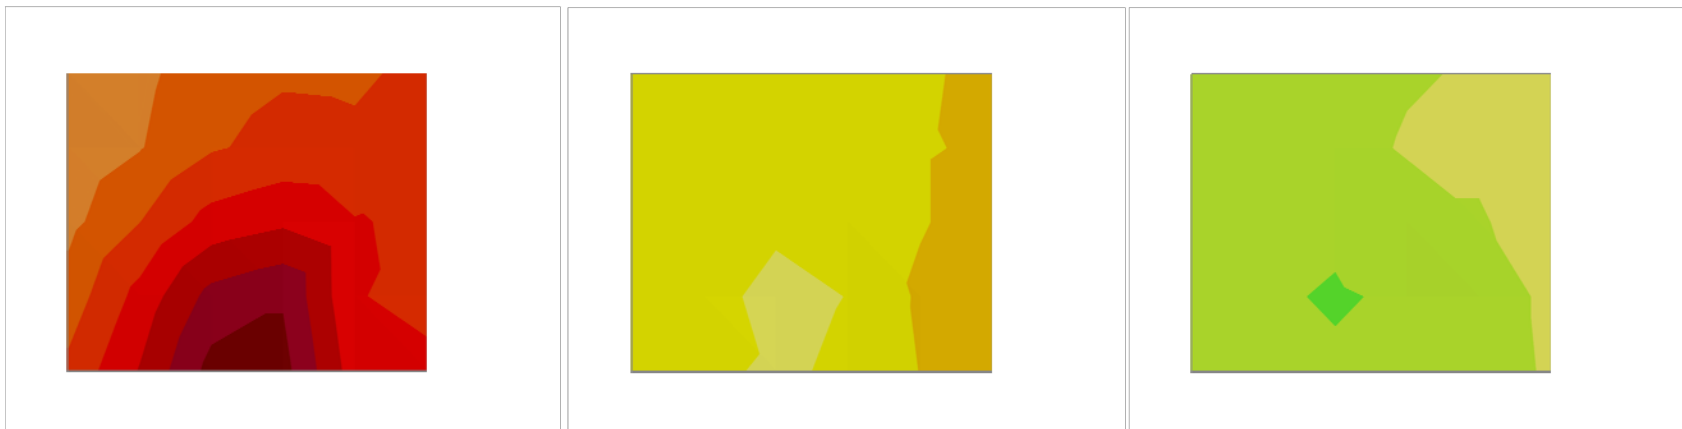
**Figure 44 – Half-cell potential mapping over time, prior to repair, after 5 ponding cycles, and after 8 ponding cycles (Sealer)**

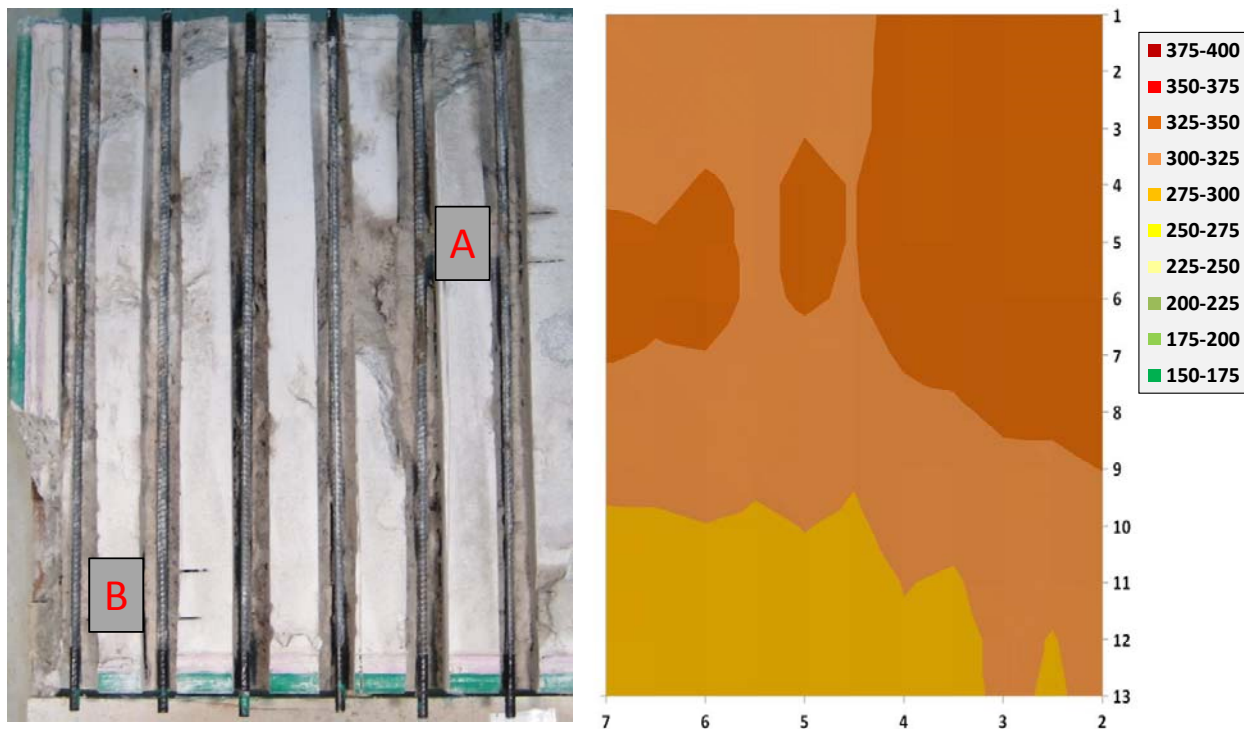
**Figure 45 – Slab 46 plan view with exposed rebar (left) compared to half-cell potential mapping (right)**

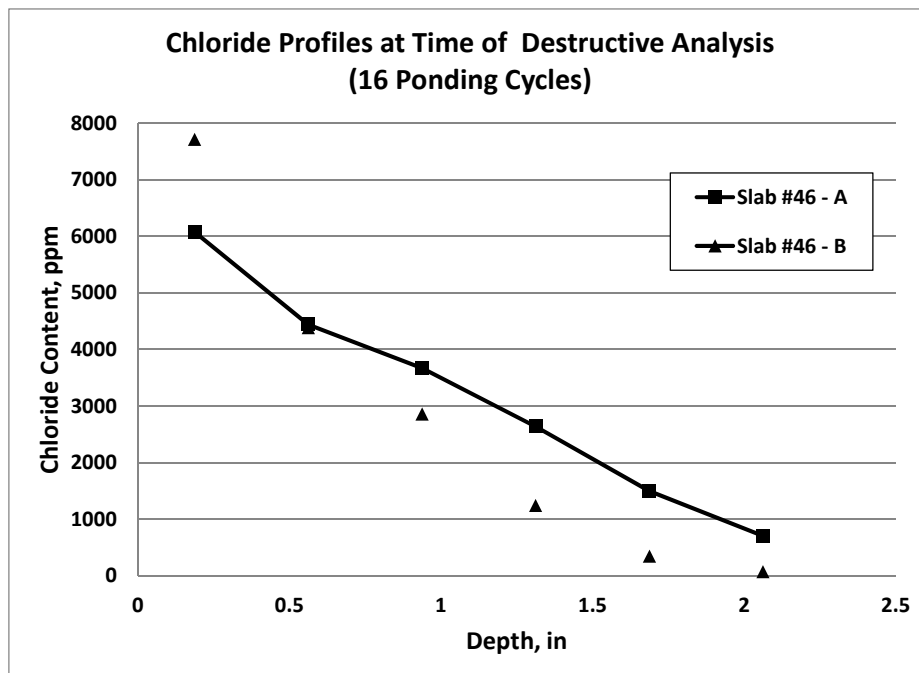
Figure 46 – Chloride profiles at “A” anodic location and “B” cathodic locations (Based on slab measurements)

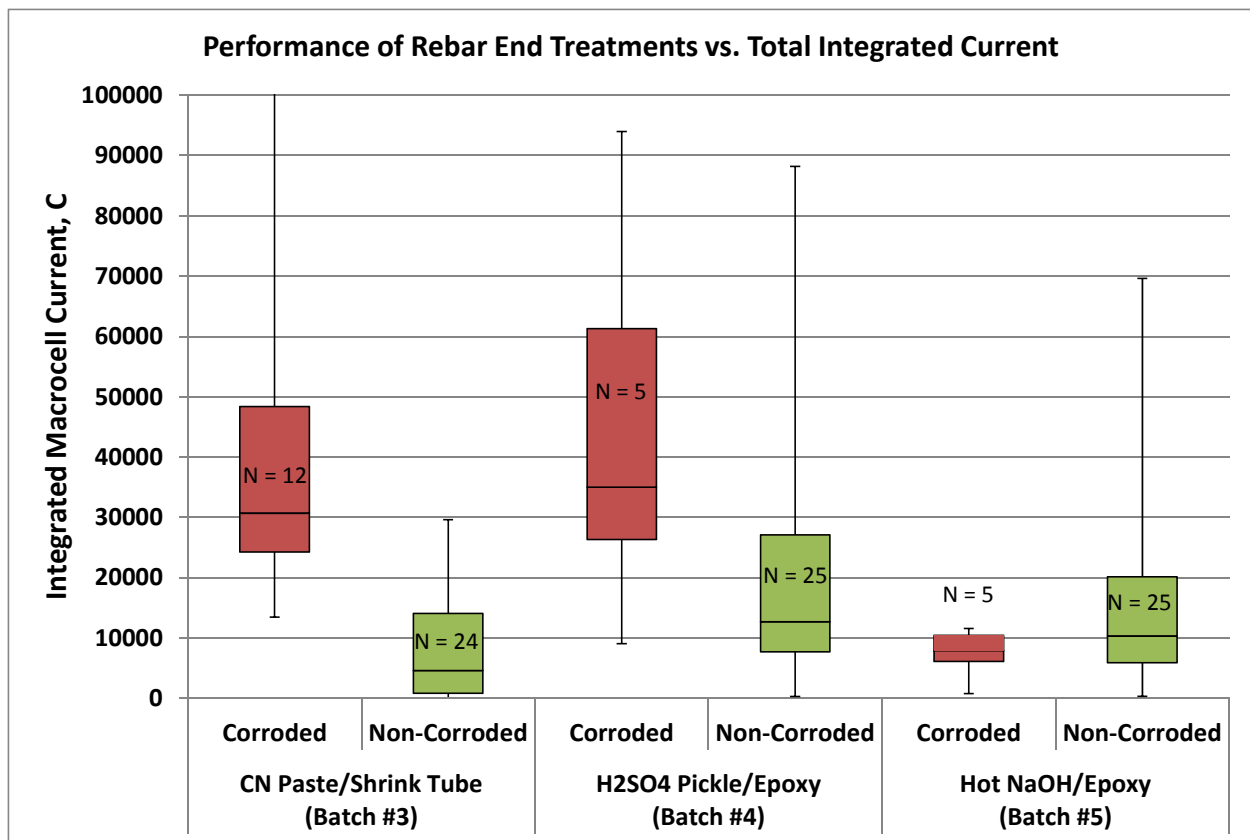
**Figure 48 – Performance of Rebar End Treatments vs. Total Integrated Current**

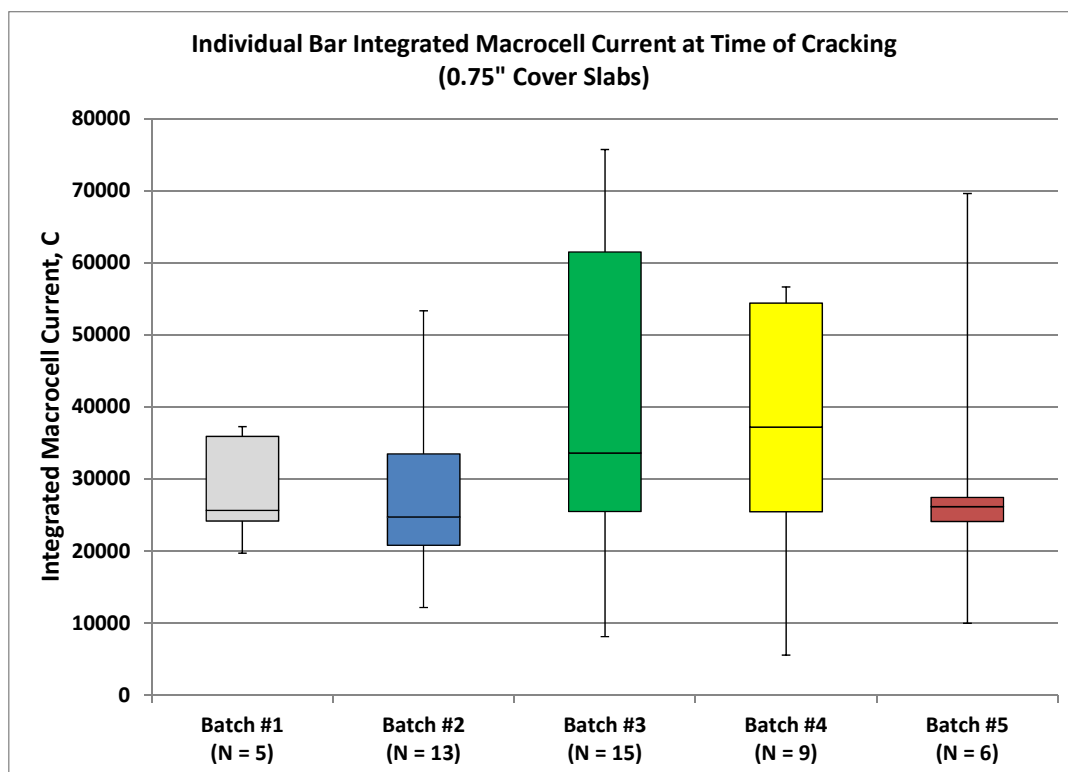
Figure 50 – Individual Bar Integrated Macrocell Current at Time of Cracking

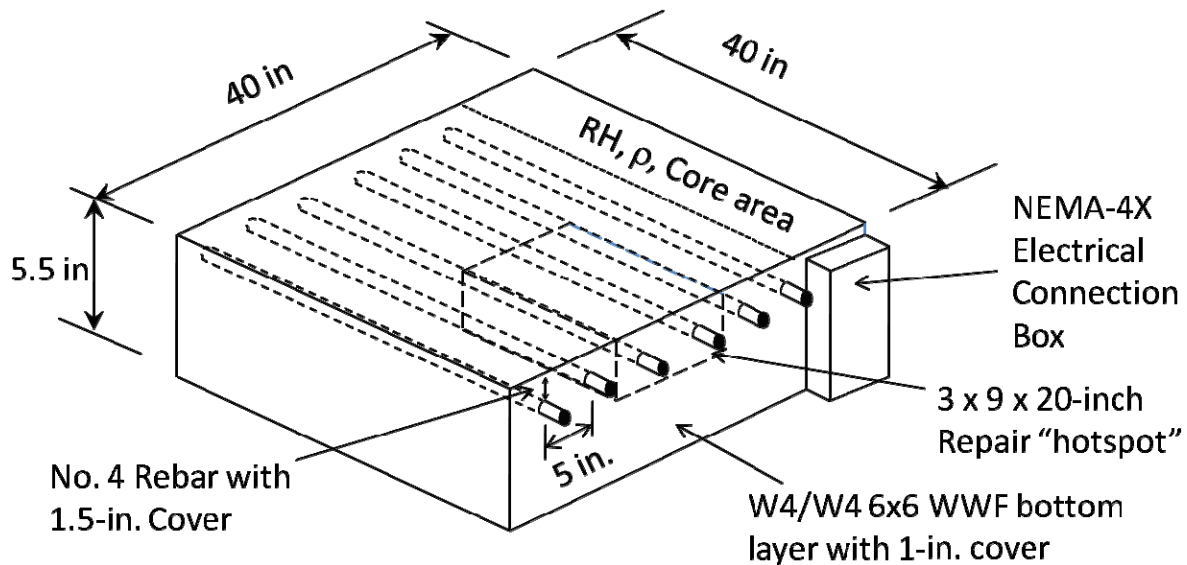
Figure 54 – Repair Test Slab Configuration  
(WWF – Welded Wire Fabric, NEMA – National Electrical Manufacturers Association)

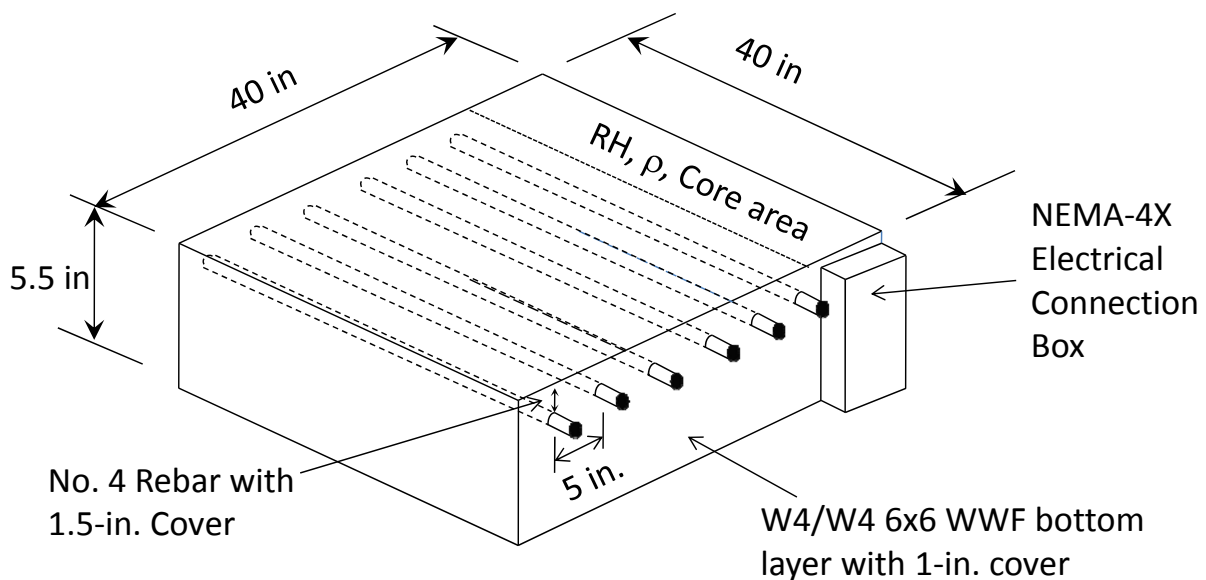
Figure 55 – Typical Treatment Test Slab Configuration

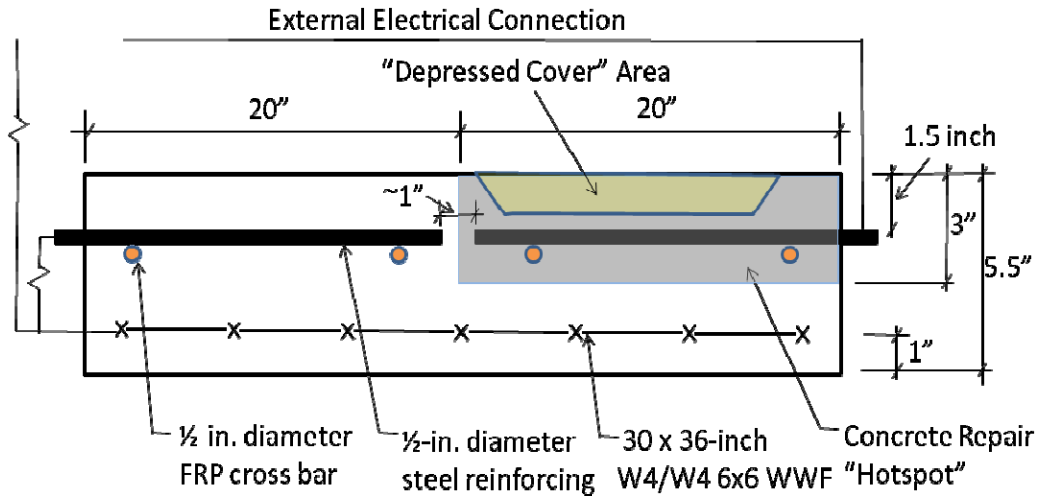
Figure 56 – Section through concrete repair test slab (FRP – Fiber reinforced polymer)
