Re: Vision 2020 – Final Report  
Contract No. R10PC80497  
TCG Project No.: 10124

# Evaluation of an Industry Suggested Protocol for Measuring the Performance of Reinforcing Steel Corrosion Mitigation Technologies for Concrete Repairs

**Bureau of Reclamation**

**TCG Project No. 10124**

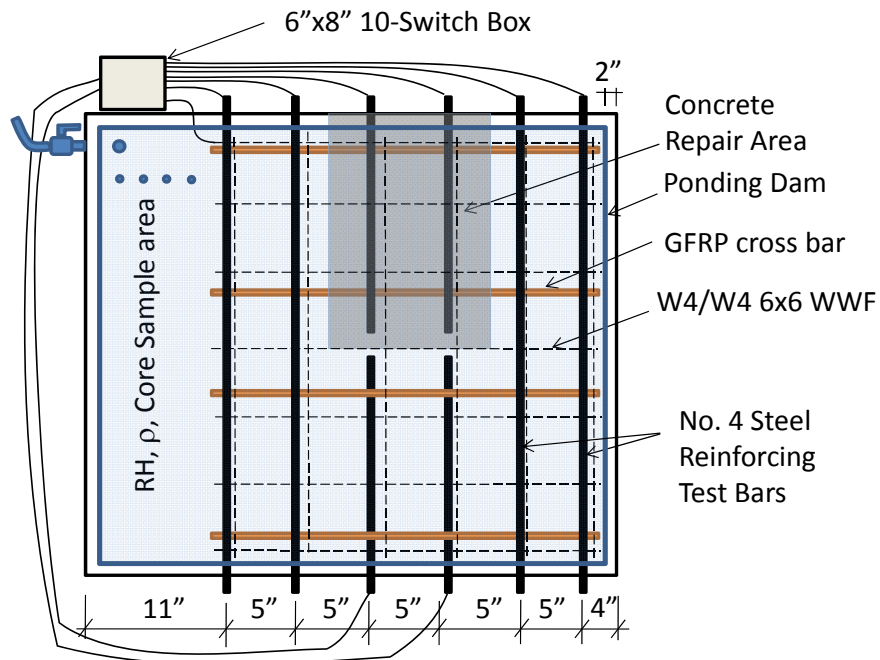
Figure 57 – Test slab reinforcing configuration plan view for concrete repair test slab

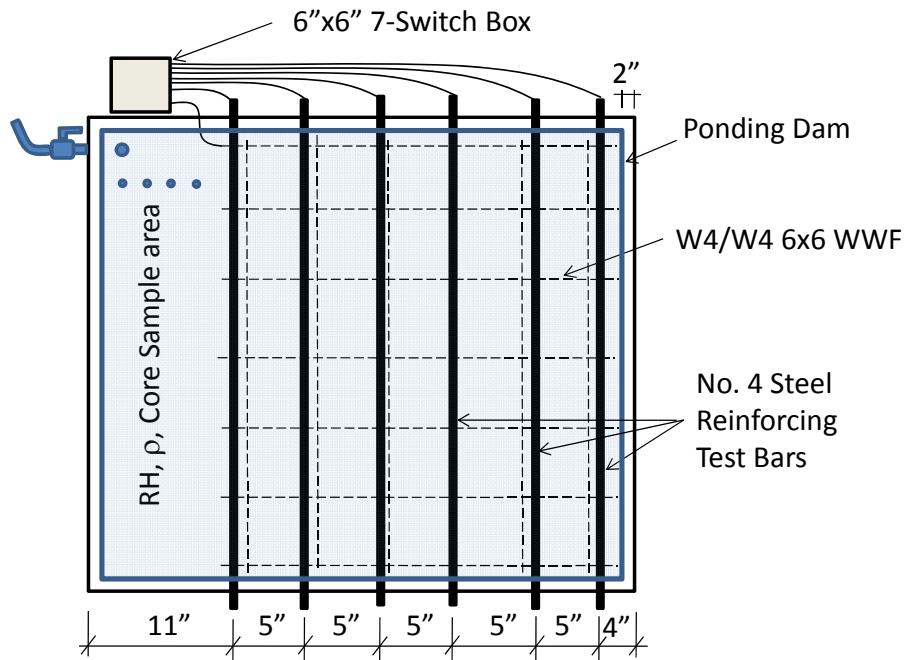
Figure 58 - Test slab reinforcing configuration plan view for concrete topical treatment test slab

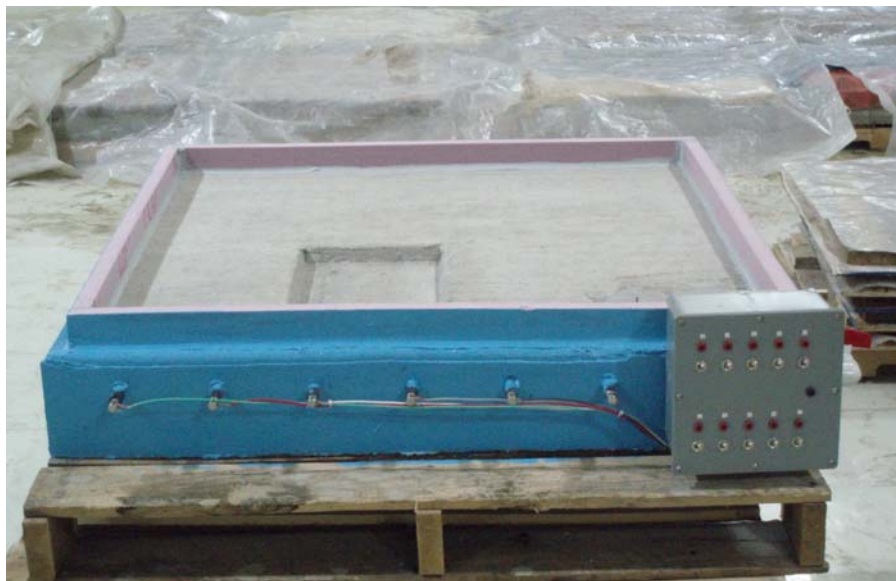
Figure 59 - Completed Batch #2 Repair Test Specimen with Depressed Cover Hotspot

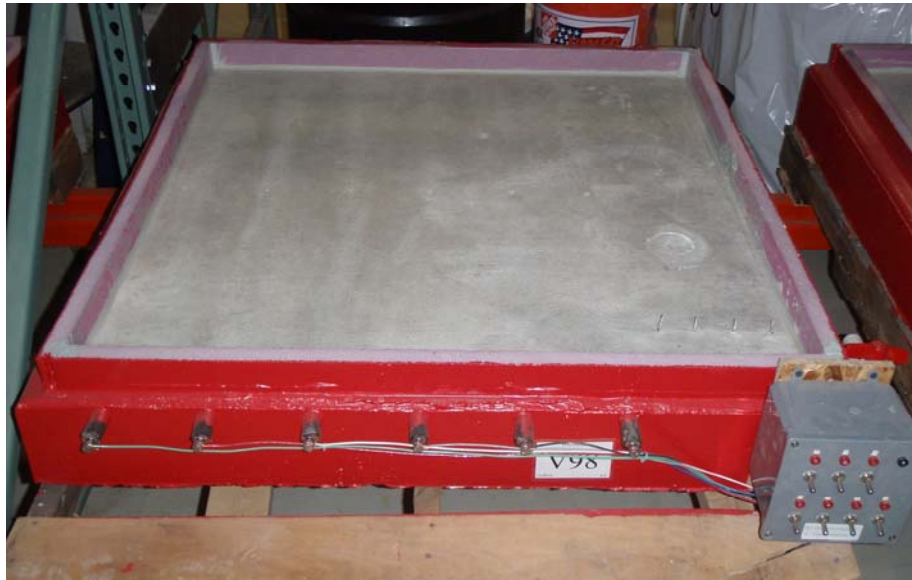
**Figure 60 – Completed Batch #5 Topical Treatment Test Specimen**

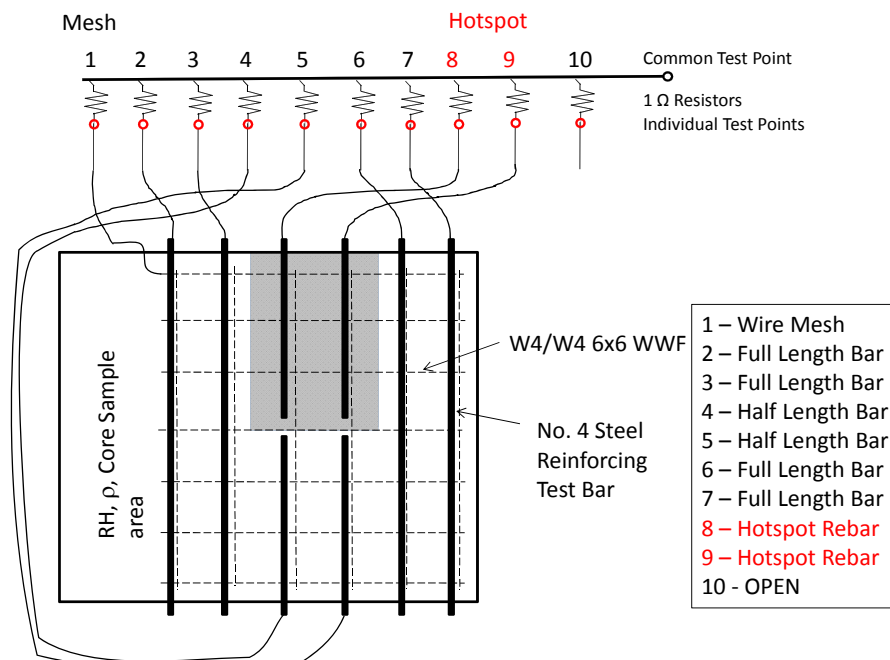
Figure 89 - Wiring Diagram for Hotspot Repair Test Specimen

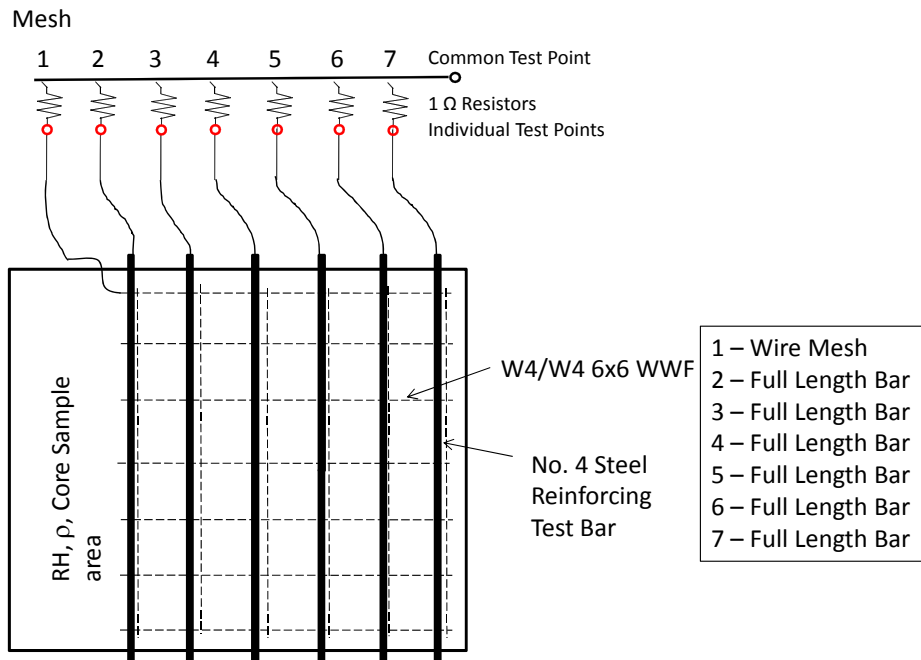
Figure 90 - Wiring Diagram for Topical Test Specimen

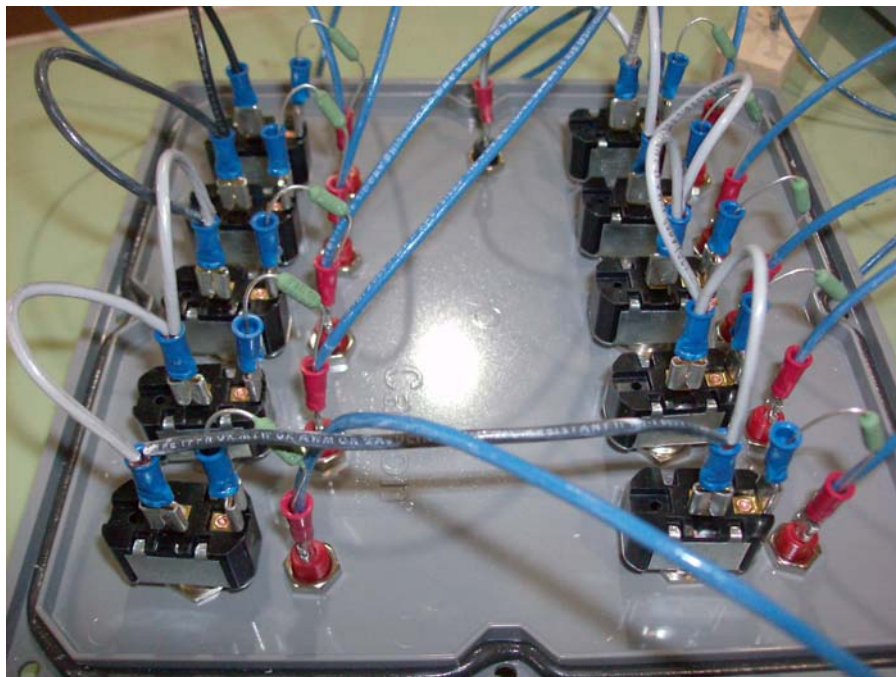
Figure 91 - Wiring in NEMA 4X Box for Ten Circuit System for Repair Test Slab

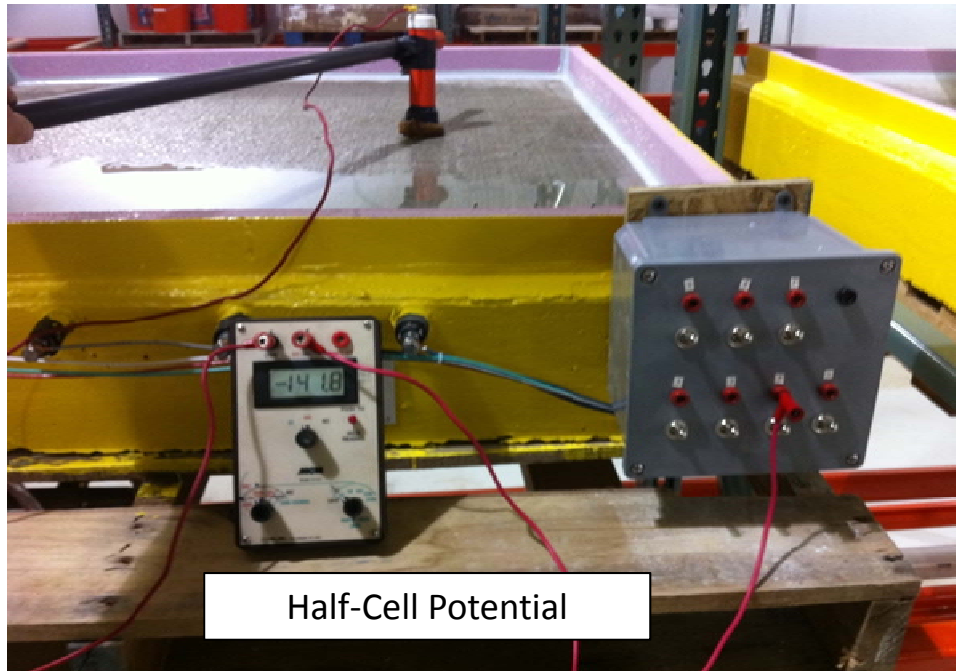
Figure 96 – Half-cell potential measurement

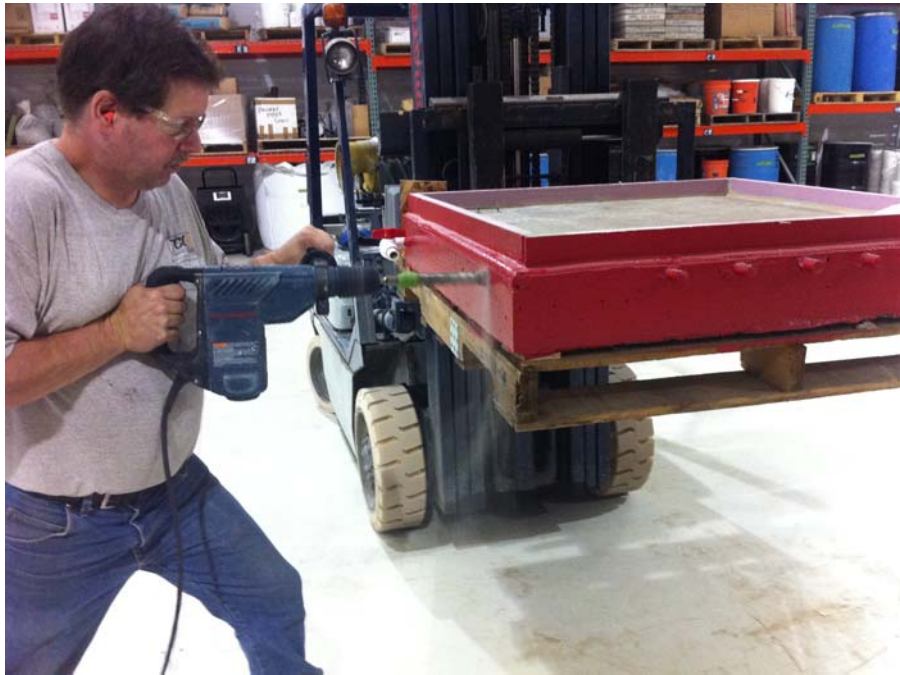
**Figure 100 – Installation of internal relative humidity and temperature ports**

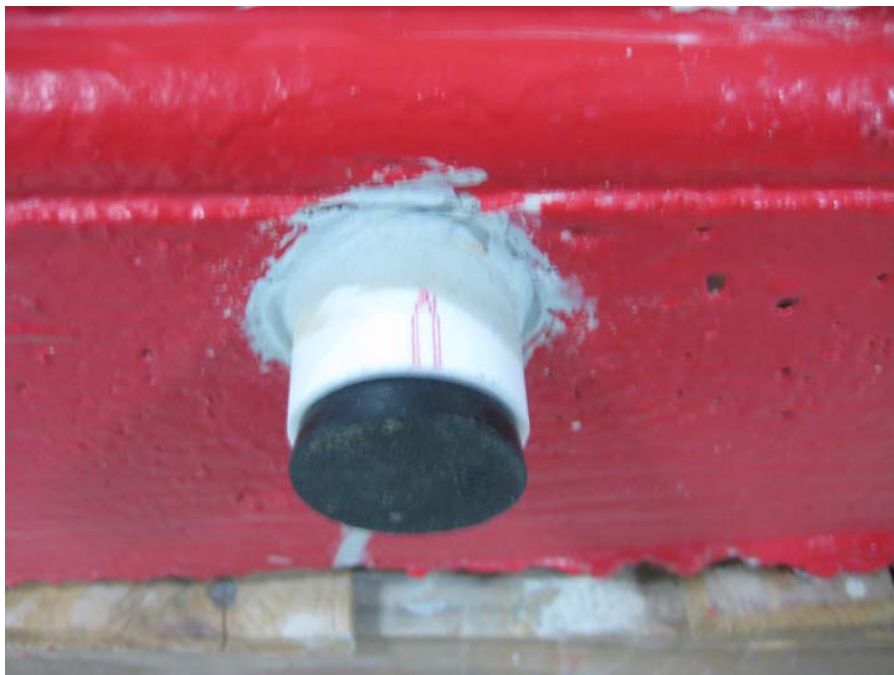
**Figure 101 – Installed port for housing data-loggers**

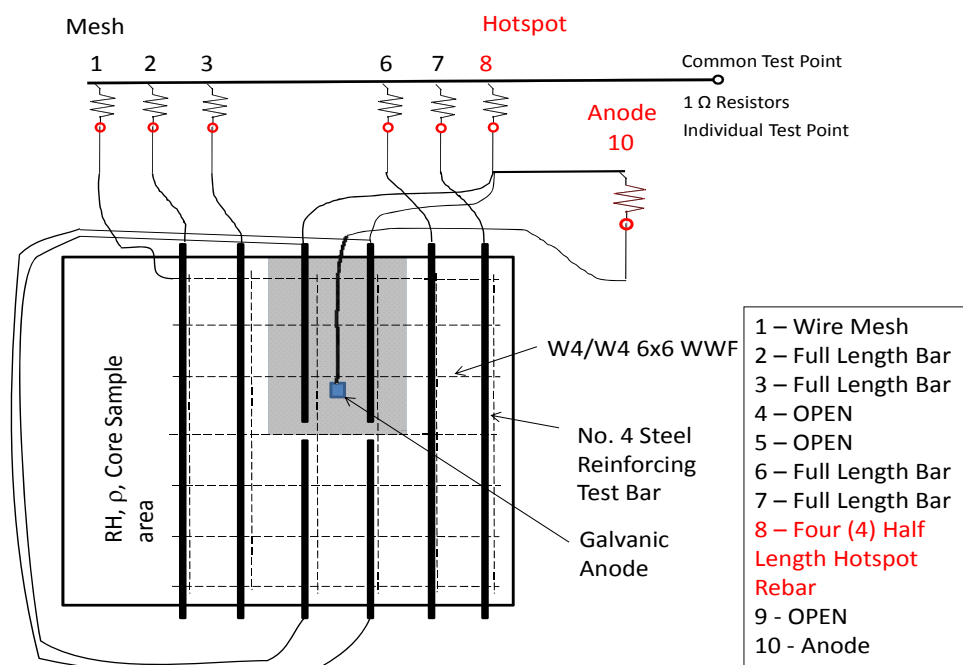
Figure 128 - Wiring Diagram for Test Specimen Repaired with Galvanic Anode

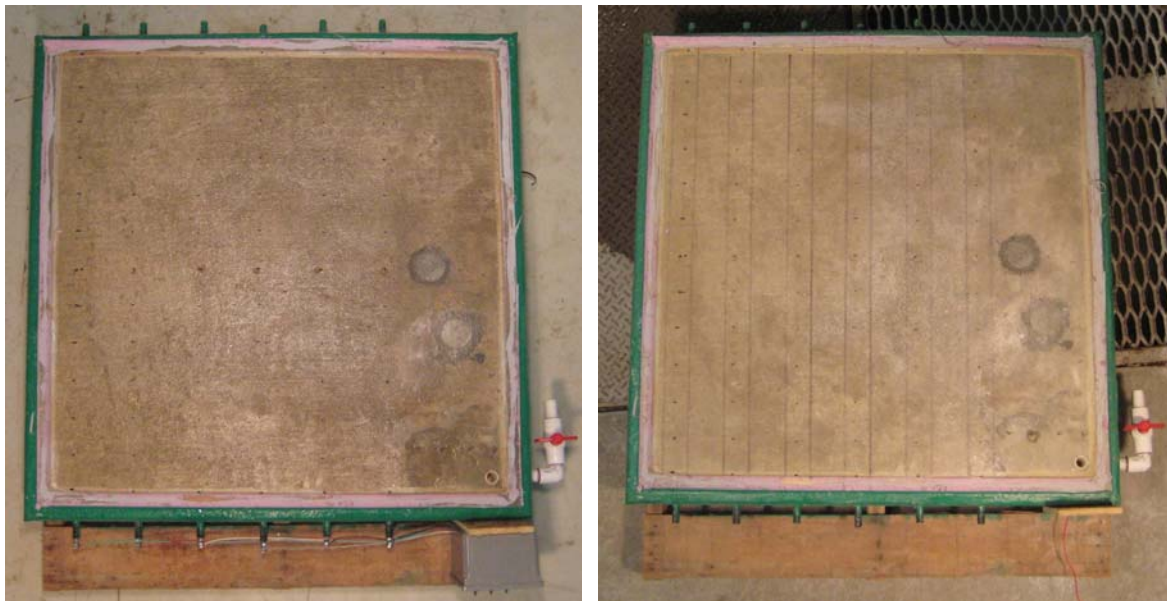
Figure 129 – Remove ponding dams, wiring, and junction boxes

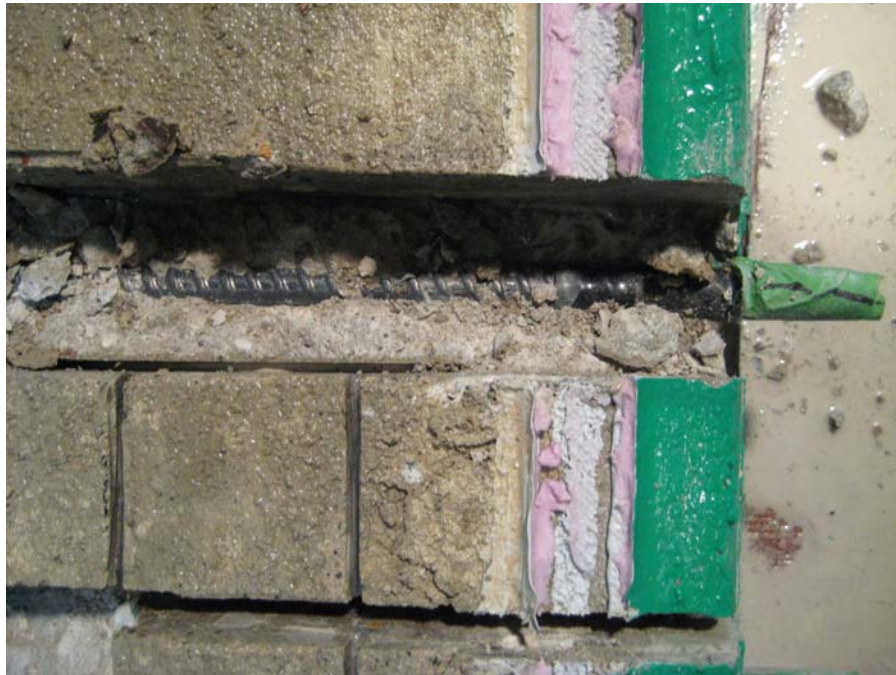
**Figure 132 – Embedded rebar exposed without visible corrosion**

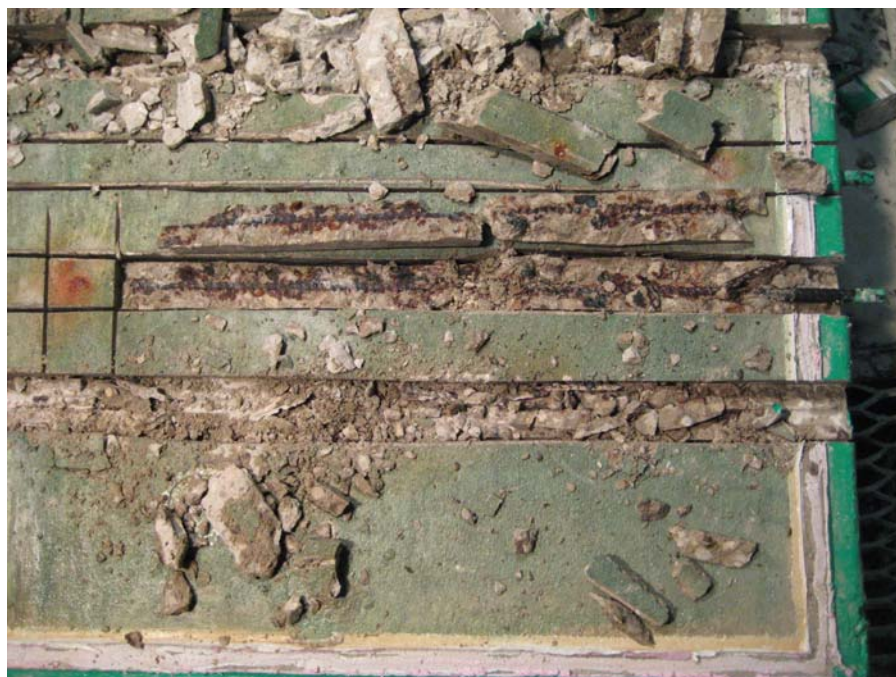
**Figure 133 – Embedded rebar exposed with visible corrosion**

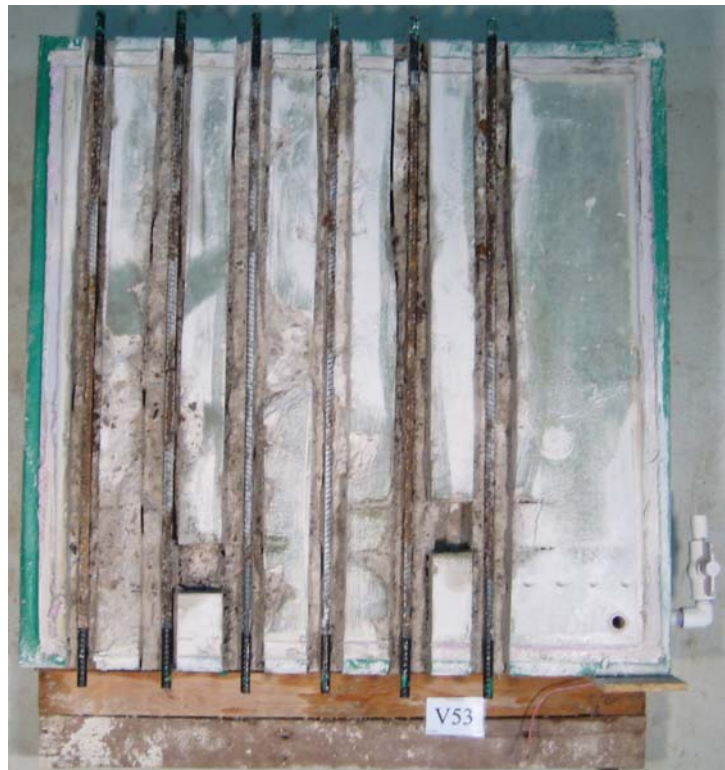
**Figure 134 – Bird's eye view of exposed rebar positioned in slab**

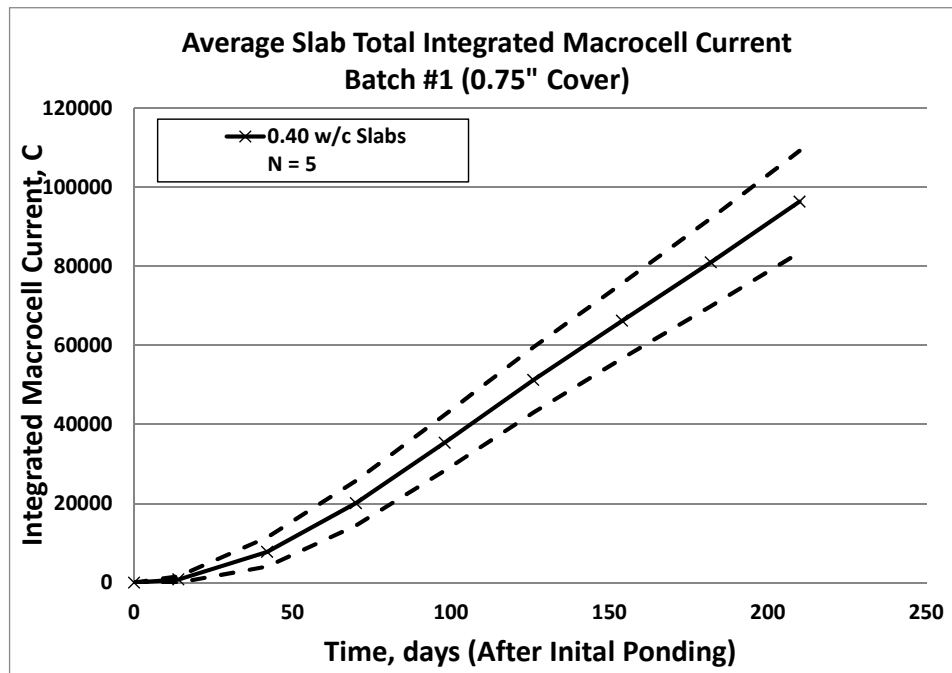
Figure 141 – Total integrated current as a function of time, average per slab, 0.75-inch topical slabs, Batch #1

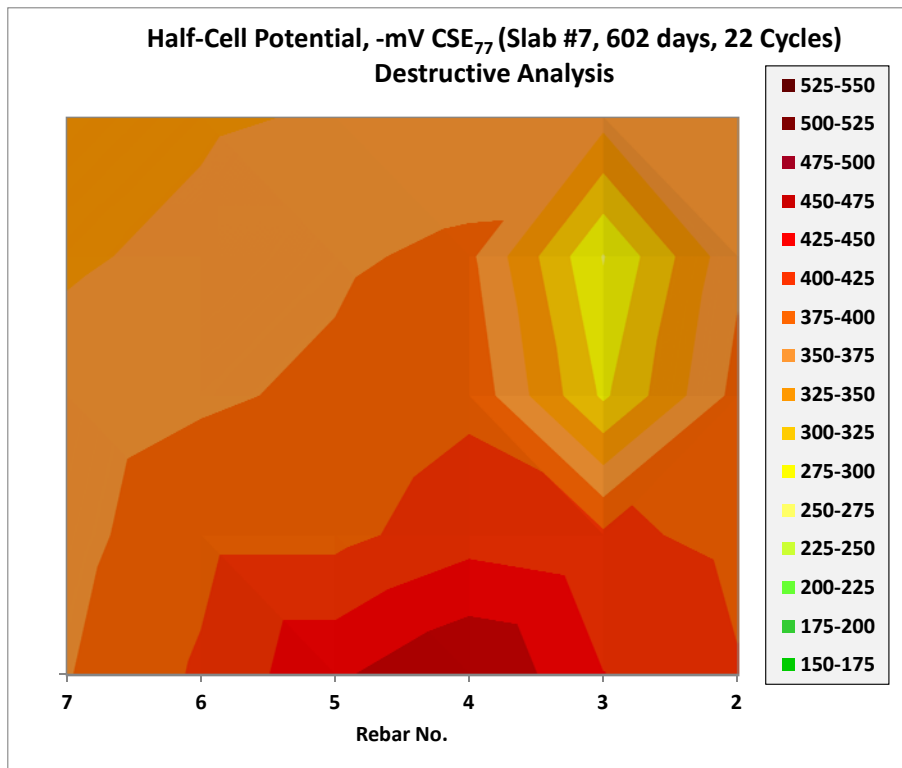
**Figure 146 – Half-cell potential mapping prior to destructive analysis, repair slab #7**

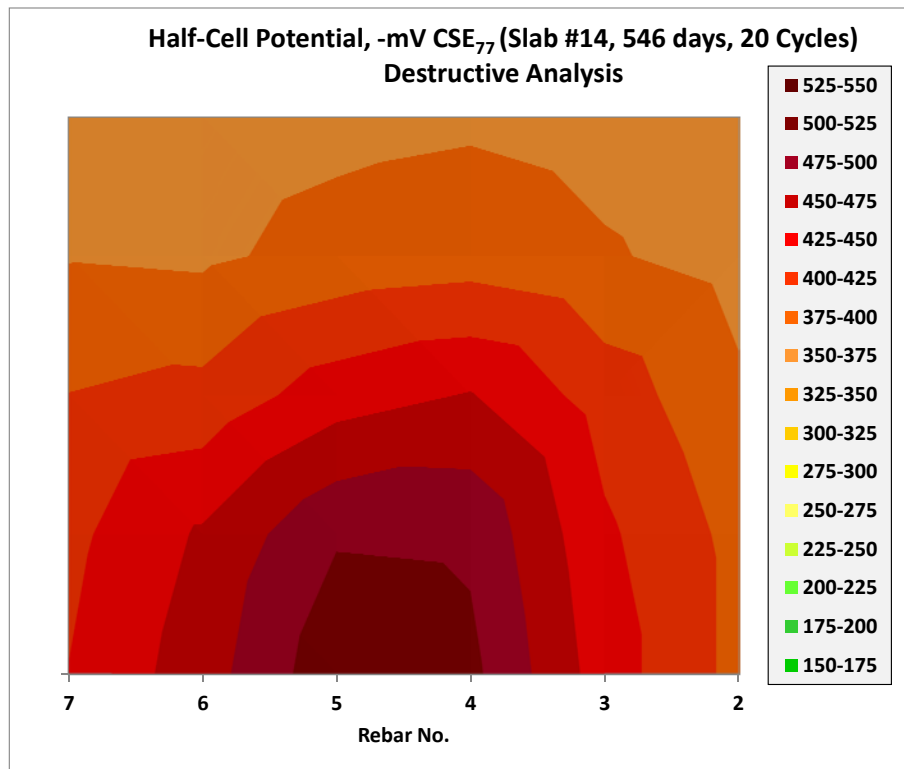
Figure 147 – Half-cell potential mapping prior to destructive analysis, repair slab #14

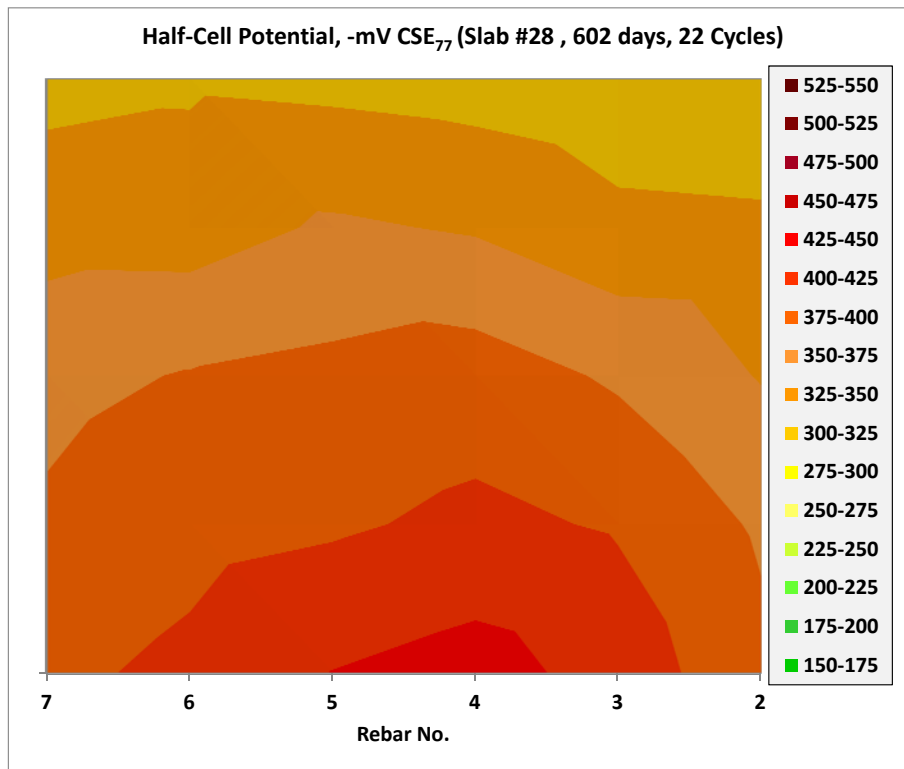
Figure 148 – Half-cell potential mapping prior to destructive analysis, repair slab #28

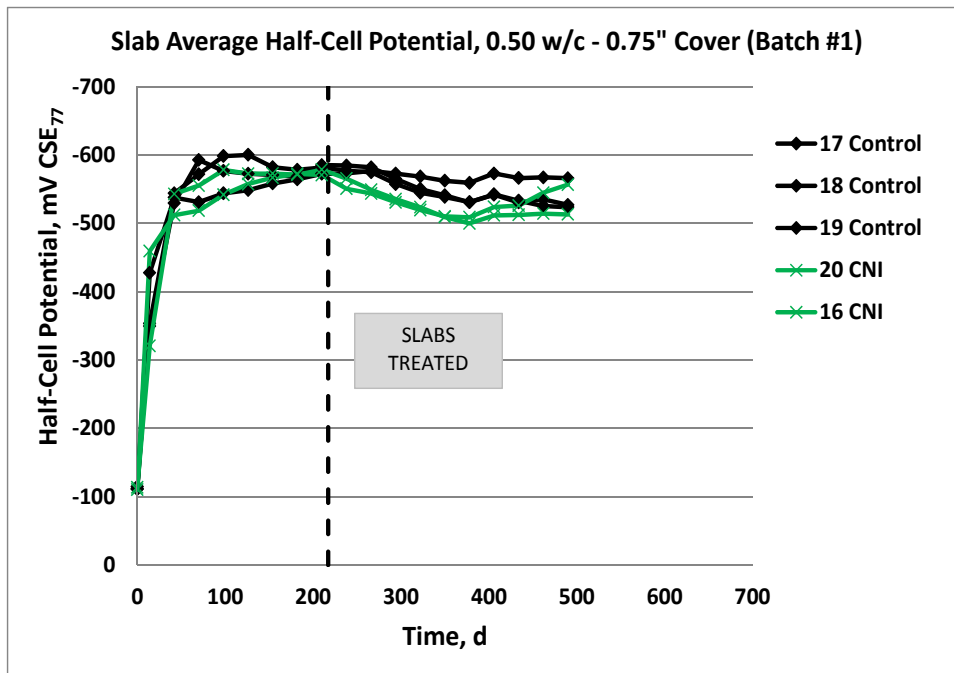
**Figure 149 - Slab average half-cell potential as a function of time (Individual slabs, Batch #1, 0.40 w/c, 0.75” cover)**

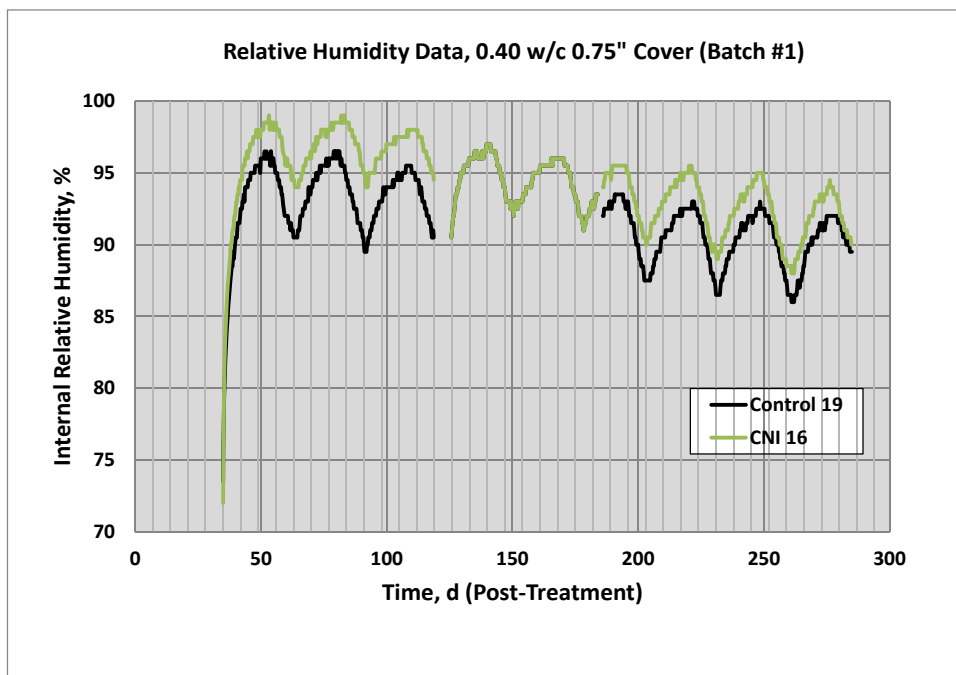
Figure 153 - Relative humidity as a function of time (Batch #1, 0.40 w/c, 0.75" cover)

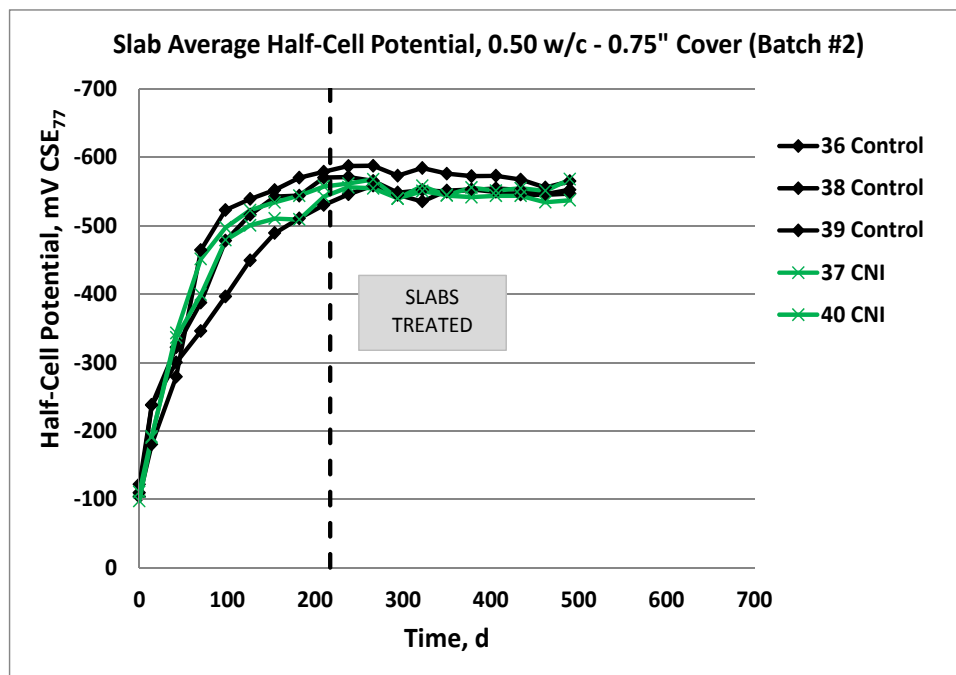
**Figure 154 - Slab average half-cell potential as a function of time (Individual slabs, Batch #2, 0.60 w/c, 0.75" cover)**

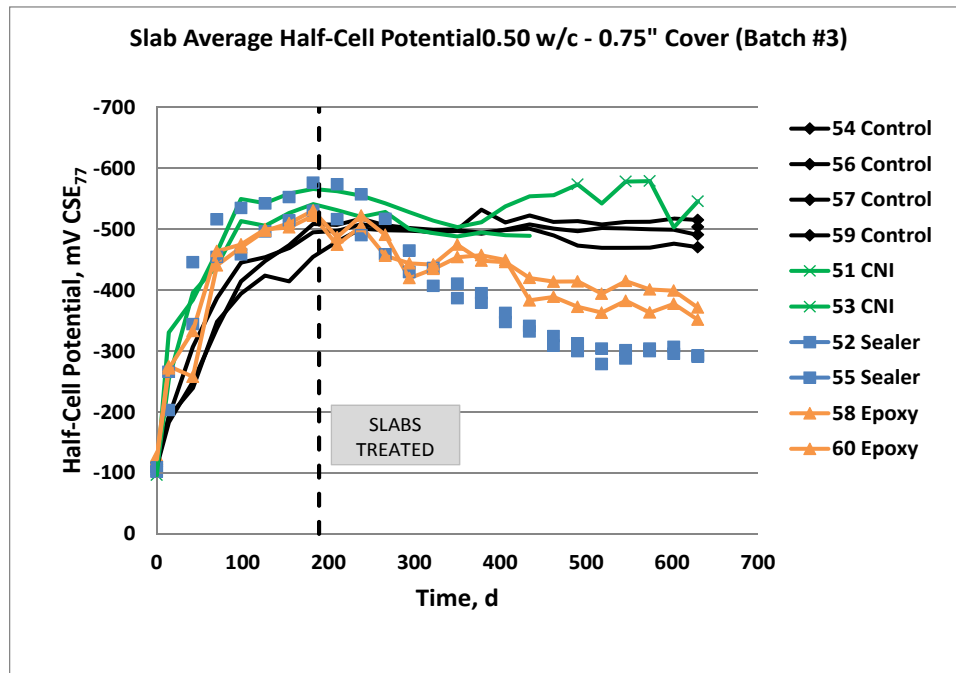
**Figure 158 - Slab average half-cell potential as a function of time (Individual slabs, Batch #3, 0.50 w/c, 0.75" cover)**

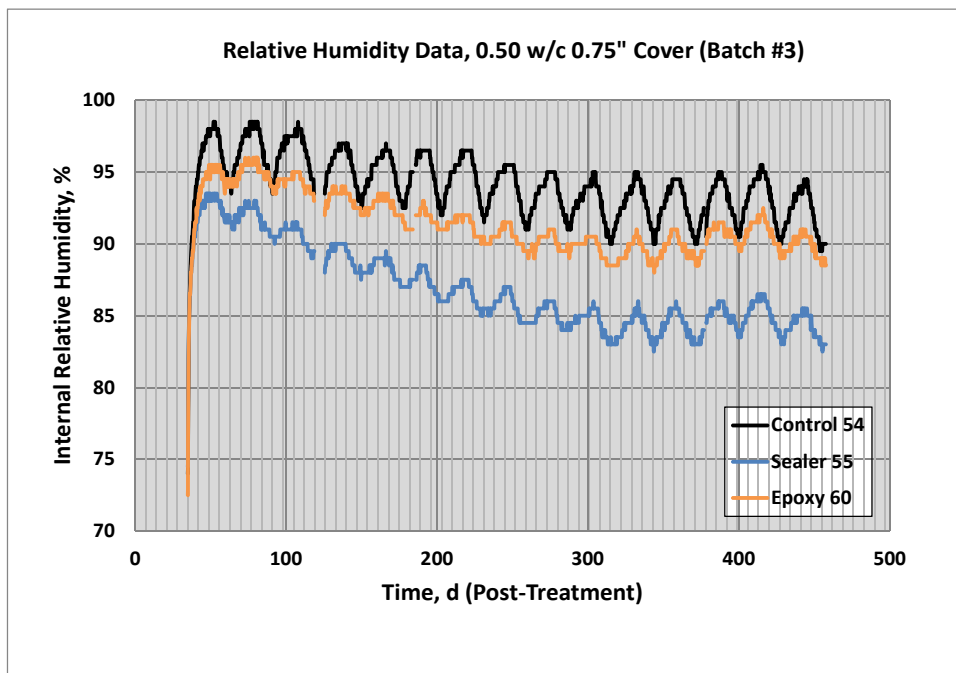
Figure 162 - Relative humidity as a function of time (Batch #3, 0.50 w/c, 0.75" cover)

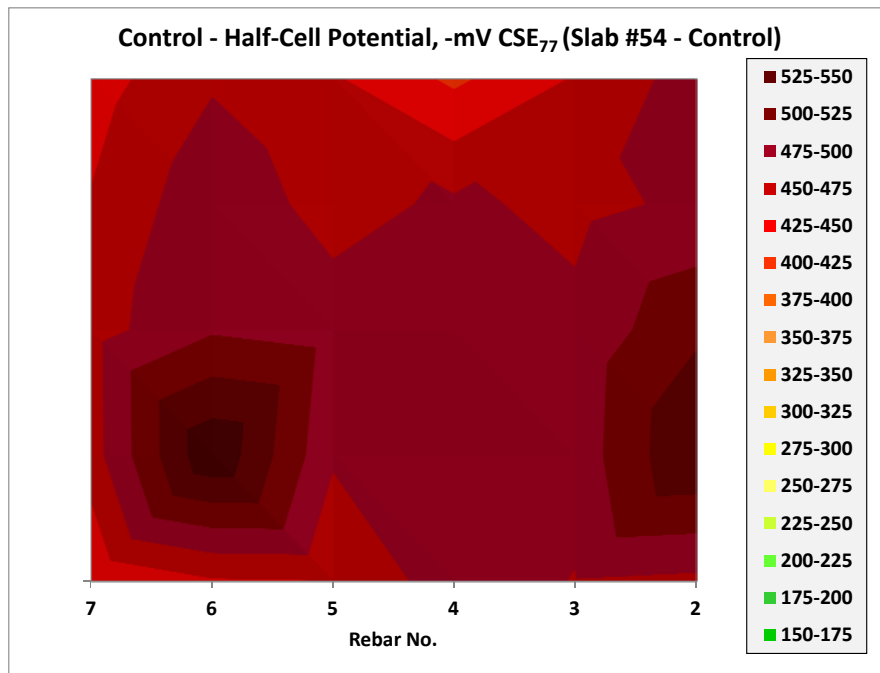
Figure 163 – Half-cell potential mapping prior to destructive analysis, slab #54 - Control

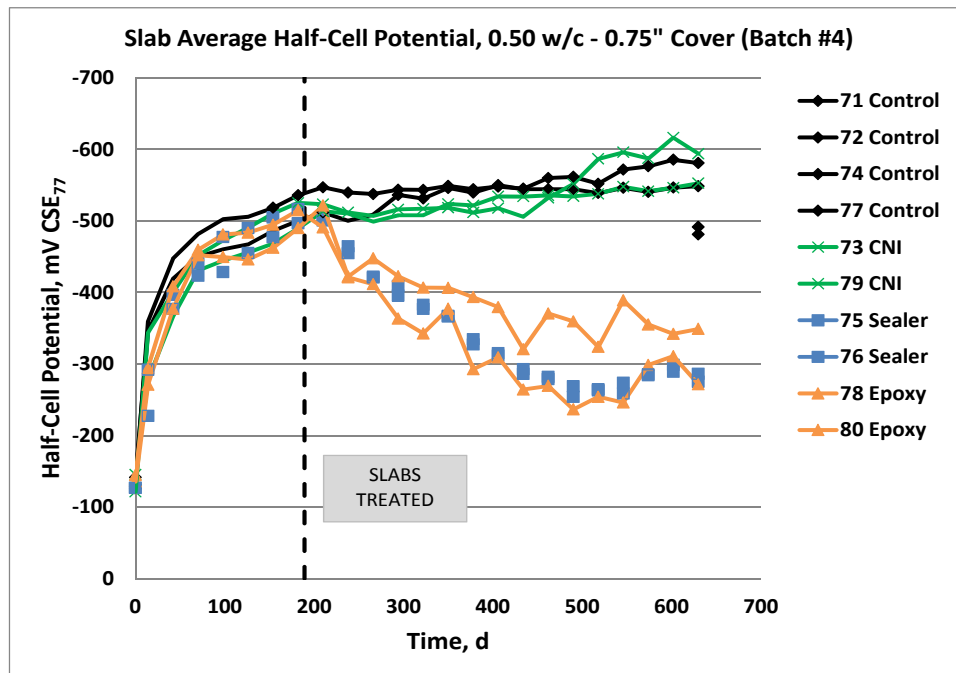
**Figure 166 - Slab average half-cell potential as a function of time (Individual slabs, Batch #4, 0.50 w/c, 0.75" cover)**

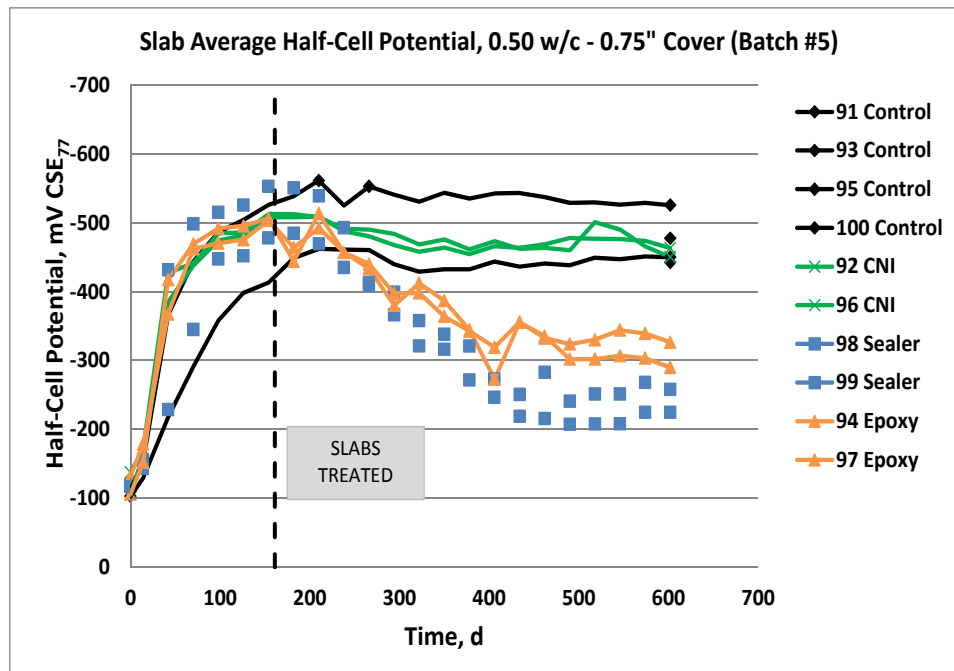
**Figure 174 - Slab average half-cell potential as a function of time (Individual slabs, Batch #5, 0.50 w/c, 0.75" cover)**

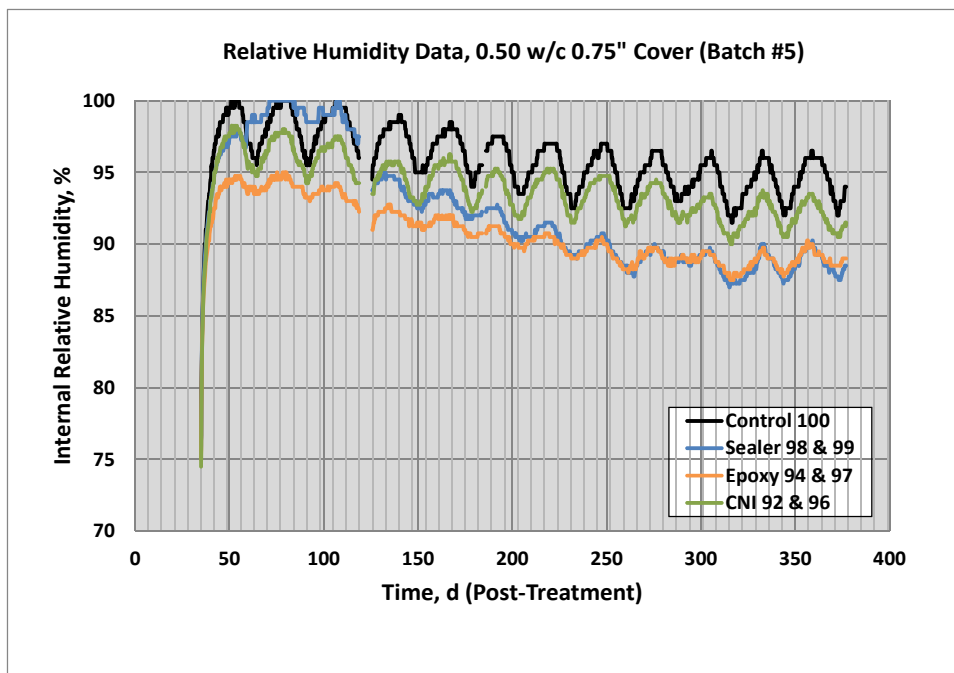
Figure 178 - Relative humidity as a function of time (Batch #5, 0.50 w/c, 0.75" cover)

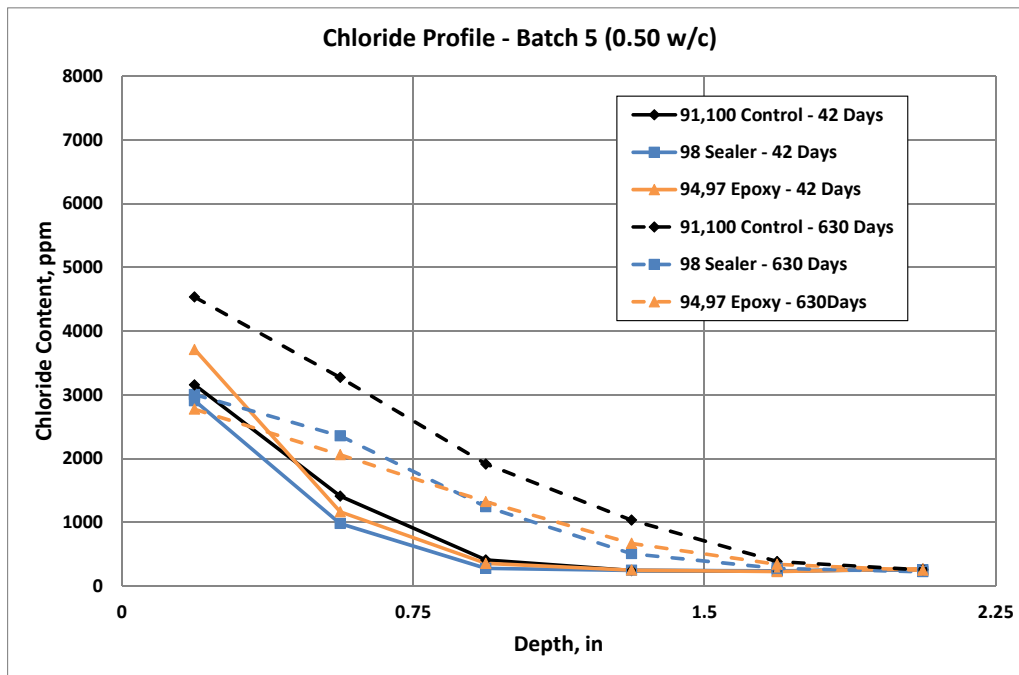
Figure 179 – Average chloride content as a function of depth at prior to treatment (42 days) and post-treatment (630 days) for control, sealer, and epoxy treated slabs – Batch #5

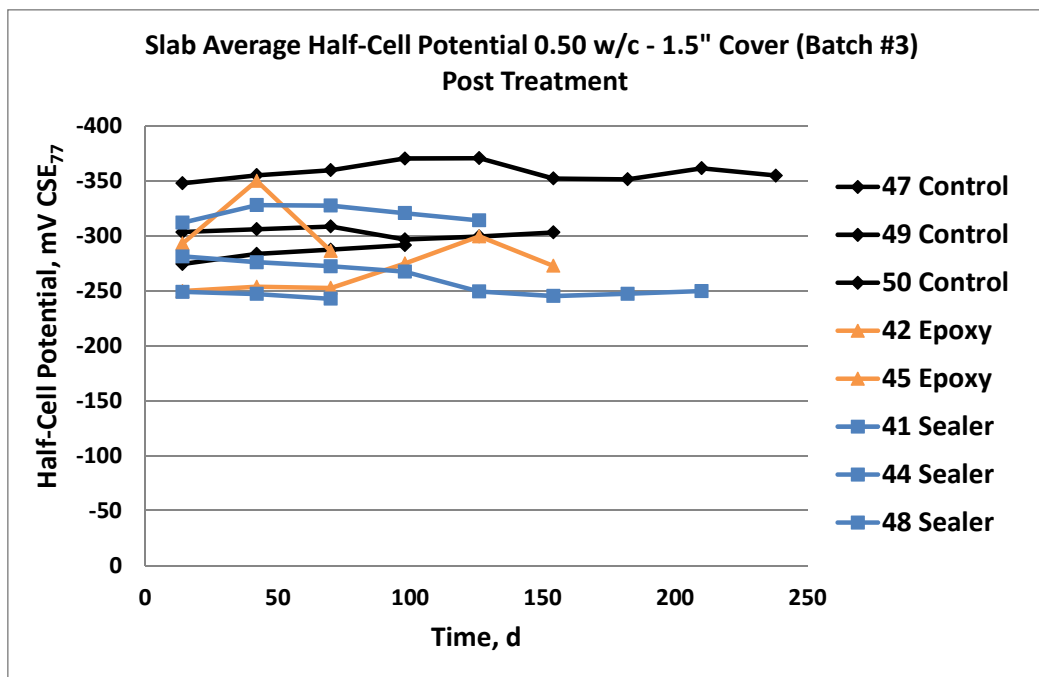
**Figure 184 - Slab average half-cell potential as a function of time (Individual slabs, Batch #3, 0.50 w/c, 1.5" cover)**

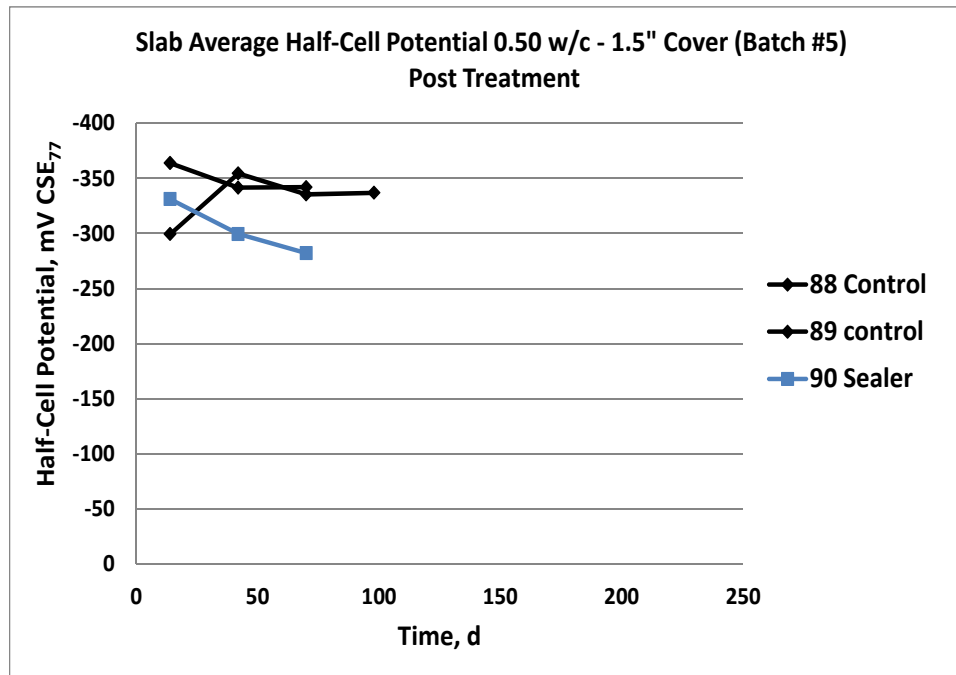
**Figure 189 - Slab average half-cell potential as a function of time (Individual slabs, Batch #5, 0.50 w/c, 1.5" cover)**

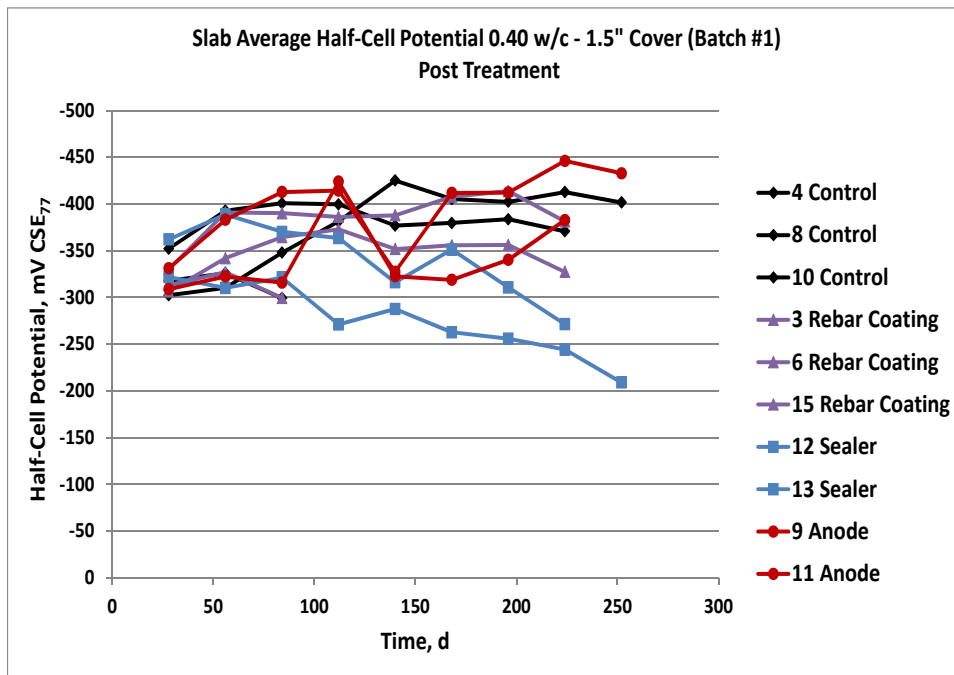
Figure 194 - Slab average half-cell potential as a function of time (Individual slabs, Batch #1, 0.40 w/c, 1.5" cover)

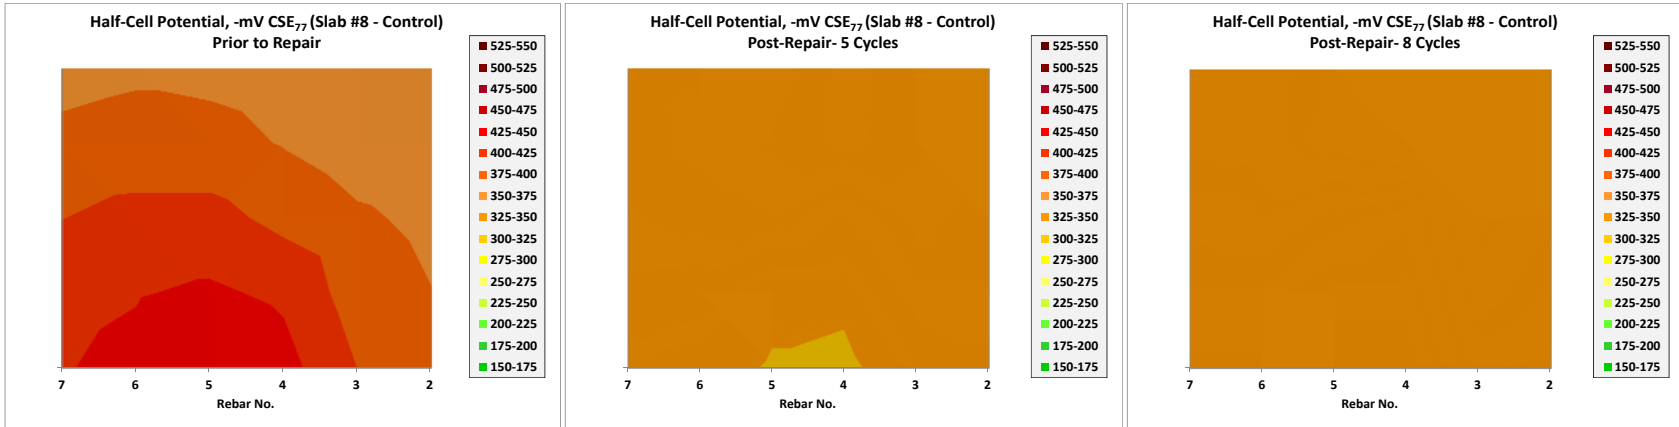
Figure 196 – Half-cell potential mapping prior to repair, 5 cycles after repair, and 8 cycles after repair – Slab #8 - Control

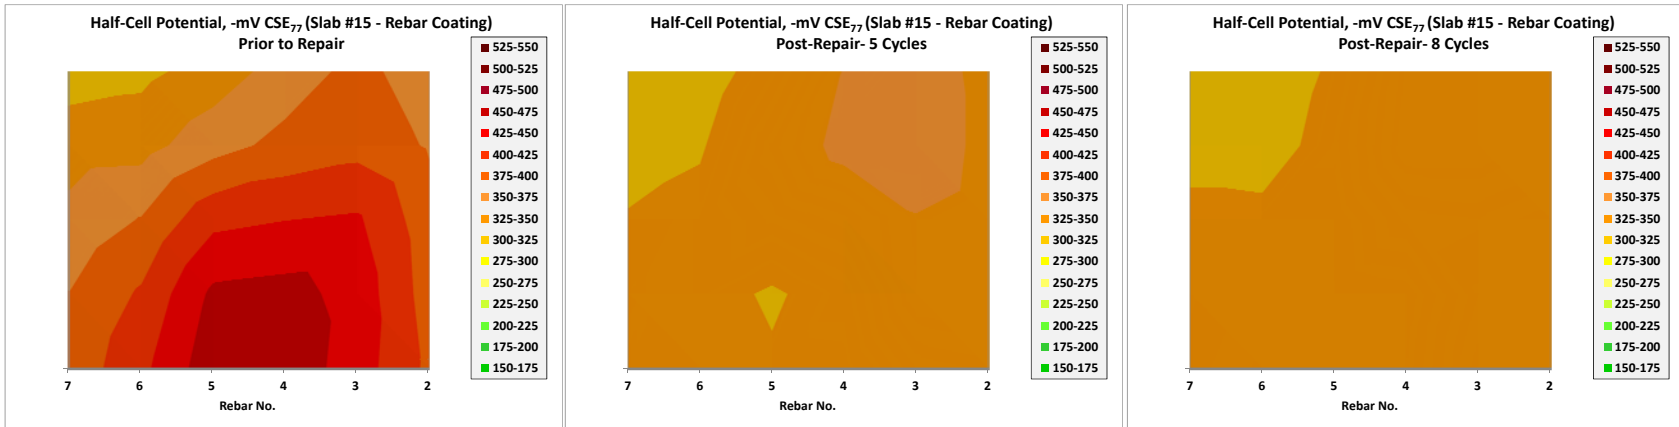
Figure 197 – Half-cell potential mapping prior to repair, 5 cycles after repair, and 8 cycles after repair – Slab #15 – Rebar Coating

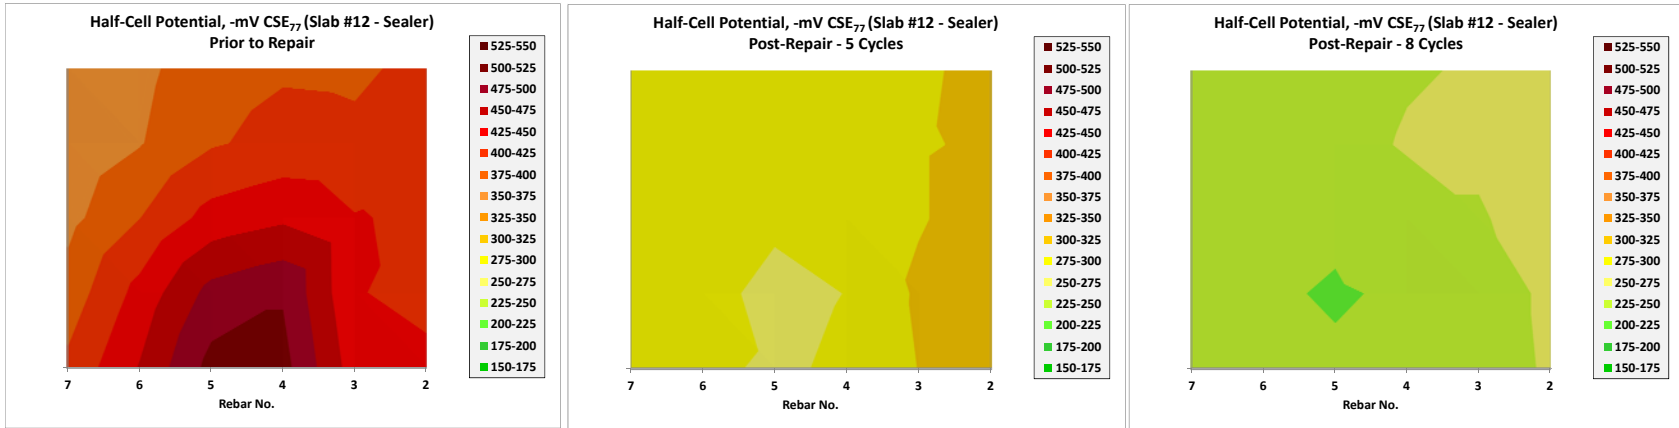
Figure 198 – Half-cell potential mapping prior to repair, 5 cycles after repair, and 8 cycles after repair – Slab #12 - Sealer
