Re: Vision 2020 – Final Report  
Contract No. R10PC80497  
TCG Project No.: 10124

# Evaluation of an Industry Suggested Protocol for Measuring the Performance of Reinforcing Steel Corrosion Mitigation Technologies for Concrete Repairs

**Bureau of Reclamation**

**TCG Project No. 10124**

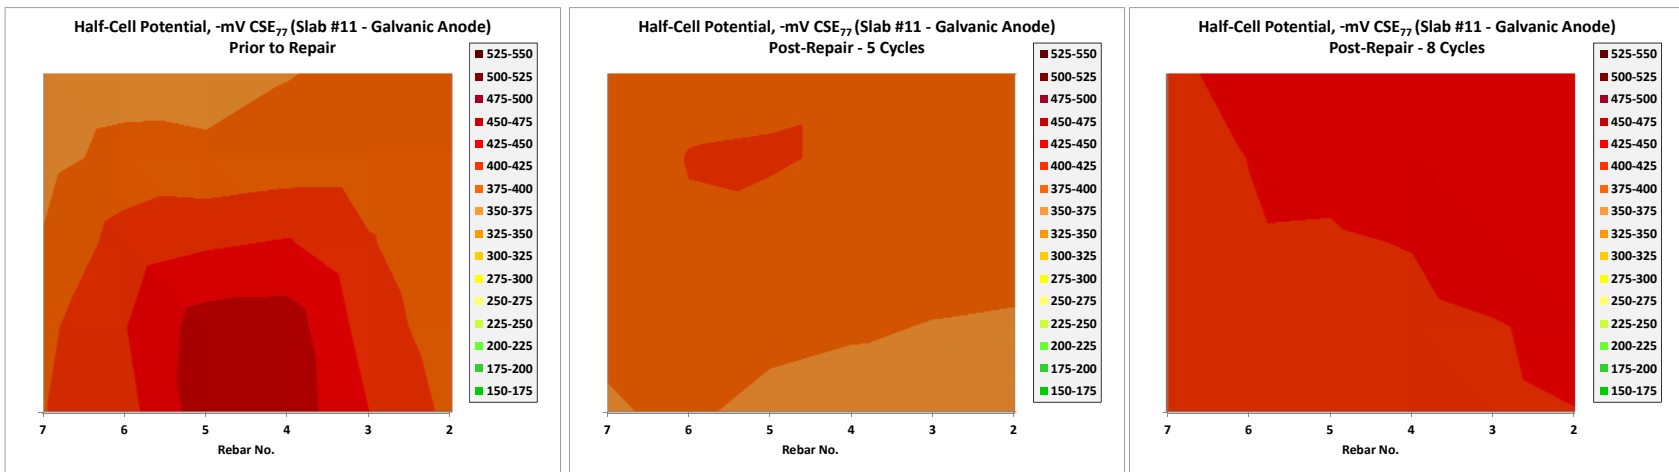
Figure 199 – Half-cell potential mapping prior to repair, 5 cycles after repair, and 8 cycles after repair – Slab #11 – Galvanic Anode

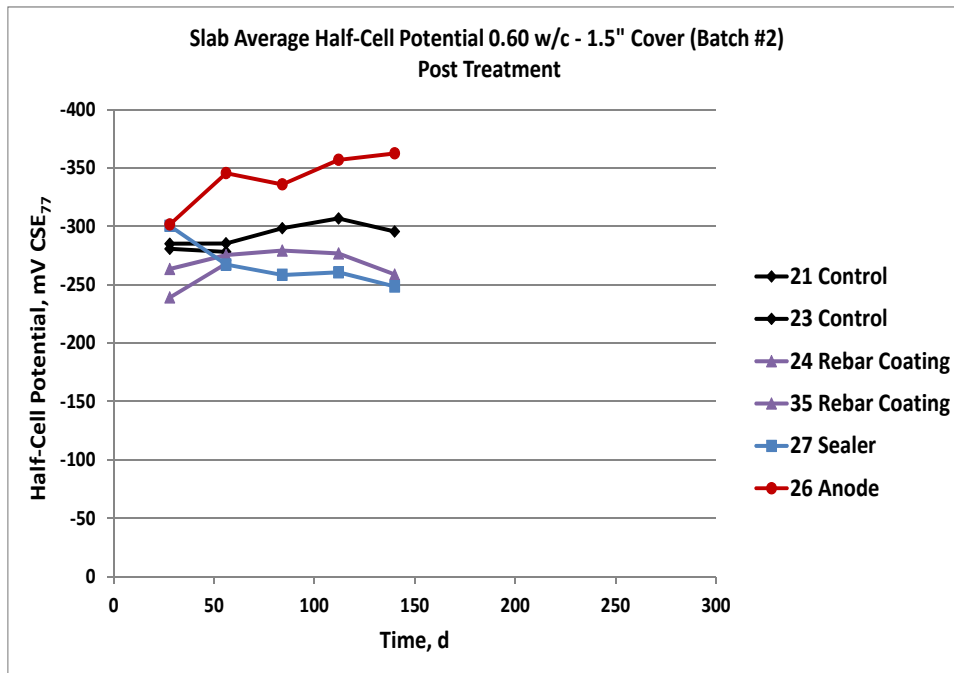
Figure 200 - Slab average half-cell potential as a function of time (Individual slabs, Batch #2, 0.60 w/c, 1.5" cover)
