Results of Geotechnical and Structural Analysis, Leadville Mine Drainage Tunnel

Leadville, Colorado
Great Plains Region

Geotechnical Engineering

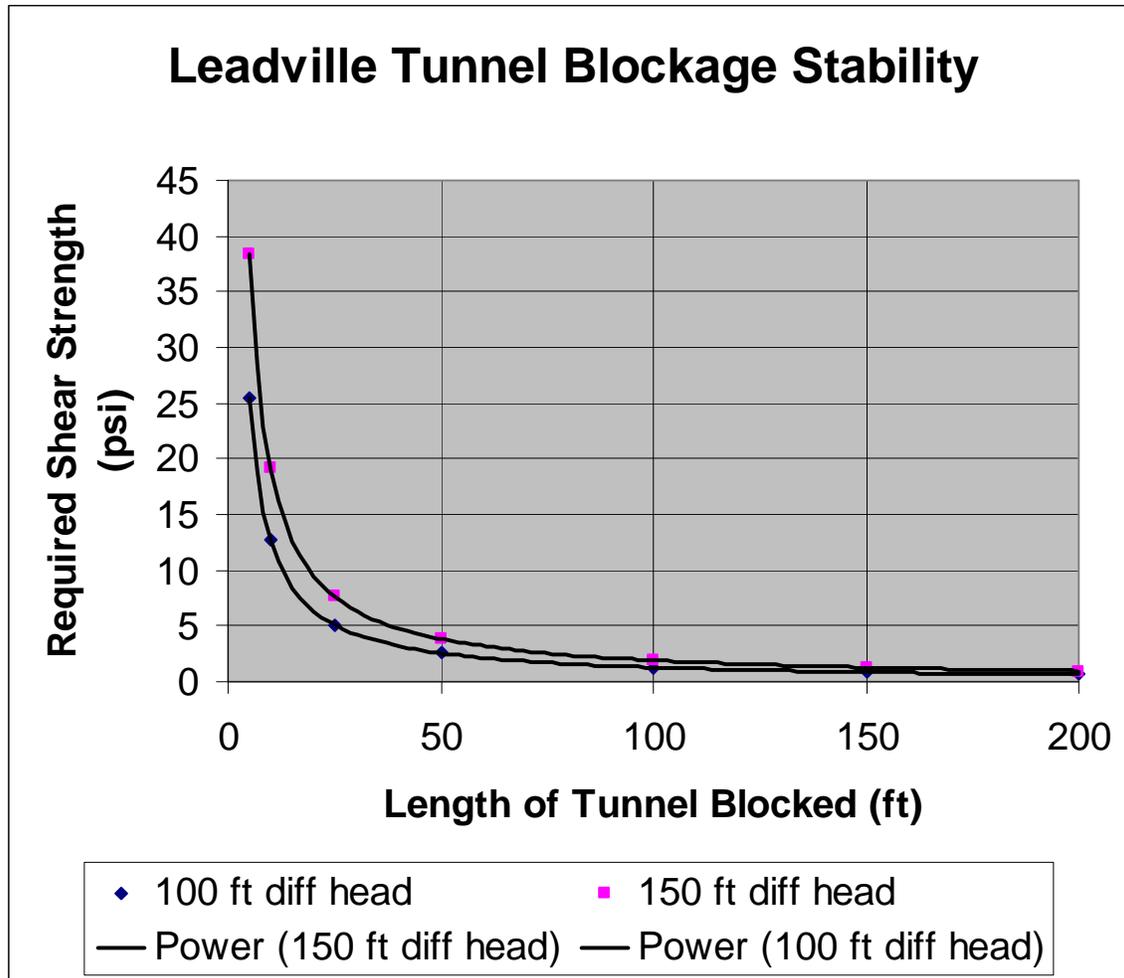
Figure 3. Required shear strength versus length of tunnel blocked from collapse in LMDT.

The results of the calculation are shown graphically in Figure 3 where the data are plotted as required shear resistance vs. length on the y and x axis respectively. Two plots, the upper representing the differential head of 150 feet, and a lower representing the differential head of 100 feet are shown. Both are asymptotic. The curves are down trending with a decrease in required shearing resistance as the length of the blockage (and total frictional contact area) increases. As expected, more shearing resistance is required to hold the larger differential head of 150 feet. Further, the shearing resistance required is seen to decrease as the length of the blockage increases.

For a length of blockage of less than thirty feet, the amount of shear strength required to maintain the blockage in place rapidly increases. At blockages greater than about 50 feet in length, the required shear strength is small and does not change significantly with increasing blockage length. The calculation is a simplification of the actual situation, but is useful in showing the approximate range of frictional shear strength needed for various lengths of blockage to resist the driving force caused by the differential head.

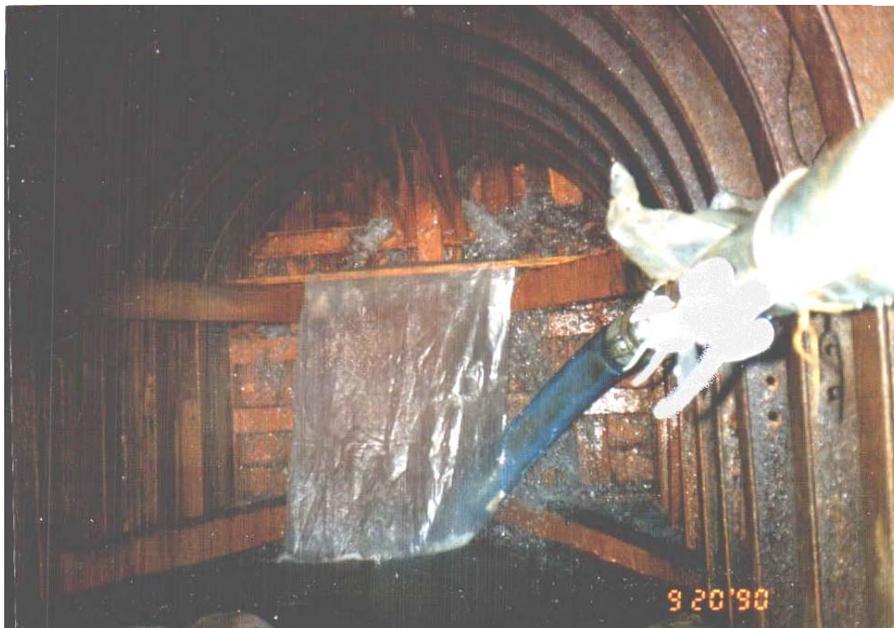
Figure 6. Photograph taken on August 20, 1990 showing the porous bulkhead located at Station 4+66.

At Station 4+66 a porous timber bulkhead was previously constructed in 1980 when the LMDT was excavated back to approximately Station 5+00 (Figure 6), new steel supports were placed, and gravel backfill was installed to bear against the sand-filled collapse zone. The tunnel along this porous plug section was originally excavated to approximately 11 feet wide and 12 feet high (Gobla and Vandeberg, 2008). Various tunnel supports and spacing were used. Both wood and steel sets were used with the only common denominator being the use of wood for blocking and lagging and the use of spiling through bad ground. The exact configuration and location of all the various support members are not documented. Spacing varied and various support members or configurations were changed over the years as maintenance and stability issues occurred.

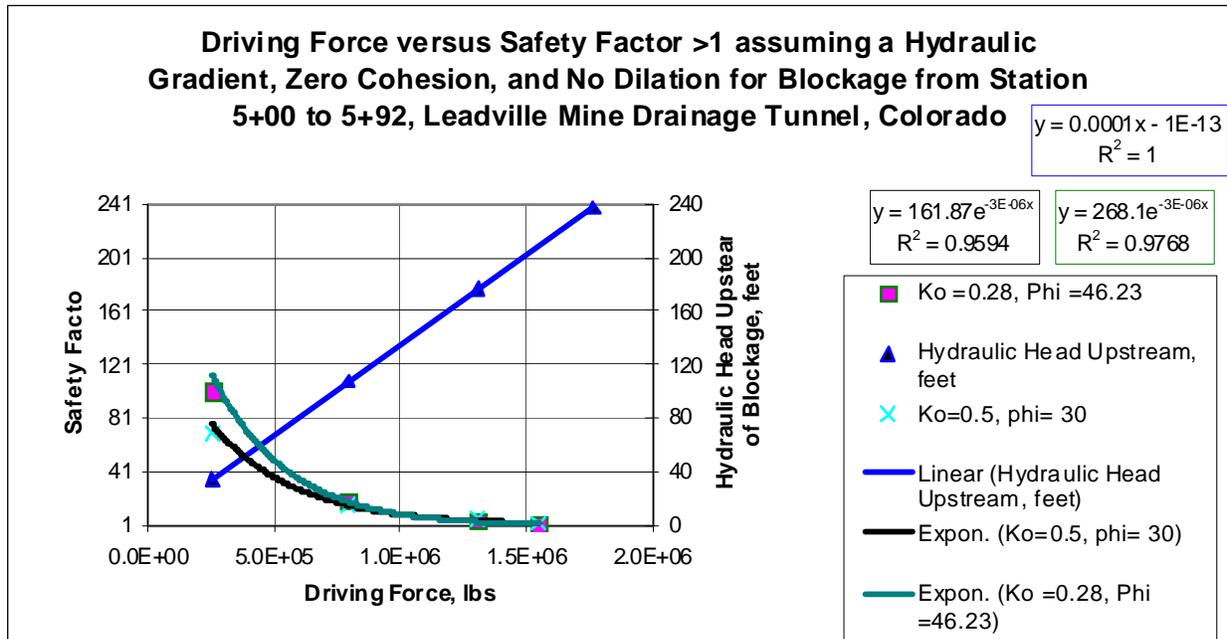
The Excel spread sheets in Appendixes B & C summarize the type of calculations that were made. The results are summarized in figures 9 and 10. Figure 9 shows the calculation for the plug considering an instantaneous loading condition. In other words, it assumes that the upper blockage near the Pendery Fault has failed and a pulse of groundwater pressure is rapidly transmitted down the tunnel to the upstream end of the plug.

As would be expected, the lower the friction angle, the lower the safety factors for a given hydraulic head. As the hydraulic head increases, the safety factor decreases for each value of friction. However, for each pair of curves, with a different friction angle, the two curves when plotted against safety factor are non linear and with increasing hydraulic head converge. At a factor of safety of 1, indicating the driving and resisting forces are equal, the hydraulic head is nearly 220 feet. This is more than 100 feet higher than any groundwater levels ever measured in

this part of the LMDT. The calculations show that this pressure pulse can be withstood and the plug will not "blowout."

Figure 9. Driving force versus differential head and safety factor for an instantaneous increase of head at the upstream end (Station 5+92) of the plug in the LMDT. The additional resistance from the manmade bulkheads and porous cobble and gravel fills located from Station 4+61 to Station 5+00 are not included in the calculation.

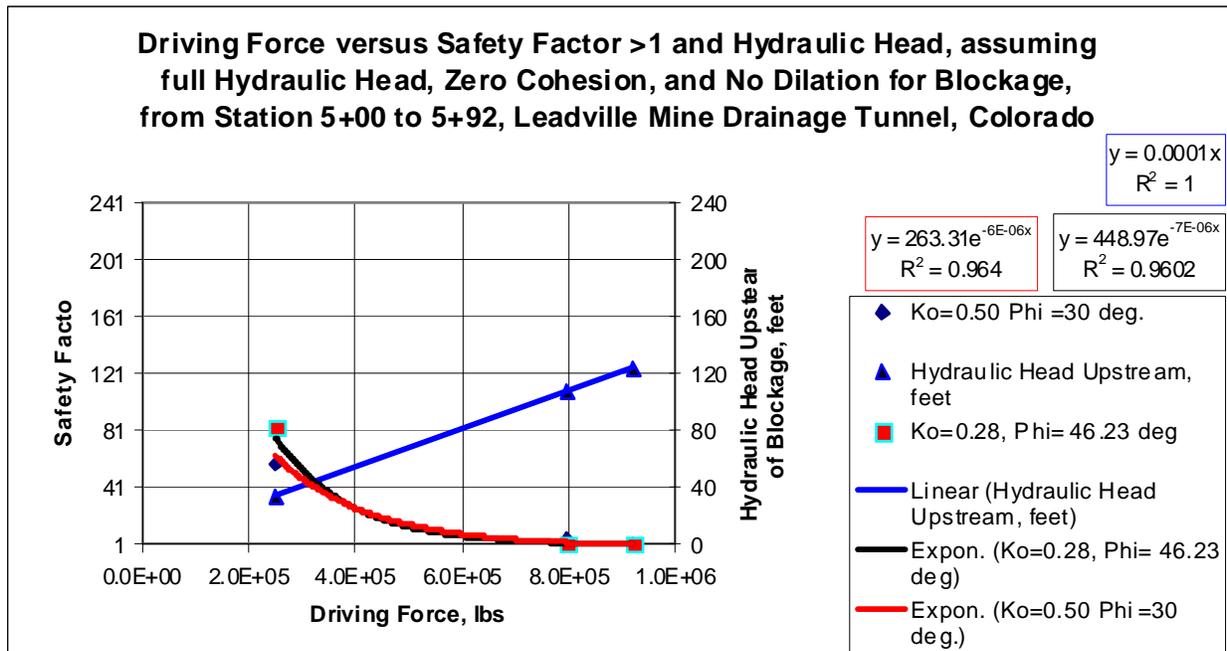
The results shown in Figure 10 for the full hydraulic head across the length of the plug indicate that the conservative factor of safety remains above 1.0 for differential heads up to about 125

feet.

Figure 10. Driving force versus safety factor for a diffusion of head along the plug from the upstream end at Station 5+92 to just above the porous fill at Station 5+00. Again the additional resistance provided by the manmade bulkheads and porous cobble and gravel fills located from Station 4+61 to Station 5+00 are not included in the calculation.

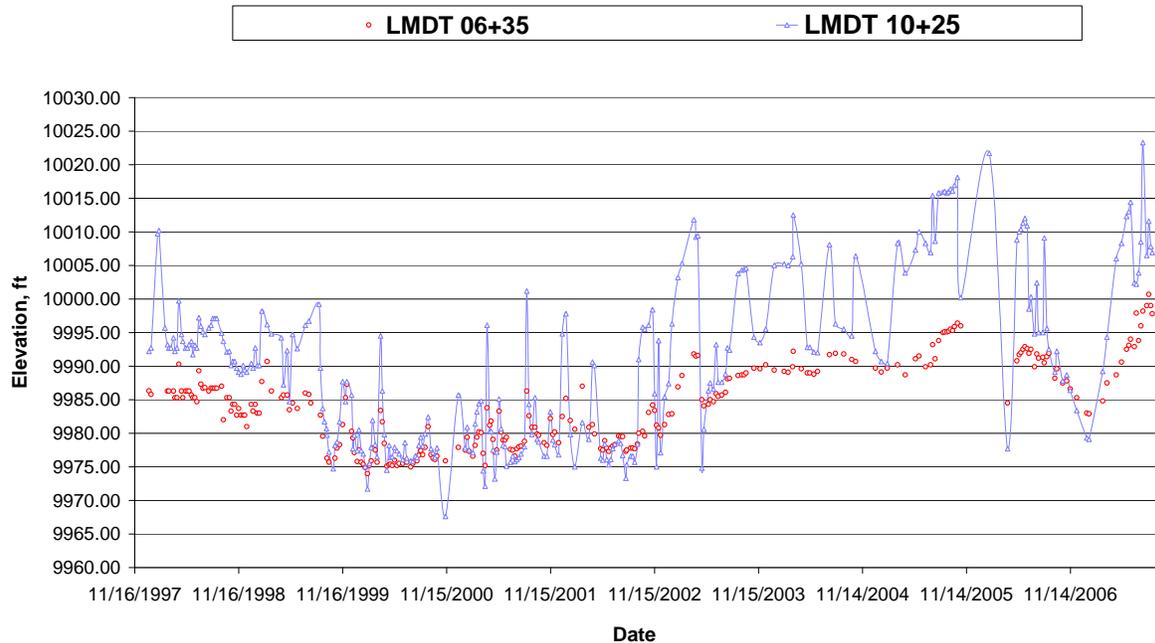
One final observation was made for the water elevation data for drill holes at Stations 6+34 and 10+25. There appears to be a difference in head between these two wells, see Figure 11. This would suggest that a small tunnel collapse or blockage may have formed some place between the two wells. Reviewing the history of the tunnel, in 1979 a well was drilled into the tunnel at Station 6+65, but while waiting for delivery of well screen, a sinkhole appeared next to the drill rig and the hole was lost. If there is a blockage in this area, then the risk to the tunnel blockage downstream of Station 6+34 may be reduced even further since the pressure gradient down the tunnel would experience another damping effect from this blockage. This also points out an important fact that given the history of the LMDT, new collapses may form and old ones may grow. As a result, there will be even more barriers to not only impede flow down the LMDT but

to create additional hydraulic barriers, which will create additional stepped pressure drops along the drainage path.

Figure 11. Water levels measured in wells at Stations 6+35 and 10+25.

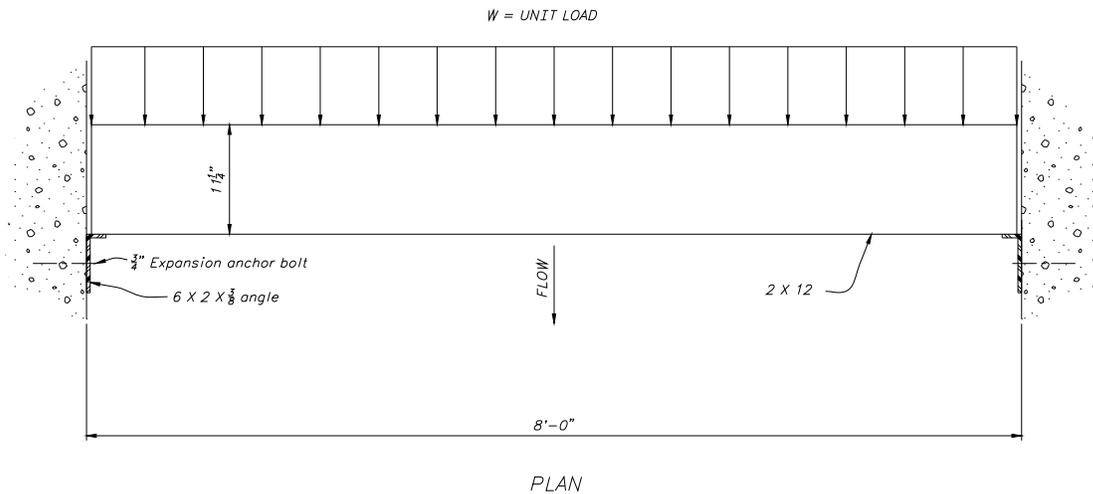
- Timber beam (see Figure 12) was assumed simply supported and uniformly loaded.

Figure 12. Plan view of timber beam.

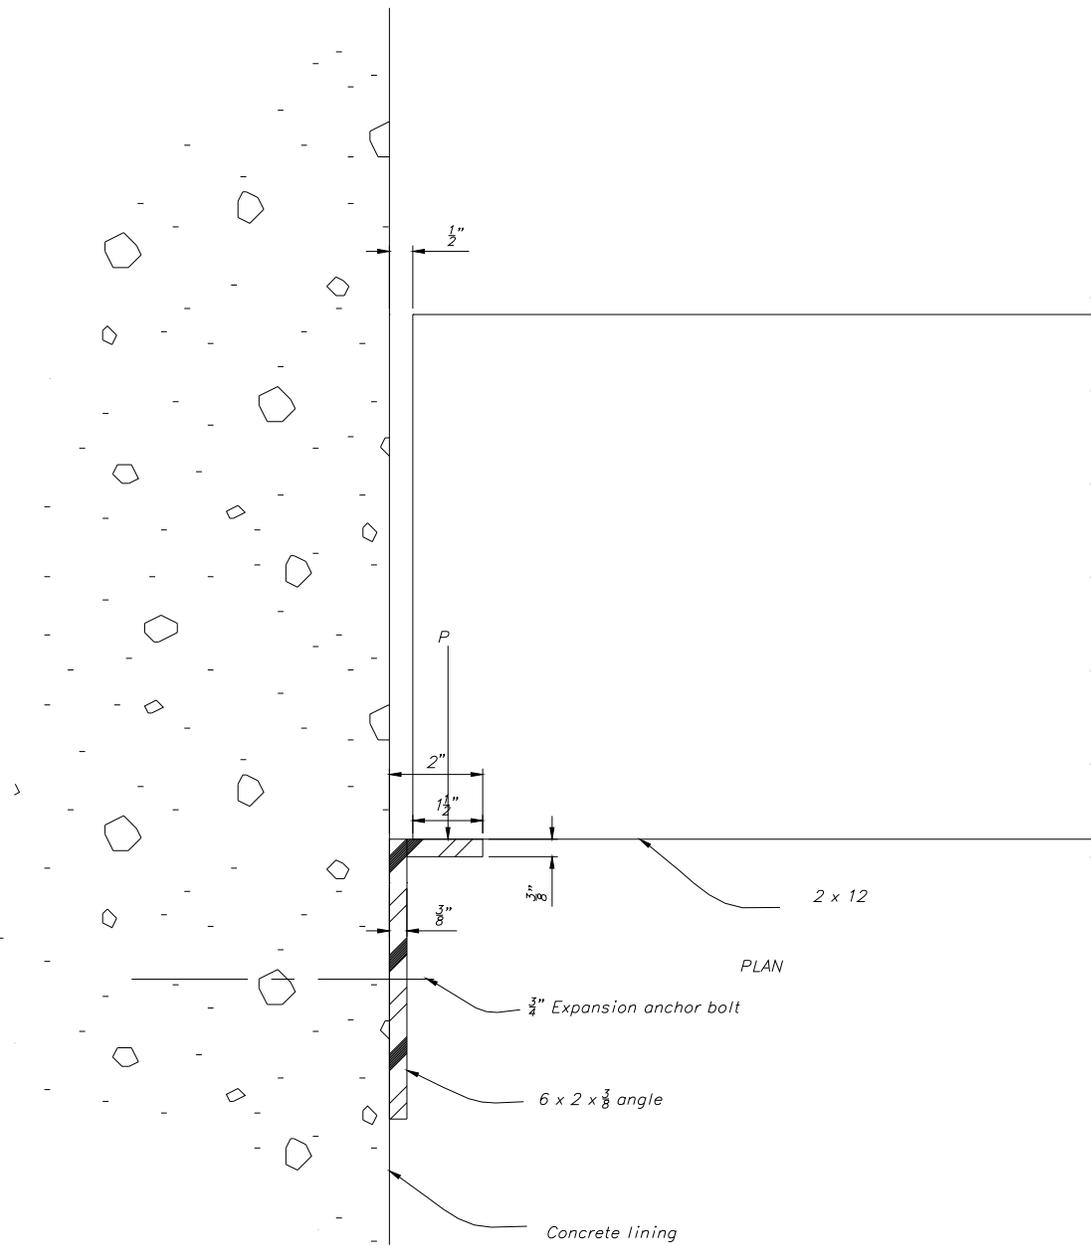
Figure 13. View of angle bracket and anchor bolt.

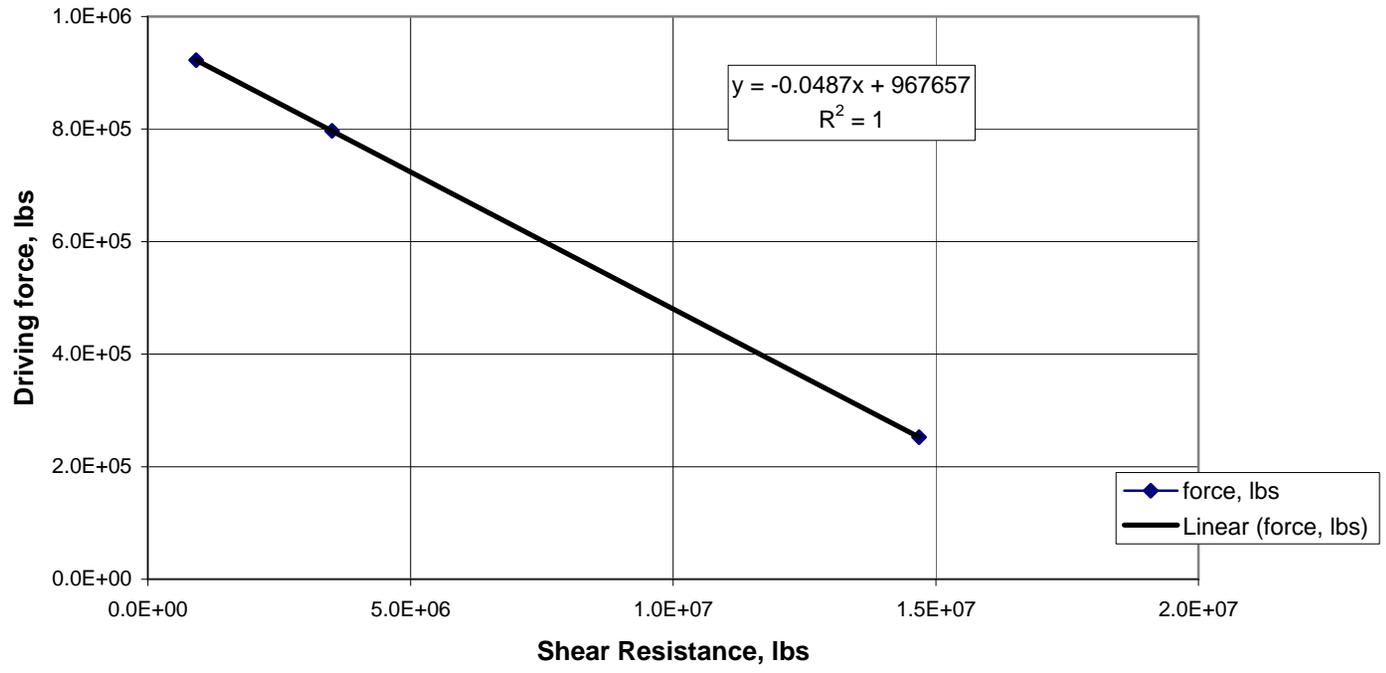
Head versus Shear resistance for Blockage with a ful Hydraulic Gradient from Station 5+00 to 5+92, Rock Contact Phi = 30 deg., zero cohesion, Internal friction Sediments 30 deg., Ko = 0.5, Leadville Mine Drainage Tunnel, Colorado

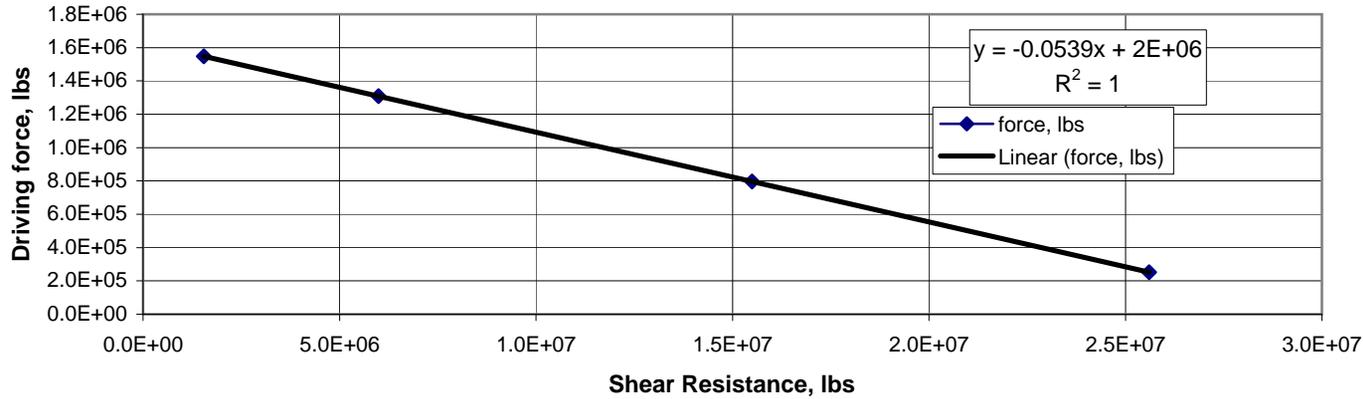
Head, with a Gradient through the Leadville Mine Tunnel blockage versus Shear resistance for Blockage from Station 5+00 to 5+92, Phi =46.23 deg., zero cohesion, Internal friction Sediments 46.23 deg., Ko = 0.28

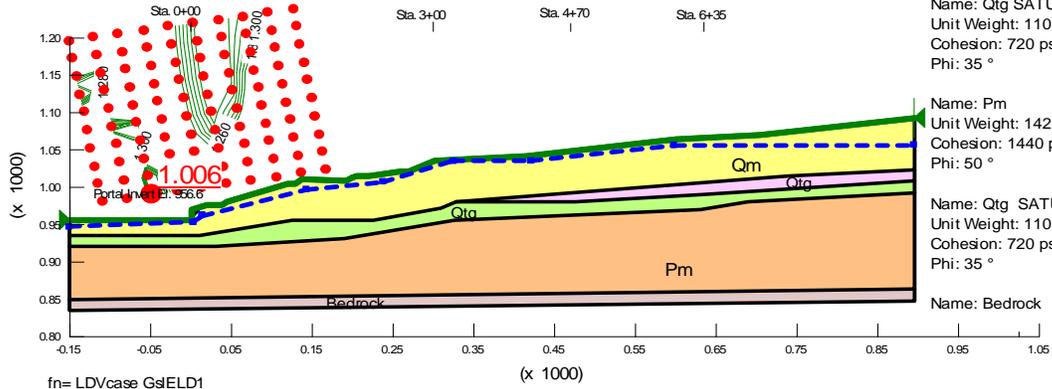
APPENDIX D - FIGURE 5
LEADVILLE DRAINAGE TUNNEL

STUDY 2008 - YIELD ACCELERATION: 0.197g
SOIL PROPERTIES: MINIMUM

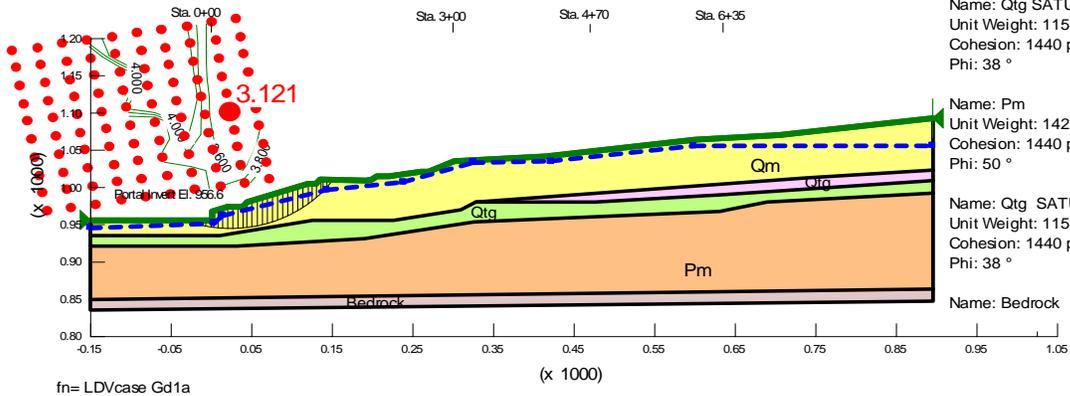
APPENDIX D - FIGURE 7
LEADVILLE DRAINAGE TUNNEL

STUDY 2008 - SEISMIC COEFFICIENT: 0.050g
SOIL PROPERTIES: AVERAGE

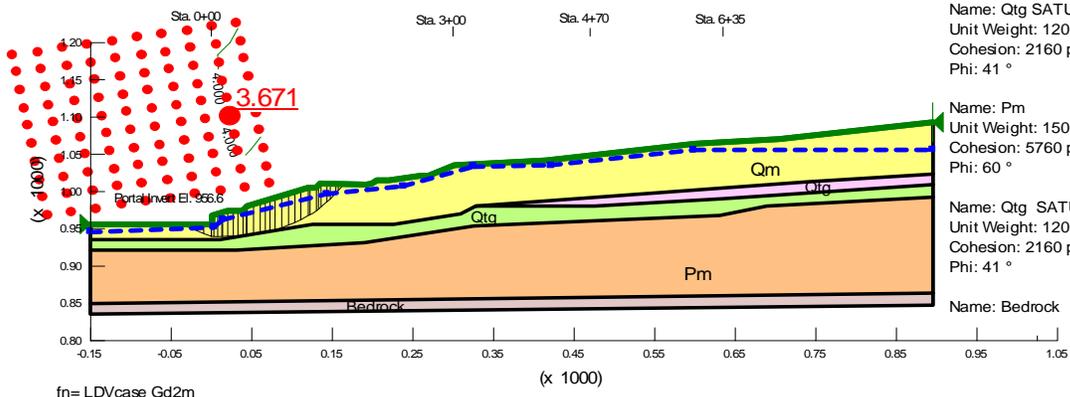
APPENDIX D - FIGURE 12
LEADVILLE DRAINAGE TUNNEL

STUDY 2008 - SEISMIC COEFFICIENT: 0.150g
SOIL PROPERTIES: MAXIMUM
