Proceedings of the 5th (1995) International
OFFSHORE AND POLAR ENGINEERING CONFERENCE
The Hague, The Netherlands
June 11-16, 1995
ISOPE Paper No. 95-JSC-214

EVALUATION OF CAPACITIES OF TEMPLATE-TYPE GULF OF MEXICO PLATFORMS

R. G. Bea, K. J. Loch, and P. L. Young

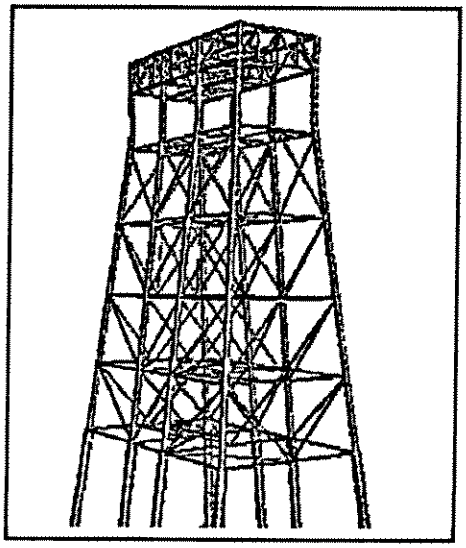
FIGURE 1: PLATFORM 'B'

Although the platform has been subjected to several severe hurricanes (Carmen, 1974, and Andrew, 1992), PB has sustained no significant structural damage. This is due in part to previous platform remediations. In 1974, the eye of Hurricane Carmen passed within ten miles of PB. Cellar deck damage suggested the largest waves were approximately 58 ft from the southeast. Hindcast studies predicted slightly higher wave heights. Post-hurricane analyses indicated that the + 10 ft. vertical diagonal joints experienced compressive yielding. The platform was the subject of a risk analysis in 1988 that identified it as a significant risk [Imm, et al., 1994]. Consequently, in 1991 all eight conductors were removed and the cellar deck was cleared of all equipment.

In 1992, the eye of Hurricane Andrew passed within eight miles of the platform. Cellar deck damage suggested a maximum wave height between 60 ft. and 64 ft. from east-southeast, approximately fifteen degrees off broadside. Hindcast studies confirmed this observation. During this event, all four + 10 ft. K-joints in the broadside vertical trusses experienced yielding; two joints were at or close to their ultimate capacity. During the post-hurricane inspection, it was discovered that there was no grout in the pile-jacket leg annulus at + 10 ft. Below the water line, the grout performed well. If all four + 10 ft. K-joints yield a collapse mechanism is formed.

It is estimated that ten percent more lateral load would have collapsed the structure [Imm, et al., 1994]. Analyses showed that the load causing the joint yielding is very close to the load experienced during Andrew. More importantly, it was estimated that removing the conductors decreased the load during Andrew by twenty percent. Analyses also showed that the platform was capable of being re-loaded to the level experienced during Andrew. However, the + 10 ft. K-joints were grouted as an additional safety measure.

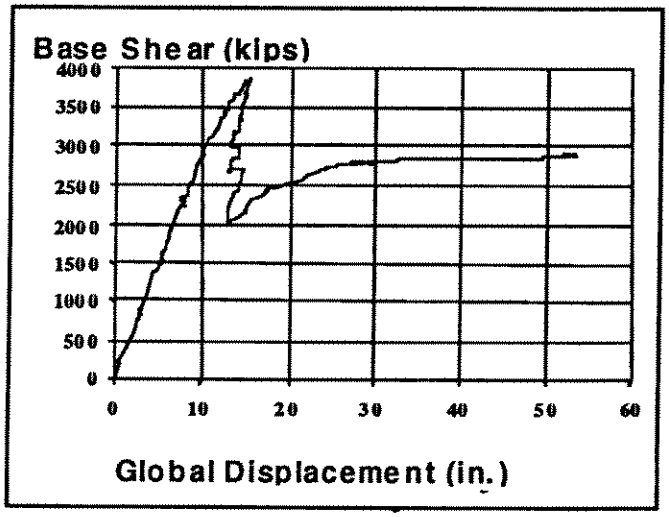
FIGURE 2: BROADSIDE FORCE-DISPLACEMENT RELATIONSHIP

The force-displacement curve for broadside loading is shown in Figure 2. This curve indicates that platform fails at 0.907 of the reference load pattern or a total base shear of 3,860 kips. This lateral loading capacity is less than the 4,900 kips reported by Imm et al. [1993]. This difference is due to the differences in the loading patterns utilized in the two analyses. The analyses reported in this paper have larger wave forces acting on the platform lower deck.

Figure 2 indicates that the platform has no reserve strength after the first brace - joint failure. However, it is important to note that the platform can experience large inelastic displacement before a failure mechanism is formed. If the force-displacement curve were extended it would show that eventually, the jacket legs develop sufficient resistance in bending to cause buckling of the braces in the third jacket bay.

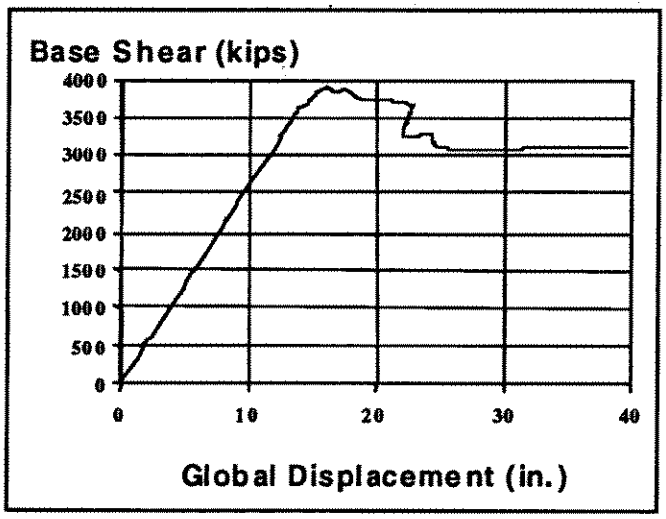
FIGURE 3: END-ON FORCE-DISPLACEMENT RELATIONSHIP

The force-displacement curve for end-on loading is shown in Figure 3. This curve indicates that the uppermost compression braces buckle at 1.12 of the reference load pattern or a total base shear of 3,900 kips. Figure 4 shows that after the compression braces - joints in the fourth jacket bay fail the platform has a small increase in resistance capacity until the compression braces in the third jacket bay and the horizontal framing between these two levels almost simultaneously fail, at which point the platform is at imminent collapse.

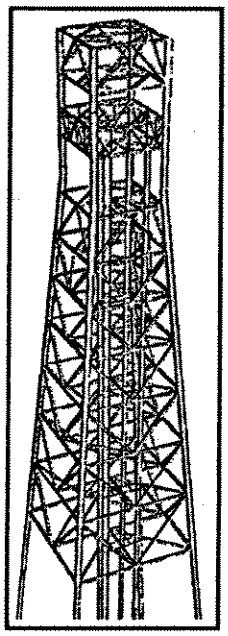
FIGURE 4: PLATFORM 'C'

Platform 'C' (PC) (Figure 4) was installed in the GOM Ship Shoal region in 1970. This platform is a self contained four pile drilling and production platform located in 157 ft. of water. PC survived hurricane Andrew without significant damage.

The initiating failure mode for PC based on the static pile characterization is pile plunging. The force-displacement history for broadside loading is shown in Figure 5. This curve indicates that platform fails at 0.628 of the reference load pattern or a total base shear of 1,700 kips at a displacement of about 24 in. From Figure 5 it can be seen that the platform has a constant stiffness after all the T-Z and Q-Z springs of the compression piles have reached their final plateaus

Since the foundation was shown to be the weak link in the platform, an analysis based on a dynamic pile characterization was also performed.. Results from the USFOS analyses showed that if the foundation was characterized based on consideration of dynamic effects, the braces in the second jacket bay became the weak link. The second bay compression braces buckled at 1.30 of the reference load pattern or a total base shear of 3,440 kips. After the compression braces in the second jacket bay buckled, the braces in the third jacket bay buckled and the jacket began to "unzip".

The hurricane hindcast data [Cardone, Cox (1992] and observed platform performance indicate that PC survived 53 - 56 ft waves during hurricane Andrew. Based on the results from the analyses performed on PC, the total lateral loading associated with these conditions ranged from 1,700 to 1,900 kips. These loadings exceed the platform capacity that was based on static pile capacities. However, they do not exceed the platform capacity that was based on dynamic pile capacities. Given that the platform survived hurricane Andrew without significant damage, it is concluded that the platform capacity based on the dynamic pile simulations is more realistic.

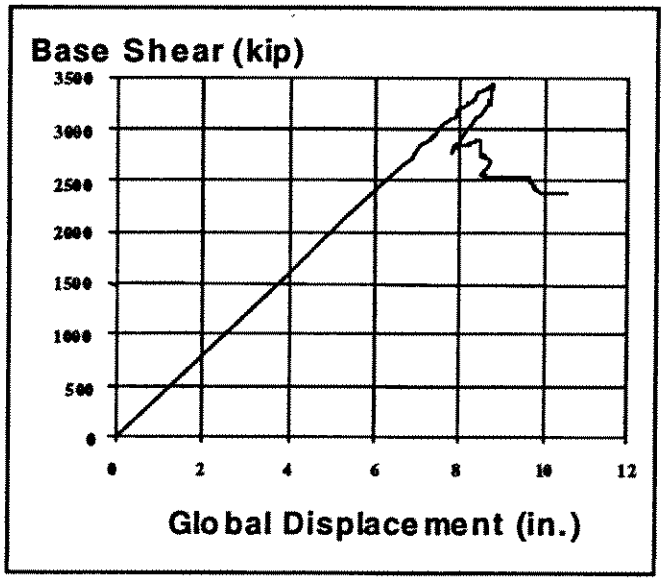
FIGURE 6: FORCE - DISPLACEMENT RELATIONSHIP FOR DYNAMIC PILE CHARACTERIZATION

The lateral force - displacement characteristics for the analyses based on the dynamic pile characterization is given in Figure 6. The peak lateral load capacity is now 3,500 kips and it is reached at a lateral displacement of about 9 in. Based on the dynamic pile characterization, the lateral load capacity of the platform is about doubled.

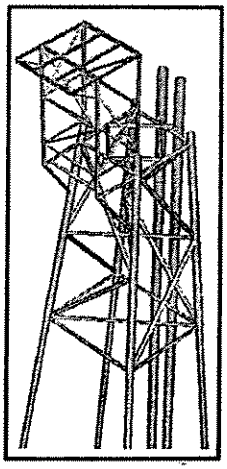
FIGURE 7: WELLHEAD PROTECTOR 1

The eye of hurricane Andrew passed within a few miles to the west of Wellhead Protectors 1 (WP1) and 2 (WP2) (Figures 7 and 8). Hurricane Andrew produced extreme storm loadings which caused WP1 to collapse. Diver surveys made after the storm indicated WP1 failed by pull out of the piles on the south side of the platform. The seemingly identical WP2 did not collapse; there was no significant damage to this structure. The goal of this study was to determine how the forces developed by hurricane Andrew could have caused the collapse of WP1 and not the collapse of WP2.

The results of the study based on StruCad*3D and ULSLEA initially indicated that WP1 and WP2 should have behaved similarly; both should have survived. At this point, the pile driving records for the structures were obtained and reviewed. It was discovered that both of the piles on the south side of WP1 had been under-driven by 5 feet. All of the piles in WP2 had been driven to their design penetrations.

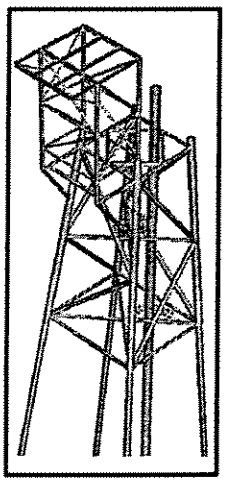
FIGURE 8: WELLHEAD PROTECTOR 2

The USFOS result that both structures fail due to pile yielding and pullout was confirmed by results from the StruCad*3D and ULSLEA analyses. The ratio of the peak lateral loading during hurricane Andrew to the maximum lateral loading capacity is 1.2 and 0.95 for WP1 and WP2, respectively. The analyses indicate that WP1 should have failed due to pile pullout and WP2 should have survived. The paradox of why these two seemingly identical structures behaved differently was due to the differences in the appurtenances (well conductors), the manner in which the wells were tied into the structures, and the under-driven piles. The effects of these differences only became evident when these "details" were determined and their implications integrated into the analyses.

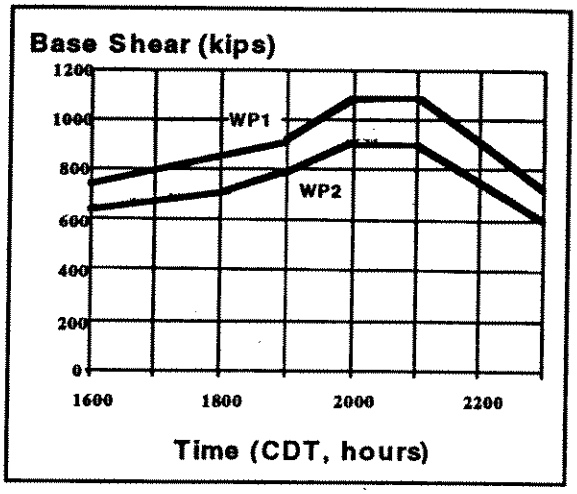
FIGURE 9: TIME HISTORY OF MAXIMUM BASE SHEARS ON WP1 AND WP2 DURING HURRICANE ANDREW

The two structures were loaded only along their principal axes to provide consistency between the various approaches employed to analyze structural response. Wave loads for USFOS were generated by the seastate program WAJAC [DNV 1993] which determines peak loads using phase angle intervals of 1°. The global base shears developed on WP1 and WP2 during the passage of Andrew are summarized in Figure 9. The results indicate WP1 experienced peak lateral loadings that were about 20 % larger than those on WP2. The peak lateral loading on WP1 was 1,100 kips and on WP2 was 850 kips.

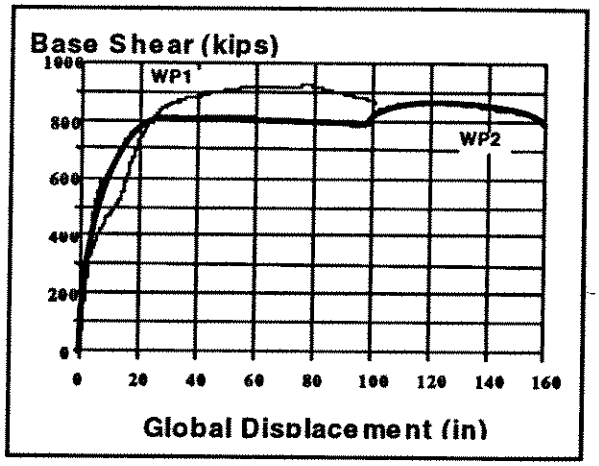
FIGURE 10: LOAD - DISPLACEMENT CHARACTERISTICS FOR WP1 AND WP2

The static push-over results for WP1 and WP2 based on the USFOS results are summarized in Figure 10. The "double humps" found in both analyses result from the increased stiffness of the structures when contact between the jacket and caissons occur. The negative stiffness found at the end of all analyses represents pile pullout. The large lateral deformations produce plastic hinges in the piles which produce a near mechanism. It is the additional strength and rigidity of the caissons which prevents the structures from soft story collapse. This added stiffness allows the full axial capacity of the soils to be exceeded to produce pile pullout. The maximum lateral load capacity of WP1 is 910 kips and WP2 880 kips.
