Analysis of Surveyor 3 material and photographs returned by Apollo 12

Preface

MAY 1971

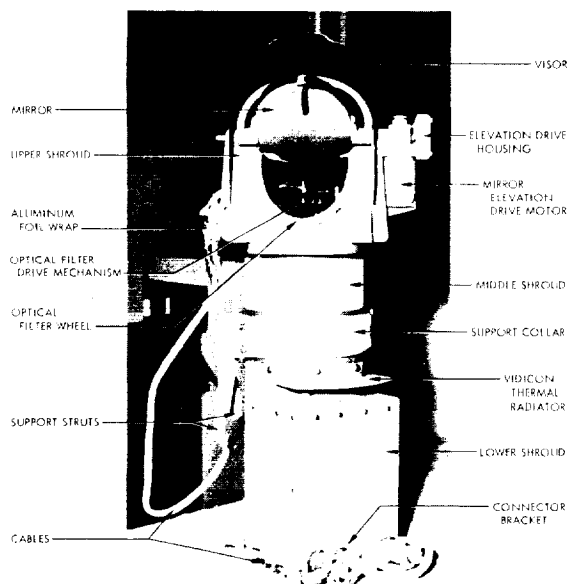
Figure 2.—Surveyor 3 television camera as it was un-bagged at the LRL after its return from the Moon. Dents in the visor occurred during transport from the lunar surface.

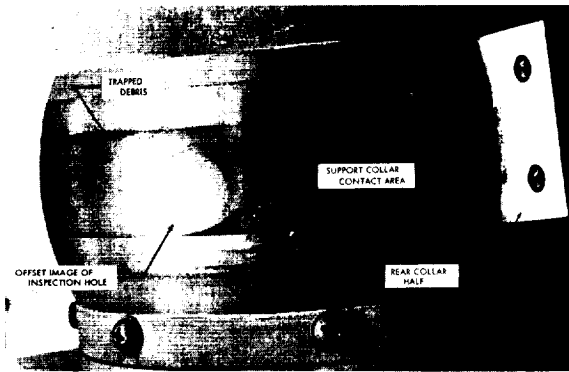
Figure 1.—Surveyor 3 television camera with front half of support collar removed. Back half has been displaced toward the right and upward from its original position.

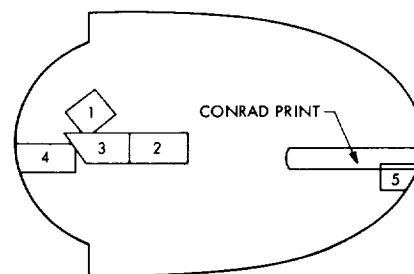
Several areas of the mirror were sampled (fig. 1). Most of the mirror appeared to be covered with dust, but some slight shading was apparent at one end. This may have resulted from shielding by the mirror housing. Also some interference bands were visible when the mirror was viewed under oblique light. Samples were taken along a strip that crossed both the shading bands and the interference bands. At each location, approximately 1-cm² pieces of acetyl cellulose tape (0.0034 cm thick), moistened with acetone, were placed on the mirror; they were removed after the acetone had dried. The debris was molded

FIGURE 1.—Location of the sample areas of the mirror. Several peels were taken at each sample location.

After several peels had been taken in areas 2, 3, and 4, the interference bands were still visible. One possibility was that the bands were caused by material adhering to the surface, so more severe steps were taken. The strip that had been sampled was rubbed vigorously with a Q-tip to remove any remaining material, then additional peels were taken. Examination of the peels

showed that almost all of the material had been removed from the surface of the mirror by the initial peels, so that the interference bands could not be attributed to dust on the surface.

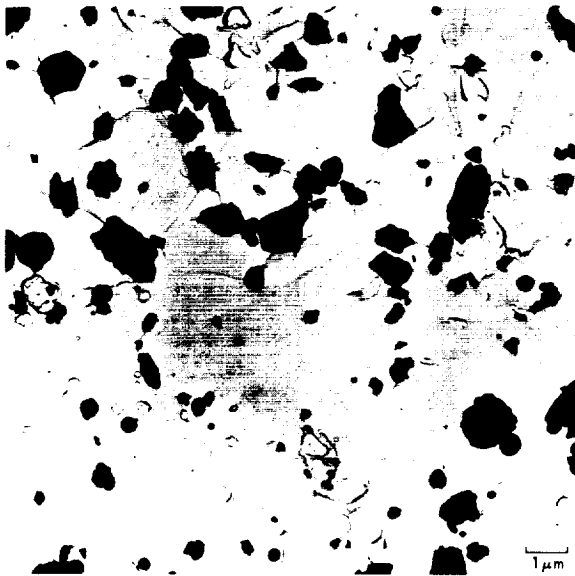
The material on the mirror consists of fine-grained, angular fragments. Spherical particles are restricted primarily to the smaller size ranges; approximately 1 particle in 100 is spherical at 0.7-μm diameter compared with 1 in 10 at 0.2-μm diameter. The particles fall within a very narrow size range. The size frequency curves for different areas (fig. 5) show a steep falloff above 3 μm and few particles smaller than 0.3 μm; 90 percent of the total mass of the sample is within

FIGURE 3.—Electron micrograph of debris from the Surveyor mirror.

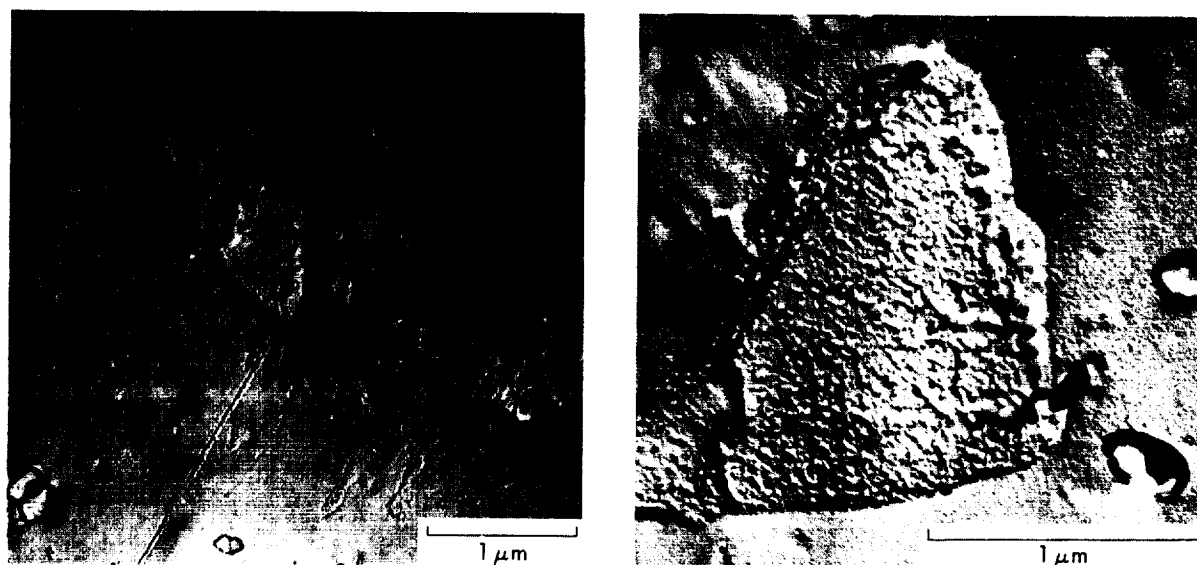
While observing the sample, a recurring defect was noted in the surface of the mirror. It was especially evident in the second and third peels taken at a particular location, as these contained virtually no masking debris. The defects are flat-bottomed, shallow depressions; they are irregular in outline, and generally less than 2 μm across. They all have a characteristically pitted floor (fig. 6). They probably indicate places in which the protective silica coating is absent. It is not known whether these defects were on the mirror before the Surveyor mission, nor whether they are a result of the mirror's manufacture or its subsequent history.

FIGURE 6.—Defects in the surface of the mirror.

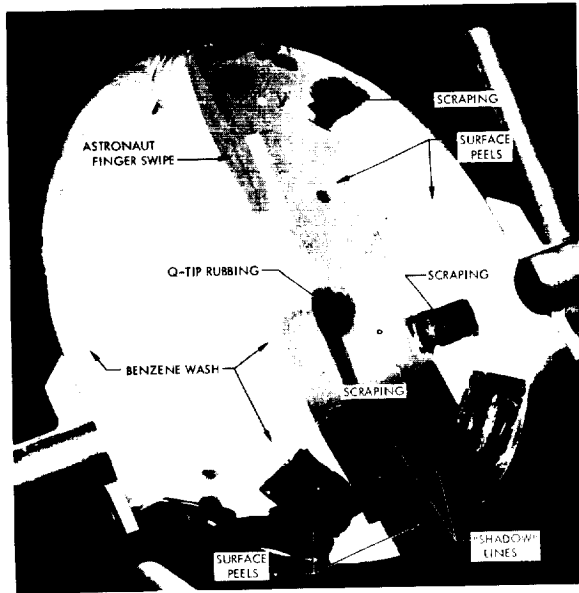
The mirror has been subjected to many tests that have modified its surface (see fig. 3); the results of these tests by other investigators are presented in this document. Lunar dust has been removed from specific areas by rubbing, by acetate and metallic film stripping techniques, by rinsing (fig. 4), by scraping (fig. 5), and by inadvertently touching the surface. The acetate film stripping technique revealed a second

FIGURE 3.—Surface features on the mirror were created by other investigators to define the nature of the adhering material and the shadow lines, to identify the film that caused the spectral band, to search for micrometeoroid impact features, and to identify organic contaminants (compare with fig. 6).

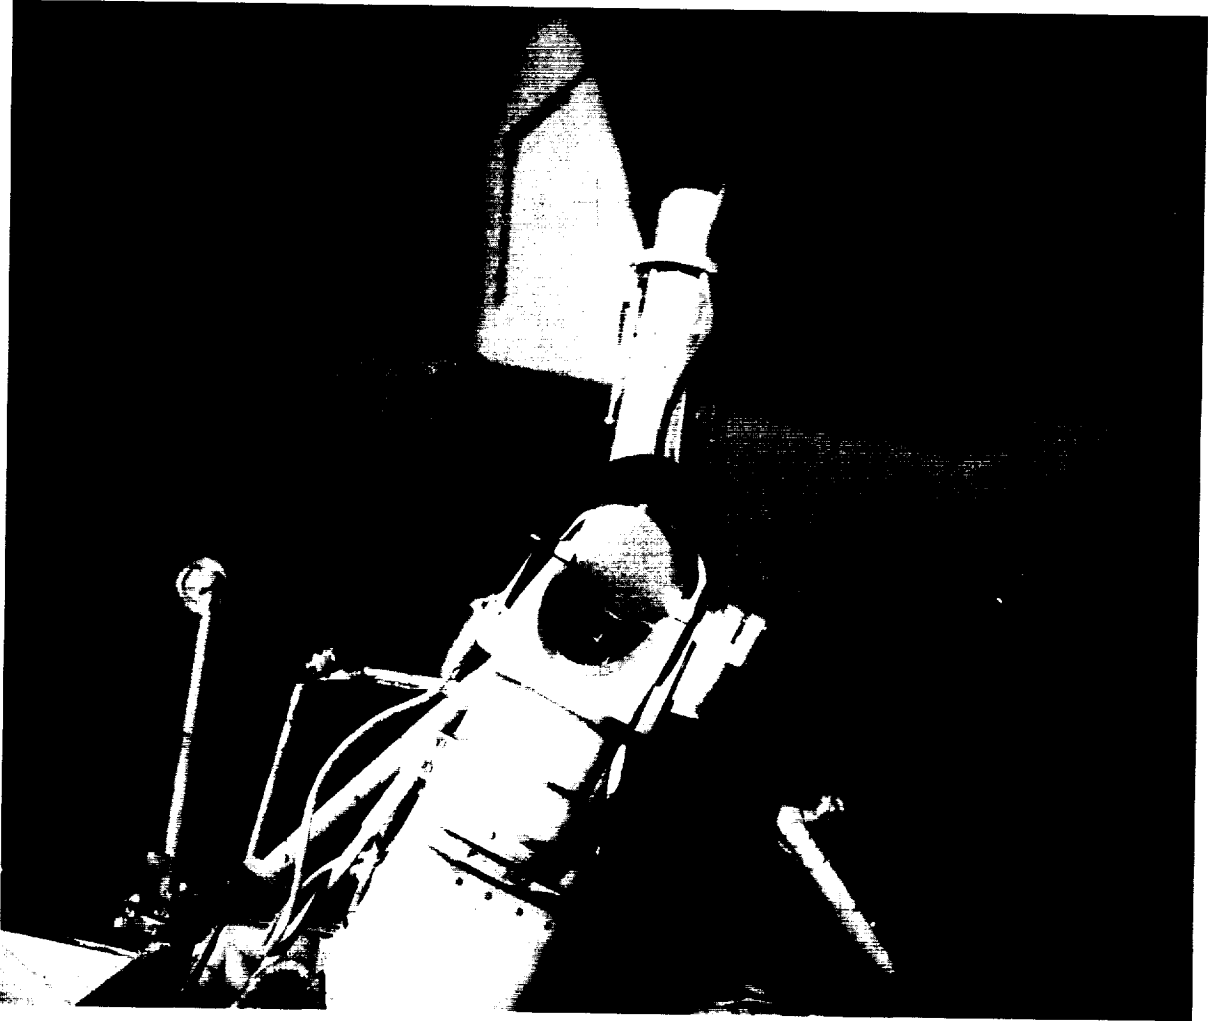
FIGURE 7.—The Surveyor 3 television camera as it existed before removal by astronauts Conrad and Bean. The front opening of the camera provided the silhouette that defines the shadow lines.

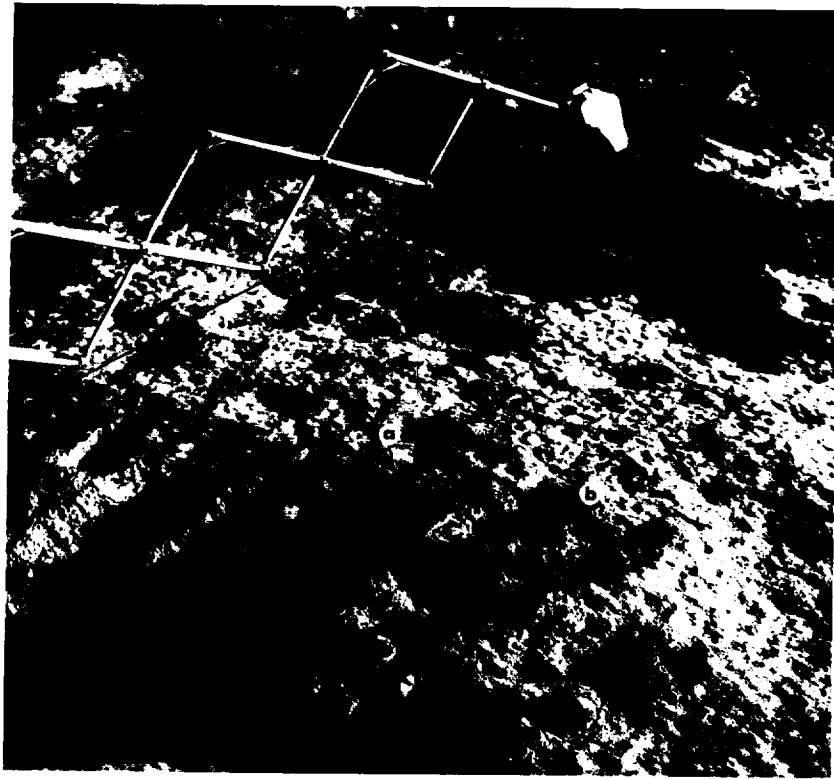
FIGURE 16.—Apollo 12 photograph of the Surveyor 3 scoop showing most of the surface area available to the scoop. Points *a* and *b* coincide with those found in figure 14. No changes in these features were noted by comparing Surveyor 3 pictures with the Apollo 12 photographs taken 31 months later by the astronauts.

Figure 16 is an Apollo 12 photograph taken from the south side of footpad 2 (see fig. 14) in a northerly direction. Points *a* and *b* have been located on figure 15 for comparison. No changes were noted between this picture and a similar one taken 31 months earlier by the Surveyor 3 television camera.

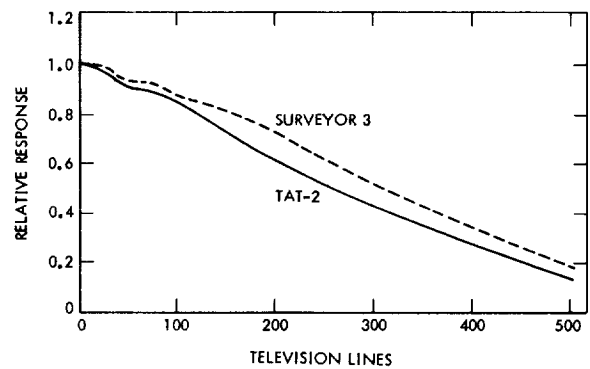
FIGURE 4.—The modulation transfer functions of the Surveyor 3 mirror and the TAT-2 mirror, used with the TAT-2 camera. The conditions were identical to preflight tests. The slight improvement may be due to positioning and flatness differences.

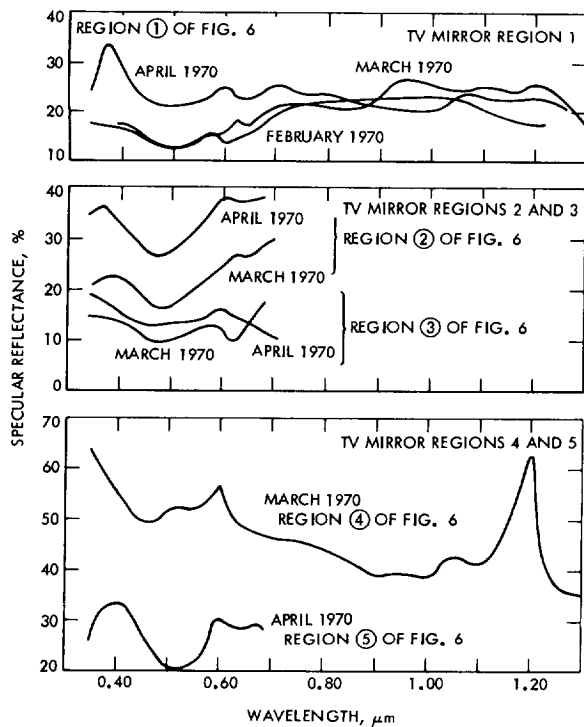
FIGURE 5.—Measurements of the spectral reflectance on the mirror made by Hughes Aircraft Co. over the period of February through April 1970. Incidence angle equals reflectance angle. (Data are through the courtesy of Hughes Aircraft Co.)

The spectral reflectance of the mirror was one of the prime types of measurements during the mirror investigation. Initial studies were made using a tungsten halogen collimator at HAC in Culver City, Calif. The detection apparatus was a EG&G spectroradiometer. Five positions were measured on the mirror at specular reflectance geometry. The positions and representative curves are given in reference 2 and are shown in this chapter as figures 5 and 6.

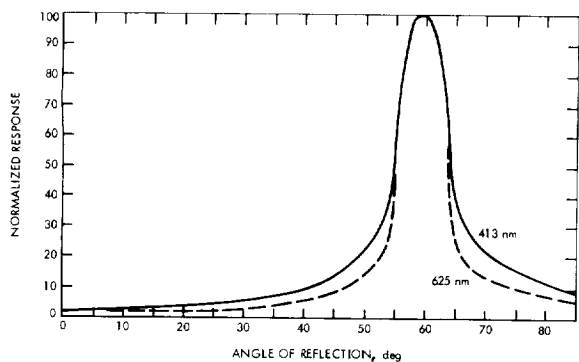
FIGURE 9.—Goniophotometric data on the reflection of the collimated light from the mirror at 2 wavelengths. Angle of incidence is 60°. The peak is normalized at 100 and is broad because of the detector acceptance angle. About 50 percent more light is scattered at 413 nm than at 625 nm. The area is beside the swipe made by Conrad.

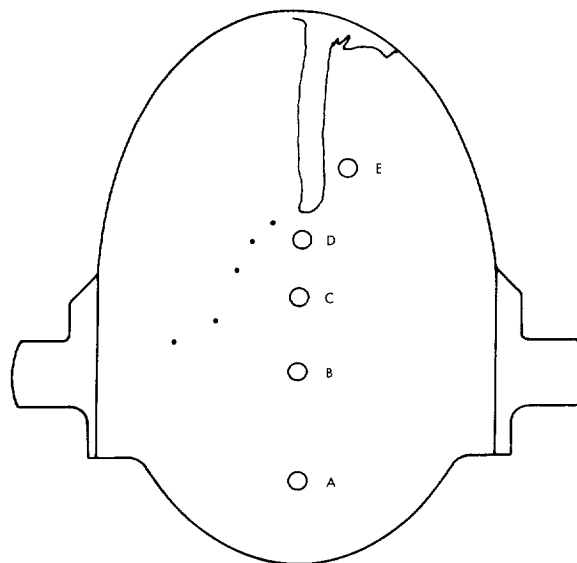
Because of the apparent symmetry of lunar material distributed around the long axis of the mirror, five positions were chosen for measurement. These are shown in figure 10. Area A is geometrically the lowest of these and represents a part of the mirror that has the highest reflectance with lunar material still in contact. Area B is important because it occupies the region of prominent color banding. Areas C and D show less coloration, but contain greater quantities of lunar material. Area E is important as a repeat of previous data taken earlier at HAC. The swipe made by astronaut Conrad was investigated by HAC, and no additional measurements were made on this area.

FIGURE 10.—Positions of the areas on the mirror used for spectral reflectance. The five white specks are indicated and discussed in the text.

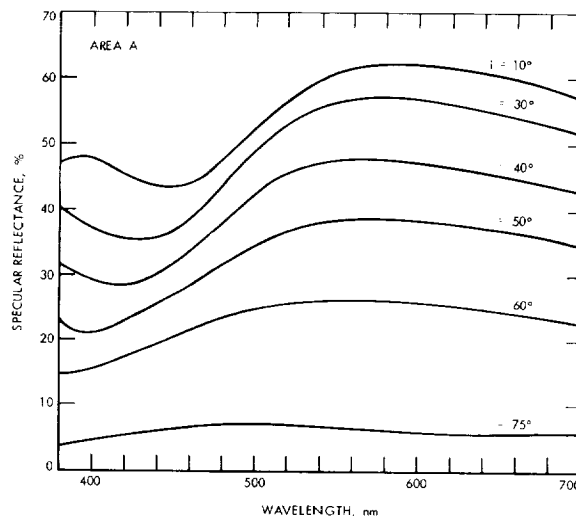
FIGURE 11.—Plot of the absolute spectral reflectance of area A at varying angles of incidence. The detector was set equal to the reflection angle.

lute reflectance curves show a large decrease with angle of incidence. For mirror surfaces in general, the reflectance is almost constant. Thus, the effect of particulate matter on the mirror is the dominant factor in decreasing the light flux reaching the detector. This result, however,

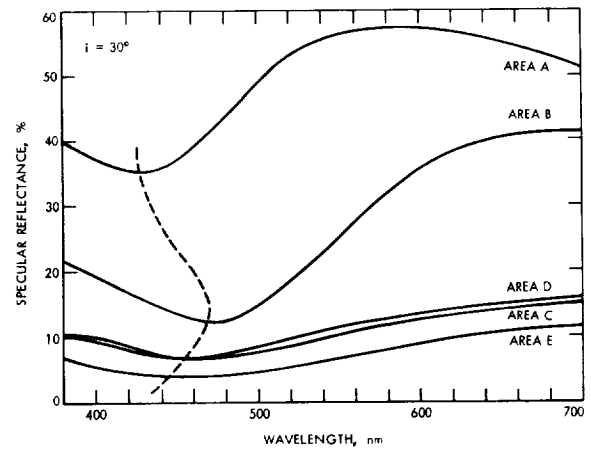
FIGURE 15.—Spectral reflectance variation with area at a constant incidence angle of 30°. The dotted curve is a trace of the minima and shows the increased film thickness at the elevation angle.

could have been predicted from the goniophotometric data taken at HAC. What is interesting is the minimum in each curve indicating an additive residual reflected color of violet, the almost normal visual impression of the color band on the mirror. The shift toward the blue or shorter wavelength as the angle of incidence increased, however, is a phenomenon closely associated with interference effects from thin

nonuniform coating of some kind of film (figs. 14 and 15). This appearance of the spectral properties, as well as the Carr and Proudfoot results (see ch. IV, pt. C), lead the authors to the conclusion that scattering or diffraction effects from the lunar material are not the cause of the colors.

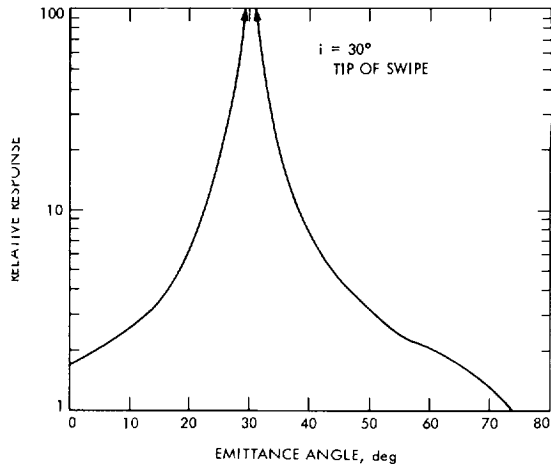
The measurements of nonspecular reflected flux at different wavelengths were closely associated. Comparisons could be made concerning the changes, if any, which occurred to the mirror as the analysis program proceeded. Figure 16 is a plot of the reflection at $i = 30°$. Less material is present on the mirror than at the start of the observations.

Figure 16.—Plot of the mirror reflectance as a function of emittance angle at $i = 30°$. It is similar to figure 9, but over the entire spectral range of the detector.

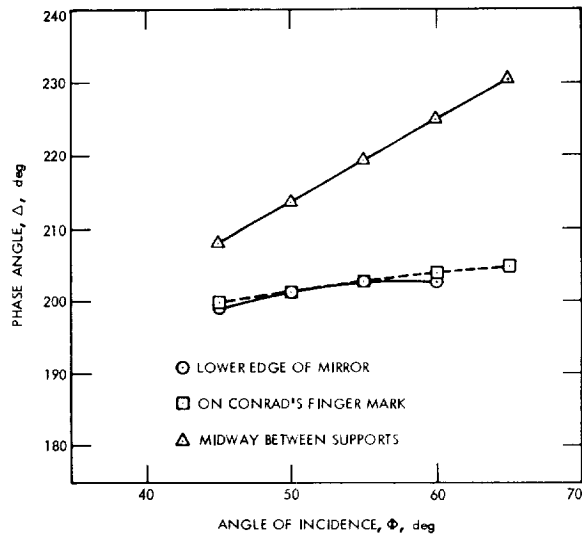
Figure 18.—Plot of the phase change Δ as a function of the angle of incidence. The slope of the Δ vs. Φ curve in the region adjacent to the elevation axis indicates increased film thickness. The top and bottom of the mirror are of approximately equal film thickness.

the range $45° \le \Phi \le 65°$. (See fig. 18.) The slope of the Δ and Φ curves increases in the region adjacent to the mounting brackets, indicating an increase in film thickness in this region. The Δ vs. Φ data also indicate that the film thickness is about the same at the top and bottom of the mirror. No calculation of film thickness and index of refraction has been made because of the lack of ellipsometric data on films deposited on silicon monoxide overcoated aluminum substrates. Work is currently in progress on developing a multilayer film theory with SiO overcoated aluminum substrates; when available, measurements on the Surveyor mirror will be interpreted and published at that time.

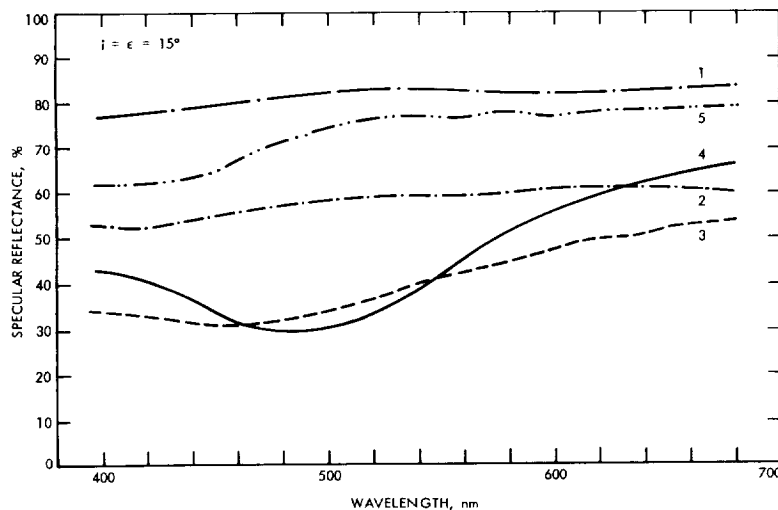
FIGURE 20. — Spectral reflectance curves of areas marked in figure 19, after replication and rubbing. The incidence and reflectance angles = 15°.

replicated and rubbed areas (fig. 20). This was measured on the goniophotometer using narrow-band interference filters. The areas are marked on figure 19. Curve 4 corresponding to area 4 closely repeats the wave at $i = 10°$ on area B, that of maximum color. The five curves were measured at $i = \epsilon = 15°$. Curves 3 and 5 are also similar to those of areas D and A, respectively. However, the rubbed areas of 1 and 2 show an almost flat response over the visible wavelength range. Curve 1 is close to that expected from a clean aluminum surface, while that of 2 indicates that some roughness or pitting is still present. Again, the spectral measurements reflect the observations made during the rubbing investigations.

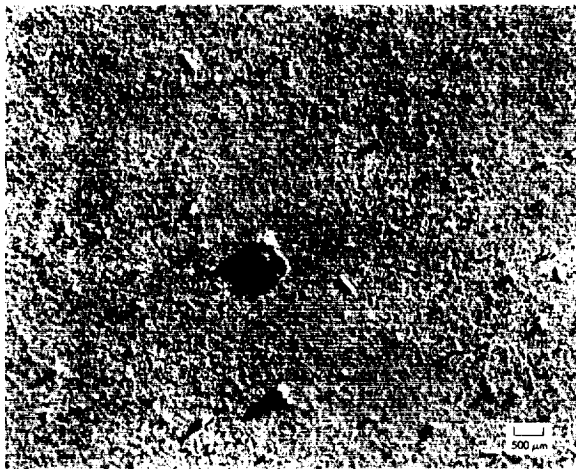
Figure 21.—Microphotograph of one of the faint boundaries of the mirror surface.

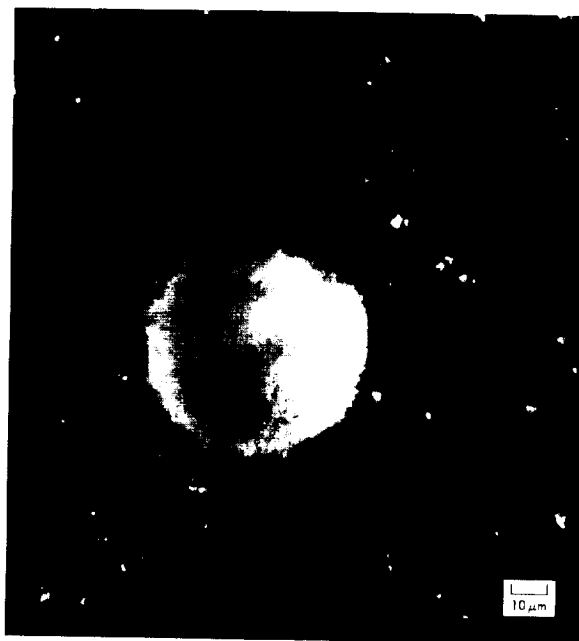
FIGURE 25.—Microphotograph in crossed polarizer illumination of a sphere with adjacent lunar material banked against the sides. The sphere is about 36 μm in diameter. The black areas are the reflecting parts of the mirror surface.

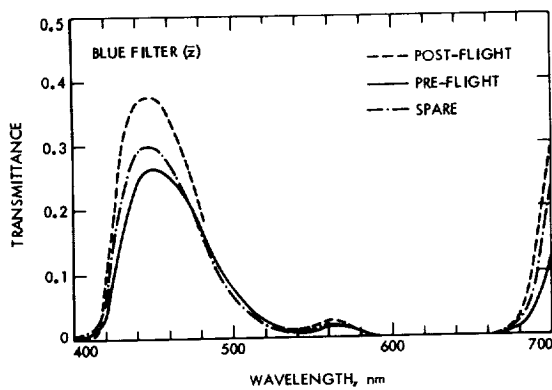
glass can be seen and probably is caused by the long ultraviolet and radiation exposure. No apparent change in the anti-reflection coating (MgF) was detected. Large changes in the filter combinations over pre-flight measurements are indicated in figures 31 through 33. In all cases, the transmission of the combination increased. The red filter (fig. 33), made of a single piece of 3-76 glass, apparently underwent a bleaching effect, resulting in increased green transmission. Much more difficult to explain is the increase in the blue and green filters. If the curves for the blue filter (BG1) and green filter (OGR3) elements of these glasses are compared with the spare set, the large transmission increase cannot be explained. If, on the other hand, the uppermost elements GG15 and OG4 are responsible, then the cause must be the Inconel coatings because both glasses, uncoated, have transmissions over 92 percent. The uppermost glasses were exposed to thermal and radiation cyclic changes that eliminated the ultraviolet transmission of the one and shifted the other cut-on position toward the red. Some removal of the Inconel coating would account for the transmission increase, but such dissipation is unknown at the temperatures involved.

FIGURE 31.—Transmission of the blue filter for pre-flight, post-flight, and spare sets. The increase in overall transmission of the post-flight measurements is apparent.

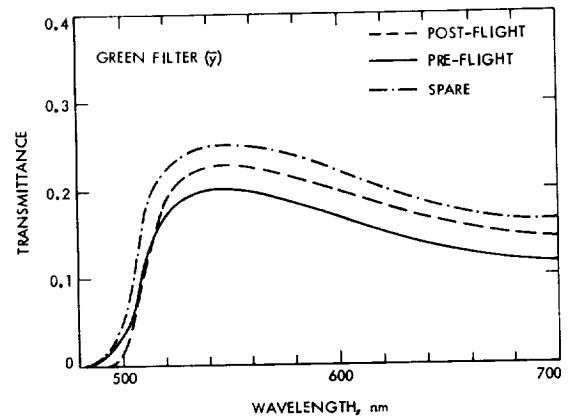
FIGURE 32.—Transmission of the green filter for pre-flight, post-flight, and spare sets. The increase in overall transmission of the post-flight measurements is apparent.

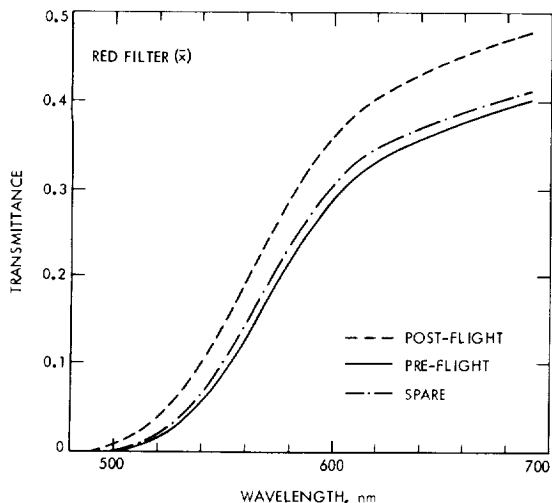
FIGURE 33.—Spectral transmission of the red filter. The increase in post-flight transmission is less than that noticed in the other two filter sets.

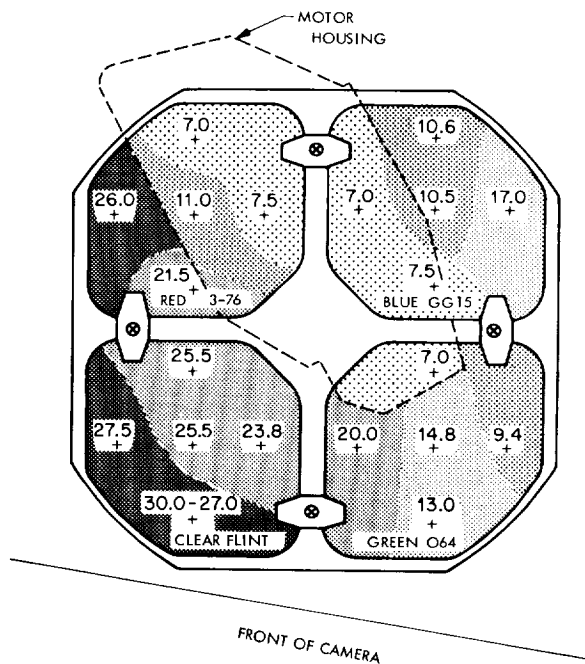
filter remained homogeneous over its area, then the area covered is directly proportional to the transmission loss. This has been substantiated by analysis of the peels taken from the filter surfaces (ref. 6). The areas covered at the five positions on each filter are given in figure 34. The dotted area shows the observed limits of the lunar fines when the filters were removed from the camera.

FIGURE 34.—Drawing showing the four filter positions and the extent of the coating of lunar fine material. The values by the filter positions (marked by crosses) are the percentages of area occupied by the fines.

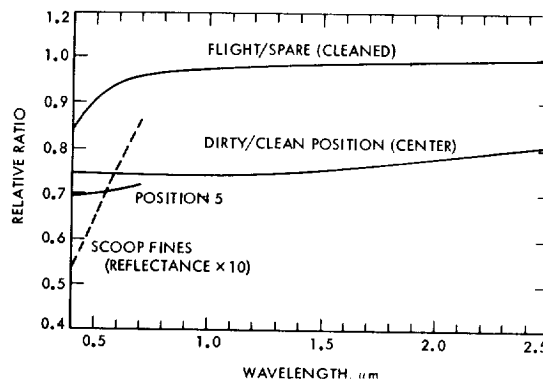
FIGURE 35.—Plot of the transmission ratios for the clear flint glass. The reflectance of lunar fine material found in the Surveyor scoop is shown as a dotted line. Its reflectance in absolute terms is one-tenth of that plotted.

of the clear filter at the five positions as a function of wavelength. Data beyond 700 nm were obtained for the center only. The transmission curves are very flat with the exception of position 5, which tends toward a red increase as seen in the reflectance of the lunar fines. Position 5 was the closest to the front edge of the camera, and thus received the greatest amount of lunar fines. The large proportion of glasses in these fines undoubtedly accounts for the spectral variation. The last curve in figure 35 clearly shows the effect of exposure on the clear filter in the visible, but the almost complete transparency in the infrared. This agrees well with the data obtained from fines on the mirror. However, the gonioreflectance of the upper surface of the clear filter shows that much less material is present on the filter than on the mirror surface.

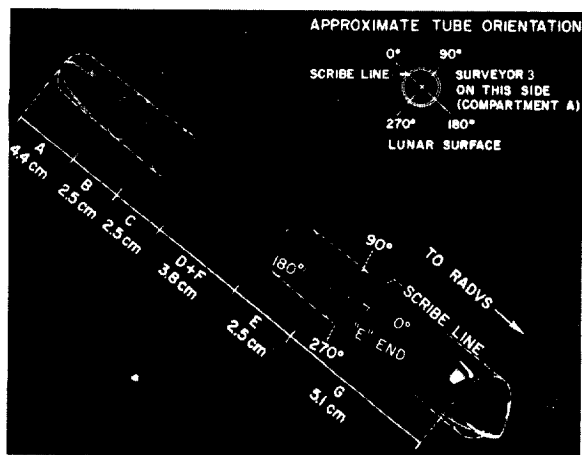
In the undisturbed state, many micrometer-sized holes, or cavities, and foreign particles were observed. The holes were found with approximately the same distribution on all parts of the tube; the particles were concentrated primarily on the side facing the spacecraft and the lunar surface. Section E was again examined

FIGURE 3.—Section of RADVS unpainted aluminum support tube, as cut from Surveyor 3 spacecraft by Apollo 12 astronauts. Locations of sections B and E are indicated.

after removal of the contaminants; the surface that had been covered with the particles appeared to have an eroded surface, where the "clean" surface appeared to have the same features as observed before contaminant removal. The B section was examined by both optical and scanning electron microscopy, but only after removal of contaminants by previous investigators. In general, this section appeared, by optical microscopy, to have the same surface characteristics observed on section E after the contaminants were removed.

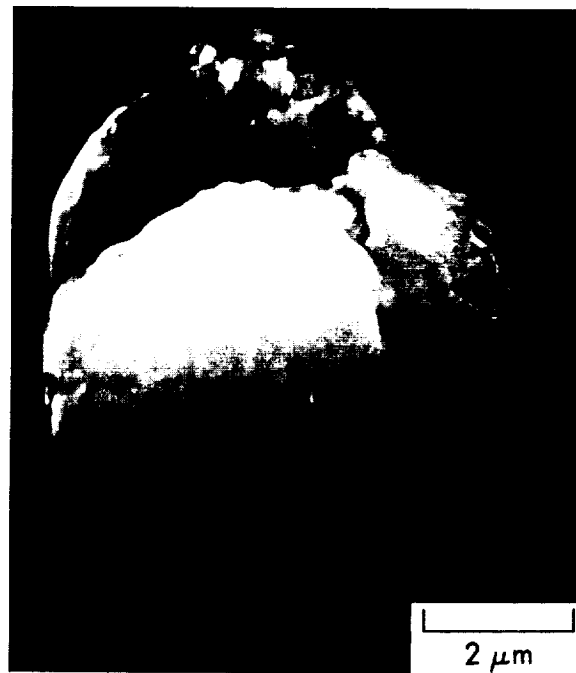
FIGURE 4.—Scanning electron micrograph of a particle embedded in the surface of section B of the RADVS support tube.

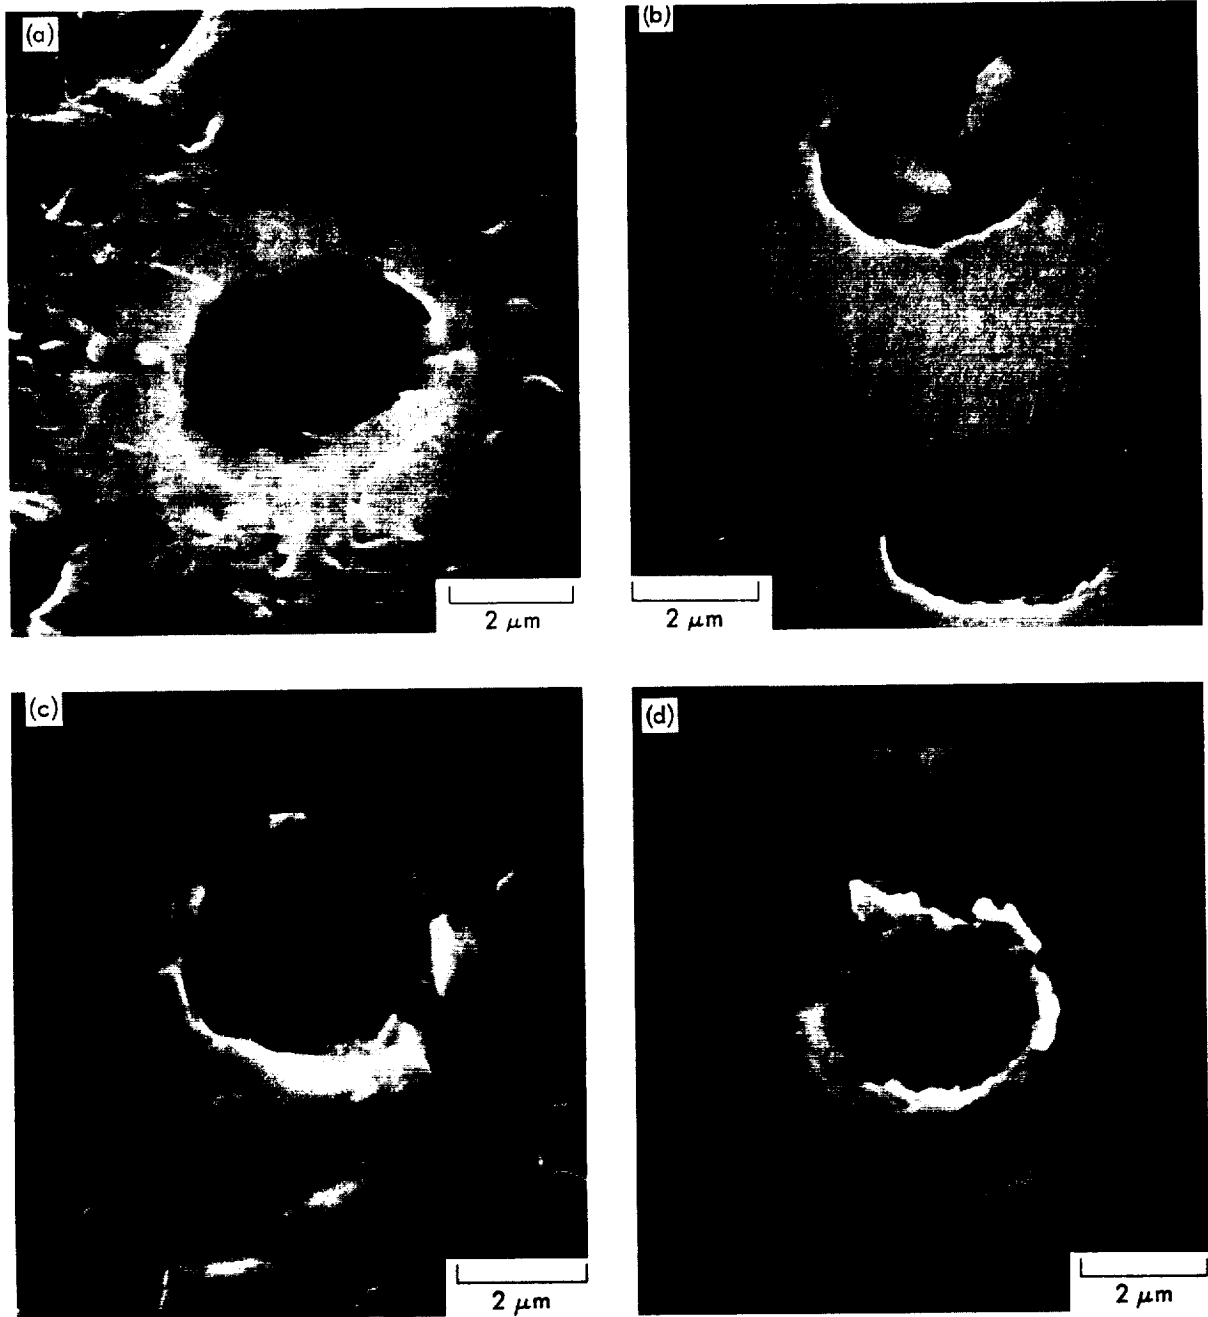
FIGURE 5.—Scanning electron micrographs of "dirty" and "clean" sides of RADVS section B. (a) "Unrimmed" hole on dirty side. (b) "Unrimmed" holes on clean side. (c) "Semi-rimmed" hole on clean side. (d) "Rimmed" hole on clean side.

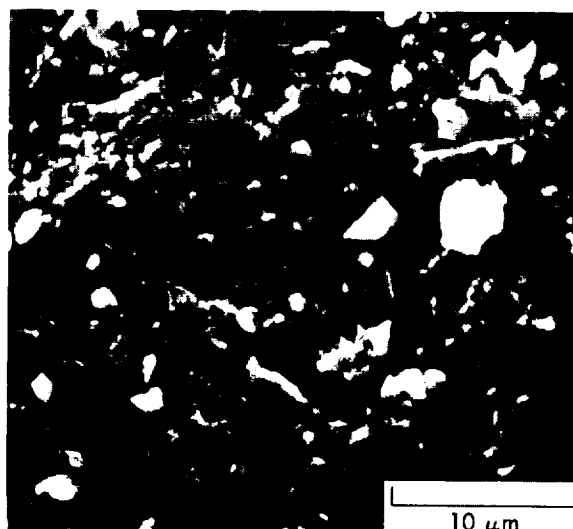
FIGURE 7.—Scanning electron micrograph of surface of unpainted screw from Surveyor 3 television camera, showing particles of "lunar" material.

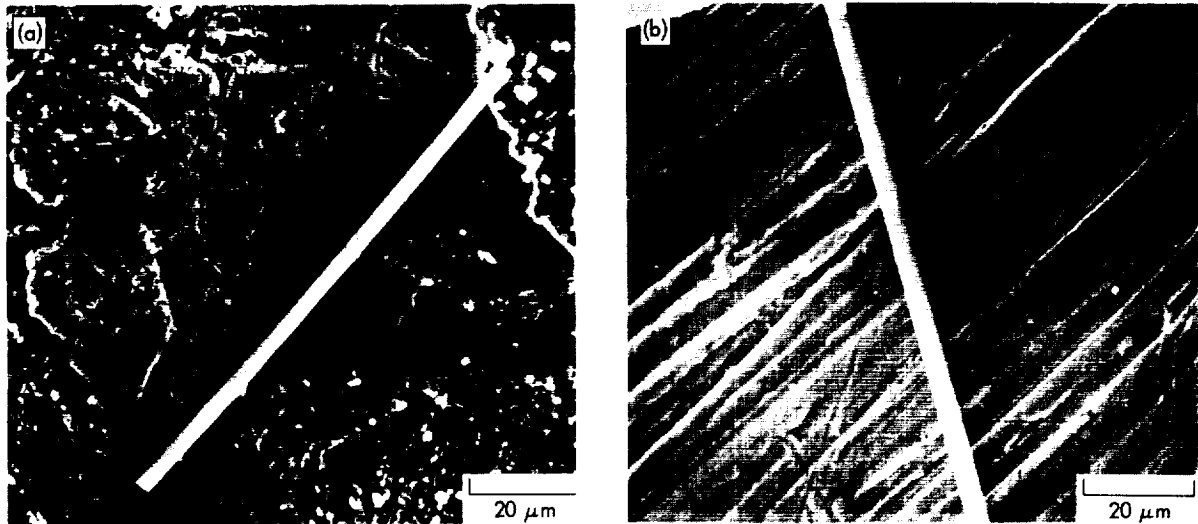
spacecraft surfaces studied. The only exceptions were the rod-like materials shown in figure 9(a). The rods, all 3 to 5 μm in diameter and up to 100 μm long, were discovered on the elevation-drive housing dust cover and on the screw shielded from the LM. Because similar rods, or fibers, were found in lunar material samples by investigators reporting at the Apollo 11 Lunar Science Conference (refs. 14 through 16), it is

FIGURE 9.—Scanning electron micrographs of rod-like material found on unpainted screw
of Surveyor 3 television camera and of fiber taken from beta-cloth space suit material of
the Apollo astronauts. (a) Rod-like material on screw surface. (b) Beta-cloth fiber.

appropriate to comment here on the dispersive X-ray analysis of these fibers, conducted as part of this study. These rods were found by this analysis to be beta-cloth fibers from the Apollo 12 astronauts' gloves or back pack. Figure 9(b) is a micrograph of a beta-cloth fiber obtained for comparison. The spectrum obtained in the X-ray analysis of the fiber was identical to the spectra of the rods found on the Surveyor 3 components.

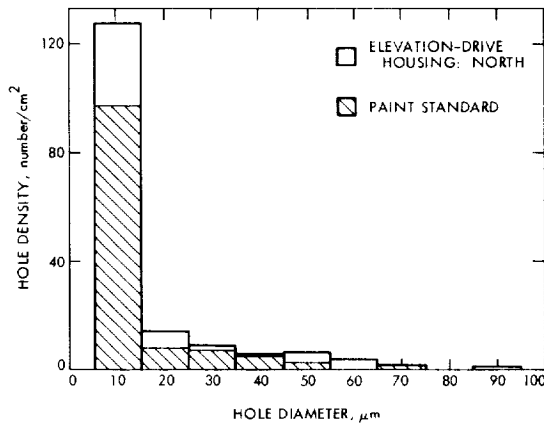
FIGURE 11.—Comparison of number and sizes of holes (or apparent impact sites) found in surfaces of thermal-control paint of elevation-drive housing of Surveyor 3 camera and laboratory standard furnished by Surveyor 3 manufacturer.

many craters with very clean white walls, which would be expected if the crater was formed just before recovery with no time for additional contamination or degradation. In this size range, these white-walled craters account for about half of the observed difference in hole density between the standard and the exposed surface.

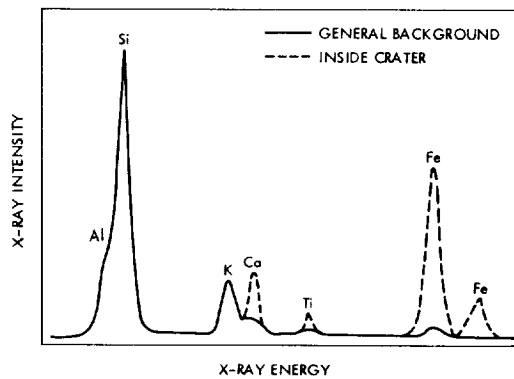
FIGURE 12.—Comparison of the X-ray spectra of the thermal-control paint of the Surveyor 3 television camera and the laboratory standard of this paint with the X-ray spectra of materials found with apparent impact craters.

camera was a white inorganic paint composed of an aluminum silicate pigment and a potassium silicate binder. Figure 12 shows representative X-ray spectra typical of those obtained from several areas of the unexposed paint standard and from the degraded paint on the elevation-drive housing. As expected, the aluminum, silicon, and potassium peaks found in the unexposed paint also predominate the spectra for the degraded paint. Small amounts of calcium, titanium, and iron also are evident. This is consistent with the composition of the dust layer found on all parts studied. Analysis of lunar soil by other investigators (ref. 14) shows the presence of these elements. Several craters were found that contained residual material with greater relative amounts of the same three elements. No craters have yet been found that contain residual material of other chemical compositions. These results tend to indicate that the craters not accounted for by natural porosity probably are due to low-velocity impacts of lunar material from the landing of the LM.

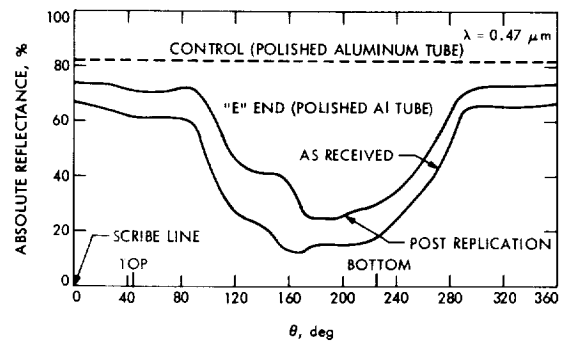
FIGURE 13.—Variation in absolute spectral reflectance around unpainted aluminum RADVS support tube compared with spectral reflectance of polished aluminum tube (from measurements taken before and after removal of contaminants, on section E).

from an α_s of 0.26 on the "clean" side to 0.75 on the "dirty" side, with little variation along the axial length of each tube section. The variation in reflectance around tube section E is shown in figure 13 for a wavelength of 0.47 μm. The part of the tube with the lowest reflection (greatest contamination) was oriented toward the lunar surface and slightly toward the spacecraft descent engine 3. The reflectance was measured again after the surface was replicated, as described previously. As indicated in figure 13, this removal of loose material increased the reflectance on all sides of the tube. Figure 14 shows the distribution of total spectral reflectance around the tube. The contamination on the dirty side appears to be primarily of lunar origin or possibly from descent engine exhaust deposits. This contamination is not easily removed, however, as some traces of it remain even after repeated attempts by other investigators to remove it with ultrasonic cleaning (ref. 17) or with normal replication processes for transmission microscopy experiments (ref. 18).

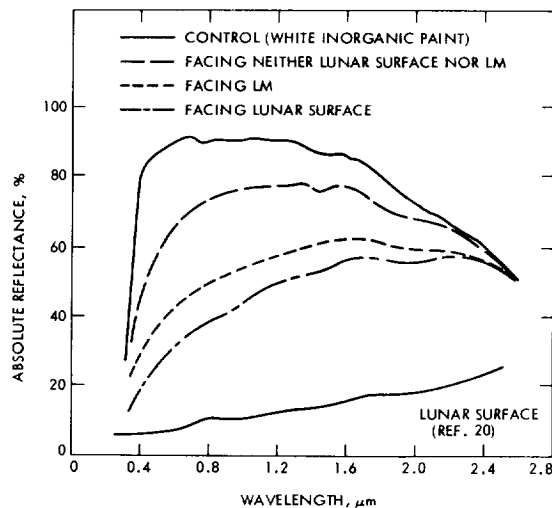
face relative to the Sun, with lunar surface, and the landing site of the LM. The final α_s values varied between 0.38 for a surface facing outer space to 0.74 for a surface facing directly toward the lunar surface. The distribution of the spectral reflectance is shown in figure 15. Note that the greatest change in reflectance occurred at the short wavelength end of the spectrum. Laboratory tests by other investigators (refs. 1 and 19) show that the reflectance of this inorganic paint could be degraded in the 0.25- to 1.5-μm range by exposure to ultraviolet radiation. The extent of this reflectance degradation is a function of the total Sun exposure; therefore, the different faces of the elevation-drive housing would exhibit different reflectances due to radiation damage only. In addition to radiation damage, a coating of lunar dust should modify the reflectance of the paint. For comparison, the spectral reflectance of lunar dust (ref. 20) is shown. This non-gray reflectance makes the influence of a dust-layer wavelength-dependent, with the greatest influence occurring at the short wavelengths. The decrease in reflectance, therefore, is due to a combination of contamination and degradation of the paint from ultraviolet radiation. A more detailed discussion of this subject is presented in reference 21.

FIGURE 15.—Spectral distribution of reflectance (absolute reflectance as function of wavelength) for several areas of surface of thermal-control paint of elevation-drive housing dust cover of Surveyor 3 television camera.

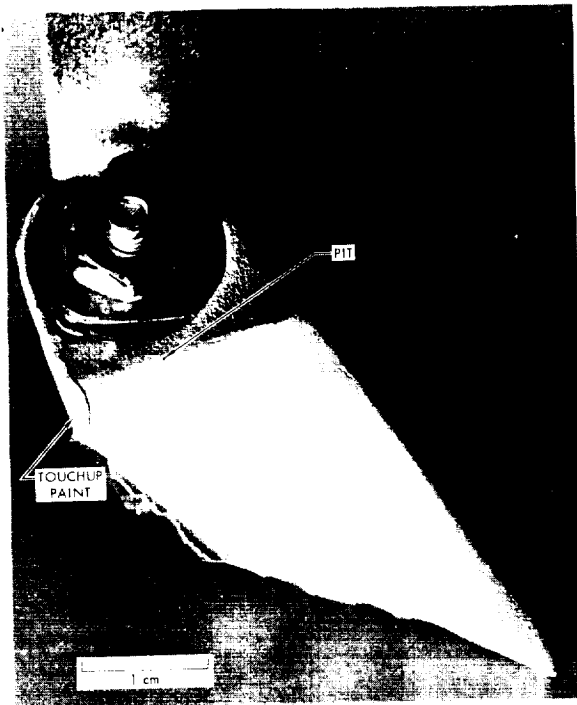
The plasmo-clay-coated specimen used in the experiment was removed from the clamp ring assembly that supported the Surveyor camera. A photograph of the specimen is shown in figure 2. The exposed paint surface was oriented approximately vertical and did not view the Apollo 12 landing point. It is evident in the photograph that a portion of this surface had been sanded before launch (scratch marks). It also can be noted in the figure that a relatively large pit is present (on the bend line), and some touchup

FIGURE 2.—Section of camera clamping bracket.

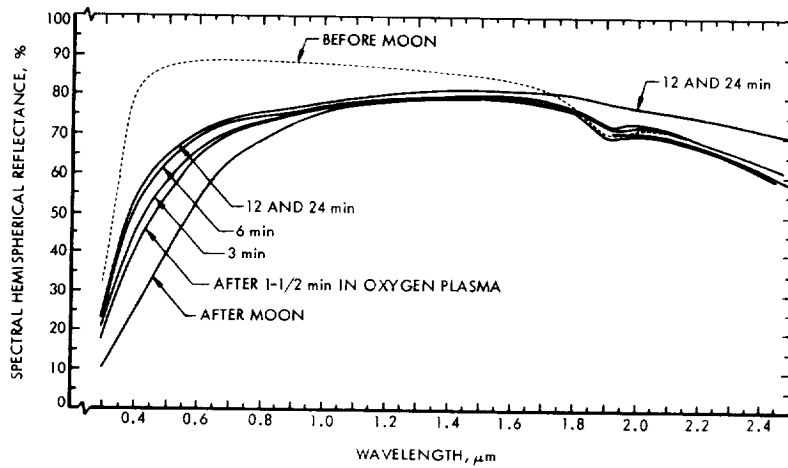
Figure 3.—Effect of lunar exposure and subsequent oxygen-plasma treatment on Surveyor plasmo-clay coating.

Results of the oxygen-plasma treatment experiment are shown in figures 3 and 4. Spectral hemispherical reflectance is shown in figure 3 and the change in spectral reflectance (ΔR) is shown in figure 4. In figure 4, a negative ΔR indicates a decrease in reflectance with respect to a control specimen, and a positive ΔR indicates an in-

crease in reflectance with respect to the "as received" specimen. Reflectance and $\triangle R$ are plotted in figure 3 for a typical control specimen, the as-received Surveyor specimen, and after plasma exposure times of 1½, 3, 6, 12, and 24 min. The data show that—

(1) The degradation occurred in a wavelength band extending from about 0.2 to 1.1 μm, with a peak degradation ($\triangle R$) of about —58 percent at 0.4 μm.

In conclusion, it was shown that the plasmo-clay coating, degraded in the lunar environment, can be partially restored by oxygen-plasma treatment. This result and similar experiments on other white coatings confirm the concept of using oxygen-plasma generators for prolonging spacecraft coating lifetime in space.

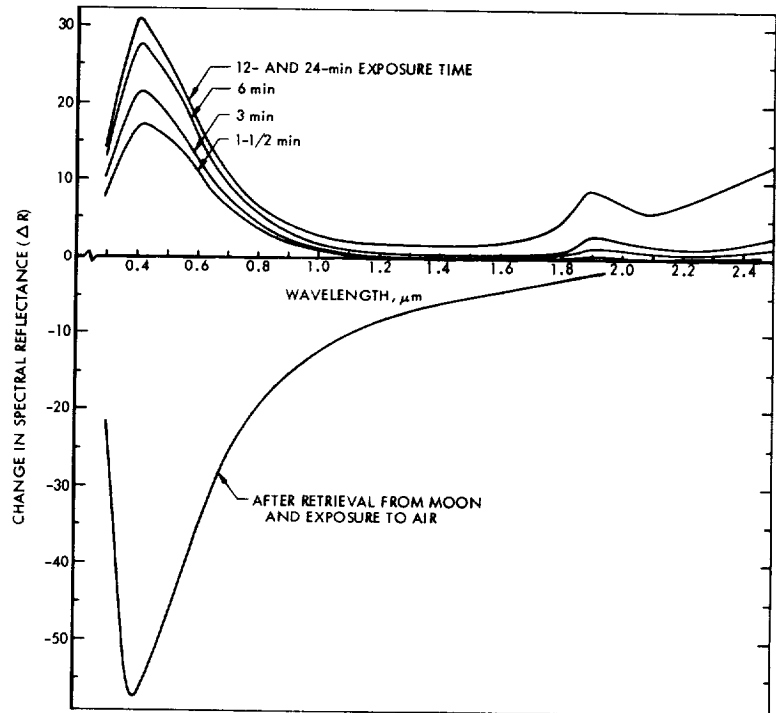
Figure 4.—Effect of lunar exposure and subsequent oxygen-plasma treatment on Surveyor plasmo-clay coating.

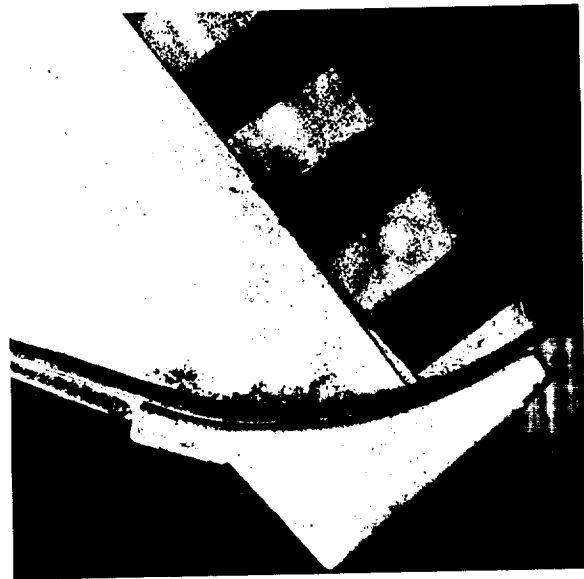
right-hand side of the scoop, a comparison of figures 3 (taken by the astronauts) and 7 clearly indicates that the bottom part of the scoop side, which was covered with lunar soil, has not changed in color to the same extent as the rest of the scoop. This would indicate that the color change process is related to the irradiation of the

FIGURE 7.—Right-hand side of surface sampler door showing reference stripes (width of field: 5 cm).

Even a cursory examination of the returned scoop shows that it has been subjected to a considerable amount of scratching and abrasion. Some of the typical larger scratches are apparent in figure 7, and photographs made at higher magnification show them clearly. For example, two photographs, magnified originally 11.5 ×, shows the condition of the laboratory scoop (fig. 16), in comparison with that of the returned scoop (fig. 17) in the same area of the surface. The terrestrial scoop has been used in a variety of soil-testing operations in various soils on Earth. The general effect of this soil contact has been to smooth down the irregularities in the painted surface without the development of scratches. (See fig. 16.) Considerably less soil contact took place with the Surveyor 3 scoop, but it is evident, as shown in figure 17, that its surface has been abraded. A general smoothing of the surface of the paint is also evident in figure 17. An undisturbed painted surface close to its original condition is shown in figure 18 (the

Some months after the initial examination of the Surveyor 3 scoop, it was disassembled for study of the individual components. When this was done, it was found that the inside surface of the scoop presented an appearance essentially identical to that of the laboratory scoop in figure 18. Because the inside had been subjected to almost as much sliding contact with the lunar soil as the outside, it must be concluded that the lunar material has not substantially abraded the painted surface and that the scratches visible in figures 7 and 17 result from pre-flight surface treatment.

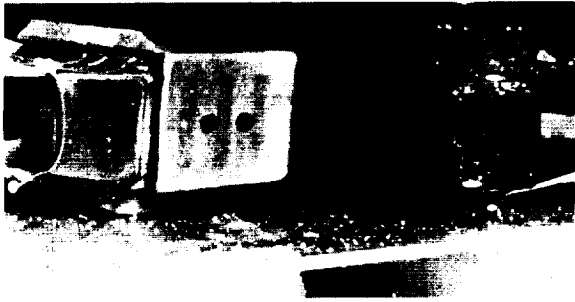
FIGURE 12.—Ultraviolet stimulation, visible recorded on film. Comparison with figure 9 focus sharp on top of motor box.

The most striking change in the appearance of the samplers can be observed by comparing the tops of the two scoops in figures 9 and 12. The brown of the returned scoop is deeper on the upper surface; this is made even more apparent by the photograph (fig. 12) in ultraviolet illumination. Figure 12 shows a yellow region at the bottom of the housing that covers the scoop door motor. This probably is due to irradiation of a spill of the epoxy coating which was applied to the terminals of the wires for protection, as it does not appear on the laboratory surface sampler to which no epoxy was applied. Alternatively, it may be the result of the irradiation of this part of the scoop which was altered by heating when the wires were soldered in place. The upper surface of both scoops is shown in figure 13 in which it is seen, as remarked earlier, that some protection to the paint was probably afforded by patches of soil at the bottom corners of the grooves. It is likely that the lighter appearance of both scoops around the edges is due to abrasion during transport and handling.
