Analysis of Surveyor 3 material and photographs returned by Apollo 12

Preface

MAY 1971

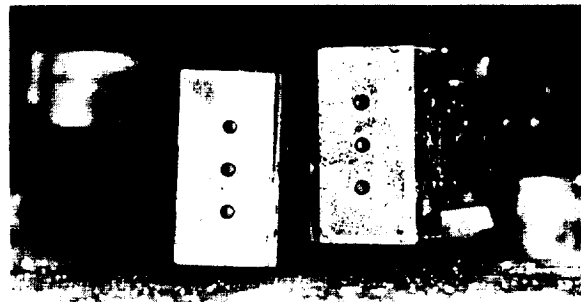
A second item of interest concerning the painted surface is the crazing or cracking of the paint on the sides and base of the scoop door. Polygonal fracture patterns are apparent in figures 5 through 7, 14, and 15. This part of the scoop was made of a glass-fiber-impregnated resin coated with the standard paint. The fracture pattern does not appear on the painted metallic surfaces of the rest of the scoop, and may therefore be related to the different thermal conduction and expansion characteristics of the paint, the resin, and the metal. It is also possible that radiation damage to the paint could have resulted in volume changes. In this case, the appearance of fracture patterns on the scoop door would be related to either the different thickness of the paint or different nature of bonding of the paint to that surface as compared with the other metallic surfaces. The chipping of the paint from the tips of the scoop door indicate that the bonding between the paint and the resin was weaker there than elsewhere, since paint at the edges of the scoop body was equally subjected to contact with the lunar surface.

FIGURE 14.—Ultraviolet stimulation, visible recorded on film (compare with fig. 15).

A comparison between the bases of the scoop doors is shown in figures 14 and 15. In the case of the laboratory scoop, much of the paint was removed from the scoop door during the test in water-saturated soil; at one stage of testing, some of it was pulled off by stripping a piece of adhesive tape that was attached to the scoop base. It is evident that the bonding of the paint to the resin of the scoop base is not very strong. In the returned scoop, on the right in figure 14, the pattern of crazing on the base is apparent, as is also the browning of the edges of the Teflon sealing the door. Once again, even though the base of the scoop was relatively protected from solar illumination, it has also undergone the color change apparent in the previous photographs. In the portions of the glass-impregnated resins, which are revealed where the paint has chipped away from the scoops, little or no color change is obvious in either figure 14 or 15. This may be an indication that the paint was removed in these areas only during and following the return of the surface sampler to Earth. The change in appearance of the Teflon surface is shown in figure 23 for a comparison with the view of the same area, as seen by the television camera of Surveyor 3, in figure 2.

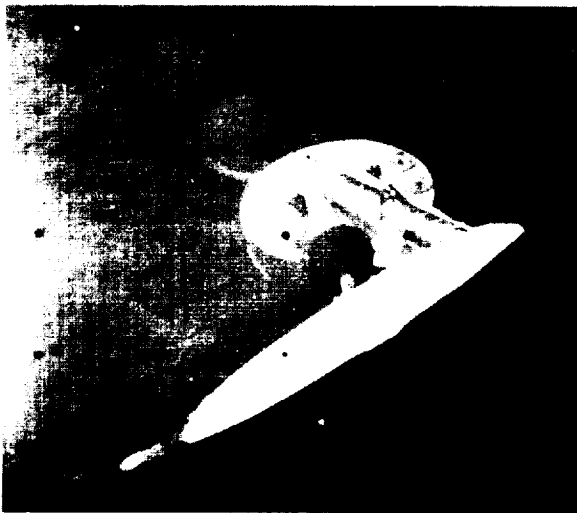
FIGURE 1.—Surveyor 3 television picture of footpad 2 taken on April 21, 1967. The image is hazy because a film of lunar dust was deposited on the camera mirror during the landing (GMT Day 111, 07:43:38).

field of view of the television camera, footpad 3 was partially visible, and footpad 1 was obscured by spacecraft components. In the last stages of landing, footpad 2 left an impression on the lunar surface some distance from its final location. This apparently penultimate contact and the footpad itself from the point of view of the Surveyor television camera are shown in figure 1.

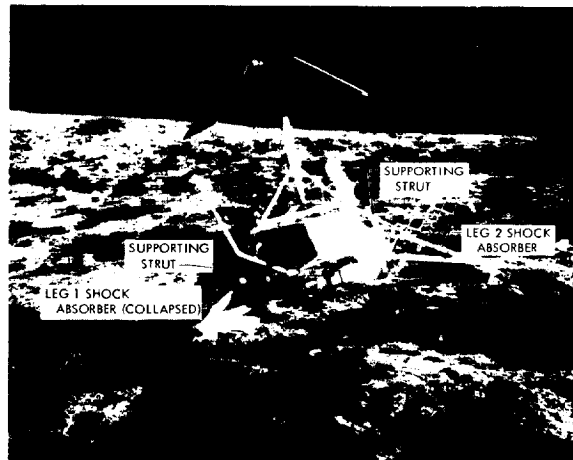
The Surveyor spacecraft moved from its landed configuration sometime between May 1967 and November 1969. It is conjectured that the movement occurred as a result of a sudden failure of the leg 3 shock absorber. The movement at footpad 2 was in the amount of 5° of tilt and 7 to 8 cm of lateral translation in the form of a rotation about footpad 1, which was embedded in the lunar soil.

FIGURE 2.—Surveyor 3 photograph taken by astronaut. Leg 2 and the surface sampler are at the right of the picture. The upper member of the leg is the extended shock absorber, which lies almost in a straight line with the fixed support running from the upper end of the shock absorber to the spacecraft structure. To the left and pointing almost toward the camera is leg 1 with the footpad embedded in the soil. The shock absorber on this leg is at an angle to the supporting member (AS12–48–7121).

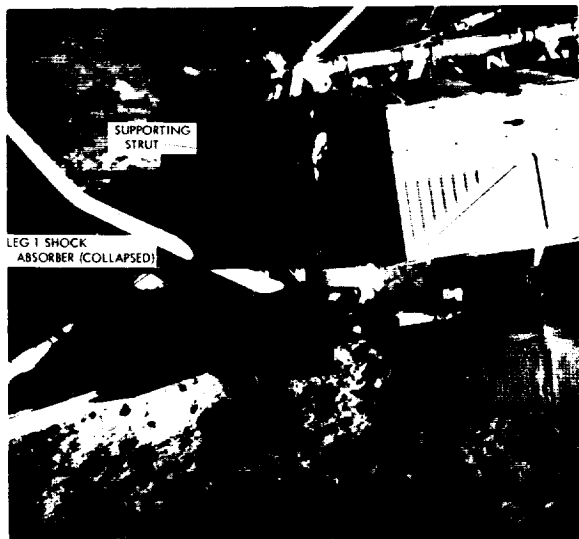
Figure 3.—Astronaut photograph showing detail of collapsed shock absorber connection on leg 1, to left, partially in shadow (AS12–48–7118).

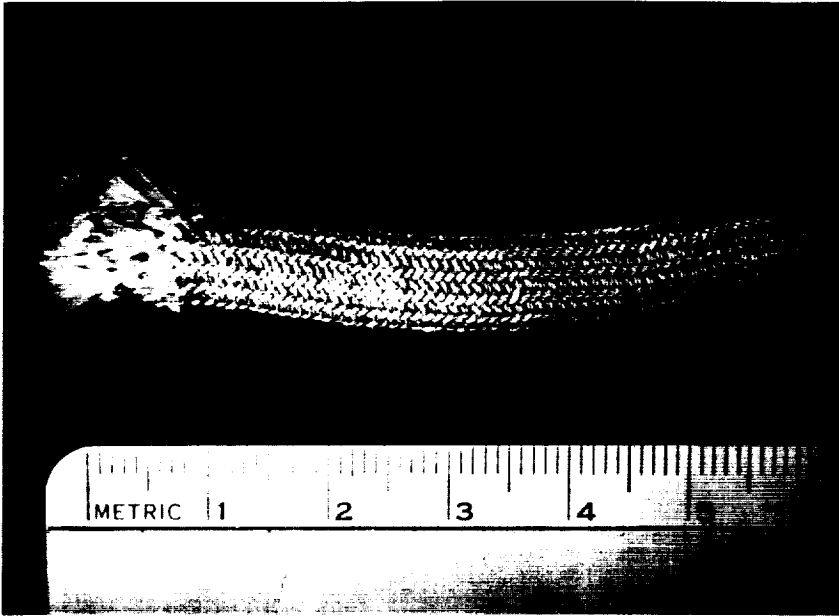
FIGURE 1.—Piece of Surveyor television cable showing glass fabric that covers more than 19 insulated wires (magnified 1.5 ×).

The Surveyor cable, as mentioned previously, consisted of a glass fabric sleeve that covered more than 19 insulated wires. (See fig. 1). The fabric appeared to be a dirty gray, darker than the TAT sample. Some small particles, presumably Moon dust, were noted on the fabric (fig. 2). The TAT sample had loose pieces of metal or dirt in its fabric sleeve; however, it is certain that the Surveyor sample had more particles and also was darker.

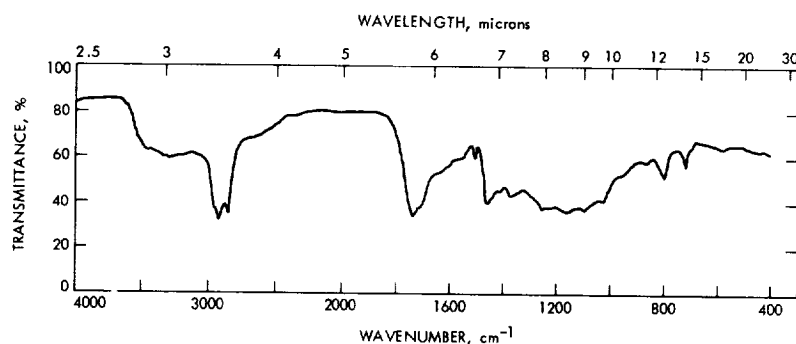
FIGURE 3.—Spectrum of chloroform extract from glass fabric on TAT sample.

solved and its infrared spectrum obtained. The spectrum (fig. 3) of the TAT sample showed primarily aliphatic esters and other carbonyl-containing compounds such as fatty acids. The spectrum of the Surveyor sample (fig. 4) was a more clearly defined pattern of aliphatic esters, indicating that some volatilization of the lower boiling constituents may have occurred in the space vacuum.

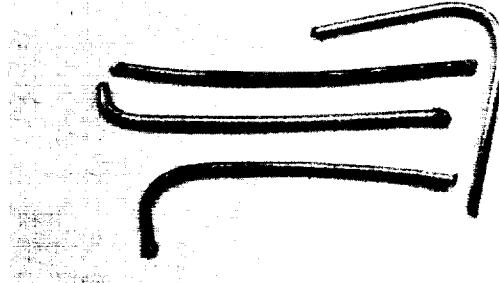
Certain parts of at least two Surveyor wires showed black areas (fig. 9). It was determined that these areas were under the insulation, rather than on the surface. These areas were examined in an electron microprobe analyzer. The results showed primarily silver and copper, but also sulfur and iron; the sulfur was associated with the silver, rather than the iron. The X-ray diffraction pattern identified the black areas as silver sulfide. There were also occasional areas on the wires determined to be high in copper and sulfur, possibly copper sulfate. It must be assumed that the sulfide corrosion was on the wires before the trip to the Moon, though it should be pointed out that no such areas were observed on any of the TAT wires.

FIGURE 9.—Surveyor wires showing corrosion on three separate wires. Fourth wire with large bend is from TAT sample.

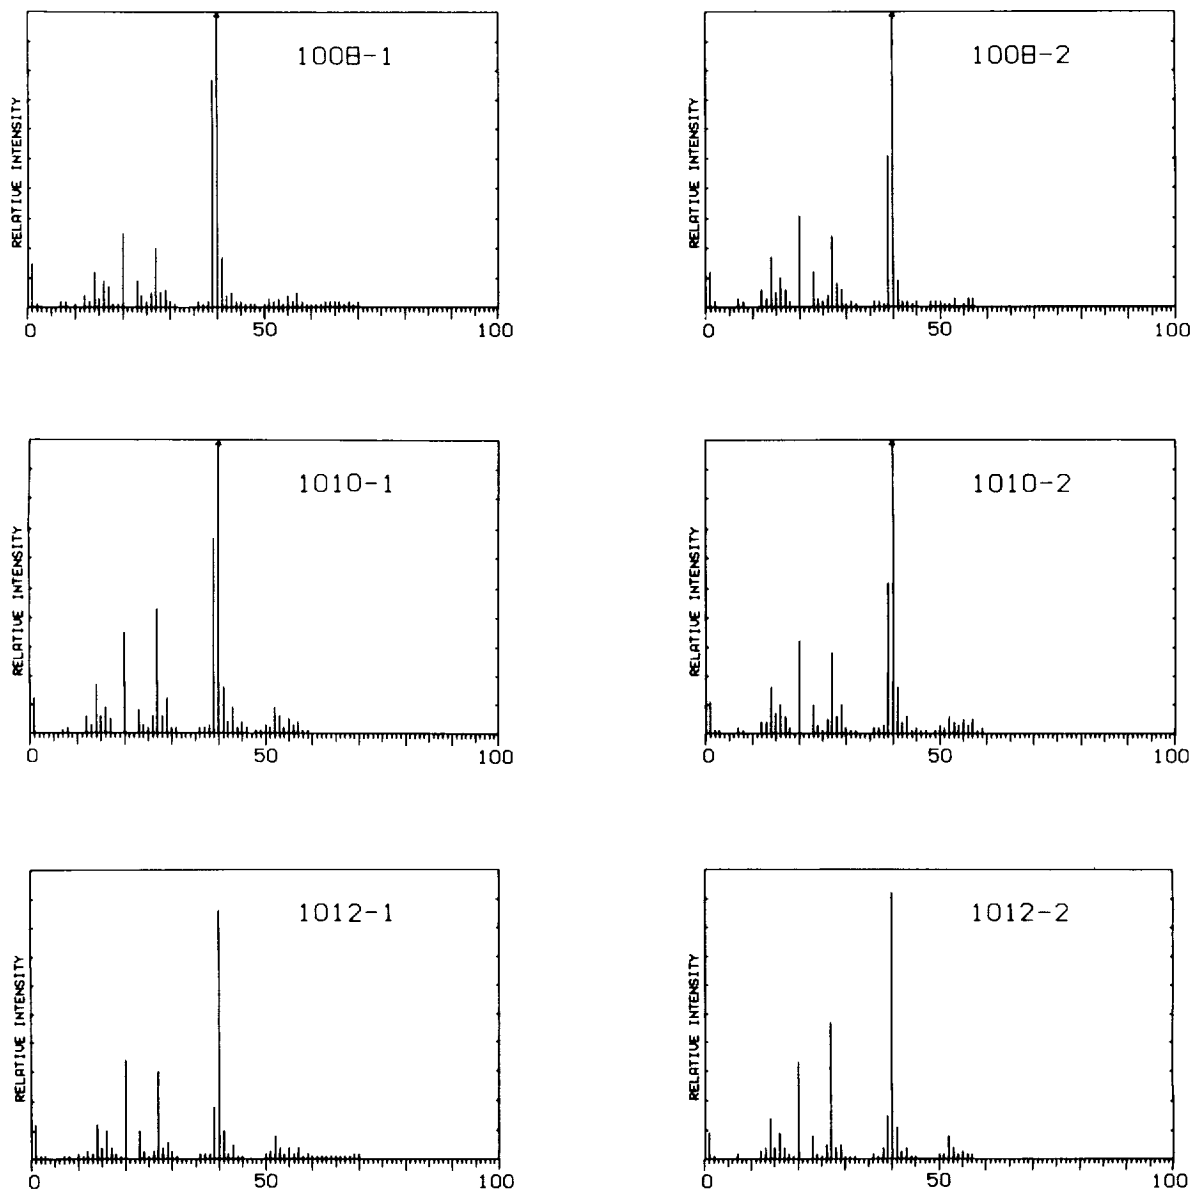
Sample 1008 is from the lower shroud on the side toward the LM and sample 1010 is from the same shroud on the side away from the LM. Both these chips have paint on them (kaolin and potassium silicate binder). Sample 1012 is an unpainted piece also from the lower shroud, but from a shielded area on the bottom. The main overall observation is the difference in the spectra of the unpainted chips vs. the two

FIGURE 9.—Low-resolution ion microprobe analyzer spectra for chips 1008, 1010, and 1012 from the Surveyor 3 lower shroud.

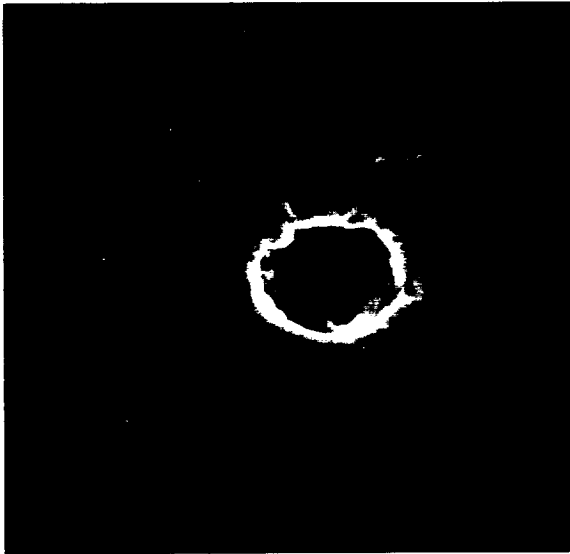
FIGURE 1.—Crater 4 μm in diameter.

On an area of 0.45 mm^2, 36 craters of the type shown in figure 1 were observed. The impacts range in size from 1 to 4.5 μm, with a peak in the size distribution between 2 and 3 μm.

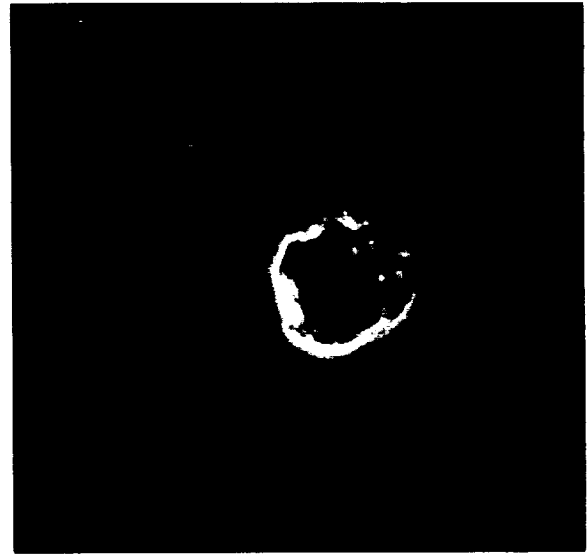
FIGURE 3.—Crater 2.5 μm in diameter.

FIGURE 2.—Crater 4 μm in diameter.

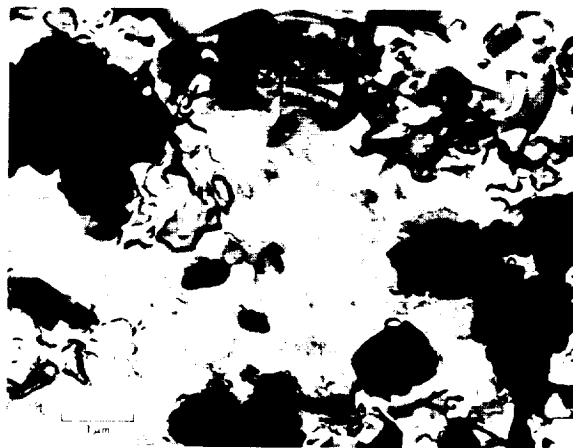
FIGURE 2.—Lower surface of section E.

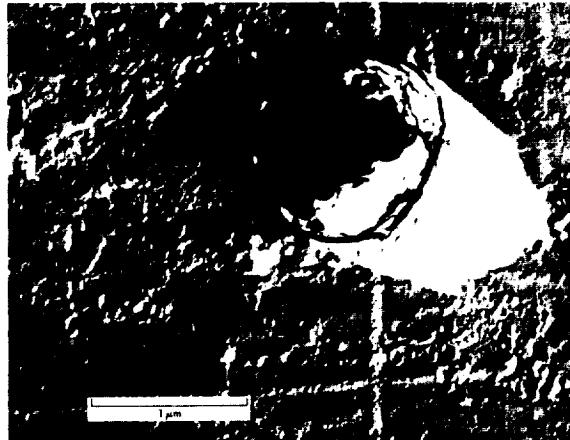
FIGURE 6.—Pit in section C.

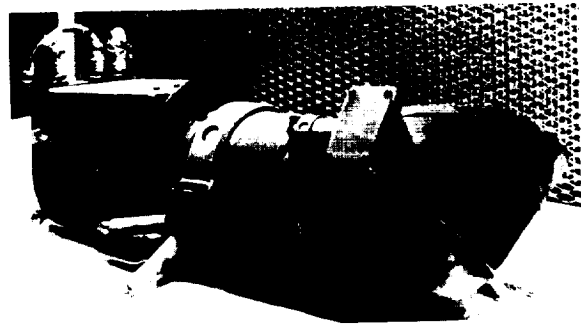
angle, darker "shadows," which are free of a large crater density, are alined with protuberances such as bolts, screw heads, and other parts of the camera. These shadows are noticeable on the mirror hood in figure 4, on the base of the camera where it was partly shielded by a plate, and near the screw heads on the mirror gear box. Figures 5 and 6 are enlargements of two of those screw heads. Note that the shadow in figure 6 is well defined, and that numerous white chipouts are found outside the shadowed region. (The darker shadow extending downward is due to the light source used to take the picture and is not a permanent feature of the surface.) Figure 7 is a top view of the camera and shows the shadow cast by the bolt with the hexagonal head.

Figure 4 shows the apparatus used to hold the camera onto the Surveyor, along with the shadows it casts. The shadows are seen in figure 8, in which the mounting tubes have been removed.

FIGURE 4.—View of the Surveyor 3 camera as seen from the Lunar Module.

The following conclusion is thus inescapable: During the 31 months that Surveyor 3 was on the Moon, the white surface of the camera was discolored; in the final stages of LM landing, lunar dust was accelerated by the LM exhaust. This dust literally sandblasted the Surveyor spacecraft, removing much of the discoloration, except in areas that were shielded. The sharpness of the shadows created by the shielding indicates that the path of the lunar dust was only slightly curved by lunar gravity, indicating the lunar dust was traveling in excess of 100 m/sec. Thus, most craters found on the camera housing are of LM origin.

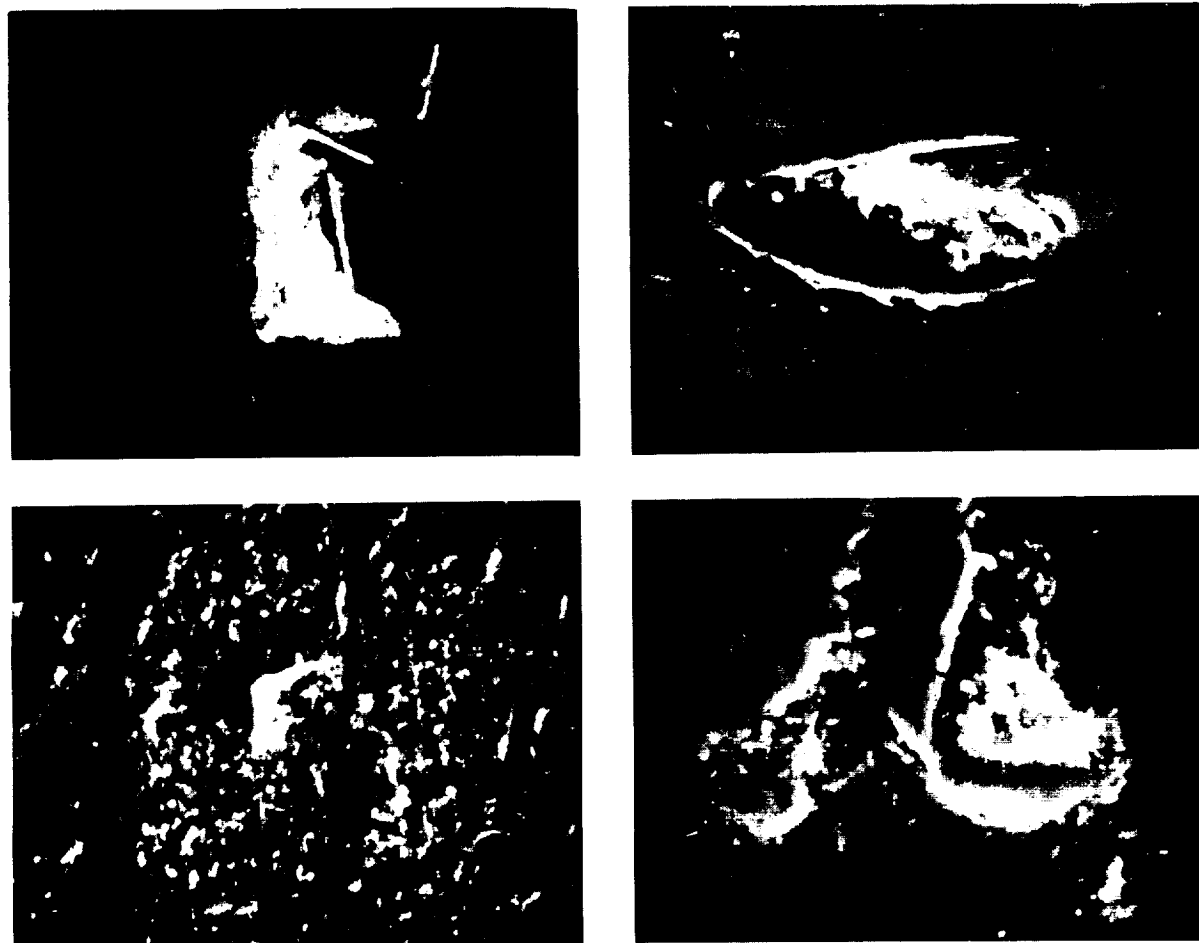
FIGURE 12.—Evidence of typical impact debris found on sections B and C of the Surveyor 3 polished tube.

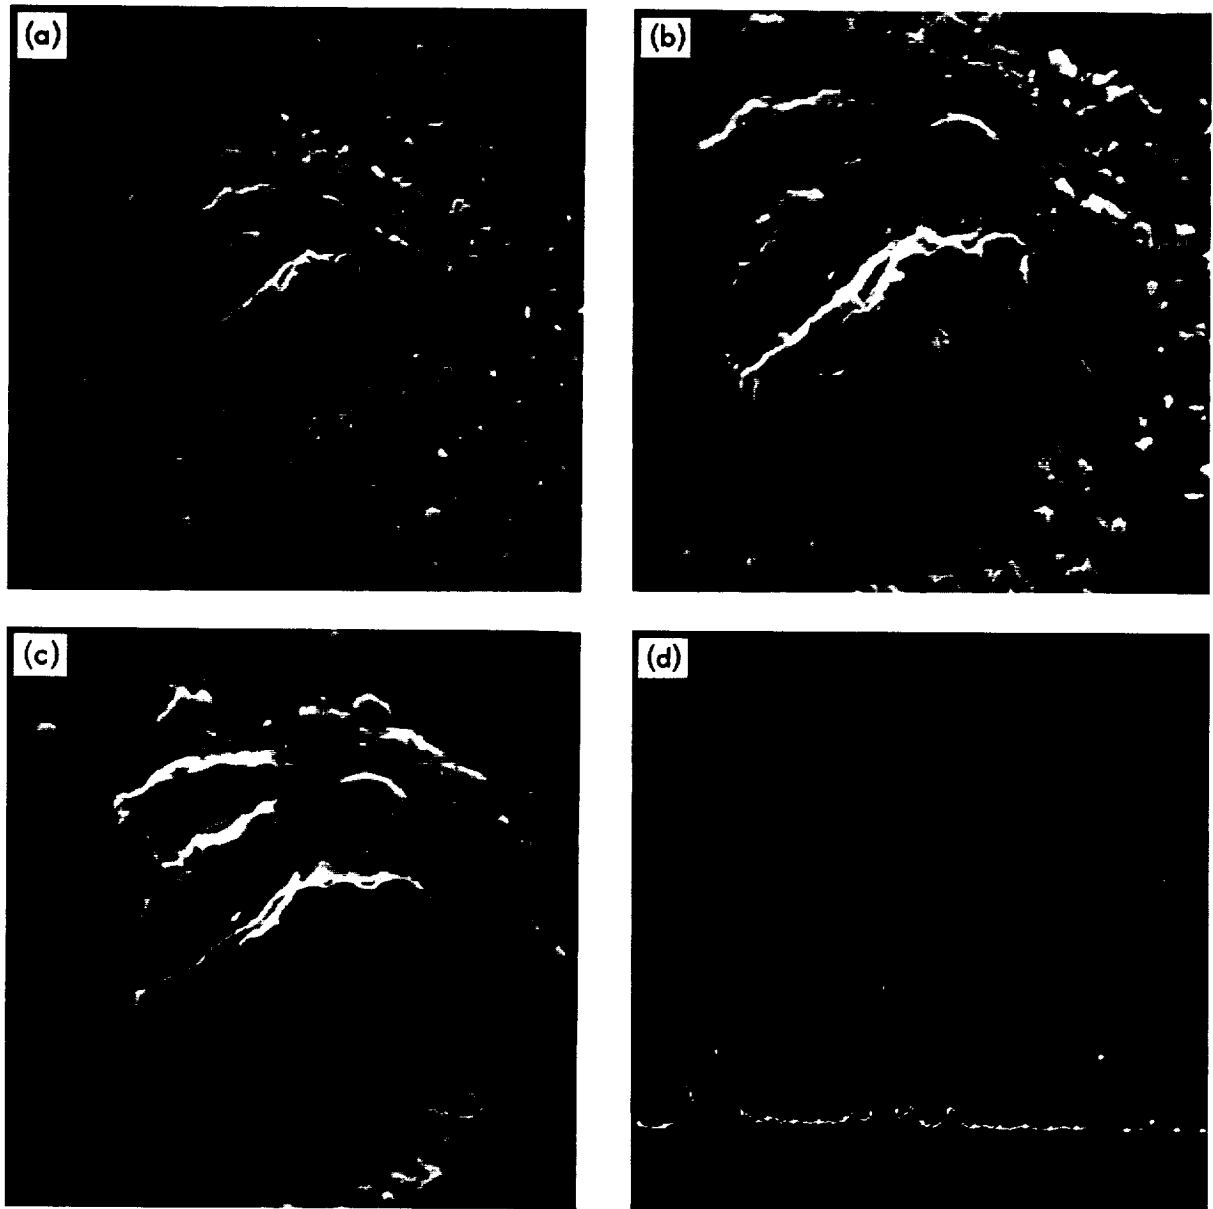
Figure 4.—Scanning electron micrograph of lunar dust embedded in bottom of lower shroud.
(a) As received; 500 ×. (b) as received; 1000 ×. (c) after ultrasonic cleaning; 1000 ×.

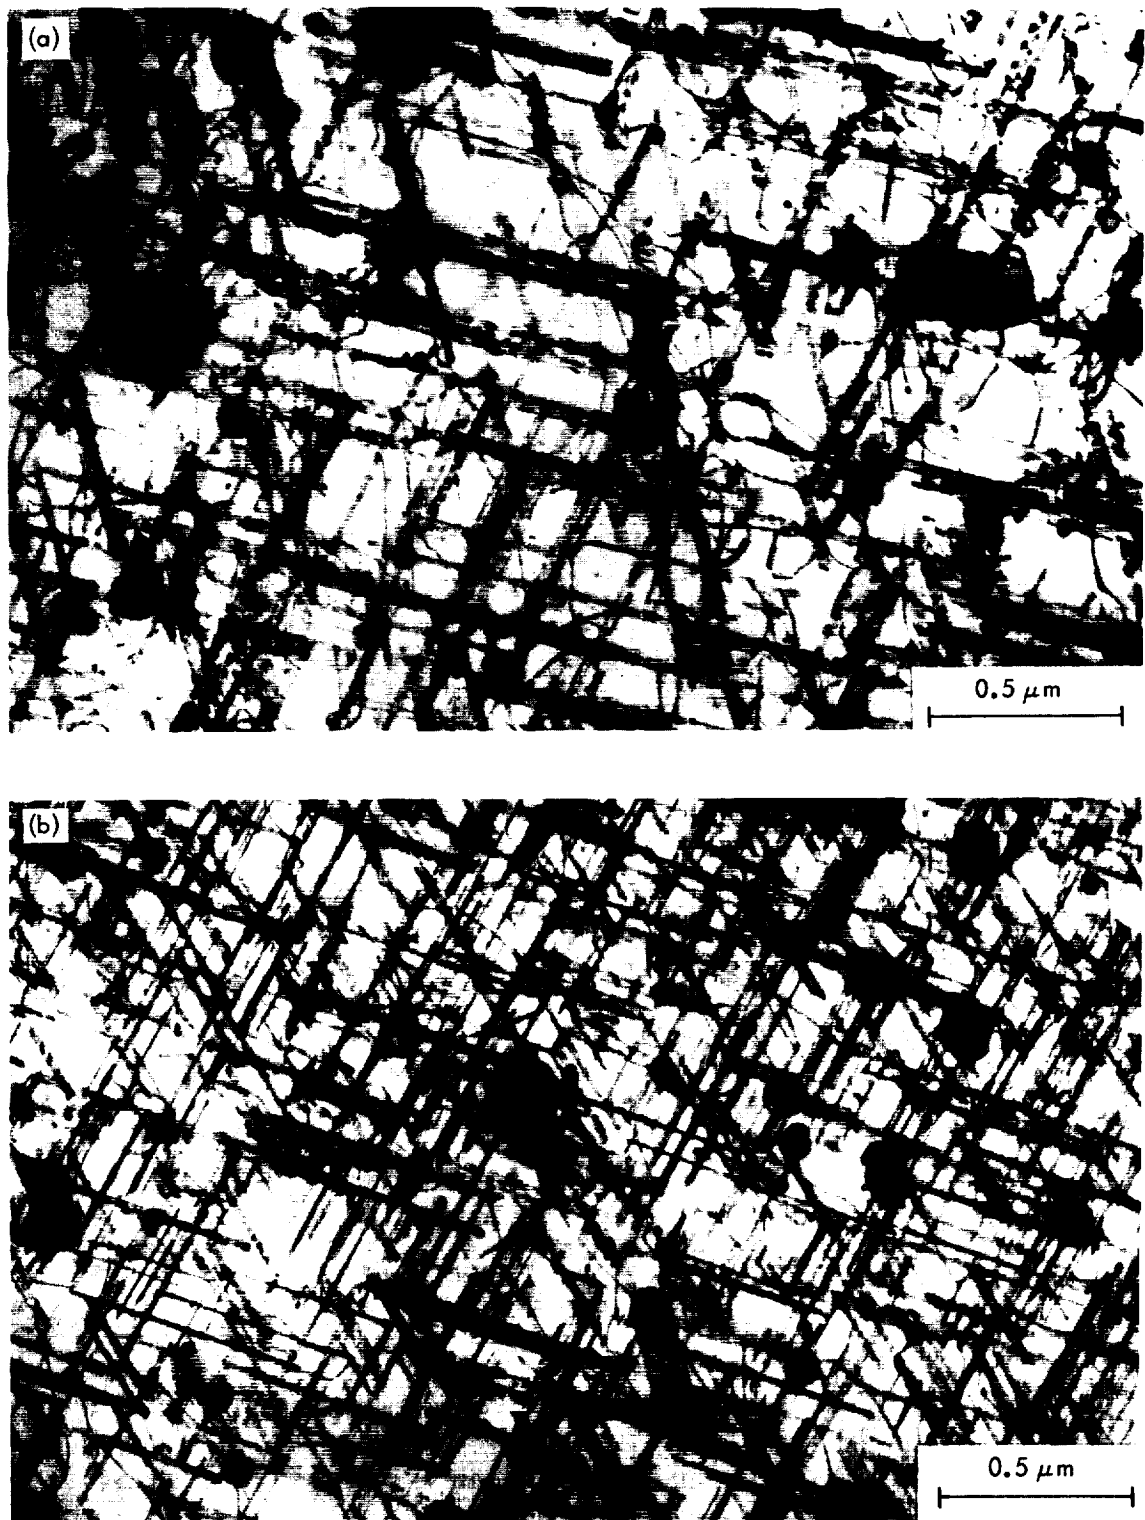
FIGURE 6.—High-voltage electron microscopy (1000 kV) of Surveyor 3 lower shroud showing Mg₂Si precipitates. (a) Side toward LM: sample 935. (b) Side away from LM: sample 936.

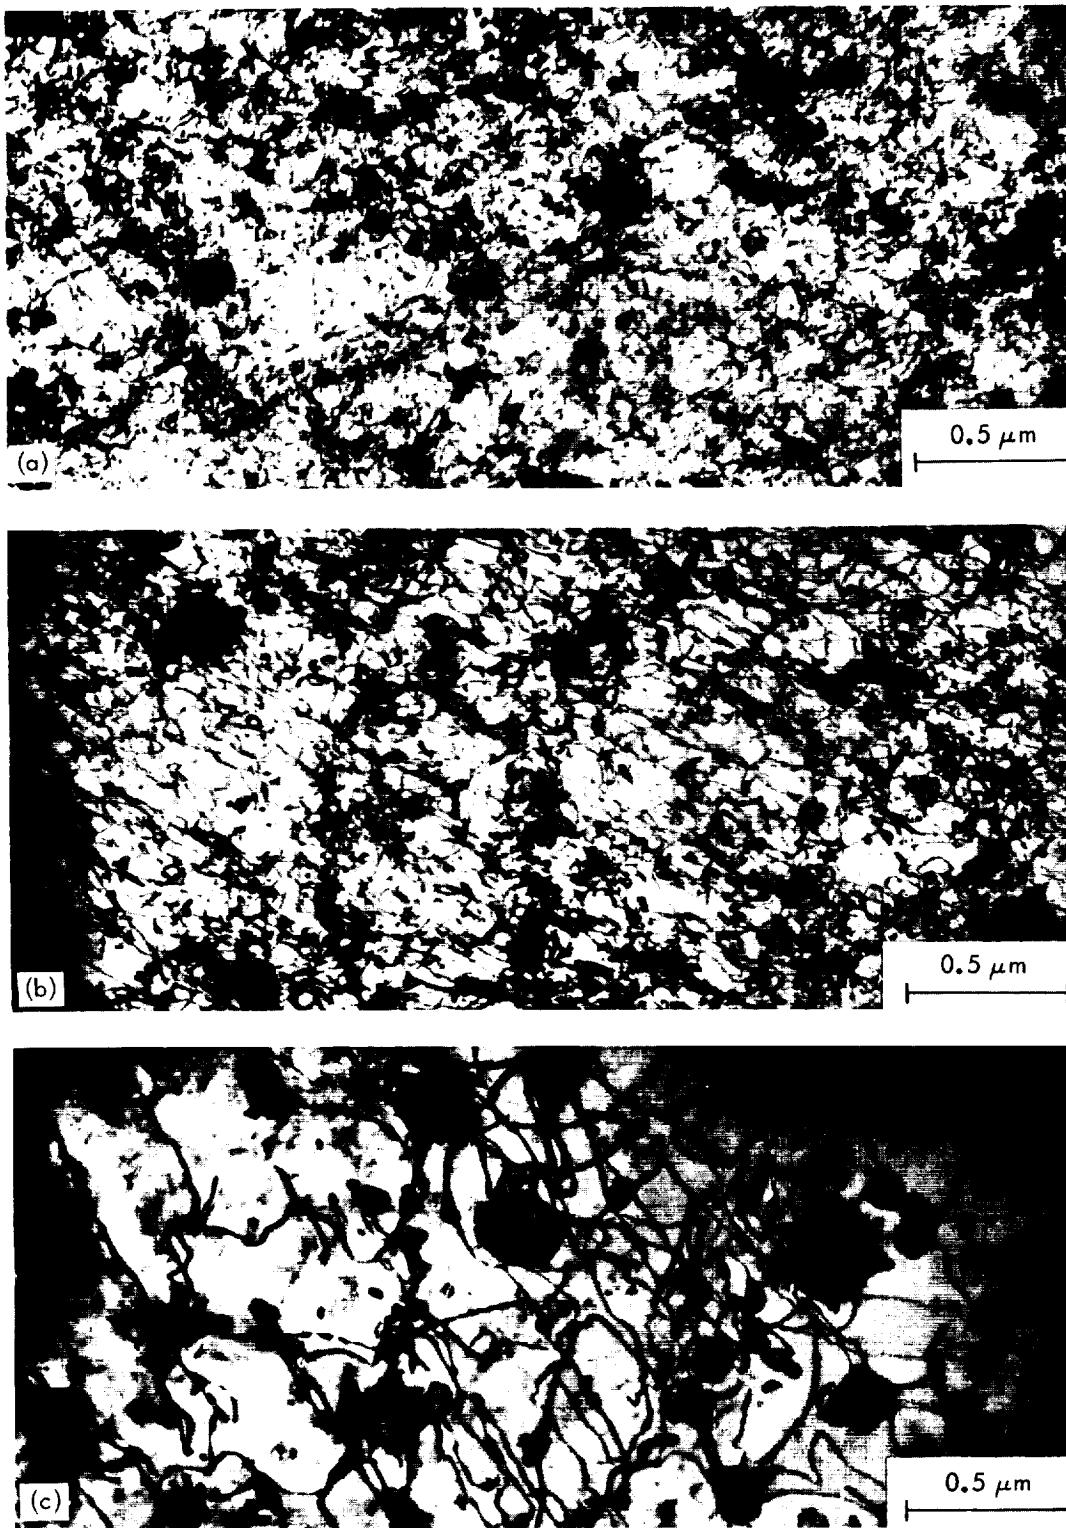
FIGURE 7.—Dislocation structure near exterior bottom surface of polished aluminum alloy camera shroud: sample 934. At 1000 kV. (a) 0 to 2 μm. (b) 5 to 8 μm. (c) 25 μm.

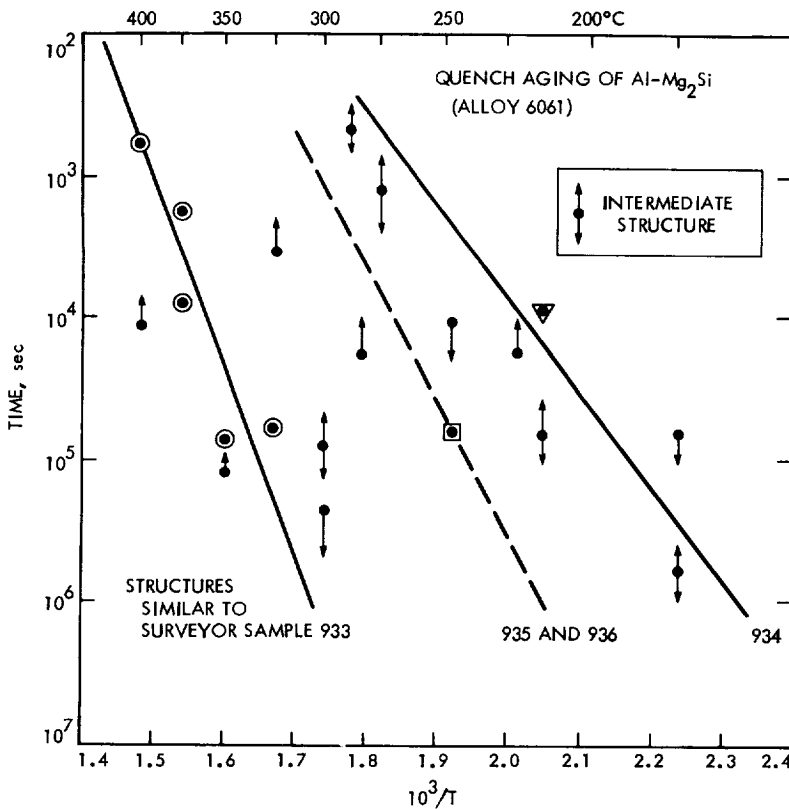
FIGURE 9.—Quench aging of Al-Mg_2Si to produce microstructures similar to those in samples of Surveyor 3 camera shrouds.

The noticeable differences in microstructures between the upper visor and the sides and bottom of the lower shroud suggest a different thermal history in each case. In terms of the extent of the aging, they rank in order as 933, 935, 936, and 934. This observation can be interpreted quantitatively to a limited extent by comparison with the simulation samples illustrated in figure 8 and summarized in figure 9. However, it is necessary to make several basic assumptions in order to estimate the thermal history. The samples did not receive any heat treatment subsequent to the T-4 temper (quench) other than ambient temperature natural aging which occurred before launch. The differences found be-

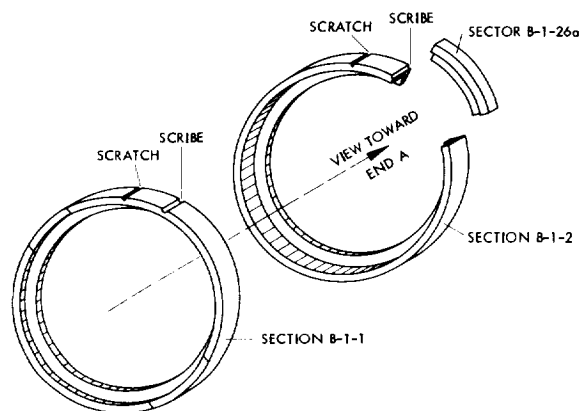
Figure 1.—Original location of returned part of Surveyor 3 strut (from NASA photograph AS12–48–7114).

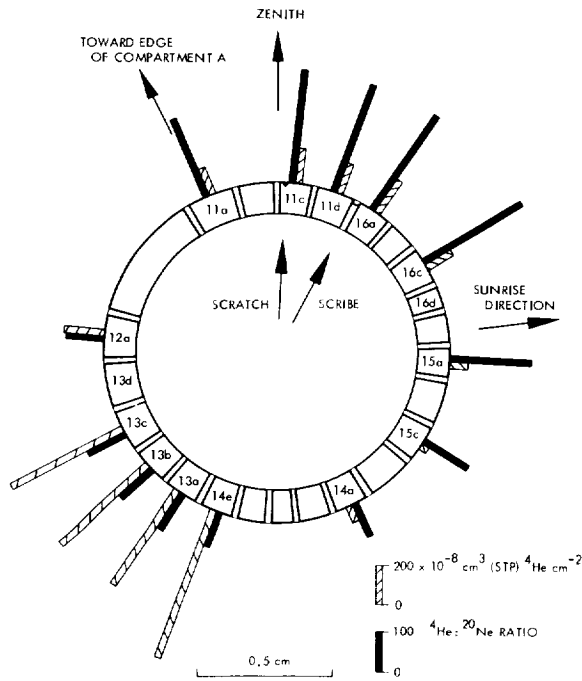
Figure 2.—Orientation of sectors cut from ring section B–1.

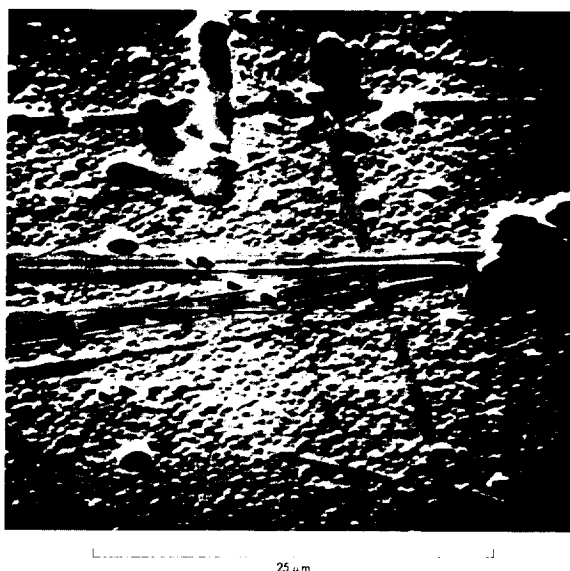
FIGURE 2.—Etched tracks on the top surface after removal of surface films. The tracks are the dark oval objects about 1 μm in size. They clearly point to the camera opening. The shallow pits also are found on the unirradiated part of the glass and are not produced by nuclear particles.

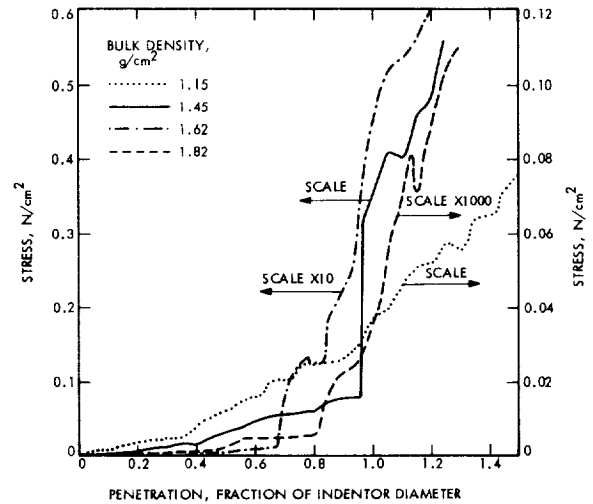
Figure 1 shows bearing stress vs. penetration curves for four runs. At low penetrations, the relation was about linear, with some tendency to curve toward higher force as the penetration increased. In most of the runs at medium and high bulk densities, the slope of the stress vs. penetration curves suddenly increased sharply,

FIGURE 1.—Bearing stress vs. penetration. Four individual test runs, at various bulk densities, are plotted. Note different vertical scales. Indentor tip diameter = 2 mm.

leading to a rapid increase in stress, often amounting to an order of magnitude or more. (See fig. 1.) A few of the runs at high bulk density showed one or more decreases in load with increasing penetration; these load decreases generally were accompanied by visible local bulging of the top surface of the material.

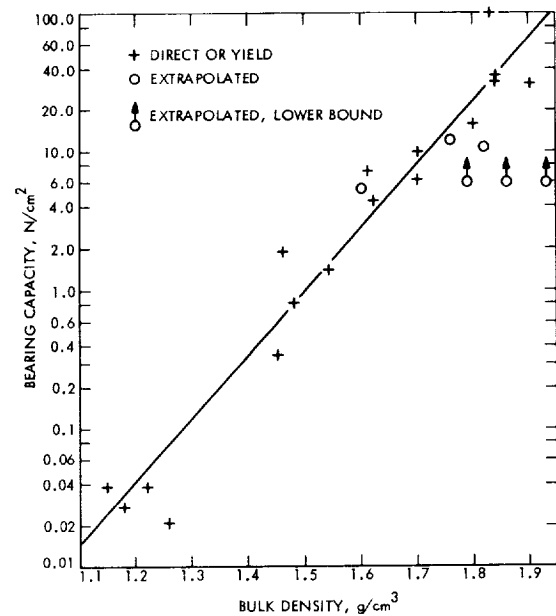
FIGURE 2.—Bearing capacity vs. bulk density. Line indicates least-squares fit. Bearing capacity was taken at a penetration equal to indentor diameter.

The closed-scoop surface sampler value of 2 N/cm² was obtained at a (penetration depth): (bearing plate width) ratio of 1, corresponding to the condition used for figure 2. Match to the curve of figure 2 occurs not at a bulk density of 1.8 g/cm³, but at about 1.6 g/cm³. This tends to suggest that the bulk density of the lunar soil at Surveyor 3, and a depth of 2.5 cm, is about 1.6 and not 1.8 g/cm³. Corrections to the bearing strengths should, in principle, be made for differences in scale, geometry, gravity, and perhaps atmosphere. It seems best, however, to await results of other tests, including shear tests, planned for the same sample of lunar soil before attempting those corrections.

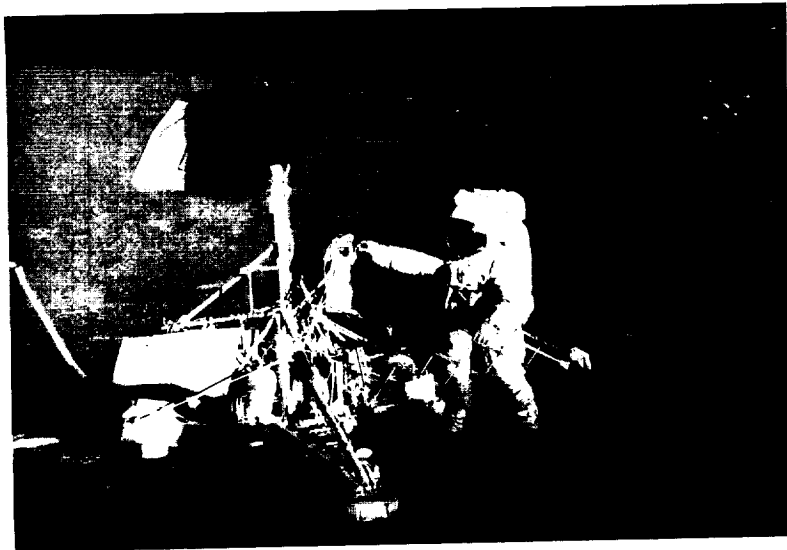
FIGURE 1.—Surveyor 3 spacecraft on its lunar landing site with astronaut Conrad inspecting the television camera. The Lunar Module Intrepid appears in the background.

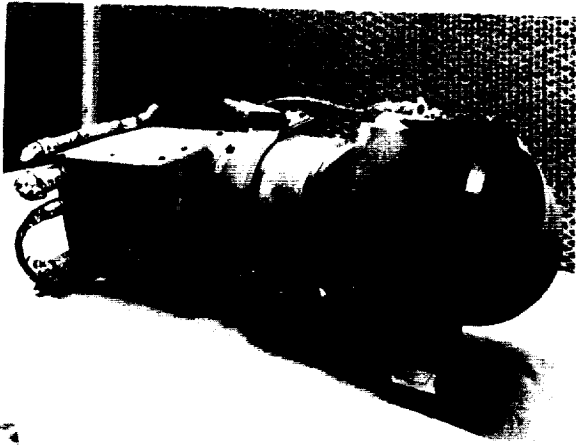
Figure 2.—The retrieved Surveyor 3 television camera, complete with shroud, original collar and cables, as it appeared in the laminar-flow hood of the Lunar Receiving Laboratory.

The retrieved camera was placed in a laminar-outflow hood equipped with high-efficiency particulate air filters (fig. 2) in the LRL astronaut debriefing room, which has an air-conditioning system separate from the system used by the rest of the LRL. Each surface of the laminar-flow hood that would be exposed to the camera was thoroughly washed twice with isopropyl alcohol before the camera was placed into the hood. A sterile cloth was placed on the floor of the hood to retain any lunar material that might accumulate as a result of the disassembly procedures. Only the personnel di-

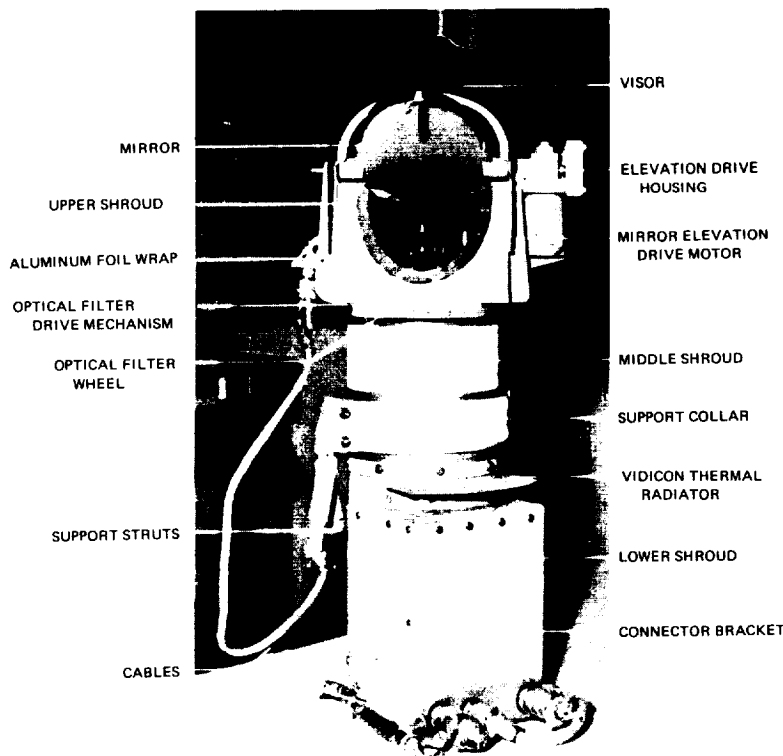
FIGURE A–4.—Surveyor 3 camera as it was unbagged at the Lunar Receiving Laboratory. Dents in the visor occurred during transport from the lunar surface.
