Ice Force and Scour Instrumentation for the White River, Vermont

Leonard J. Zabilansky

April 1996

Special Report 96-6

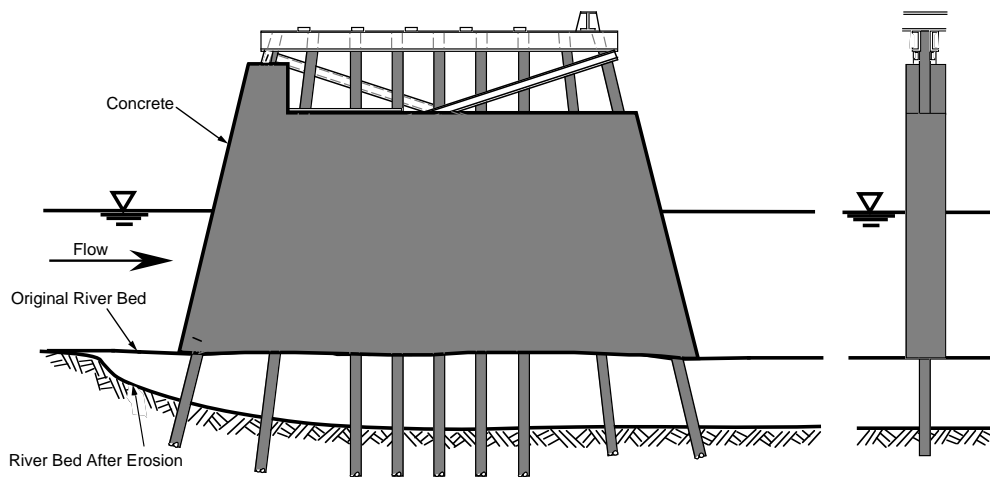
This temporary bridge lasted until January 26, 1990, when it collapsed during ice breakup. One pier collapsed first, dropping two spans into the river. Fifteen minutes later a second pier failed, dropping a third span into the river (Fig. 3). Historical flow and weather data (App. A) show that the bridge had been subjected to breakups with potentially more ice, due to lower temperatures or higher stage levels or both, than in previous years (Fig. 4). Then why should it have failed? The most likely cause is deterioration of the structural integrity of the foundation due to the cumulative effect of scour. Several post-failure observations indicate that scour around the Bridge Street piers was the primary cause of failure, aggravated by the ice. The local newspaper reported that the bridge "seemed more flexible" to local commuters on the day of the failure. Also heard were comments on how good the fishing was underneath the concrete piers. The concrete used to encase the piles was cast directly on the riverbed, without a cutoff wall or bed protection.

Figure 3. Failure of the Bridge Street bridge, January 26, 1990.

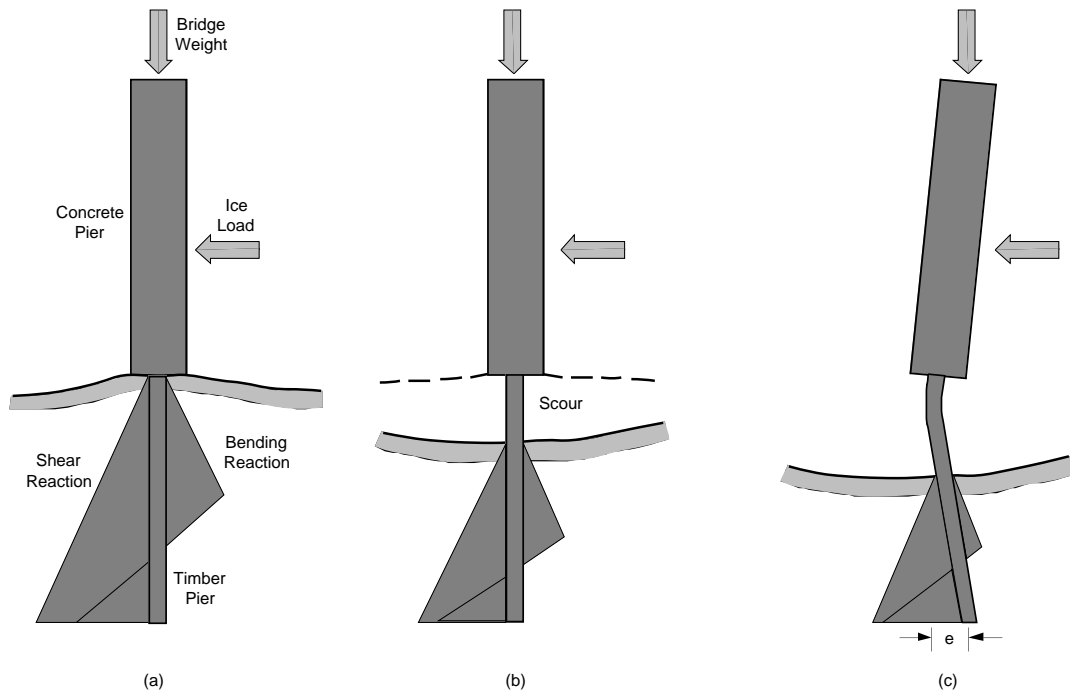
Figure 5. Simplified failure scenario: a) as built, b) reduction in embedded pile length caused by scour, and c) lateral displacement of the pile, making the bridge weight an eccentric load.

depends on the developed lateral and bending stiffness of the piles. Both aspects are a function of the pile's embedded length (Fig. 5a). As built, the piers had sufficient stiffness to resist any lateral movement of the foundation.

Removing gravel, as during a scour event, reduces the pile's embedded length and compromises the structural integrity of the pier. As the length of the exposed pile increased, the relatively slender piles are more prone to flexing. In the extreme case with short penetration, the pile will rotate as a unit within the soil (Fig. 5b). In this condition most of the bridge weight is supported by the point bearing at the tip of the piles. Basically, 10 ft of scour would leave the pier as a block of concrete supported by nine 16-ft stilts. With the relatively low stage during the 1990 breakup, the ice impacted the pier close to the bed, requiring the foundation to take a larger portion of the load. Because of the scour the pier would be more flexible, allowing the pier to deflect sideways as it experiences side impacts. The lateral deflection causes the weight of the bridge to be an eccentric load (Fig. 5c), increasing the bending stresses. The abrupt transition from the timber piles to the piles encased in concrete further aggravates the stress conditions. There is a considerable difference in the stiffness between the two sections, with the wooden piles being more flexible. The increases in stress (i.e. bending and shear) ultimately resulted in the piles snapping at the change in cross section. With the limited lateral support, the piles could easily be deflected or move sideways by the ice loads. The combined shear and bending stresses could easily have exceeded the bending resistance at the transition between the pile and concrete, causing the pier to buckle. This scenario is supported by the snapped timber pile left in the riverbed and in the concrete. The concrete portions of the piers were found on the bottom of the river adjacent to the line of timber piles (Fig. 6).

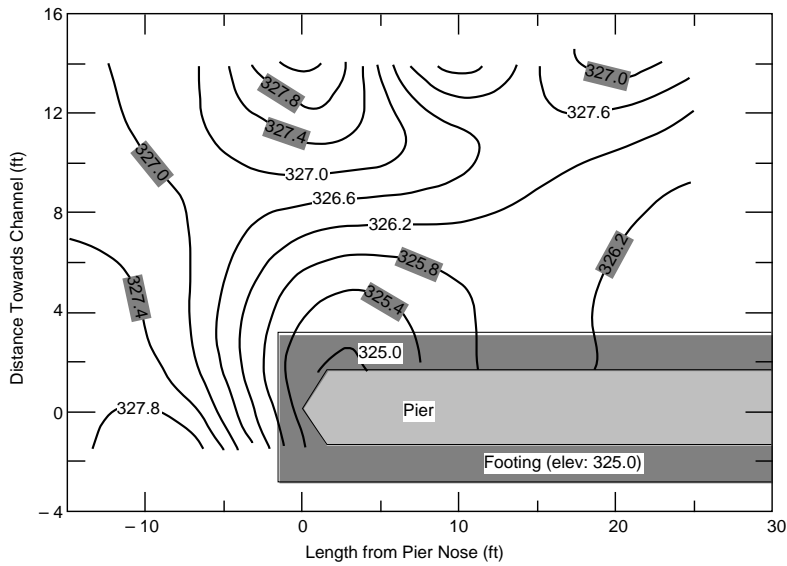
22. Elevation contours adjacent to the Route 5 bridge pier, August 1992. The contour lines are at 0.4-ft intervals.

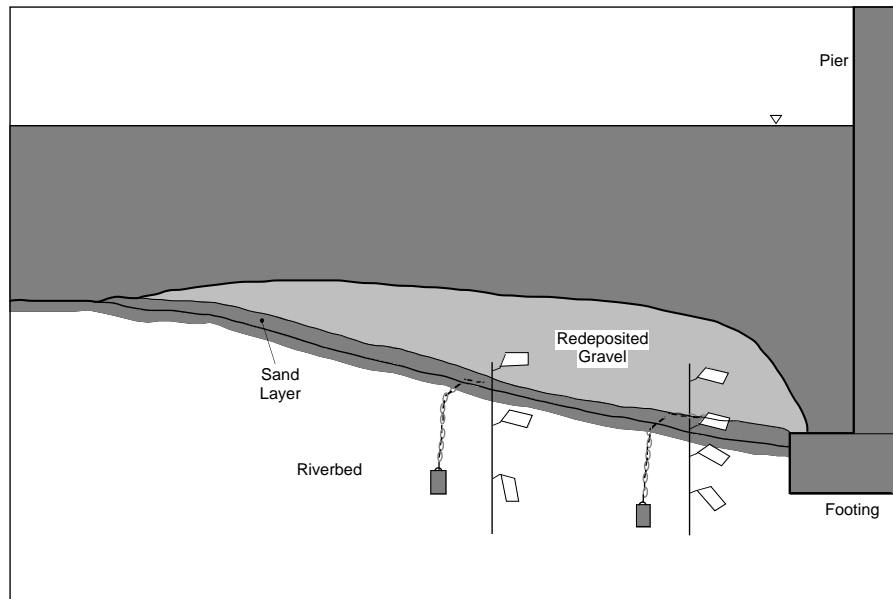
The chains were found in a sand layer that represent a radial cross section along the centerline of the pier (Fig. 28). Extrapolation of the point measurements of scour depth at the chains showed that this 4-in. layer of sand returned to the surface approximately on the same radius as the bubbles observed during installations. Figure 29 shows the contour lines of the scour hole as defined by the sediment chains. The active fish (140.020 MHz) was above the sand layer defined by the chain, confirming that scour did occur. In the process of restoring the riverbed to the "natural" contour, the sediment chains were reset. The instrument fish will be reinstalled using a different mast arrangement for sheltering the fish.

Figure 28. Cross section of the scoured and redeposited gravel wedge.

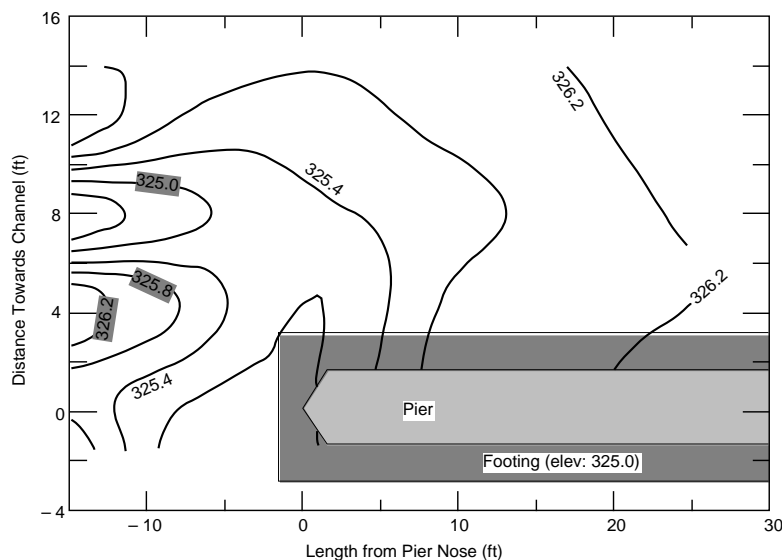
Figure 29. Contours of the scour hole.
