THE RELATIONSHIP OF ROOF MOVEMENT AND STRATA-INDUCED MICROSEISMIC EMISSIONS TO ROOF FALLS

A.T. Iannacchione, P.R. Coyle,
L.J. Prosser, and T.E. Marshall
NIOSH
Pittsburgh, PA

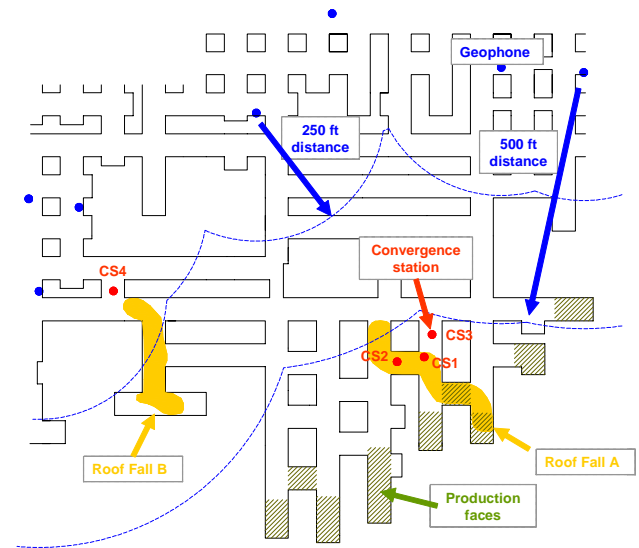
Figure 1. Location of geophones, roof-to-floor convergence stations, and production faces advanced between March and June 2002.

Observation data were collected which consisted of the date and location of roof falls and face advances (Figure 1 and Figure 2). From March to June 2002, roof-to-floor convergence was measured during several periods of unstable roof rock conditions. In addition, about 2,400 microseismic emissions were recorded that represent the development of new rock fracture surfaces. Knowledge was gained on roof rock failure patterns and the capabilities of the roof monitoring systems. The goal of this research is to develop a more complete understanding of the mechanisms that cause roof failures and to improve warning techniques for unstable roof rock conditions. These advancements would lead to safer and less hazardous working environments for our nation's miners.

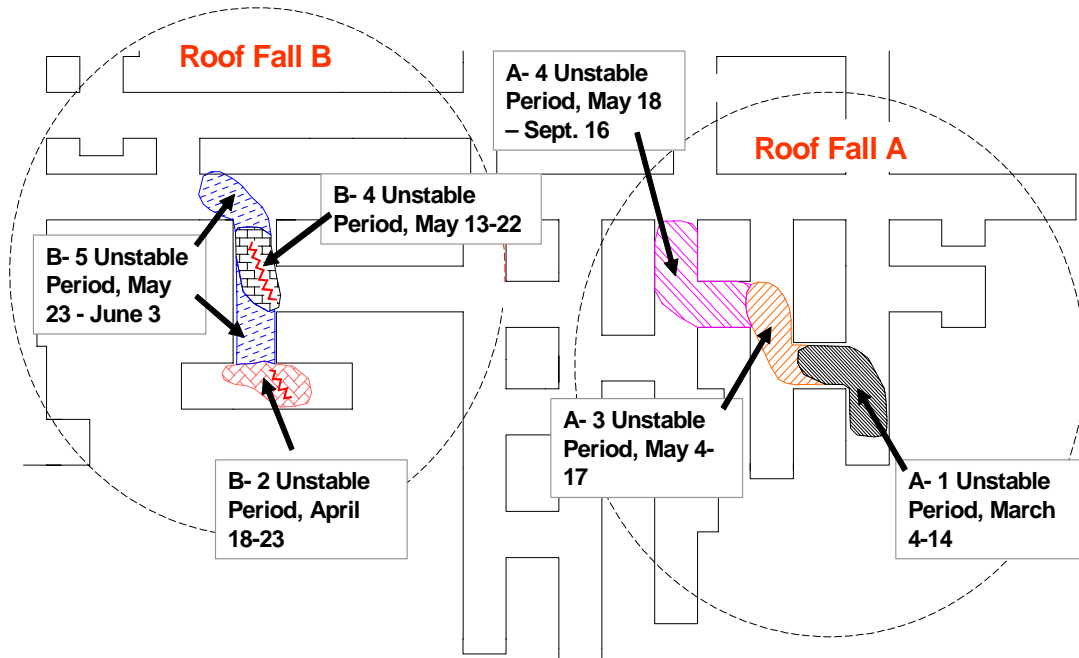
Figure 2. Location of Roof Fall A and B areas. Also shown are the locations and dates of the distinct unstable roof rock periods. Note: Periods A-2, B-1, and B-3 are classified as semi-stable roof rock and are discussed later in the paper.

Roof Fall A developed from three unstable roof rock periods. The first period occurred from March 4 to 14 and can be described as failing in several distinct stages (Figure 2, period A-1). The initial observed stage of unstable roof rock period A-1 occurred when a shear failure was noticed by mine officials around 3 am on March 7. By that afternoon, a small shallow fall extended approximately 2 ft into the roof. Sometime during the evening of March 7 the roof fall cavity extended across the intersection and approximately 10 ft into the roof, encountering the soft red shales of the Mauch Chunk Formation. From late March 10 into the morning of

A second unstable period occurred in the Roof Fall A area starting on May 4. The period was defined by a series of small roof falls and ended on May 17 with a fairly large roof fall extension (Figure 3b). At this time the roof fall cavity occupied the area shown in Figure 2, period A-3. On May 18 roof rock to the northwest of A-3 began to slowly fail over a four-month period until September 16 when a large roof fall occurred (Figure 2, period A-4).

Roof Fall B was located some 500 ft away from Roof Fall A and included three distinct periods of unstable roof rock conditions. The first unstable period occurred from April 18 to the 23, when a shallow roof fall encompassed an entire intersection (Figure 2, period B-2). This area had experienced some roof rock fracturing in the past and

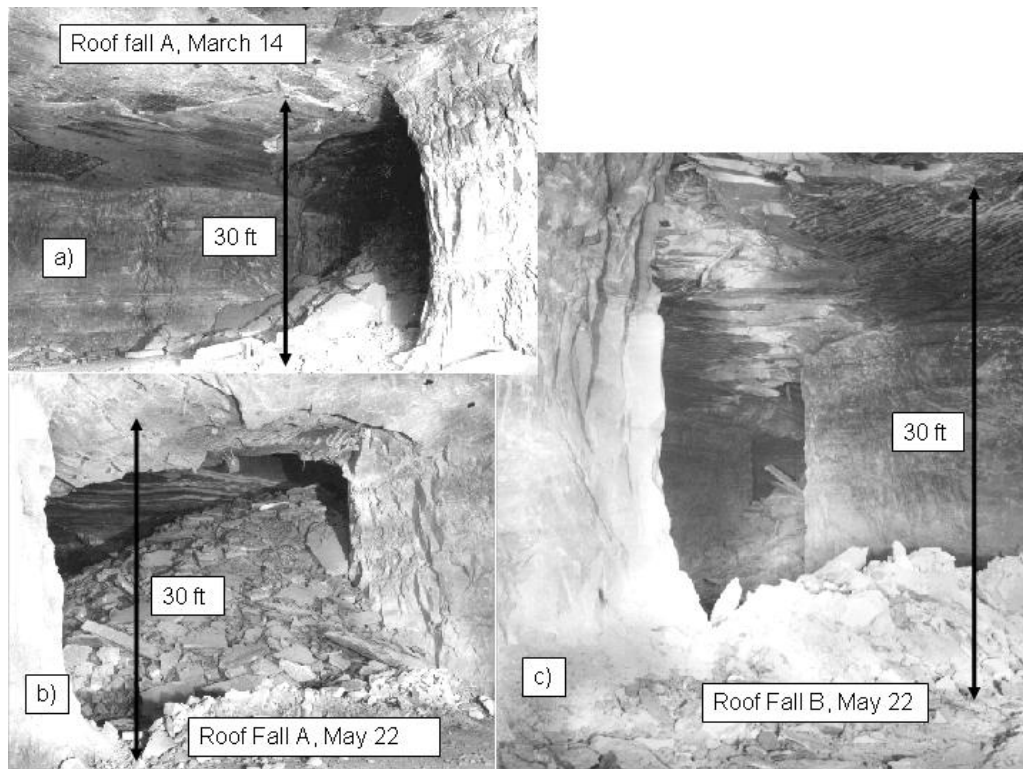
Two major roof falls occurred during this study. Each of these falls comprised numerous individual roof falls that fell either as one mass or in distinct segments during different periods of time. Roof Fall "A" occurred in the southeast corner of the mine while Roof Fall "B" occurred approximately 500 ft to the west-northwest of Roof Fall A (Figure 2). From March to June 2002, 48 face cuts were advanced by blasting in the study area (Figure 1). The circles surrounding the two roof falls (Figure 2) represent the approximate area where most of the microseismic events occurred.

Figure 3.   Photographs showing the size and character of the roof falls within the study area. Note: Dates on photo refer to the date when the picture was taken.

failure propagated rapidly across an entry on May 6. By May 22 the entire intersection had fallen (Figure 2, period B-4 and Figure 3c). Two weeks later on June 6, this roof fall extended both to the south and the northwest (Figure 2, period B-5). By mid-June, Roof Fall A extended almost 250 ft in length, while Roof Fall B was closer to 300 ft in length.

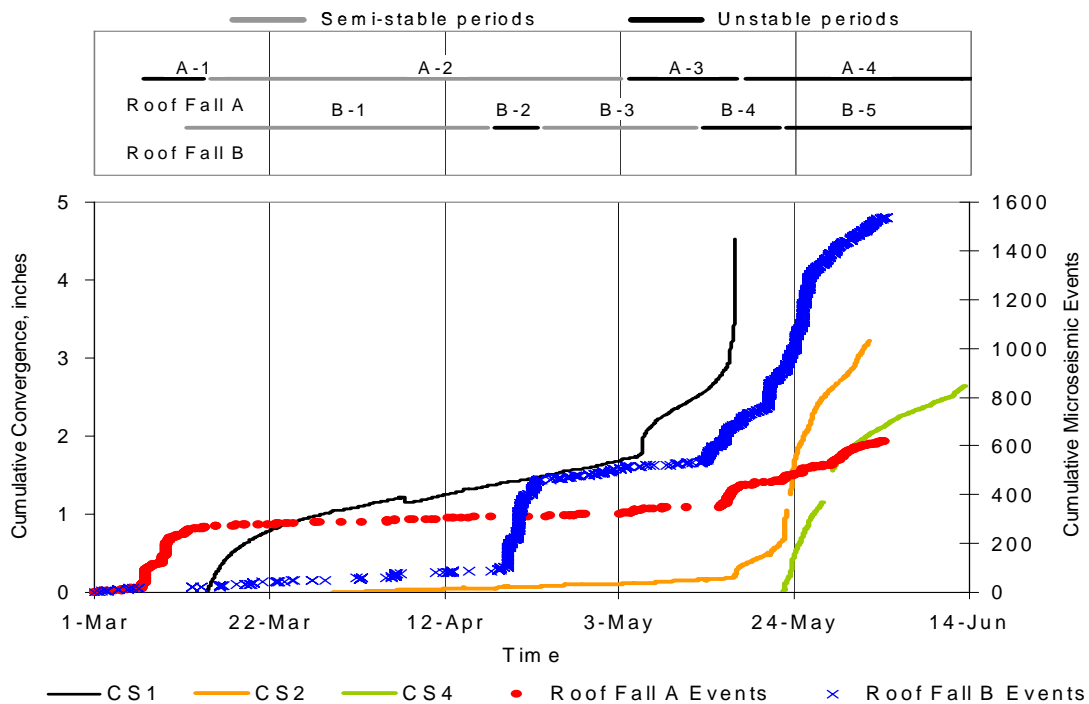
The first roof-to-floor convergence station, CS1, was installed on March 14 (Figure 4). At this point in time, station CS1 was approximately 75 ft to the northwest of the March 4 to 14 roof fall (period A-1). Immediately

second unstable period during Roof Fall A produced an additional convergence of 2.82 inches (Figure 4, period A-3). Station CS1 operated until May 16 at which time it was destroyed by a rock fall.

Convergence station CS4 was installed on May 22 approximately 100 ft away from Roof Fall B (Figure 4, period B-4). The convergence rate remained steady at 0.26 in/day until May 28 at which time it dropped to approximately 0.07 in/day. This station was in operation until June 13 when it was relocated farther away from the fall area.

Figure 4. Cumulative convergence and microseismic emissions from Roof Fall A and B areas with associated stability periods.

Almost 2,400 microseismic events were located in the two roof fall areas. Approximately 800 occurred in Roof Fall A area and another 1,600 in Roof Fall B area (Figure 4). In Roof Fall A area, 473 events produced a rate of 43 events/day in association with the March 4 to 14 roof fall (period A-1). During the semi-stable roof rock period from March 15 to May 3, microseismic activity was reduced to an average of 1.2 events/day (period A-2). On May 4 and again on May 15 and 16, activity increased in conjunction with local roof instabilities (period A-3). After this time, microseismic activity assumed a higher rate of 10.8 events/day. The

Perhaps the most important role for microseismic monitoring is that it can provide very early indications of roof instabilities. Detailed analysis of Figure 4 shows that microseismic activity often precedes convergence. Prior to the first signs of roof rock failure on March 7,

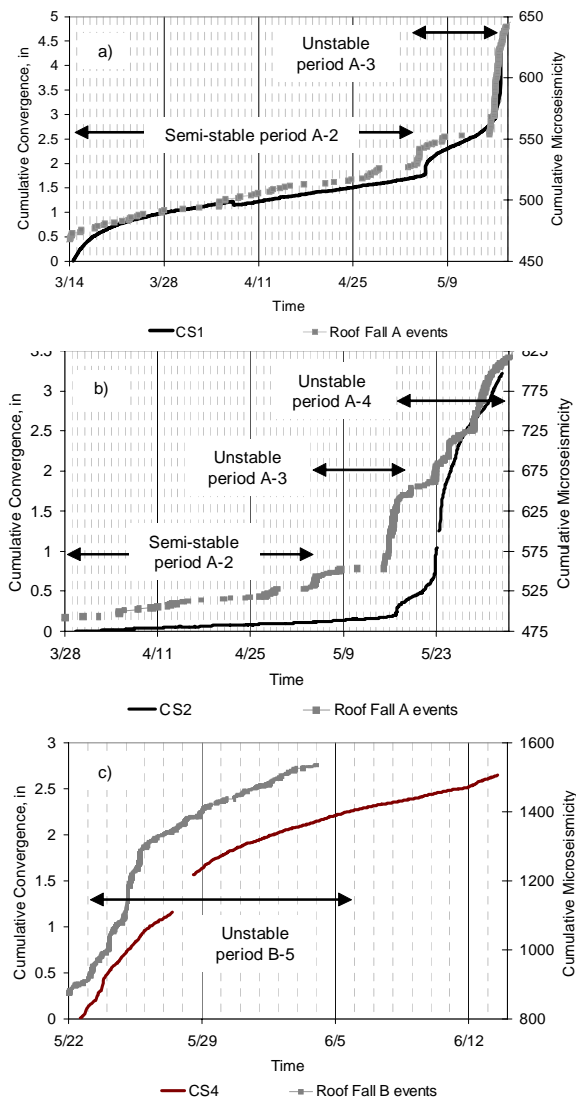
Figure 5. Comparison between convergence, microseismic event frequency, and local stability conditions.

Comparisons were made between each convergence station, the local microseismic event count, and the local stability conditions for the semi-stable and unstable periods (Figure 5). Clearly, agreement exists between the relative trends in convergence and microseismic activity. In general, periods of semi-stable roof rock conditions are accompanied by lower levels of convergence and microseismic activity. Periods of unstable roof rock conditions are accompanied by higher levels of convergence and microseismic activity. These trends are shown in Table 1. Here the nine different roof rock stability conditions are listed along with their corresponding dates, convergence measurements, and microseismic event counts. Microseismic events were

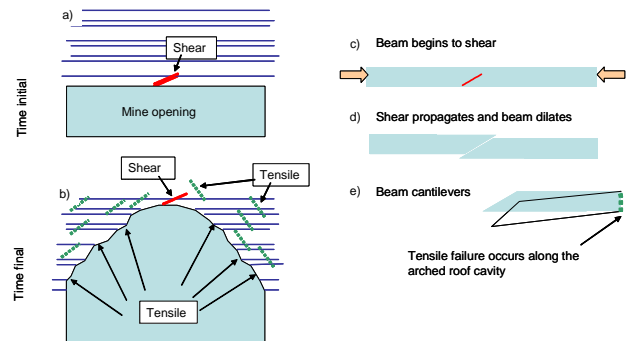
The convergence and microseismic monitoring data along with in-mine observations provide a clear picture of the behavior of strong roof rock failing from excessive levels of horizontal stress (Figure 6). The following generalized sequence of events was identified during this study:

- Initial shear failure occurs in individual roof beams subjected to excessive levels of horizontal stress (Figures 6a and 6c).
- Adjacent layers begin to fail in shear as stresses are added from a) dissipated stresses from prior beam failure, and b) layers experiencing volumetric increase in mass as a result of failure (Figure 6d).

- At some point in this process the roof rock can begin to deflect enough that its progress can be measured over a significant area with convergence monitors (Figure 6e).

- The roof begins to fall into the mine opening once enough beam deflection or sag from cantilevering occurs, causing tensile failures along the perimeter of the beam (Figure 6e).

- The roof fall can happen as a single, dramatic event or over a series of smaller events spanning days or weeks.
- The roof fall cavity eventually assumes a stable arch shape (Figure 6b).

Figure 6. Examples of roof rock failure characteristics in high horizontal stress conditions.

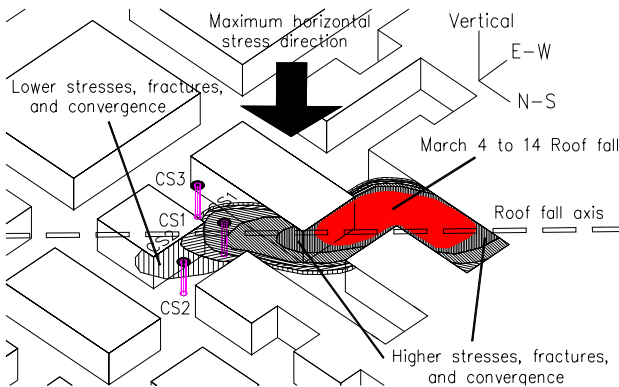
of the horizontal stress field where this axis will be perpendicular to the maximum horizontal stress direction (Figure 7).

Figure 7. Idealized distribution of roof-to-floor convergence associated with the March 4 to 14 roof fall.

As has been demonstrated, the zones of highest convergence are close to the axial ends of the roof fall and dissipate gradually along the axis for distances ranging from 50 to 100 ft. Conversely, convergence decreases

significantly perpendicular to the axial trend of a roof fall. This direction is parallel to the direction of maximum horizontal stress (Figure 7). The areas adjacent to the roof fall cavity, but away from its axial ends, have lower stresses and are thought to be within the roof fall's stress shadow. Understanding these trends is important in identifying the appropriate ground control response (Emery, 1964; Parker, 1966; Mark and Mucho, 1994; Iannacchione, et al., 1998).
