Noise assessment of stone/aggregate mines: six case studies

E.R. BAUER AND D.R. BABICH

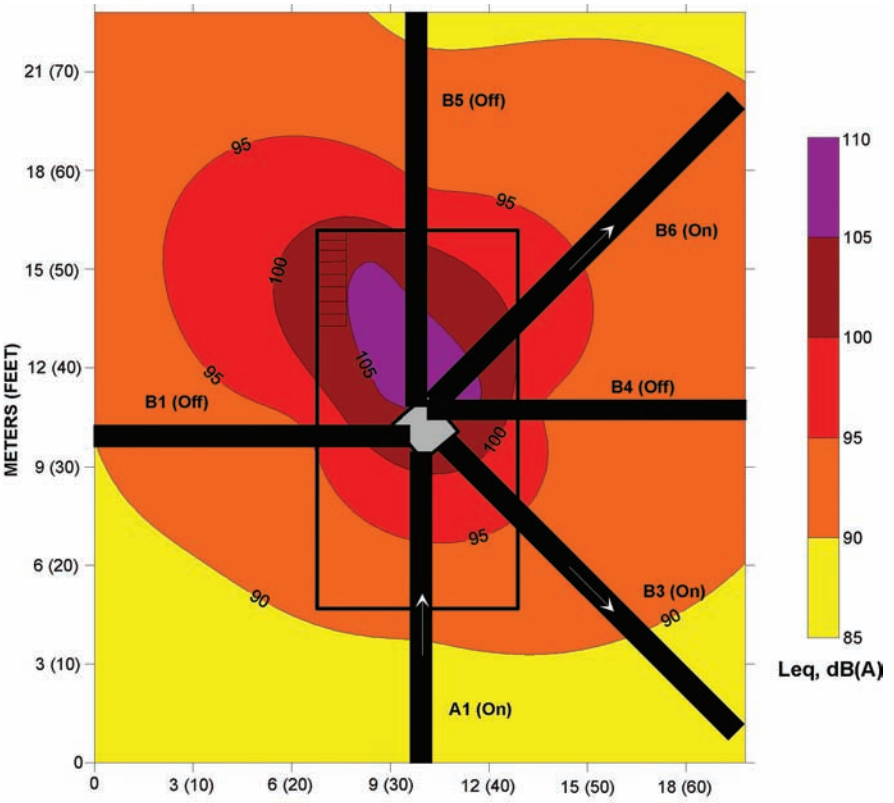
FIGURE 1

Sound profile plot for the primary screening tower.

Equipment and plant sound levels: Table 1 lists the range of sound levels measured around various processing equipment and indicates that the sound levels varied greatly throughout the plants. The highest sound levels were recorded at the primary screening tower, surge tunnel, secondary crusher, secondary screening tower and the fourth level of the agricultural lime crusher. Most of the recorded readings were 93 dB(A) or less. A sound profile plot for the primary screening tower is illustrated in Fig. 1. The measurements ranged from 87 to 96 dB(A) outside the building and 105 to 107 dB(A) inside the screening tower.

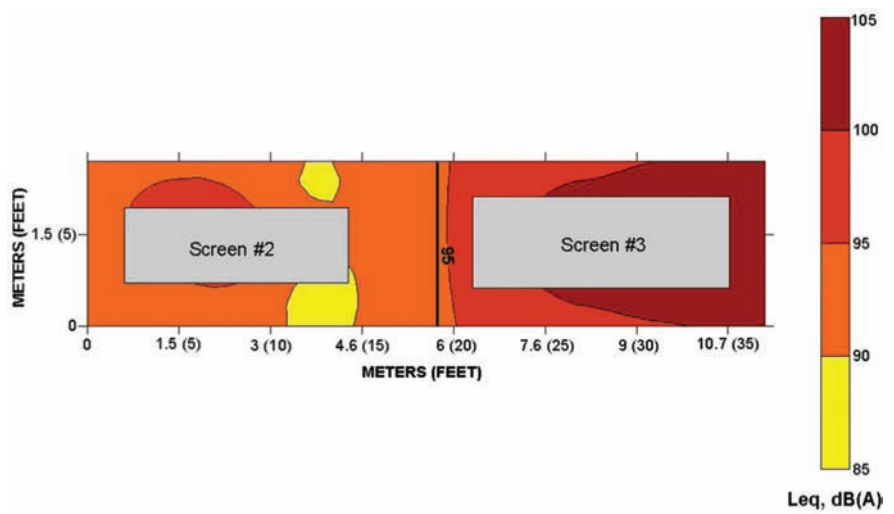
FIGURE 2

Sound profile plot for Telsman screens 2 and 3.

the sound levels measured is illustrated in Fig. 2, which is the sound profile plot for screens 2 and 3 in Plant A. Sound levels from 88 to a little more than 100 dB(A) were recorded.

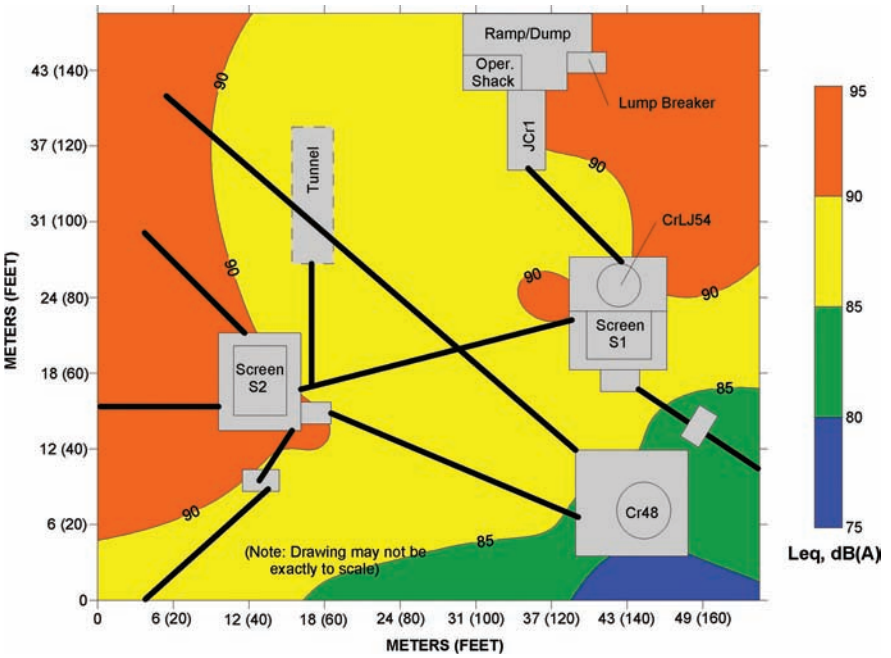
FIGURE 3

Sound profile plot for portable plant.

Equipment and plant sound levels – Case study No. 3: Measurements were taken in the plant known as the portable plant. Forty-six sound level measurements were taken around the transfer points, belts, crushers and screens, the control room and the primary pit crusher. Table 5 lists and Fig. 3 illustrates the results of the sound-level measurements around the stationary equipment. The data indicate that the sound levels varied greatly throughout the portable plant. The locations where high sound levels (greater than 90 dB(A)) were recorded included Screens S1 and S2 and Crushers JCr1 and CrLJ54.

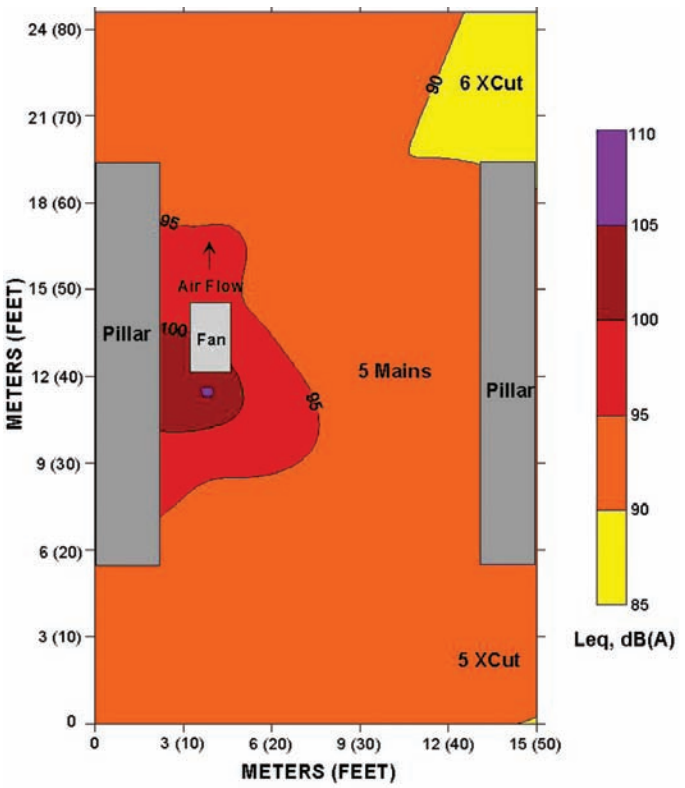
FIGURE 5

Sound profile plot for Joy Axivane 25-hp fan.

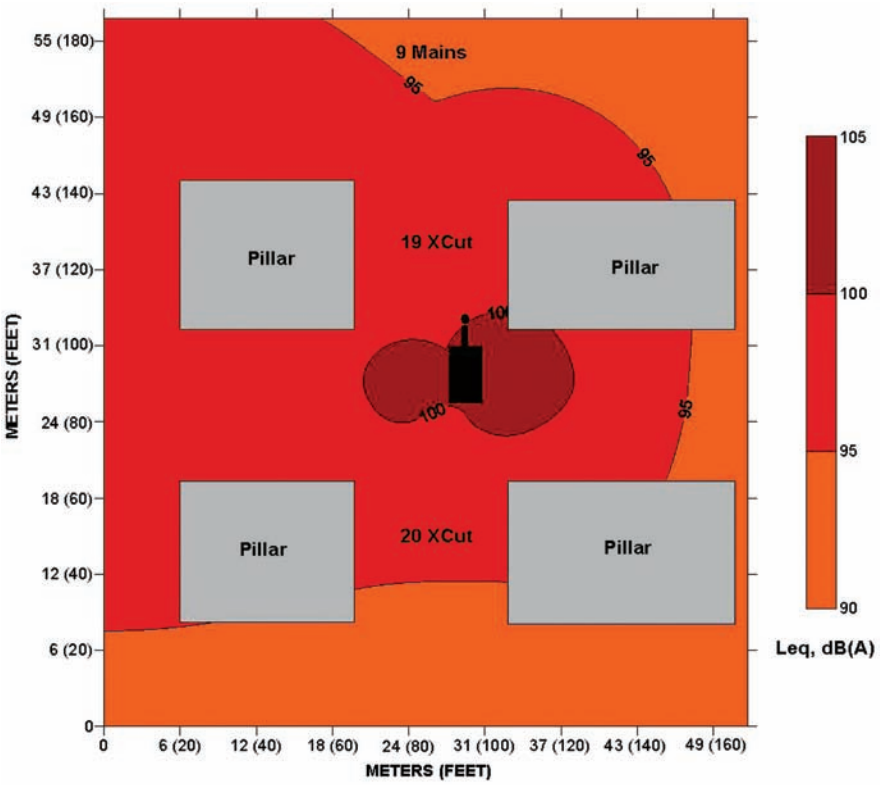
FIGURE 7

The underground face equipment included a Tamrock floor drill and Cannon face drill (both diesel) and a Gradall scaler. Sound levels around these three pieces of equipment were high, ranging from 89 to 103 dB(A). However, the sound level measured inside the enclosed cab of the Cannon face drill was only 83 dB(A). Figures 4 and 5 include a photograph and a sound profile plot of a JOY Axivane 18.8 kw (25-hp) fan. The sound levels near the fan ranged from 90 to 106 dB(A). Another example is illustrated in Figs. 6 and 7, which are a photograph and sound contour plot for a Tamrock Ranger 500 floor drill. Figure 7 illustrates that sound levels up to 102 dB(A) were recorded near the drill.

Sound profile plot for Tamrock floor drill.

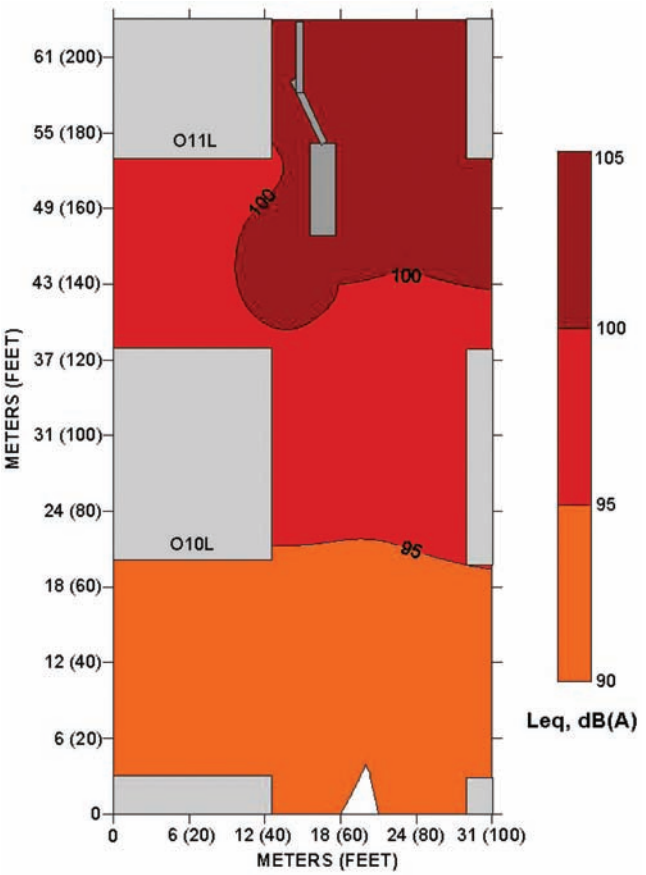
FIGURE 8

the bucket truck and more than 90 dB(A) near the water pump, scaler and face drill. The face drill had the highest measured sound levels, ranging from 86 to 105 dB(A) (Fig. 8). In the processing facilities, sound levels above 90 dB(A) were recorded nearly everywhere except in the jaw crusher control room and at the belt drives (Fig. 9).

Sound profile plot for Gardner Denver MK45H face drill.
