Advances in Digital Radioscopy for Use in Historic Preservation
Grant Number MT-2210-03-NC-07

December 2005

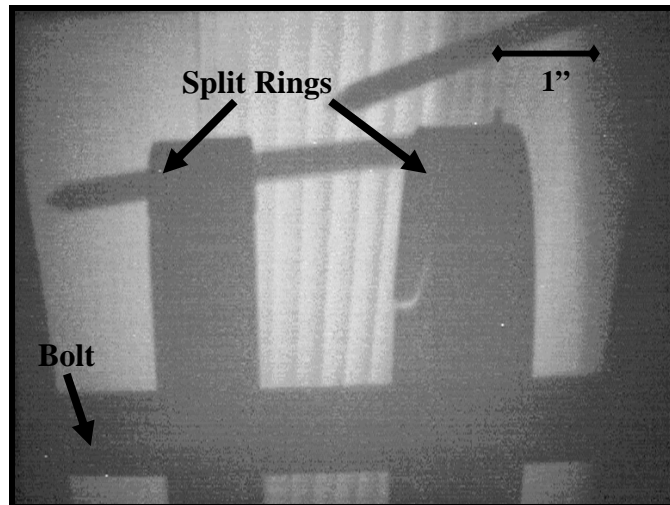
The bolt, visible in Figure 8, showed no evidence of corrosion as determined by observing the smooth, parallel edges of the bolt. The connections in the roof trusses used 4-inch split ring connectors. Joints with diagonal web members used four split rings while splices in bottom chords used only two. As was observed on the bolts, the radiographs showed that the split rings are in good condition and do not exhibit signs of corrosion or failure. Further, based on the radiographs, the wood adjacent to the fasteners is in good condition and has not deteriorated.

Figure 8. Radiograph of bottom truss chord, view from below.

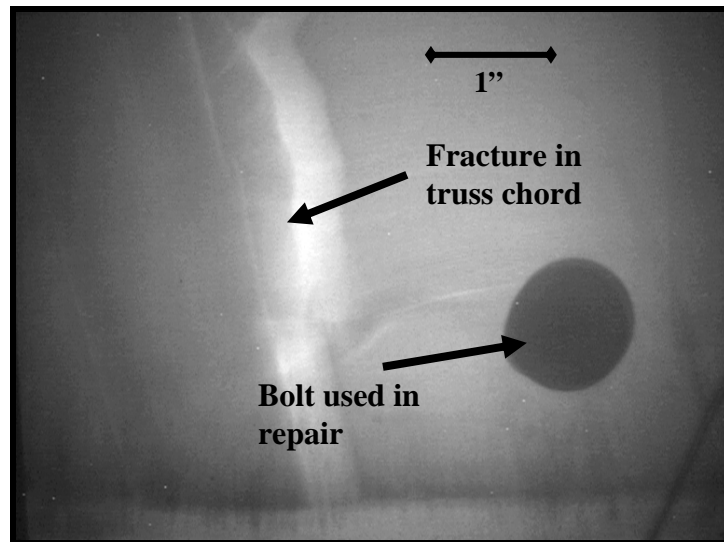
Figure 10. Radiograph of repair to bottom truss chord, side view. Note the fracture in the original timber (bright area).

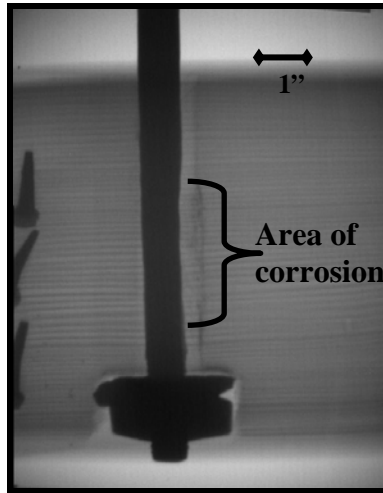
beam in the same configuration used on Pavilion I. The rod was shown to have minimal surface corrosion as evidenced by the reduced cross section of the rod within the beam. The remaining cross section of the rod could be measured during post-processing of the radiograph data stored on a computer. Note the lack of a void in the wood surrounding the rod; a condition that might be expected if the corrosion was due to the presence of moisture.

Figure 12. Radiograph of a corroded rod embedded in a timber beam.

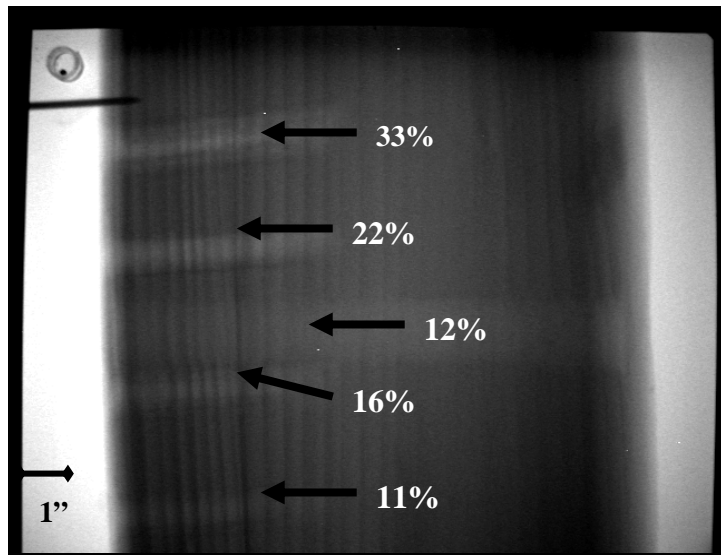
Figure 15. Radiograph of simulated termite damage showing measured loss of cross section at various locations.

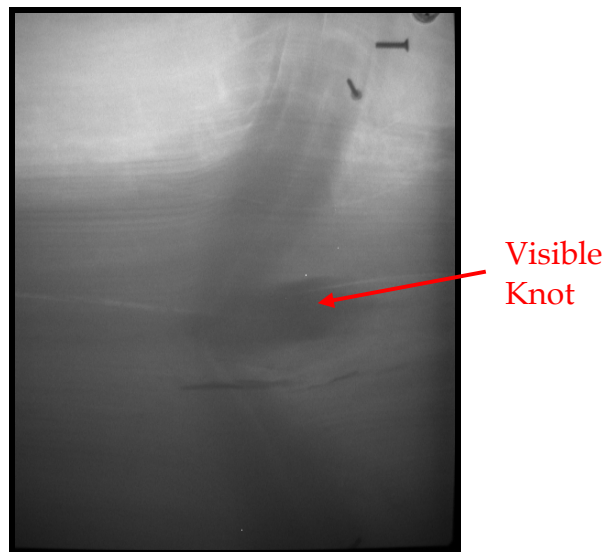
Figure 43. Radiograph of the decayed timber shown in Figure 42.

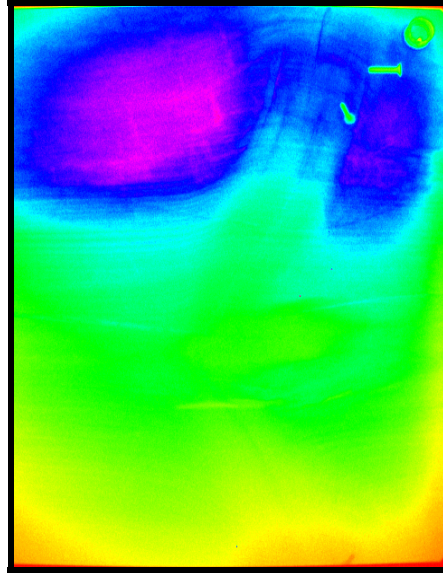
Figure 44. Colorized radiograph of the decayed timber shown in Figure 42.

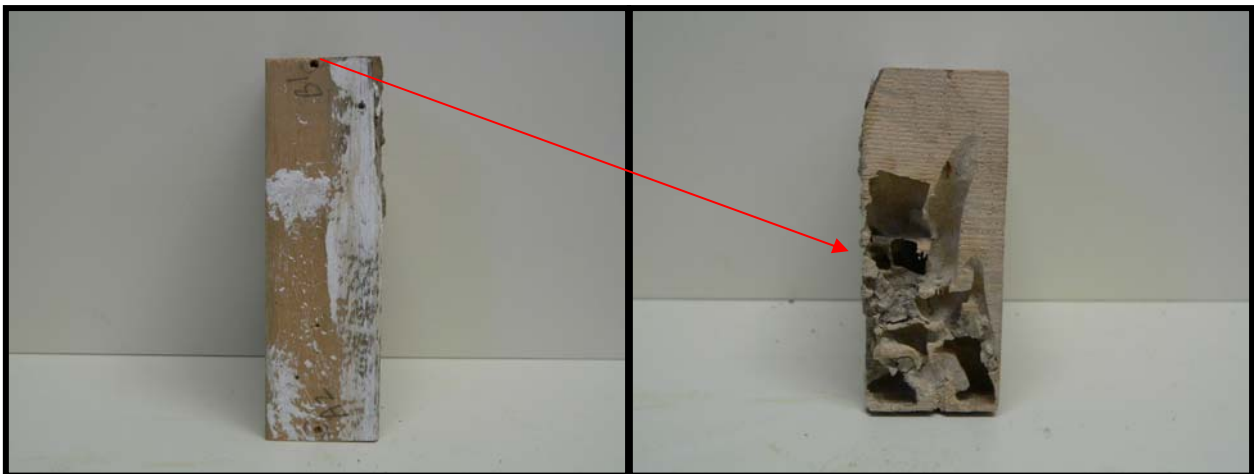
Figure 45. Section of a stud with termite damage, showing side view on left (with no visible damage) and the corresponding end view on right (showing termite damage). The arrow shows which end view is displayed.

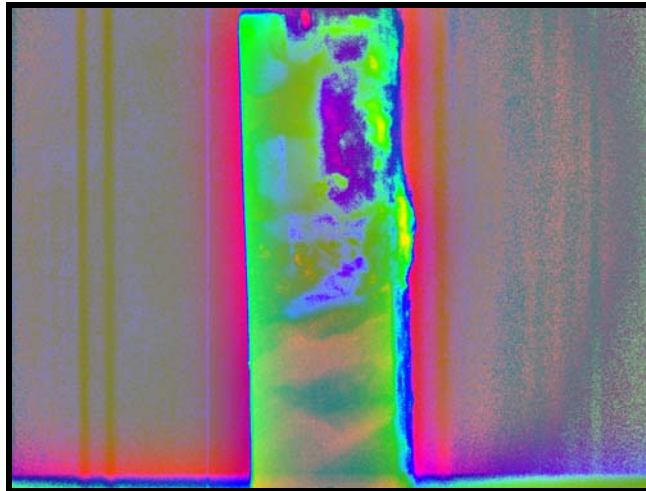
Figure 46. Colorized radiograph of a termite-damaged stud in a wood-frame wall (side view).

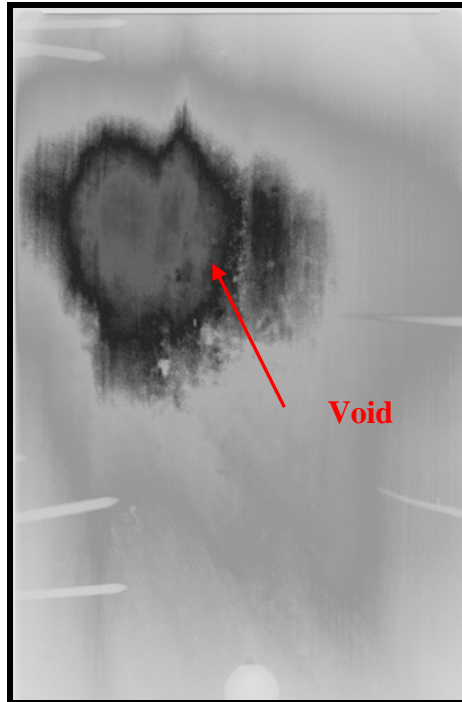
While at St. Anne's Church, visual inspection of some of the timbers revealed minor pockets of deterioration due to decay fungi. The radioscopy equipment was configured again as shown in Figure 92. The radiograph (Figure 94) was colorized to accentuate the differences in absorption of x-ray energy by the timber. Converting the image to grey scale still allows for noticeable differences in absorption of x-ray energy. The light-colored area in most of the radiograph

represents sound wood.   The approximately round, dark area is where a void could be seen in the timber.   Although the loss of wood could not be determined visually, it was possible to estimate the extent of the void by measuring the dark area on the radiograph. Using the technique described in the section on Quantification of Decay, the maximum void was estimated at 50 percent loss of section.

Figure 94. Radiograph showing the location and size of an internal void in a timber.

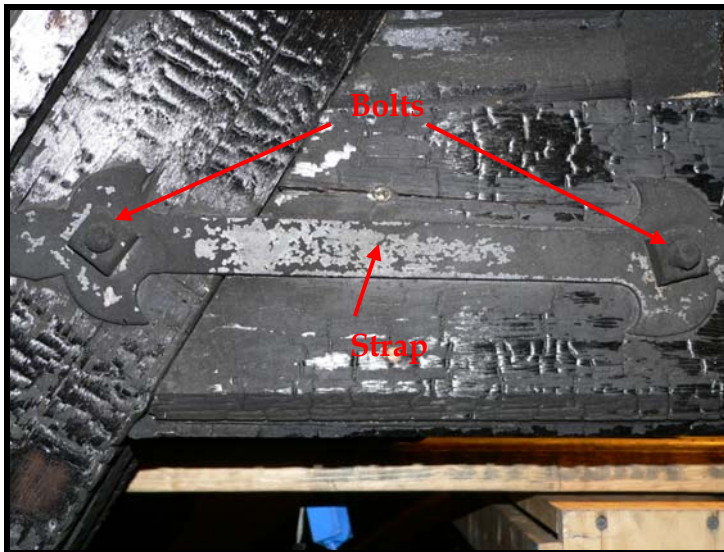
Figure 98. Area of interest showing two bolts and a metal strap at Location B1 on Truss 7 (north side).

The radiograph corresponding to this setup is shown in Figure 99. The image is as seen from the position of the x-ray source and is essentially the left side of the view seen in Figure 98. In the radiograph, the two metal straps are visible, as is metal conduit at the top of the image. The conduit is on the back of the truss tie and is, therefore, not visible in Figure 98 but can be seen in Figure 97. The diagonal line is the edge of the diagonal truss chord. To the right of the truss chord is the truss tie. Nails that secure wood trim to the tie are visible at the bottom of the radiograph. The uneven surface at the bottom of the wood trim is due to charring of the trim.

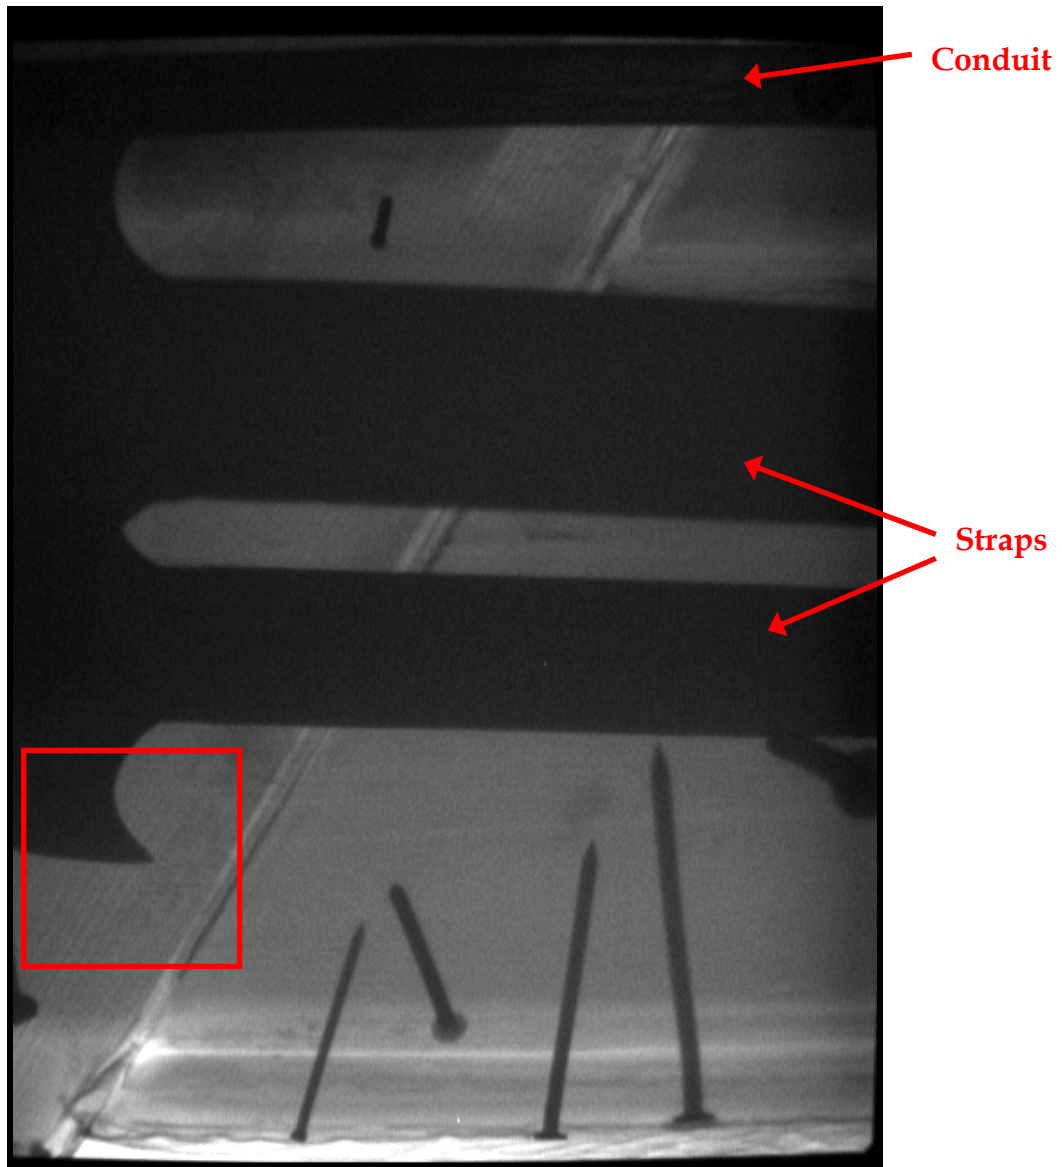
Figure 99. Radiograph of Location B1 on Truss 7 showing no internal rods or other fasteners (view from the x-ray source seen in Figure 24). The source position was offset to see both the front and back straps for purposes of identifying any hidden fasteners located between the straps; there are none.

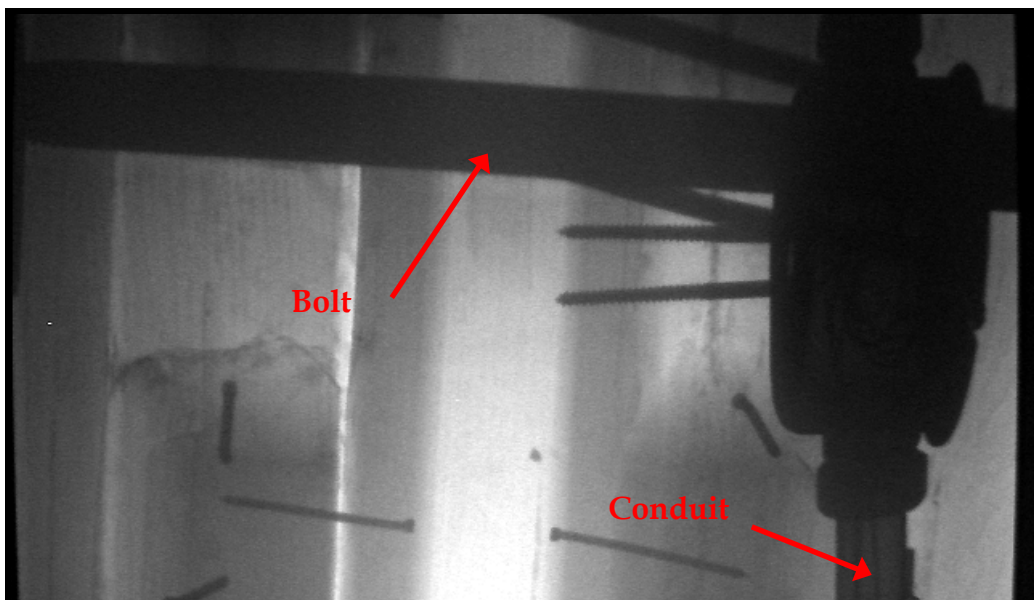
Figure 101.   Radiograph of Location B1 on Truss 7 showing one of the bolts and the electrical conduit.   No other internal rods or fasteners are visible.

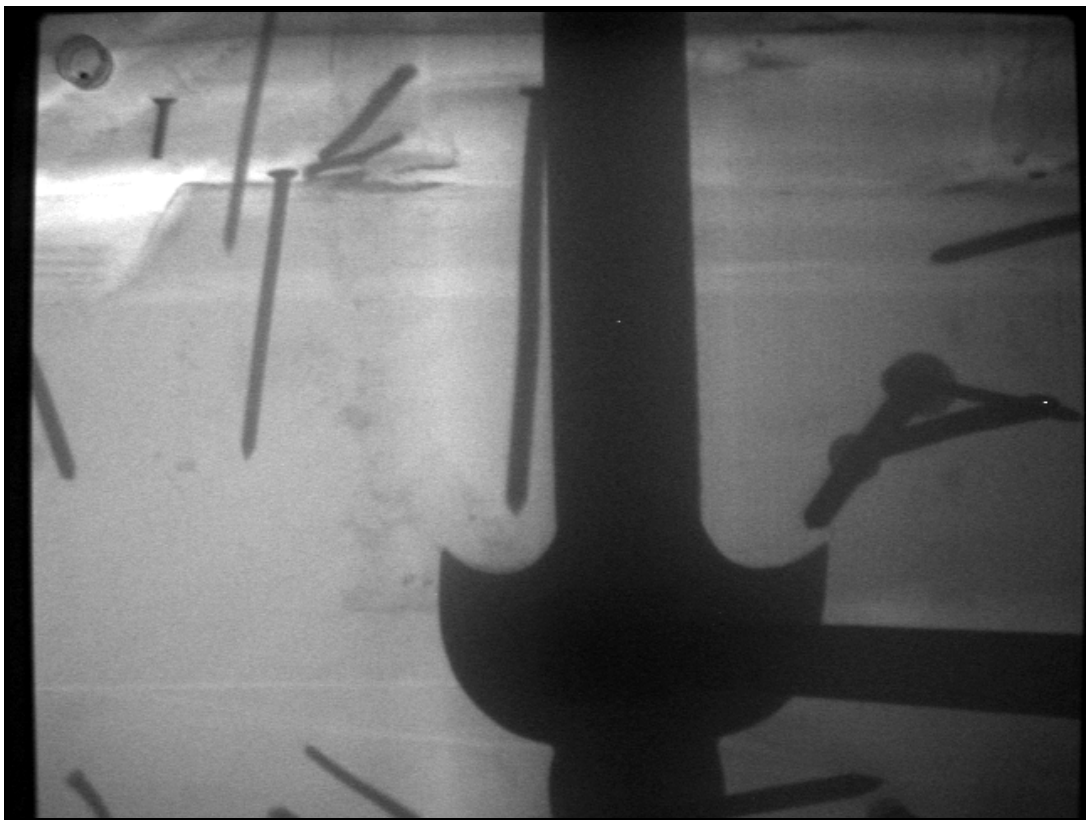
Figure 105. Radiograph of Location B2 on Truss 6 showing one of the bolts securing the metal strap. No other internal rods or fasteners are visible, except for nails.

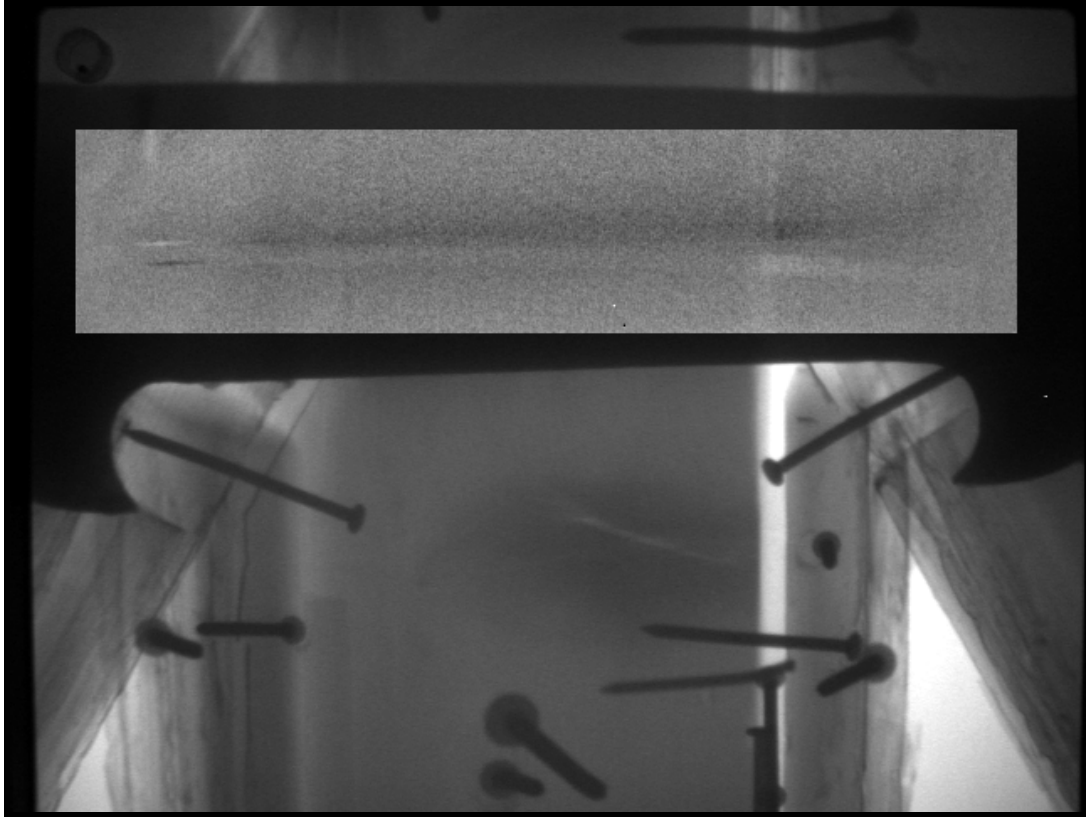
Figure 108. Radiograph of Location A on Truss 7 showing no internal rods or other fasteners. The area between the straps has been enhanced to verify that no metal fasteners are located between the straps.

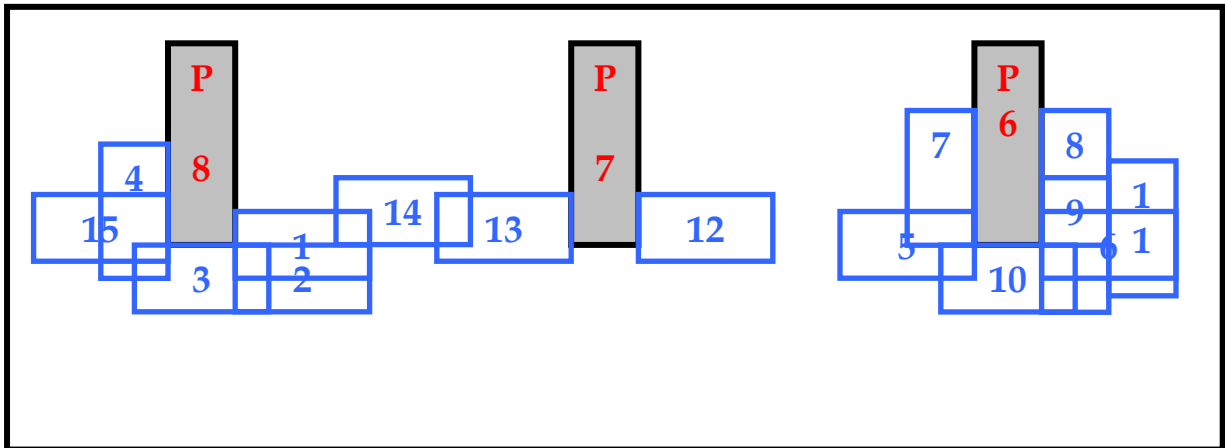
Figure 112.   Schematic of radioscopic images.   Purlins are colored gray and labeled in red (6 through 8). The imaging plate locations and orientation corresponding to each shot are in blue.

Images were captured systematically along the length of the truss chord between three purlins (the area of interest to the structural engineer) so that the radiographs could be "connected" to continuously show the internal construction of the lower truss chord.   The schematic shown in Figure 112 shows both the location and orientation of the imaging plate for each shot.   The radiographs were oriented to show the internal view of the truss chord as it appears below the imaging plate (as opposed to being viewed from the source side of the truss).

- Steel plates were present below where purlins 6 and 8 intersected the truss.
- Vertical threaded rods were visible at purlins 6 and 8.
- No steel plate was present below purlin 7 at truss 3.

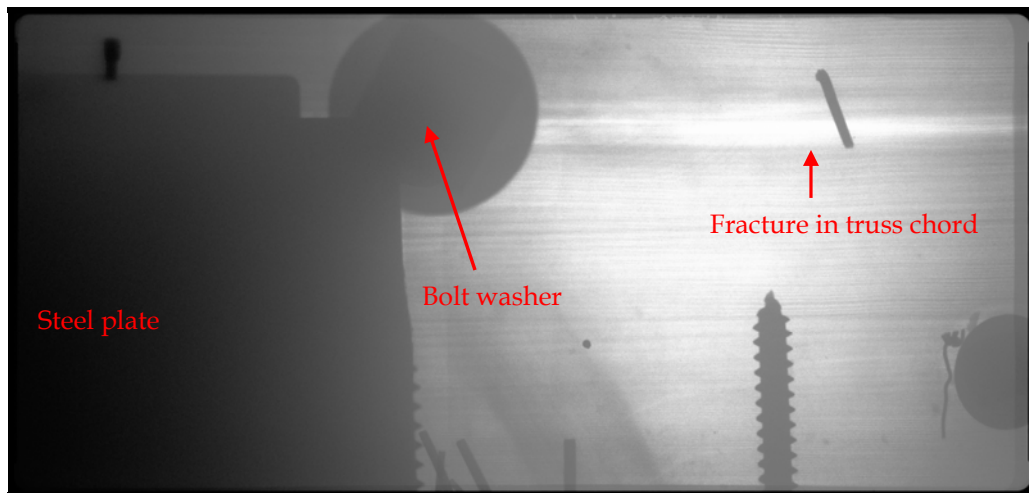
Figure 113.   Radiograph of shot #1.

As shown in the radiographs in Figures 113 through 114, the radiographs successfully identified metal connections of the truss system, such as screws, nails, threaded rods, bolts and steel plates.   In addition the sensitivity of the radiographs was sufficient to identify more subtle features such as wood grain in

- A wood diagonal truss chord was visible at purlin 6.
- A probable fracture (as opposed to a seasoning check in the lumber due to drying) was visible in images 15, 1, 14, 13 and 12 (proceeding from west to east).   The fracture extended at least from west of purlin 8 to west of purlin 6, based on the number of images taken. Subsequent destructive testing verified the extent of the fracture.
