DAMAGE ASSESSMENT OF RAILROAD TANK CARS INVOLVED IN ACCIDENTS: Phase II — Modeling and Validation

1. AGENCY USE ONLY (Leave blank)	2. REPORT DATE December 2002	3. REPORT TYPE AND DATES COVERED Final — March 1996 to June 1999

4. TITLE AND SUBTITLE	5. FUNDING NUMBERS
DAMAGE ASSESSMENT OF RAILROAD TANK CARS INVOLVED IN ACCIDENTS: Phase II — Modeling and Validation	DTFR53-93-C-00001
6. AUTHOR(S) Richard W. Kloop, Steven W. Kirkpatrick, and Donald A. Shockey	TASK ORDER 115

9. SPONSORING/MONITORING AGENGY NAME(S) AND ADDRESS(ES)	10. SPONSORING/MONITORING AGENCY REPORT NUMBER
U.S. Department of Transportation Federal Railroad Administration Office of Research and Development 1120 Vermont Avenue, NW Washington, DC 20590	DOT/FRA/ORD-02/04

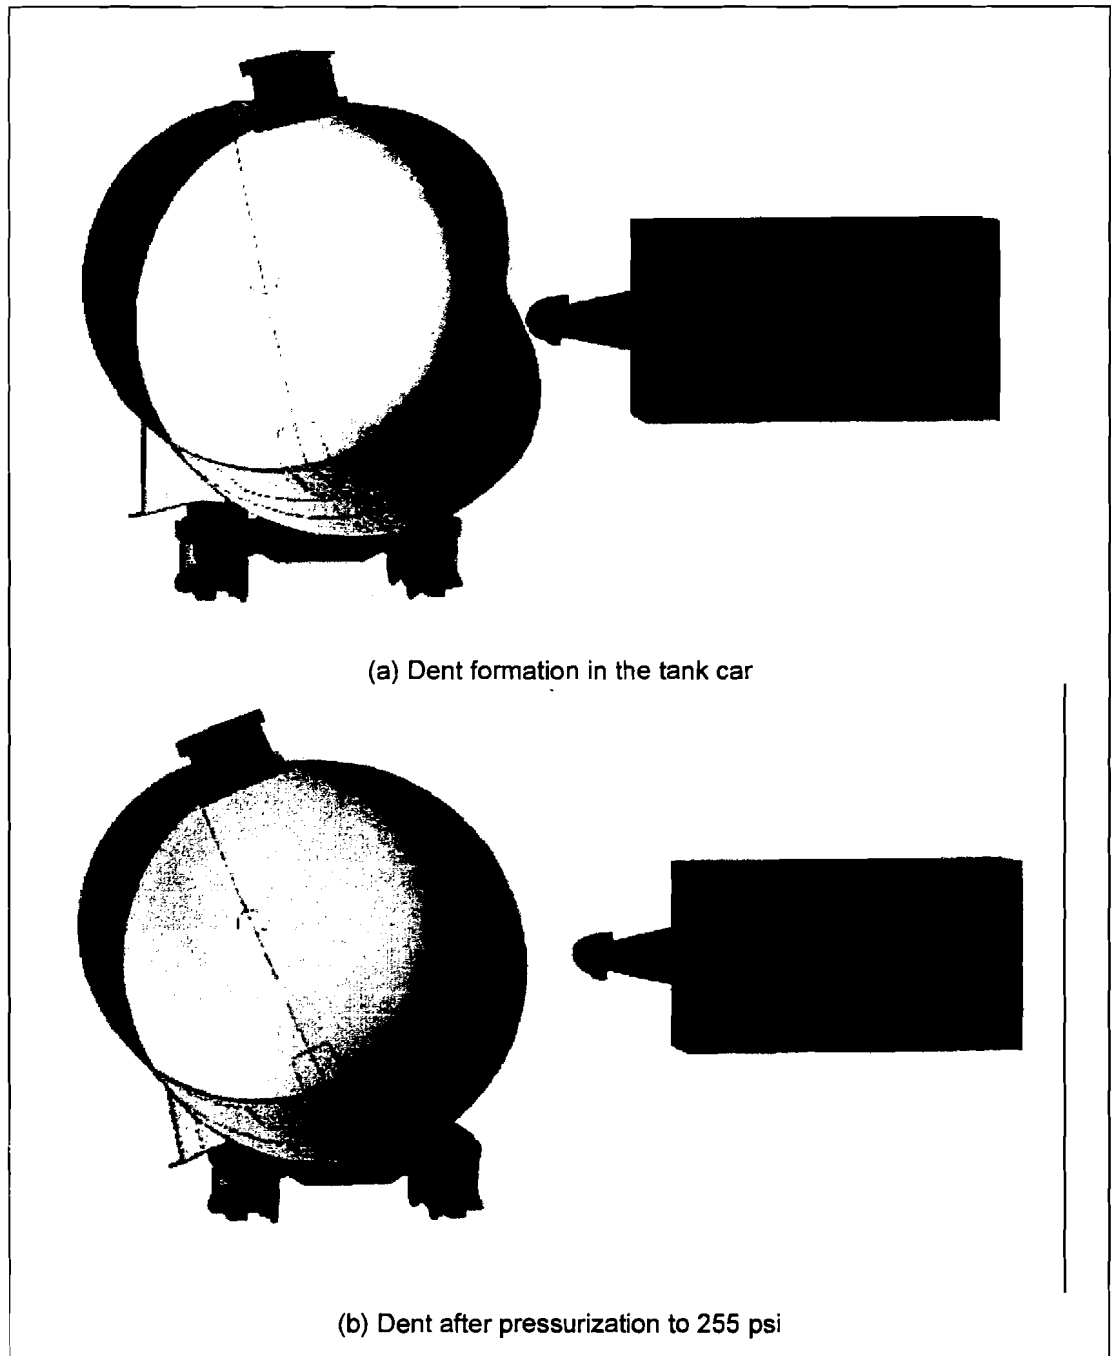
Figure 38. Analysis of a Longitudinal Dent Response with Internal Pressure

The calculated response is shown in Figure 38. The formation of the dent is shown in Figure 38(a). For visualization, only one-half of the tank car model is shown in the figure. The maximum dent depth is approximately 6 in. (15 cm) at the center in the unpressurized tank. However, as the tank car is pressurized to 255 psi (1.76 MPa), the dent is pushed outward to the point where the original dent is no longer visible at the tank centerline. Therefore, the internal pressure clearly has a greater influence on this longitudinal dent geometry. This geometry effect is expected because the pressure stresses in an undamaged tank car are twice as large in the circumferential direction than in the longitudinal direction. Thus, the stresses normal to the major dent axis are larger with the longitudinal dent configuration.

From the above simulations, the longitudinal dent is seen to be the more critical dent geometry in the presence of internal tank pressure. To further investigate the behavior of a longitudinal dent, a series of two-dimensional ring analyses were performed as will be described in Section 4.3.3.

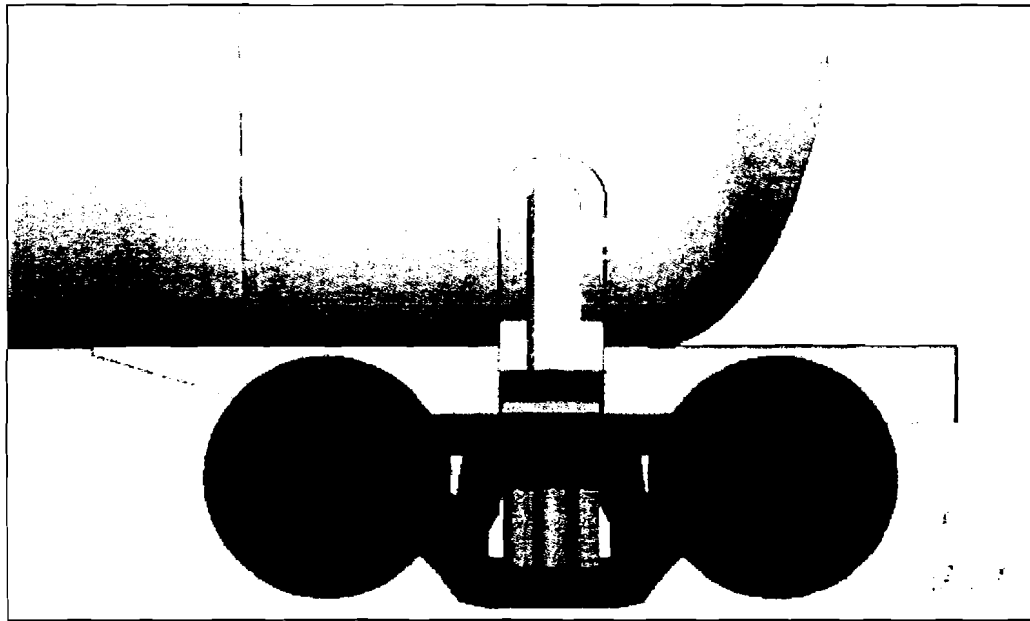
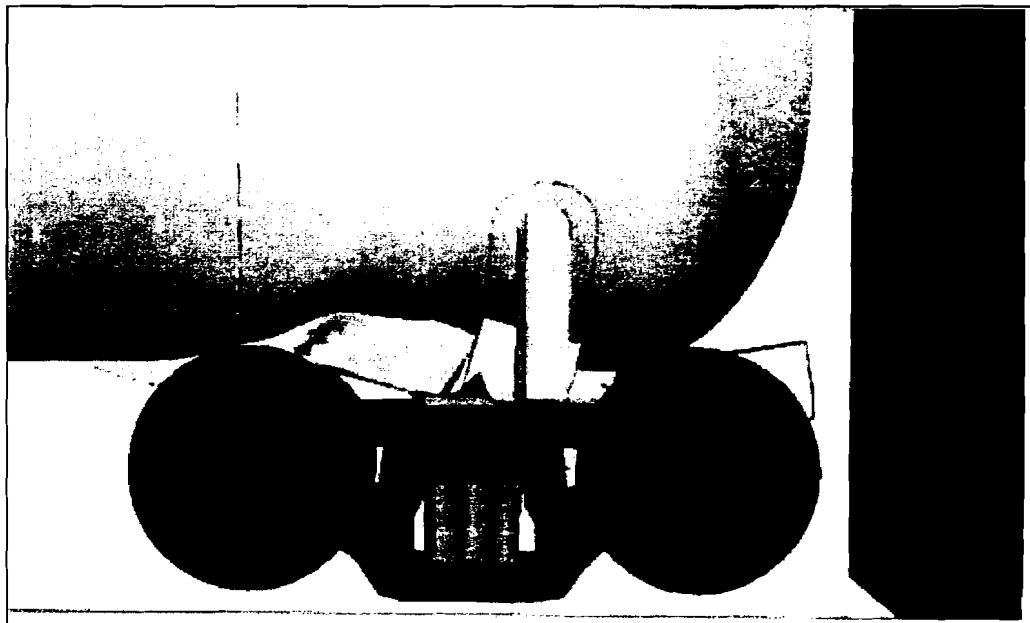
Figure 39. Analysis of a Longitudinal Impact Response of the Tank Car

The end-on impact response of the tank car is shown in Figure 39. The impact of the stub sill, tank end, and bogie against the rigid block produces damage that is concentrated mainly in the bolster and stub sill regions. The load on the sill and bogie produces a response that rotates the bolster away from the impact and forms a maximum dent in the tank approximately 3 feet (1 meter) behind the bolster location as seen in Figure 39(b). The presence of the stub sill and doubler plate at this location reinforces the tank structure such that the internal pressure does not significantly push the dent back out after the collision. This deformation mode and dent location are similar to those observed in the Flomaton collision.

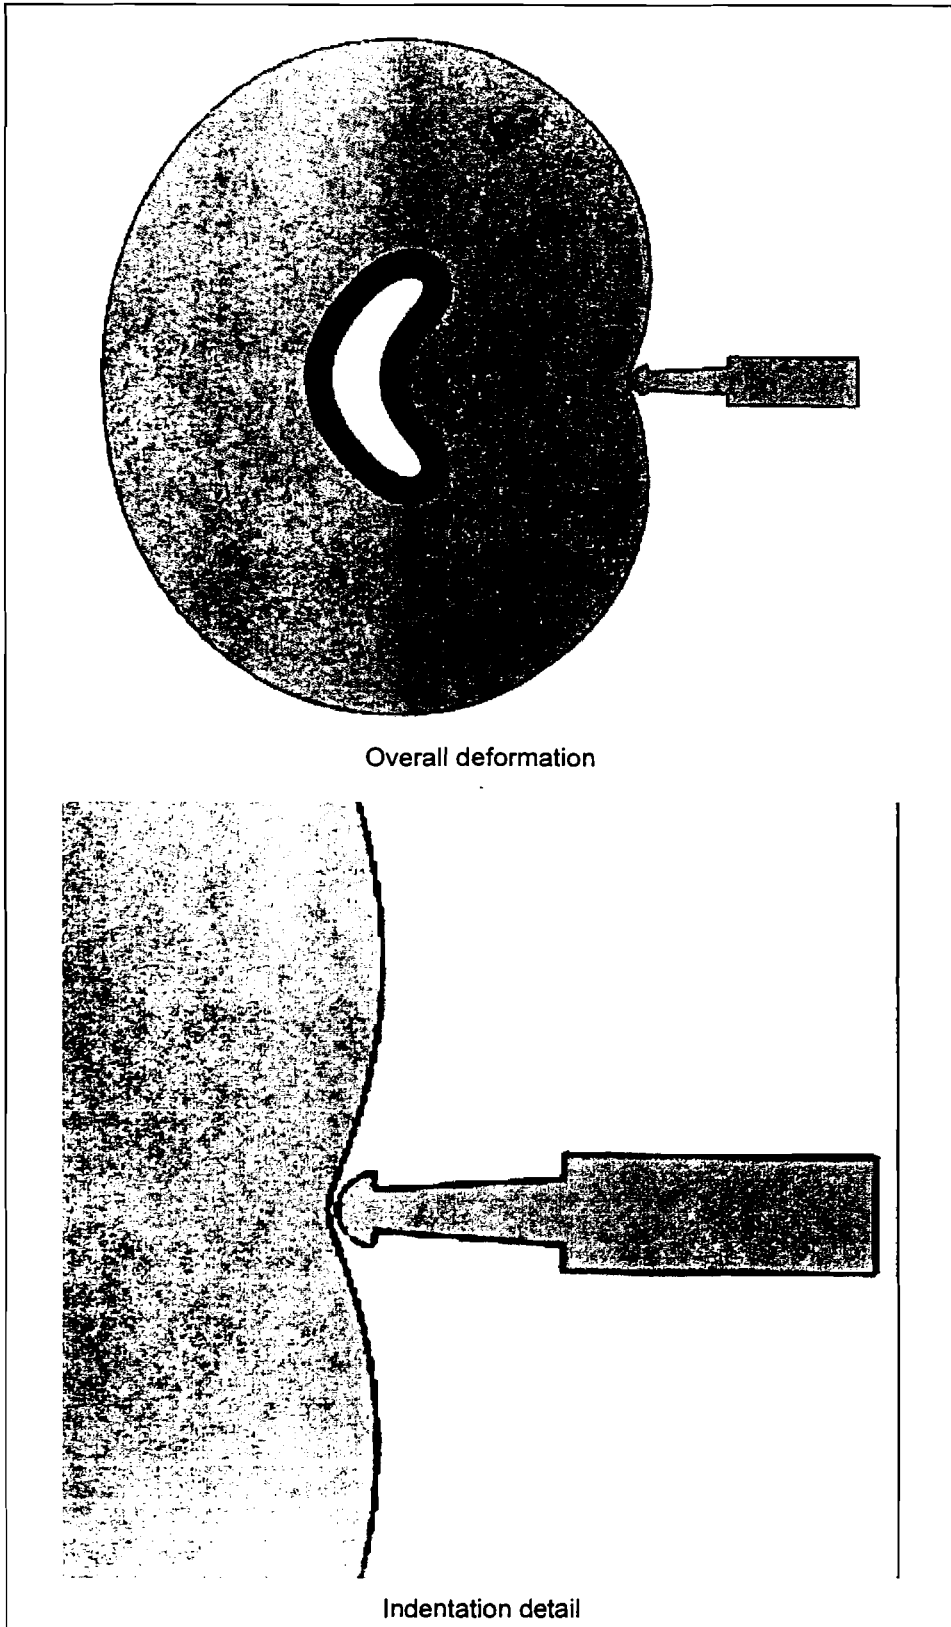
Figure 40. Unpressurized Indentation at 40 mph for an A515-70 Ring at 100° F

The finite element analyses of the two-dimensional ring sections provided results on the deformation and stress history near a longitudinal dent. The overall shape of the tank at the innermost denting is shown in Figures 40 and 41 for room temperature and -40°F (-40°C). The progression of the dent shape as the tank rebounds away from the indenter is shown in Figure 42 for the room temperature case. The variable spacing between the traces of the dent shape is due to oscillation of the overall shape of the tank as it moves. At -40°F (-40°C), the dent is not as sharp or deep. This is illustrated in Figure 43, which compares the profiles of room-temperature and -40°F (-40°C) dents at their peak deformation.

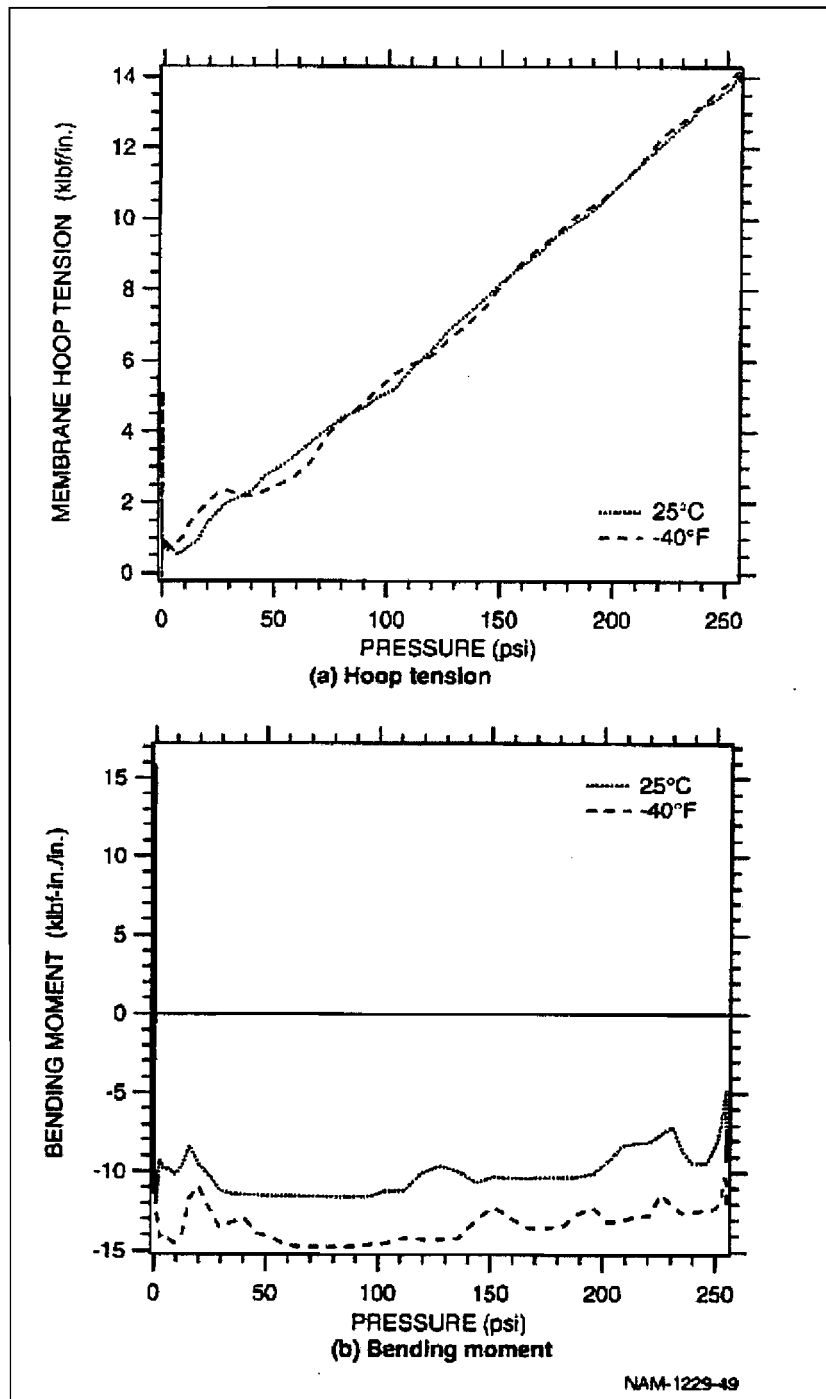
Figure 45. Dent Root Tensile Force Resultant and Bending Moment History following Impact and Subsequent Pressurization

Figure 45(a) shows that dent root net tensile force per unit length is essentially the same as the hoop stress in an undeformed tank times the shell thickness. This force is proportional to the tank pressure and is little affected by the impact or subsequent oscillatory motion of the tank. Figure 45(b) shows, however, that dent root bending moment is largely independent of pressure for pressures beyond about 100 psi. This result is expected because the dent root is fully plastic, and the plastic moment of the plate is roughly constant at ≈10,000 lbf-in./in.

The ring section modeling shows that a crack at a longitudinal dent root would be subjected to a tensile hoop stress equal to that for an undented tank and a bending moment equal to the yield moment of the plate, 10,000 lbf-in./in.

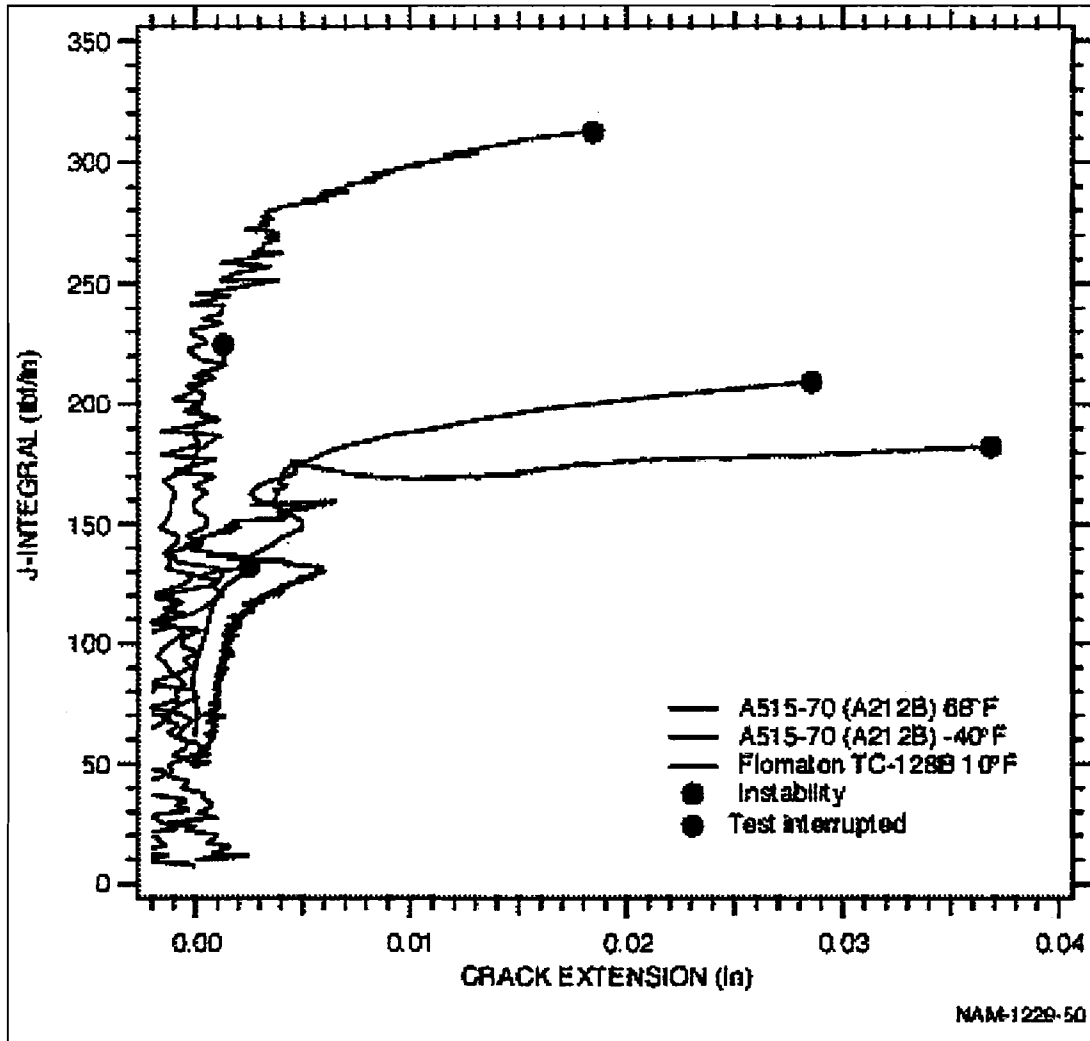
Figure 46. Results of J-R Curve Tests on Pressure Tank Car Steels

J-resistance (J-R) curves and J-crack-mouth opening displacement (CMOD) curves resulting from the fracture mechanics tests are shown in Figures 46 and 47. As shown in the J-R curves, three of the specimens sustained several hundredths of an inch of stable crack growth, and three of the specimens had negligible stable crack growth prior to instability. The tests in which the three specimens sustained stable crack growth were interrupted prior to instability. For the A515-70 (A121B) steel, the lowest value the J integral at crack initiation was 51 lbf-in./in.^{2} (8.9 kJ/m^2), and the lowest value of J at instability was 132 lbf-in./in.^{2} (23.1 kJ/m^2). Test temperature was -40°F (-40°C) in both cases. For the as-rolled TC-128B (Flomaton) steel, the lowest value of J at instability, which occurred at crack initiation, was 225 lbf-in./in.^{2} (39.4 kJ/m^2). The highest value of J achieved in any test was 312 lbf-in./in.^{2} (54.6 kJ/m^2). Test temperature for the TC-128B was nominally 10°F (-12°C).[17]

Tables 7 and 8 and Figure 46 show that predicted instability crack lengths for as-rolled TC-128B steel at 10°F (-12°C) are longer than those for A515-70 (A212B) at room temperature. Thus, newer, TC-128B cars are predictably more flaw-tolerant than older A212B cars, and the safety of the overall car population will increase as A212B cars are withdrawn from the fleet.

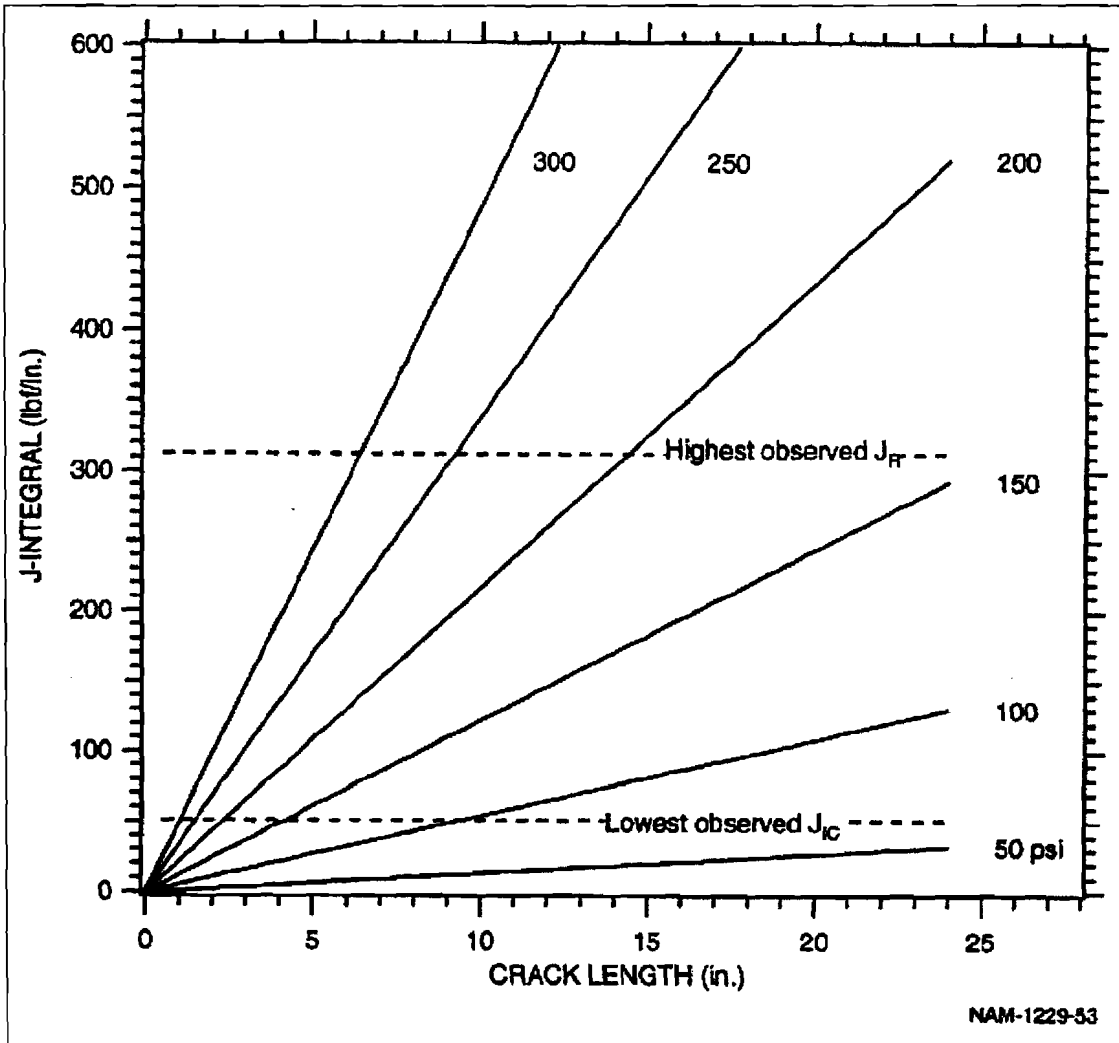
Figure 49. Applied J Versus Crack Length for Through-wall Crack

The resulting curves of applied J versus crack size for various tank pressures is shown in Figure 49 for the case of a through-wall crack in an undented tank and in Figure 50 for the case of a thumbnail crack in a dented tank. Figure 50 shows results for both crack length along the surface and for crack depth into the plate. The levels of the lowest and highest values of J observed in the fracture toughness tests are indicated. The intersection points with the applied J curves gives the expected crack length for fracture initiation and propagation for the extremes of steel behavior that we observed.

The validity of this statement is not clear, because long rail burn dents have resulted in tank rupture at pressures around 200 psi (i.e., a reduction in tank burst rating of perhaps 75%). The Newman and Raju [19] fracture mechanics analysis results in Figure 49 and Table 7 show why long dents parallel to the long axis of the tank can be hazardous. Let's assume that the dent root contains a 0.25-in-deep, 1.38-in-long thumbnail crack. With the crack plane oriented parallel to the long axis of the tank and for 5/8-in.-thick plate, 60-in.-radius, and 250-psi tank pressure, Newman and Raju [19] show that, when the crack is subject to hoop tension only, the peak J-integral is around 17 lbf-in./in.^{2} When a dent has been formed inward and then pushed outward by the tank pressure, a bending moment of 10,000 lbf-in./in. is combined with the tension and the resulting J-integral is 114 lbf-in./in.^{2} The bending moment due to the dent has increased the J-integral applied to the crack by a factor of 7.

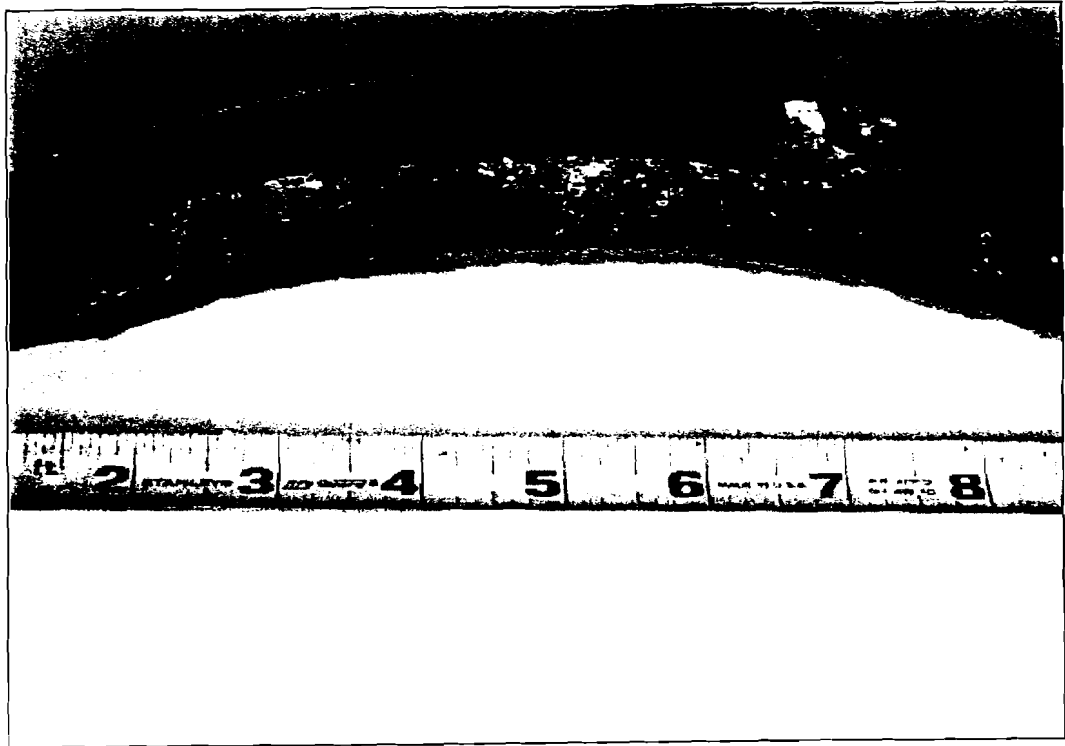
Figure B-2 shows the transverse crack within the buckled area of ACFX 80417. One half of the fracture is shown in Figure B-3, and the chevron patterns on the fracture face indicate that the crack initiated from the toe of the weld securing the lower bracket of the placard holder. This weld appears to have been a manual arc weld. There appears to be a 1/32 to 1/16-in.-long heat-affected-zone tear at the origin of the 36-in.-long crack, Figure B-4. There is no visible evidence of fatigue cracking at the origin. Further, the entire 36-in.-long crack was brittle. No evidence of plastic fracture was evident by visual inspection and there was no measurable lateral expansion or contraction along the thickness of the plate.

**Figure B-2. Buckle and Crack in ACFX 80417**
