U.S. Department of
Transportation

**Federal Railroad
Administration**

Passenger Cab Car Grade Crossing Impact Test Report

Rail Passenger Equipment Impact Tests

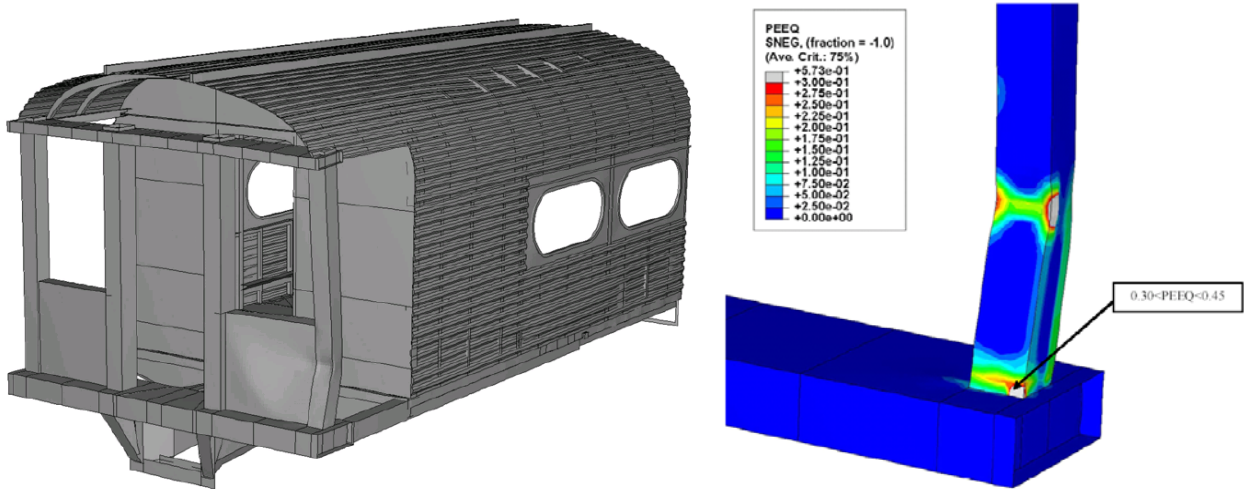
Figure 5. Corner Post Mode of Deformation at 7.75 in (197 mm) of Crush; Load Applied 18 in (457 mm) Above Floor

Figure 5 shows representative results from a large deformation quasistatic analysis of the corner post subjected to an overload. The load is applied at a height of 18 in (457 mm) above the corner post to the end/buffer beam connection. The load is supported by the corner post and the following support members: the lateral shelf, the bulkhead sheet, the corner post-cant rail-AT plate connection, and the corner post-end/buffer beam-extended side sill connection. The lateral shelf and the bulkhead sheet are very effective in shedding load into the rest of the end frame structure. A plastic hinge has formed at the corner post-end/buffer beam-extended side sill connection. The corner post-cant rail-AT plate connection experienced torsional deformations. These deformations result in plastic hinges forming at both the cant rail-AT plate connection and the connection of the collision post to the AT plate.

The contour plot of effective plastic strain for the corner post shows some areas of the post exhibiting strains in excess of the elongation strain on the material certification sheets for the A710 plate stock used to construct the corner post. The bulkhead sheet has been removed for clarity. The deformation state shown is for the corner post at 7.75 in (197 mm) of inward longitudinal deformation. The areas where the strains are highest are where failure of the post would be expected.

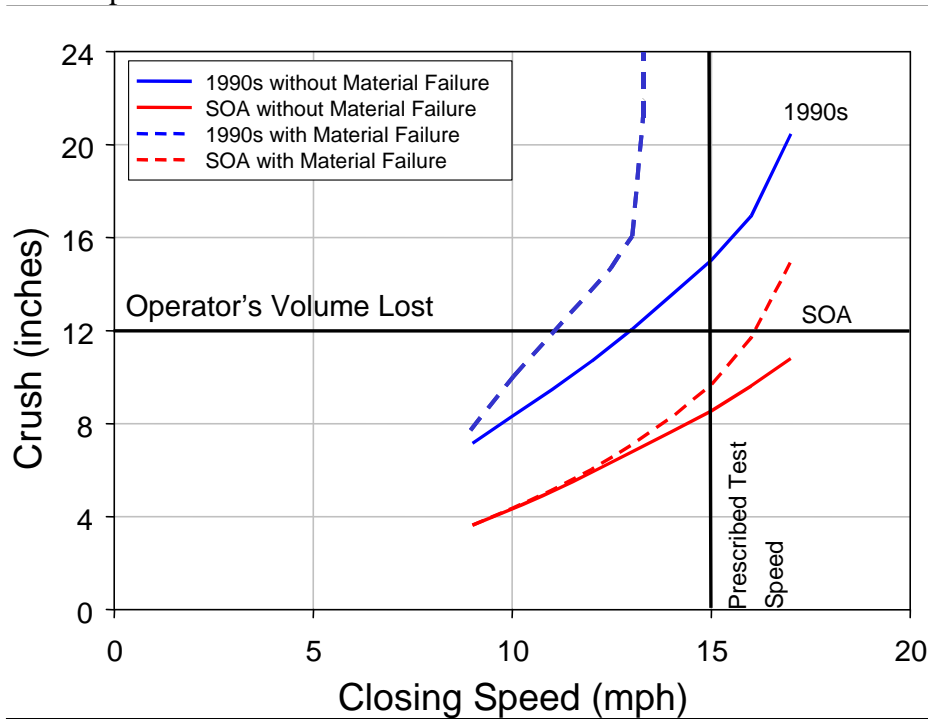
Figure 10. Comparison of Crush Estimation versus Initial Collision Speed

Figure 10 shows a plot of the cab car maximum crush as a function of the impact speed. The black horizontal line indicates the crush at which intrusion into the occupant compartment occurs. These analyses results were used in developing the test requirements, to determine the desired impact speed of 15 mph (24.1 km/h). A single

collision speed was chosen in order to cause significant deformation of the corner post during the tests, with the expectation that the operator's survival volume would be preserved in the test of the SOA design, i.e., that the intrusion into the occupant volume would be less than 12 in (305 mm). For the test of the 1990s design, the deformation of the corner post was expected to exceed 12 in (305 mm) and consequently intrude into the operator's survival volume. Before the tests, the 1990s design corner post was predicted to fail for an impact speed greater than 16 mph (25.7 km/h). During its test, the corner post of the 1990s design cab car end structure failed at the tested impact speed of 14.4 mph (23.2 km/h), a speed approximately 10 percent slower than predicted. The graph in Figure 10 shows that the increased standards for the corner posts prove more effective in crashworthiness protection.

The above plot shows the increased level of crashworthiness performance of the SOA design over the 1990s design. Post-test results demonstrate that the 1990s design will fail at a closing speed about 5 mph (8.05 km/h) less than the SOA design. APTA's improved design standards for corner posts allow an increased ability for preserving the operator's survival volume.

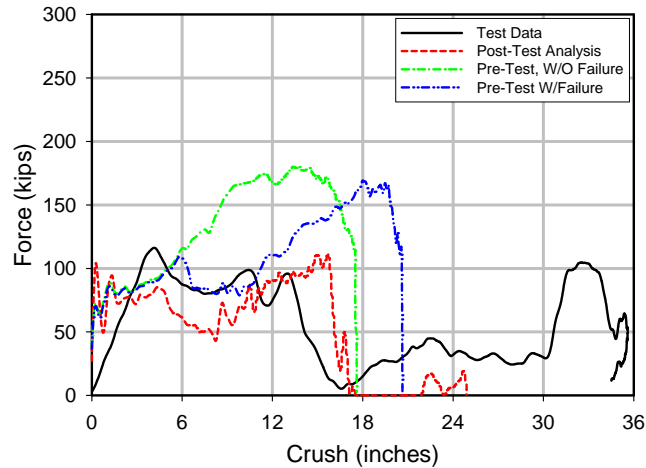
Figure A-3. Measured and Predicted Force-Crush Characteristic, 1990s Design

Figure A-3 shows the force-crush characteristic developed for the 1990s design as predicted with the model and as measured during the test. The plot shows pre-test and post-test predictions. The pre-test predictions from the analysis, including material failure and the test measurements, are in close agreement up to approximately 12 in (305 mm) of crush. After 12 in (305 mm) of crush, the pre-test predictions show the force

increasing, while the test measurements show the force decreasing. A source of the discrepancy could have resulted from late changes in the attachment of the AT plate to the cant rail that were not incorporated in the model before the test and from limitations of the current approach to modeling material failure in FE solvers. As a result, failure of the upper attachment of the corner post occurred sooner in the test than predicted.

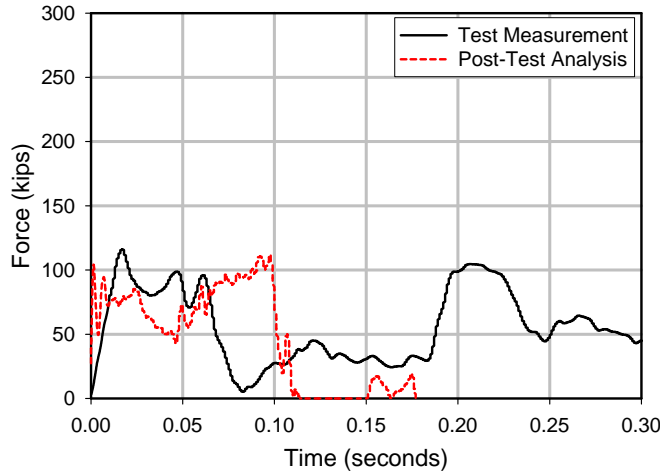
Figure A-4. Measured and Predicted Force-Time History, 1990s Design

Figure A-4 shows the force time post-test FE results, as well as the derived force time curve, taken from test measurements. A nine-accelerometer array was used on the steel coil for the test, and the force presented is the resolved acceleration times the mass of the steel coil. The results from the simulation and those derived from the test are very close for the first 0.03 second (s). Between 0.03 s and 0.05 s the measurements show somewhat elevated force levels compared to the analysis (approximately 25 percent). The results overlay one another again between 0.05 s and 0.06 s. The key difference occurs after 0.06 s where the measurements indicate softening behavior due to the failure of the lateral member/shelf and pull out of the corner post from the AT plate over approximately 0.015 s. The model is predicting a peeling/tearing failure of the lateral member/shelf from the corner post, thereby losing a source of load transfer. This resulted in a decreased load in the FE results between 0.02 s and 0.05 s. The pull out failure of the corner post from the AT plate occurs in the FE model around 0.1 s. The softening behavior occurs over a much shorter time frame at approximately 0.004 s. The differences in predicted failure response in time is not surprising given the current SOA in ductile material failure modeling.

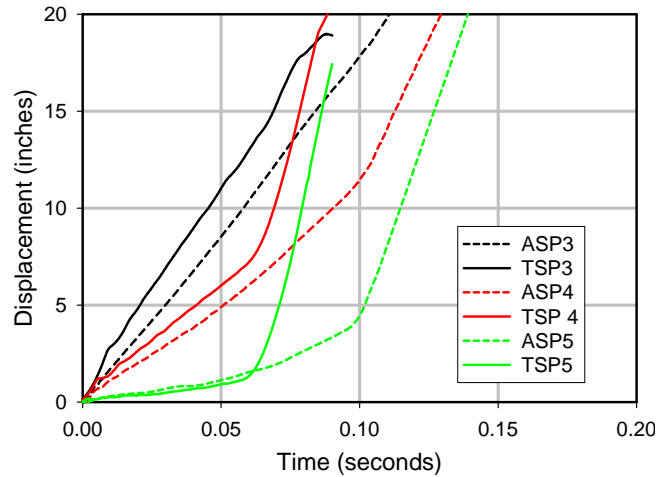
**Figure A-5. Measured and Predicted Longitudinal Displacement-Time Histories on
the 1990s Design Corner Post**

Figure A-5 shows a comparison of the post-test FE results taken from corresponding positions on the corner post and the measured longitudinal displacements taken from selected string potentiometers. String potentiometer position varies from bottom to top, starting at position 1 and ending at position 5 with the lead letter differentiating the test measurement (T) from the analysis result (A). The string potentiometers are symmetrically placed to equally divide the corner post between the end beam and the AT plate.

A detailed discussion of the information presented by TSP3 is given that represents the
mechanisms occurring for all the string potentiometers. The first slope occurs between
initial impact and 0.01 s, which corresponds to approximately 2.75 in (69.9 mm) of
displacement. The second slope range occurs between 0.01 s and 0.09 s and corresponds
to failure of the lateral member/shelf, as well as pull down of the AT plate. Finally,
between 0.07 s and 0.09 s, the last slope corresponds to pull out of the corner post from
the AT plate. This shows the lag time in response from the position of TSP3, TSP4, and
TSP5. The nearest string potentiometer to the AT plate, TSP5, shows disturbances from
the AT plate before the further removed string potentiometer, TSP3, shows disturbances.
The test data has only been plotted to just after failure of the AT plate attachment; data
past that time is unreliable due to failure of the gauges.

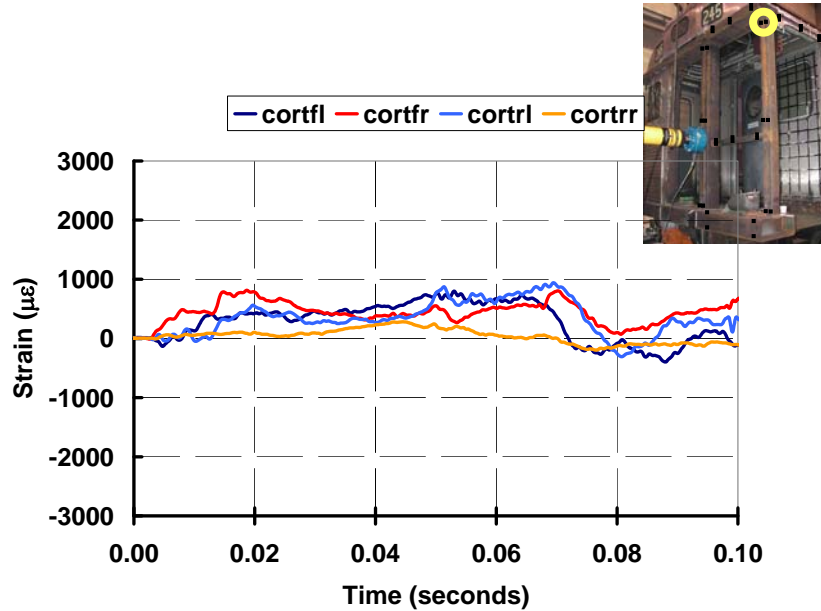
Figure A-7. 1990s Design Corner Post Strain Gauge Measurements—Top

Figures A-7 and A-8 show the combined results from the strain gauges placed at the base as well as at the top of the corner post. The accompanying photograph shows the approximate locations of these gauges on the corner post. After initial contact of the coil with the corner post, the load built up, reaching a peak around 0.02 s. After that time, the central hinge fully forms, and the secondary hinge at the base of the post grows. The

corner post completely pulls out of the AT plate at 0.07 s. After that time frame the post is allowed to fully rotate at the corner post—buffer/end beam connection until the coil forces the corner post into the back partition wall. The strain gauge information at the base of the corner post experienced an initial offset, but the shape of the strain time curve is consistent with that obtained from the top of the corner post.

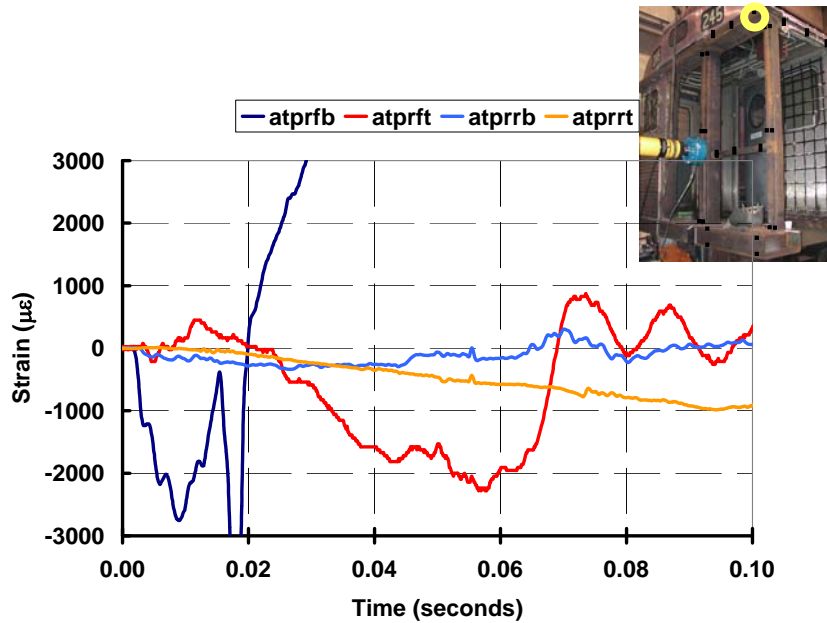
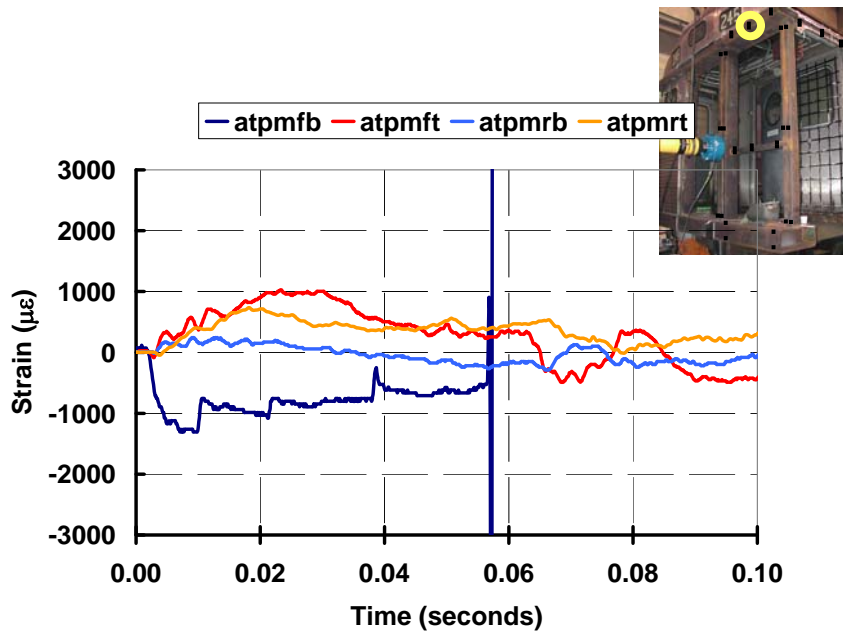
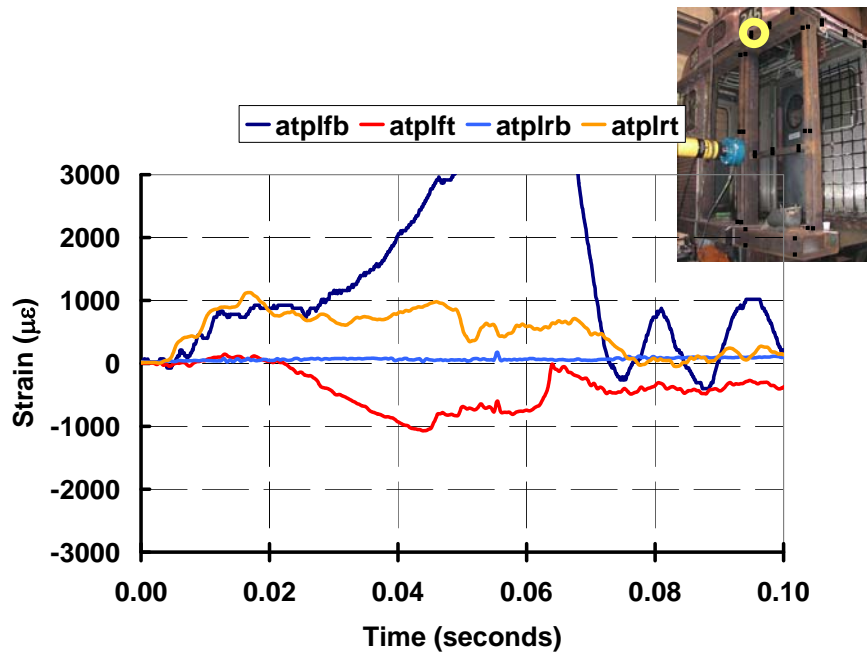
Figures A-9 through A-11 show the information obtained using the strain gauges placed on the AT plate. Impact is registered with a slight delay in timing. The first set of peak strains occur between 0.01 s and 0.02 s. It is during this time frame that only the post deforms. At 0.04 s the AT plate starts to form a hinge at the connection with the collision post. The photometric analysis also shows that this time also corresponds with the frangible box structure upon which the steel coil rested strikes the buffer/end beam. The plastic hinge continues to evolve until the corner post pulls out of the AT plate between 0.07 and 0.08 s. The smallest strains measured occurred in the middle of the AT plate.

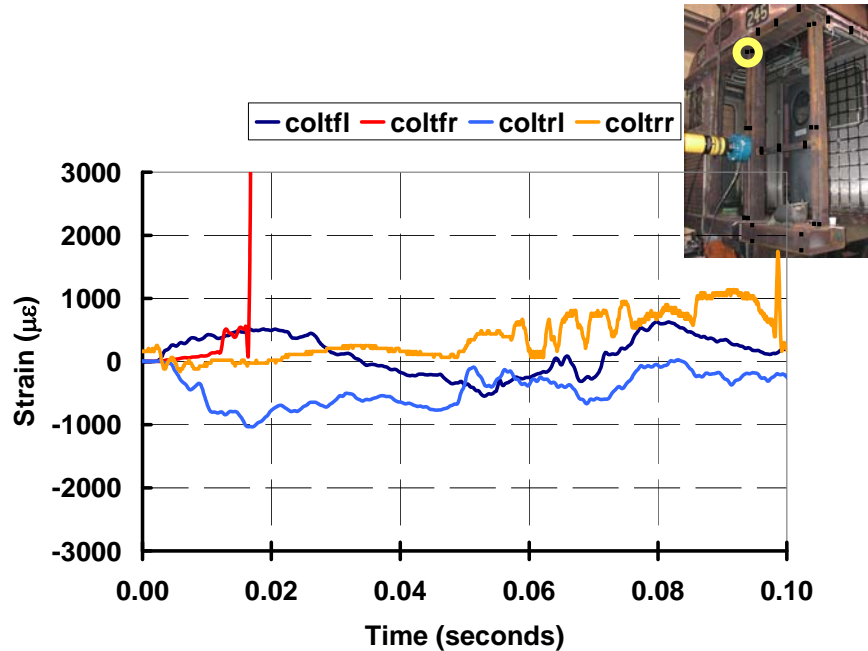
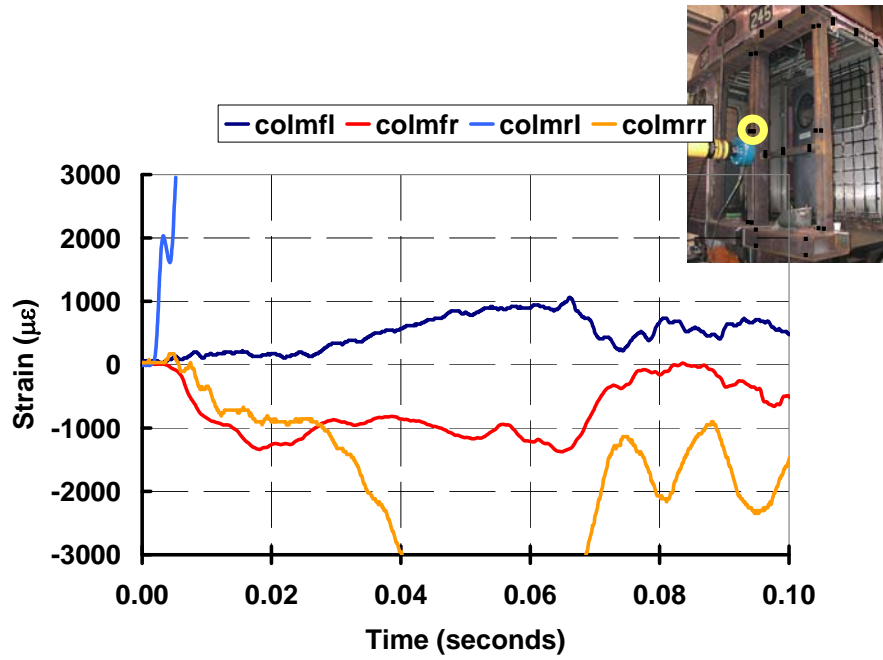
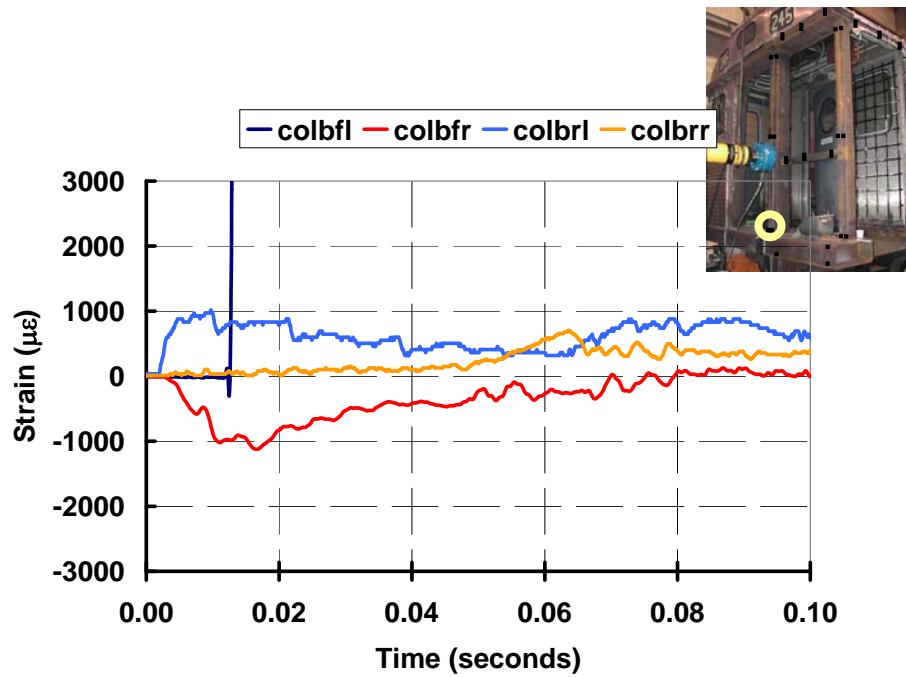
Figures A-12 through A-14 show the strains measured at the top, middle, and base of the collision post. Strains build up upon initial contact with the load first being transferred from the lateral member/shelf to the middle of the collision post, then proceeding through the AT plate, and finally through the end beam. The end beam is very stiff and acts like a

fixed boundary condition on the corner post, while the AT plate acts more like a longitudinally pinned connection with a rotational spring. Between 0.02 and 0.05 s, the lateral member shelf experiences a combined tensile and shear load as it tears out of its connection to the collision post. The lateral member/shelf completely fails at 0.05 s. Load is then only transferred through the AT plate and the buffer/end beam into the collision post. The strains are greatest at the base of the collision post due to the long moment arm through which the longitudinal load is transferred from the top of the collision post through the AT plate. Pull out of the corner post is very apparent in all measurements due to the rapid change in slope of the strain between 0.07 and 0.08 s.

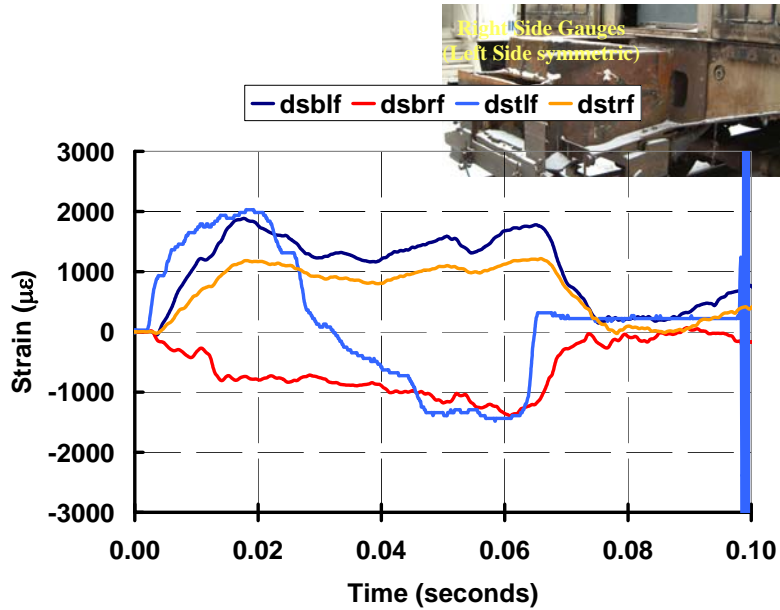
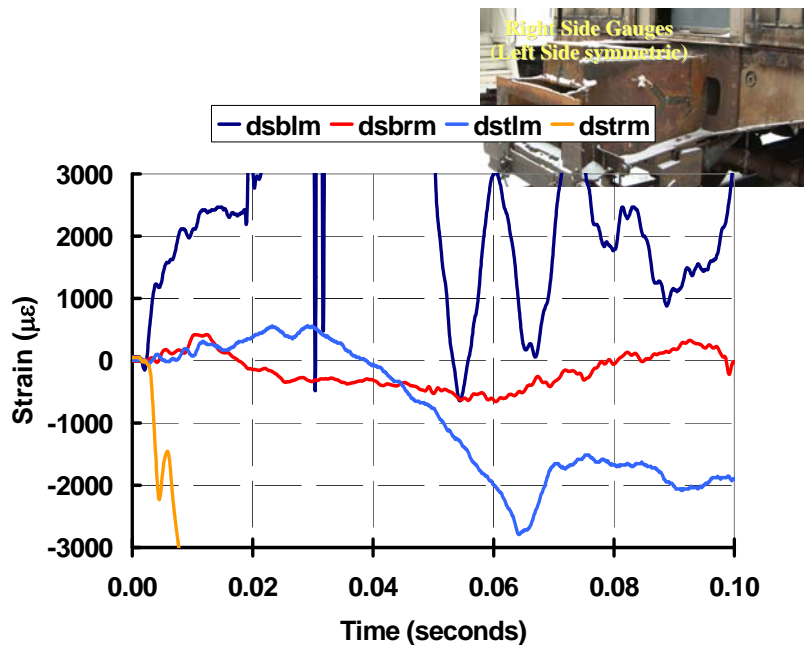
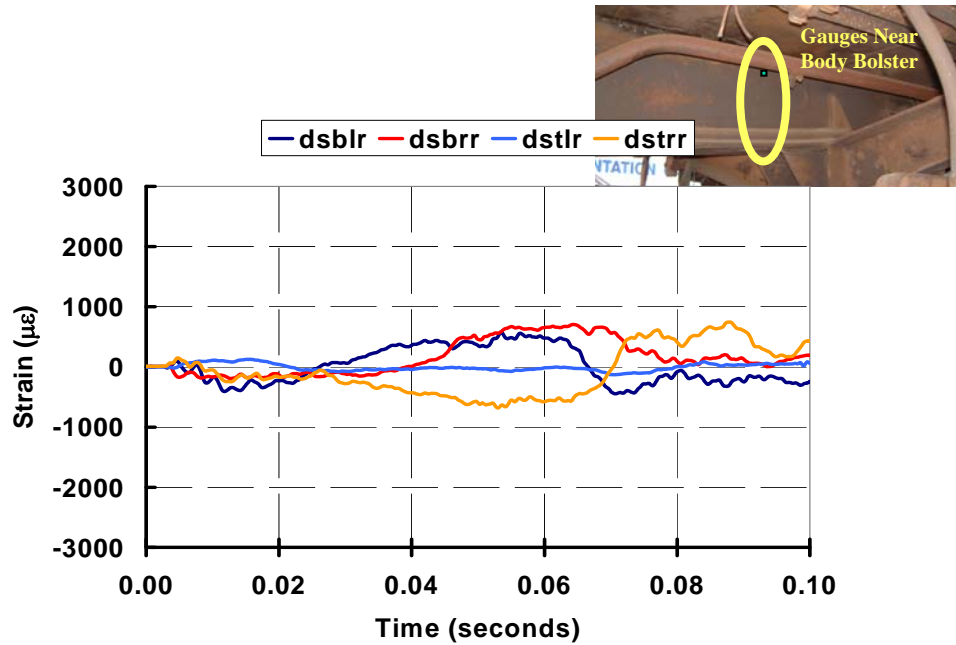
Figures A-15 through A-17 show the strain gauge measurements taken on the draft sill for the 1990s design. The magnitudes of strains are largest near the point of loading and progressively decrease further back into the car structure. The load goes into the draft sill as a bending load with compressive strains measured on the side closest to the loading point and tensile strains on the opposite side of the draft sill. The load builds up gradually to a peak in the first 0.02 s. Pull out of the corner post is again apparent because of the rapid change in strain in the same time period as discussed previously.

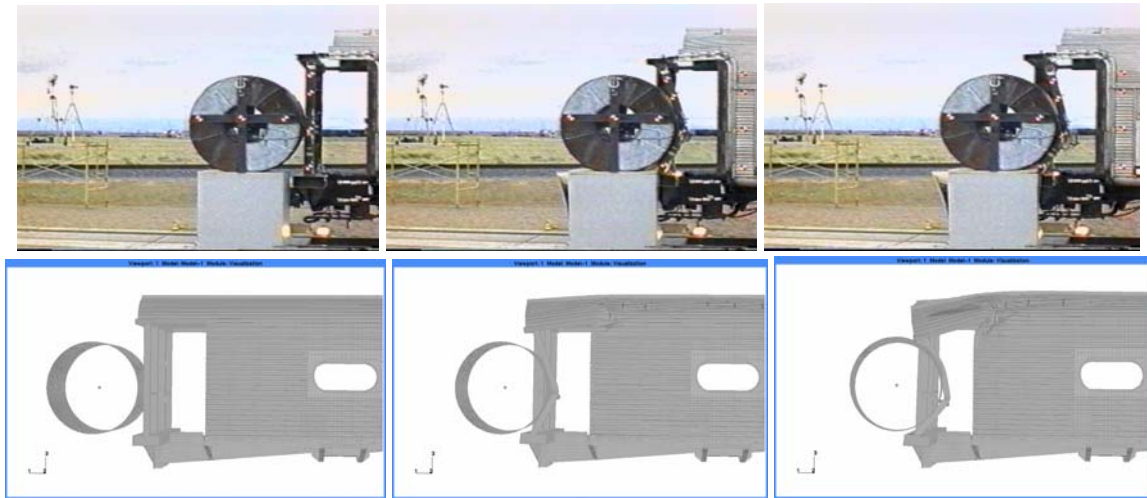
Figure A-18. Measured and Pre-Test Predicted Mode of Deformation, 1990s Design, Up to Corner Post Upper Attachment Failure

Figure A-18 shows three still photographs taken from a high-speed movie film of the 1990s design grade crossing test. The first frame shows the coil and corner post at the instant of impact. The second frame shows the coil and cab car just before complete failure by pull out of the corner post from the AT plate at approximately 0.08 s. At this time the post has displaced inwards 18 in (457 mm). The third frame shows the coil and cab car after 0.09 s and 19 in (483 mm) of displacement of the corner post. Just below those three frames are results from the pre-test analysis with material failure for the mode shape of the cab car end structure at the same times and nearly the same displacements.

The predicted deformation mode shape matches that observed in the test but for one detail. In the third frame, the frame from the test shows only a small amount of vertical distortion of the roof above the upper rear corner of the near-side doorway, while the frame from the model predictions shows more distortion of the top of this doorframe. This difference in mode may result from the changes in the attachment of the end frame to the original car structure, as well as the strain-to-failure criterion used. In addition, the difference in length of roof material is not present on the test vehicle. The original model integrally attached roof sheeting to the AT plate, which experiences a counterclockwise torque as the AT plate is pulled downwards. To maintain compatible deformations, this load is reacted above the doorframe where a plastic hinge is formed in the cant rail, the roof sheeting, and the hat sections on top of the roof.

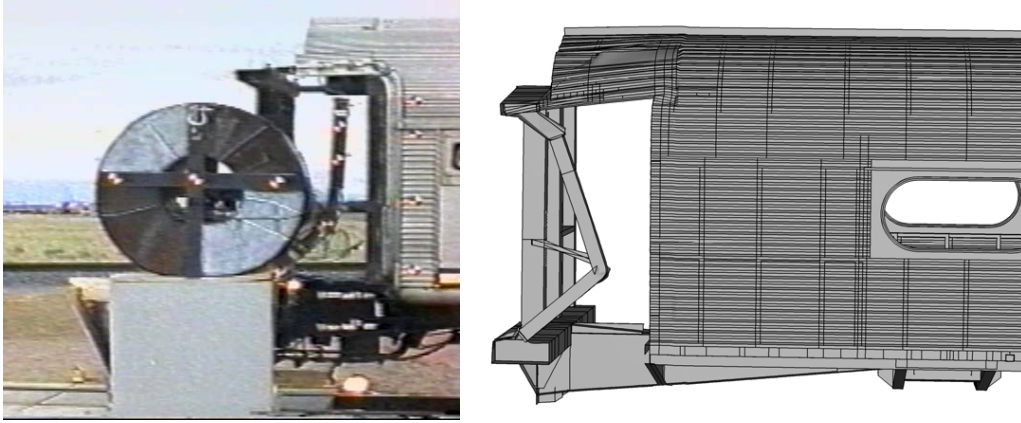
Figure A-19. Measured and Post-Test Predicted Mode of Deformation, 1990s Design, Corner Post Upper Attachment Failure

Figure A-19 shows a still photograph taken from the high-speed film. This frame shows the failed upper attachment of the corner post. The photograph on the right is a plot of the deformed mesh from the revised FE analysis. The coil has been removed for clarity. The results of the revised analysis are in close agreement with the test observations. The pull out mode of failure has been captured using the model with a refined mesh. A shift has occurred in the time it takes for the pull out failure to occur as noted in the string potentiometer discussion.

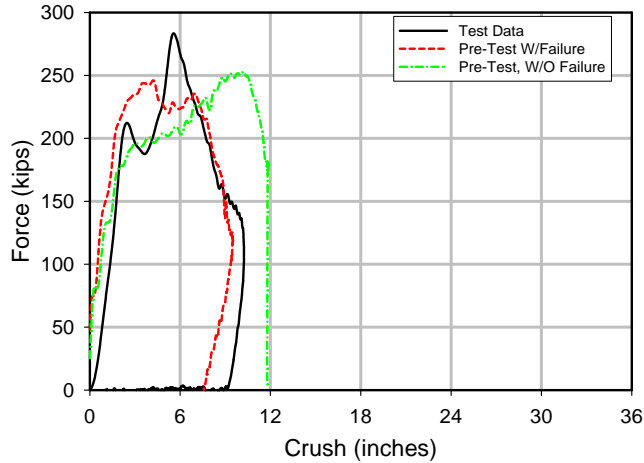
Figure A-20. Measured and Predicted Force-Crush Characteristic, SOA Design

Figure A-20 shows the pre-test predictions for the force-crush characteristic for the SOA design. The model was exercised with and without material failure. The model predictions with material failure nearly overlay the test results. Similar to the results discussed with the 1990s design, a small phase shift occurred in the timing of events. The peak load caused by the initial contact occurs almost instantaneously for the FE model and is higher than what occurs in the test measurements. As seen from the test measurements, a finite rise time occurs for the initial load, and the peak load is smaller. In the test measurements and the crush model results, the initial peak is associated with the formation of the central plastic hinge on the corner post. The second and third peaks with their associated load plateaus correspond to the formation of the plastic hinges at the corner post/end beam connection and the corner post/AT plate connection respectively. The difference between the crush models with and without failure is apparent after 4 in (102 mm) of crush. The model without failure considerably overpredicts the load after 6 in (152 mm) of crush, but has a similar unloading slope as observed in the test. The model with failure predicts slightly higher loads after 7 in (178 mm) of crush, but the same maximum crush distance as observed in the test. The rate of unloading predicted with the no failure model, however, is slower than observed in the test.

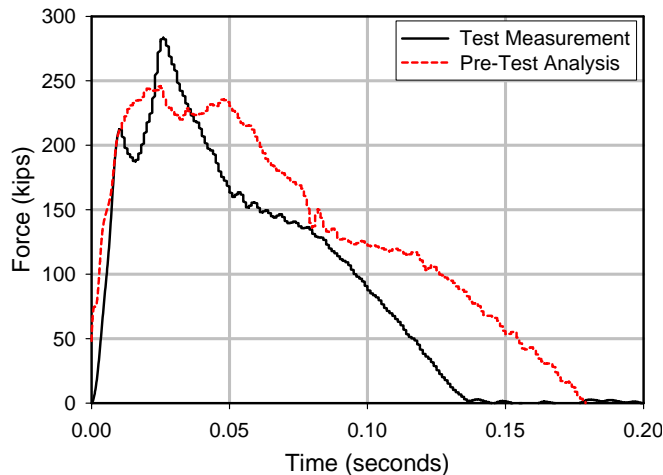
Figure A-21. Measured and Predicted Force-Time Histories, SOA Design

Figure A-21 shows the force-time comparison of the test measurements and the crush model with failure. The force-time trace from the test was derived using the resultant deceleration taken from the nine-accelerometer array on the coil multiplied by the coil mass. These results are unfiltered. Despite the minor inconsistencies between the test measurements and the crush model results, very good agreement exists. The phase shift experienced in the model is not surprising given the simplicity of the failure criterion used. In the FE model, when elements fail they are removed from the calculation. When too much material is removed, the predicted response in the FE model is softer than the response seen in the test.

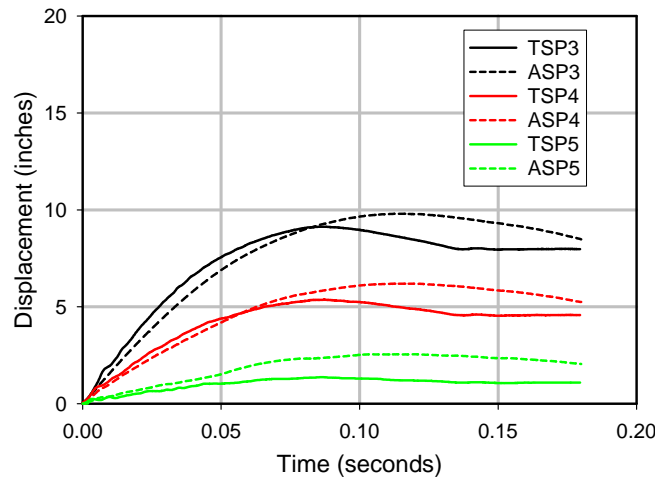
Figure A-22. Measured and Predicted Longitudinal Displacement-Time Histories on SOA Corner Post

Figure A-22 shows a comparison of the measured string potentiometer longitudinal displacement (solid line) with that predicted before the test (dashed line). The crush model results reflect the average displacement taken at the centroid of the center element at the appropriate height on the corner post. The results presented are for the same string potentiometers as discussed in the 1990s design discussion above. Initially, the displacements predicted in the crush model are less than those measured in the test at a given point in time, which means the response predicted is stiffer. However, when failure is predicted to start in the model, the structural stiffness decreases as a result of

too much material being removed during element removal. While the peak predicted displacements are larger in the model than predicted by the tests, the unloaded final displacements are close. The flat lines at the end of each test result plotted show the final position of the post after rebound of the coil has occurred. The test measurement taken at the point closest to the point of initial contact is 8 in (203 mm) while that predicted by the model is 8.5 in (215 mm).

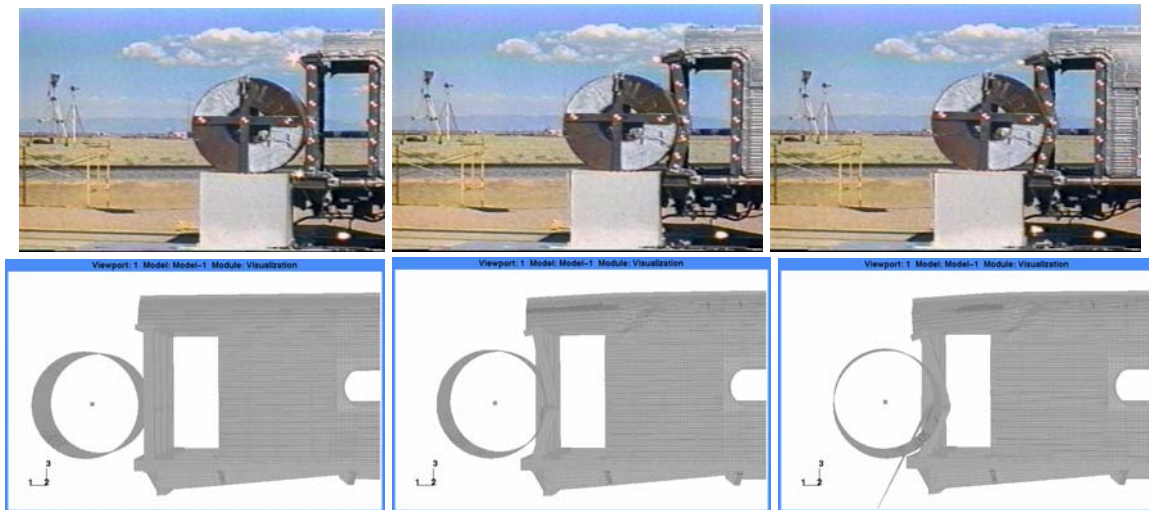
Figure A-23. Measured and Pre-Test Predicted Mode of Deformation, SOA Design

Figure A-23 shows three still photographs taken from a high-speed movie film of the test of the SOA design. The first frame shows the coil and corner post at the instant of impact; the second frame shows the coil and the cab car after approximately 0.03 s and 5.25 in (133 mm) rearward displacement of the corner post. The third frame shows the coil and the cab car after approximately 0.08 s and 9 in (229 mm) of displacement of the corner post. Just below those three frames are results from the pre-test analysis with material failure for the mode shape of the cab car end structure at the same times and nearly the same displacements. The predicted mode shape closely matches the mode shape observed in the test. Slightly more vertical distortion of the roof occurs above the upper trailing corner near-side doorway predicted by the model than seen in the test result. Similar late changes in the attachment of the end frame to the original car structure were made in the SOA design as in the 1990s design; however, the SOA design is not as sensitive to these changes, since the corner post was attached to the top and bottom plates of the AT plate. The additional strength of the attachment in the SOA design forced the AT plate to deform downward, rather than allowing the attachment to fail, as it did in the 1990s design.

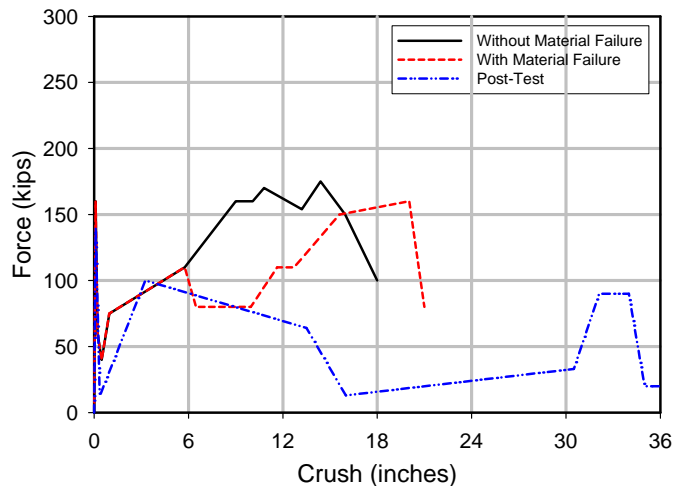
Figure A-27. 1990s Force-Crush Characteristics

Following the full-scale test, the force-crush characteristics input into the CD model can be updated with the test measurements. The pre-test prediction for the 1990s cab car force-crush characteristic proved accurate up to about 12 in (305 mm). After this point in the full-scale test, the corner post pulled out of its upper attachment at the AT plate. After the test, the input for the 1990s CD model was updated with force-crush from the processed test data. With this one change, the 1990s model results compare closely with the test results for the amount of cab car crush and for the gross motions of the cab car and coil. The SOA cab car test went nearly exactly as simulated, with approximately 9 in (229 mm) of longitudinal deformation occurring in the corner post. Consequently, the input to the SOA CD model did not require post-test changes. Figures A-27 and A-28 show the pre-test and post-test force-crush curves.

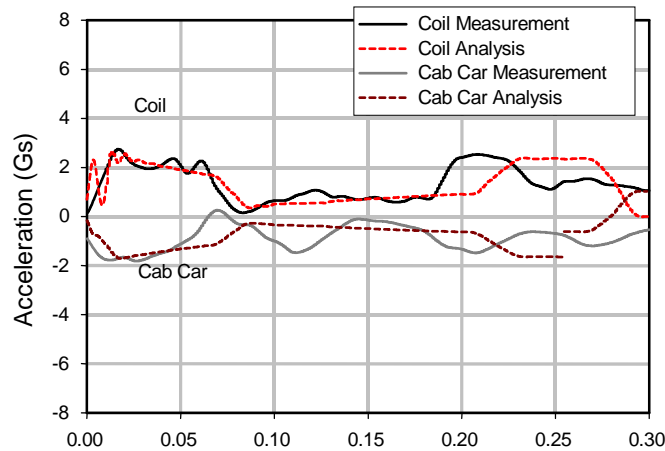
Figure A-29. Longitudinal Decelerations of 1990s Cab Car

The deceleration records for the two impact tests are displayed in Figures A-29 and A-30, plotted with corresponding data from the CD model. While in contact, the coil and the carbody acceleration histories are essentially mirrors of each other, scaled according to weight.

The difference between the 1990s and SOA designs is evident in these results. The SOA design displays higher accelerations due to the increased strength of the end structure required by the revised 1999 APTA standards. The 1990s design receives lower accelerations over a longer time period, indicative of the prolonged deformation. The failure is seen in the drop off of acceleration at around 0.1 s, as the corner post gives way and briefly looses contact with the coil.

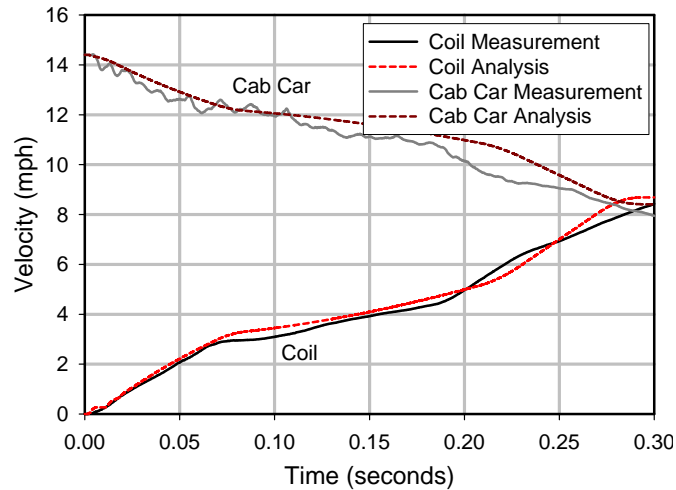
**Figure A-31. Velocity-Time History of 1990s Cab Car**

The raw accelerometer data was integrated to produce the velocity-time histories. Figures A-31 and A-32 show the comparison of the model results to the test data. The CD models accurately predict the gradient of speed and final time at which the colliding bodies come to a constant velocity.

In both collisions the trains arrive at a post-impact velocity of about 8 mph (12.8 km/h). The SOA cab car impact takes approximately half the time of the 1990s cab car impact to reach this constant velocity due to the increased stiffness of the SOA design.

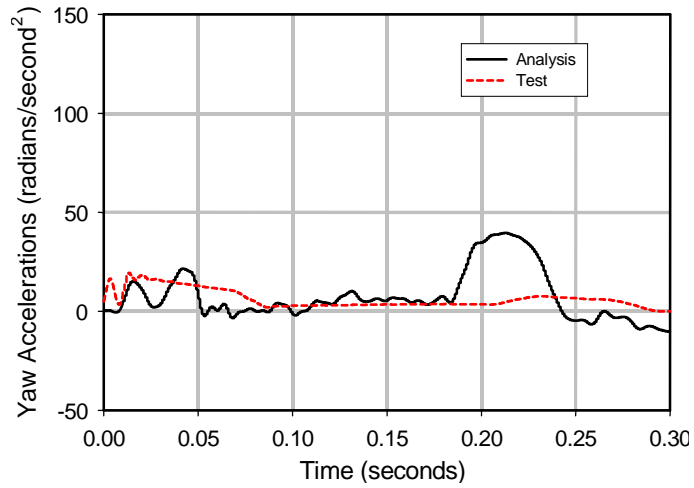
Figure A-33. Comparison of Coil Yaw Acceleration, 1990s Cab Car Impact, Test Data, and Analysis Results

The CD model also accurately predicts the yaw of the coil. Figures A-33 and A-34 show comparisons of the coil's rotational acceleration about the vertical axis. The coil yaw acceleration is reflective of the pattern of the contact force. In the 1990s cab car test, the coil shows a peak rotational acceleration of about 22 radians per second squared. The CD model predicts a yaw acceleration of about 20 radians per second squared. The second significant peak, occurring at about 0.2 s, shows when the coil breaks through the corner post and impacts the passenger compartment wall. This second peak in the yaw acceleration occurs because the contact point on the coil is different for the rear of the doorframe than it is for the corner post. The CD model currently does not account for this shift, although it could be modified. The SOA cab car comparison shows that the CD model follows the slope of the test data very precisely. Double integrating the test data produces a final rotational displacement of about 20 degrees. The still shots shown in Figure A-35 depict general visual agreement with the position of the rotated coil.

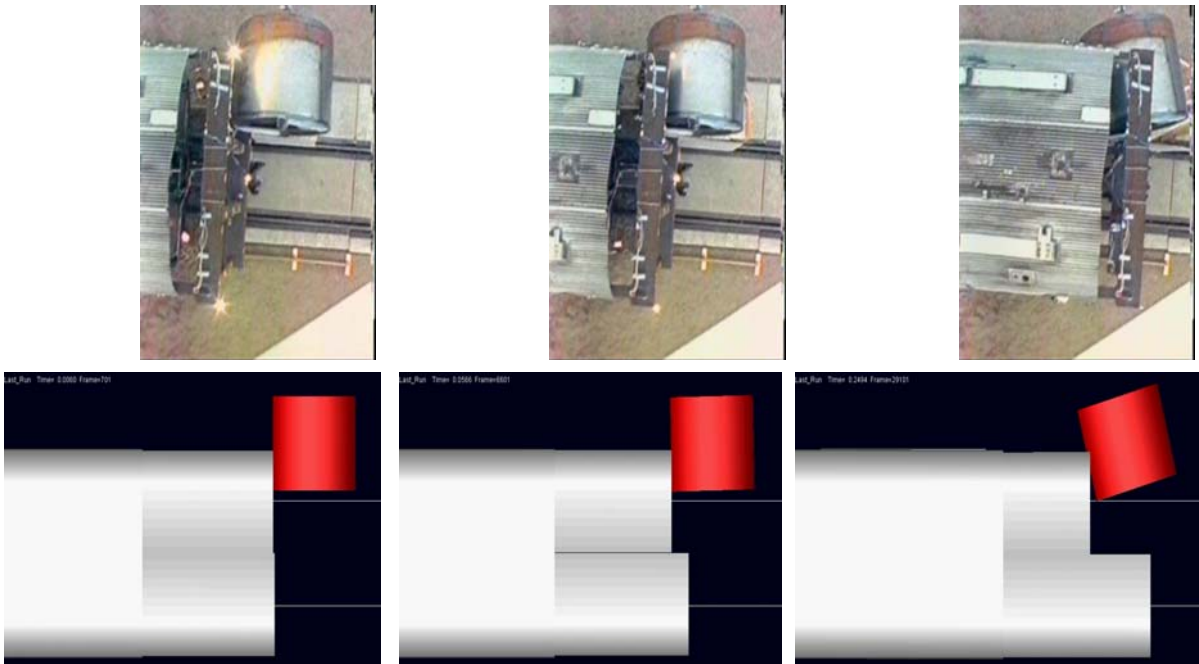
Figure A-35. Still Photographs of CD Simulation and 1990s Full-Scale Test

The CD models estimated the gross motions of the objects with relative accuracy. Figure A-35 shows still shots from an overhead view of the CD simulation in comparison with the high-speed camera of the 1990s full-scale collision. The pictures show the position at which the coil:
