ANCIENT HAWAII SHORE ZONE FISHPONDS:

AN EVALUATION OF SURVIVORS

HISTORICAL PRESERVATION

July 1975

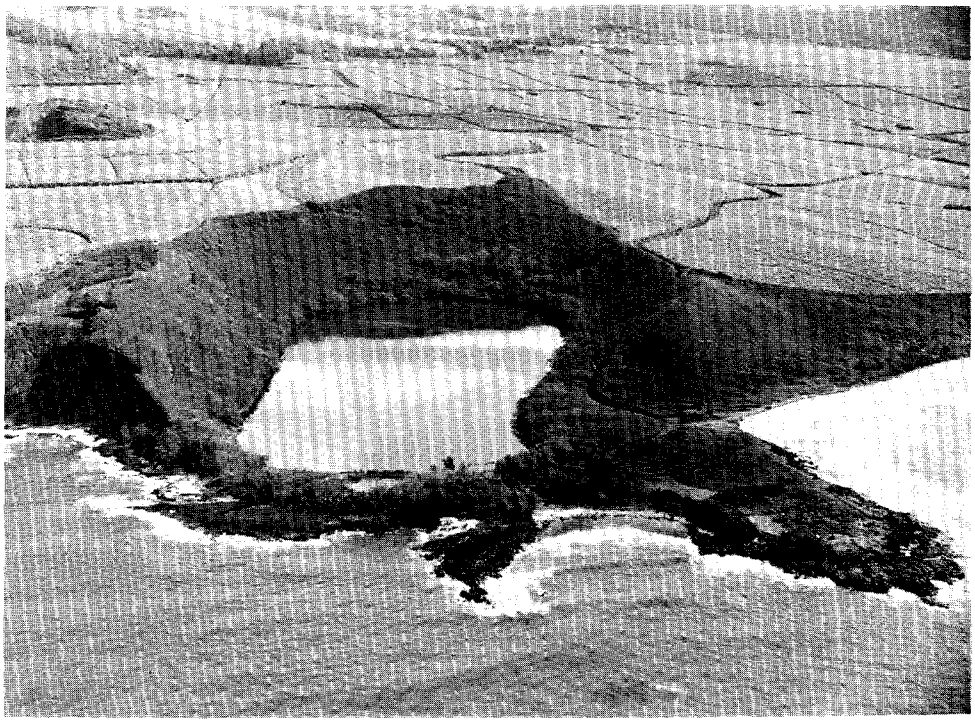
Fig. 2 Nomilu pond, May 15, 1974. Neg. # NPS - Kaua'i 1-22A.

B18 NOMILU, at Kalāheo-kai, Kaua'i
USGS Quad: Koloa
Tax Map Key: Portion of 2-3-10-2
Acreage 4 (?)
Ownership: Private

Ratings:	Apple	Kikuchi	
Basin	.9	.7	
Contents	.9	.8	
Setting	.9	.9	
Total	2.7	2.4	Final Rating: 2.55

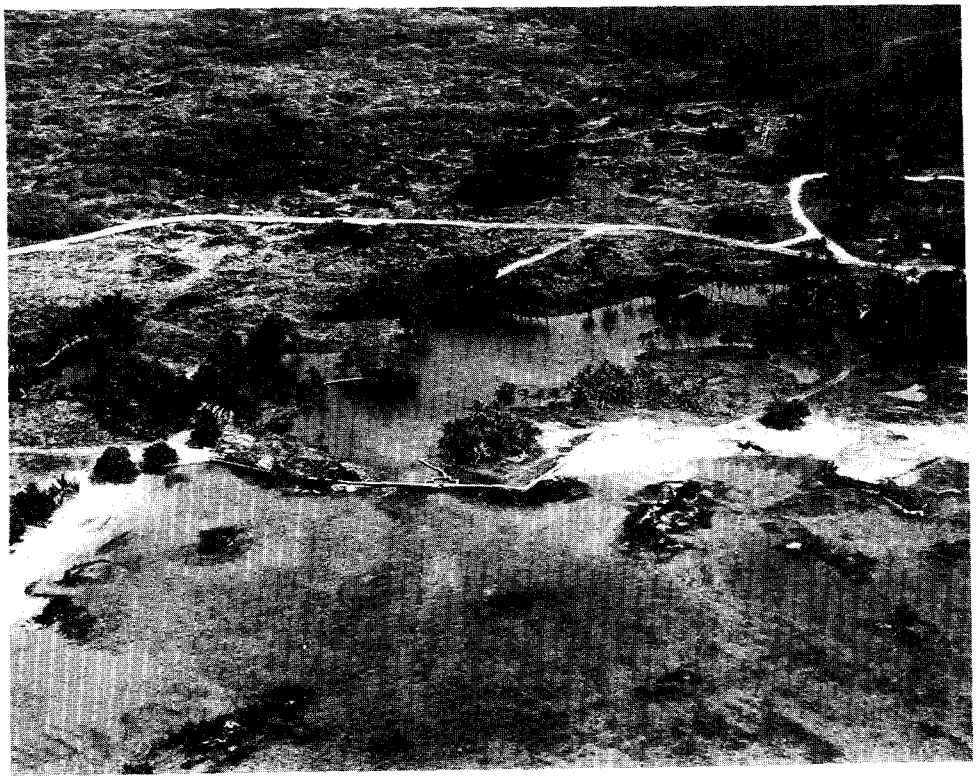
Fig. 3 Lahuipua'a and associated ponds, May 22, 1974.
Neg. # NPS - Hawai'i 4-34.

H41 LAHUIPUA'A, at Kalahuipua'a, Kohala, Hawai'i.
USGS Quad: Pu'uhinai
Tax Map Key: Portion of 6-9-01-3
Acreage 10 (?)
Ownership: Private

Ratings:	Apple	Kikuchi	
Basin	.9	.7	
Contents	.9	.8	
Setting	.7	.9	
Total	2.5	2.4	Final Rating: 2.45

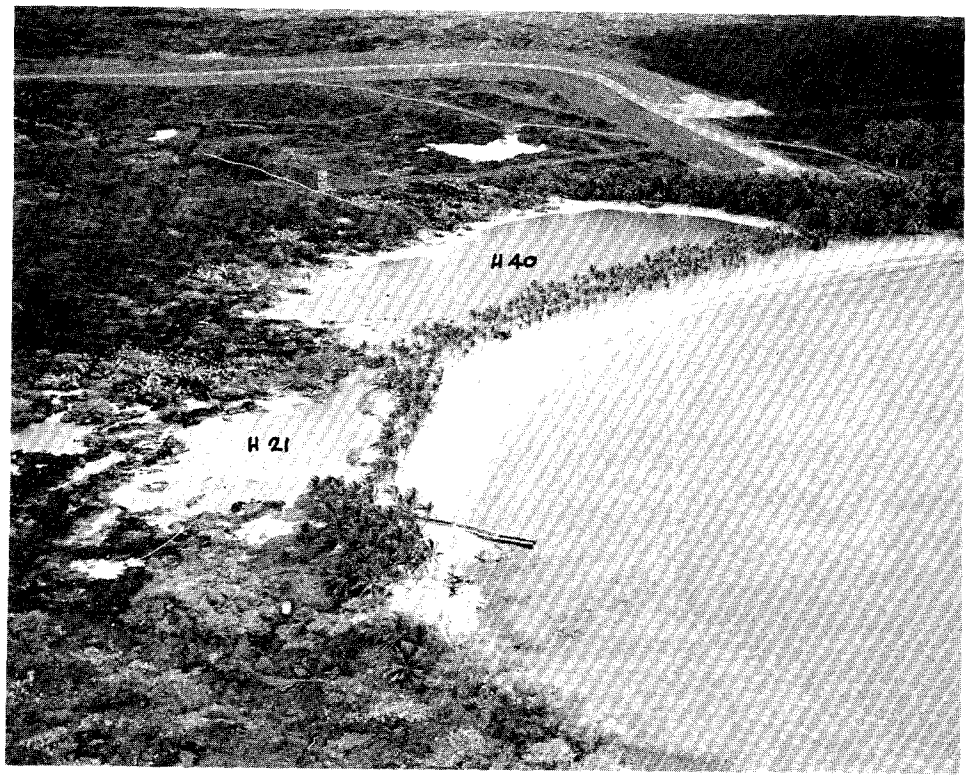
Fig. 4 Kahapapa and Ku'uali'i ponds, May 22, 1974. Neg. # NPS - Hawai'i 4-28. Note dredge in Ku'uali'i and mortared 'auwai-kai in Kahapapa.

H21 KAHAPAPA, at Anaeho'omalu, Kona, Hawai'i
USGS Quad: Anaeho'omalu
Tax Map Key: Portion of 6-9-07-16
Acreage 7 (?)
Ownership: Private

Ratings:	Apple	Kikuchi	
Basin	.7	.8	
Contents	.6	.7	
Setting	.8	.7	
Total	2.1	2.2	Final Rating: 2.15

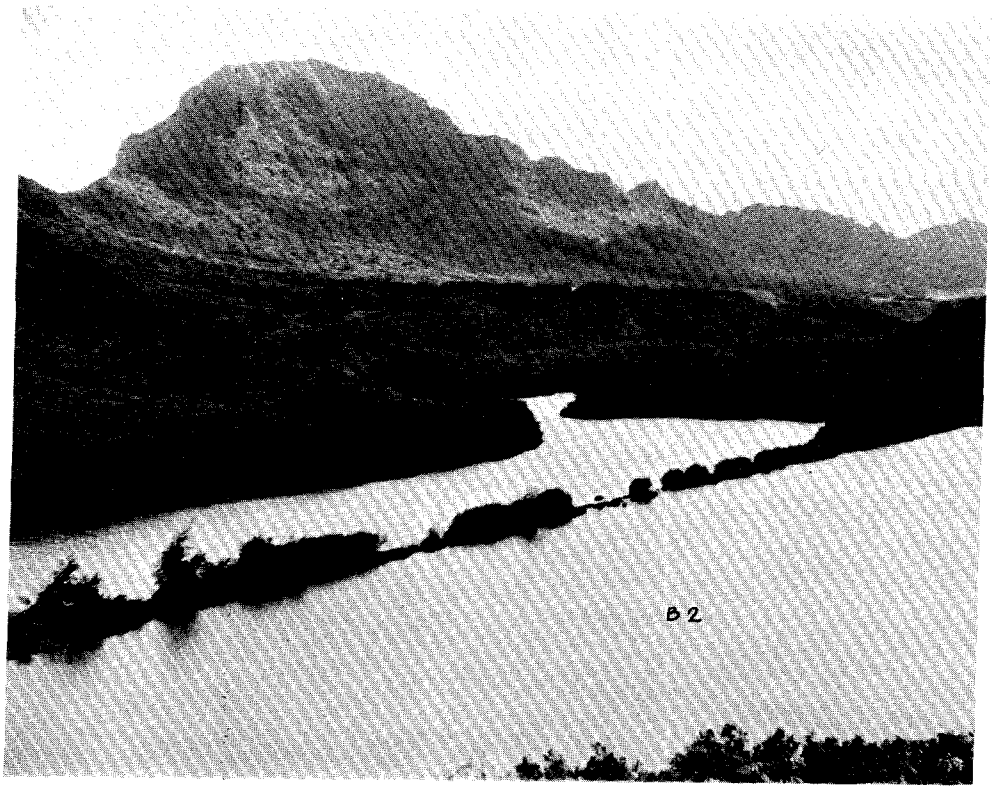
Fig. 6 Alekoko pond, June 20, 1974. Neg. # NPS - Kaua'i 7-13A.

B2 ALEKOKO, at Nawiliwili, Kaua'i.
USGS Quad: Lihue
Tax Map Key: Portion of 3-2-01-1
Acreage 32 (?)
Ownership: Private

Ratings:	Apple	Kikuchi	
Basin	.7	.6	
Contents	.7	.5	
Setting	.9	.8	
Total	2.3	1.9	Final Rating: 2.10

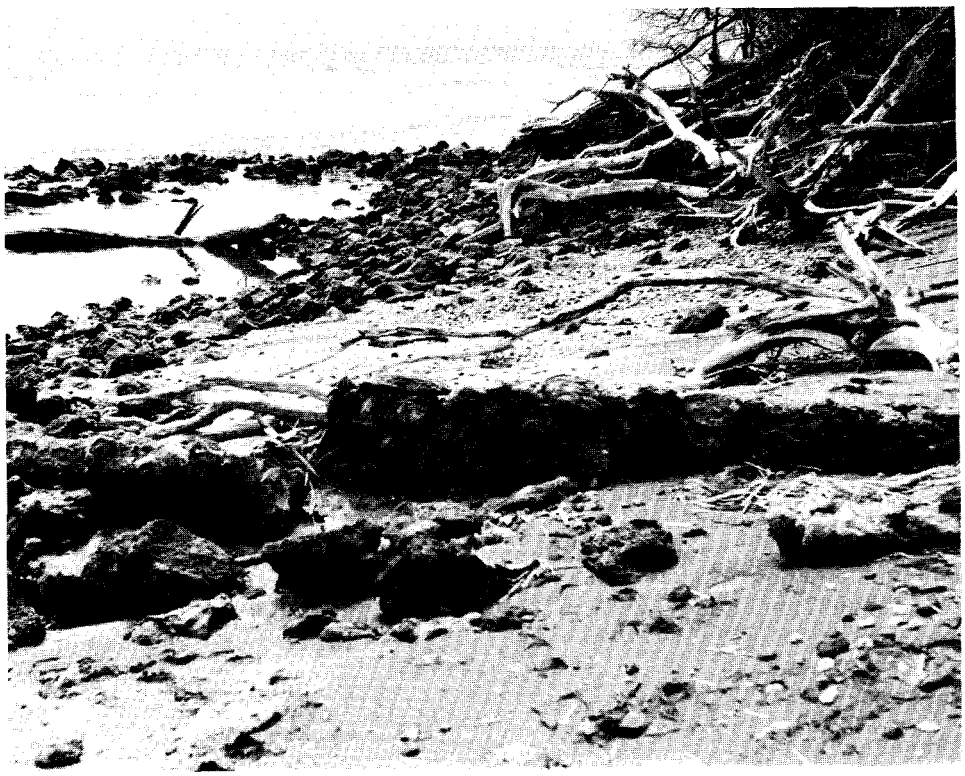
Fig. 7 Mortared 'auwai-kai at E2, March 5, 1974. Neg. # NPS - Lana'i 1-29.

E2 nameless, at Lopā, Kaohai, Lana'i
USGS Quad: Lana'i
Tax Map Key: 4-9-03-9
Acreage 1 (?)
Ownership: Private

Ratings:	Apple	Kikuchi	
Basin	.8	.8	
Contents	.5	.4	
Setting	.9	.8	
Total	2.2	2.0	Final Rating: 2.10

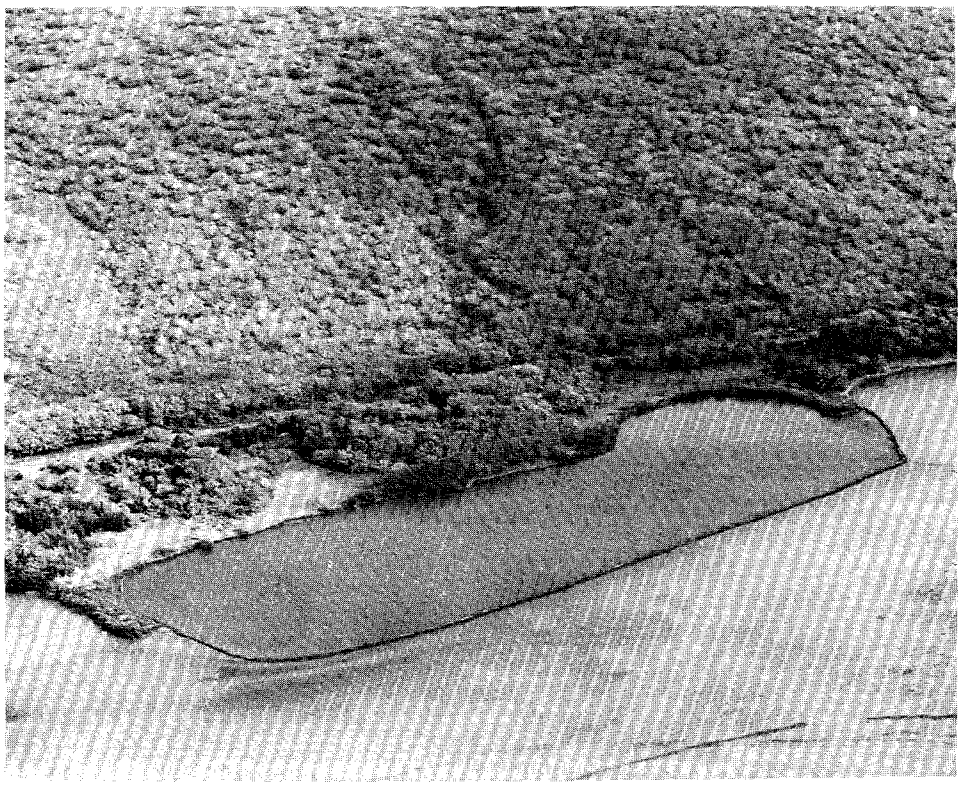
Fig. 8 Kaina'ohe pond, Feb. 20, 1971. Neg. # Photo by George Bacon #20, 2/20/71 - Pond 30.

D12 KAINA'OHE, at Ka'amola, Moloka'i
USGS Quad: Kamalo
Tax Map Key: 5-6-05-22
Acreage 17 (?)
Ownership: Private

Ratings:	Apple	Kikuchi	
Basin	.7	.6	
Contents	.6	.7	
Setting	.8	.7	
Total	2.1	2.0	Final Rating: 2.05

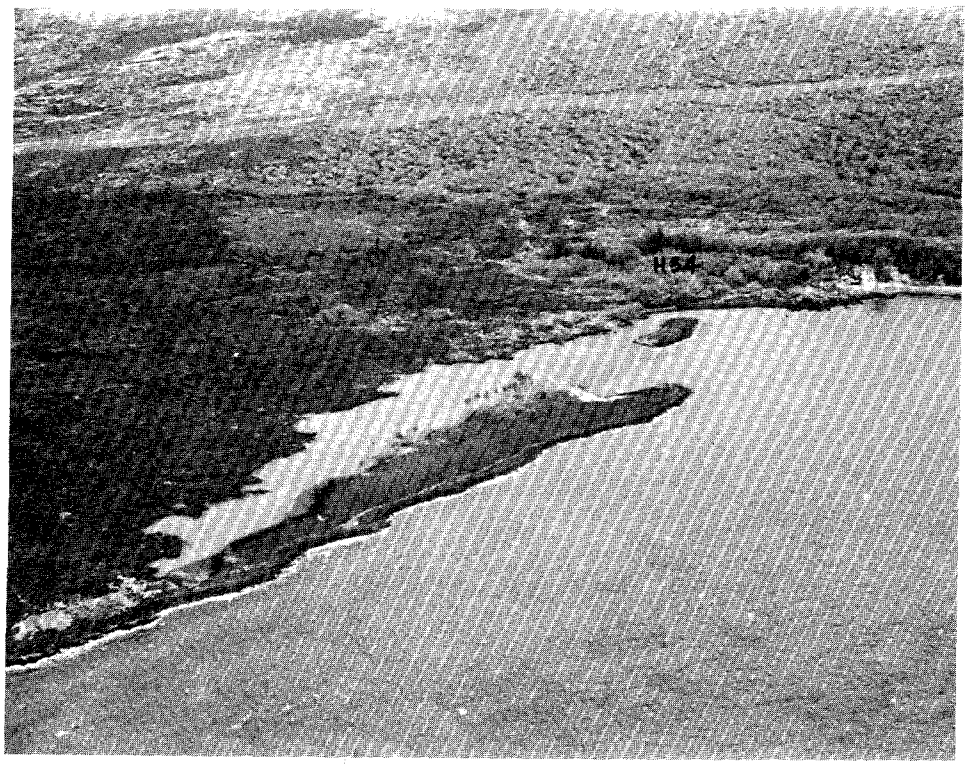
Fig. 10 Setting of "Kiholo" pond, May 22, 1975. Neg. # NPS - Hawai'i 4-20. Dark area on left is 1859 lava flow.

H34 "KIHOLO", at Pu'uwa'awa'a, Kona, Hawai'i
USGS Quad: Kiholo
Tax Map Key: 7-1-02-8
Acreage 3 (?)
Ownership: State of Hawai'i

Ratings:	Apple	Kikuchi	
Basin	.9	.6	
Contents	.6	.7	
Setting	.6	.7	
Total	2.1	2.0	Final Rating: 2.05

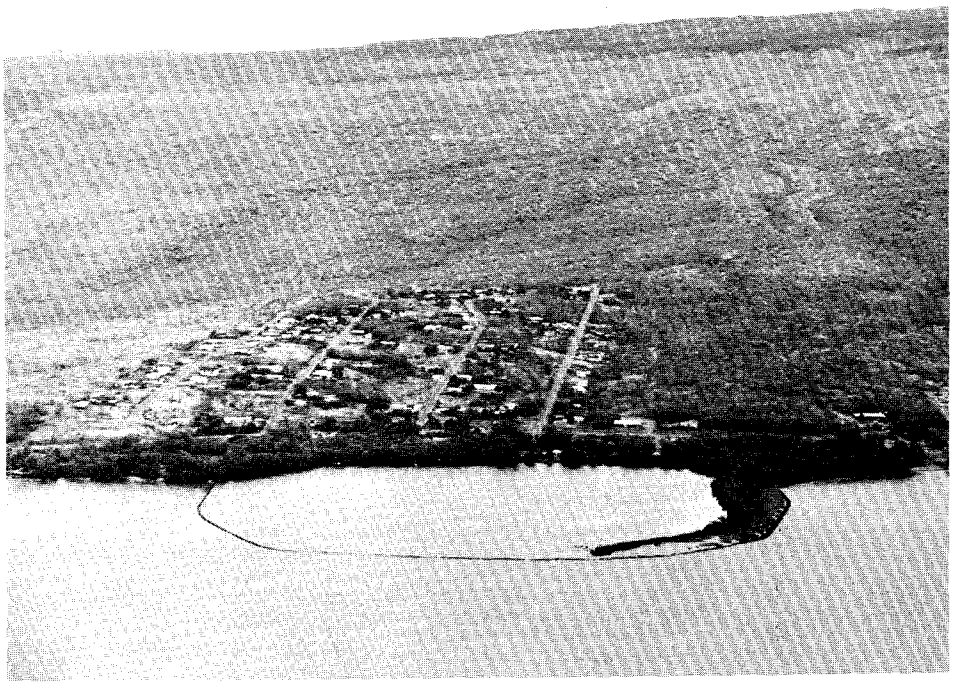
Fig. 11 Kaloko'eli pond, May 22, 1974. Neg. # NPS - Moloka'i 0-25A.

D15 KALOKO'ELI, at Kamiloloa, Moloka'i
USGS Quad: Kaunakakai
Tax Map Key: 5-4-02-14
Acreage 28 (?)
Ownership: State of Hawai'i

Ratings:	Apple	Kikuchi	
Basin	.7	.8	
Contents	.6	.5	
Setting	.7	.7	
Total	2.0	2.0	Final Rating: 2.00

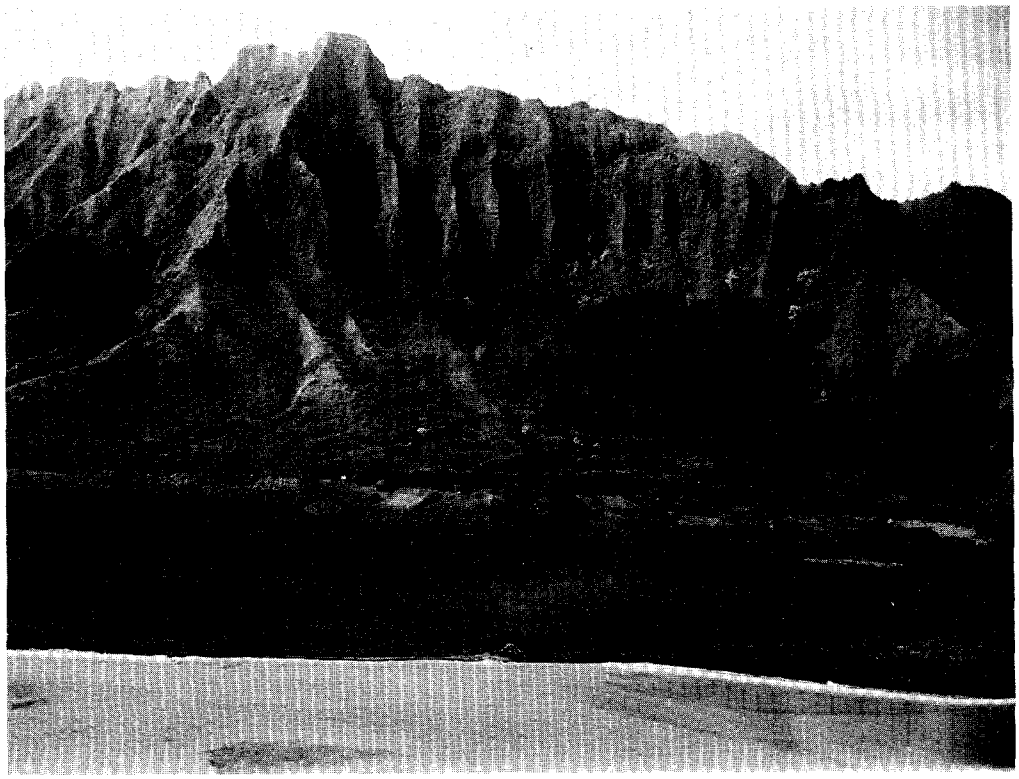
Fig. 12 Moli'i pond, July 23, 1974. Neg. # NPS - O'ahu 10-10.

C112 **MOLI'I**, at Kualoa, Ko'olaupoko, O'ahu
USGS Quad: Kahana
Tax Map Key: 4-9-03-43
Acreage 124 (?)
Ownership: Private

Ratings:	Apple	Kikuchi	
Basin	.9	.4	
Contents	.9	.4	
Setting	.7	.5	
Total	2.5	1.3	Final Rating: 1.90

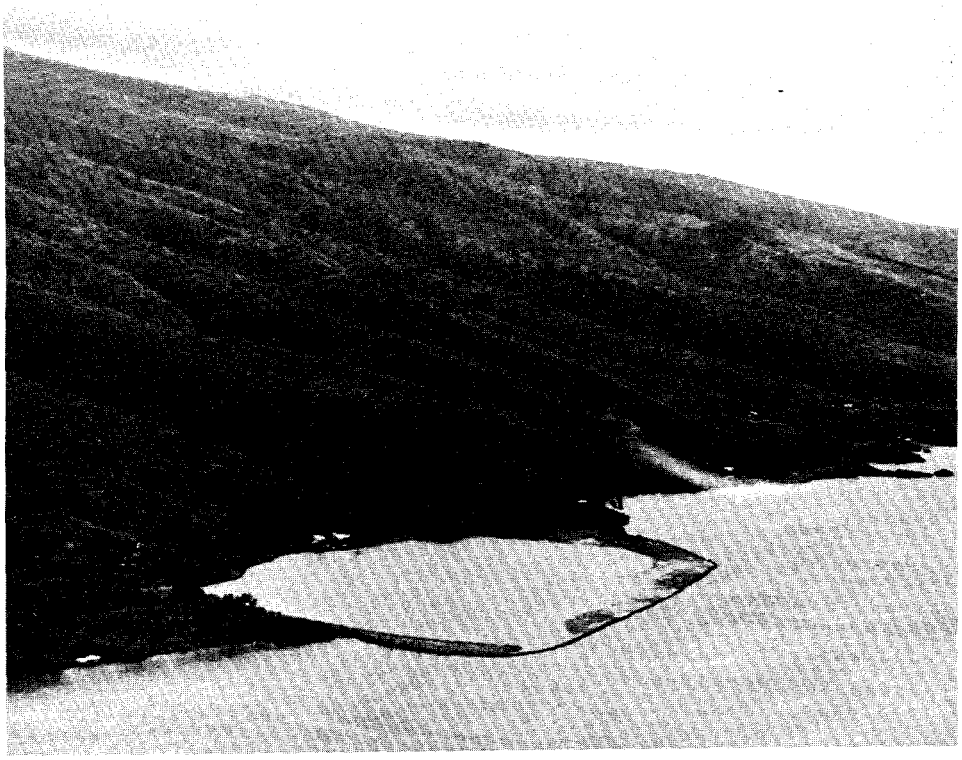
Fig. 13 Kupeke pond, May 22, 1974. Neg. # NPS - Moloka'i 0-9A.

D38 KUPEKE, at Kupeke, Moloka'i
USGS Quad: Halawa
Tax Map Key: Portion of 5-7-06-1
Acreage 30 (?)
Ownership: Private

Ratings:	Apple	Kikuchi	
Basin	.8	.7	
Contents	.6	.5	
Setting	.6	.6	
Total	2.0	1.8	Final Rating: 1.90

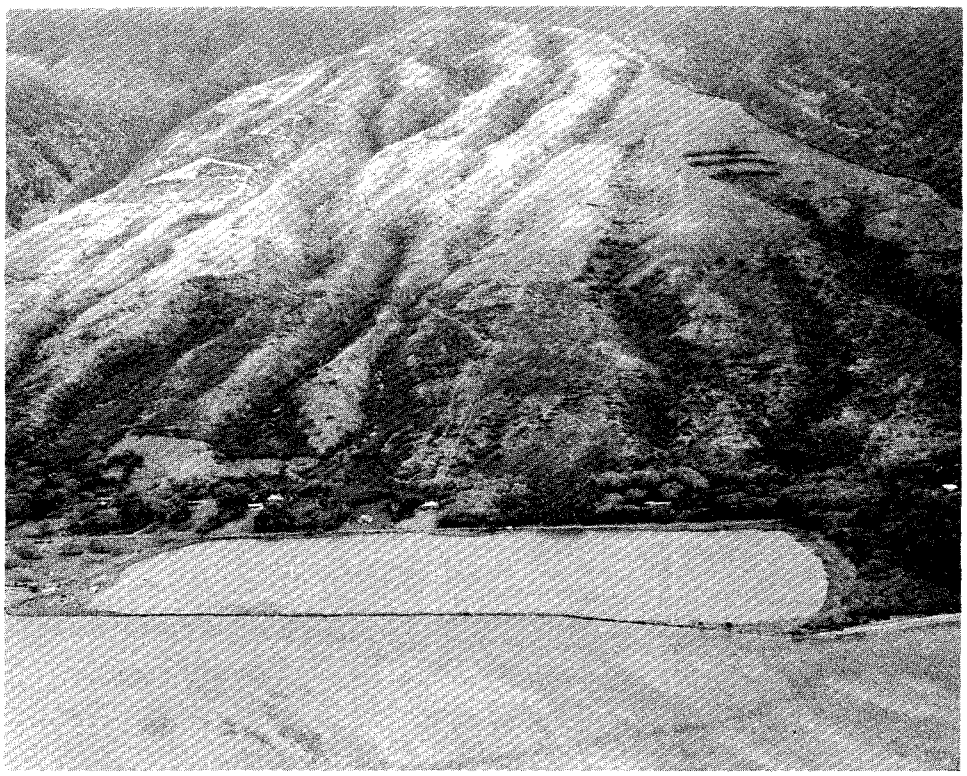
Fig. 14 Ni'auhala pond, Feb. 20, 1971. Neg. # Photo by George Bacon 10, 2/20/71 pond 42.

D43 NI'AUHALA, at Kalua'aha, Moloka'i
USGS Quad: Halawa
Tax Map Key: 5-6-08-8
Acreage 34 (?)
Ownership: Private

Ratings:	Apple	Kikuchi	
Basin	.5	.7	
Contents	.6	.6	
Setting	.6	.6	
Total	1.7	1.9	Final Rating: 1.80

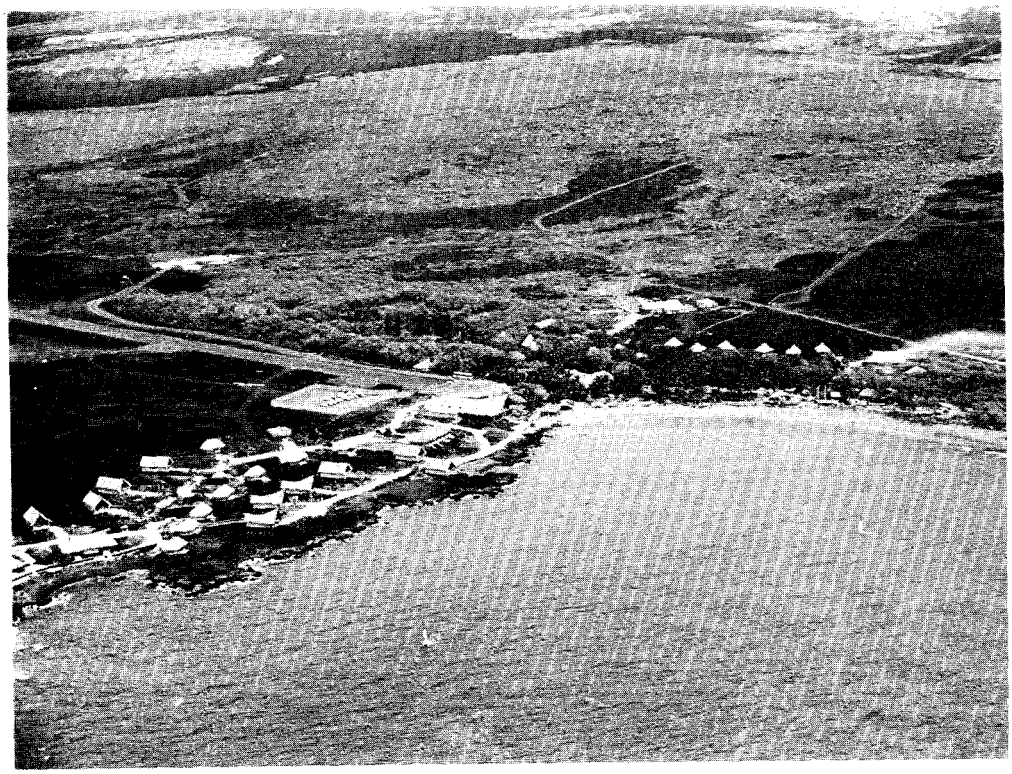
Fig. 15 Setting of nameless pond at Ka'upulehu. Neg. # NPS - Hawai'i 4-16.

H28 nameless, at Ka'upulehu, Kona, Hawai'i
USGS Quad: Kiholo
Tax Map Key: 7-2-03-2
Acreage 2 (?)
Ownership: Private

Ratings:	Apple	Kikuchi	
Basin	.9	.8	
Contents	.4	.5	
Setting	.8	.2	
Total	2.1	1.5	Final Rating: 1.80

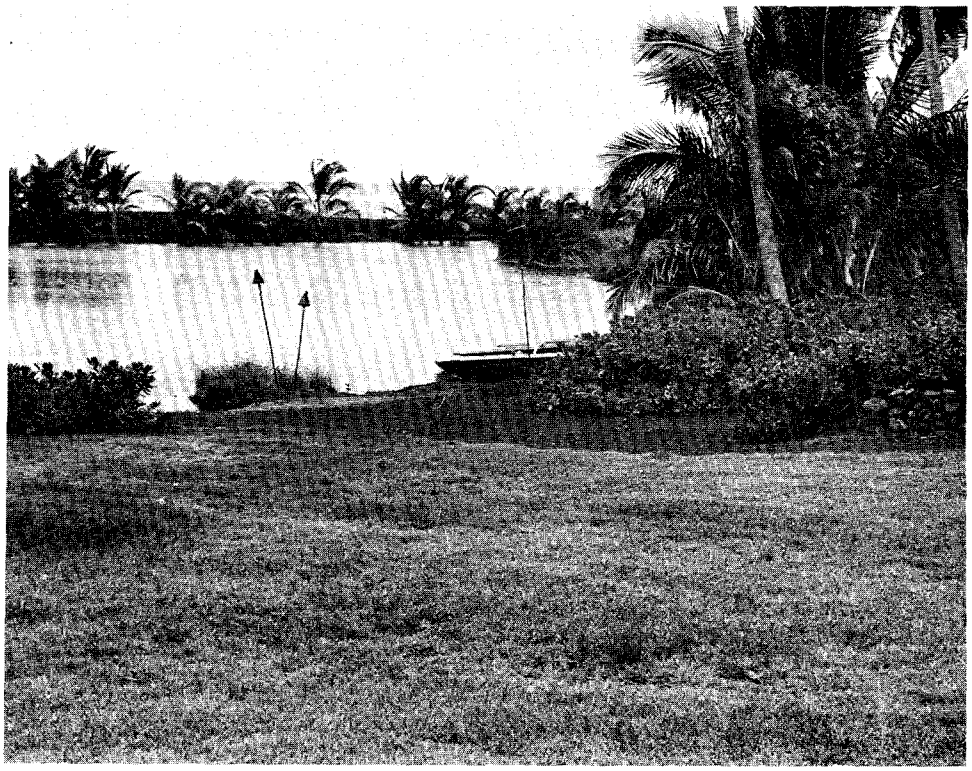
Fig. 16 'Ilo'i pond, June 25, 1974. Neg. # NPS - Hawai'i 5-8.

H19 'ILO'I, at Punalu'u, Ka'ū, Hawai'i
USGS Quad: Punalu'u
Tax Map Key: Portion of 9-5-19-11
Acreage
Ownership: Private

Ratings:	Apple	Kikuchi	
Basin	1.0	.3	
Contents	.9	.7	
Setting	.4	.2	
Total	2.3	1.2	Final Rating: 1.75

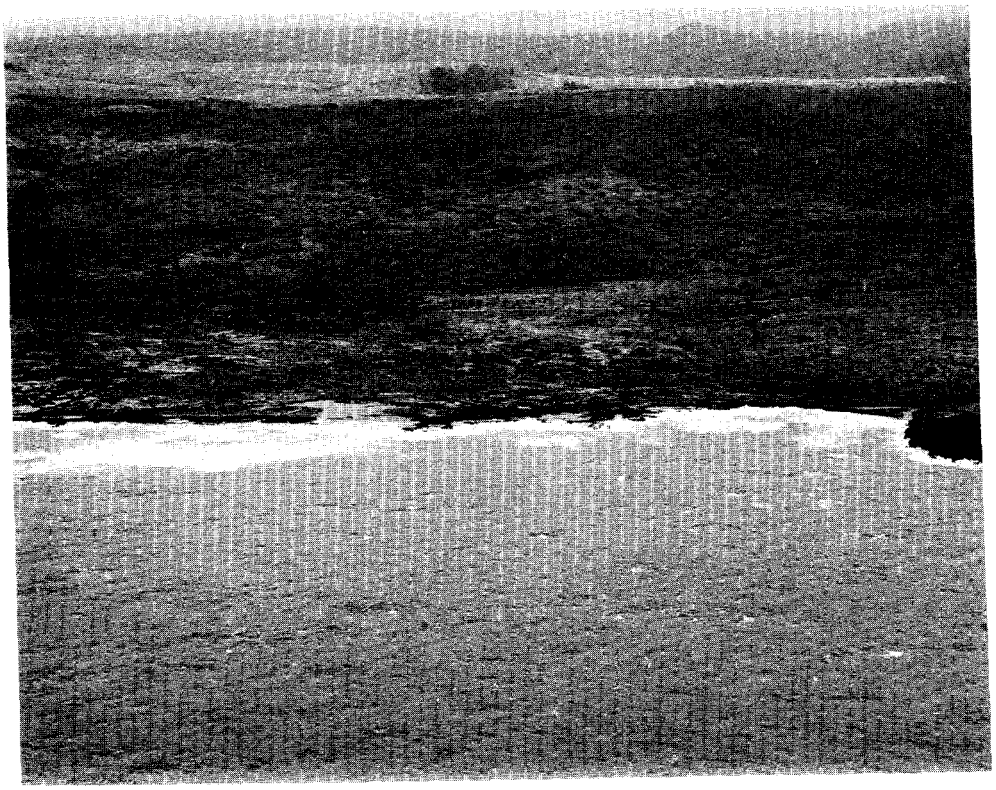
Fig. 17 nameless pond at Kawa'a. Neg # NPS - Hawai'i 2-31A.

H29 nameless, at Kawa'a, Ka'ū, Hawai'i
USGS Quad: Naalehu
Tax Map Key: 9-5-16-32
Acreage 2 (?)
Ownership: State of Hawai'i

Ratings:	Apple	Kikuchi	
Basin	.1	.6	
Contents	.5	.7	
Setting	.9	.7	
Total	1.5	2.0	Final Rating: 1.75

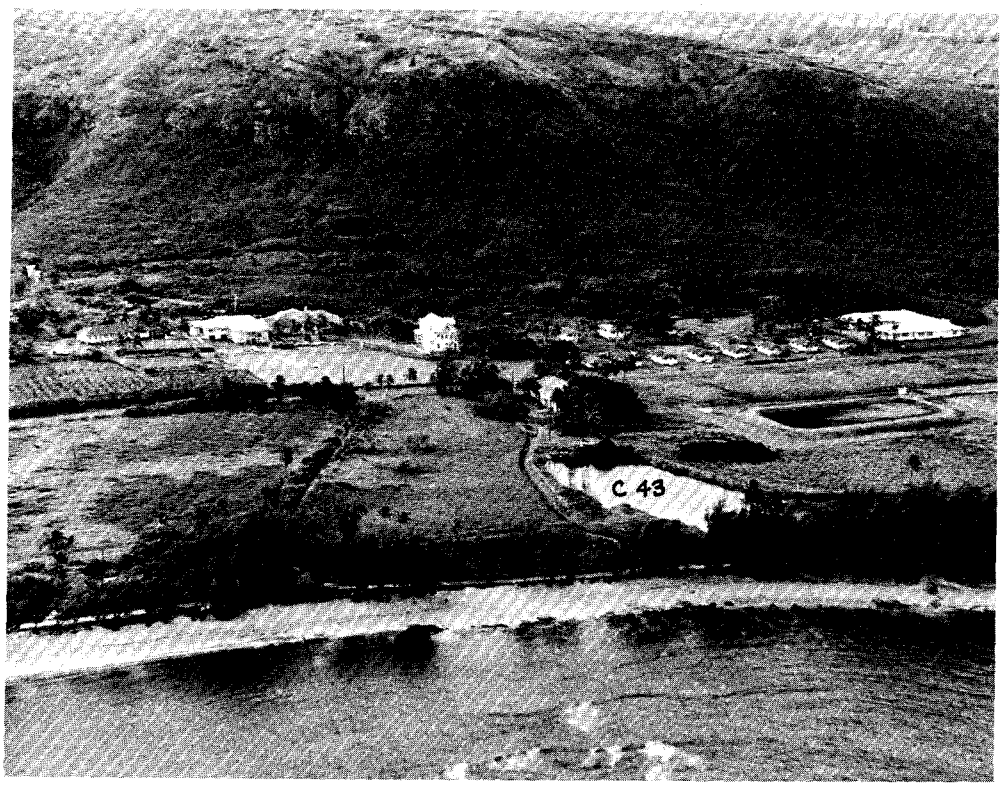
Fig. 18 Kalouwai pond, May 1, 1974. Neg. # NPS - O'ahu 3-20.

C43 KALOUWAI, at Waiale'e, Ko'olau Loa, O'ahu
USGS Quad: Waimea
Tax Map Key: 5-8-01-55
Acreage 1 (?)
Ownership: State of Hawai'i

Ratings:	Apple	Kikuchi	
Basin	.8	.3	
Contents	.6	.6	
Setting	.7	.4	
Total	2.1	1.3	Final Rating: 1.70

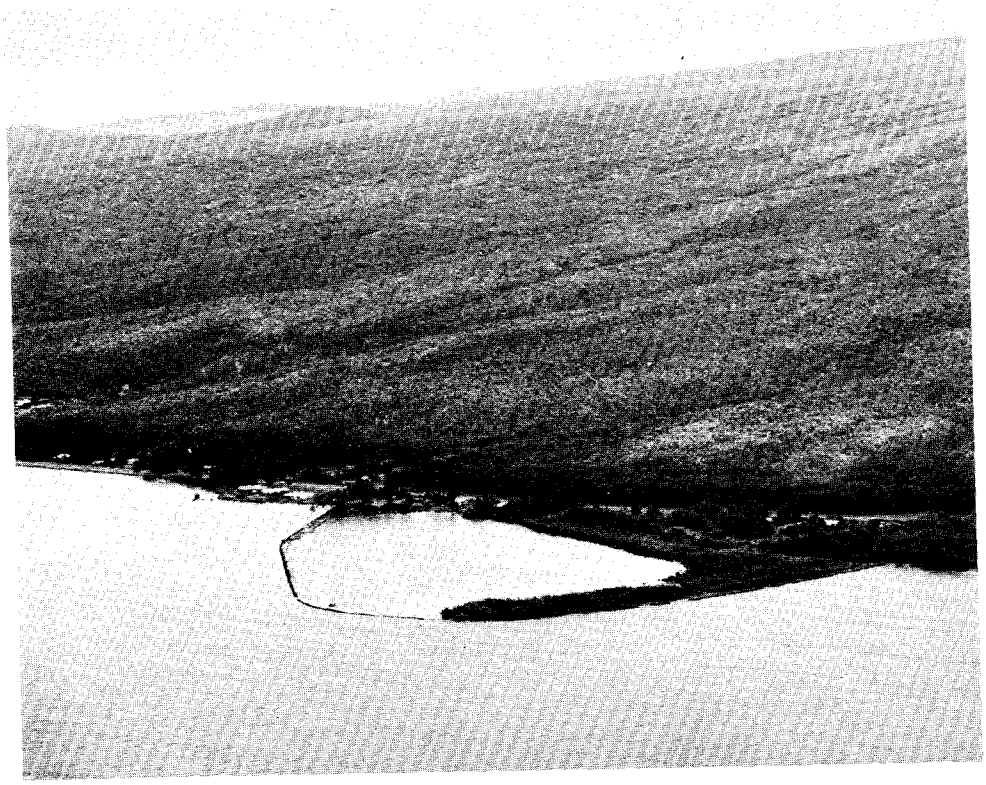
Fig. 19 Ali'i pond, May 22, 1974. Neg. # NPS - Moloka'i 0-23.

D2 ALI'I, at Makakupaia I, Moloka'i
USGS Quad: Kaunakakai
Tax Map Key: 5-4-06-23
Acreage 27 (?)
Ownership: Hawaiian Home Lands

Kuapā was 2,700 feet long, 4 feet wide and 3½ feet high; 1 makahā.

Ratings:	Apple	Kikuchi	
Basin	.4	.6	
Contents	.4	.7	
Setting	.5	.8	
Total	1.3	2.1	Final Rating: 1.70

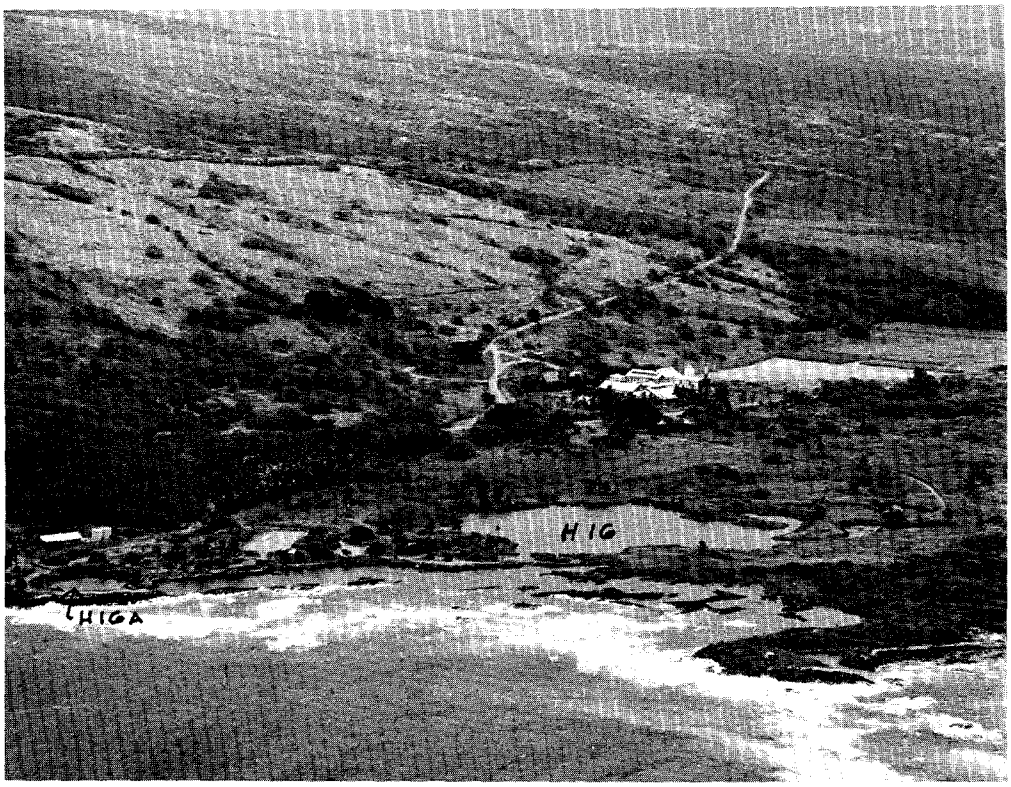
Fig. 20 nameless pond at Honu'apo (16) and nameless pond (16A), May 22, 1974. Neg. # NPS - Hawai'i 2-34A.

H16 nameless, at Honu'apo, Ka'ū, Hawai'i
USGS Quad: Naalehu
Tax Map Key: Part of Sea
Acreage 10 (?)
Ownership: State of Hawai'i

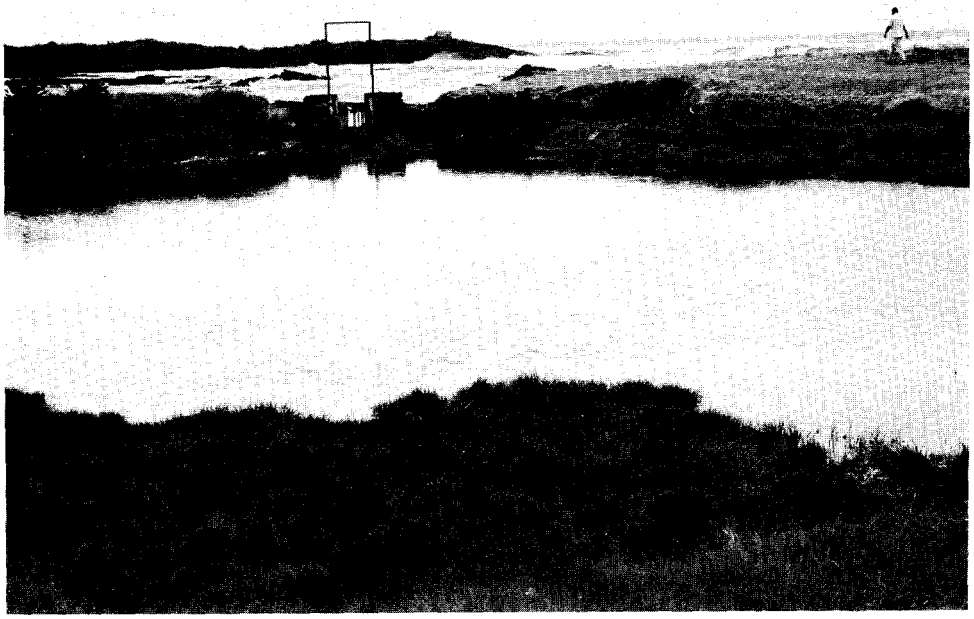
Fig. 21 Modern makahā in H16A, June 25, 1974. Neg. # NPS - Hawai'i 5-22. See figure 20 for aerial view of H16A.

Ratings:	Apple	Kikuchi	
Basin	.8	.4	
Contents	.6	.4	
Setting	.9	.2	
Total	2.3	1.0	Final Rating: 1.65

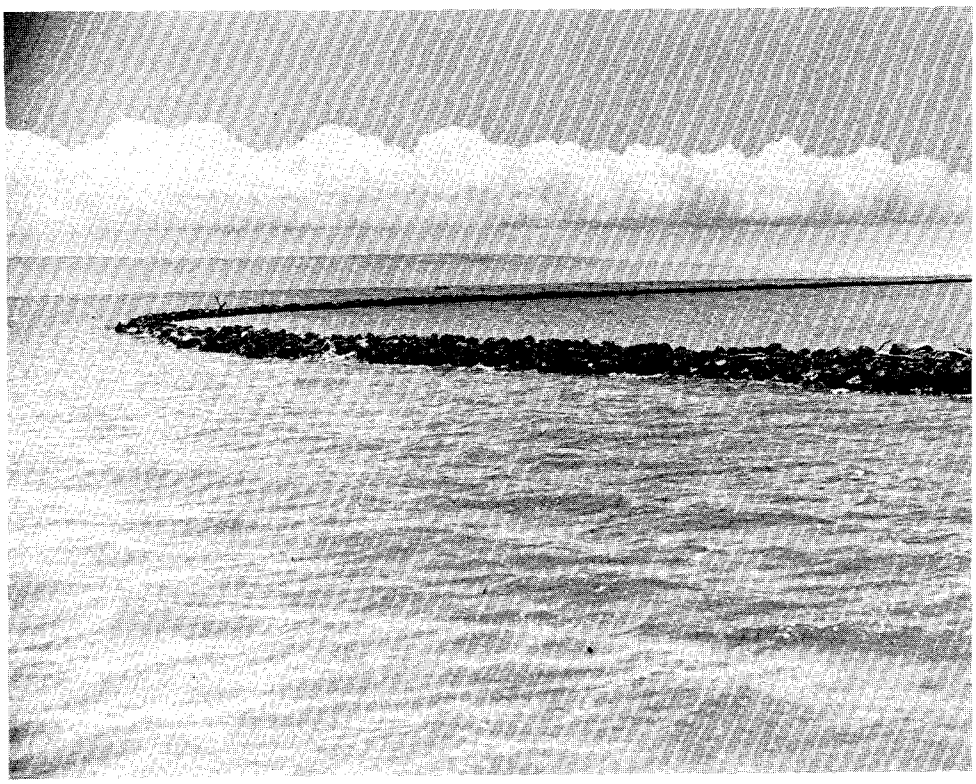
Fig. 23 Kuapā of Ka'ope'ahina pond, July 29, 1974. Neg. # NPS - Moloka'i 3-33A.

D29 KA'OPE'AHINA, at Kalua'aha, Moloka'i
USGS Quad: Halawa
Tax Map Key: 5-7-09-1
Acreage 19 (?)
Ownership: Private

Kuapā was 1770 feet long, 4-7 feet wide and 5-8 feet high; no makahā. Menehune built pond.

Ratings:	Apple	Kikuchi	
Basin	.3	.7	
Contents	.3	.7	
Setting	.5	.7	
Total	1.1	2.1	Final Rating: 1.60

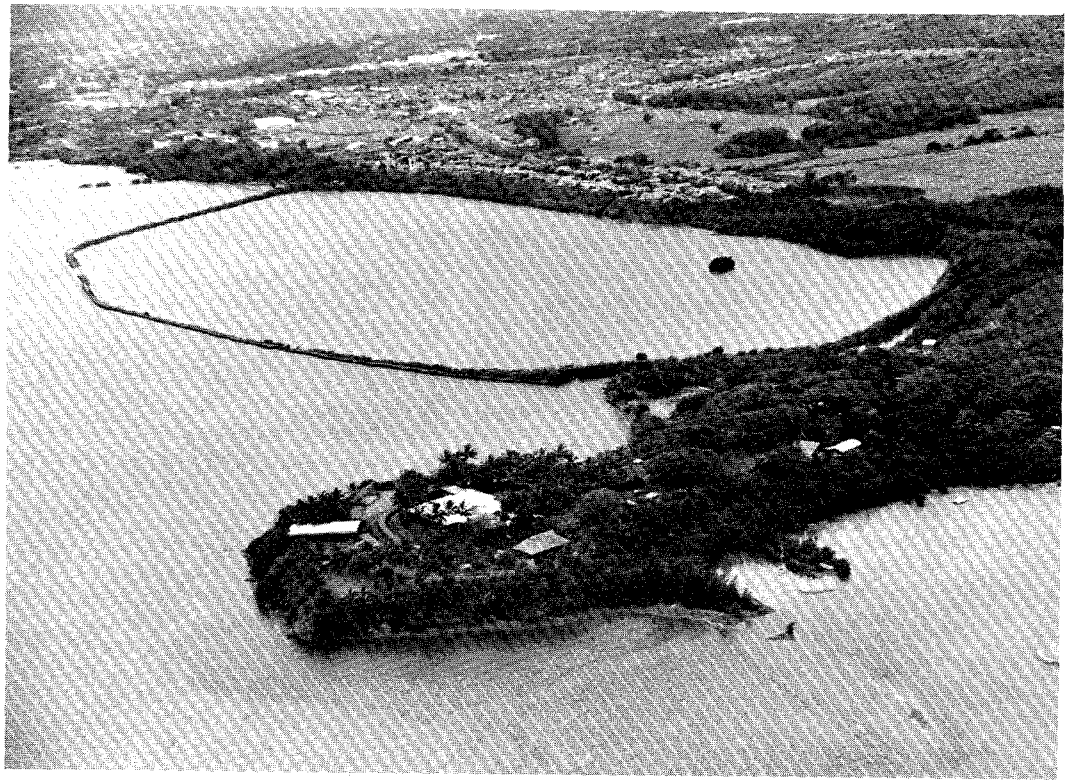
Fig. 24 He'eia'uli pond, May 1, 1974. Neg. # NPS - O'ahu 4-16.

C15 HE'EIA'ULI, at He'eia, Ko'olaupoko, O'ahu.
USGS Quad: Kaneohe
Tax Map Key: 4-6-05-1
Acreage 88 (?)
Ownership: Private

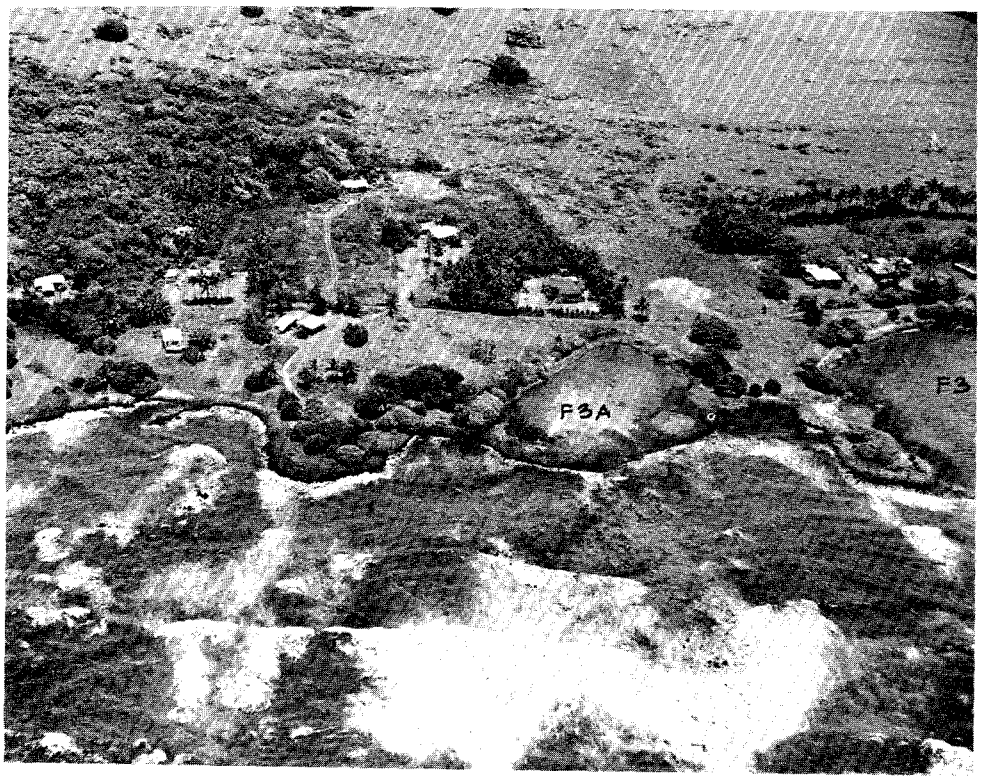
Fig. 26 Loko-iki pond, June 19, 1974. Neg. # NPS - Maui 5-8A.

F3A LOKO-IKI, at Maui
USGS Quad: Hana
Tax Map Key: 1-4-08-4
Acreage 2 (?)
Ownership: Private

Kuapā was 750 feet long, 35 feet wide, 6 feet high; 3 secondary walls; 2 makahā; unnamed mo'o. Dredged in 1973.

Ratings:	Apple	Kikuchi	
Basin	.5	.3	
Contents	.8	.2	
Setting	.6	.6	
Total	1.9	1.1	Final Rating: 1.50

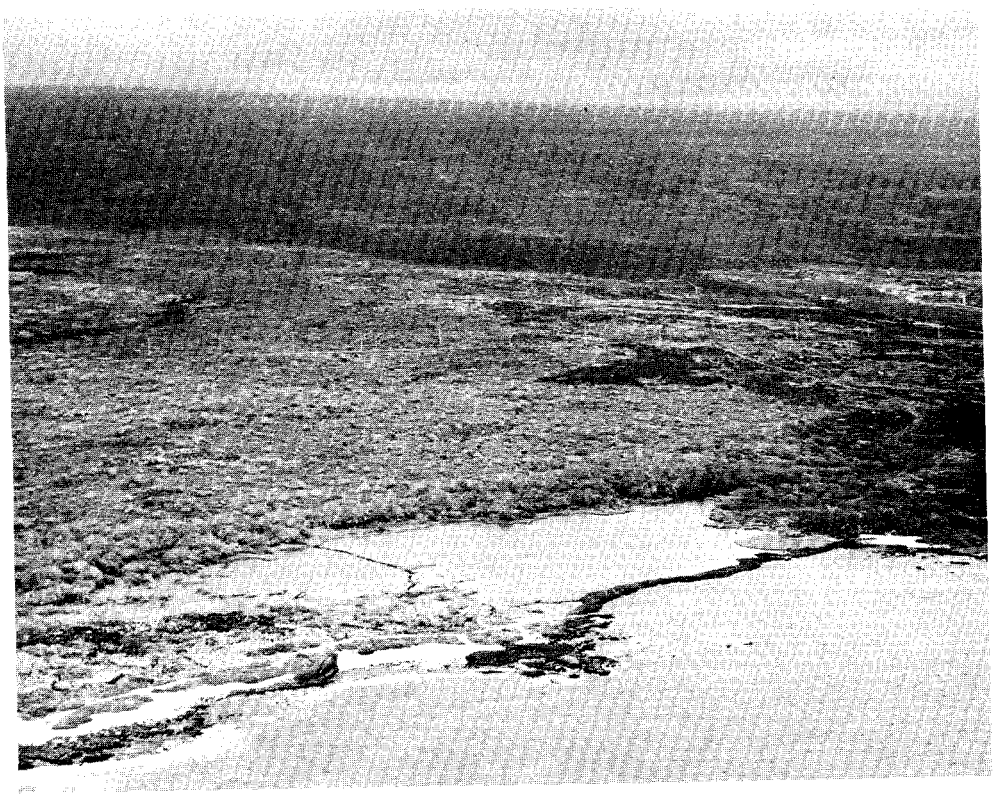
Fig. 27 Kaloko pond, May 22, 1974. Neg. # NPS - Hawai'i 4-12. Note secondary walls.

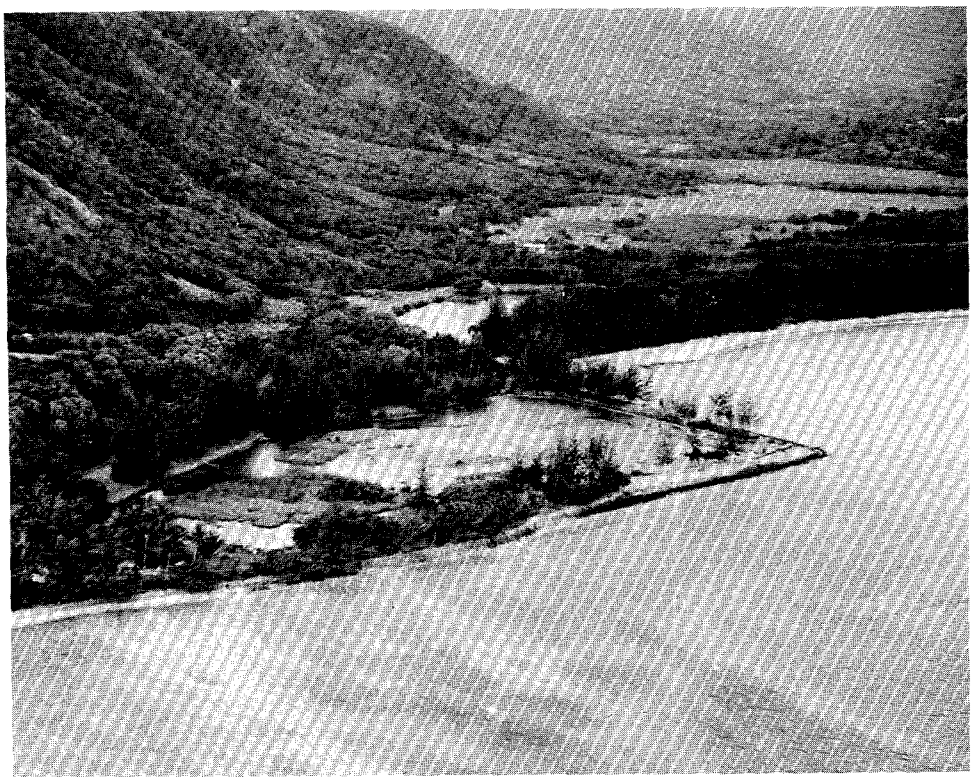
Fig. 28 Huilua pond, May 1, 1974. Neg. # NPS - O'ahu 3-31A.

C18 HUILUA, at Kahana, Ko'olaupoko, O'ahu
USGS Quad: Kahana
Tax Map Key: 6-2-03-2
Acreage 14 (?)
Ownership: State of Hawai'i

Ratings:	Apple	Kikuchi	
Basin	.7	.3	
Contents	.6	.4	
Setting	.6	.3	
Total	1.9	1.0	Final Rating: 1.45

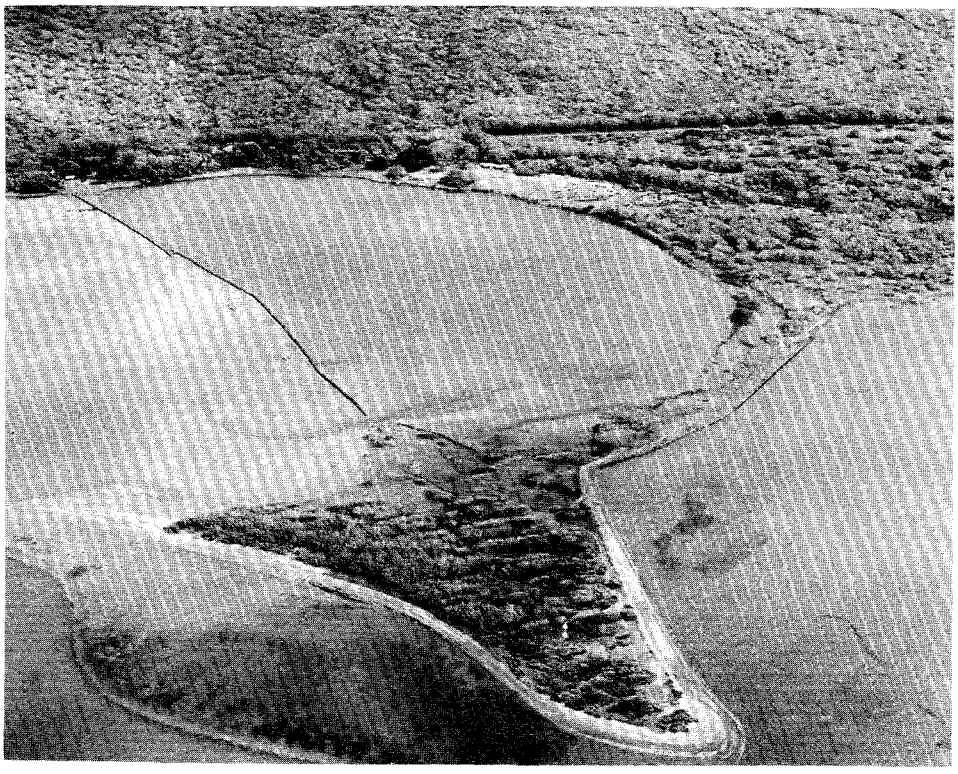
Fig. 30 Keawanui pond, Feb. 20, 1971. Neg. # Photo by George Bacon 19, 2/20/71 Pond 32.

D34 KEAWANUI, at Kalaeloa, Keawanui, Moloka'i
USGS Quad: Kamalo
Tax Map Key: 5-6-06-8
Acreage 54 (?)
Ownership: Private

Kuapā was 2,000 feet long; 1 makahā. Lohelohe built pond ca. A.D. 1575. Konohiki at time of Pohano was Hekilika'aka'a.

Ratings:	Apple	Kikuchi	
Basin	.3	.5	
Contents	.4	.2	
Setting	.8	.7	
Total	1.5	1.4	Final Rating: 1.45

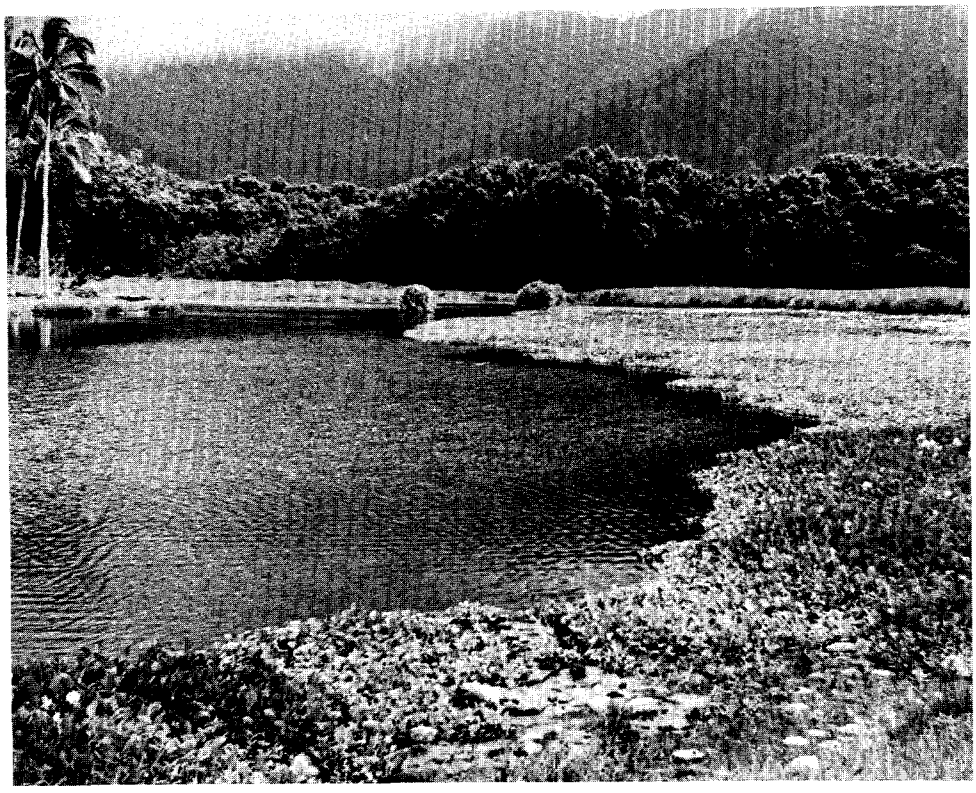
Fig. 31 Kanoa pond, June 21, 1974. Neg. # NPS - Kaua'i 5-28A.

B4A KANOA, at Hanalei, Kaua'i
USGS Quad: Hanalei
Tax Map Key: Portion of 5-5-01-2
Acreage 4 (?)
Ownership: Private

Kuapā was 1770 feet long; 1 makahā.

Ratings:	Apple	Kikuchi	
Basin	.4	.3	
Contents	.4	.2	
Setting	.7	.7	
Total	1.5	1.2	Final Rating: 1.35

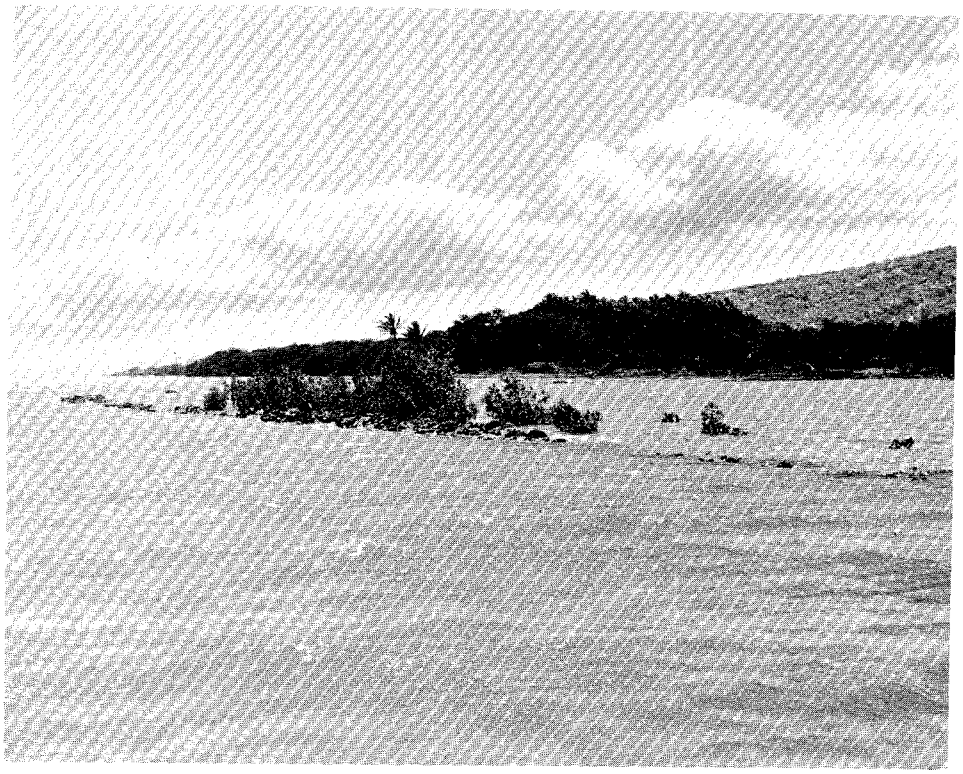
Fig. 32 Open water and mangrove, Kuapā awash, Pahiomu pond, July 29, 1974. Neg. # NPS - Moloka'i 5-33.

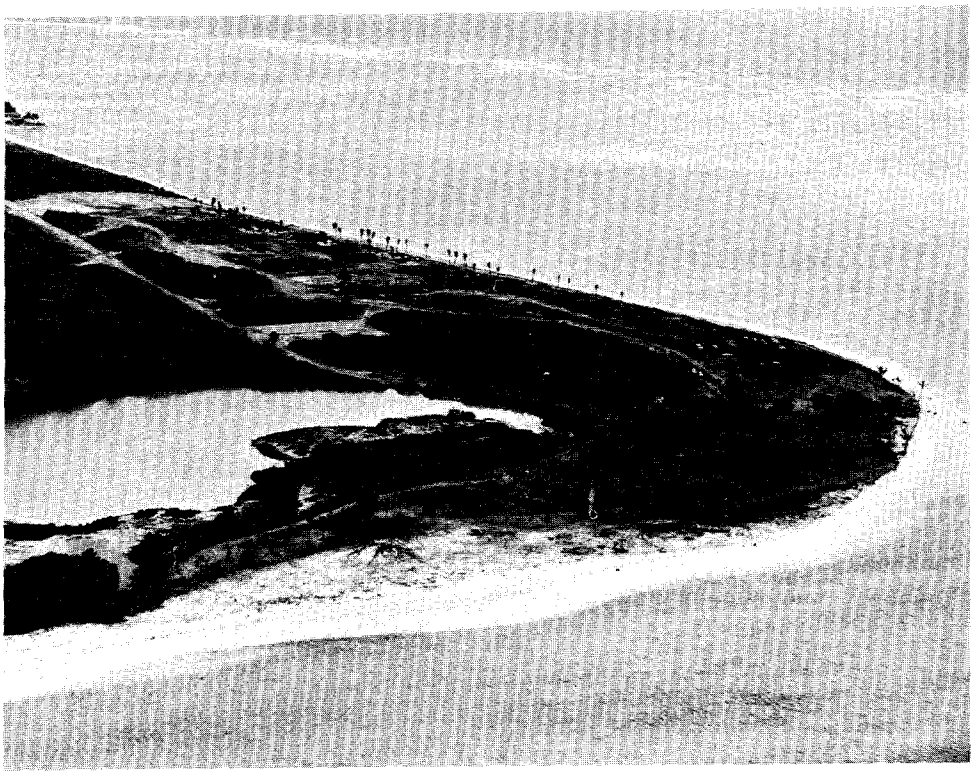
Fig. 33 Koholālele pond, May 1, 1974. Neg. # NPS - O'ahu 4-7.

C82 KOHOLĀLELE, at Kualoa, Ko'olaupoko, O'ahu
USGS Quad: Kahana
Tax Map Key: 4-9-04-1
Acreage 2 (?)
Ownership: State of Hawai'i

Ratings:	Apple	Kikuchi	
Basin	.8	.3	
Contents	.4	.2	
Setting	.5	.3	
Total	1.7	0.8	Final Rating: 1.25
