ANCIENT HAWAII SHORE ZONE FISHPONDS:

AN EVALUATION OF SURVIVORS

HISTORICAL PRESERVATION

July 1975

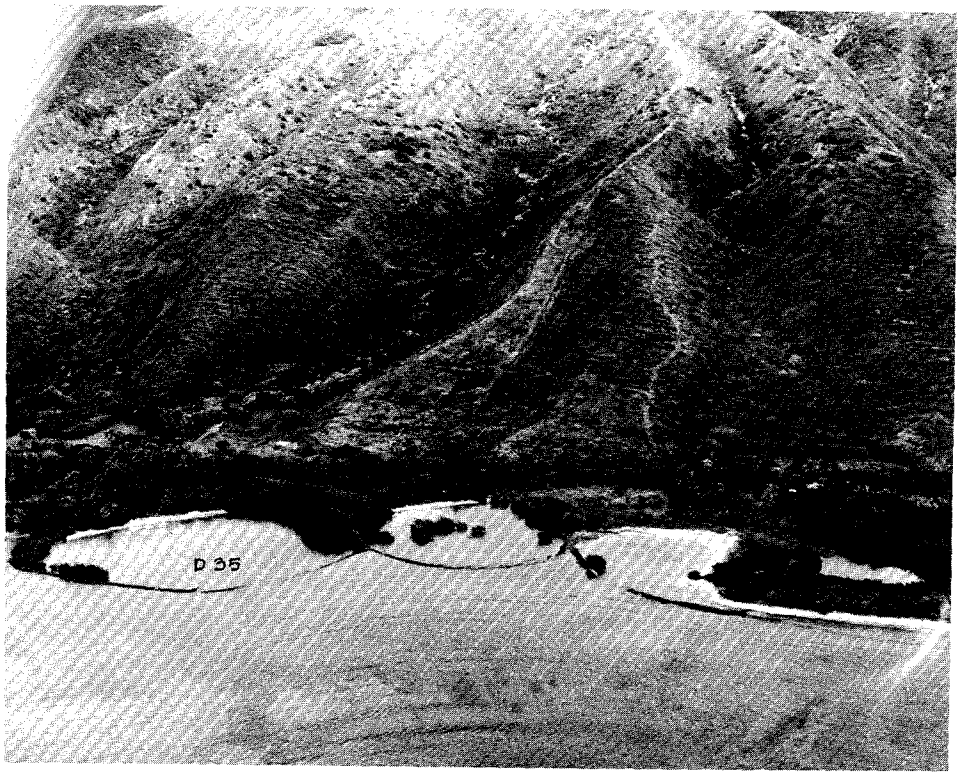
Fig. 34 Pond on left in Kihaloko, Feb. 20, 1971. Neg. # Photo by George Bacon 5, 2/20/71, Ponds 47, 48, 49.

D35 KIHALOKO, at Aha'ino II, Moloka'i
USGS Quad: Halawa
Tax Map Key: Portion of 5-7-06-22
Acreage 5 (?)
Ownership: Private

Ratings:	Apple	Kikuchi	
Basin	.3	.4	
Contents	.2	.5	
Setting	.4	.7	
Total	0.9	1.6	Final Rating: 1.25

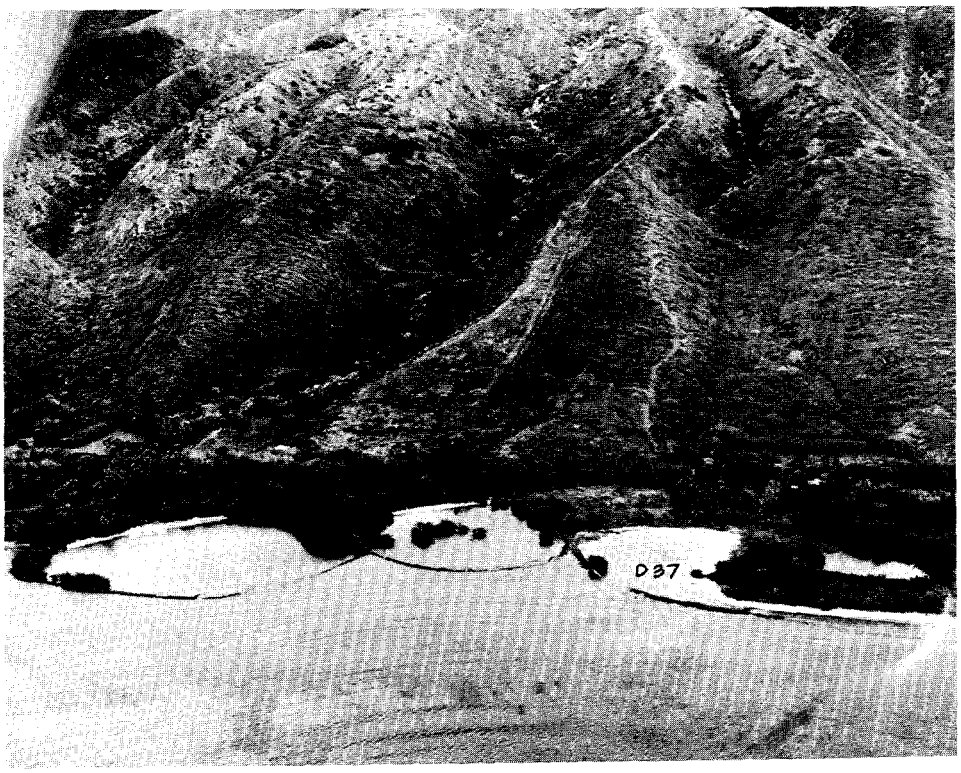
Fig. 35 Pond on right is Kula'alamihi, Feb. 21, 1971. Neg. #
Photo by George Bacon 5, 2/21/71, Ponds 47, 48, 49.

D37 KULA'ALAMIHI, at Honomuni, Moloka'i
USGS Quad: Kamalo
Tax Map Key: Portion of 5-7-04-34
Acreage 4 (?)
Ownership: Private

Ratings:	Apple	Kikuchi	
Basin	.3	.4	
Contents	.2	.5	
Setting	.4	.7	
Total	0.9	1.6	Final Rating: 1.25

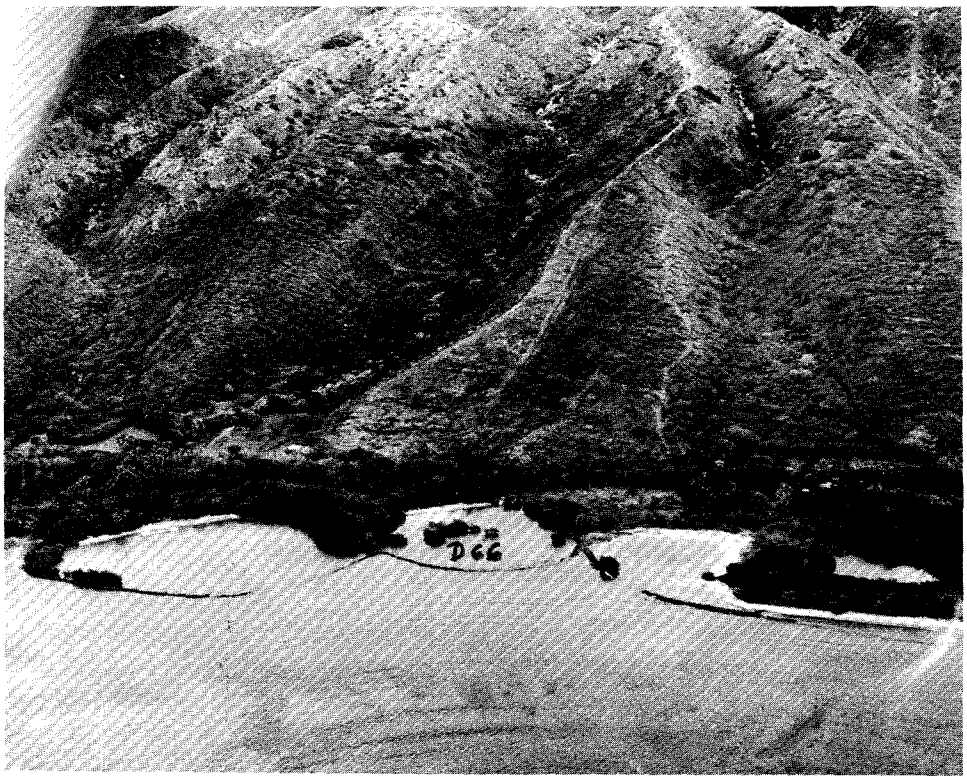
Fig. 36 Pond in center is Waihilahila, Feb. 20, 1971. Neg. # Photo by George Bacon 5, 2/20/71, Ponds 47, 48, 49.

D66 WAIHILAHILA, Ka'ili'ula, Moloka'i
USGS Quad: Halawa
Tax Map Key: Portion of 5-7-06-27
Acreage 4 (?)
Ownership: Private

Ratings:	Apple	Kikuchi	
Basin	.3	.4	
Contents	.2	.5	
Setting	.4	.7	
Total	.9	1.6	Final Rating 1.25

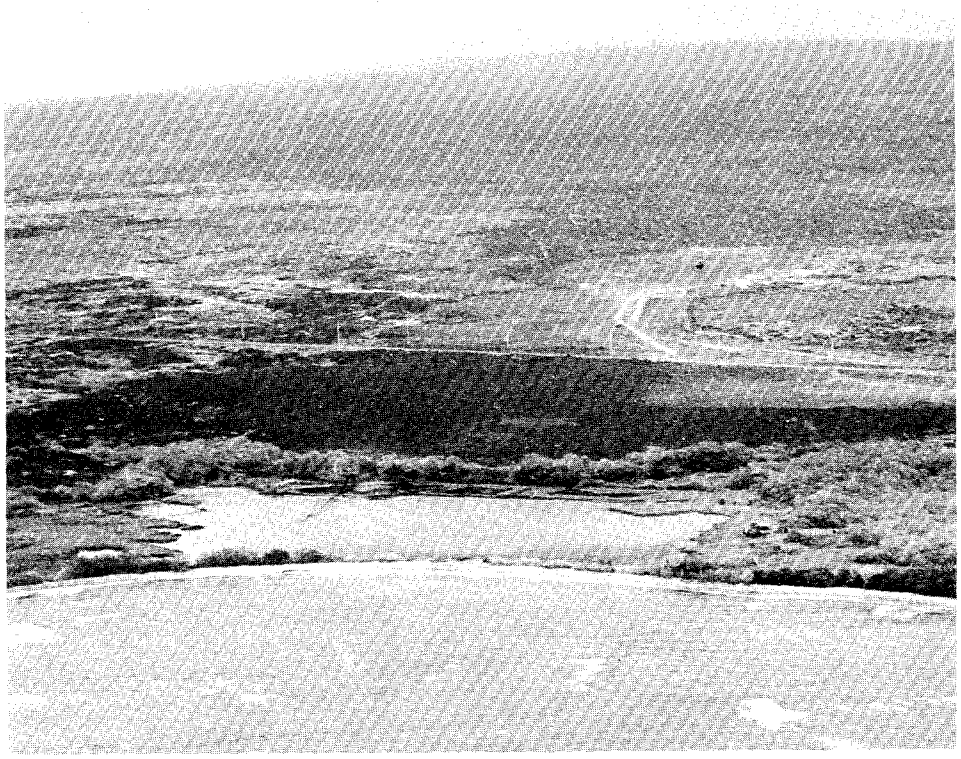
Fig. 37 'Aimakapa'a pond, May 22, 1974. Neg. # NPS - Hawai'i 4-10.

H1 'AIMAKAPA'A, at Honokohau II, Kona, Hawai'i
USGS Quad: Keahole Point
Tax Map Key: Portion of 7-4-08-10
Acreage 15 (?)
Ownership: Private

Ratings:	Apple	Kikuchi	
Basin	.8	.3	
Contents	.2	.3	
Setting	.5	.4	
Total	1.5	1.0	Final Rating: 1.25

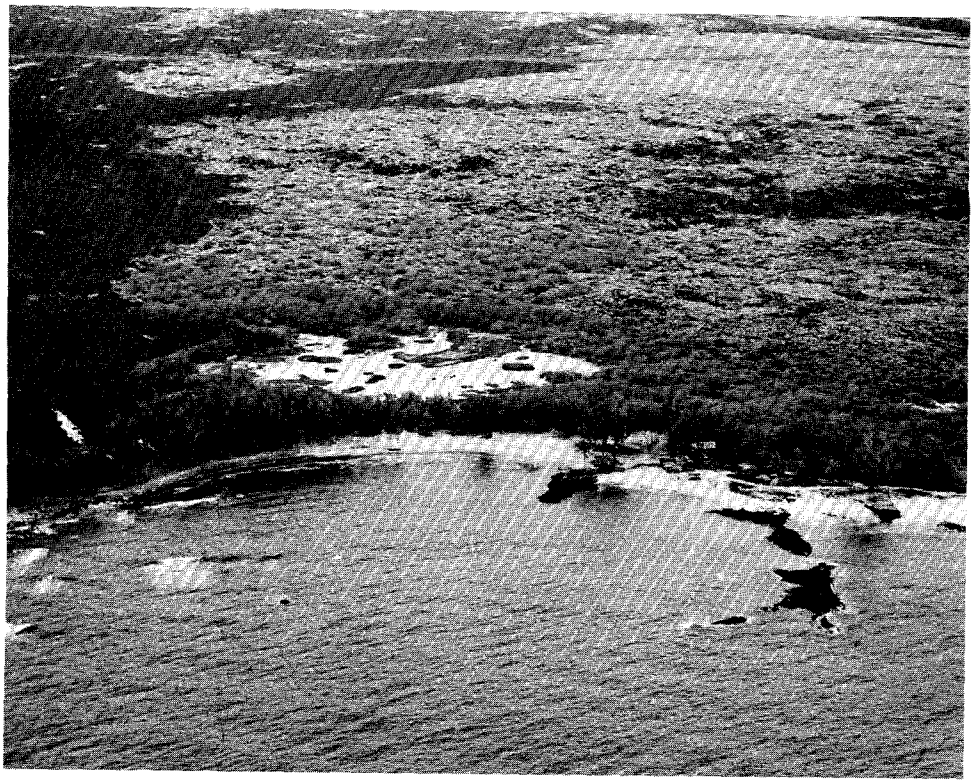
Fig. 38 'Opae'ula pond, May 22, 1974, Neg. # NPS - Hawai'i 4-13.

H54 'OPAE'ULA, at Makalawena, Kona, Hawai'i
USGS Quad: Makalawena
Tax Map Key: 7-2-04-1
Acreage 7 (?)
Ownership: Private

Ratings:	Apple	Kikuchi	
Basin	.7	.1	
Contents	.2	.1	
Setting	.8	.6	
Total	1.7	.8	Final Rating: 1.25

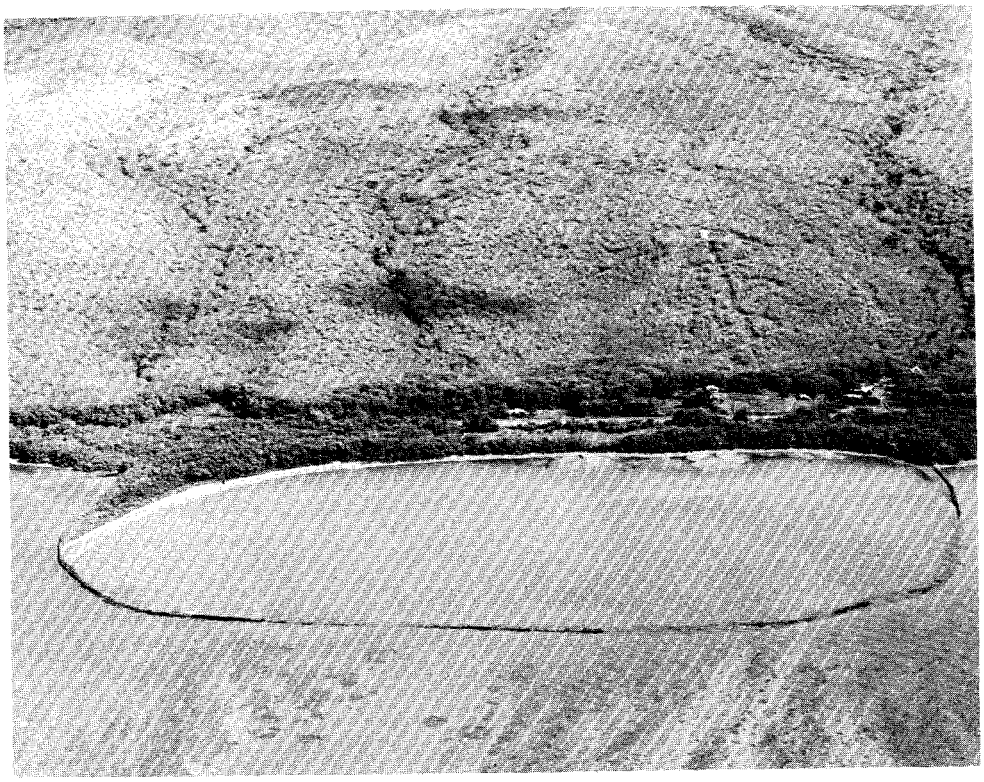
Fig. 39 Kanoa pond, Feb. 20, 1971. Neg. # Photo by George Bacon 2-9, 2/20/71 Pond 18.

D24 KANOA, Kawela, Moloka'i
USGS Quad: Kaunakakai
Tax Map Key: 5-4-03-23
Acreage 50 (?)
Ownership: Private

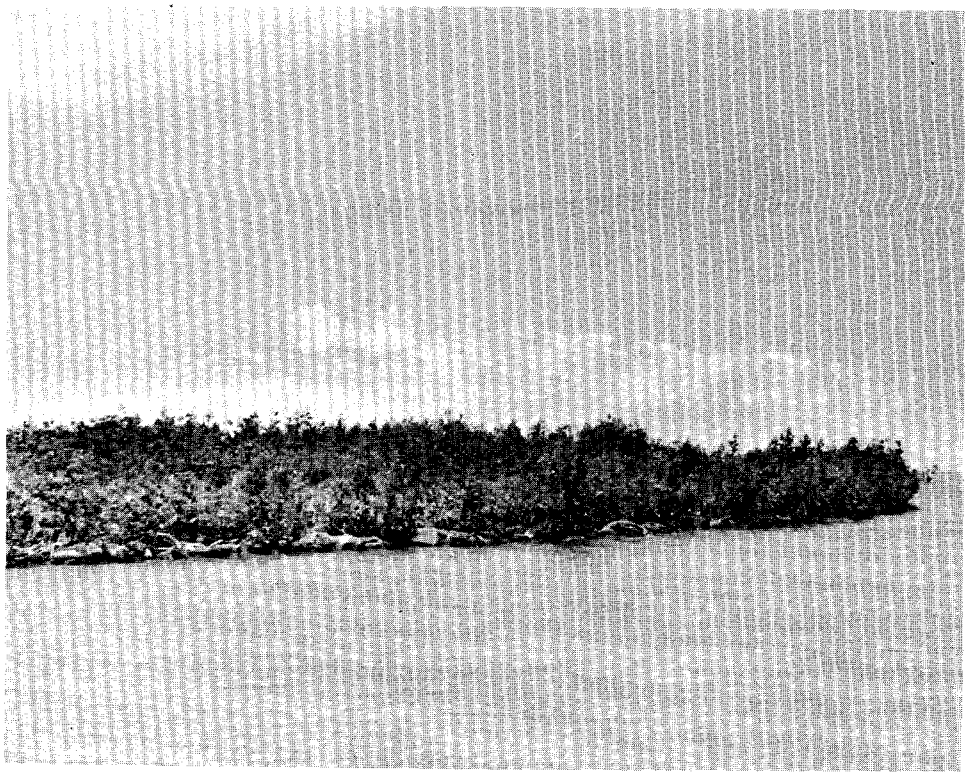
Fig. 40 Silt and mangrove in Kipapa pond, July 29, 1974. Neg. # NPS - Moloka'i 5-28. See Fig. 1, Chapt. II, for aerial view of Kipapa.

Ratings:	Apple	Kikuchi	
Basin	.3	.2	
Contents	.3	.1	
Setting	.8	.4	
Total	1.4	0.7	Final Rating 1.05

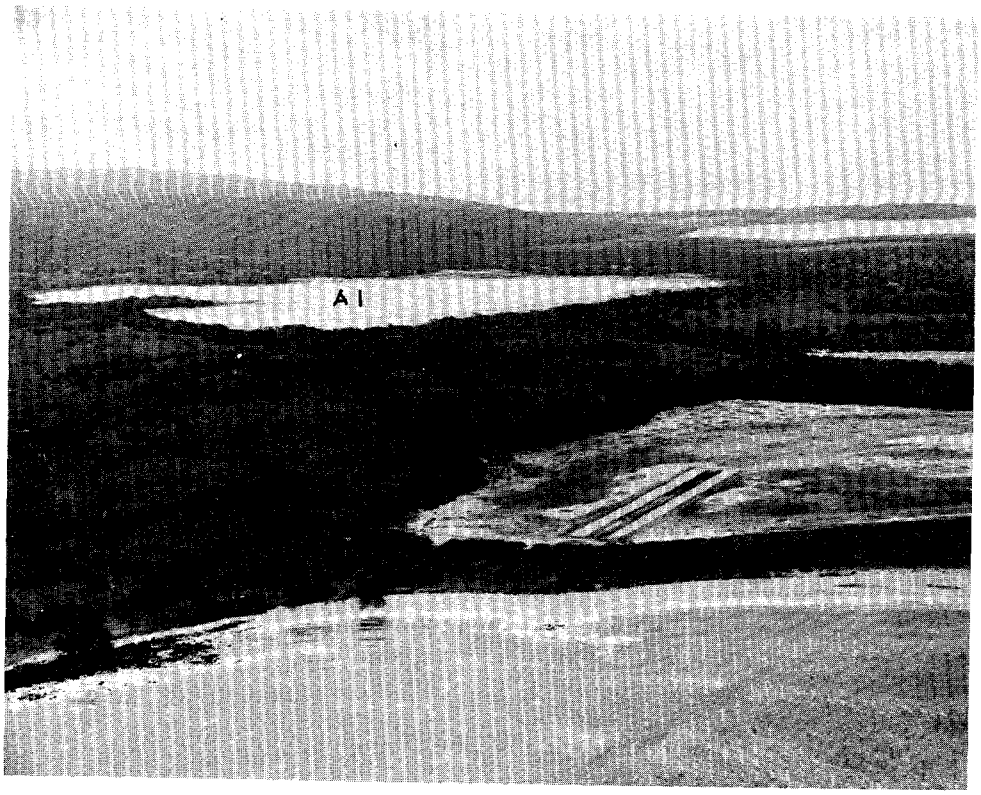
Fig. 42 nameless pond A1 (Halulu Lake), May 15, 1974. Neg. # NPS - A1-18A.

A1 nameless, at Halulu (lake), Ni'ihau

Final Rating:	Less than 1.00

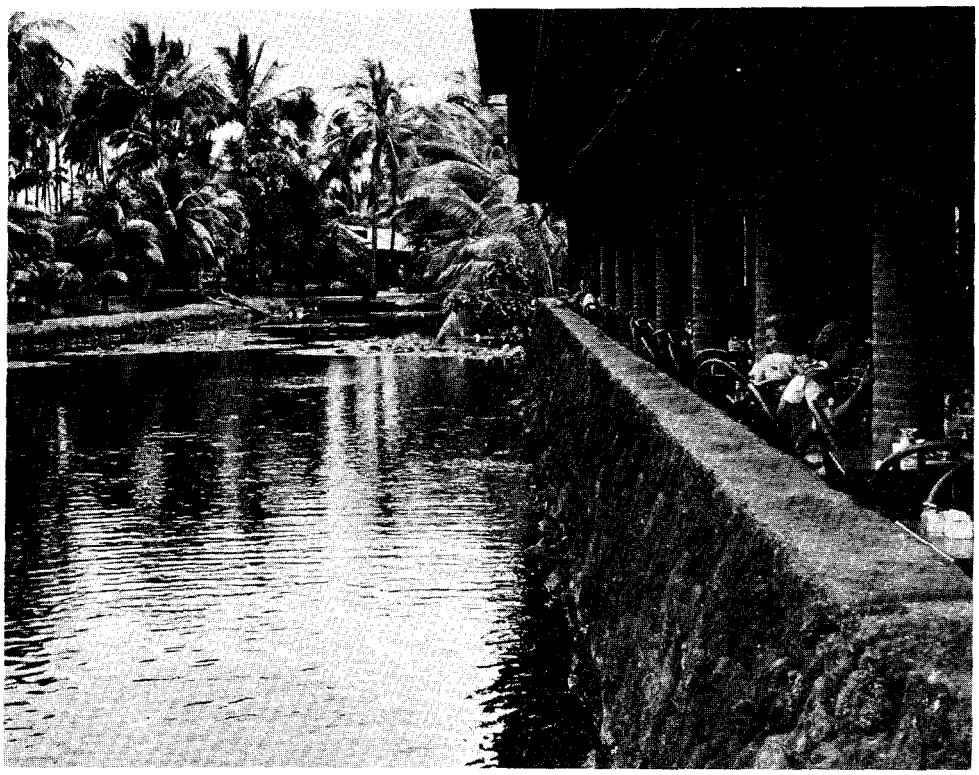
Fig. 45 nameless pond (B22A) at Wailua, June 22, 1974. Neg. # NPS - Kaua'i 6-35.

B22 nameless, at Coco Palms Hotel, Kaua'i
USGS Quad: Kapaa
Tax Map Key: Portion of 4-1-03-16
Acreage 3 (?)
Ownership: Private

Final Rating: Less than 1.00

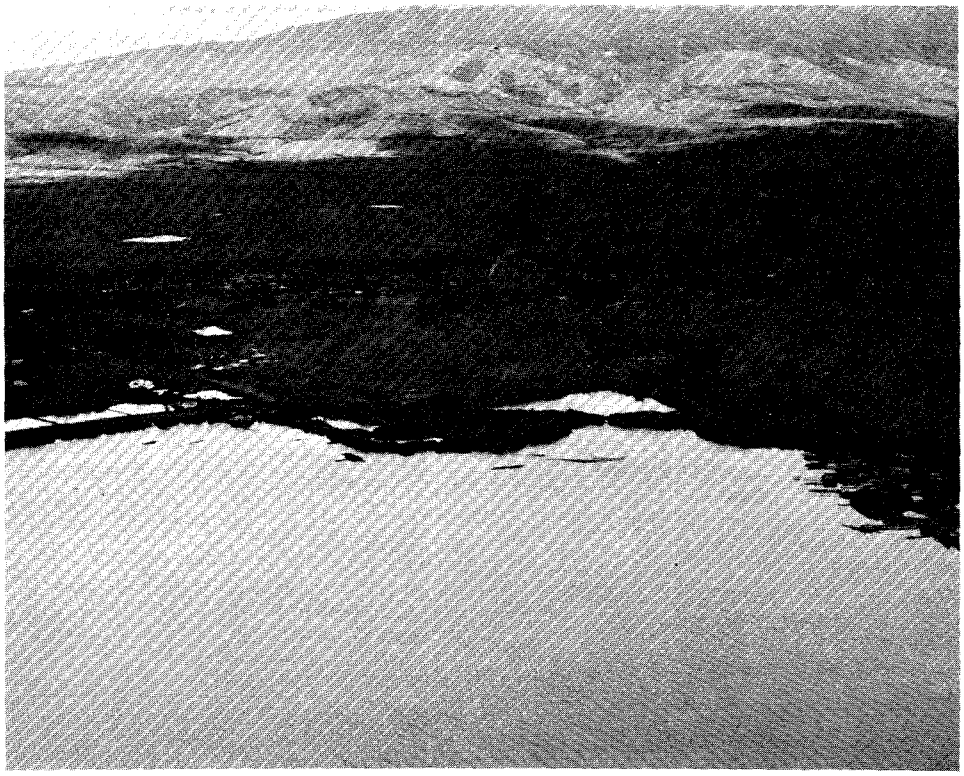
Fig. 46 Ka'auku'u pond, May 1, 1974. Neg. # NPS - O'ahu 2-22.

C21 KA'AUKU'U, at Waikele, Pearl Harbor, O'ahu
USGS Quad: Waipahu
Tax Map Key: 9-4-01-12
Acreage 4 (?)
Ownership: Private

Final Rating: Less than 1.00

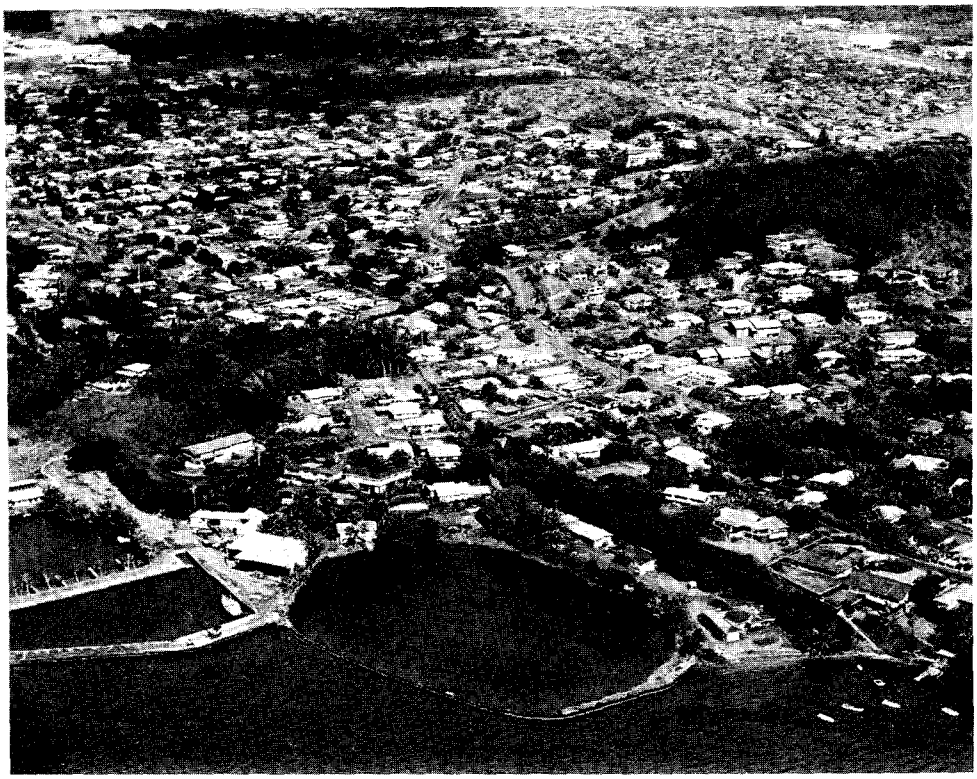
Fig. 47 Kanohulu iwi pond, July 23, 1974. Neg. # NPS - O'ahu 10-33.

C50 KANOHULU IWI, at Kane'ohe, Ko'olaupoko, O'ahu
USGS Quad: Kaneohe
Tax Map Key: 4-5-57-1
Acreage 3 (?)
Ownership: Private

Final Rating:	Less than 1.00

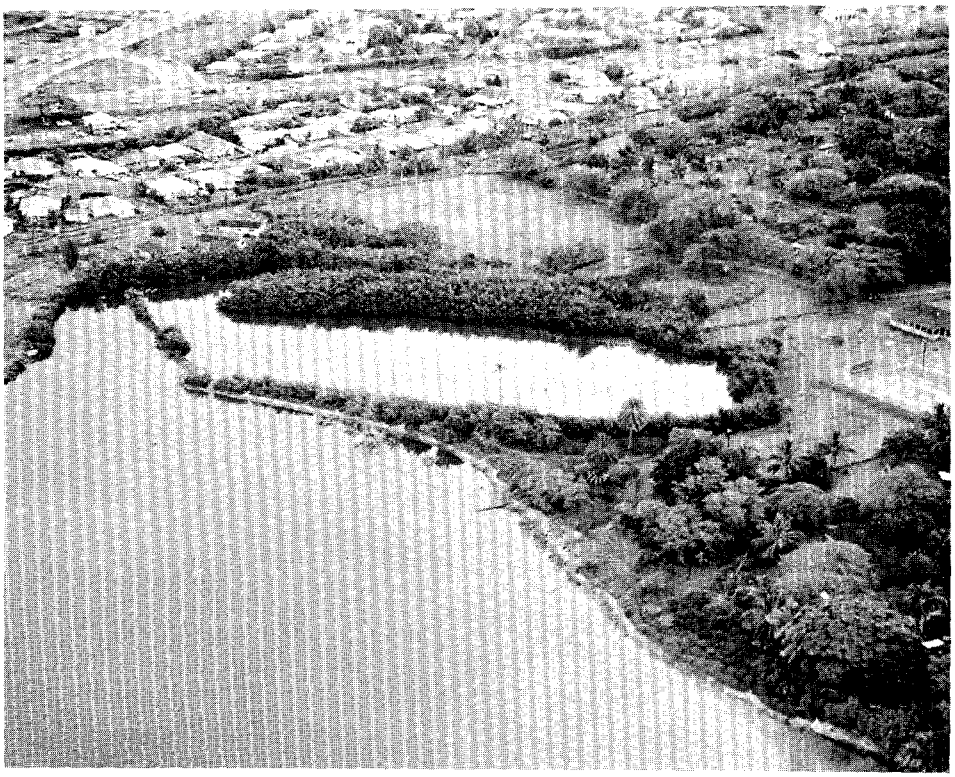
Fig. 50 Pa'aiau pond, May 1, 1974. Neg. # NPS - O'ahu 1-5.

C123 PA'AIAU, at McGrew Point, Kalauao, Pearl Harbor, O'ahu
USGS Quad: Waipahu
Tax Map Key: 9-8-19-3
Acreage 3 (?)
Ownership: United States of America

Final Rating: Less than 1.00

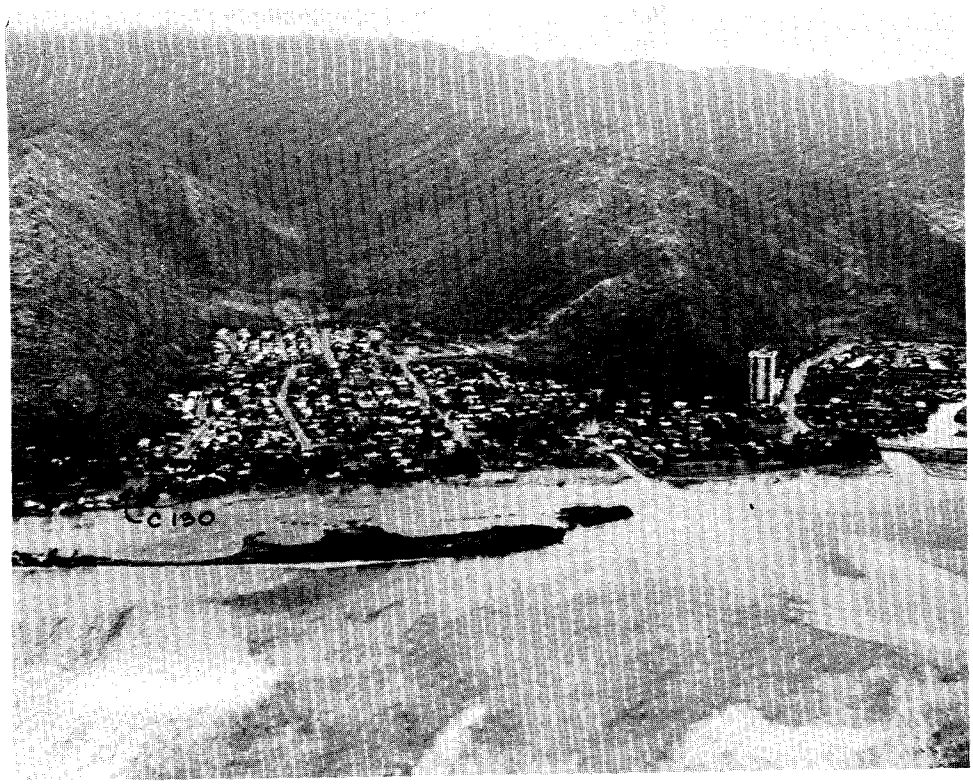
Fig. 51 "Paiko" pond, May 1, 1974. Neg. # NPS - O'ahu 5-21A.

C130 "PAIKO", at Kuliouou, Honolulu, O'ahu
USGS Quad: Koko Head
Tax Map Key: 3-8-02-2/13/21/22/24/25/26/27/28/36/37
Acreage 2 (?)
Ownership: Private

Final Rating:	Less than 1.00

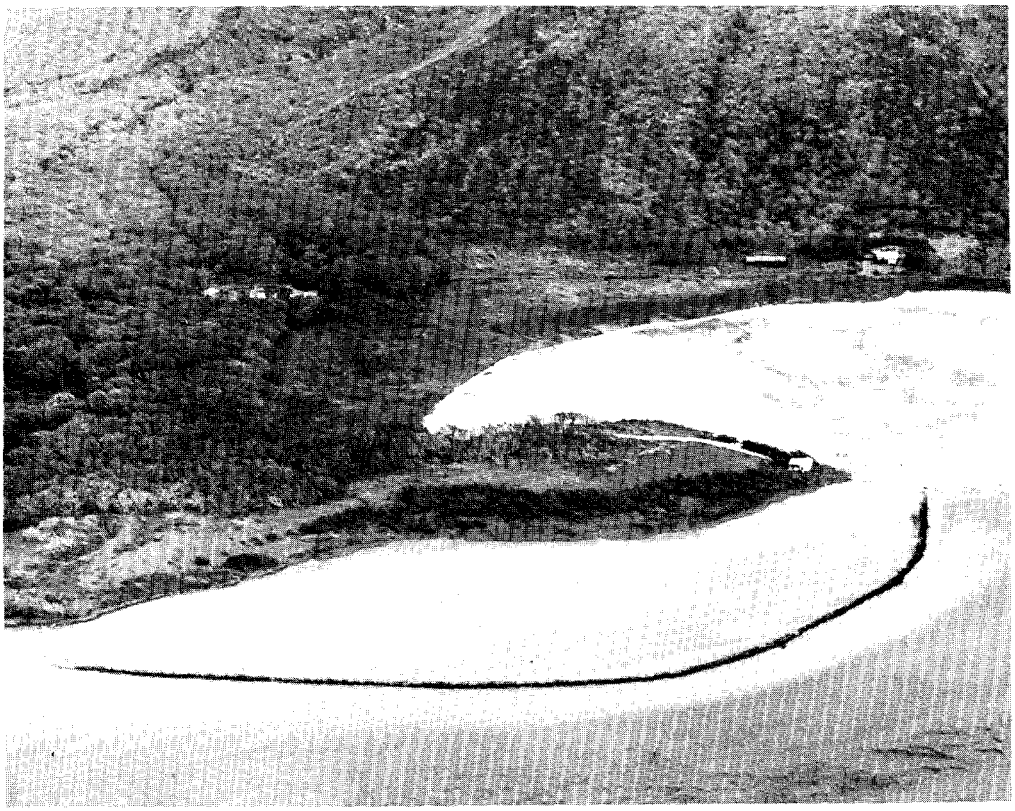
Fig. 53 Kaloko'iki pond, Feb. 20, 1971. Neg. # Photo by George Bacon #23, 2/20/71 Pond 28.

D16 KALOKO'IKI, at Wawaia, Moloka'i
USGS Quad: Kamalo
Tax Map Key: Portion of 5-6-08-20
Acreage 6 (?)
Ownership: Private

Final Rating:	Less than 1.00

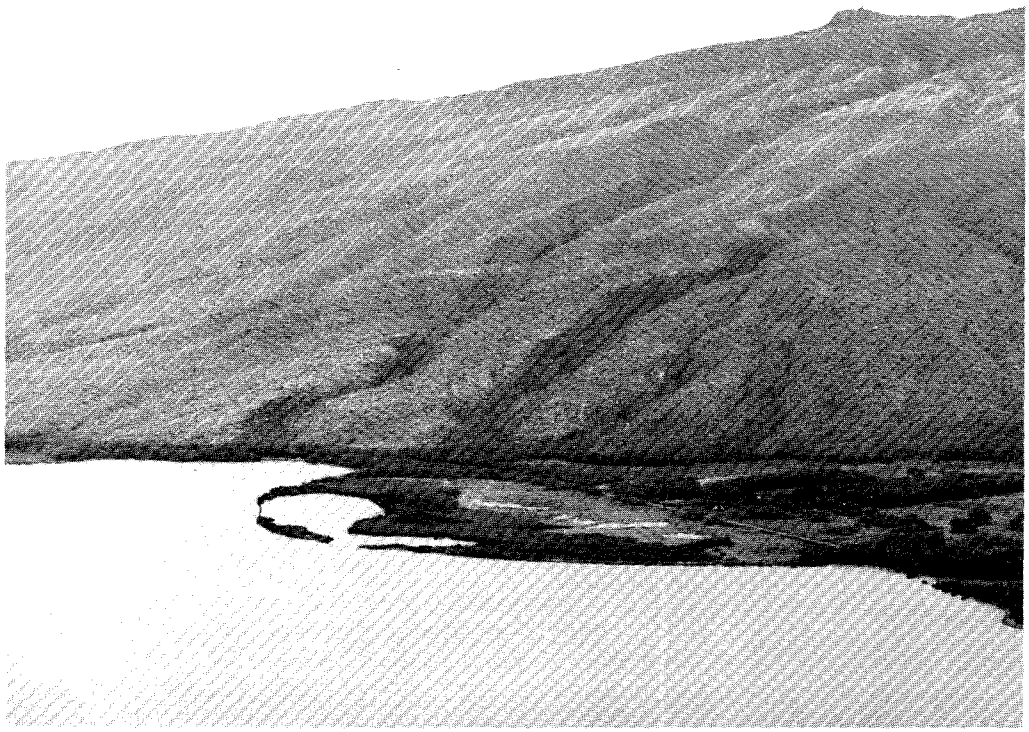
Fig. 54 Kamahu'ehu'e pond, May 22, 1974. Neg. # NPS - Moloka'i 0-18.

D22 KAMAHU'EHU'E, at Kamalo Moloka'i
USGS Quad: Kamalo
Tax Map Key: 5-5-02-5
Acreage 37 (?)
Ownership: Private

Final Rating:	Less than 1.00

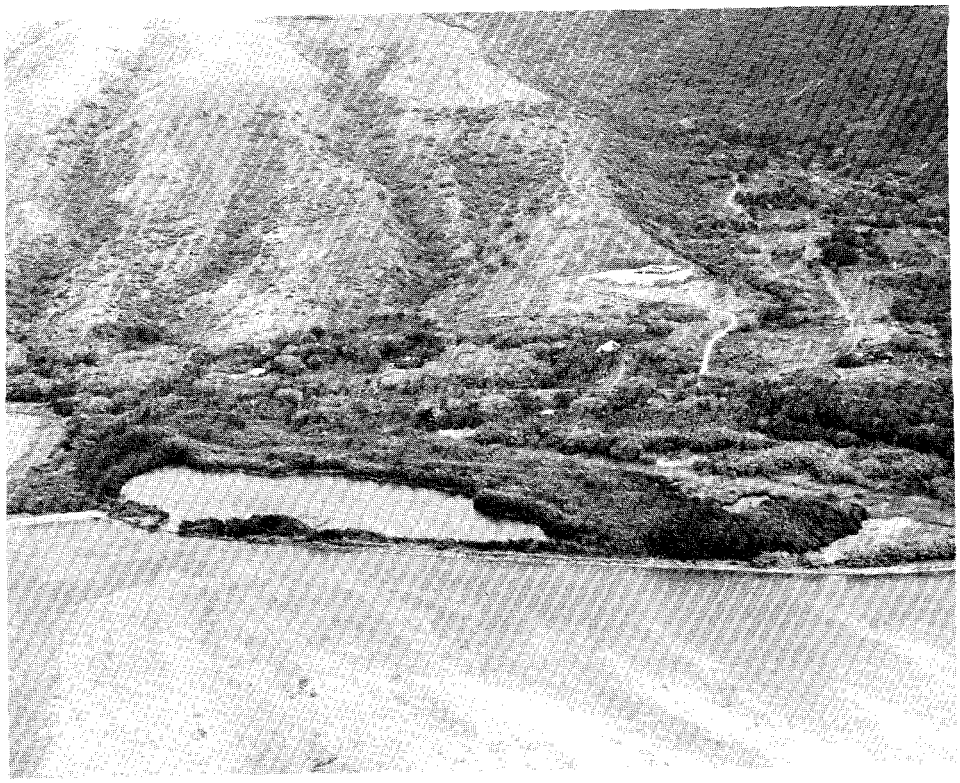
Fig. 55 Pi'opi'o pond, Feb. 20, 1971. Neg. # Photo by George Bacon 9, 2/20/71 Pond 43.

D56 PI'OPI'O, at Mapulehu, Moloka'i
USGS Quad: Halawa
Tax Map Key: 5-7-08-77
Acreage 17 (?)
Ownership: Private

Final Rating: Less than 1.00

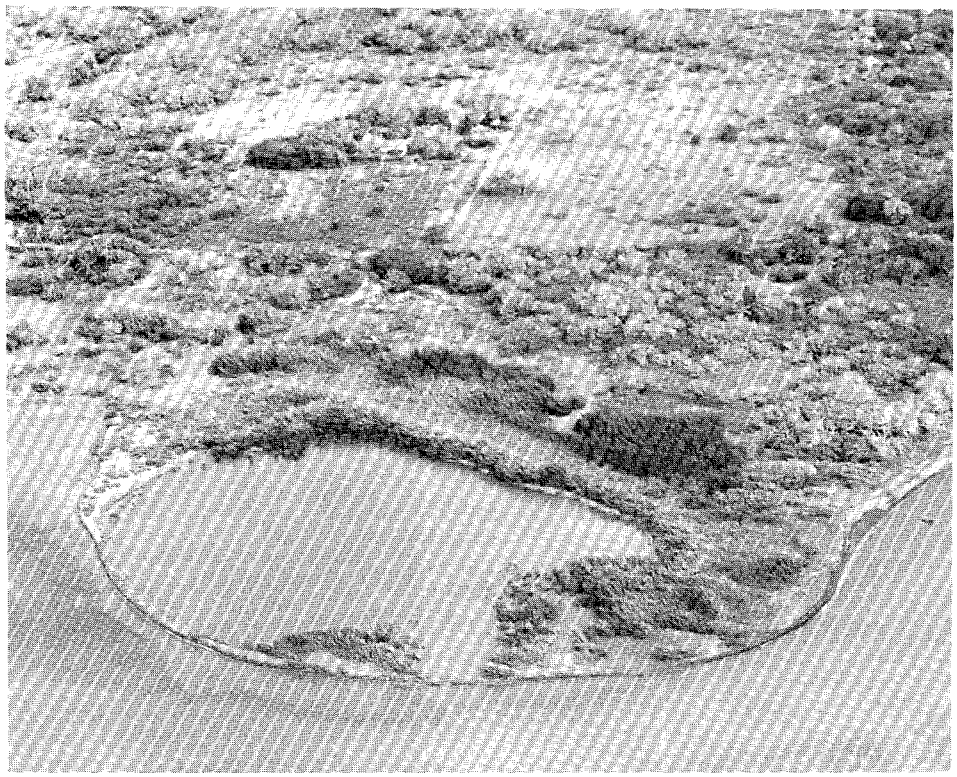
Fig. 56 Pūhāloa pond, Feb. 20, 1971. Neg. # Photo by George Bacon 16, 2/20/71, Pond 36.

D57 PŪHĀLOA, at Manawai, Moloka'i
USGS Quad: Kamalo
Tax Map Key: 5-6-04-29
Acreage 6 (?)
Ownership: Private
