RPP-ASMT-46452
Revision 0

Tank 241-C-105
Leak Assessment Completion Report

Washington River Protection Solutions LLC

Date Published
May, 2010

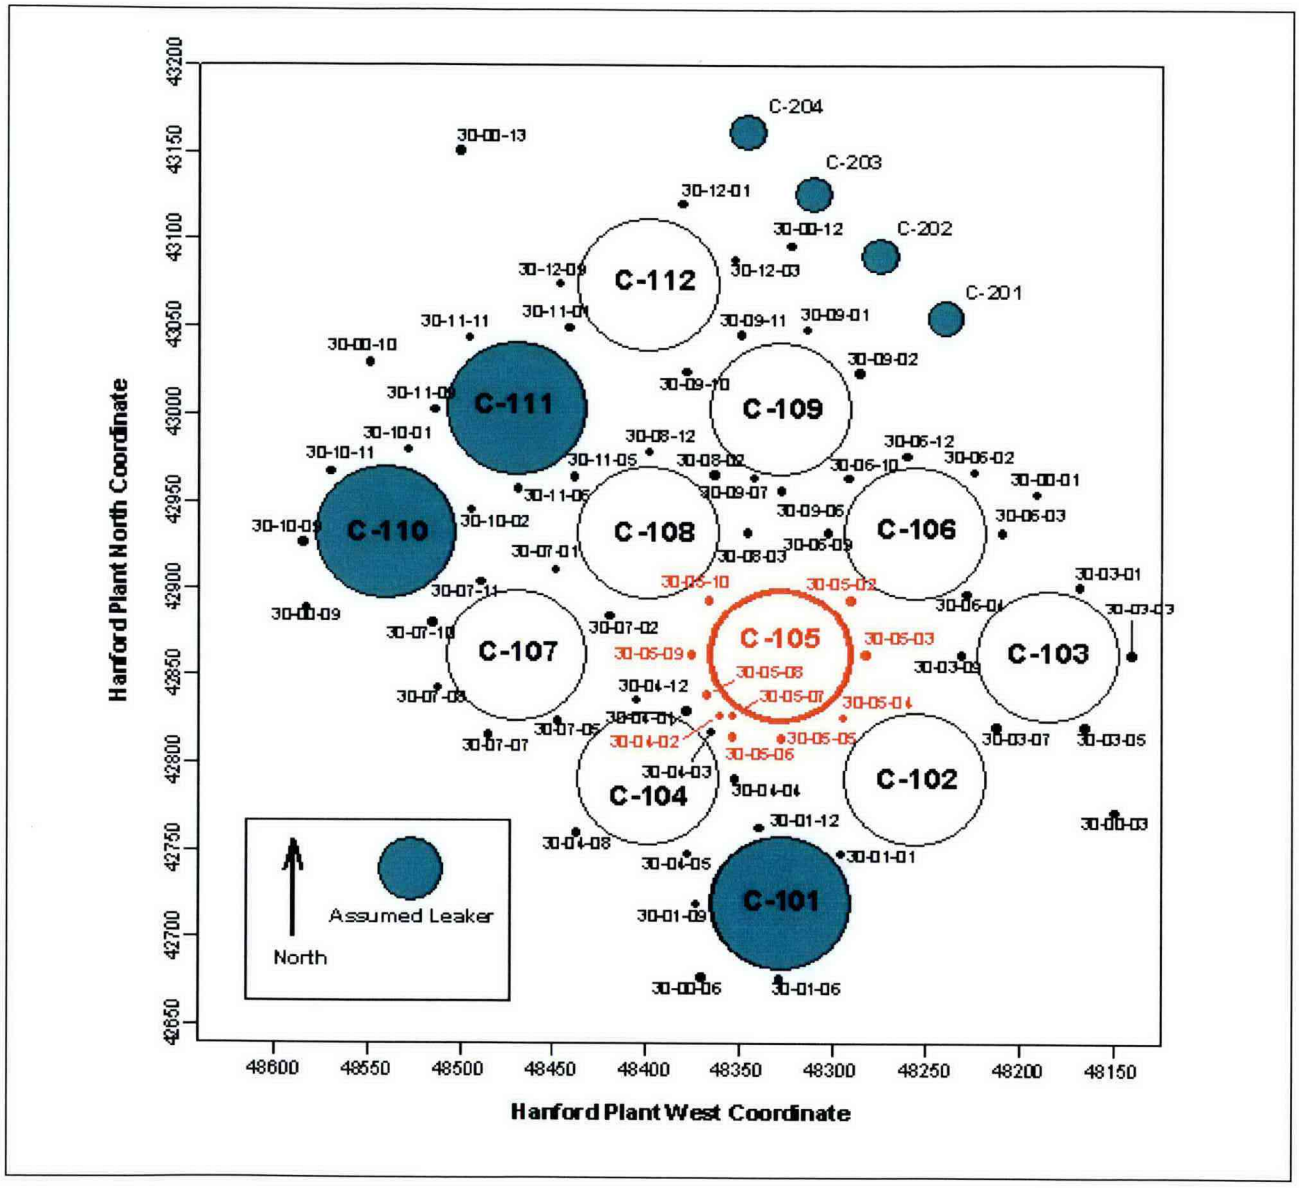
Figure 1-1 Plan View of Tanks and Drywells in the 241-C Tank Farm

Tank C-105 is the second tank in the tank C-104, C-105, C-106 cascade. Drywells illustrated in the plan are identified by their associated tank number and clock position from North. (from GJ-HAN-83, Vadose Zone Characterization Project at the Hanford Tank Farms – Tank Summary Data Report for Tank C-105)

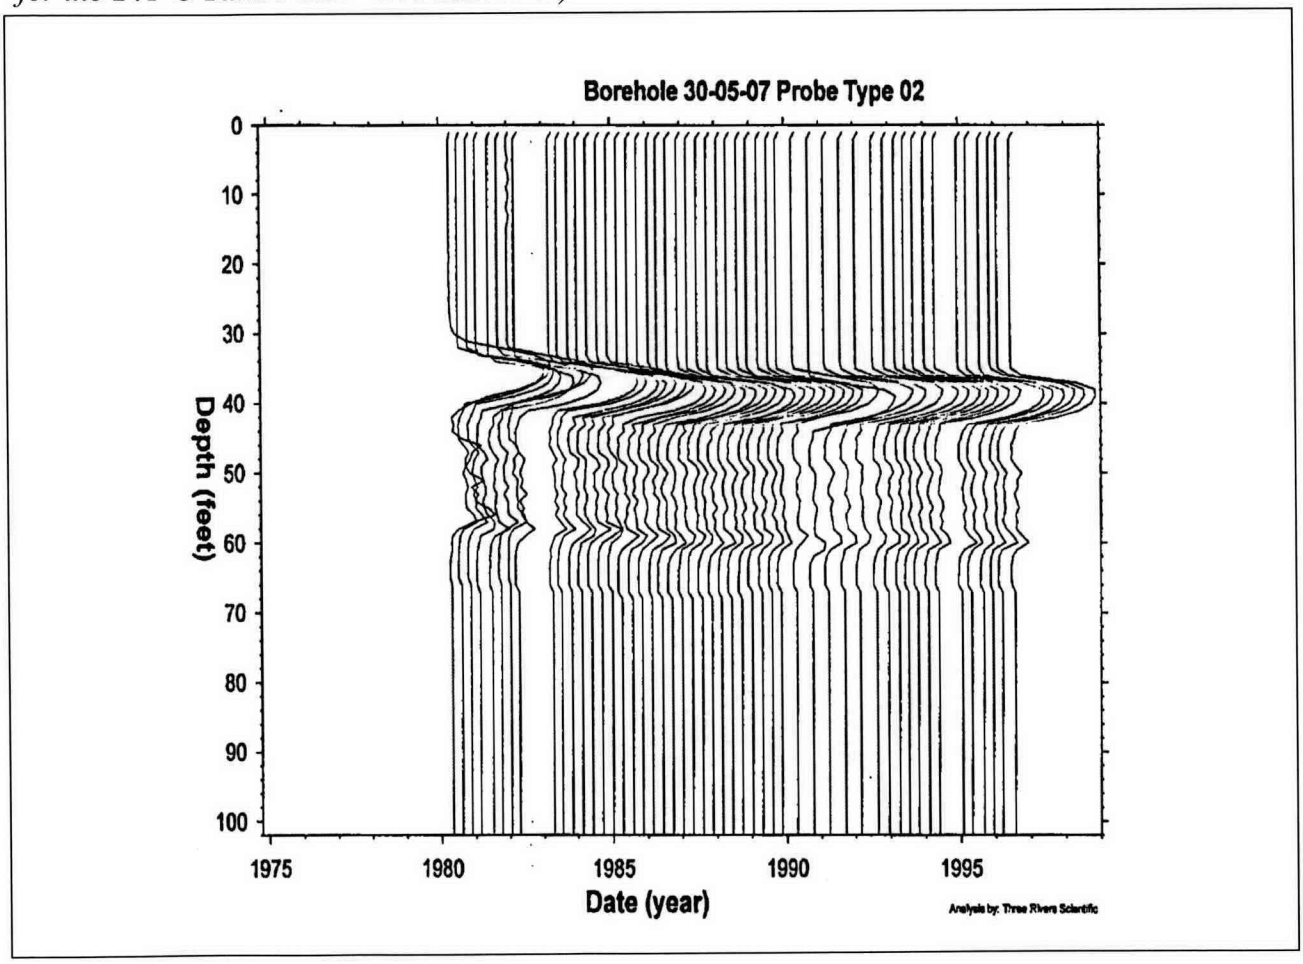
Drywell 30-05-07 was drilled in July, 1974. A high activity peak was identified at a depth of 37-ft bgs with a GM probe (Figure 3-2).

The gross gamma scans between 1974 and 1997, when the scans were discontinued, show that the peak was stable and decaying with a Cs^{137} half-life. The peak stability indicated that the peak was not being supplied by an active plume. If the peak was evidence of a tank leak, then the leak occurred prior to 1974 and apparently self-sealed by the time the drywell was drilled..

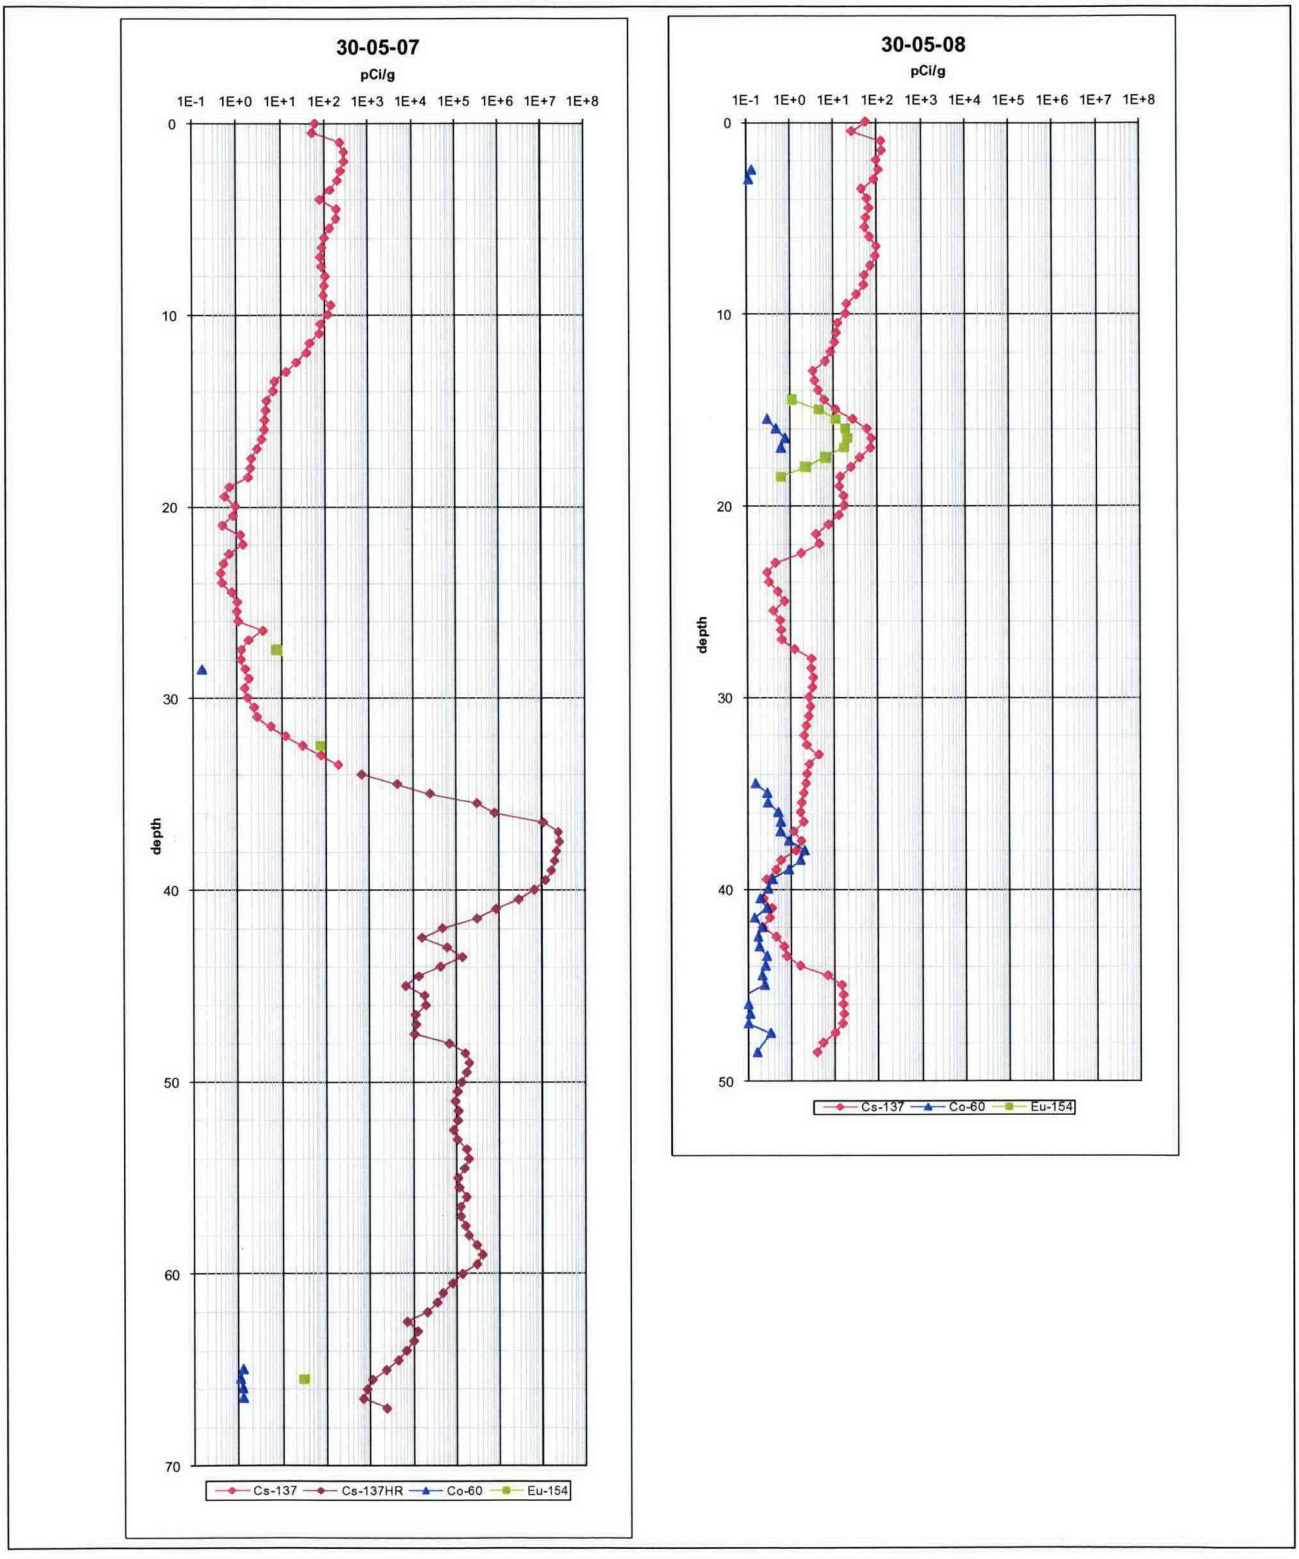
The Spectral Gamma Logging System (SGLS) was used to log the drywell in 1997. Figure 3-3 shows the SGLS log for drywell 30-05-07. The SGLS log for drywell 30-05-08, located about 20.5-ft from drywell 30-05-07, is shown for comparison.

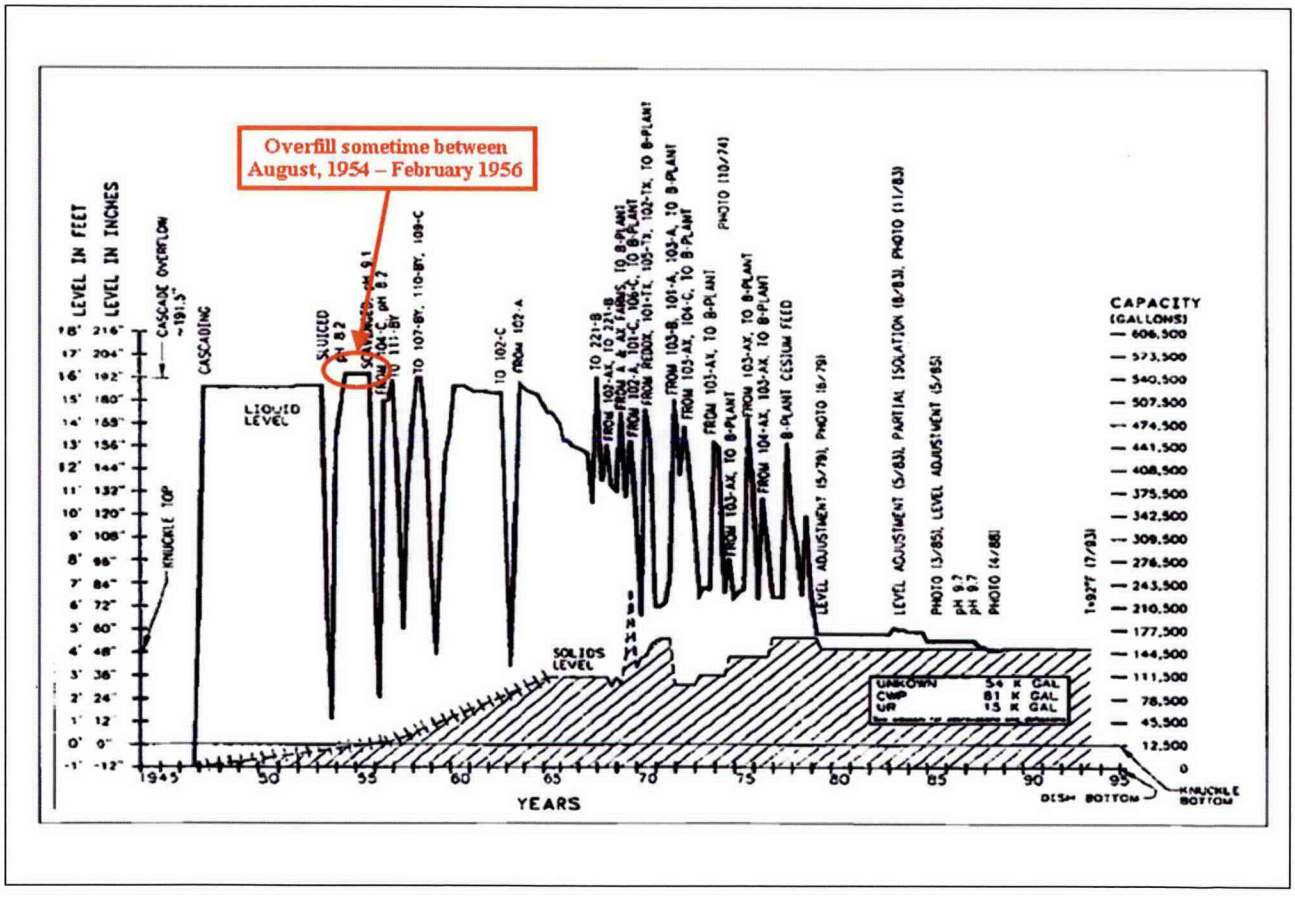
Figure 4-1 Tank C-105 Fill History

Quarterly production records show the waste volume in tank C-105 as 546-kgal during the August, 1954 – February, 1956 period (Figure 4-1). At this volume the inlet cascade line sidewall penetration would have been partially submerged in waste.

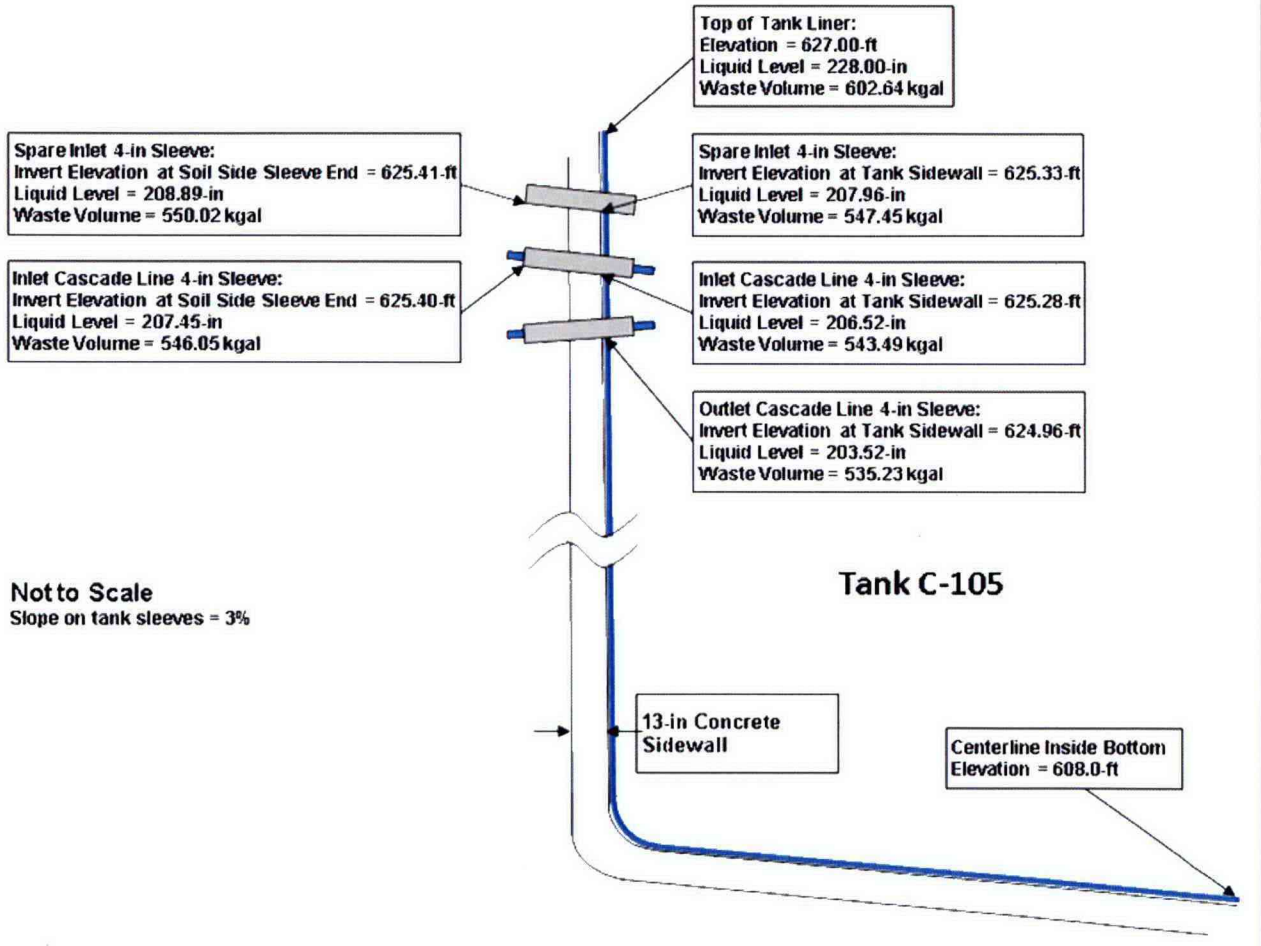
Figure 4-2 Tank C-105 Sidewall Penetration Elevations

Tank C-105 sidewall penetrations, their invert elevations at the sidewall referenced to the centerline of the tank bottom, and the liquid level and waste volume held in the tank at the invert elevations are displayed in Figure 4-2.

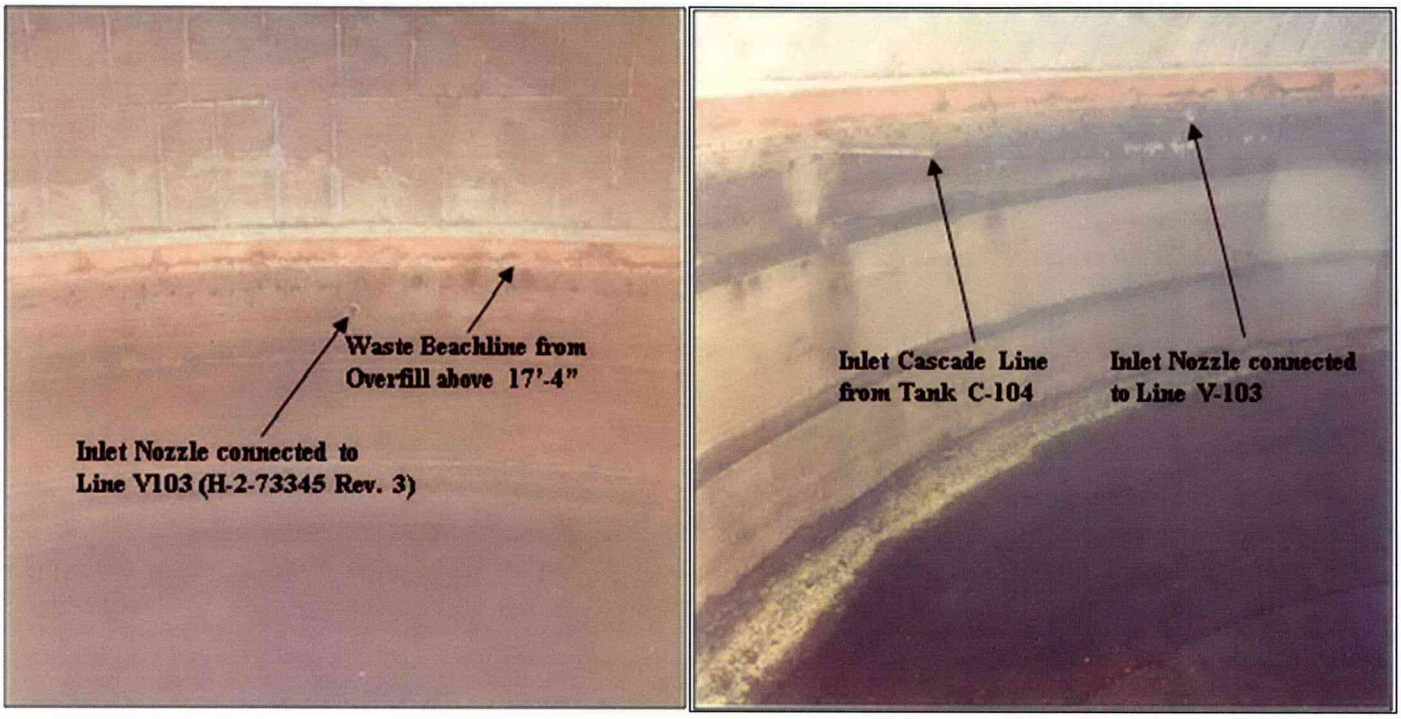
Figure 4-3 Tank C-105 Overflow Beachline with Cascade and Inlet Lines

Missing paint and the presence of a waste beachline above the spare inlet nozzles indicate that tank was filled above the spare inlets at one time. (Negative 746325-29CN, October 11, 1974) (from October 11, 1974 Negative 746325-29CN [Waste Level – 78.5-in] and March 28, 1985 Negative 8502079-6CN [Waste Level = 55-in])

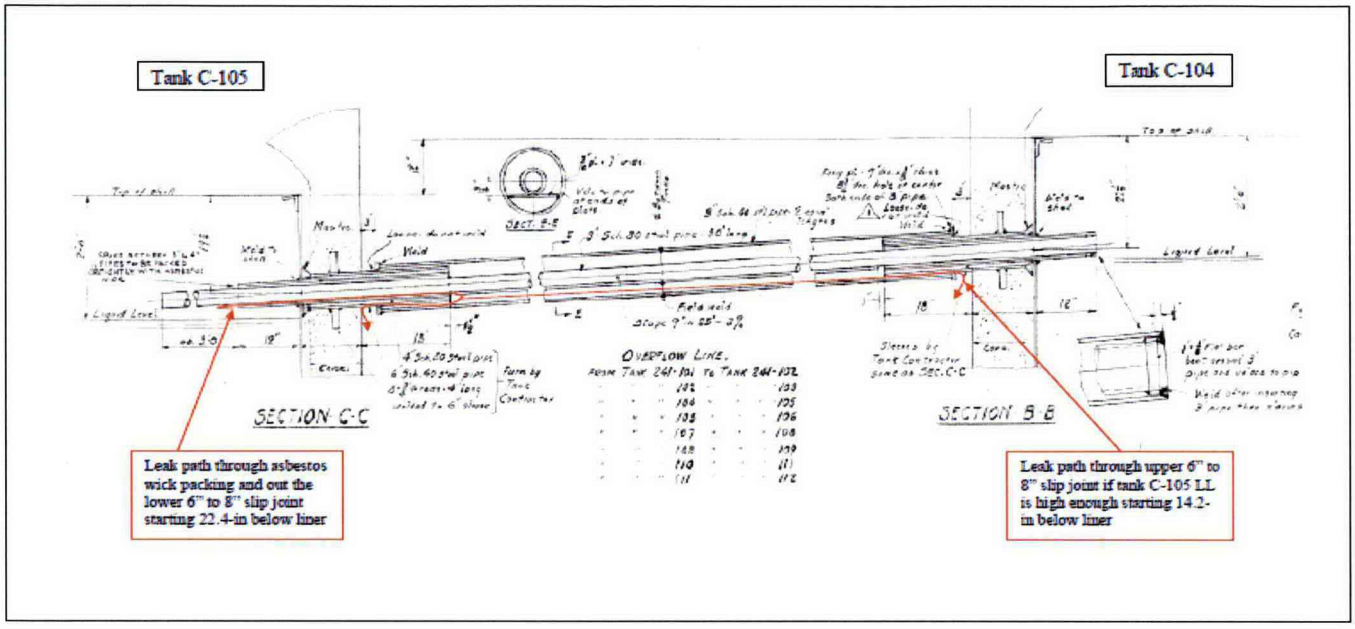
Figure 4-4 Tank C-104 to Tank C-105 Cascade Line Leak Paths

The cascade line tank sidewall penetration consists of a 43-in long, 4-in diameter Schedule 80 pipe sleeve holding the cascade line. The 3/16-in annular space between the 4-in sleeve and the 3-in diameter Schedule 80 cascade line has a total cross-section of 1.88-in^2. During construction the space was tightly packed with asbestos wick to prevent waste from leaking through the gap if the tank was ever overfilled. It seems unlikely that the entire 43-in long annulus could have been packed with the asbestos wick considering its length and narrow width; probably the wick was inserted as far a practical from both ends and tamped in place.

There is anecdotal evidence that the cascade line penetration would leak if it were submerged. The tanks in the 241-C tank farm are arranged in 3-tank cascades, with each downstream tank in the cascade set 12-in lower than the previous tank to facilitate gravity flow from one tank to the next, to the next. Tank C-104, located upstream of tank C-105, was equipped with both inlet and outlet cascade lines. The outlet penetration was set 3-in below the inlet penetration. During normal, gravity flow operation, the annular gap between the cascade line and the 4-in sleeve would be partially submerged. During installation of the drywells in 1974 evidence of past leakage was found near the tank C-104 outlet cascade line penetration.

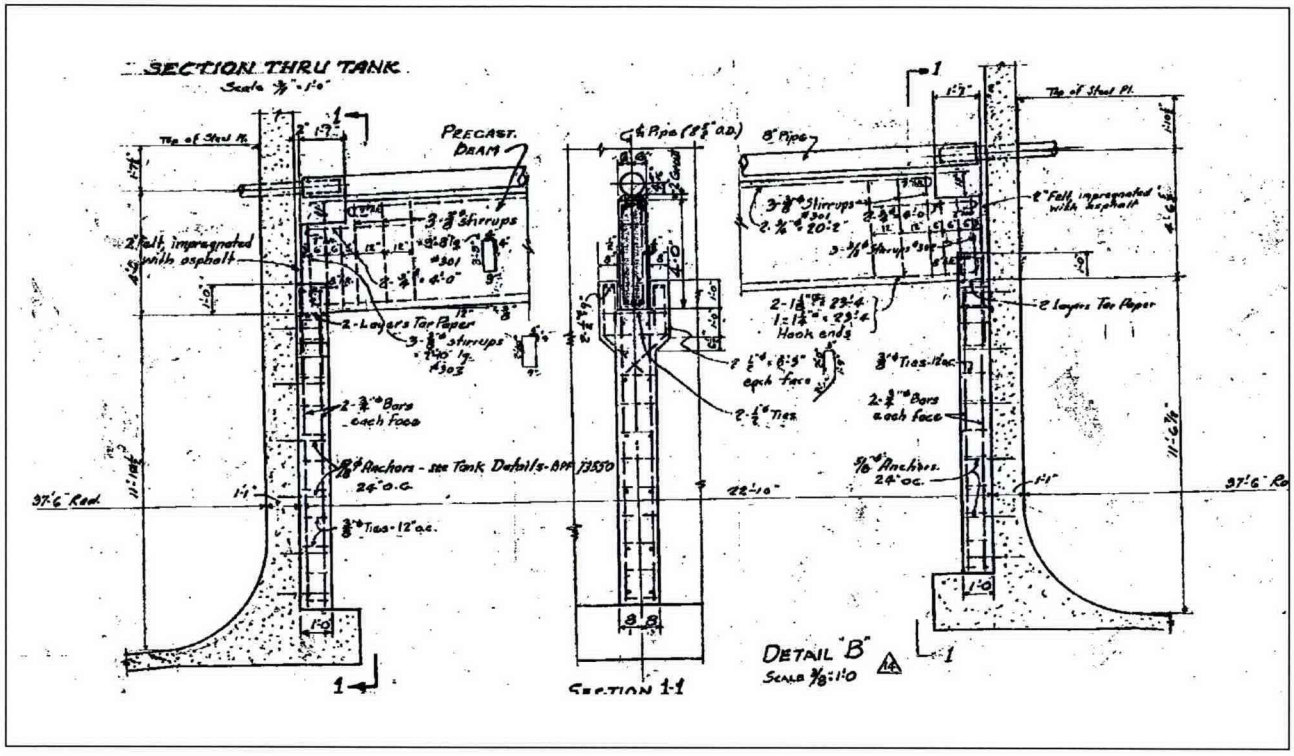
Figure 4-5 Cascade Line Support Beam and Columns

The cascade line between tanks C-104 and C-105 is mounted on a concrete beam. The beam is supported by a series of vertical concrete columns. The arrangement is shown in Figure 4-5. At the tank C-105 sidewall the beam is supported by a concrete buttress attached to the tank

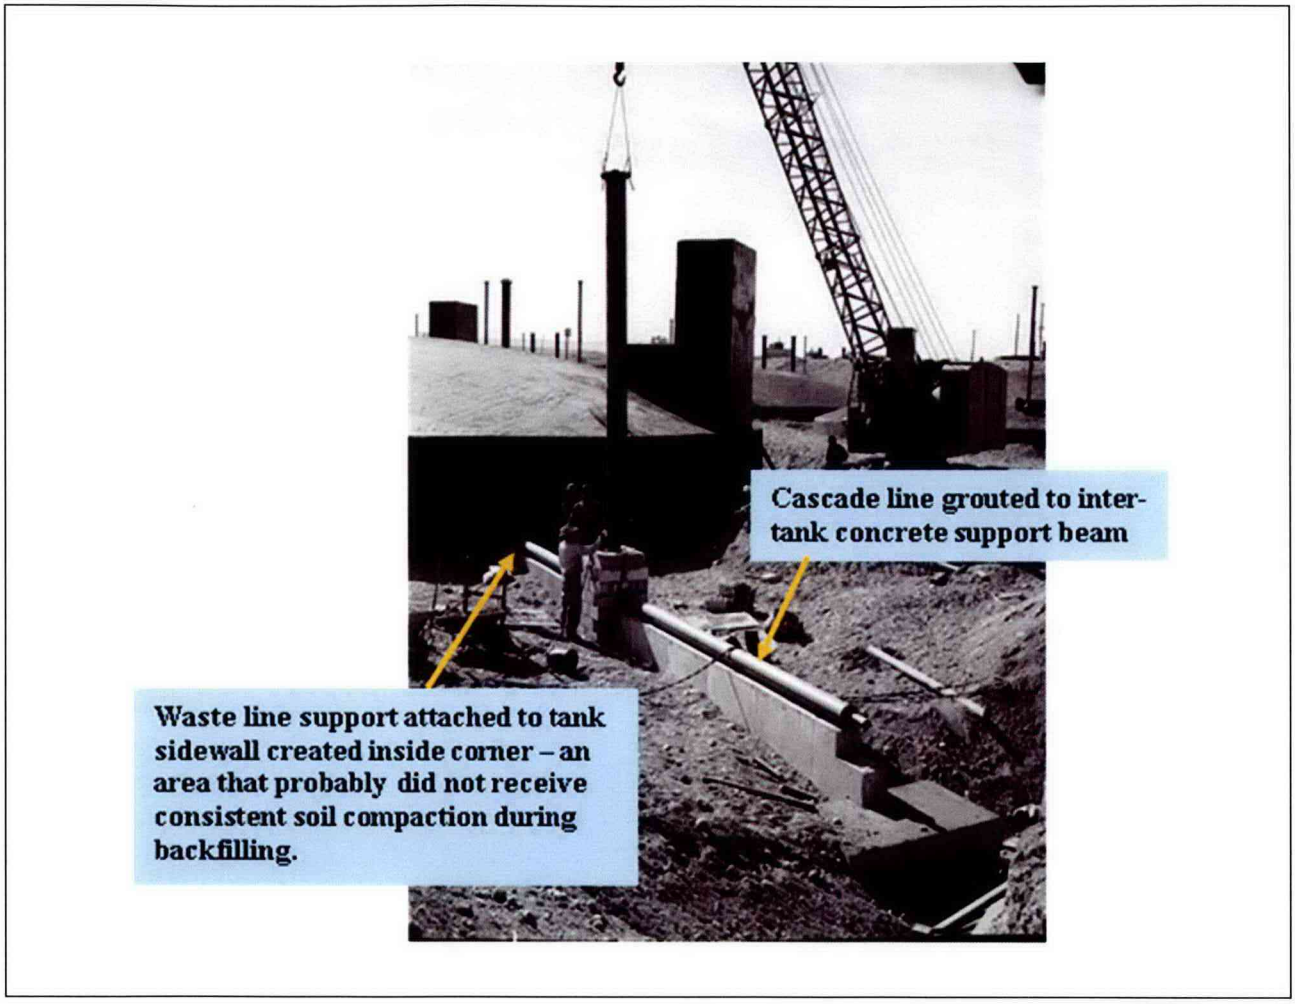
Figure 4-6 Cascade Line Installation in 241-BX Tank Farm

The buttress and columns were installed before the tank excavation was backfilled. Once backfilling neared the tops of the columns, the beam was placed and the cascade line mounted on the beam (Figure 4-6). During backfilling, soil compaction of the inside corner formed by the buttress and the tank sidewall would have been problematic. It is likely that this area would not have been accessible for machine tamping, and therefore was probably not compacted to the same extent as the surrounding area. In the event of a leak through the cascade line penetration, the waste plume would move down through the loosely compacted soil column in the inside corner toward the tank footing. Lateral movement of the plume away from the inside corner would be restrained because of the higher compaction forces that had been applied to the backfill outside of the immediate area.

The 241-BX tank cascade line features illustrated in the photograph are identical to the 241-C tank features. Photographs of the 241-C tanks are not available.

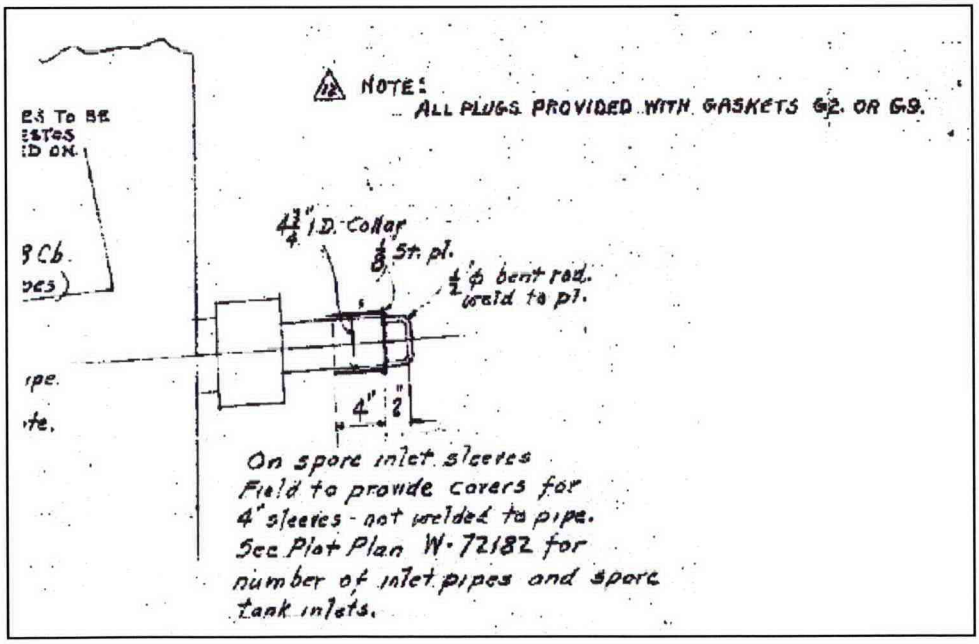
The penetrations consist of a 4-in schedule 80 open pipe stub covered on the soil side of the tank with a loose-fitting metal cap. The spare inlet penetration detail is shown in Figure 4-7. The 4-3/4-in id x 4-in long cap was fit over the 4-in pipe sleeve. The cover was not welded in place but provided with a gasket, according to the construction drawing. The outer diameter of 4-in Schedule 80 pipe is 4-1/2-in, so the clearance between the loose-fitting cap and the pipe sleeve was about 1/8-in. This created an open annular cross-section of about 1.82-in between the cap

The tank C-105 spare inlet penetrations were excavated in October,1967, to connect one of them to the new V-103 process line. During the excavation, soil contamination of 3.71 µCi/ml (~1.8 x 10^6 pCi/g) was found beneath the penetrations indicating waste had leaked out through the caps. The Cs^{134}:Cs^{137} ratio of the contaminated soil indicated that the contamination was not from the waste stored in tank C-105 at the time of the excavation. There is no documentation of the as-found condition of the spare inlet penetrations or their loose-fit caps.

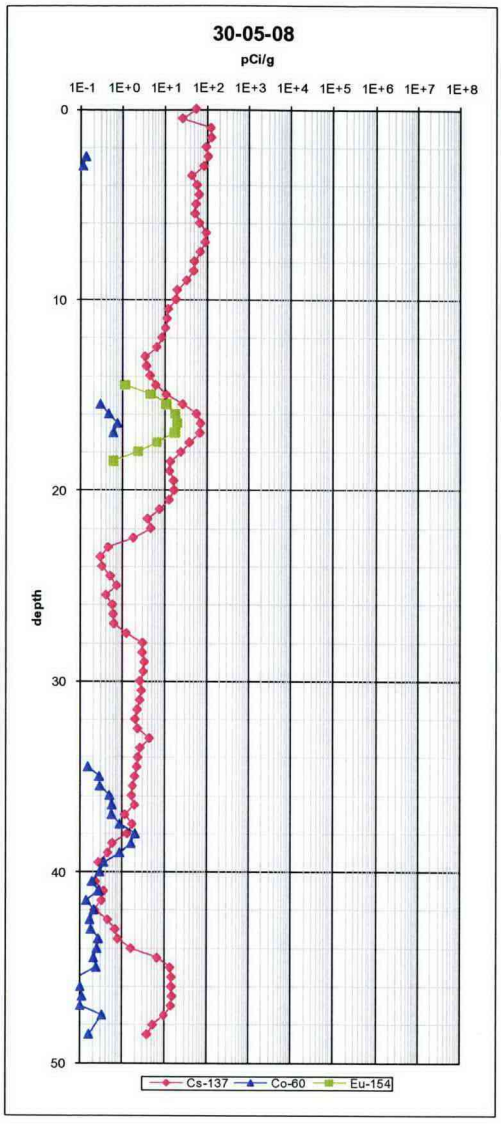
Figure 4-8 Drywell 30-05-08 Spectral Gamma Log

It is likely that the soil contamination occurred when the tank was overfilled during the 1954 – 1956 time period. Interestingly, drywell 30-05-08, located 8.9-ft. from the termination of the spare inlet penetrations 18-in outside of the tank, and 4.65-ft from the edge of the 2-ft wide tank footing, has never showed evidence of a contamination plume. Low concentrations of Cs^{137} soil contamination extend from the surface down to about 50-ft bgs (Figure 4-8).

During tank excavation backfilling, access to the area around and beneath the spare inlet penetrations would not have been restricted as it was near the inlet cascade line penetration. Soil compaction should have been uniform. With uniformly compacted soil, waste leaking through the spare inlet penetrations should have moved downward and outward simultaneously. If the leak had been large, the plume should have been intercepted by drywell 30-05-08 when it was drilled in 1974.

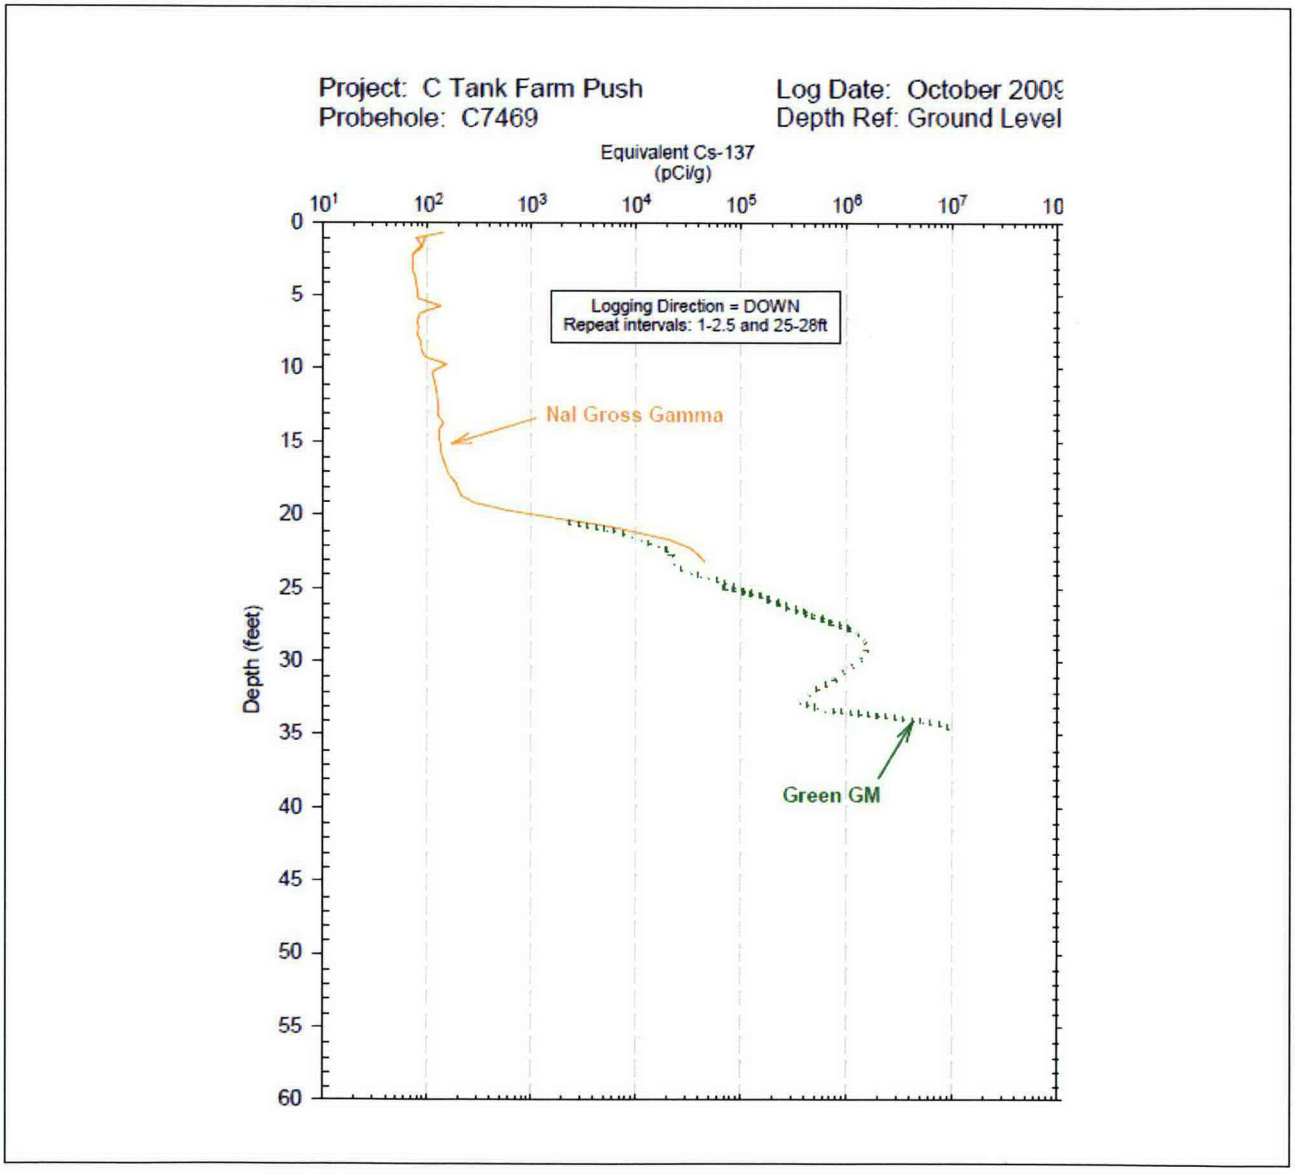
Logging was started with a sodium iodide detector until high count rates from soil contamination saturated it at about 23.5-ft bgs. A lower sensitivity "Green – GM detector was used to complete the log of the lower portion of the direct push.

Log data show the presence of increased soil contamination at the depth of the inlet cascade line indicating tank waste had leaked through the sidewall penetration. Soil contamination continued to increase below the penetration, reaching a peak concentration of ~ 1 x 10^6 pCi/g at about 28-ft bgs before starting to decrease. The concentration at 28-ft bgs is similar to the concentration reported beneath the spare inlet penetrations during the 1967 excavation for line V-103.

The increase in soil contamination with depth is contrary to expectations – typically the highest soil contamination would be found adjacent to a leak site, and would decrease with distance. It is possible that the contrary behavior of the inlet cascade penetration leak plume resulted from limited soil compaction at the inside corners formed between the cascade line buttress and the tank sidewall described in Section 4.1. The waste plume would move down through the loosely compacted soil column in the inside corner toward the tank footing. Lateral movement of the plume away from the inside corner would be restrained because of the higher compaction forces that had been applied to the backfill outside of the immediate area.

Below the 28-ft bgs peak, the soil contamination continued to decrease with depth before rising again in a second, much more intense contamination peak at the base of the tank. The peak indicates that either the inlet cascade line penetration leak accumulated at the tank base, or else a second waste source is present at this depth.

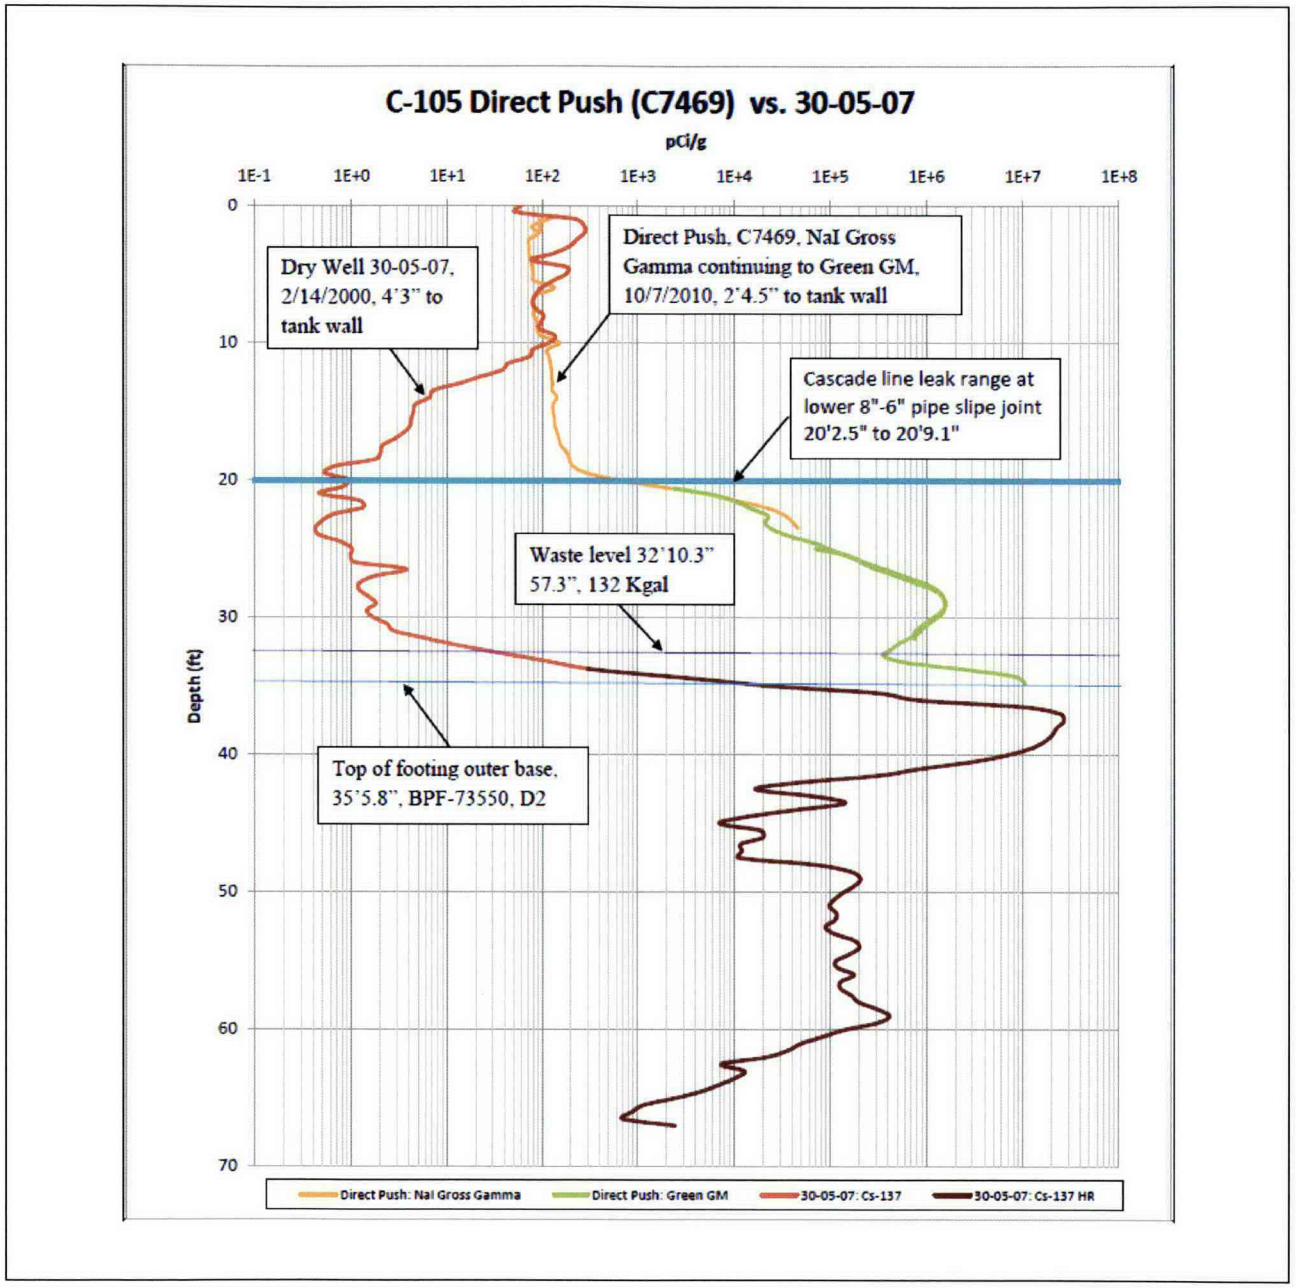
**Figure 5-2 Direct Push C7469 and Drywell 30-05-07
Soil Contamination Profiles Comparison**

Figure 5-2 combines the logs from drywell 30-05-07 and Direct Push C7469. Drywell 30-05-07 is located 7.71-ft from the sidewall exit of the inlet cascade line penetration, and 4.25-ft from the tank sidewall – roughly twice the distance from the features as C7469. The drywell 30-05-07 log shows no evidence of the inlet cascade line penetration leak detected by C7469. At the top of the tank footing, drywell 30-05-07 logged soil contamination of ~ 1 x 10^4 pCi/g; at this same depth C7469 recorded ~ 1 x 10^7 pCi/g, an attenuation factor of 1000x over a horizontal distance of 3.9-ft.

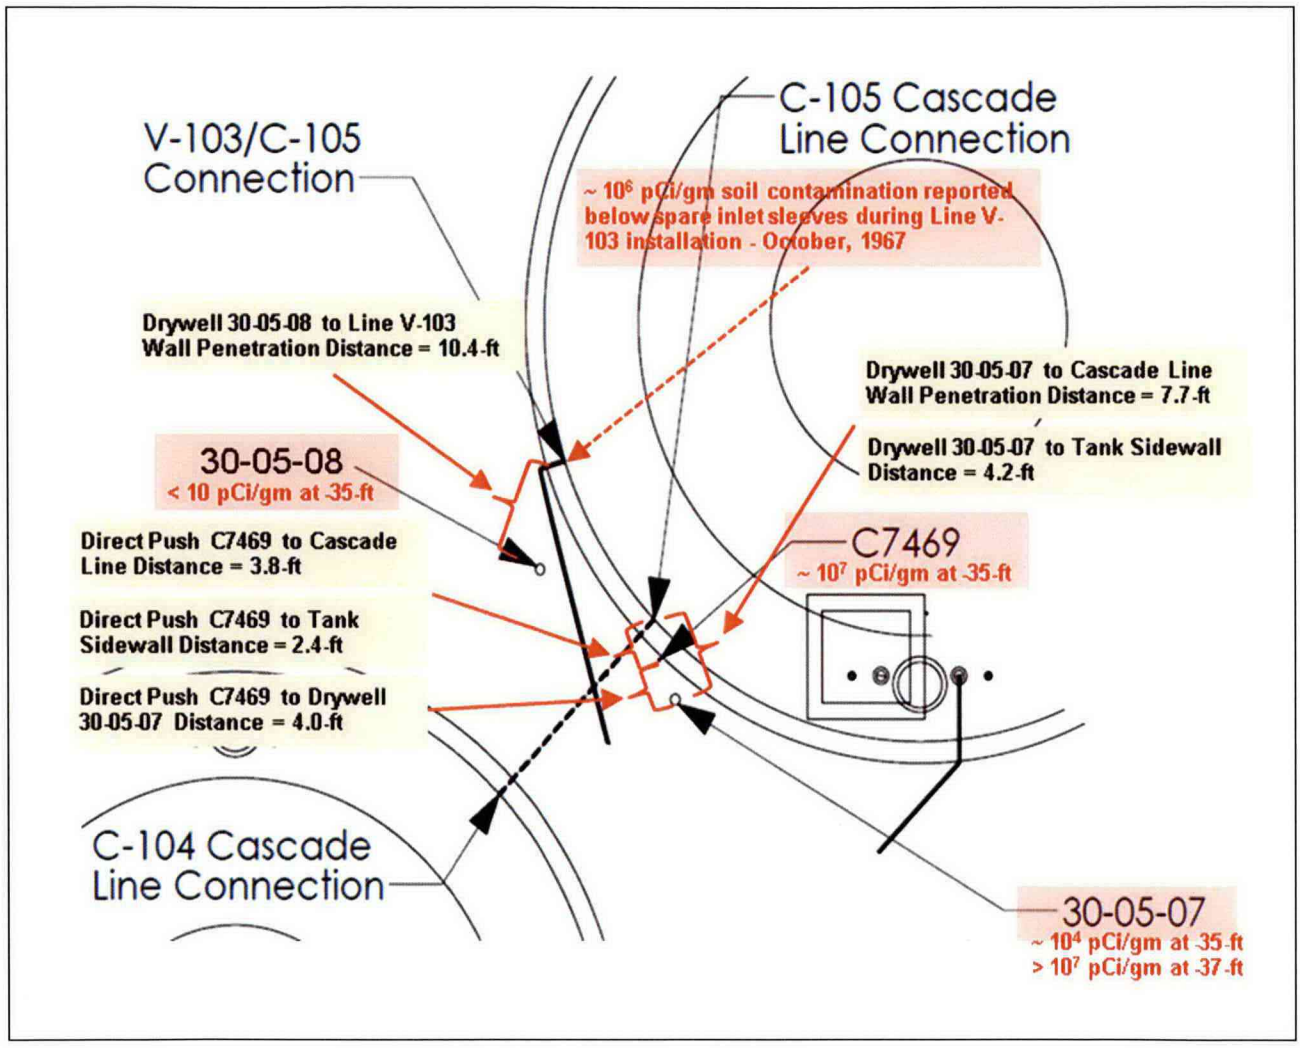
Figure 7-1 Tank Features and Separation Distances

In 1974 when drywell 30-05-08 was drilled 10.4-ft from the closest spare inlet penetration, no significant soil contamination was detected from grade to well below the tank base. Regardless of how deep the Line V-103 excavation was, a leak plume remnant should still have been evident over at least part of the 15-ft vertical distance from the spare inlet penetrations down to the top of the tank footing if the overflow was very large.

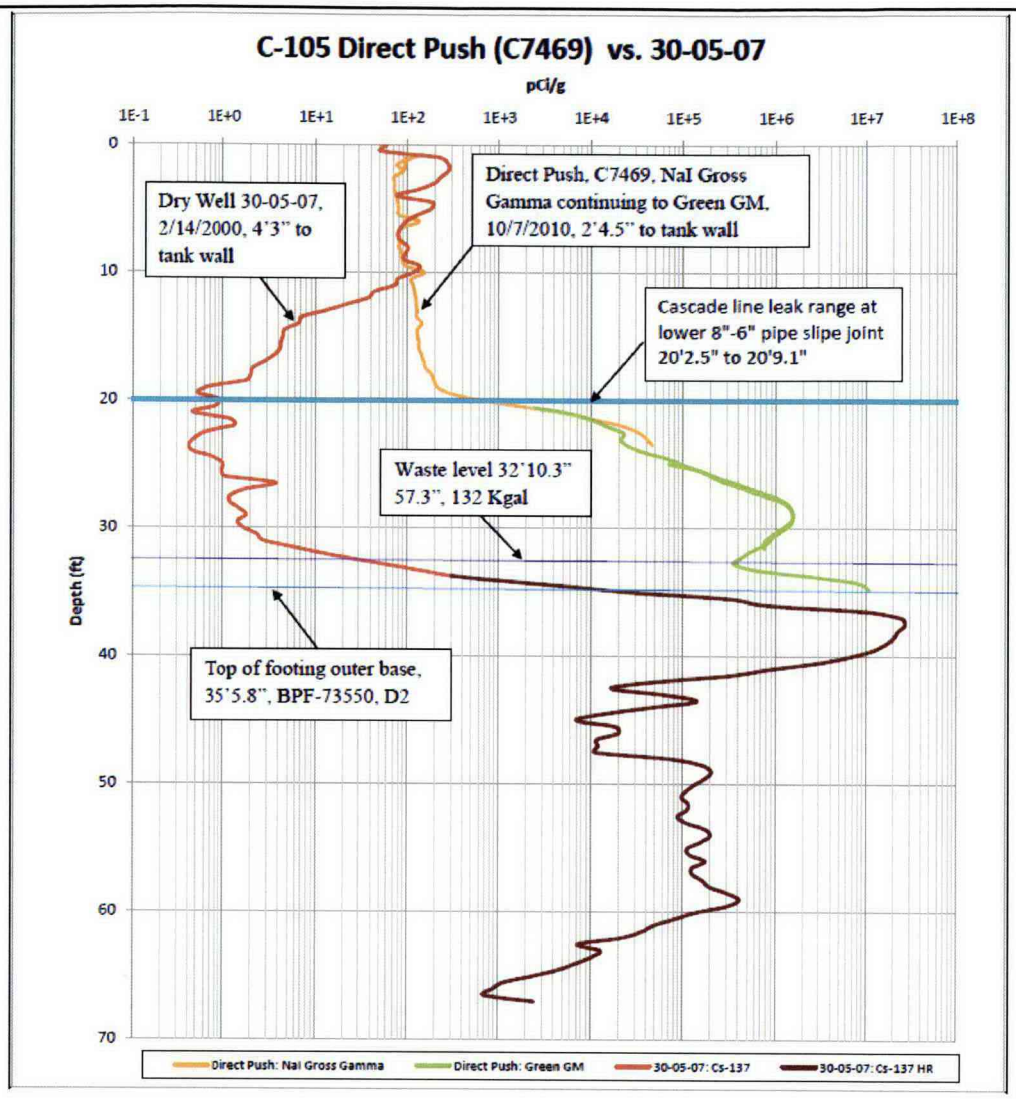
**Figure C-2. Summary of Interpreted Data Set for the BX Tank Farm** The tank C-105 combined drywell 30-05-07 with C7469 indicated on the following graph shows the 30-05-07 drywell as increasing contamination with increasing depth, the opposite of the tank BX-102 21-02-04 drywell. One of the 30-05-07 drywell interpretations has been a pooling of the waste at the foundation of the tank and lateral migration to the drywell. Another interpretation could be that the smaller tank C-105 leak required more depth (10 - 12-feet) to reach the 30-05-07 drywell 4-feet 3-inches from the tank wall.

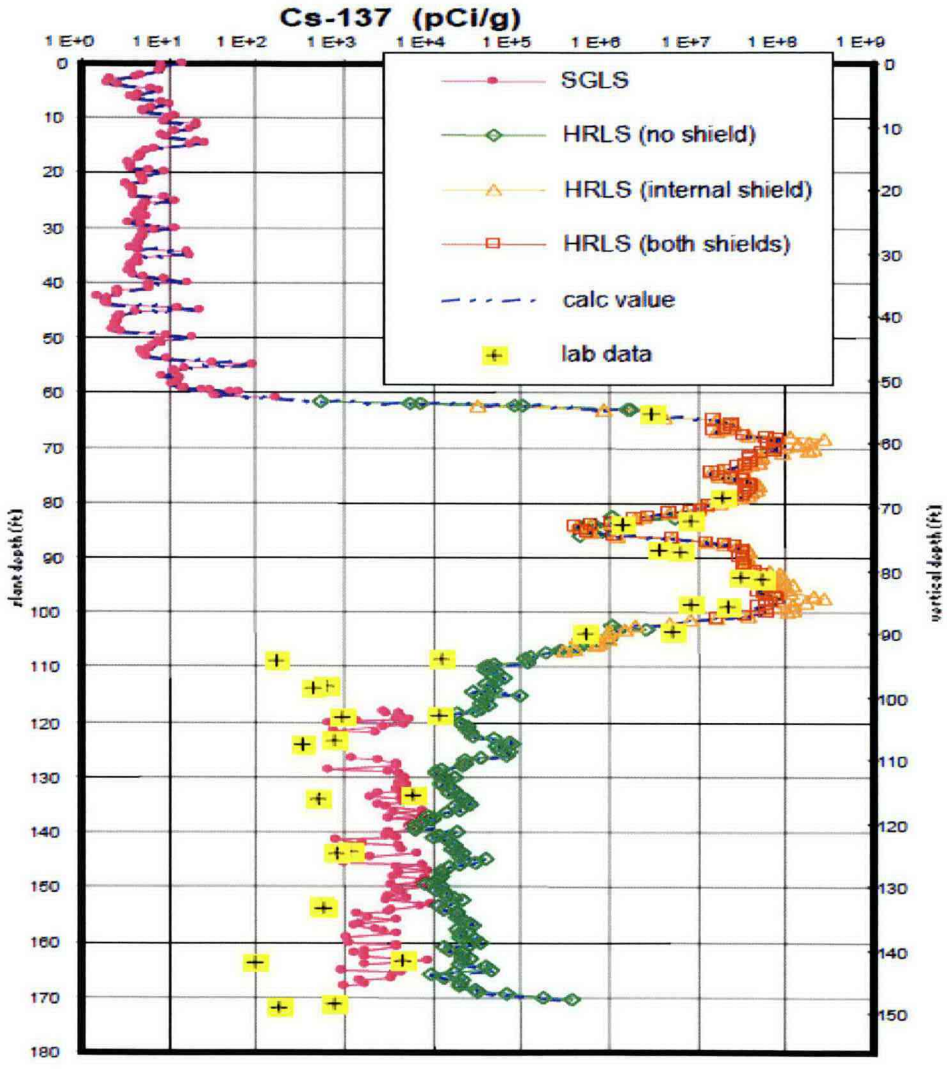
4.	J. G. Field	Review tank SX-108 double peak drywell for possible comparison with tank C-105, C7469 direct push. *Status:* Complete. The tank SX-108 drywell log/sample data is shown on the following graph:

This shows an example where there is both logging and sample data and that the two are similar. SX-108 was a bottom leaker. Past estimates were 35,000 gal. With cooling water it could have been 50-100,000 gal. This spread out across several dry wells and laterals (considerable lateral movement, see figures after this table). This is a different situation than is present for tank C-105.
