RPP-ASMT-46452
Revision 0

Tank 241-C-105
Leak Assessment Completion Report

Washington River Protection Solutions LLC

Date Published
May, 2010

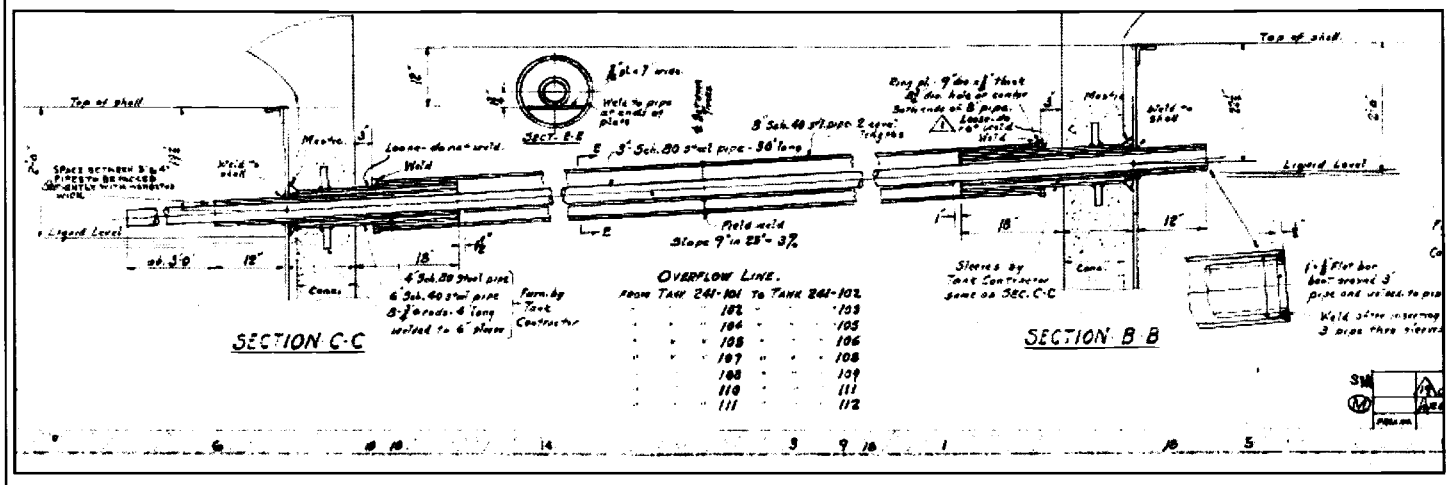
(Tank 241-C-105 Spare Inlet Nozzle Cap (Drawing H-W-72743 *Hanford Engineer Works - BLD.#241 75'6" Dia. Storage Tanks T-U-B & C Arrangement*)

A possible cascade line/tank interface leak would follow a path through the asbestos wick packing between the 3-inch inner pipe and a 4-inch pipe sleeve and then out the 8-inch to 6-inch pipe slip joint located 3-inches from the tank wall.

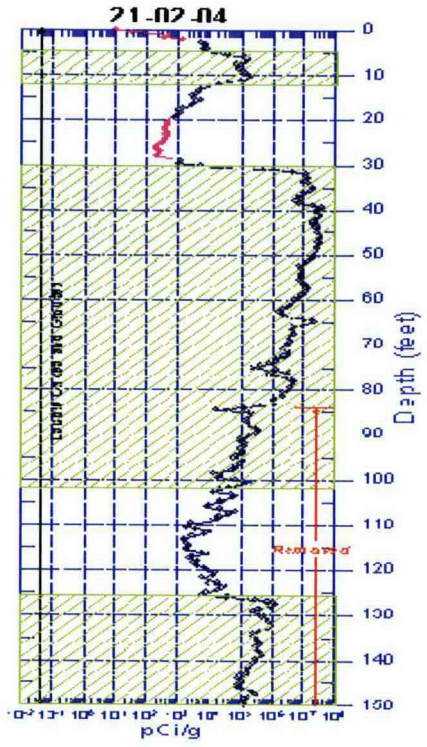
2.	J. G. Field	Compare tank C-105 and BX-102 drywell logs for similarities/differences in the cascade line and spare inlet line overfill effects. *Status:* Complete. Updated dimensions. The tank BX-102 drywell 21-02-04 is located 5.2-ft from the tank wall on the southeast side of tank BX-102 and about 8.7-ft from the middle of the four spare inlet lines. The spare inlets are spaced 2-ft apart. **Tank BX-102 Drywell**

The spare inlet lines are at an elevation of 632.33 which is a depth of 23.22-ft bgs. The above plot appears to have started increasing ~4.5-ft below the depth of the spare inlet lines to a peak at ~31.5-ft and gradually decreased with increasing depth. The leak volume was 90,000-gallons or more as opposed to between 40 and 2,000-gallons for the tank C-105 leak.

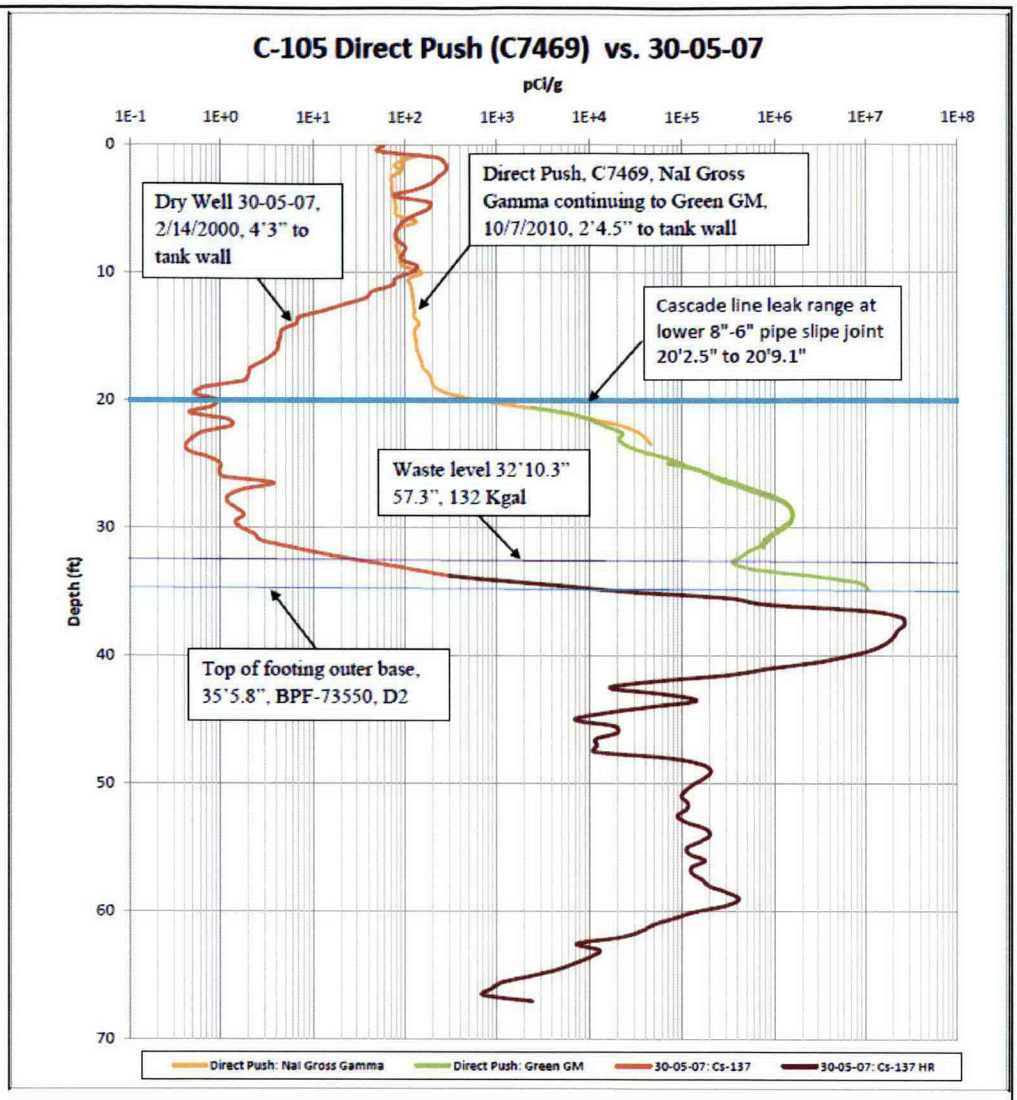
The tank C-105 combined drywell 30-05-07 with C7469 logs indicated on the following graph shows the 30-05-07 drywell as increasing contamination with increasing depth, the opposite of the tank BX-102, 21-02-04 drywell. One of the 30-05-07 drywell interpretations has been a pooling of the waste at the foundation of the tank and lateral migration to the drywell. Another interpretation could be that the smaller tank C-105 leak required more depth (10 - 12-feet) to reach the 30-05-07 drywell 4-feet 3-inches from the tank wall.

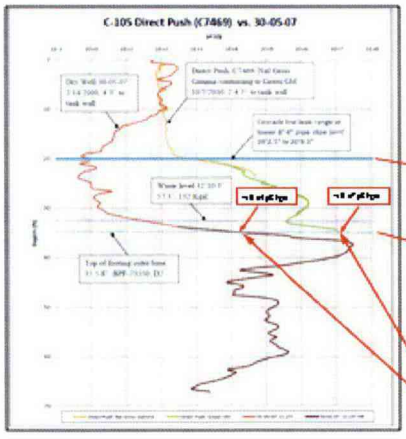
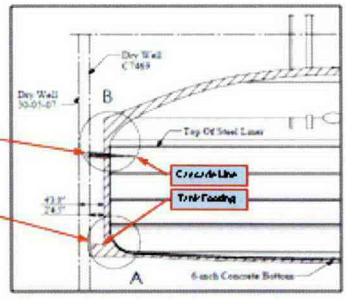
Comparison of C7469 Direct Push and Drywell 30-05-07 Logs with Tank Features

- Cascade line leak plume evident in Direct Push C7469 3.8-ft from line
  - Plume did not spread laterally to Drywell 30-05-07 located 7.7-ft from line
  - ~1000x plume attenuation over 4-ft separation between C7469 and 30-05-07 at depth of tank footing
- By 1974 plume had moved laterally and vertically below tank footing

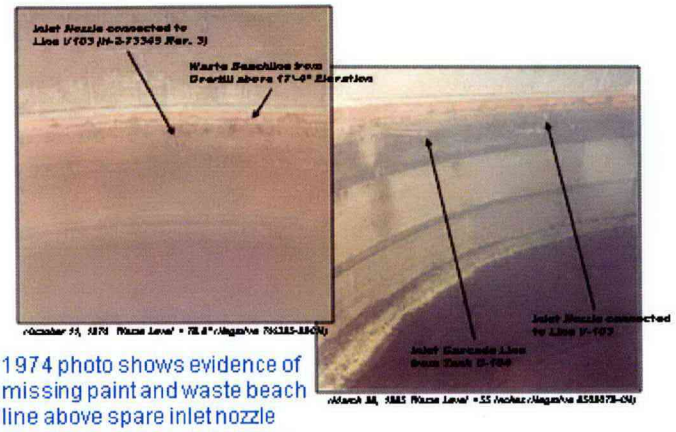
In-Tank Evidence of Overfill

1974 photo shows evidence of missing paint and waste beach line above spare inlet nozzle elevation which is higher than cascade line

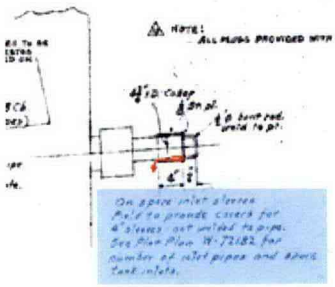
Sidewall Sleeve Leak Path from Overfill

- The 4-3/4" ID x 4" nozzle cover is fit over the 4" Sch. 80 pipe sleeve and not welded in place
- The OD of 4" Sch. 80 pipe is 4-1/2", so the annular gap between the nozzle cover and the pipe sleeve would be about 1/8"
- Pipe sleeve terminates 18" from tank wall

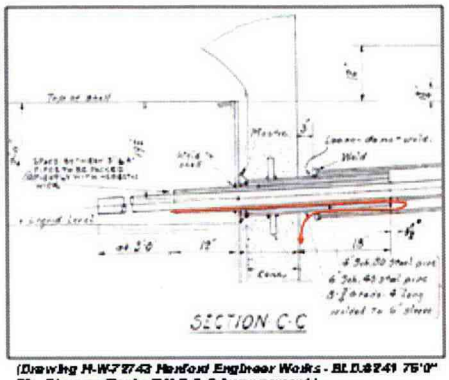
Leak path through 43-in long asbestos wick- packed 3/16-in annular gap between 3-in cascade line and 4-in pipe sleeve and then out the 8-in to 6-in pipe slip joint located 3-in from the tank wall.

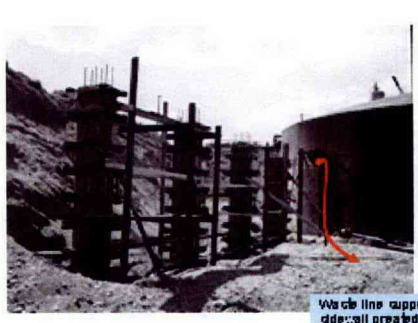
Cascade Line Leak Path via Uncompacted Soil Column to Tank Base

Viaducts were extended to sidewall sleeves in the first tank of the 3-tank cascades. Tank C-104 has a viaduct; tank C-105 does not.

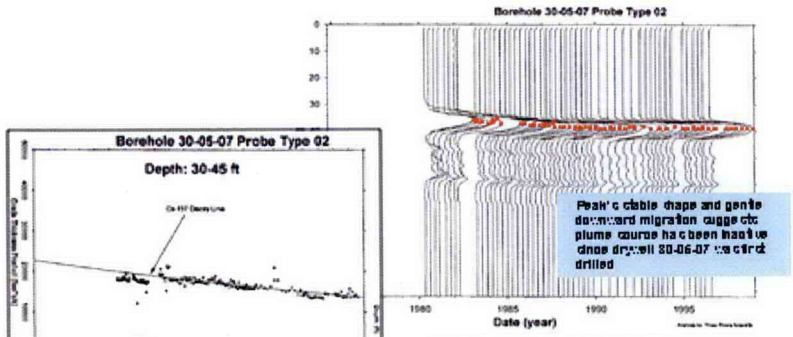
Drywell 30-05-07 Peak Stability

- Peak at the base of tank C-105 was found when Drywell 30-05-07 first drilled in 1974
- Between 1974 and latest 2004 log, peak has been stable
- If the peak represents a liner leak, the leak occurred earlier than 1974, and had self-sealed by the time the drywell was drilled

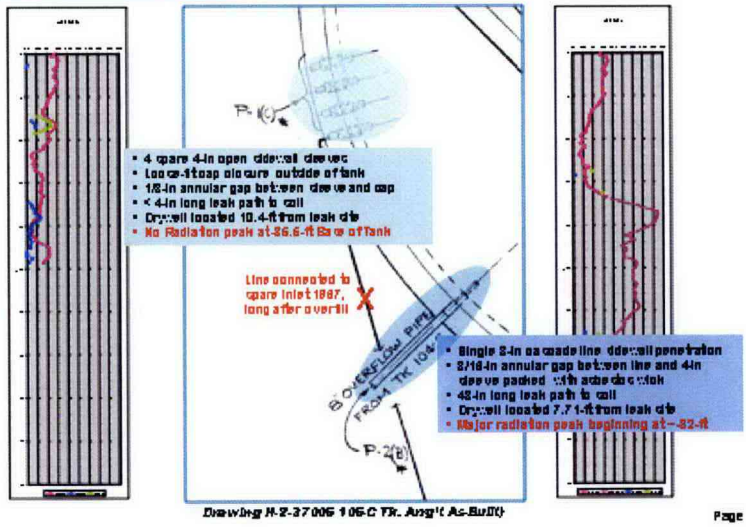
Drawing H-2-37005 105-C Tk. Assy't As-Built

- Regardless of the duration of the overfill, the leak volume through gaps between the 4 sidewall sleeves and their loose-fitting caps (7.26-in^2 total cross-section) should have been greater than the leak volume through the long asbestos-packed gap (1.88-in^2 cross-section) in the cascade line sleeve.
- It follows that a peak at the base of the tank below the spare sidewall sleeves should also be much greater than a peak at the base of the tank beneath the cascade line penetration if the source was an overfill.

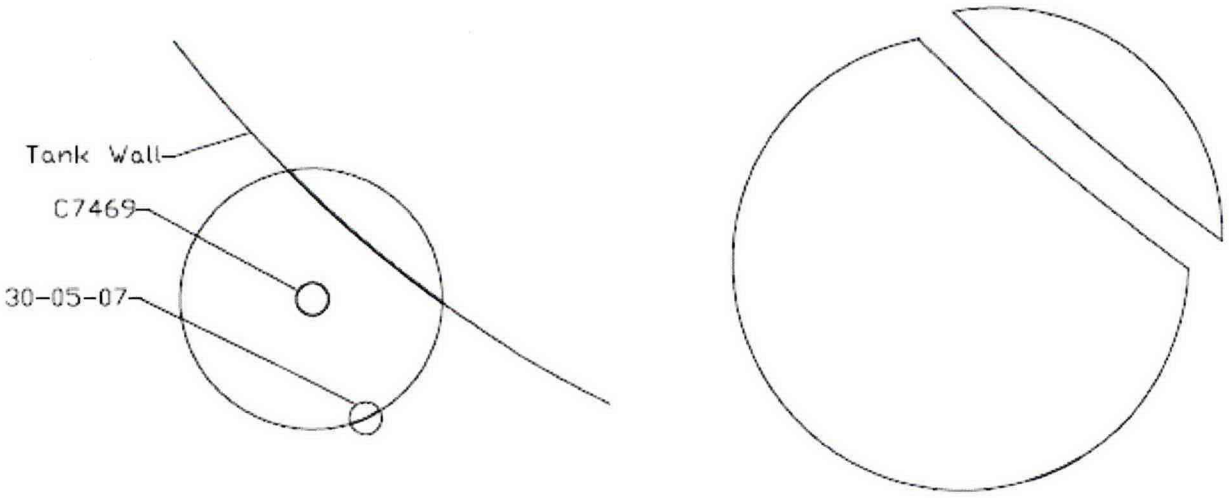
Figure D-2 Minimum Leak Volume Estimate Plume Shape

1. For a minimum leak volume, a 14-ft long cylinder, with a point source leak and a 4-ft radius is assumed. The length of the cylinder is provided by the length of the plume, from 21 to 35-ft bsg, and the radius is estimated as the distance from the direct push to the nearest drywell which did not see any activity, drywell 30-05-07. This radius actually intersects the tank, so the cylinder has a lens-shaped section removed, as shown in Figure D-2.

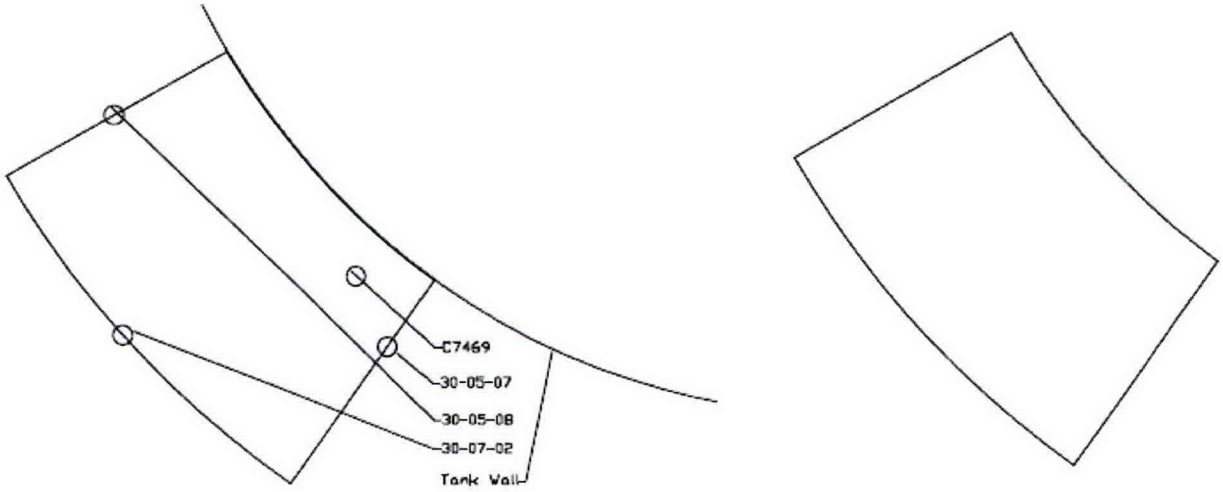
Figure D-3 Maximum Leak Volume Estimate Plume Shape

2. For a maximum leak volume, a more complicated plume shape was assumed. Theoretically, a plume could have travelled "above" the push, "below" the push, and away from the tank. This section is bounded below by drywell 30-05-07, above by drywell 30-05-08, and out by drywell 30-04-02. This shape is depicted in Figure D-3. The plume then extends down 14-ft, as with the minimum estimate.

This shape has outer radius, R_2, of 50.47-ft, and inner radius, R_1, of 37.5-ft. To determine the fraction of the total circle, the central angle of the triangle formed by the center of the tank, drywell 30-05-08, and drywell 30-05-07 was used. This triangle had lengths 44.15-ft, 41.75-ft, and base 18.43-ft. Using the law of cosines, the central angle was found and divided by 360 to determine the fraction of the total circle:

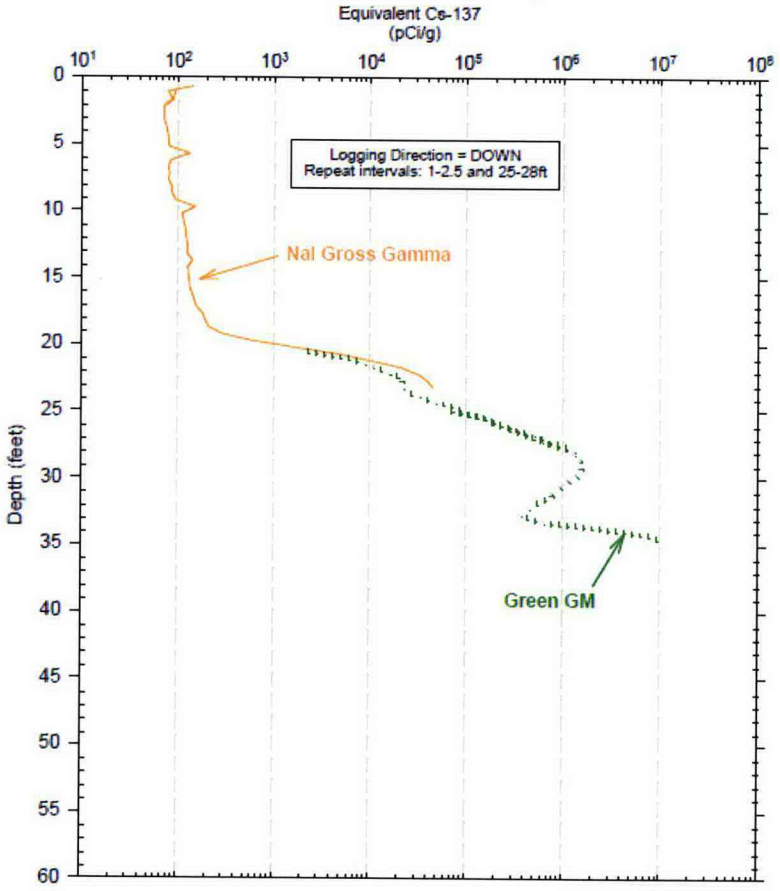
Project: C Tank Farm Push
Probehole: C7469

- Based on review of the log data from the C7469 direct push, the team concluded that a leak from tank C-105 could not be ruled out by the available evidence
  - The leak through the cascade line wall sleeve likely contributed to the peak at the base of the tank, but extent is uncertain
  - Additional direct pushes are unlikely to help further discriminate among possible leak sources
- Recommendation:

"Change tank C-105 leak integrity status from "Sound" to "Assumed Leaker" with estimated leak volume < 2,000 gallons."
