Technical Memo

Project 0-6132: Task 6 – Test Sections in the Districts

To:	Frank Espinosa, Dale Rand, Stephen Kasberg, & Darlene Goehl Frank.Espinosa@txdot.gov; Dale.Rand@dot.state.tx.us; Stephen.Kasberg@txdot.gov ; Darlene.Goehl@txdot.gov
CC:	Tom Scullion (t-scullion@tamu.edu)
From:	Lubinda F. Walubita
Date:	February 10th , 2011
Subject:	Lab Test, Distress (Crack) Survey, and Construction Reports for the TTI Sections on FM 158 (Brazos County, Bryan District, TX)

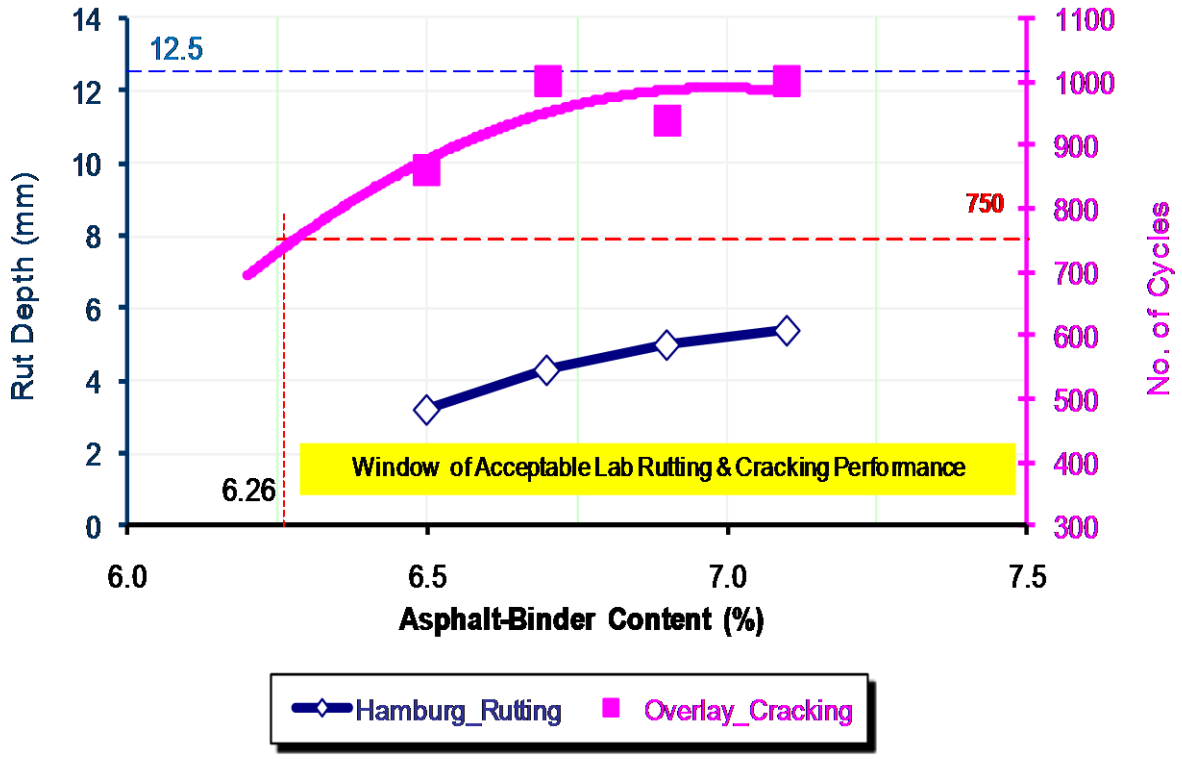
Fig I-2. Hamburg and OT Results for Jebro PG 76-22.

b) Two alternative PG 76-22 asphalt-binders were evaluated, Valero and Jebro, both of which had no problems passing the HWTT and OT requirements.
c) The contractor elected to use the Jebro PG 76-22 asphalt-binder and the Bryan District's Special Specification Item 3131 with the volumetric design requirement (98% density after 50 gyrations); the optimum asphalt-binder content was found to be 7.1%. At this asphalt-binder content, the HWTT rut depth was 5.4 mm after 20,000 passes and 1000 OT cycles.

d) TTI performed performance tests at a lower target density of 96.5% on both asphalt-binders (Valero and Jebro) and found that all criteria were met while using approximately 0.5% less asphalt-binder; i.e., Hamburg < 5.0 mm rutting after 20 000 passes and OT > 750 cycles for 6.5% PG 76-22 Jebro and 6.6% PG 76-22 Valero, respectively.

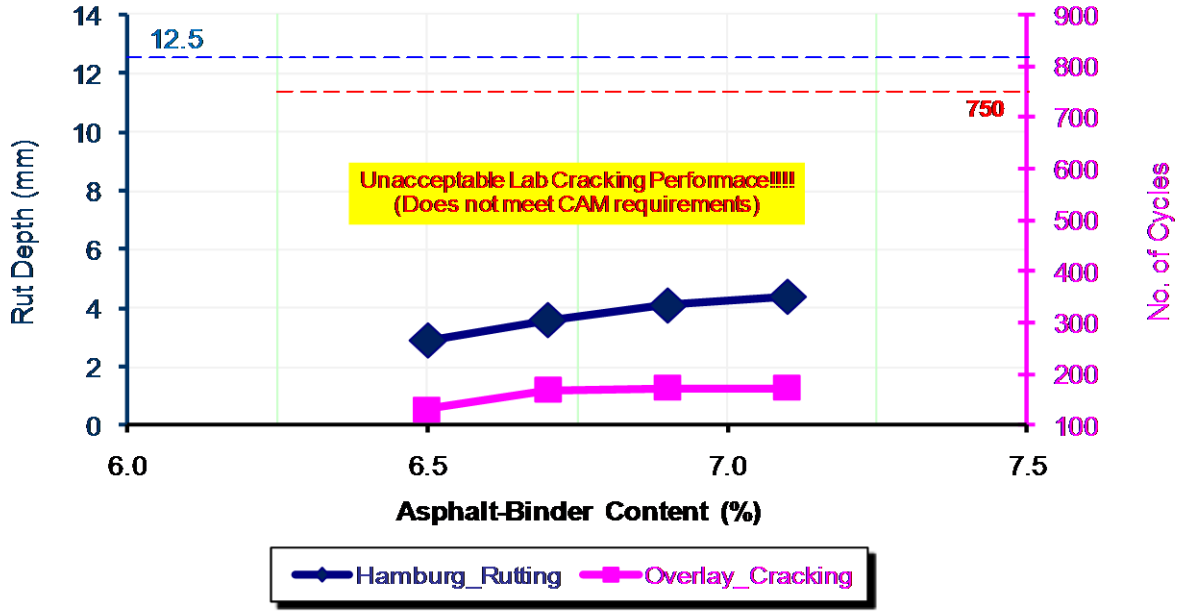
Fig I-4. Hamburg and OT Results for Martin PG 76-22.

a) The cause of the contractors' problem was that the initial asphalt-binder proposed (Martin PG 76-22) actually graded out as a PG 82-22. While having good performance in the HWTT, the mix made with this asphalt-binder could not pass the OT requirements (< 200 cycles).

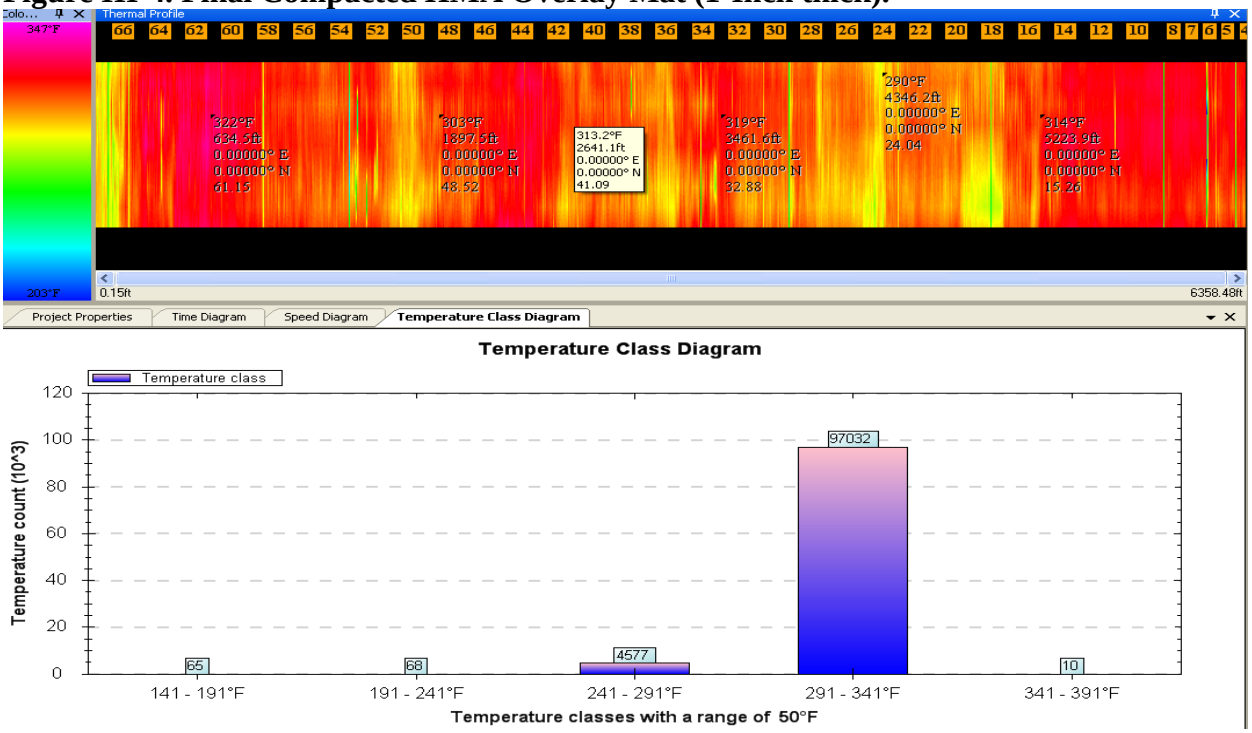
Figure III-5. Example of Infra-Red Thermal Profiles.

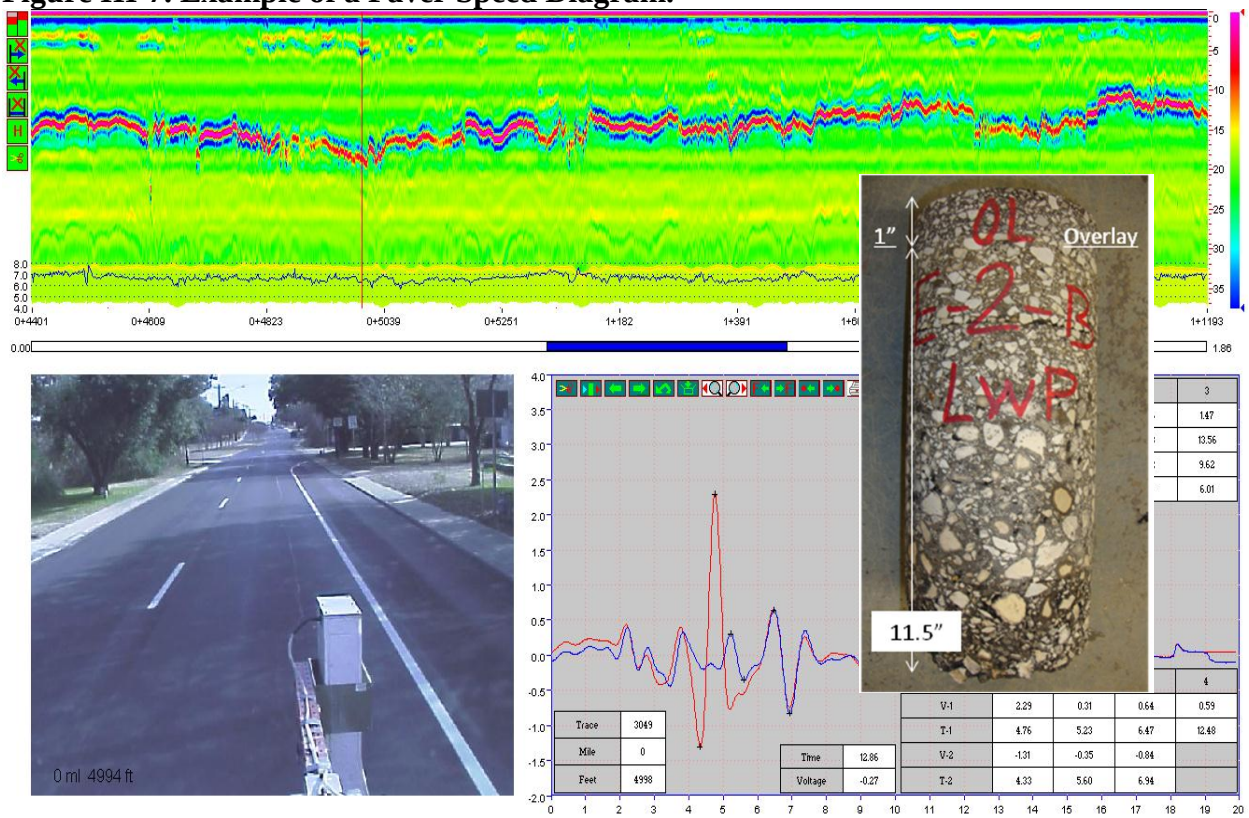
Figure III-8. GPR on EB Outside Lane Just after Construction.

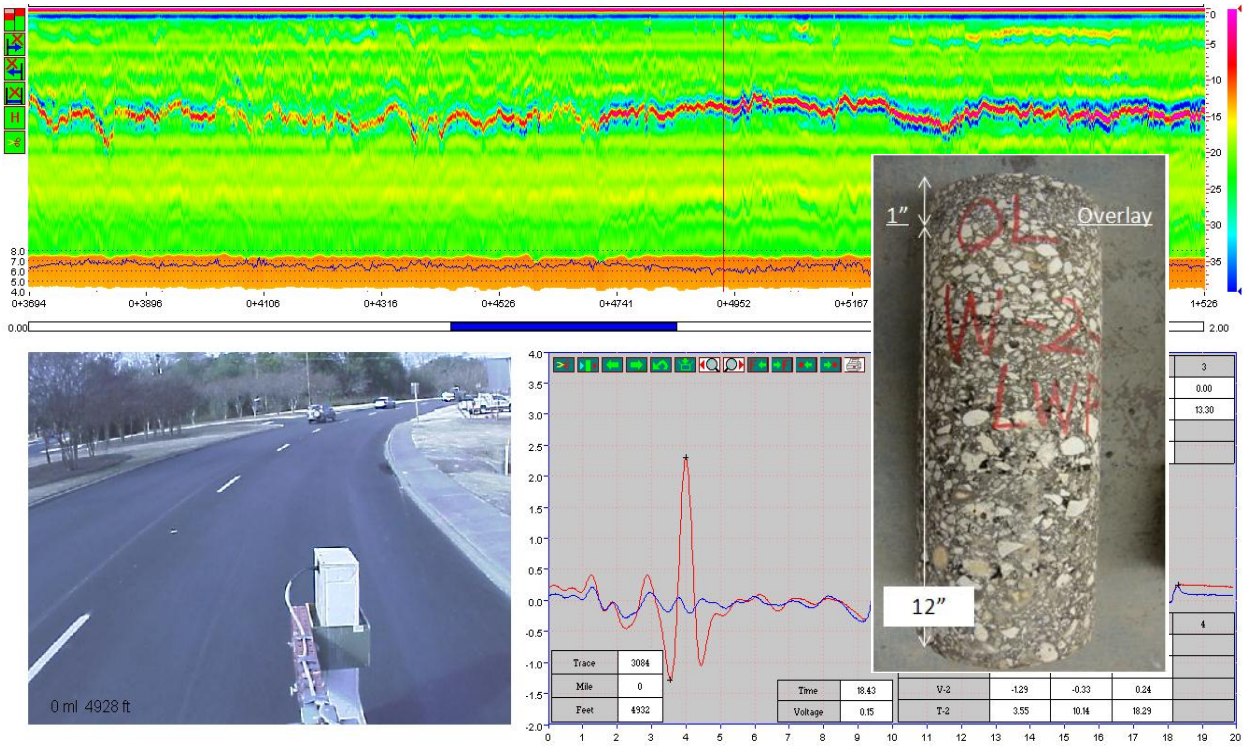
Figure III-9. GPR on WB Outside Lane Just after Construction.

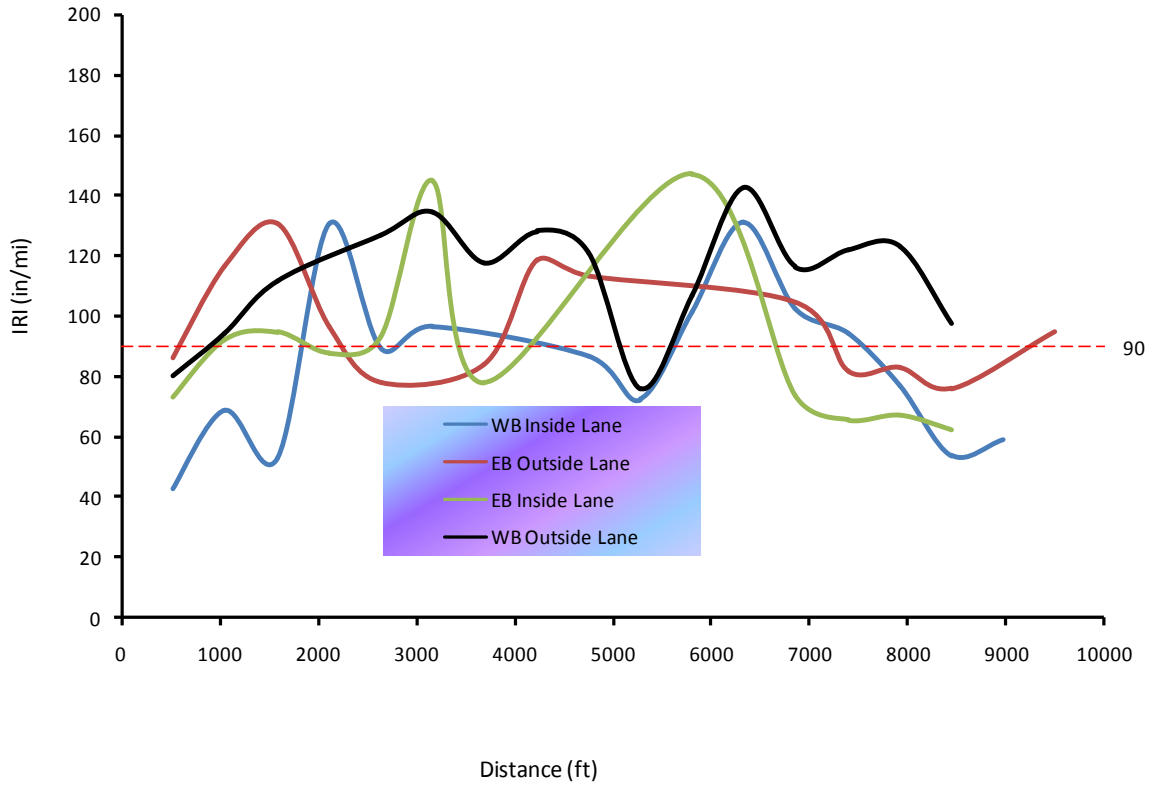
Figure III-10. IRI Plots (Just after Construction, Jan 2011).

i) The ride values on the completed project were a cause for concern. However, it should be noted that this is an urban section with construction occurring under high traffic. The section also has many drainage structures and multiple stop and go intersections.

Note: Looks like it is not easy get good ride in urban sections with all of the drainage and tight curves. Nonetheless, it is a low speed road (35-40 mph).
