SCHEMATIC DESIGN SUBMITTAL

APPROVED : ASSOCIATE DIRECTOR	DRAWING TITLE: EXIST. COND. & MODIFICATIONS
APPROVED : CHIEF OF STAFF	APPROVED : CHIEF, LOGISTICS
APPROVED : ASSOC DIR FOR PATIENT/ NURSING SERVICES	APPROVED : MED CTR SAFETY MANAGER
APPROVED : MEDICAL CENTER DIRECTOR	
APPROVED : STATION ENERGY MANAGER	APPROVED : DIR., INFRASTRUCTURE / APPROVED : INFECTION CONTROL

PROJECT TITLE: VA CAMPUS PARKING AND ROAD UPGRADES

WILLIAM JENNINGS BRYAN DORN V A MEDICAL CENTER COLUMBIA, SOUTH CAROLINA

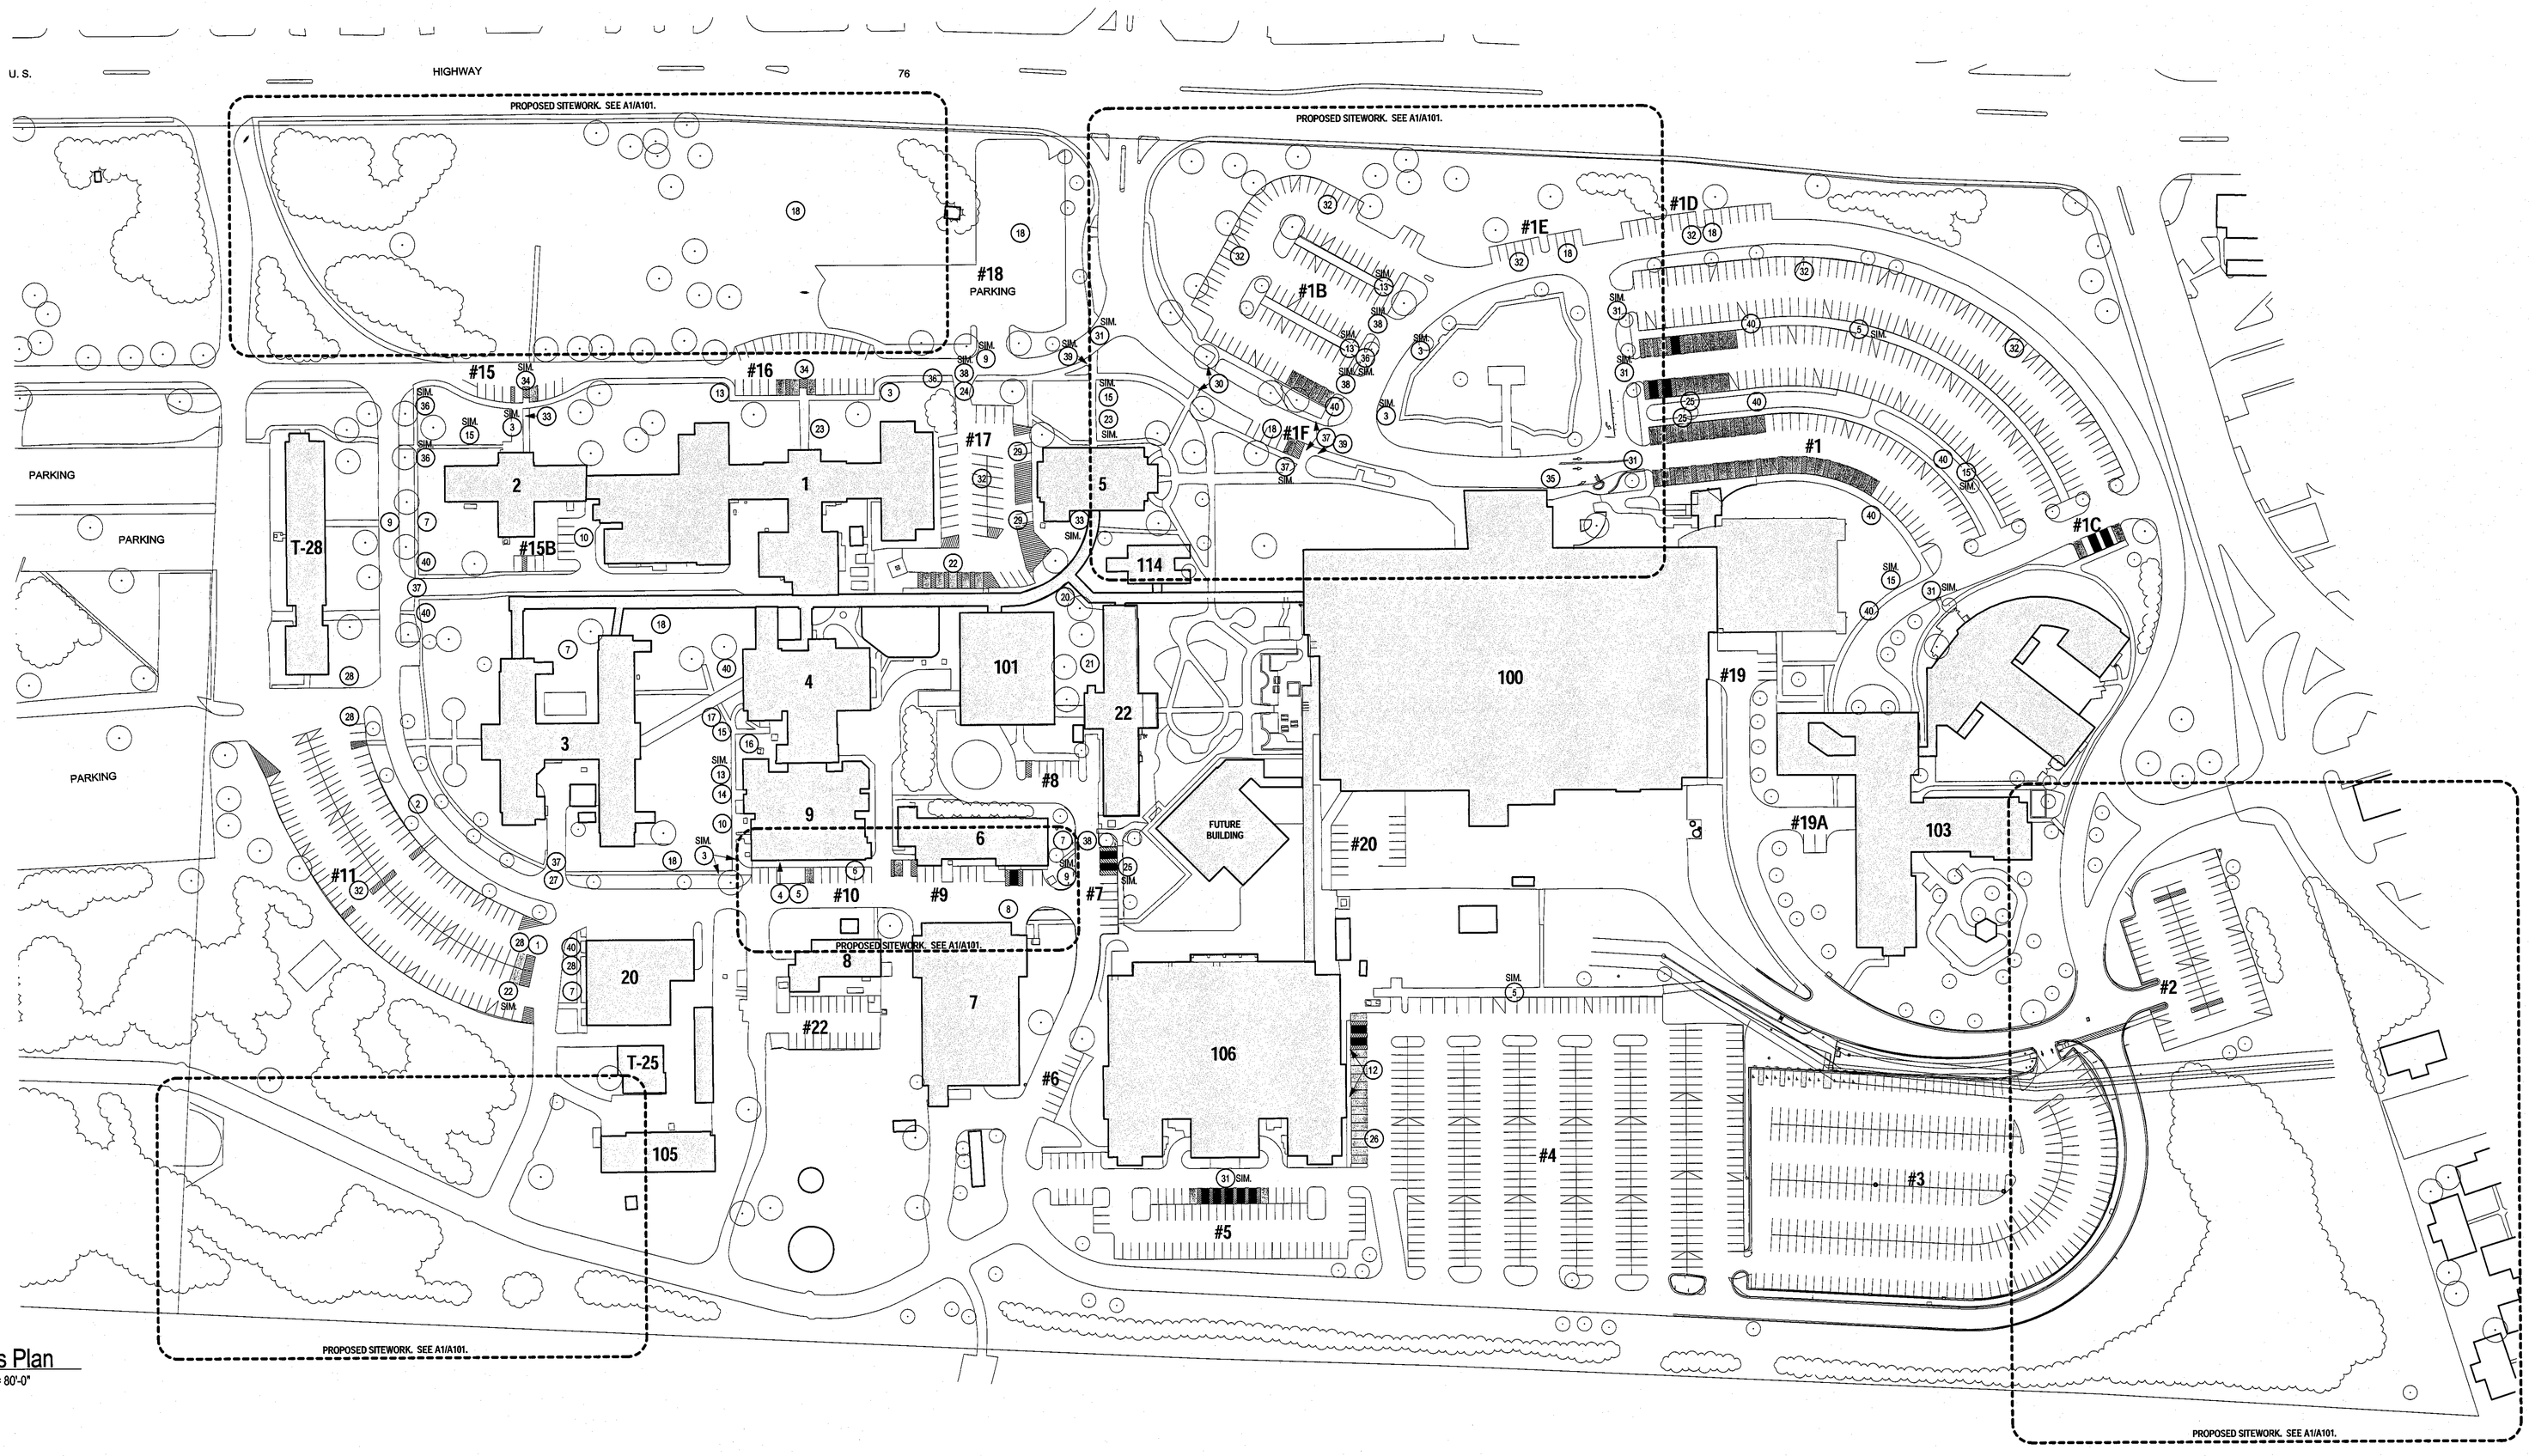
B1 / A100 Campus Plan
SCALE: 1" = 80'-0"

1. CROSSWALK, CURB CUTS AND SLOPE CORRECTIONS REQUIRED TO CREATE ACCESSIBLE ROUTE FROM PARKING IF DESIRED. SEE F1/A201 FOR PHOTO.
2. STEEP GRADE IN THIS AREA PROHIBITS RAMP TO MAKE ACCESSIBLE ROUTE.

3. CRACKS IN SIDEWALK. RECOMMEND REMOVAL AND REPLACEMENT. SEE F2/A201 FOR PHOTO.
4. CRACKS IN CONCRETE. RECOMMEND REMOVAL AND REPLACEMENT. SEE F4/A201 FOR PHOTO.

5. 96" SIDEWALK ABUTTING PARKING. SEE F4/A201 FOR PHOTO.
6. UNEVEN CONCRETE IN PARKING AREA NEEDS TO BE REMOVED AND REPLACED. SEE F5/A201 FOR PHOTO.
7. 48" SIDEWALK. REQUIRED TO BE 60" PER VA SDDM 14.6.E.

8. ASK VA ABOUT LOADING REQUIREMENTS. PARKING LAYOUT MAY NEED ADJUSTING. SEE F6/A201 FOR PHOTO.
9. CURB CUTS REQUIRED TO MAKE AN ACCESSIBLE ROUTE. SEE F8/A201 FOR PHOTO.

10. VERIFY WITH VA WHICH ENTRANCES IN THIS AREA SHOULD BE ACCESSIBLE.
11. NOT USED.
12. 48" SIDEWALK ABUTTING ACCESSIBLE PARKING. 96" REQUIRED PER VA SDDM 14.6.E. SEE D1/A201 FOR PHOTO.

13. UNEVEN CONCRETE NEEDS TO BE REPLACED. SEE D2/A201 FOR PHOTO.
14. LEVEL CHANGE AT ENTRANCE. VA TO ADVISE IF CORRECTING PART OF PROJECT SCOPE. SEE D4/A201 FOR PHOTO.

15. MINOR CRACKS ALONG SIDEWALK. ASK VA IF NEEDS CORRECTING. SEE D5/A201 FOR PHOTO.
16. DEEP CRACKS IN SIDEWALK. RECOMMEND REMOVAL & REPLACEMENT. SEE D6/A201 FOR PHOTO.

17. STEEP GRADE. VA TO ADVISE IF NON-COMPLIANT SIDEWALK SLOPE IS ACCEPTABLE.
18. SURVEY DOESN'T MATCH EXISTING CONDITIONS. ASK VA IF ADDITIONAL SURVEYING IS DESIRED AS A SUPPLEMENTAL AGREEMENT.

19. NOT USED.
20. LARGE CRACK AT ENTRANCE RAMP NEEDS TO BE REPAIRED. SEE D8/A201 FOR PHOTO.
21. RAMP LEADS TO GRAVEL PATH. IS THIS PART OF AN ACCESIBLE ROUTE? SEE B1/A201 FOR PHOTO.

22. HANDICAP PARKING DOES NOT PROVIDE (2) ADJACENT 5' MIN. ACCESS AISLES AS REQUIRED BY VA BFDG 4.6.3. SEE B3/A201 FOR PHOTO.
23. ENTRANCE RAMP APPEARS STEEP. VERIFY THAT SLOPE MEETS ACCESSIBILITY REQUIREMENTS. SEE B4/A201 FOR PHOTO.

24. SLOPE AND CRACKS IN CONCRETE AT PARKING ENTRANCE NEED TO BE REPAIRED OR REPLACED. SEE B5/A201 FOR PHOTO.
25. 76" SIDEWALK ABUTTING ACCESSIBLE PARKING. 96" REQUIRED PER VA SDDM 14-6-E.

26. PARKING LACKS SIDEWALK ACCESS TO BUILDING ENTRANCE.
27. CROSSWALK REQUIRED TO CREATE AN ACCESSIBLE ROUTE.
28. POSSIBLE LOCATION OF ACCESSIBLE PARKING AND ACCESSIBLE ROUTE FROM PARKING.

29. AN ACCESSIBLE ROUTE COULD BE PROVIDED TO ENCLOSED WALKWAY IF PARKING HERE BECOMES PARALLEL. SEE B6/A201 FOR PHOTO.
30. CURB RAMP APPEARS STEEP. 1:12 MAX SLOPE ALLOWED PER ANSI 405.2. SEE B8/A201 FOR PHOTO.

31. APPEARS TO BE AN ACCESSIBLE ROUTE TO PARKING. VERIFY IF CURB CUTS ARE COMPLIANT. SEE A1/A201 FOR PHOTO.
32. NO PEDESTRIAN PATH PROVIDED FOR PARKING. VERIFY IF THIS IS REQUIRED.

33. RAMP HANDRAIL IS NOT COMPLIANT. SEE A2/A201 FOR PHOTO.
34. CURB TRANSITIONS FROM PARKING ARE CRACKED AND NON-COMPLIANT. RECOMMEND REMOVAL AND REPLACEMENT. SEE A4/A201 FOR PHOTO.

35. BUS STOP LOCATION.
36. LEVEL CHANGES IN SIDEWALK GREATER THAN 1/4." 1/4" MAX ELEVATION VARIANCE ALLOWED PER VA STANDARD. RECOMMEND REMOVAL AND REPLACEMENT. SEE A5/A201 FOR PHOTO.

37. CURB RAMP SLOPE APPEARS ACCESSIBLE. SEE A6/A201 FOR PHOTO.
38. CURB RAMPS AND CROSSWALK REQUIRED TO CREATE AN ACCESSIBLE ROUTE. SEE A8/A201 FOR PHOTO.

39. FLARED SIDES OF CURB RAMP APPEAR STEEP. 1:10 MAX SLOPE ALLOWED PER ANSI 406.3. SEE A9/A201 FOR PHOTO.
40. SIDEWALK SLOPE APPEARS STEEP. 1:33 MAX SLOPE ALLOWED PER VA BFDG FOR AN ACCESSIBLE ROUTE.
